COMANDO DA AERONÁUTICA
CENTRO DE INVESTIGAÇÃO E PREVENÇÃO DE
ACIDENTES AERONÁUTICOS

FINAL REPORT
A-091/CENIPA/2019

OCCURRENCE:	ACCIDENT
AIRCRAFT:	PR-MPN
MODEL:	ATR-42-320
DATE:	15JUN2019

This Final Report pertains to the 15 June 2019 accident involving the model ATR-42-320 aircraft of registration marks PR-MPN. The occurrence was typified as “[SCF-NP] System/Component Failure or Malfunction (Non-Powerplant).”

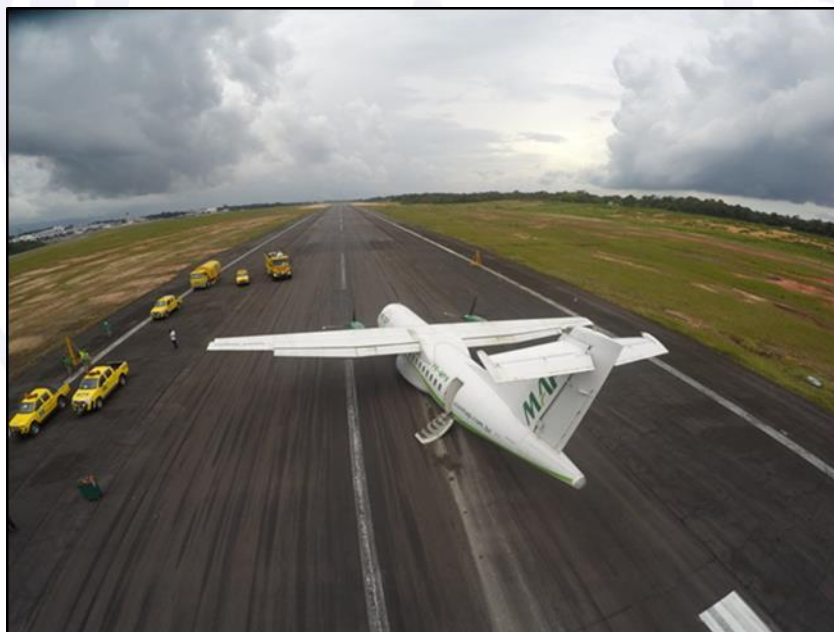
Figure 16 – View of the aircraft after coming to a full stop.

The level of damage to the fuselage, caused by abrasive friction against the asphalt surface, indicated that the aircraft had a high horizontal velocity and a low rate of descent at the moment of impact.

The internal and external wing flaps had a deflection of 30°, consistent with the position required for approach and landing. The propellers did not contact the runway due to the high-wing design of the aircraft.

After the landing, the front and rear doors were opened to expedite the evacuation of passengers and crew.

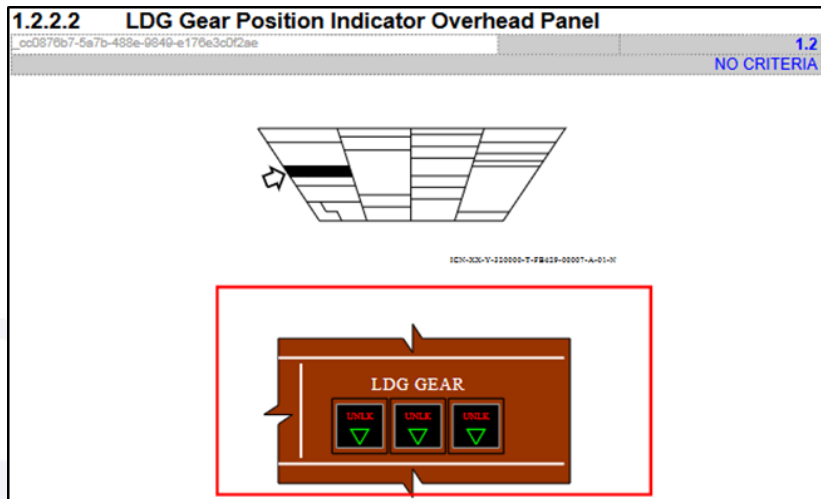
Figure 31 - Location of the landing gear position indicator on the *Overhead Panel*

Also at those interviews, the pilots reported checking the status of the landing gear being locked down using the secondary indication panel located on the *Overhead Panel*. However, during the execution of the *Before Landing Checklist*, the PIC made the callout "*down 3 green*" less than one second after being prompted by the SIC, without referencing verification via the secondary indication system (Figure 31).

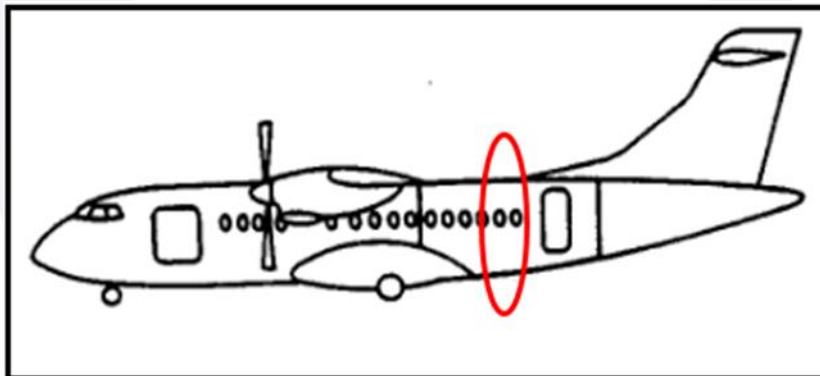
Figure 35 - Approximate location of frame 33.

Following the assessment, the manufacturer issued a report that, in addition to the damage to the landing gear, identified multiple instances of corrosion in structures and panels. Among such instances, the ones below should be noted:

- The central section of the rear fuselage, inside the aircraft, near frame 33, where the stringer 20RH was found to be severely corroded, compromising its structural function at that location (Figures 35 and 36).

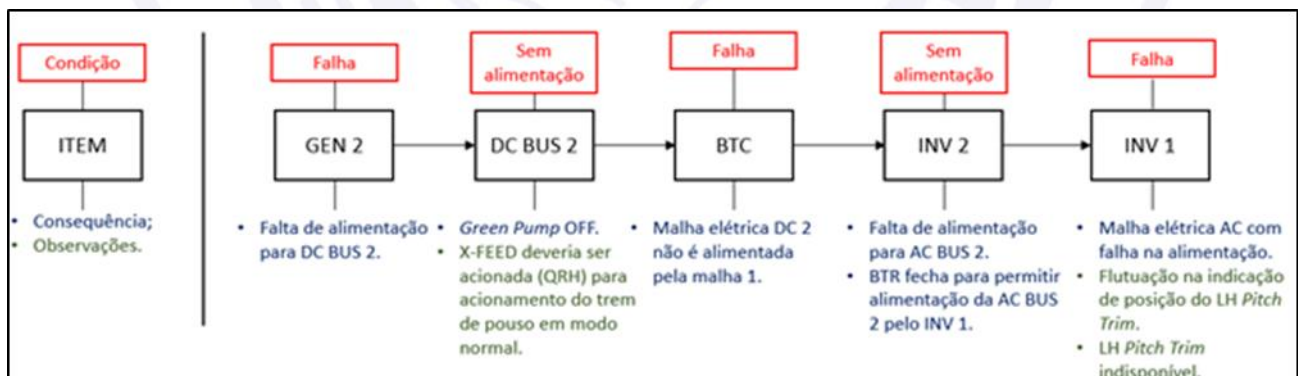
Figure 40 - Block diagram representing the event tree related to the electrical system failures in the PR-MPN aircraft.

The inconsistencies in the left elevator trim tab indications may have caused a synchronization error with the right elevator trim tab indications, resulting in the inoperability of the trim system in both the "*Normal*" and "*Standby*" modes.
