**COMANDO DA AERONÁUTICA**  
**CENTRO DE INVESTIGAÇÃO E PREVENÇÃO DE**  
**ACIDENTES AERONÁUTICOS**

**FINAL REPORT**  
**A-116/CENIPA/2024**

**PS-VPB**

**ATR-72-212A (500)**

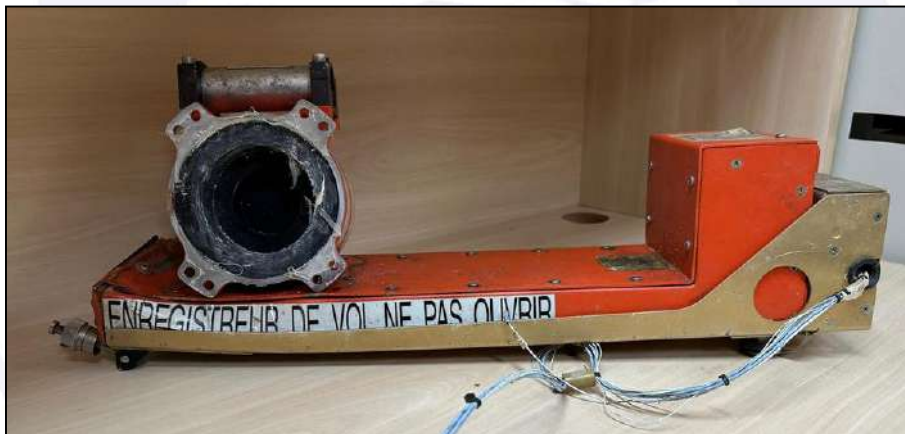
Figure 47 – FDR of the PS-VPB aircraft.

ANAC had granted a temporary exemption, through Decision No. 600, dated 01 MAR 2023, allowing the operator to operate the ATR-72-212A (ATR-72-500) model without recording eight flight data parameters in the FDR, establishing an exception to the requirements of Section 121.344 of RBAC 121 for a defined period of 18 months.

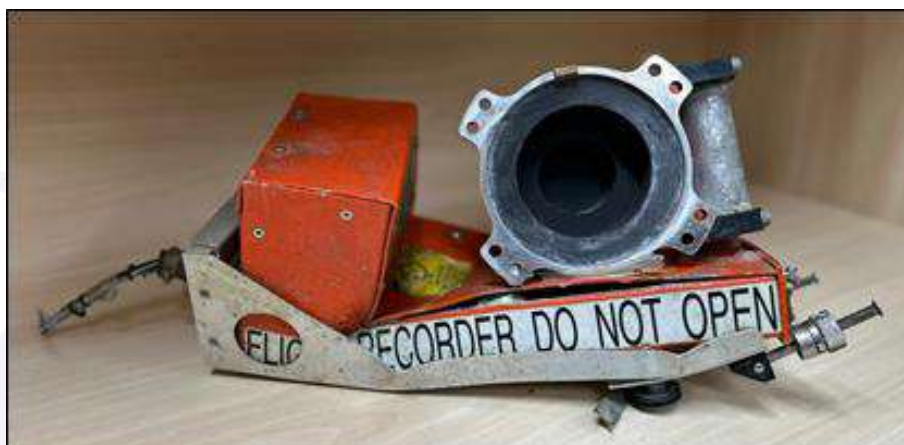
Figure 48 – CVR of the PS-VPB aircraft.

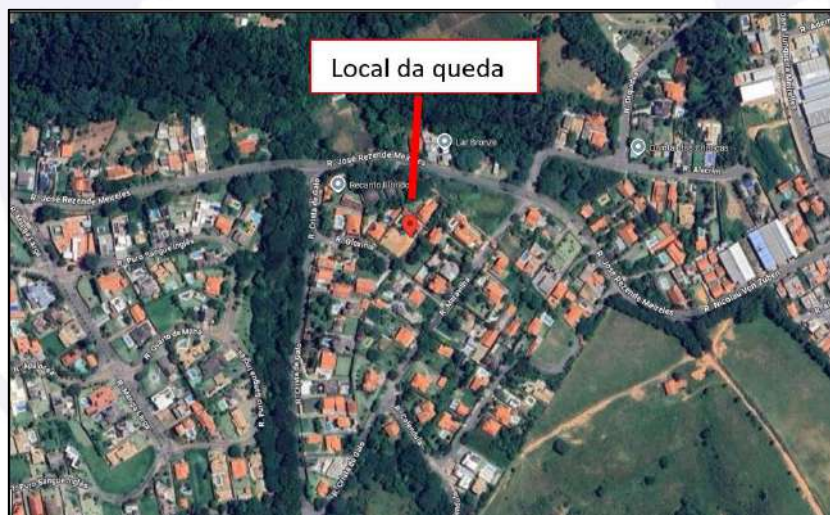
The aircraft impacted the ground in a residential area in the municipality of Vinhedo, São Paulo State.

Figure 50 – Accident site within the residential area.

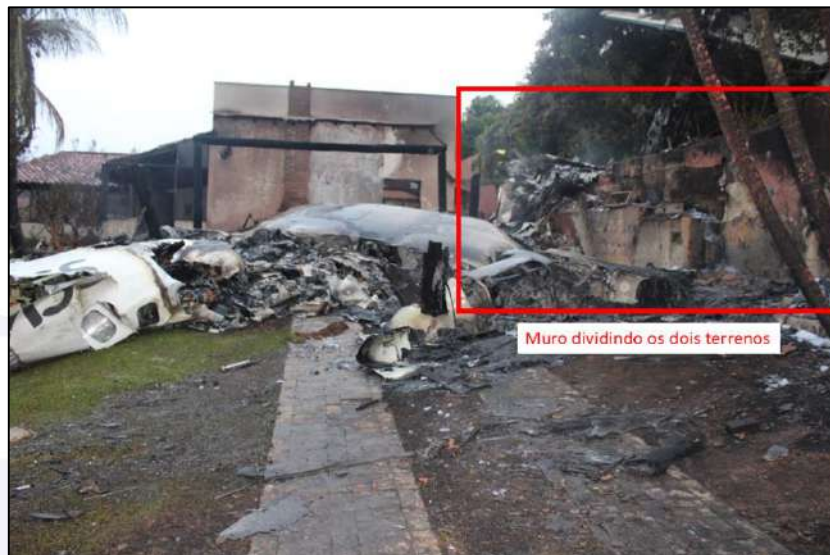
The aircraft impacted the ground with high vertical speed and low horizontal speed, resulting in a compact wreckage distribution within an area approximately 30 meters in diameter.

Part of the tail cone separated from the rest of the aircraft at the moment of impact due to the presence of a wall dividing two plots of land with an elevation difference of approximately two meters between them. The remainder of the aircraft came to rest on the lower portion of the terrain.

Figure 51 – Approximate view of the accident site.

At the moment of impact, the radome was projected forward, striking a wall approximately 30 meters from the accident site. The right wingtip was severed upon impact with a tree and was projected ahead of the location where the remainder of the wing came to rest. The engines remained in their original positions. No evidence of in-flight structural separation was found.

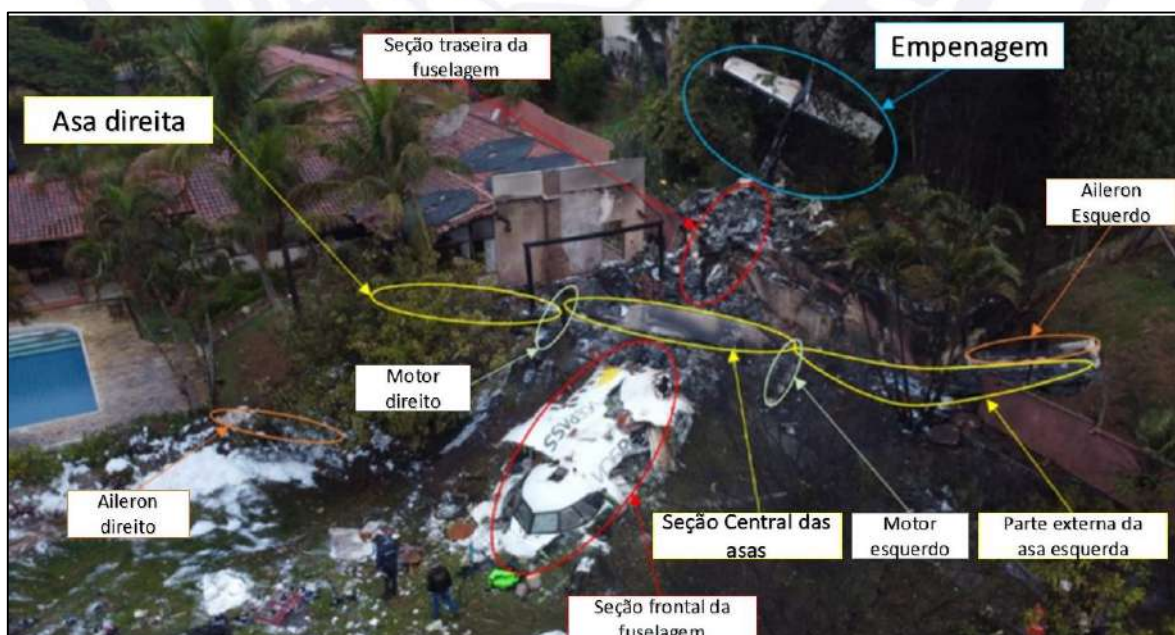
The fire suppression efforts were carried out by the *São Paulo* State Military Fire Department (CBMSP - *Corpo de Bombeiros Militar do Estado de São Paulo*); however, due to the difficulty in controlling the fire, a large portion of the aircraft was consumed by the flames.

The degree of destruction and carbonization hindered the examination of certain parts and systems of the aircraft. Figure 52 shows the main components of the airplane and their post-fire locations.

Figure 52 – Illustration showing the location of aircraft components after the impact.

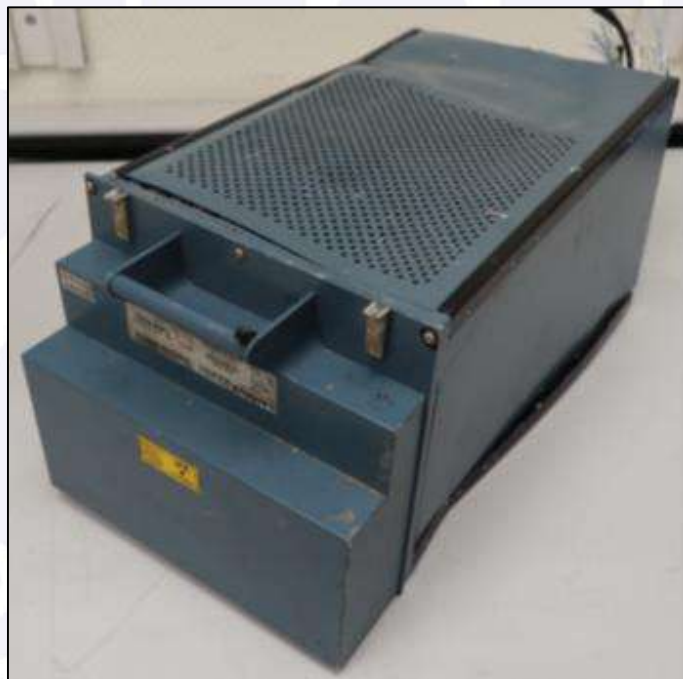
The BITE data memories from modules A and B of MFC1 (MFC1A and MFC1B) and from module A of MFC2 (MFC2A) were recovered from the damaged computers. However, the memory from module B of MFC2 (MFC2B) was not located. The decoding software provided by Airbus Avionics assisted the SIPAER Investigation Commission in reading and analyzing the recovered memories.

Figure 56 – General condition of the MFC1 prior to disassembly.

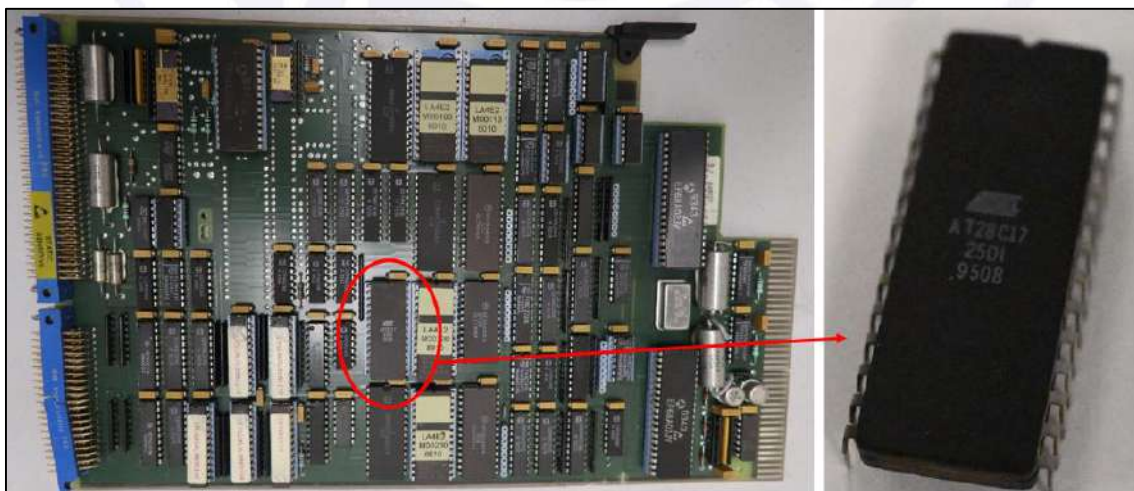
The MFC1A board was removed, and it was verified that the memory component remained attached to it (Figure 57). The data readout was successfully completed, generating files with complete and consistent data (Figure 58).

Figure 57 – MFC1A board with the memory component highlighted in red; on the right, a detail of the component.

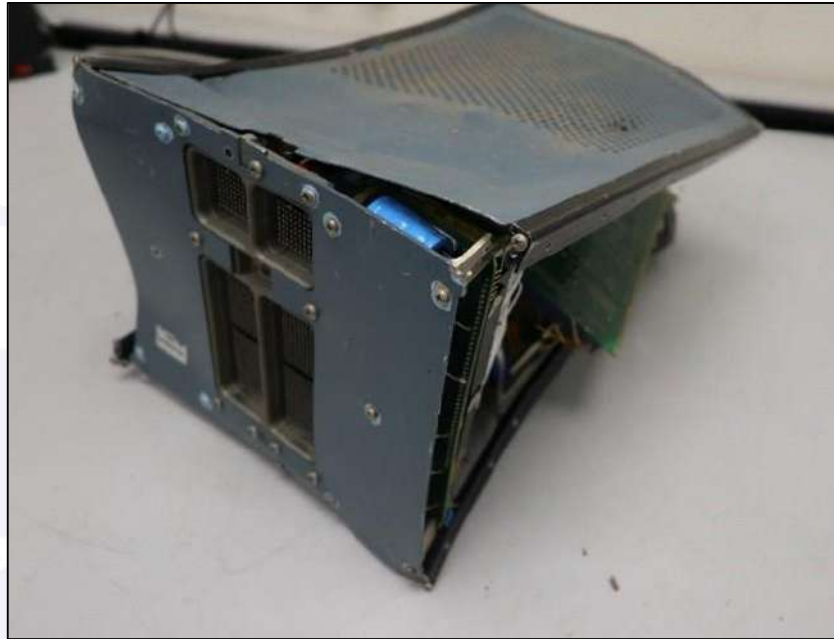
The MFC2 exhibited more severe deformation of its housing, and the front cover was missing (Figure 60).

Figure 60 – General condition of the MFC2 prior to disassembly.

The electronic boards of the MFC2 were severely damaged. On the MFC2B board, the memory component slot was empty. On the MFC2A board, the memory was in its slot, but with most of its pins disconnected from the contact holes (Figure 61).

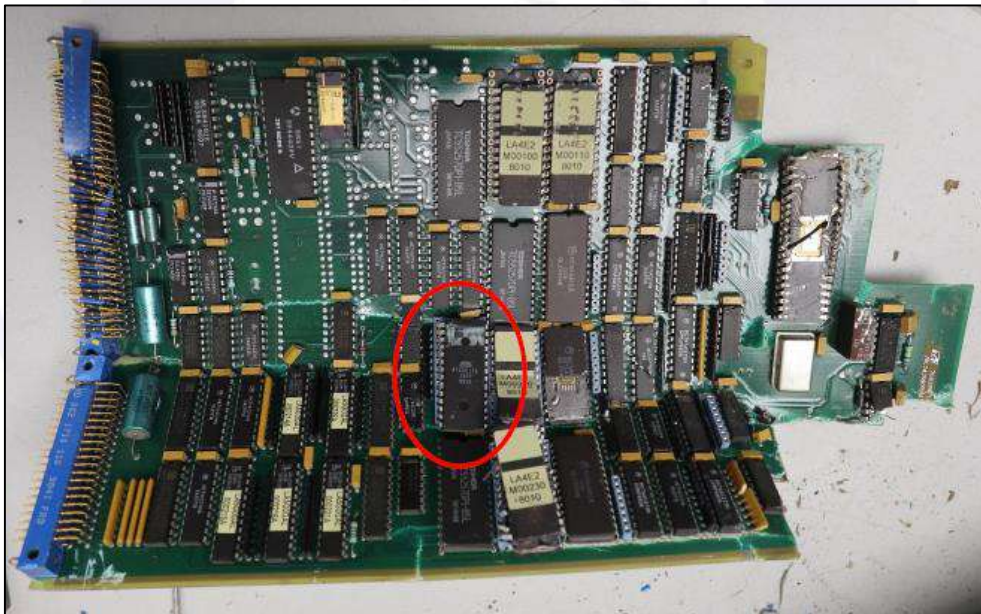
Figure 61 – MFC2A board with the memory component circled in red.

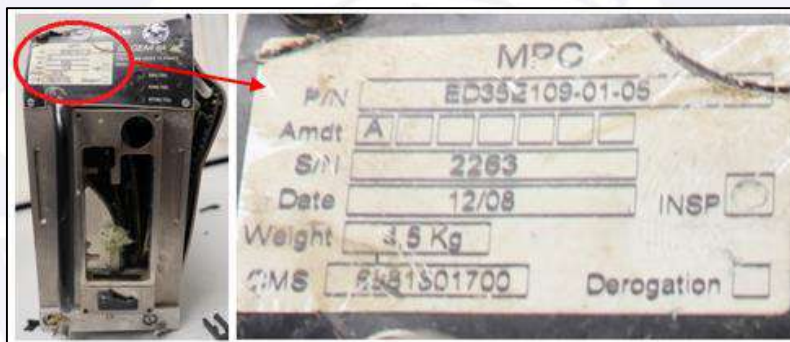
The MPC exhibited severe structural damage, with visible deformation of its housing.

Figure 66 – Front face of the MPC with a detail of its identification placard.

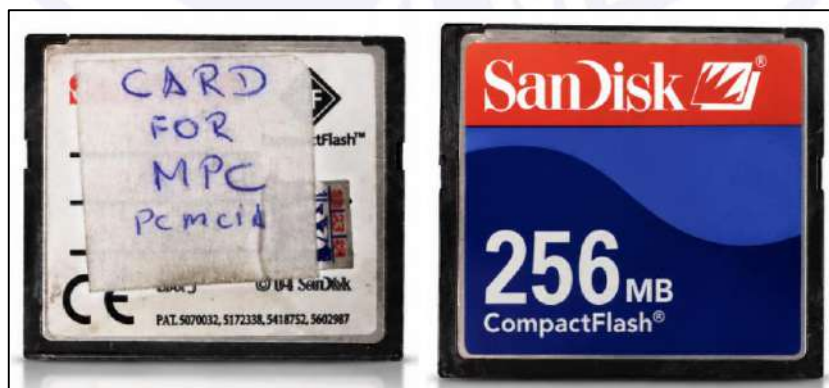
The PCMCIA card was removed from its slot in the MPC and sent for laboratory examination (Figure 67).

Figure 67 - On the left, rear face; on the right, front face of the PCMCIA card removed from the MPC slot of aircraft PS-VPB.

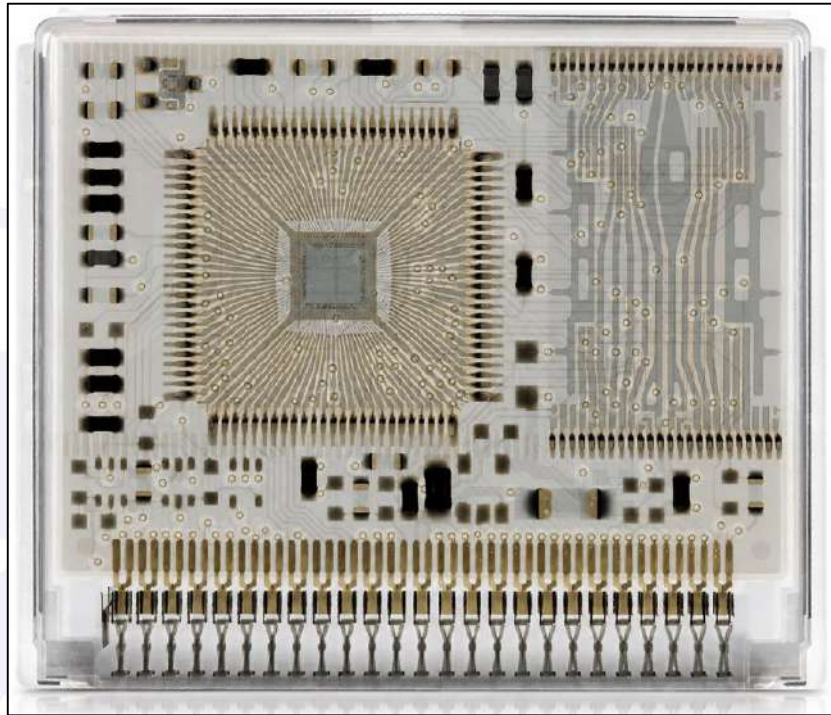
Figure 68 – X-ray view of the PCMCIA flash memory.

As no damage to the PCMCIA flash memory was observed, the card was connected to a computer using a specialized adapter. The files from the MPC's PCMCIA card were successfully recovered, containing data from flights "0", "-1", and "-2".

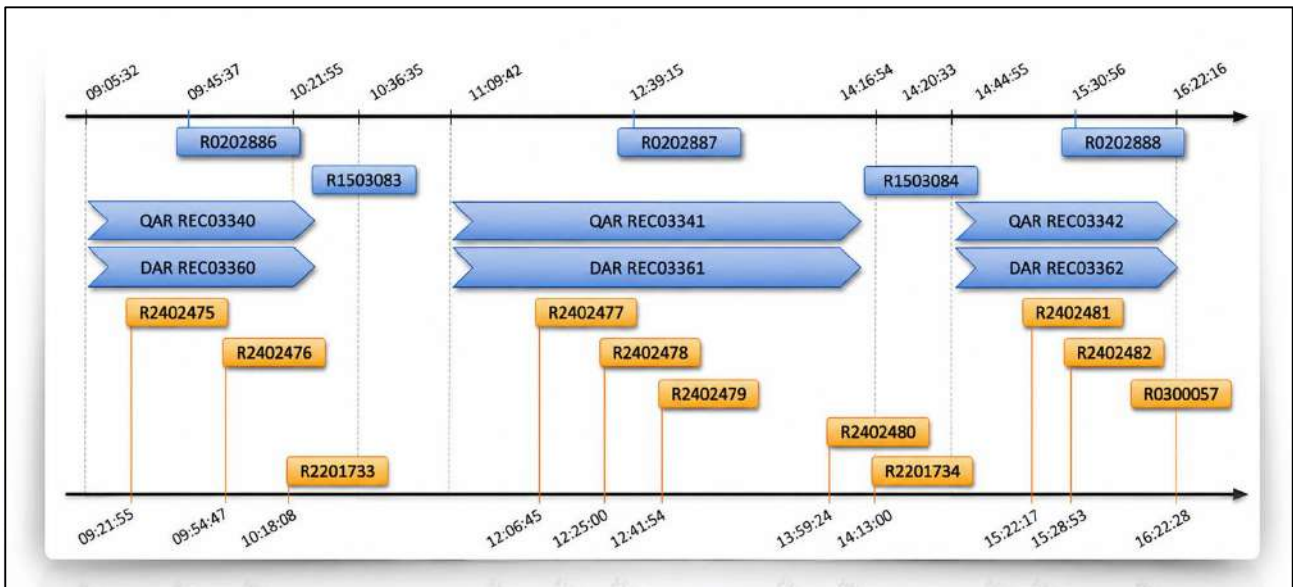
Figure 69 - Data from the MPC's PCMCIA card, organized by report type, including the timestamps recorded across the three flights.

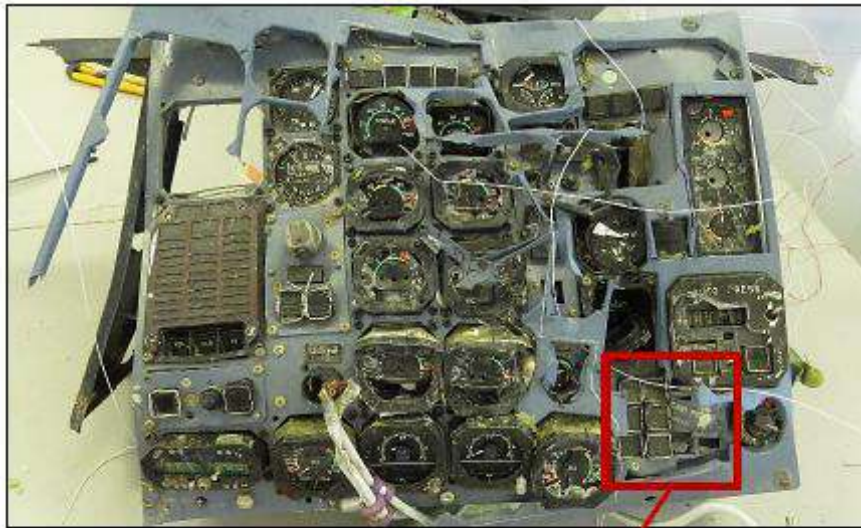
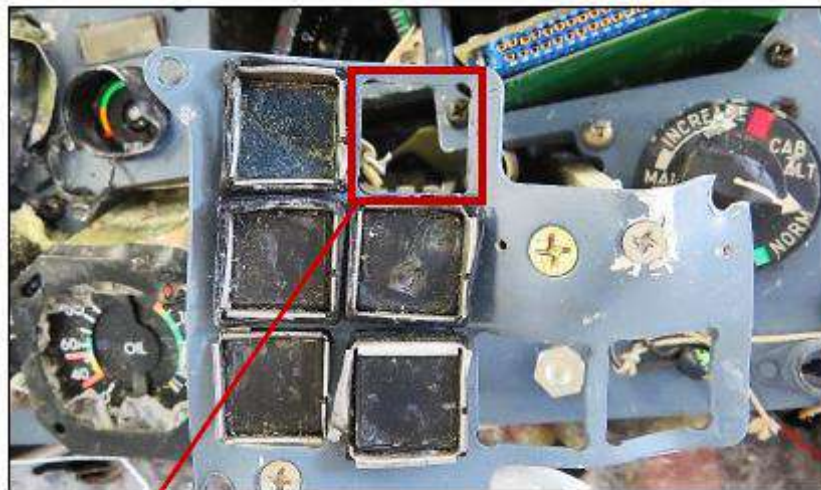
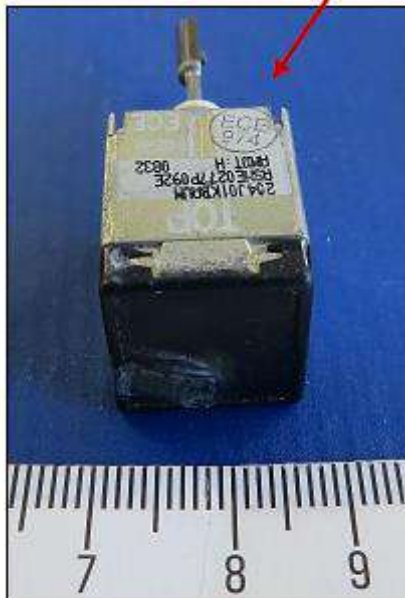
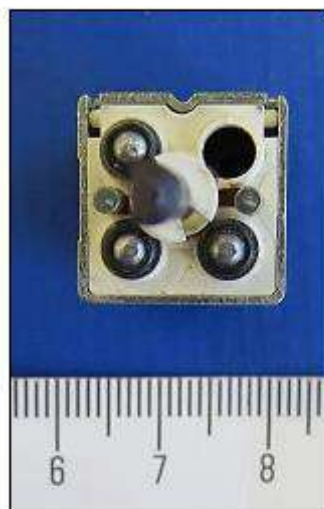
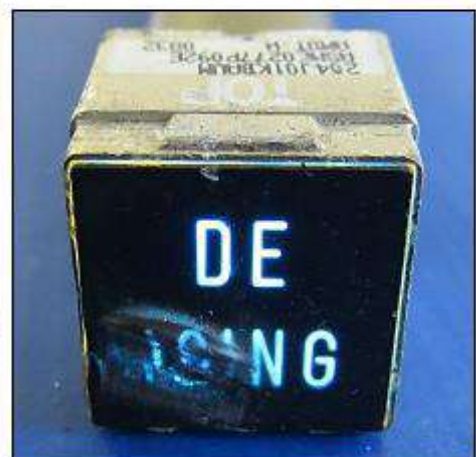
The image illustrates the location of the memo panel on the central panel and the sequence of steps for removing the DE-ICING indication lamps, as well as a detail of the location of the upper lamp socket. It is also noted that one of the four lamps was not found. Finally, confirmation that it was the DE-ICING indication light was established through the use of external illumination (flashlight).

Figure 83 – (I, II and III) Photographs illustrating the location of the memo panel on the central panel and the sequence of steps for removing the DE-ICING indication lamps; (IV) detail of the location of the lamp socket in the upper section and the absence of one of the lamps; and (V) confirmation obtained using external illumination (flashlight).

It should also be noted that some indicative messages had missing lamps, such as the DE ICING indication mentioned previously.

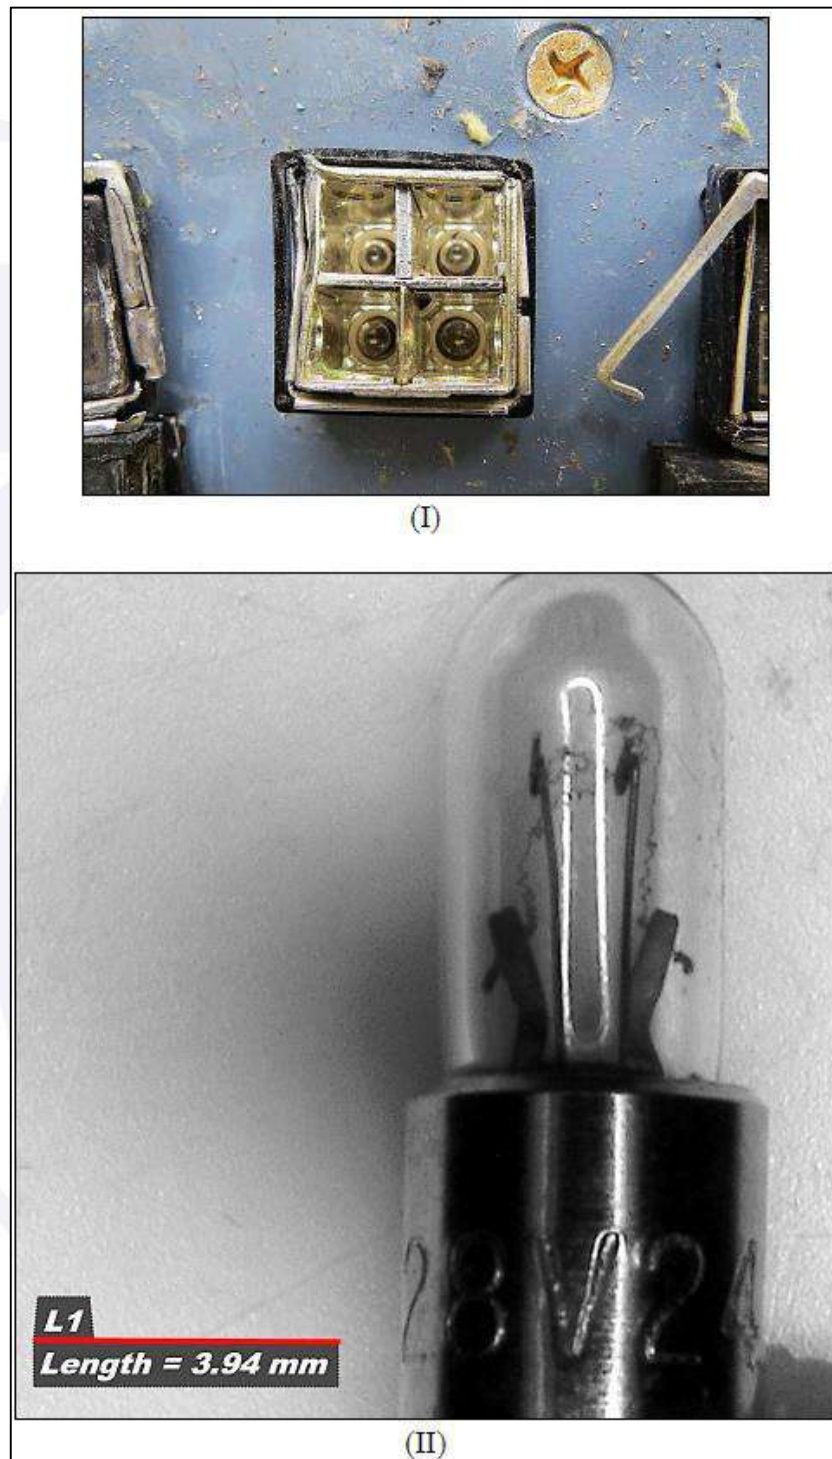
Figure 84 highlights the image of the DE-ICING indication composed of four lamps, without the front cover, as well as a photograph of one of the lamps.

Figure 84 – (I) DE ICING indication composed of four lamps and (II) photograph of one of the lamps.

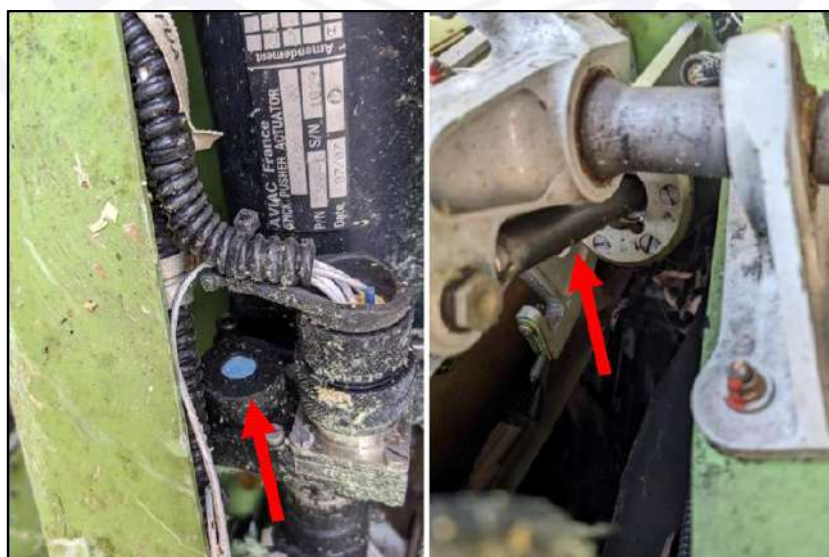
The Stick Pusher actuator was found installed in its position and with its mechanical integrity apparently preserved. The actuator rod was in the extended position, corresponding to the non-activated condition, and the desiccant cartridge was blue, indicating the absence of moisture saturation.

Figure 90 – On the left, a red arrow indicating the desiccant cartridge in blue; on the right, a red arrow indicating the extended position of the actuator rod, consistent with the non-actuated condition.

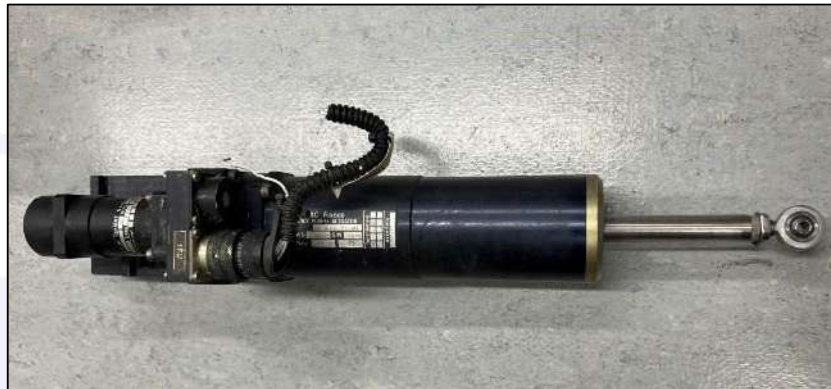
The actuator was subjected to examinations and tests conducted by the SIPAER Investigation Commission at the component manufacturer's facilities. Electrical and insulation tests were performed on the component, with results within specifications and no discrepancies.

Figure 91 – Stick Pusher actuator prior to the start of examinations and tests, with the actuator rod in the extended position.

An immersion test of the actuator in a water bath was conducted to verify the sealing of the actuator and its internal electrical components. During this procedure, leaks were identified at different points of the actuator casing; however, the desiccant capsule showed no signs of internal moisture. Considering the electrical tests previously performed, the investigators concluded that the leakage was a consequence of the aircraft's impact with the ground.

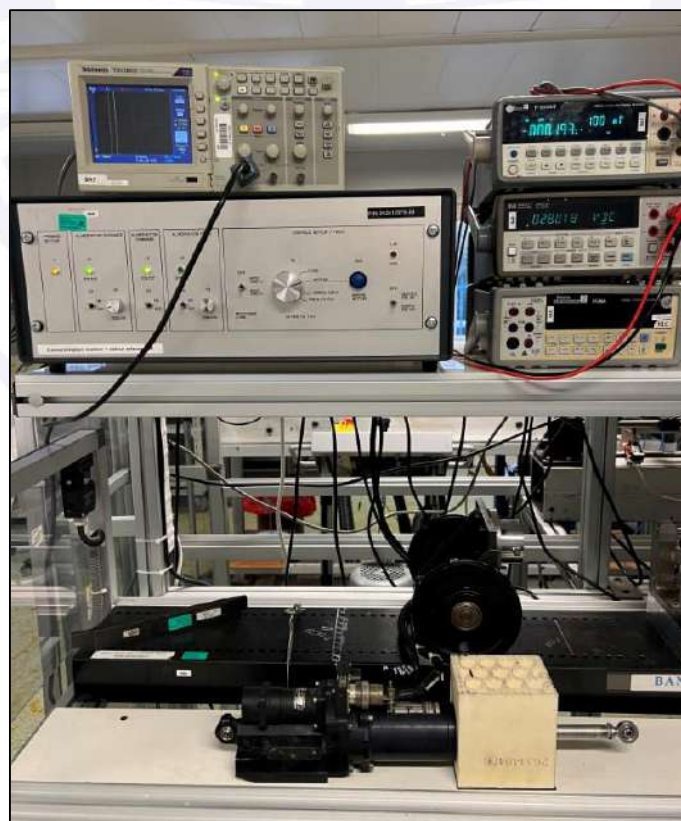
Subsequently, no-load tests were performed (Figure 92), including the microswitch activation test, which showed normal operation of the activation indication light when the actuator left the standby position. The electrical signal from this microswitch was responsible for illuminating the green Stick Pusher indication lamps on the PIC's left panel and the SIC's right panel.

Figure 92 – No-load test of the Stick Pusher actuator.

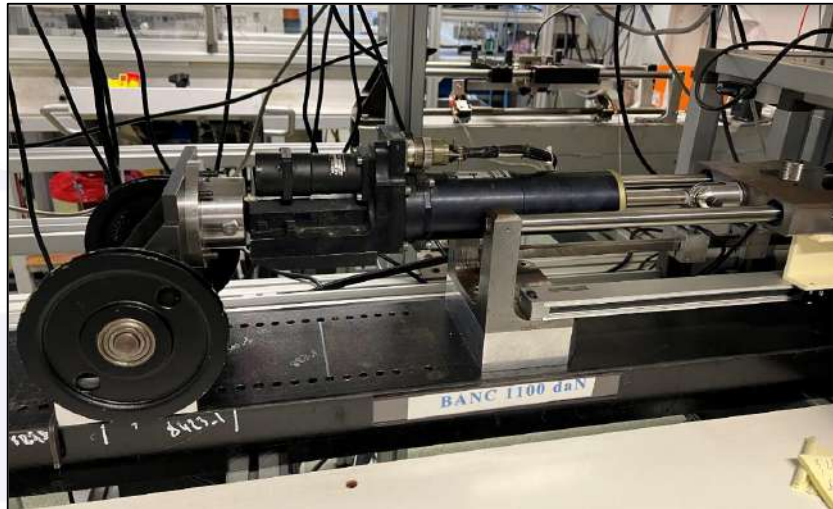
Bench tests identified that the measured time for the actuator retraction (activation) cycle (stroke) was slightly outside the tolerance, with a value of 0.45 seconds instead of 0.40 seconds, but without impact on system operation.

Figure 93 – Test bench of the Stick Pusher actuator under mechanical load.

The mechanical characteristics of the compression spring were within the established parameters, ensuring that the counterforce effort by the pilots was within the expected levels.

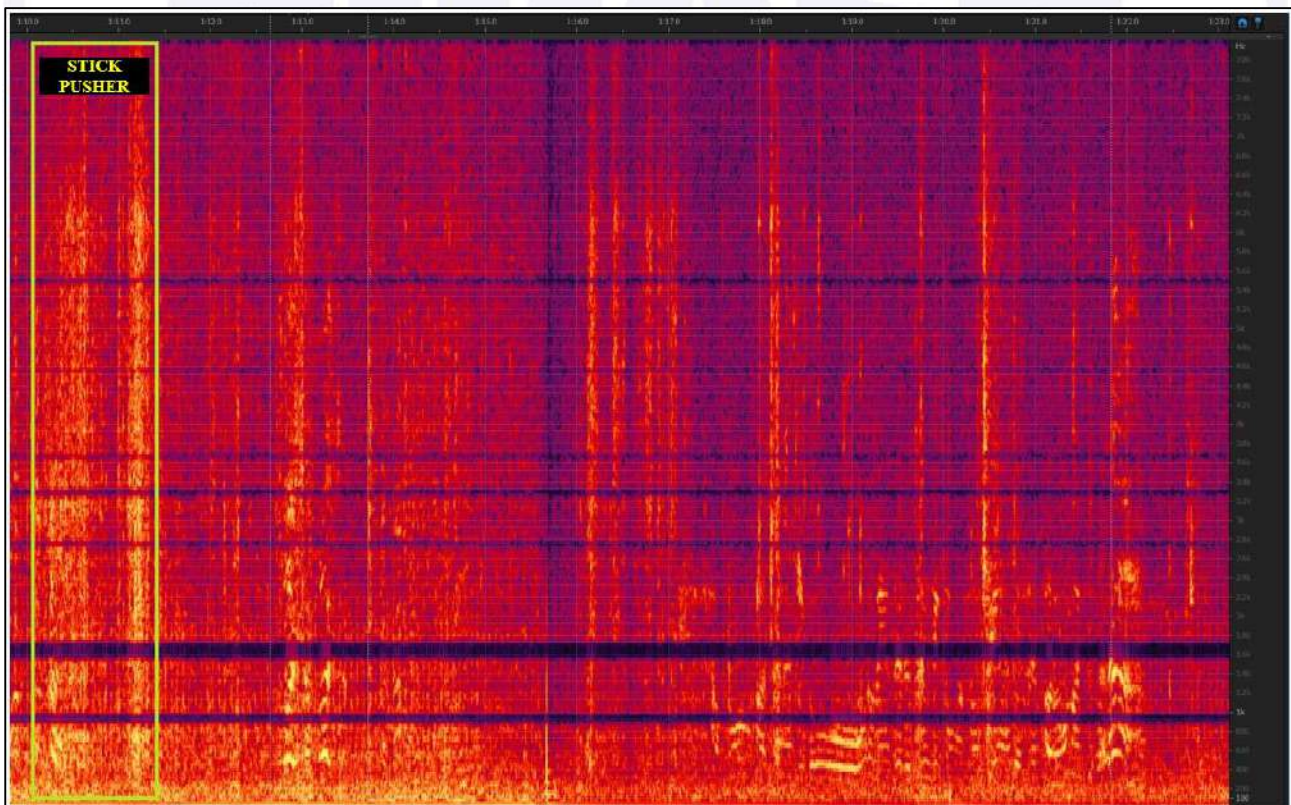
The audio recordings captured by the CAM of the accident aircraft were consistent with the characteristic alert sequence found in the BEA's audio database under stall approach conditions, consisting of Cricket, Stick Shaker, and Stick Pusher.

Figure 94 –Excerpt from the spectral analysis of aircraft PS-VPB CAM. Yellow rectangle consistent with the characteristic signal of Stick Pusher activation.

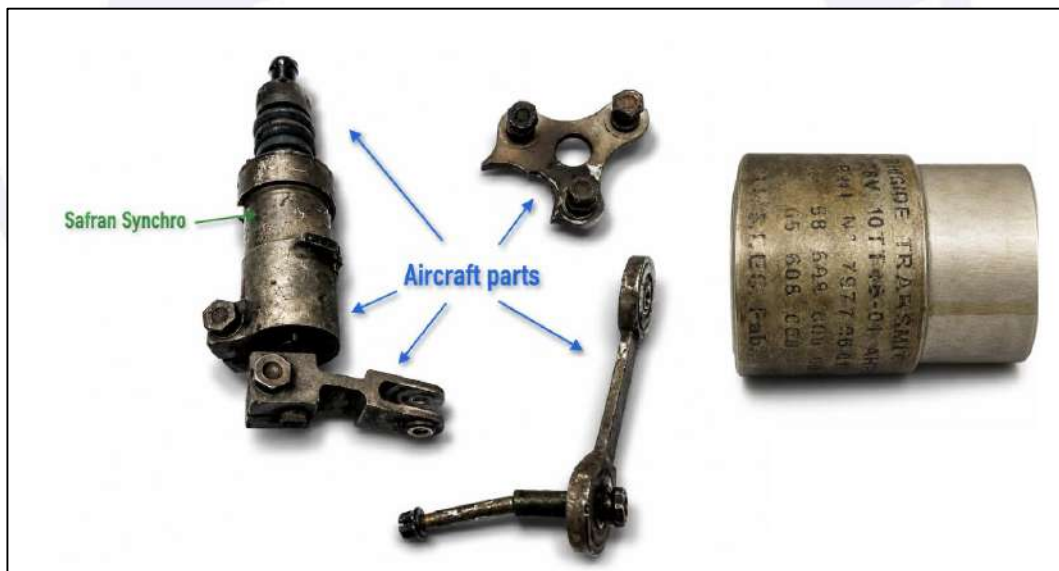
Figure 95 – Images of the Synchro Transmitter, its linkage interfaces with the elevator (links), and its identification label.

During the inspection, significant soot contamination, fractures in the casing, and visible damage—such as plastic deformation in the linkage rods (Figure 96)—were observed. The damage identified in the component was assessed as consistent with the mechanical effects of the aircraft's impact with the ground and exposure to fire.

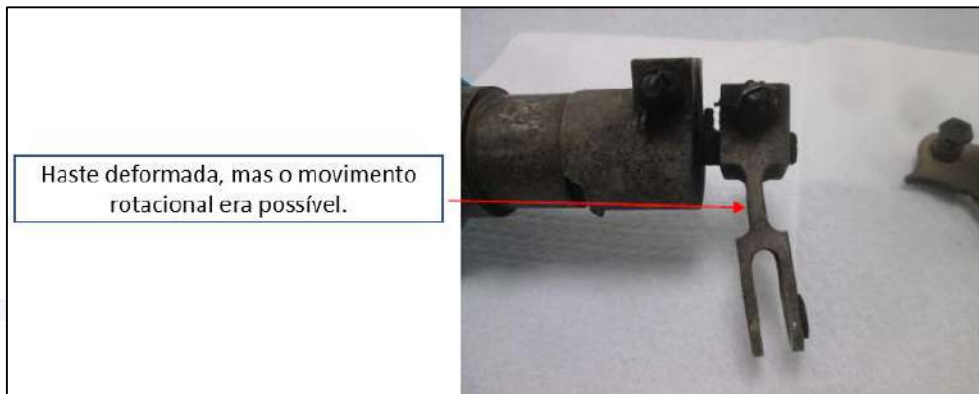
Figure 96 – Synchro transmitter linkage rod deformed, yet still functional.

Even so, these damages did not impair the movement of the rod responsible for the mechanical transmission of the elevator motion to the sensor, allowing the synchro transmitter to adequately perform the signal transduction to the FDR.

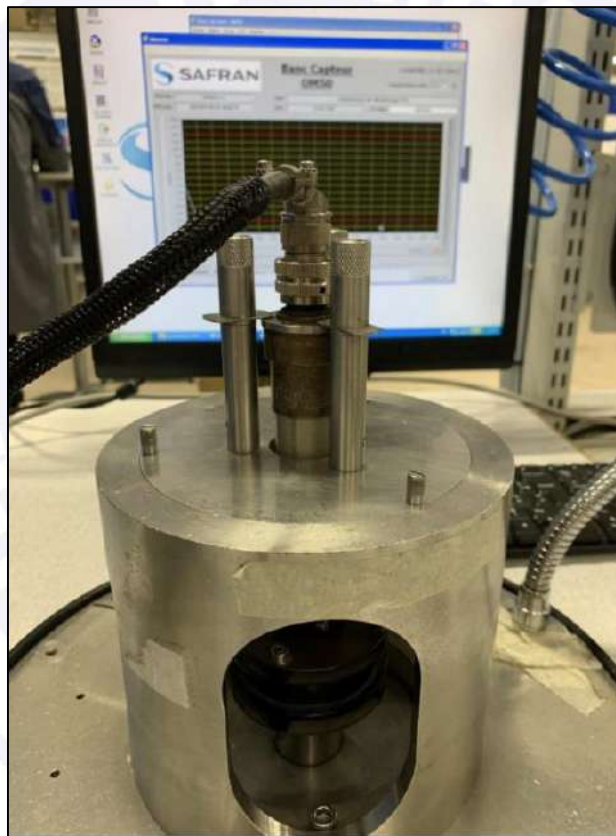
Subsequently, the component was installed on a test bench for functional testing (Figure 97). During the tests, free rotation of the Synchro Transmitter was confirmed. Although friction was higher than expected for a new unit, this condition did not compromise its functional performance.

Figure 97 – Synchro Transmitter mounted on a test bench for functional testing.

The electrical tests, including continuity, insulation, and resistance tests, yielded results within the specified limits.

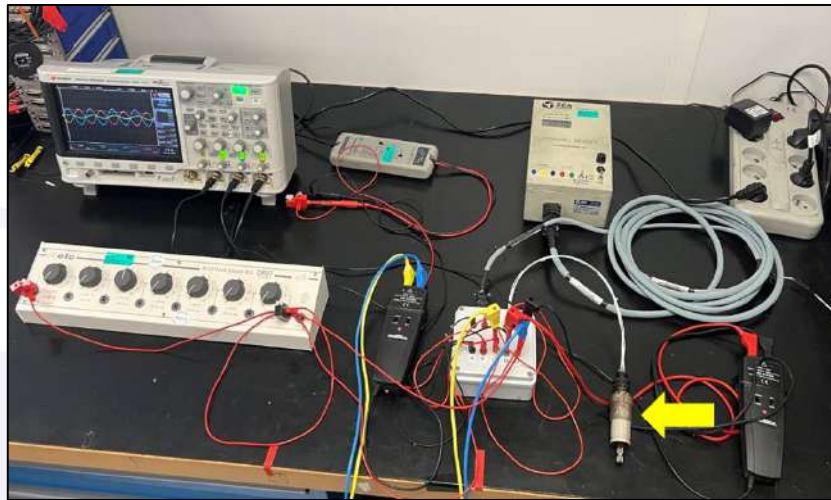
Figure 98 – Second round of tests at the aircraft manufacturer's facilities.  
The yellow arrow indicates the synchro transmitter connected to the test equipment.

Even with the additional tests, it was not possible to reproduce or explain the anomaly observed in the data recorded by the FDR.

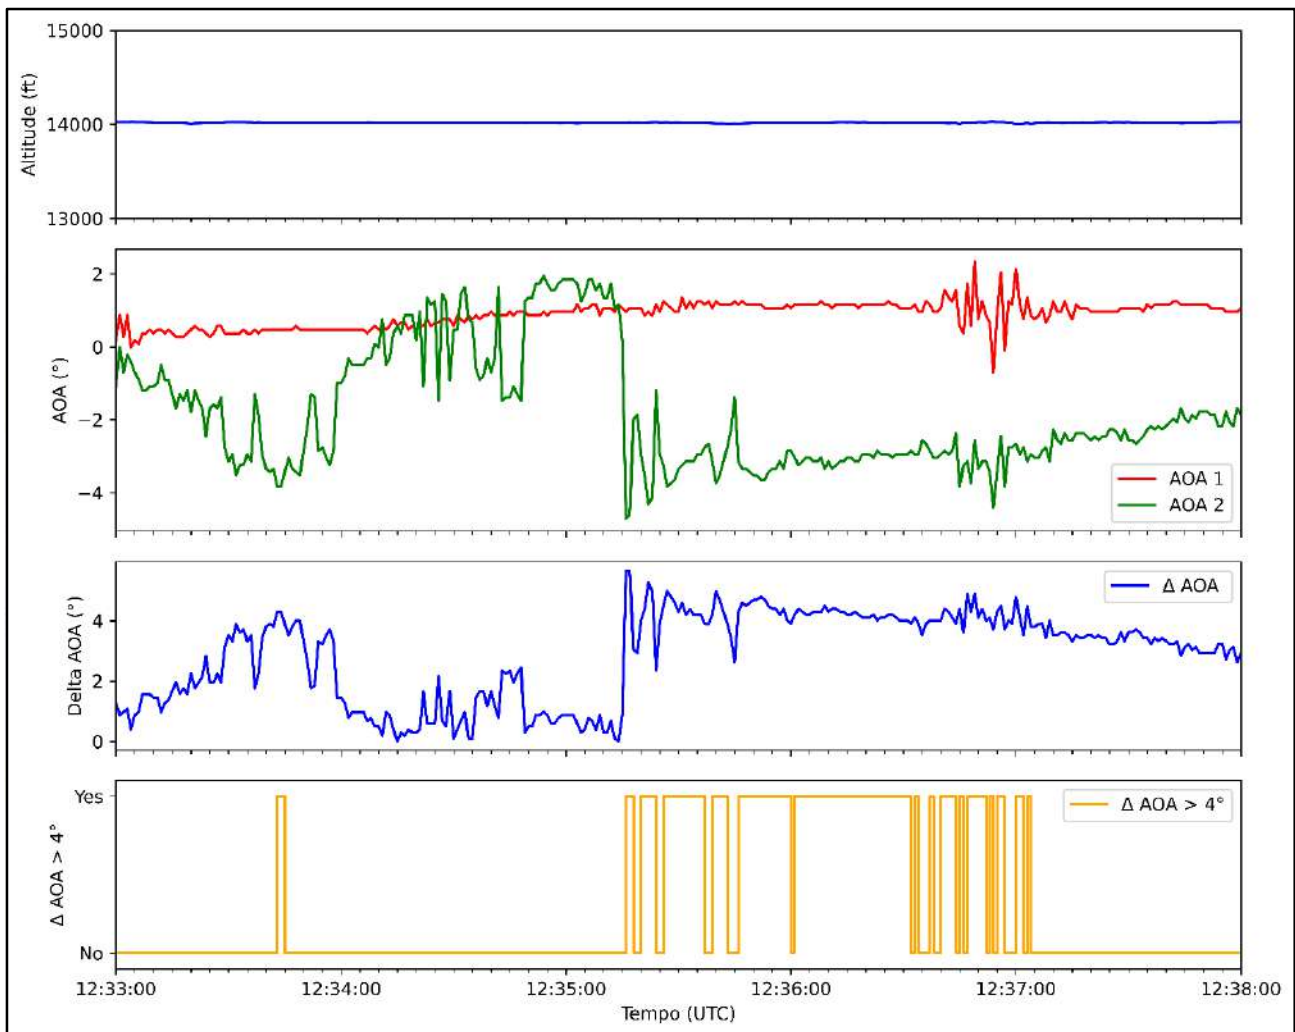
It was also identified that, during the same “flight -1”, STICK PUSHER FAULT messages were recorded in the MPC. Cross-checking these faults with the FDR data indicated temporary discrepancies greater than 4° between the information provided by the two AOA sensors simultaneously, as detailed in the following figure 101. Jumps in the values of the right AOA sensor (AOA2) were observed.

Figure 101 –Excerpt from “flight -1” showing a discrepancy greater than 4° between the AOA sensor indications.

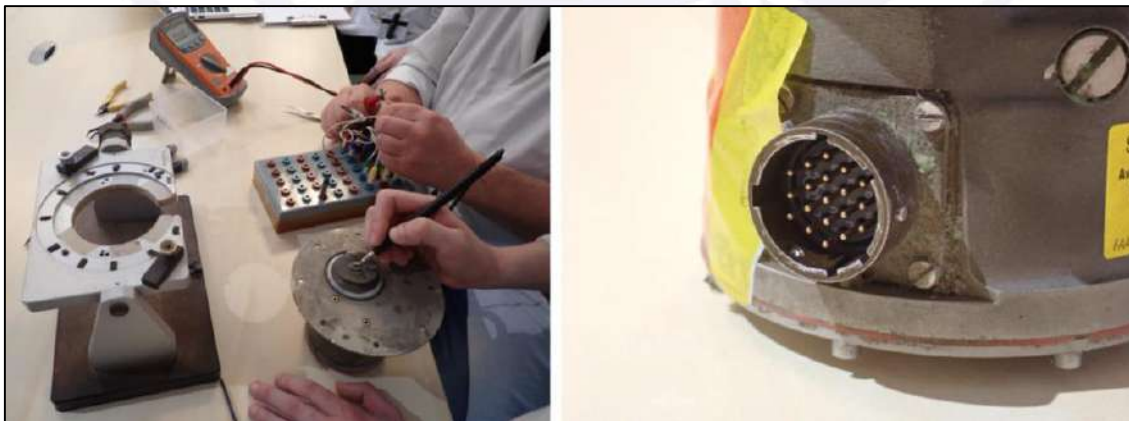
During the examinations, it was verified that both power wires for the heating elements were electrically connected to their respective pins in the connector, and that both the sensor housing and its connector were in good condition.

Figure 102 – Images recorded during the examinations and tests performed on the right AOA sensor. On the left, execution of electrical tests on the heating wiring; on the right, the good condition of the connector pins.

The examinations and tests performed on the right AOA sensor showed that it was in good overall condition, with most quantitative measurement parameters within the specified ranges.

The bench tests performed did not reproduce the condition observed on flight minus one ("flight -1"), which is consistent with a scenario of intermittent failures in the heating of the right AOA sensor.

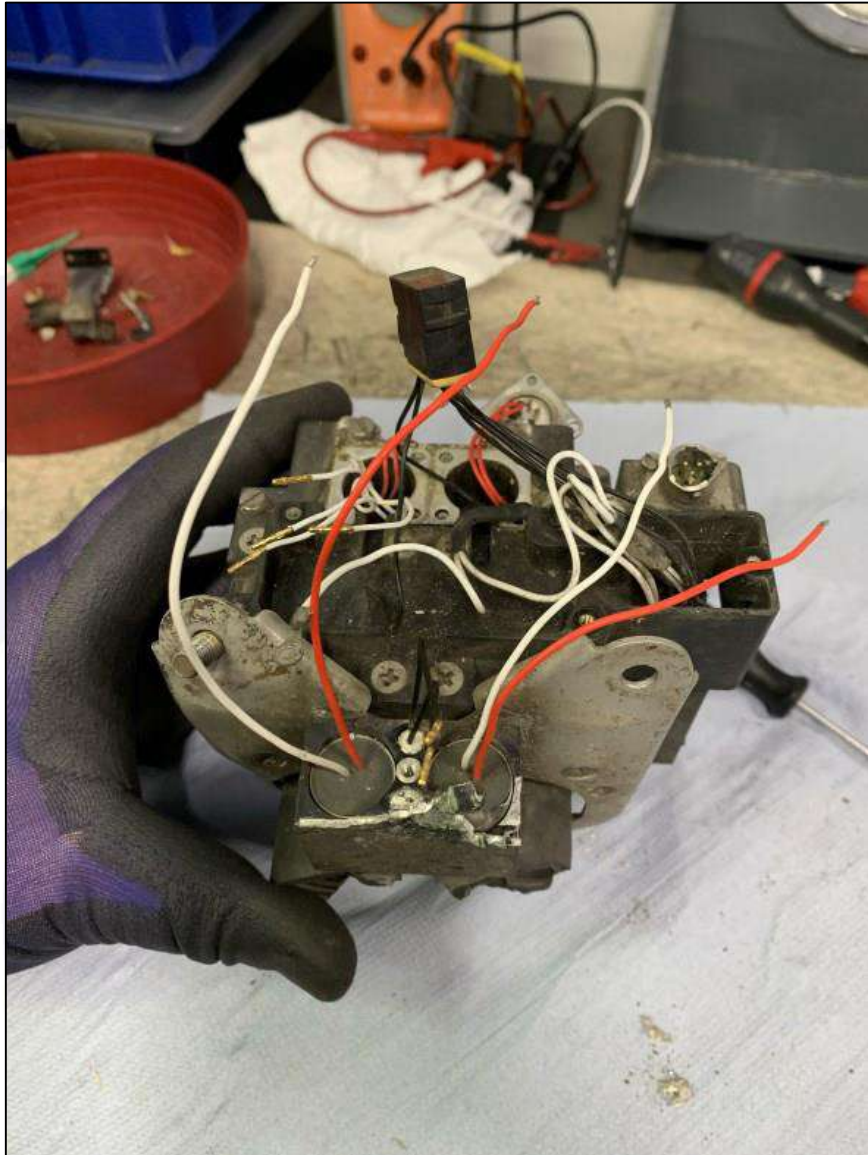
Electrical tests of continuity, impedance, and insulation were performed, with results showing minimal variations outside the specified tolerances, without functional impairment. Subsequently, functional tests were carried out on the valve's two solenoids, both yielding results within specifications and with no discrepancies recorded.

Finally, the component was fully disassembled for inspection of the two pressure sensors (pressure switches). The tests indicated that the sensor in channel B was operating within specifications, while the sensor in channel A showed damage due to impact and thermal deformation resulting from the post-impact fire.

Figure 106 – DDV responsible for actuating the horizontal stabilizer boots subjected to examination.

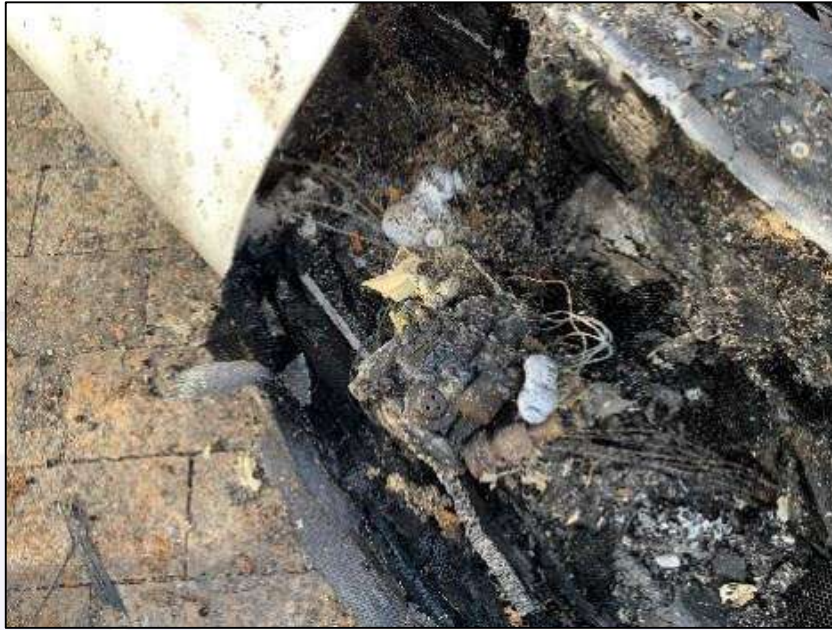
The second DDV located could not be identified due to degradation resulting from the post-impact fire, which also precluded any functional testing.

Considering the position in which it was found, near the tip of the right wing, the SIPAER Investigation Commission inferred that it corresponded to the DDV associated with FIN 10DM, responsible for actuating the right-wing outboard boots. (Figure 107).

Figure 107 – Image of the FIN 10DM DDV at the crash site.

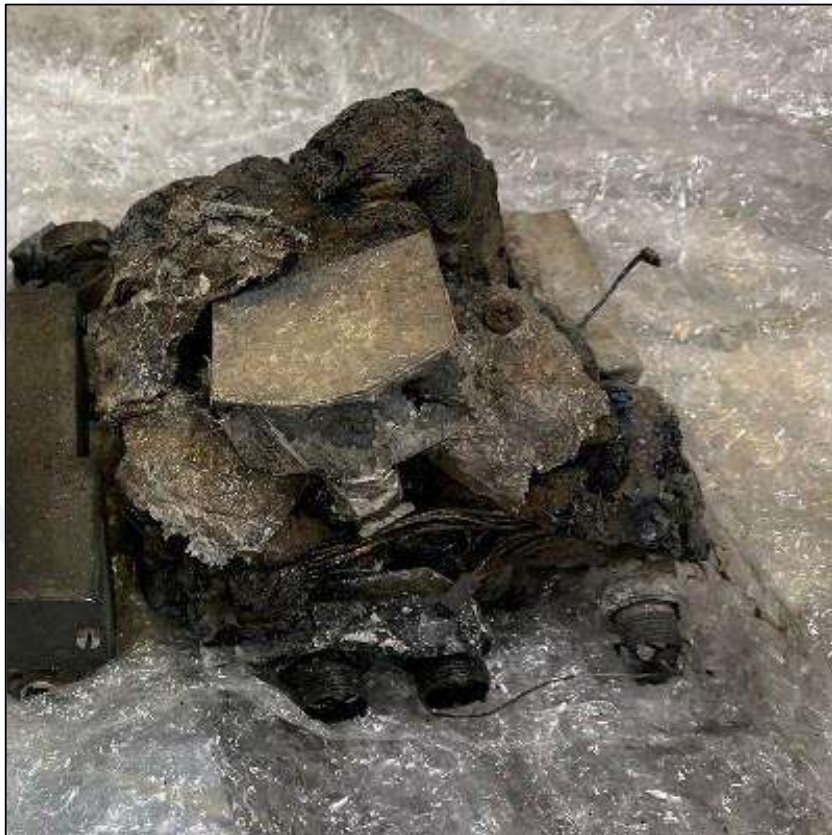
The DDV was subjected to a 3D X-ray computed tomography scan in order to obtain a three-dimensional reconstruction of the valve for information extraction. However, it was not possible to obtain elements that would allow the operational condition prior to the impact and fire exposure to be inferred.

Figure 108 – Photograph of the DDV responsible for actuating the outer boots of the right wing on the test bench for analysis.

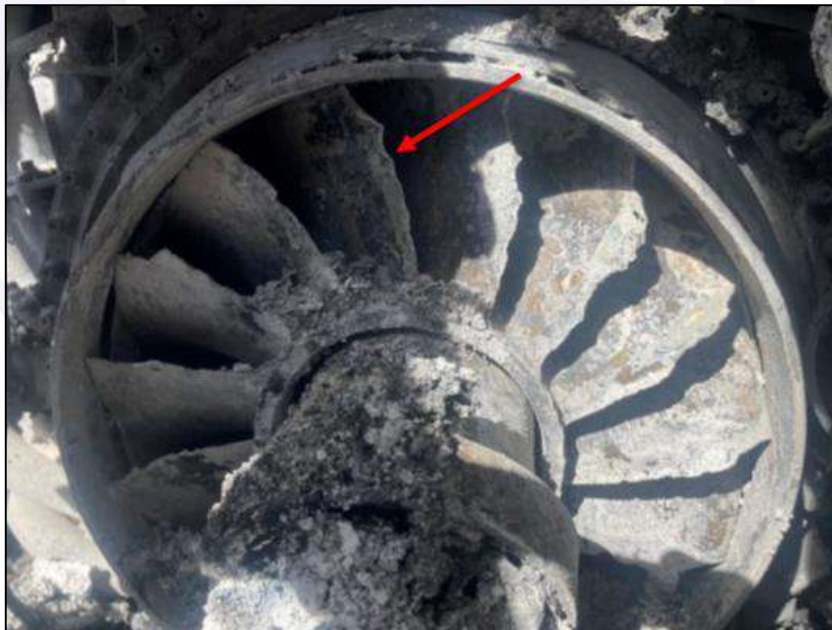
The LPC rotors of both engines showed signs of Foreign Object Damage (FOD) on the leading edges of their blades. Some LPC blades also exhibited deformation in the direction opposite the rotation of the rotor shaft (Figures 111 and 112).

Figure 112 – Image of the LPC rotor of engine No. 2. Red arrow indicating blade deformation in the direction opposite to the rotation of the rotor shaft.

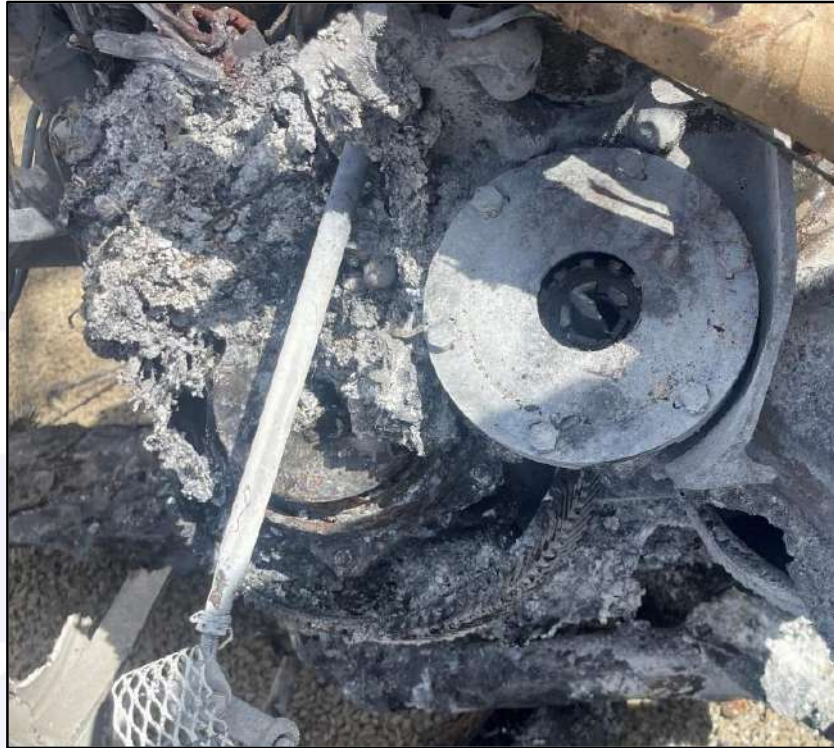
The components of the Reduction Gear Boxes (RGB) of both engines were also exposed, showing damage resulting from both the impact with the ground and the post-impact fire (Figures 113 and 114).

Figure 113 – Image of the RGB of engine No. 1.
