**COMANDO DA AERONÁUTICA**  
**CENTRO DE INVESTIGAÇÃO E PREVENÇÃO DE**  
**ACIDENTES AERONÁUTICOS**

**FINAL REPORT**  
**A-116/CENIPA/2024**

**PS-VPB**

**ATR-72-212A (500)**

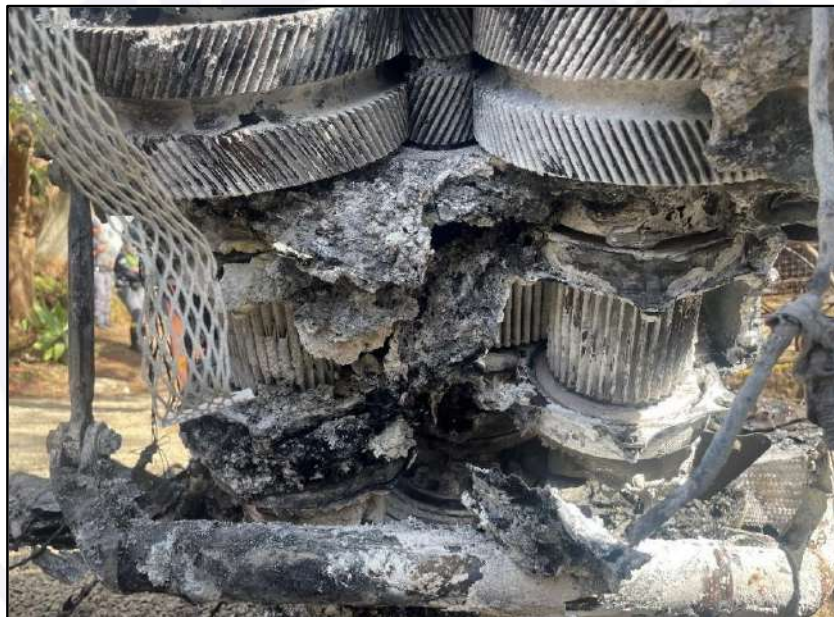
The components of the Reduction Gear Boxes (RGB) of both engines were also exposed, showing damage resulting from both the impact with the ground and the post-impact fire (Figures 113 and 114).

Figure 114 – Image of RGB of the engine No. 2.

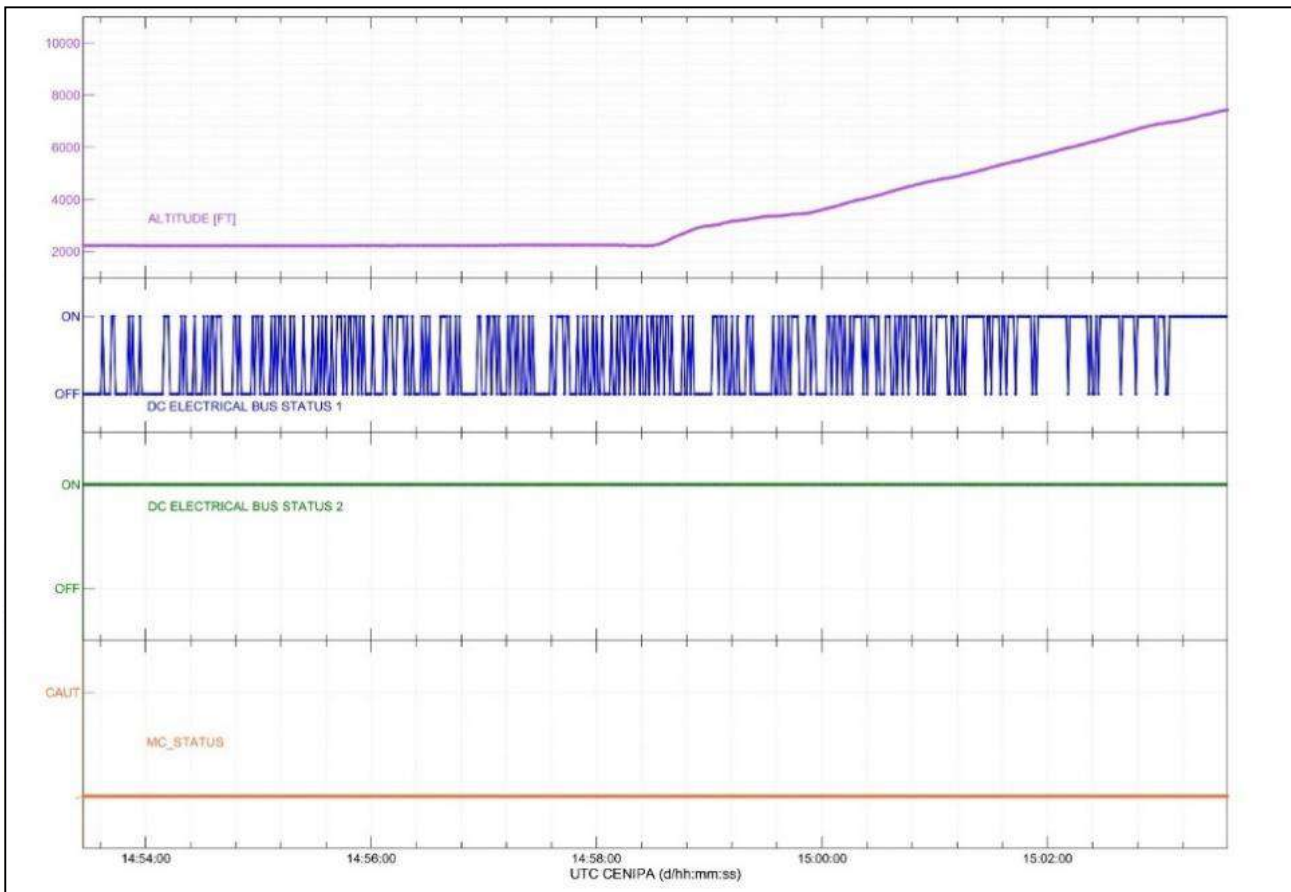
Figure 118 – DC Bus 1 status graph based on FDR and MPC data.

The records showed that the status of the DC Bus 1 electrical bus (blue trace in the figure 118) fluctuated continuously from the beginning of taxi, a behavior that contrasted with DC Bus 2 (green trace in the figure 118), whose operation remained stable and continuously energized throughout the analyzed period.

The absence of MASTER CAUTION alerts was consistent with a scenario in which the DC Bus 1 was effectively energized throughout the entire flight, and the fluctuations recorded by the FDR in the status of this parameter occurred spuriously, not correlated with actual system failures, being consistent with an intermittent contact in the electrical grounding of the DC Bus 1 indicator light.

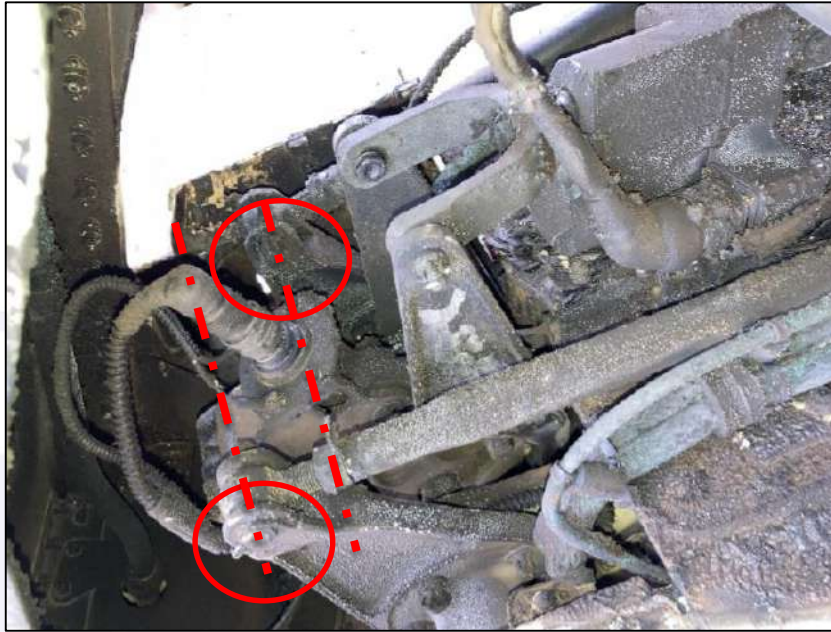
In order to ensure that the entire pitch control chain functioned correctly, the SIPAER Investigation Commission evaluated the Pitch Uncoupling Mechanism at the wreckage site during the initial on-site action. The component was visually identified in the uncoupled position (Figure 119), consistent with the in-flight activation of the pitch uncoupling mechanism.

Figure 119 – Pitch uncoupling mechanism found in the disengaged position.

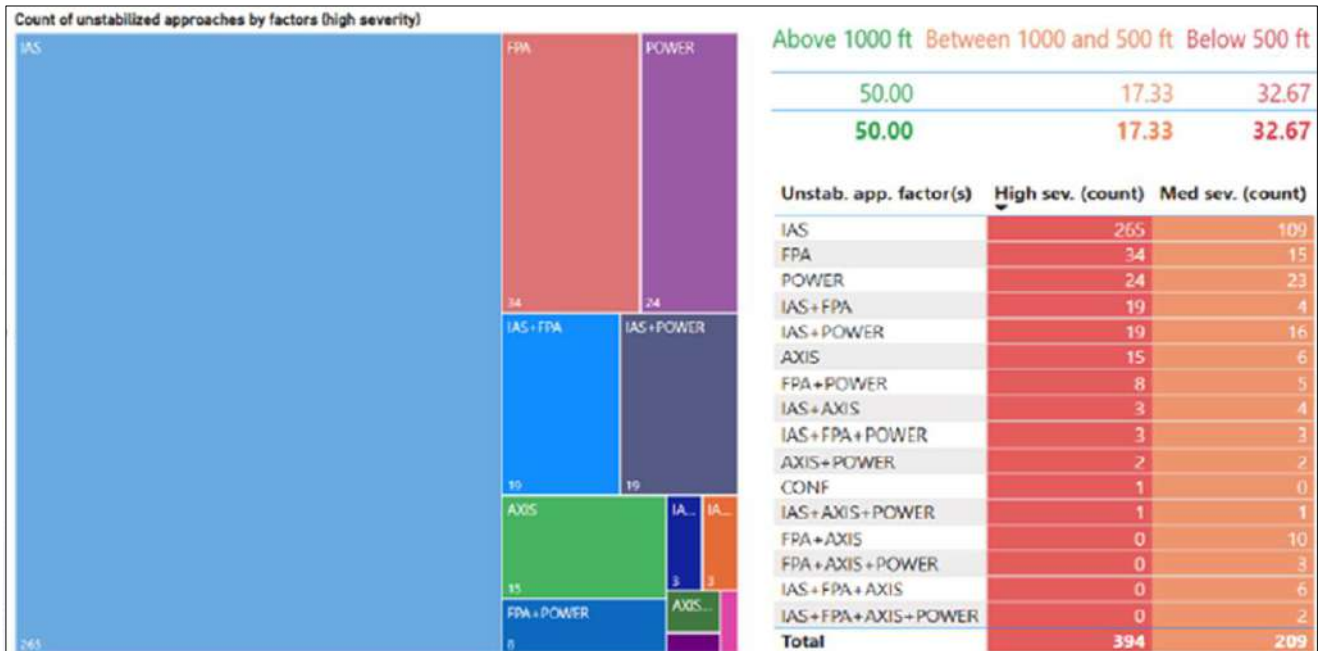
With regard to unstable approach events, the graph in Figure 129 presents the triggers defined for the identification of these conditions, classified by the SIPAER Investigation Commission in terms of severity as LOW, MEDIUM, and HIGH.

Out of the total of 1,206 flights analyzed, 394 (32.67%) were categorized as HIGH by the SIPAER Investigation Commission for failing to meet one or more stabilization criteria below 500 feet AGL. The most frequent criterion was related to elevated IAS values during the final approach.

Figure 129 – Graphical representation of the parameters contributing most significantly to unstable approach triggers. The majority of these cases were associated with elevated IAS values.

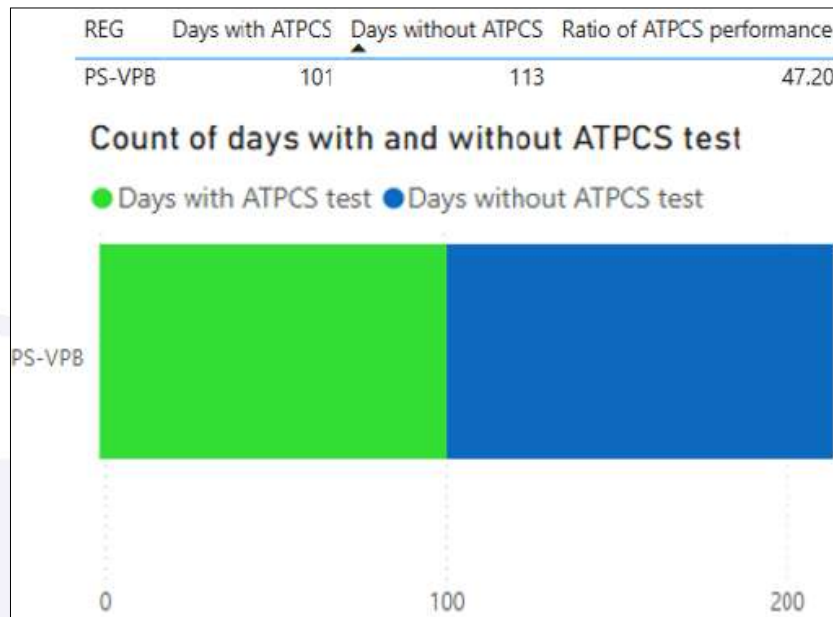
The SIPAER Investigation Commission verified that the number of daily ATPCS tests performed within the scope of the analysis, considering the flights conducted by aircraft PS-VPB, indicated an execution rate of 47.2% (Figure 132).

Figure 132 – Graph illustrating the number of days with and without the execution of the aircraft PS-VPB daily ATPCS test.

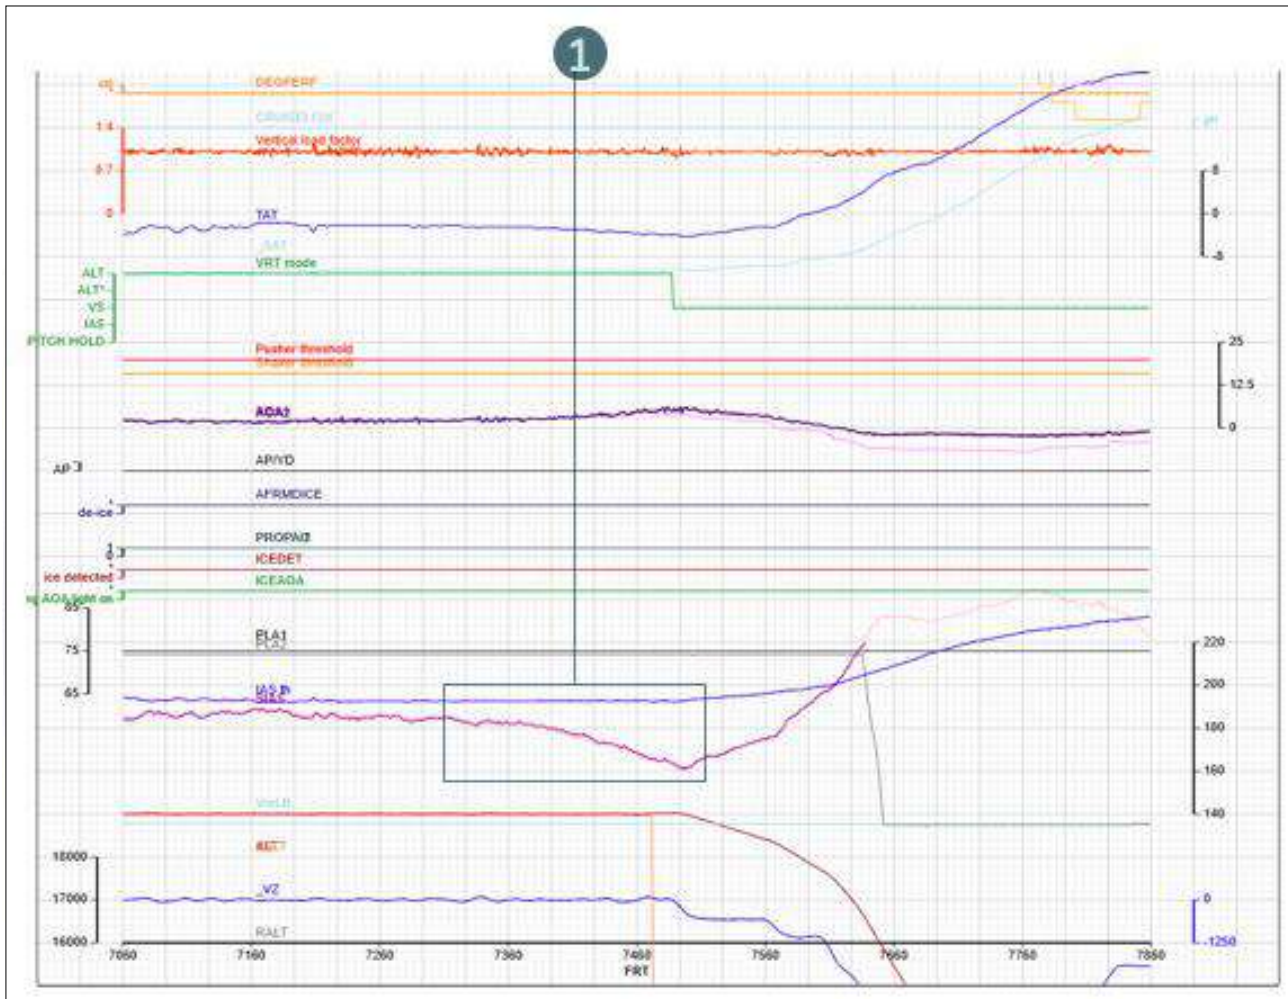
During the flight, there was a reduction in IAS of about 20 kt over a 2-minute interval, in a profile consistent with performance degradation due to ice accretion on the wings (Figure 133).

Figure 133 – Graph showing flight data parameters for Flight 2242.

No ice accretion detection was recorded by the Electronic Ice Detector, and the ice protection system (Anti-Icing or De-Icing) was off. The SIPAER Investigation Commission was unable to ascertain with the flight crew of that flight whether there had been any visual perception of ice accretion on the IEP.

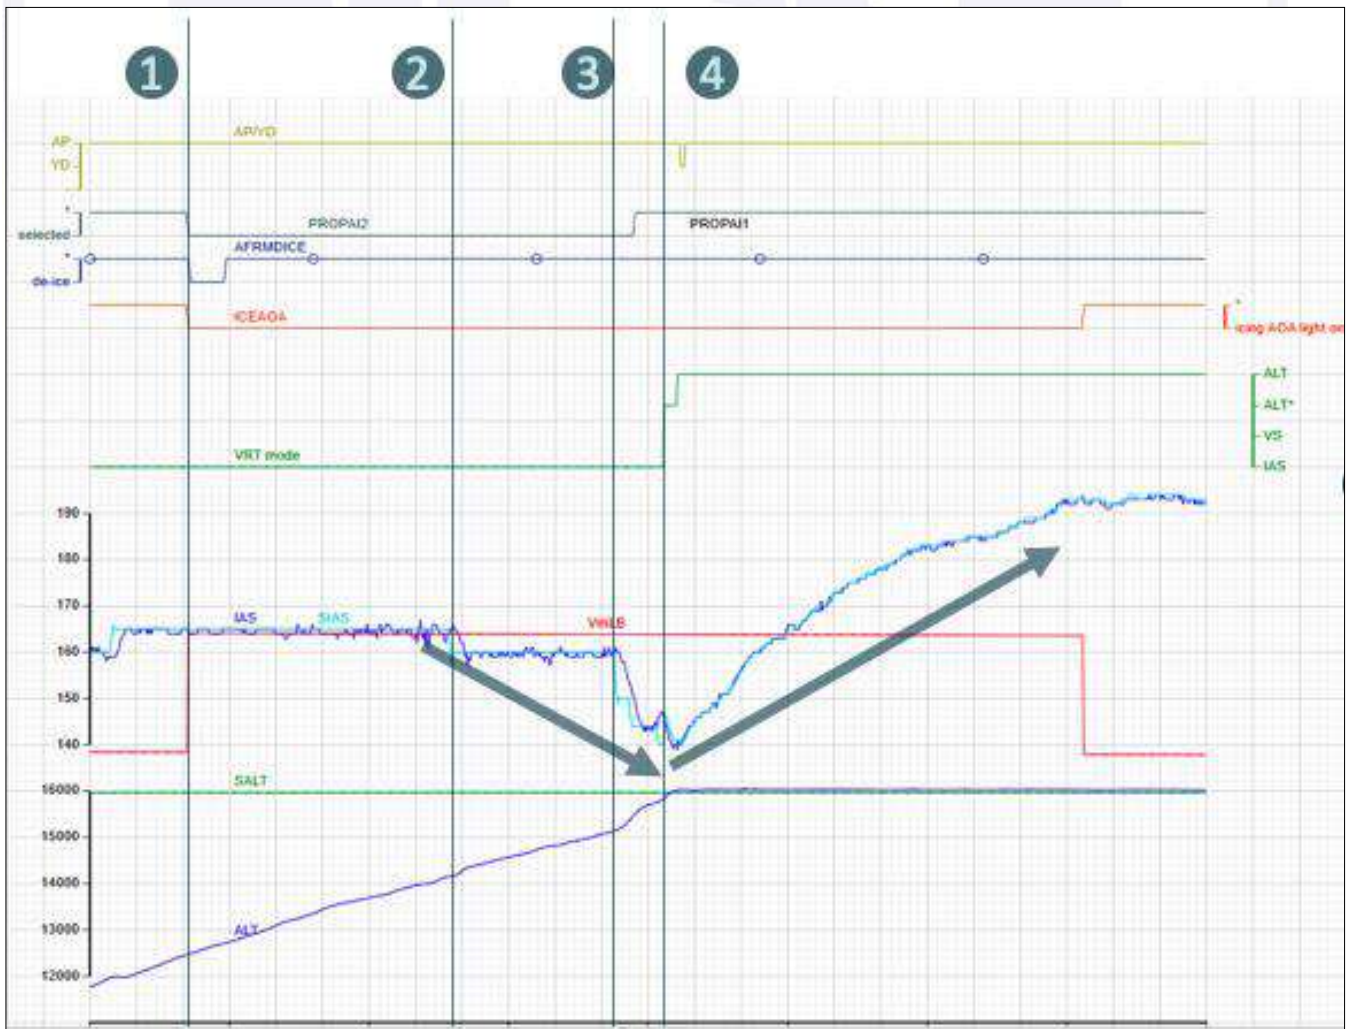
Line 1 (Figure 134) highlights the moment at which level 2 of the Anti-Icing systems was activated (parameters PROPA1 and PROPA2, referring to Propeller Anti-Icing 1 and

Line 3 highlights the onset of successive reductions in selected IAS, initially to 144 kt and then to 140 kt. The IAS followed these selections, reaching a minimum value of 143 kt (descending arrow), which represented a value 20 kt below  $V_{MLB0icing}$ . In response, the AOA increased, although without reaching the stick shaker activation threshold, remaining approximately  $2^\circ$  below that limit.

Line 4 indicates the moment the aircraft leveled off at FL160 and the beginning of the IAS increase (ascending arrow). A brief AP disconnection was also recorded.

Figure 134 – Graph with flight data parameters of Flight 2231.

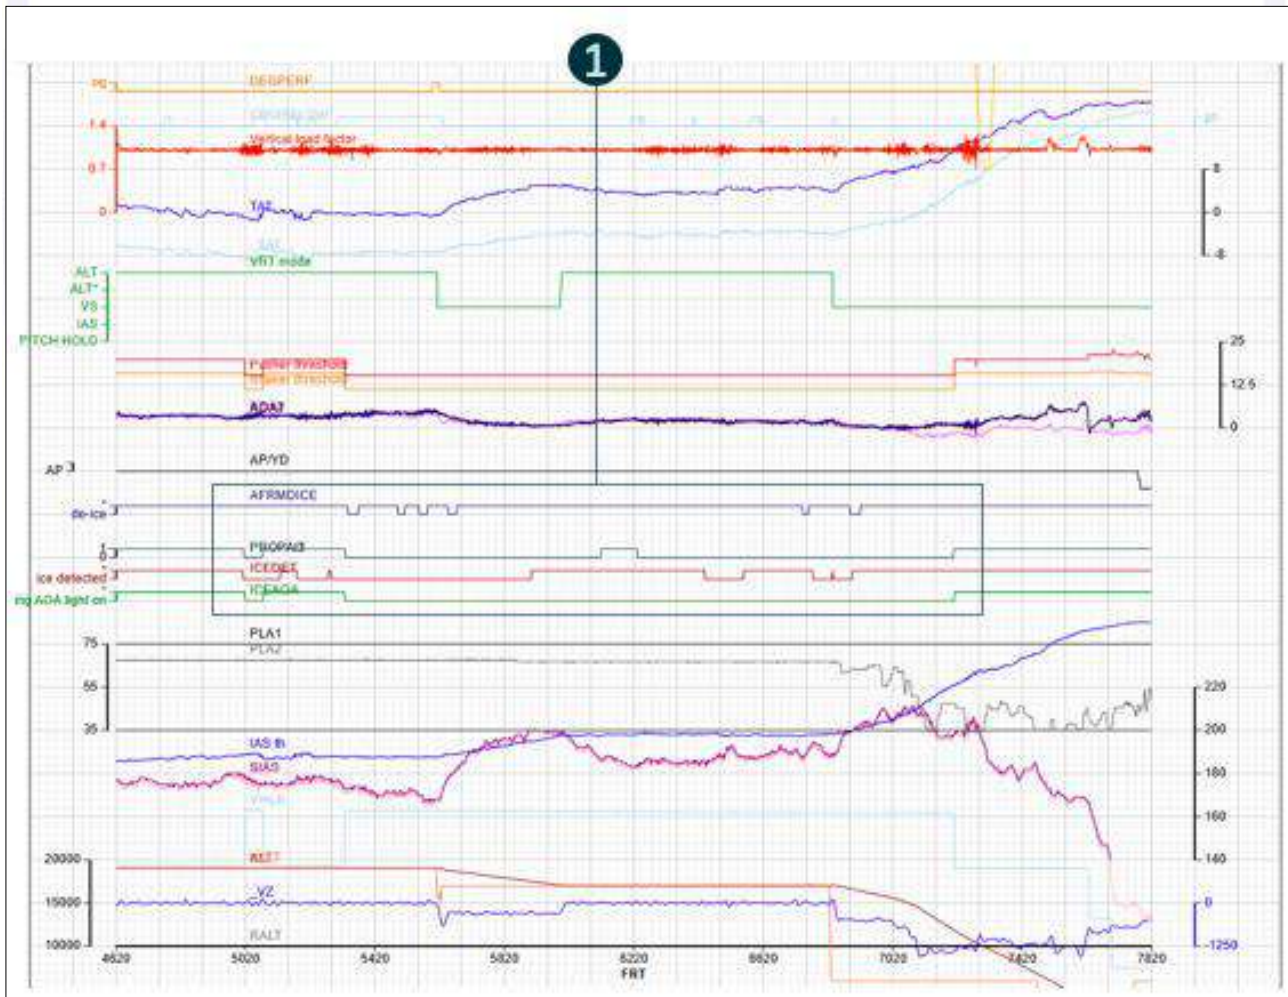
During the cruise flight at FL190, several ice accretion detections were recorded by the Electronic Ice Detector, followed by multiple activations and deactivations (resets) of the Airframe De-Icing system (box 1 in Figure 135).

Following the first ice detection (ICE DETECT parameter), a loss of performance and a reduction in the aircraft's indicated airspeed were identified. APM advisories/alerts for CRUISE SPEED LOW and DEGRADED PERFORMANCE were issued.

Following the third reset, a descent from FL190 to FL170 was recorded, along with the corresponding increase in the aircraft's indicated airspeed.

Figure 135 – Graph with flight data parameters related to Flight 2230.

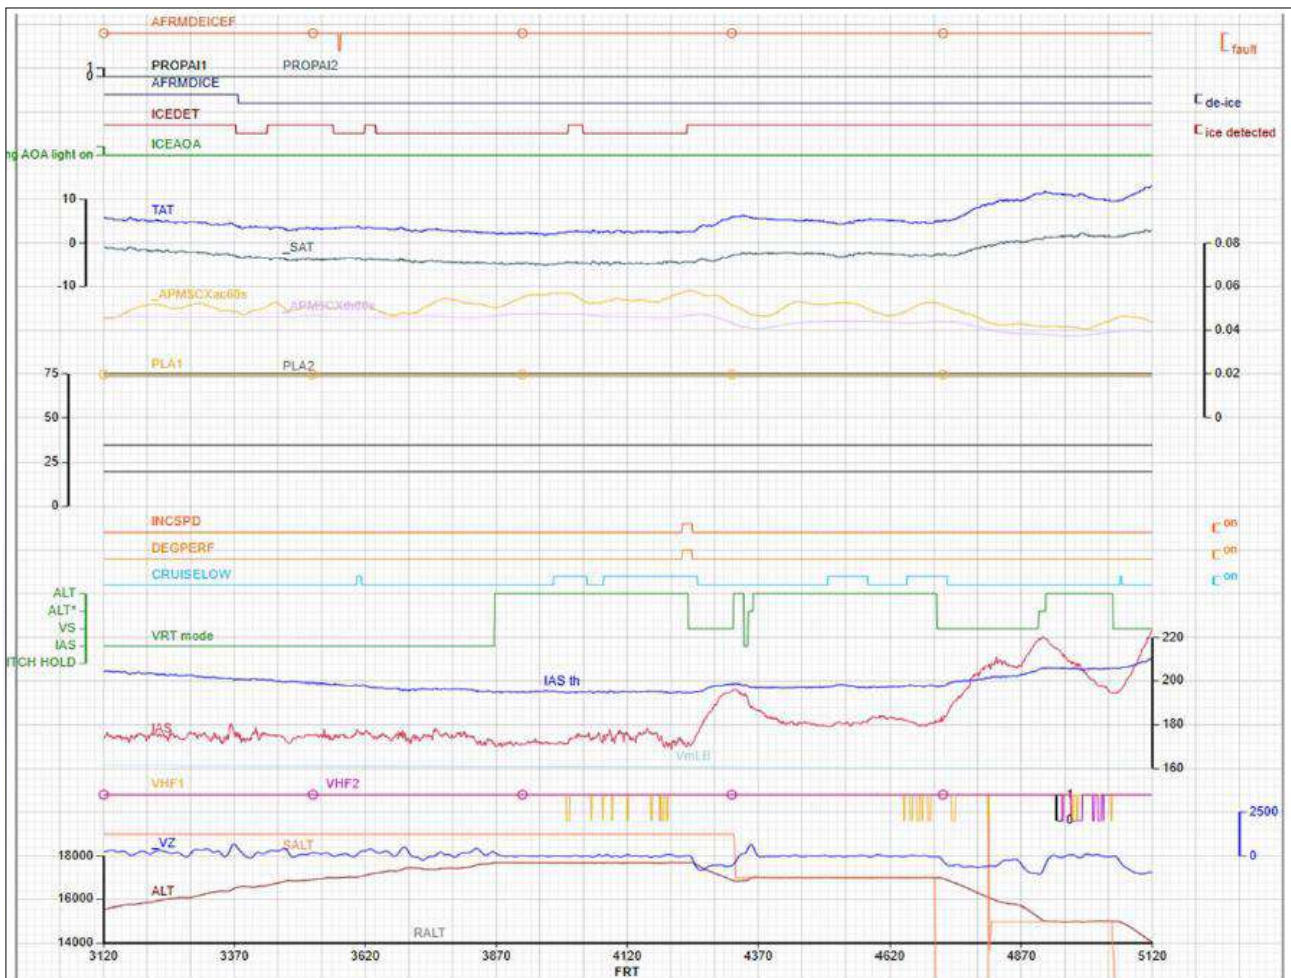
In a flight conducted by the company using another aircraft in the fleet, the theoretical IAS was 195 kt and the VmLB0icing was 160 kt (Figure 137). The Anti-Icing and Airframe De-Icing systems were activated; however, the Airframe De-Icing system presented a fault message.

Throughout the entire cruise phase, the aircraft operated with an indicated airspeed below 180 kt, reaching a minimum speed of 170 kt, that is, 25 kt below the theoretical IAS and 10 kt above the VmLB0icing. The increase in speed occurred only during the descent phase.

Figure 137 – Graph with flight data parameters from a flight conducted by the operator using an aircraft other than PS-VPB.

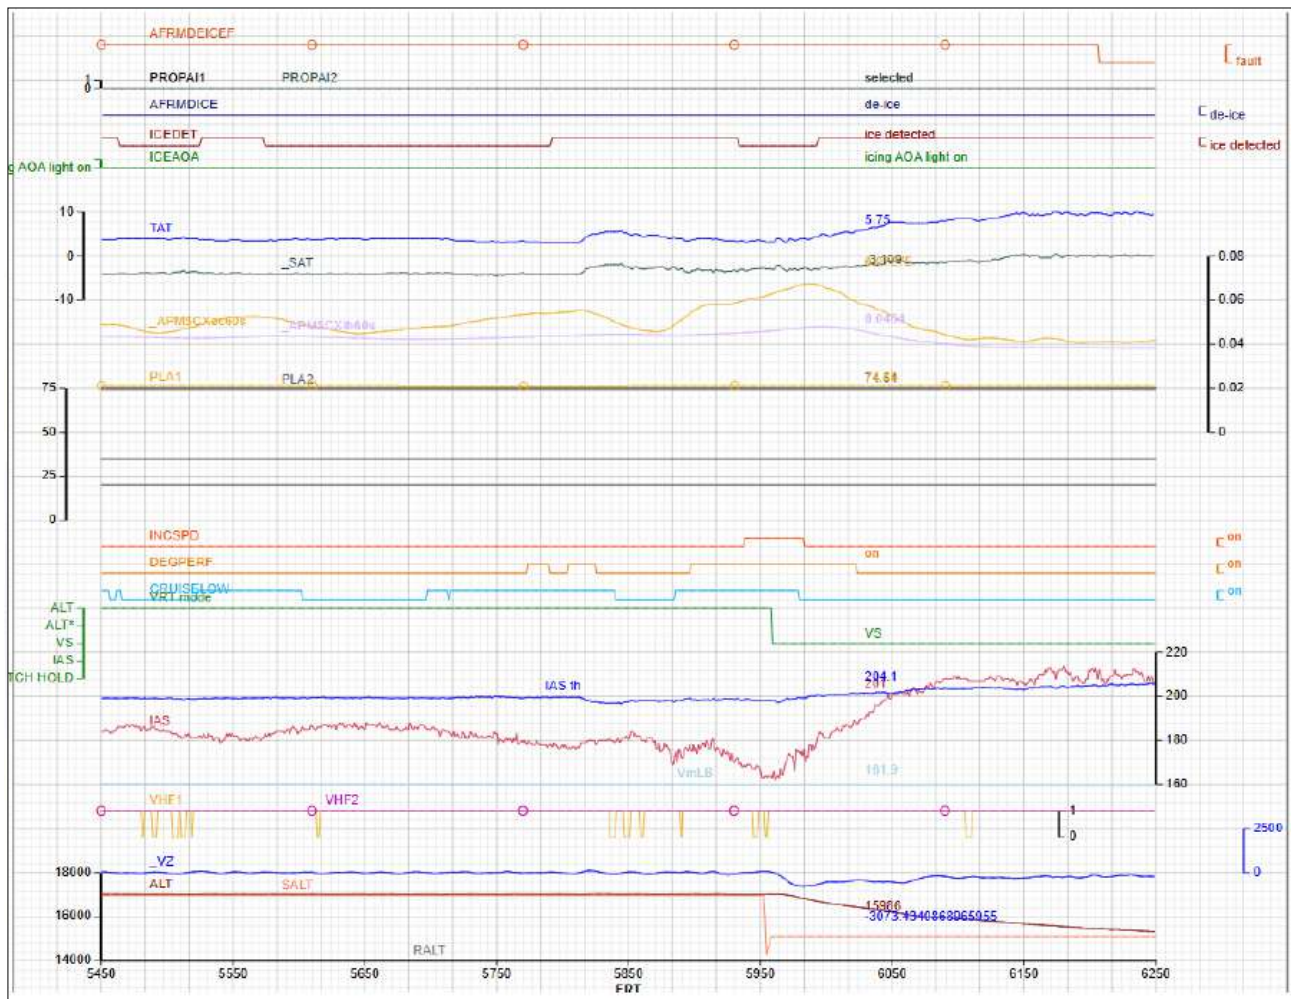
During the cruise phase, the aircraft operated with the IAS fluctuating around 180 kt. However, in the final portion of the cruise, prior to the start of the descent, there was a rapid and significant degradation of the IAS consistent with severe icing condition. The IAS reached a minimum value of 163 kt, that is, approximately 41 kt below the theoretical IAS and 1 kt above the VmLB0icing (Figure 138).

During the segment in question, several CRUISE SPEED LOW advisories, three DEGRADED PERFORMANCE alerts, and one INCREASE SPEED alert were recorded. The increase in IAS occurred only with the onset of the descent.

Figure 138 – Graph with flight data parameters from flights conducted by the operator using an aircraft other than PS-VPB.

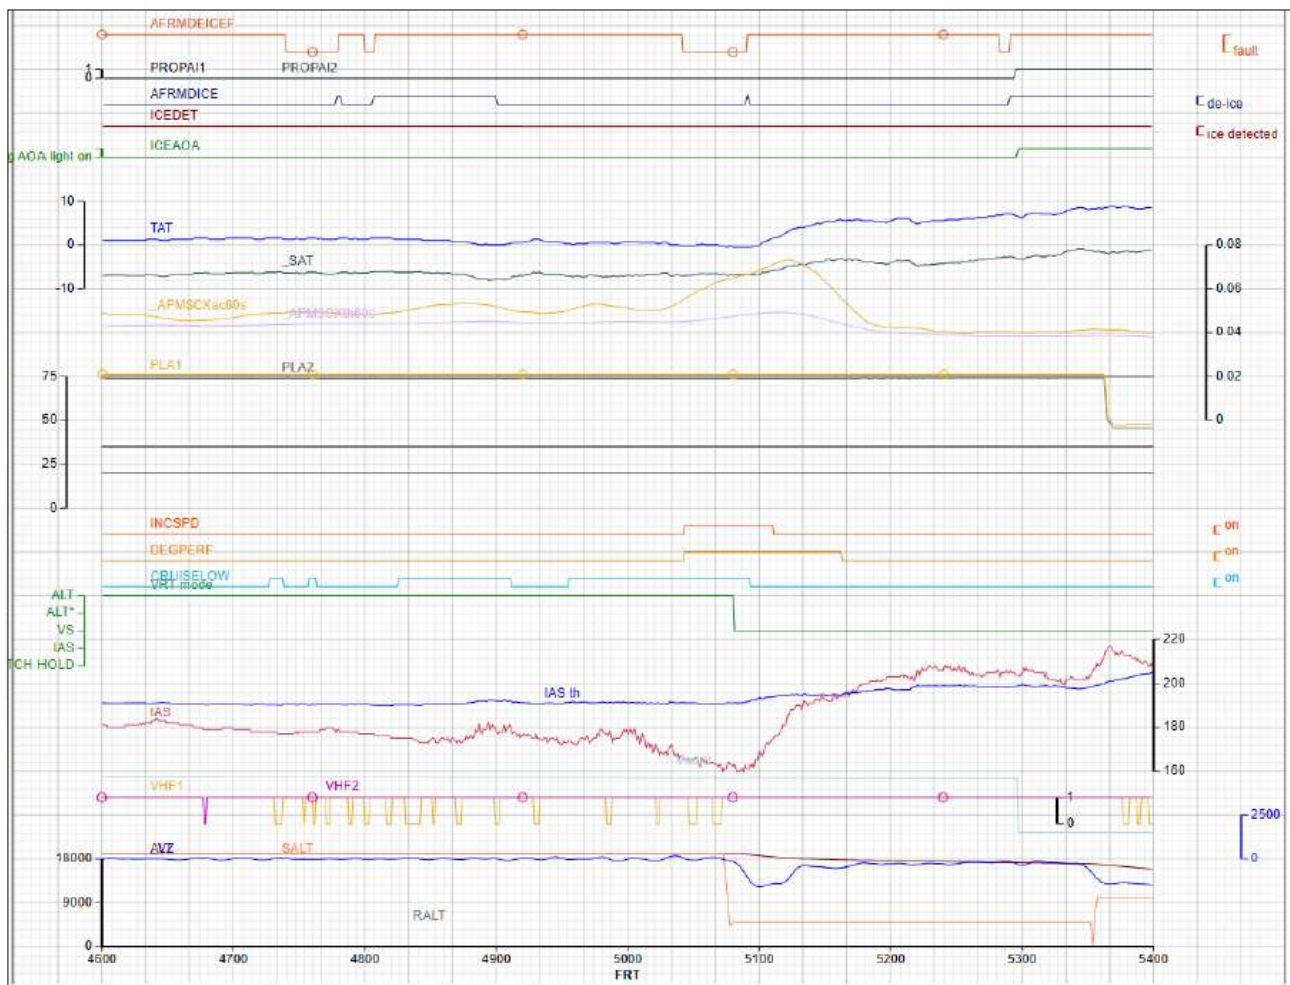
In another flight conducted by the company using an aircraft other than the one involved in the accident, the theoretical IAS was 190 kt and the VmLB0icing was 156 kt (Figure 139). The Anti-Icing and Airframe De-Icing systems were activated, and multiple fault messages were recorded in the Airframe De-Icing system throughout the flight.

During the cruise phase, the aircraft operated with indicated airspeed oscillating around 180 kt. At a certain point, there was a rapid and significant degradation of IAS, consistent with a severe icing condition, reaching a minimum value of 160 kt, that is, 30 kt below the theoretical IAS and 4 kt above the  $V_{mLBO_{icing}}$ .

During the affected segment, several CRUISE SPEED LOW advisories, one DEGRADED PERFORMANCE alert, and one INCREASE SPEED alert were recorded, appearing almost simultaneously. The increase in IAS occurred after the aircraft initiated the descent.

Figure 139 – Graph with flight data parameters from a flight conducted by the operator using an aircraft other than PS-VPB.

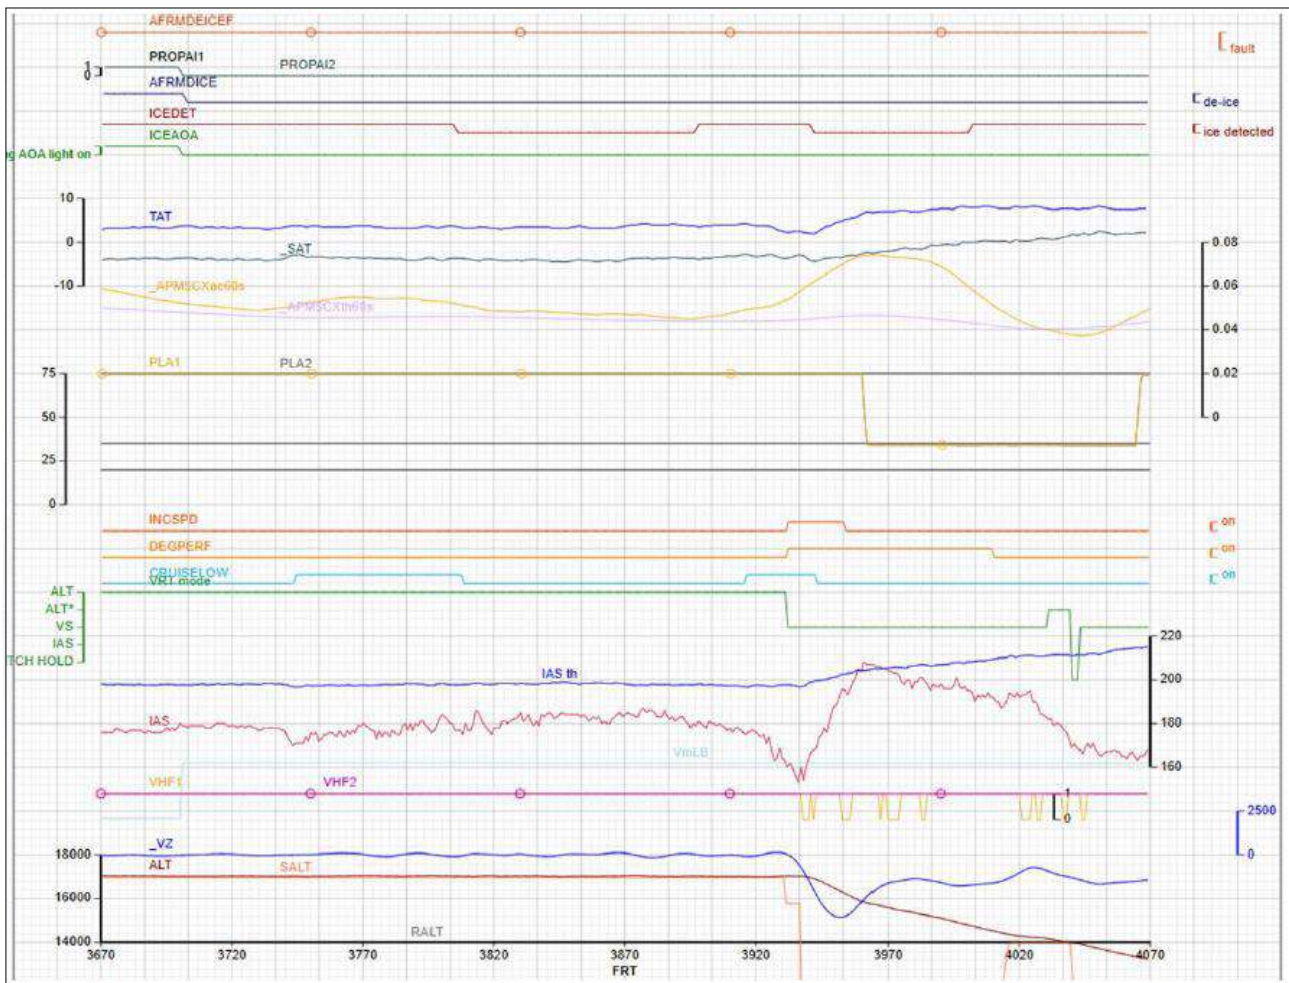
Another record of a flight conducted by the operator on an aircraft other than PS-VPB, indicated that the theoretical IAS was 198 kt and the VmLBOicing was 162 kt (Figure 140). The Anti-Icing and Airframe De-Icing systems were activated, and no fault-messages were recorded in the Airframe De-Icing system during the flight.

Throughout the entire cruise phase, the aircraft operated with the IAS around 180 kt. At a certain point, there was a rapid and significant degradation of the IAS, consistent with a severe icing condition, reaching a minimum of 157 kt, that is, 41 kt below the theoretical IAS and 5 kt above the VmLBOicing.

During the affected segment, two CRUISE SPEED LOW advisories, one DEGRADED PERFORMANCE alert, and one INCREASE SPEED alert were recorded, appearing almost simultaneously. The increase in IAS occurred only with the aircraft's descent.

Figure 140 – Graph with flight data parameters from flights conducted by the operator on an aircraft other than PS-VPB.

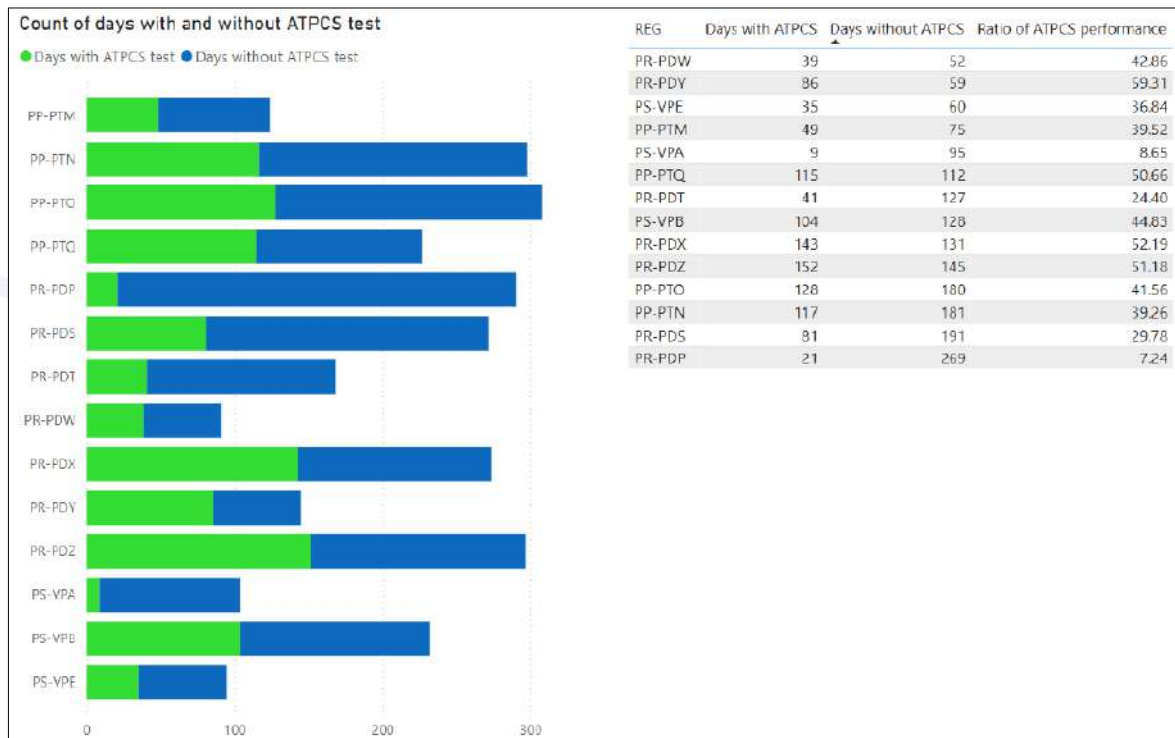
With regard to ATPCS execution data for other aircraft in the operator's fleet, the average execution rate was found to be approximately 37% (Figure 141).

This result highlighted a considerable number of commercial flight operations in which the aircraft took off without performing the dynamic ATPCS test, contrary to what is prescribed in the operational manuals.

Figure 141 – Graph illustrating the number of days with and without the execution of ATPCS tests for the aircraft in the operator's fleet.

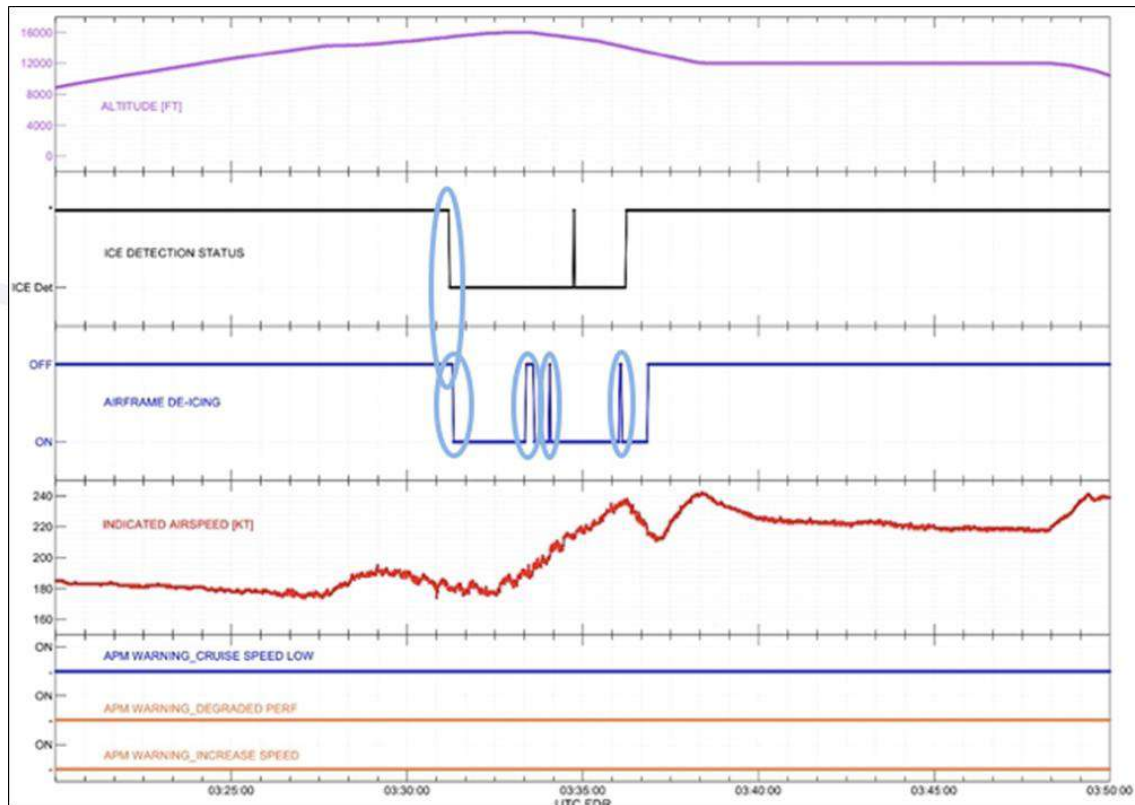
During this flight, the Electronic Ice Detector detected ice accumulation, with the illumination of the ICING light. Subsequently, the Airframe De-Icing system was activated. This can be verified in the graph of Figure 142, indicated by the first blue ellipses, one on the ICE DETECTION STATUS parameter and the other on the AIRFRAME DE ICING parameter.

Figure 142 – Graph of flight data parameters for “Flight -3”, highlighting ice accumulation detection, activation of the DE-ICING system, and execution of three system resets.

Following the MASTER CAUTION alert, the Airframe De-Icing system was reset three times (turned off and then on) as indicated by the subsequent blue ellipses in the AIRFRAME DE-ICING parameter in Figure 142.

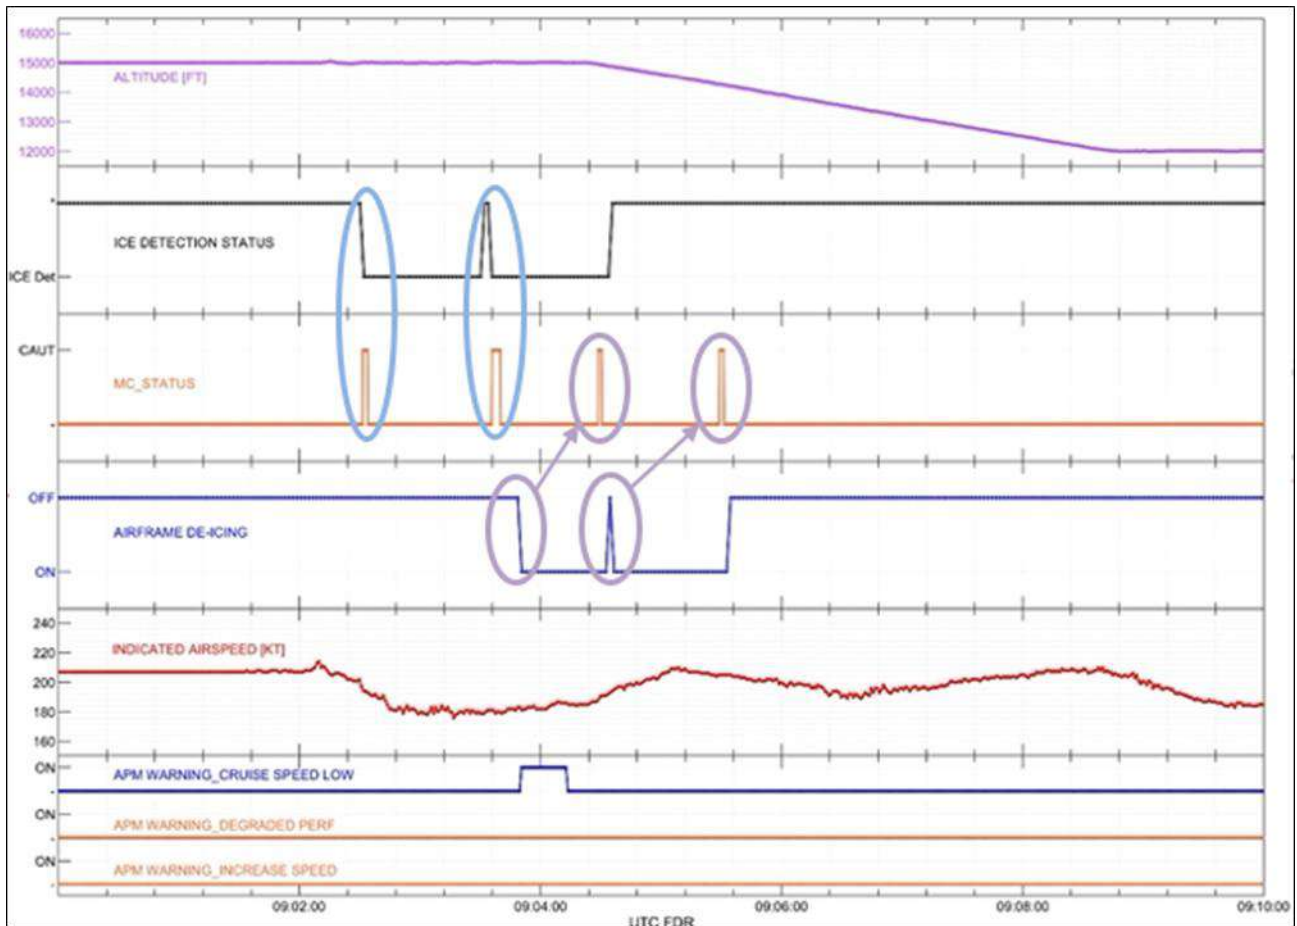
En route, during the cruise phase at FL150, the Electronic Ice Detector detected ice accumulation twice (blue ellipses in Figure 149). These detections were accompanied by MASTER CAUTION alerts and the single chime aural warning.

Figure 149 – Graphs of flight data parameters for “flight -2”.

Immediately following this alert, a reset of the system was performed. Shortly thereafter, however, the Electronic Ice Detector no longer detected ice accumulation. Approximately one minute later, a new fault was observed. On this occasion, however, the Airframe De-Icing system was turned off by the crew (purple ellipses in Figure 149).

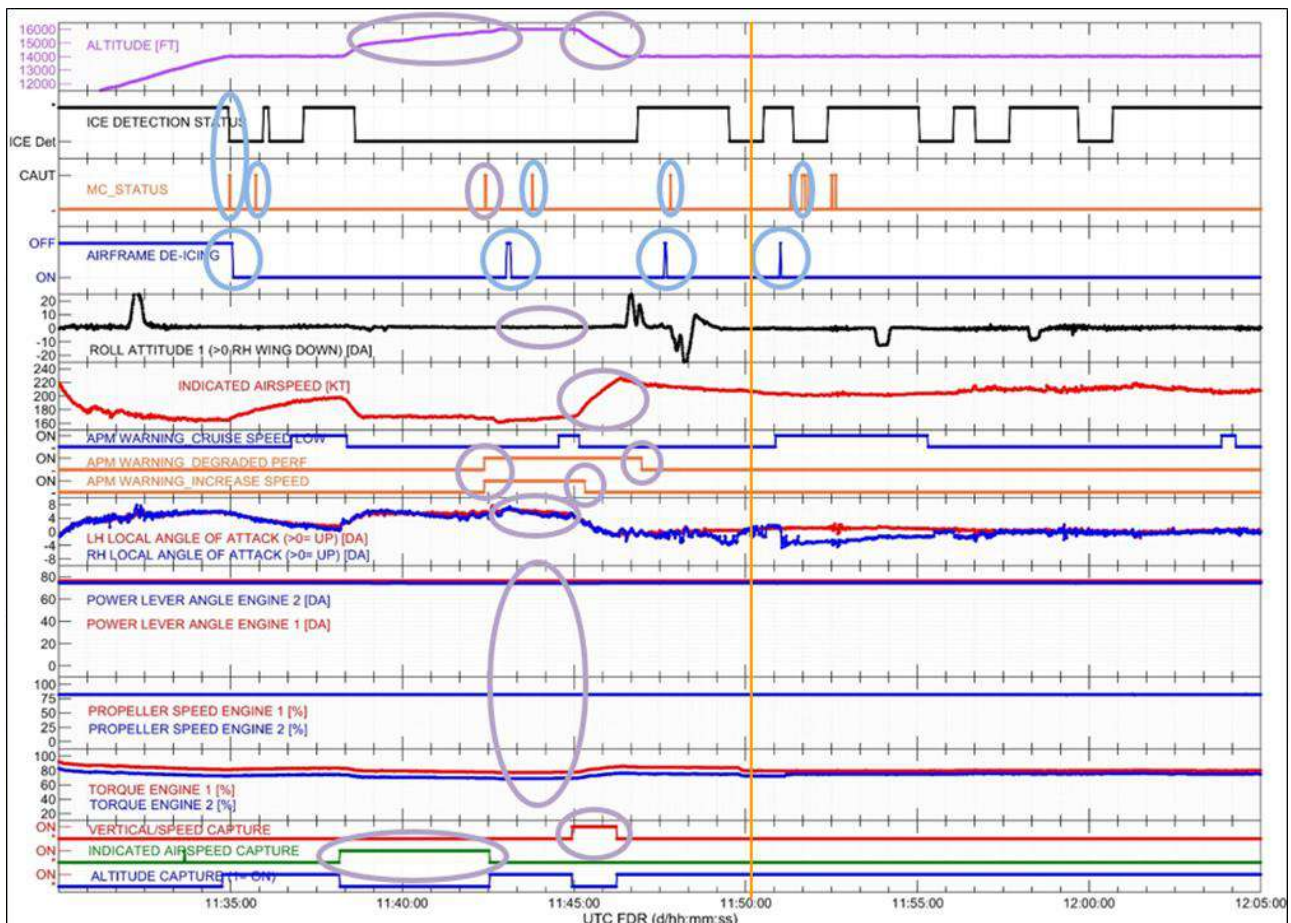
Ice was detected by the Electronic Ice Detector at the end of the climb phase, near FL140, culminating in the triggering of the MASTER CAUTION alert (blue ellipse positioned in the upper left corner), associated with the single chime aural warning.

The FDR subsequently recorded the activation of the Airframe De-Icing system by the flight crew (Figure 152)

Figure 152 – Graph with flight data parameters related to “flight -1”.

A few seconds later, another MASTER CAUTION alert was issued, accompanied by a single chime aural warning. Data recorded on the MPC memory card indicated that this alert was associated with the AIRFRAME FAULT message. Despite these alerts, the flight crew maintained the AIRFRAME DE-ICING system on, contrary to the DE ICING AIRFRAME FAULT procedure set forth in the QRH (Figure 147).

Another condition observed by the Commission was the simultaneous activation of the DEGRADED PERFORMANCE and INCREASE SPEED alerts, both classified as CAUTION level. This situation was evidenced during “flight -1” (item 1.18.1.3) and illustrated in Figure 152, as well as in other flights presented in item 1.17.8.1, whose graphs are shown in Figures 129, 131, and 132.

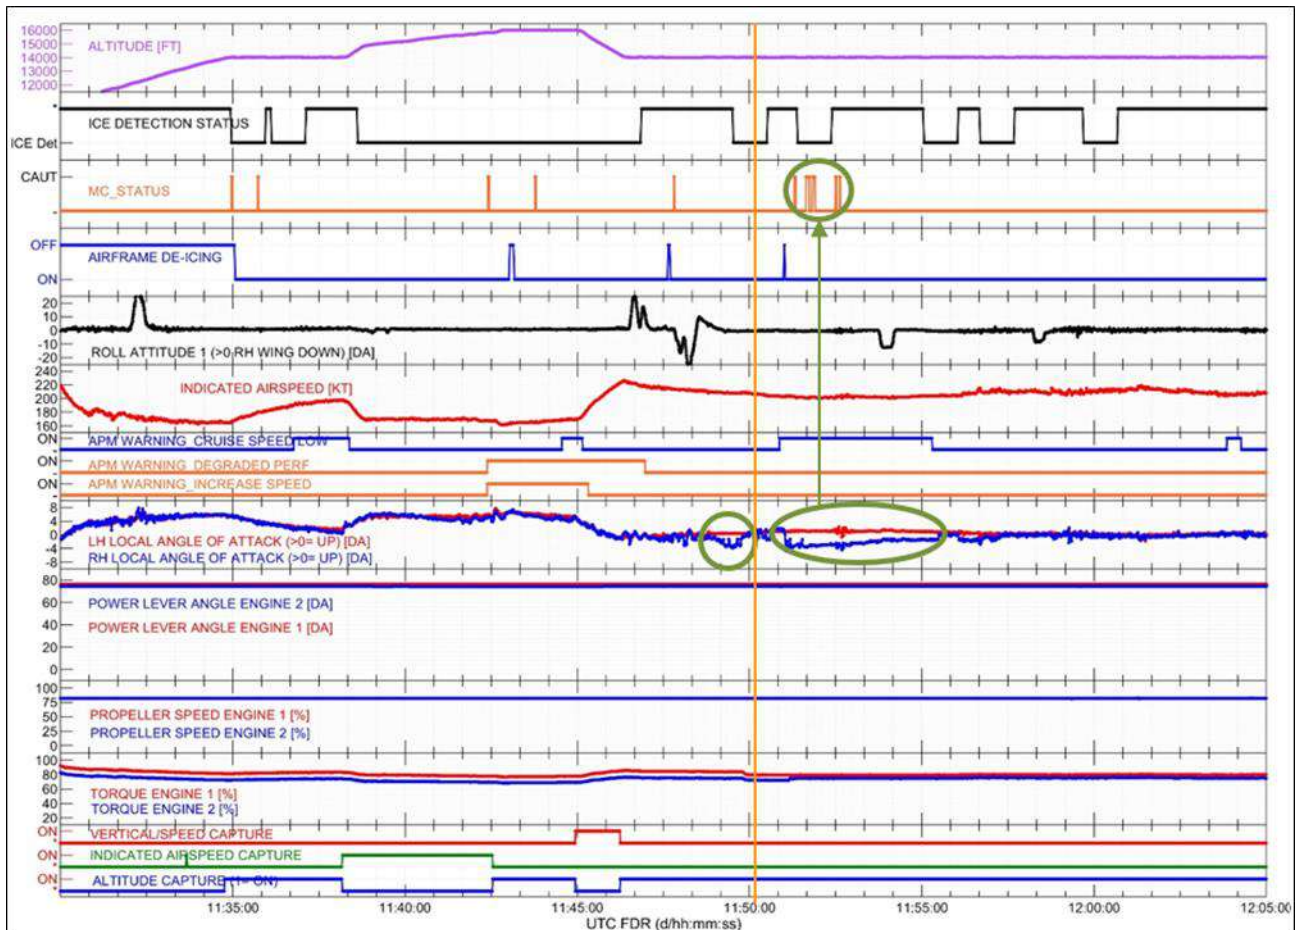
In Figure 156, the green ellipses highlight moments when the two AOA sensors began to register discrepant values. When this difference exceeded 4° for more than 5 seconds, the MFC inhibited the availability of the stick pusher and stick shaker system. As a result, a MASTER CAUTION alert was generated, accompanied by the single chime aural warning and illumination of the FAULT light on the STICK PUSHER/SHAKER button.

The F/O ALPHA PROBE HEAT message, related to the heating of the right-side AOA sensor, was recorded 16 times by the MPC during this flight.

The STICK PUSHER FLT message was also recorded by the MFC; however, it is important to note that the AOA threshold for stick pusher activation was not reached during this flight.

Figure 156 – Graph of flight data parameters, highlighting moments when the two AOA sensors began to register discrepant values, with activation of the MASTER CAUTION alert.

Once the values measured by the two AOA sensors returned to agreement, the alert was suppressed and the stick pusher system resumed its normal functionality. This discrepancy between the values recorded by the AOA sensors did not occur during the accident flight.

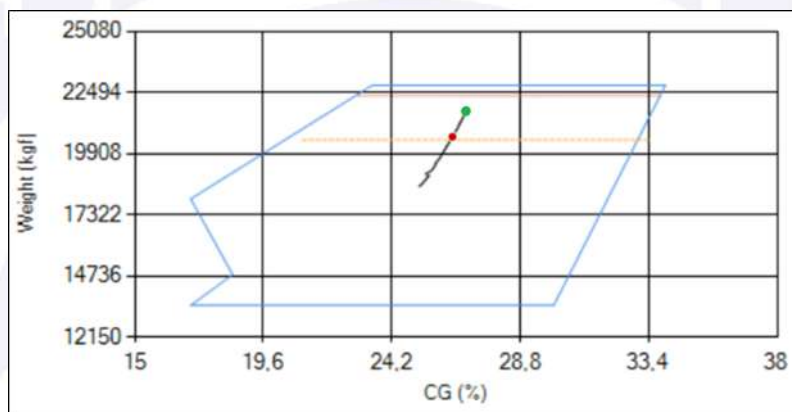
Considering the weight of the passengers, the cargo carried, and the fuel consumed on the ground, the takeoff weight was estimated at 21,665 kg, with the CG at 26.9% of the Mean Aerodynamic Chord, within the operational envelope (green point in Figure 159).

Based on the flight time and the average consumption derived from the FDR fuel flow data, it was calculated that, at the time of the accident, the aircraft had approximately 2,189 kg of fuel on board, corresponding to a total weight of 20,654 kg and a CG at 26.3% of the Mean Aerodynamic Chord (red point in Figure 159). Ice accretion was not considered in the weight and balance calculation at the time of the accident.

Figure 159 – Aircraft weight and balance envelope showing the estimated weight and CG position, without considering ice accretion.

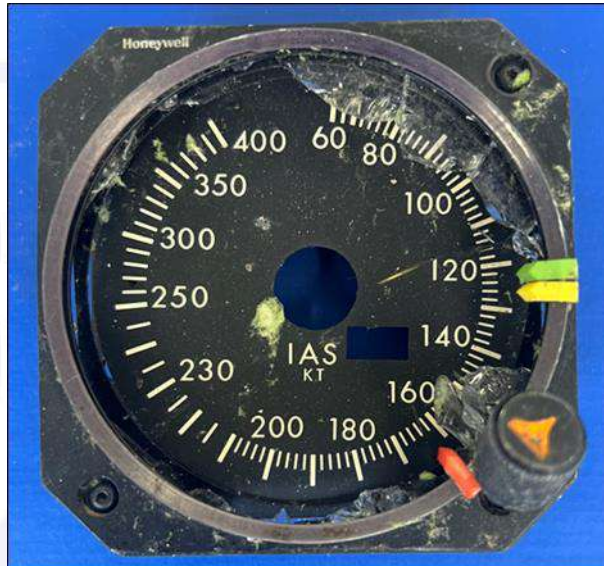
Furthermore, PIC's airspeed indicator (Figure 161) was found at the accident site with the ICING BUG (RED BUG) speed set close to the calculated value, indicating that the pilots did, in fact, set the V<sub>MLB0</sub>icing speed as reflected in the audio recordings. However, it was not possible to identify the position of the SPEED BUG on the airspeed indicator.

Figure 161 – PIC's airspeed indicator with the RED BUG set to a speed close to 165 kt.
