**COMANDO DA AERONÁUTICA**  
**CENTRO DE INVESTIGAÇÃO E PREVENÇÃO DE**  
**ACIDENTES AERONÁUTICOS**

**FINAL REPORT**  
**A-116/CENIPA/2024**

**PS-VPB**

**ATR-72-212A (500)**

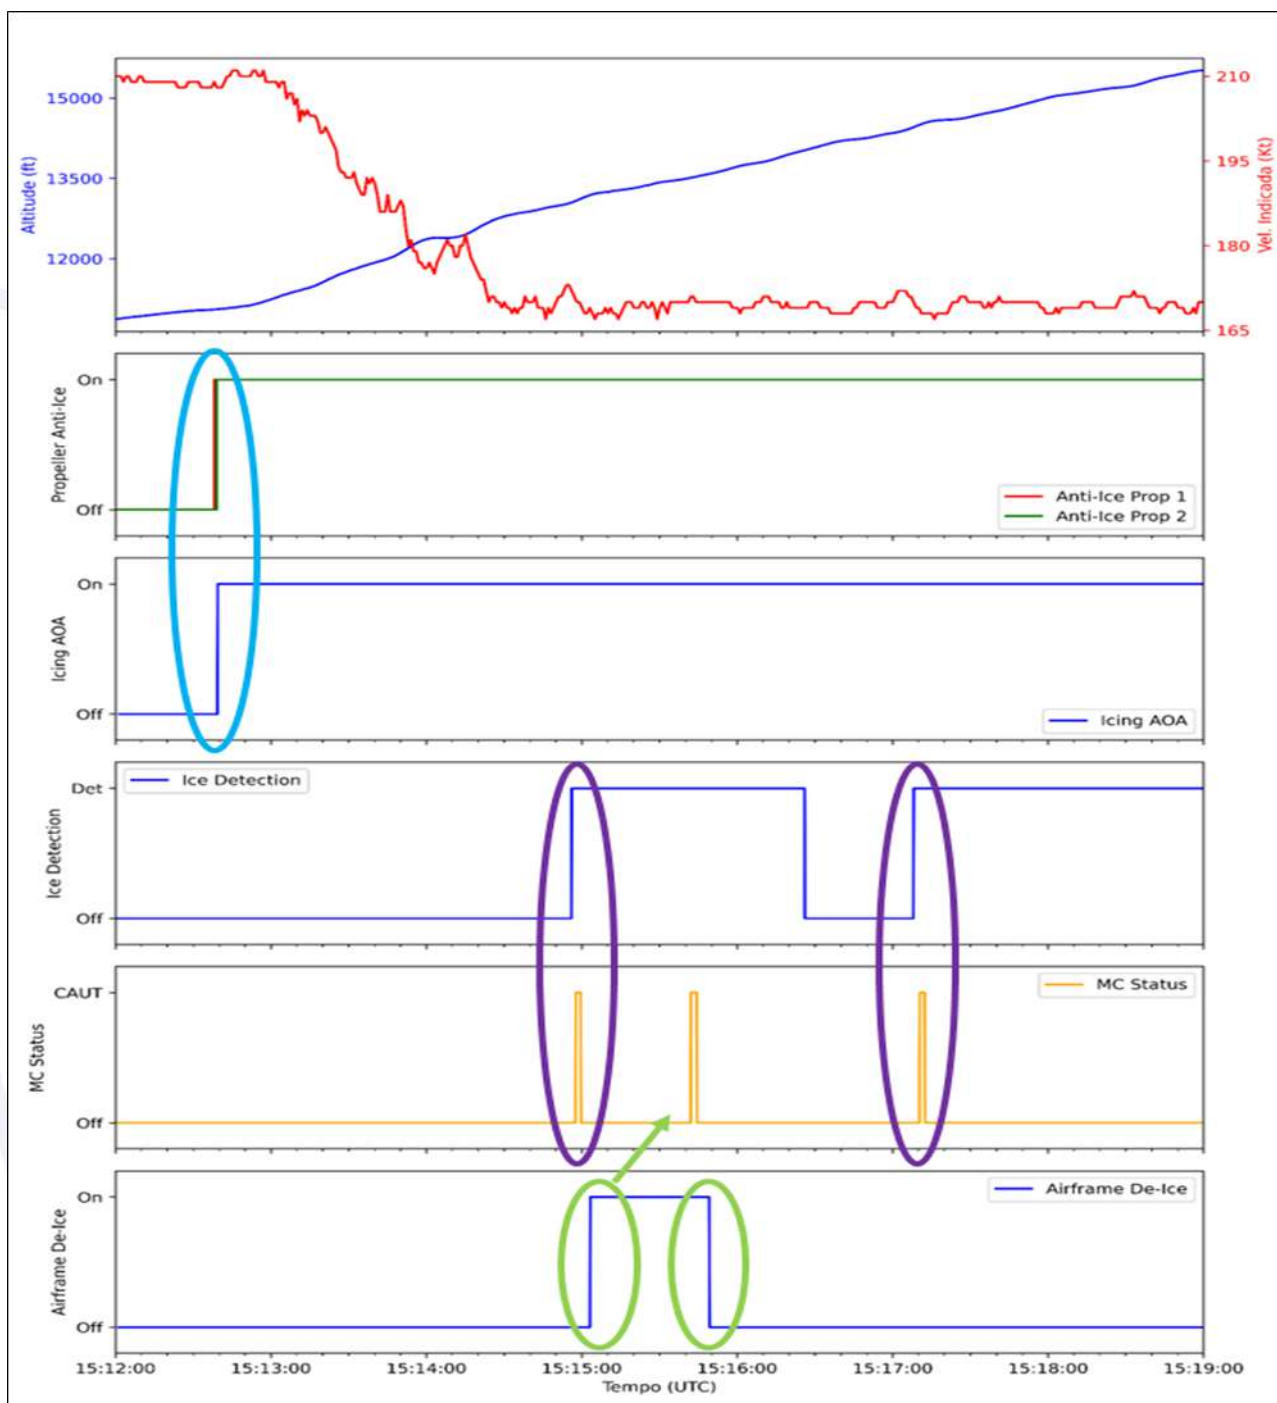
Figure 162 – Graph of flight data parameters highlighting information from systems related to ice detection and Anti-Icing/De-Icing.

The blue ellipse highlights the moment when the level 2 Anti-Icing systems were activated. The purple ellipses indicate the moments when icing was detected by the Electronic Ice Detector, along with the triggering of the MASTER CAUTION alert. The green ellipses refer to the moments of activation and deactivation of the Airframe De-Icing system. The green arrow indicates another instance of MASTER CAUTION alert activation. Data recorded in the non-volatile memories of the MFCs indicated that this alert was associated with the Right Wing Boot B Fault message.

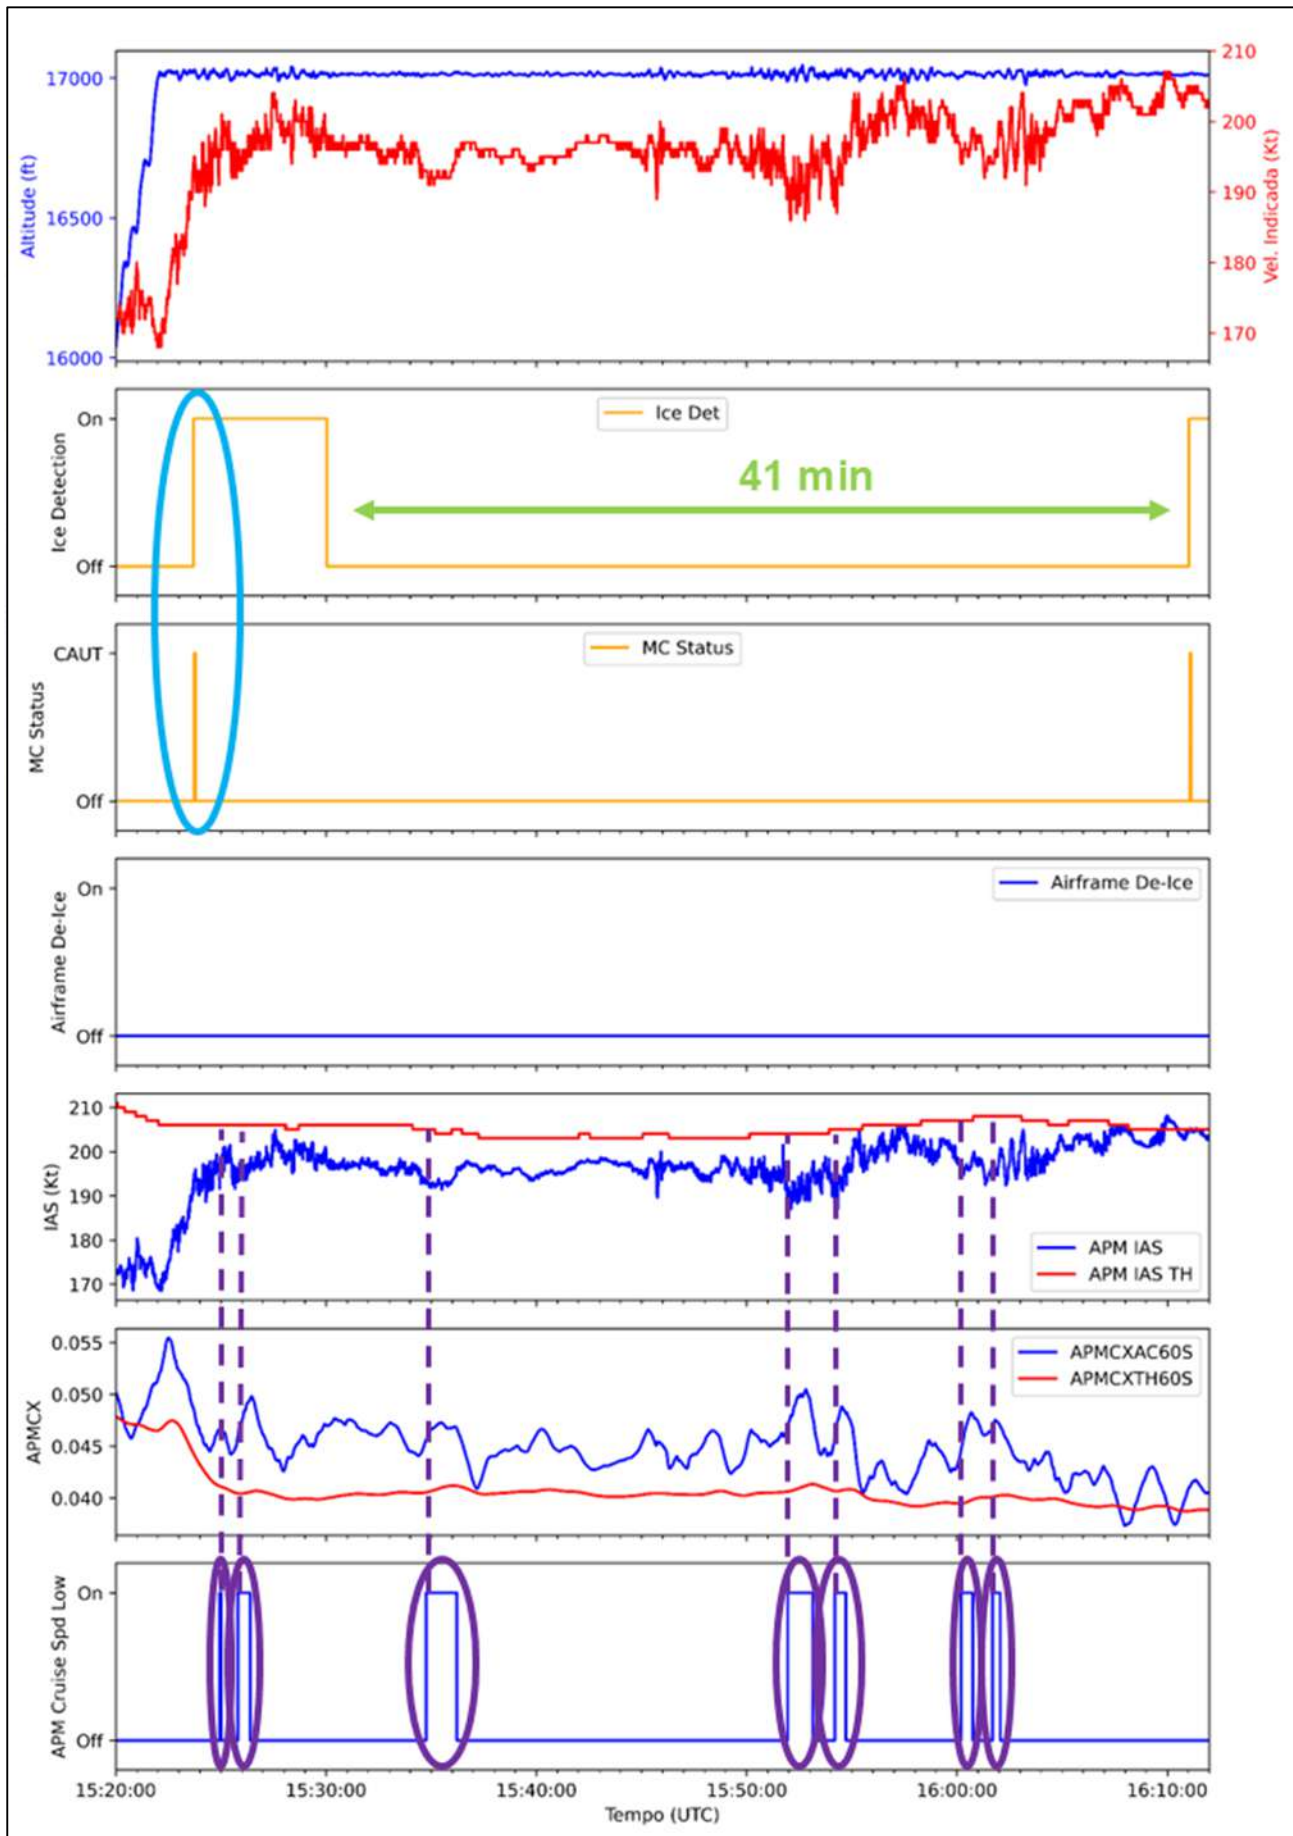
Figure 163 – Graph of flight data parameters highlighting the moments of ice detection and the warnings/alerts issued.

At 15:23:42 UTC, approximately two minutes after the aircraft leveled off at FL170, the Electronic Ice Detector indicated ice accretion, which was accompanied by the issuance of a MASTER CAUTION alert (blue ellipse) and the automatic recording by the MPC of a message related to ice detection while the De-Icing system was not activated (ICE DETECTED WHILE D/ICE SYSTEM IS OFF).

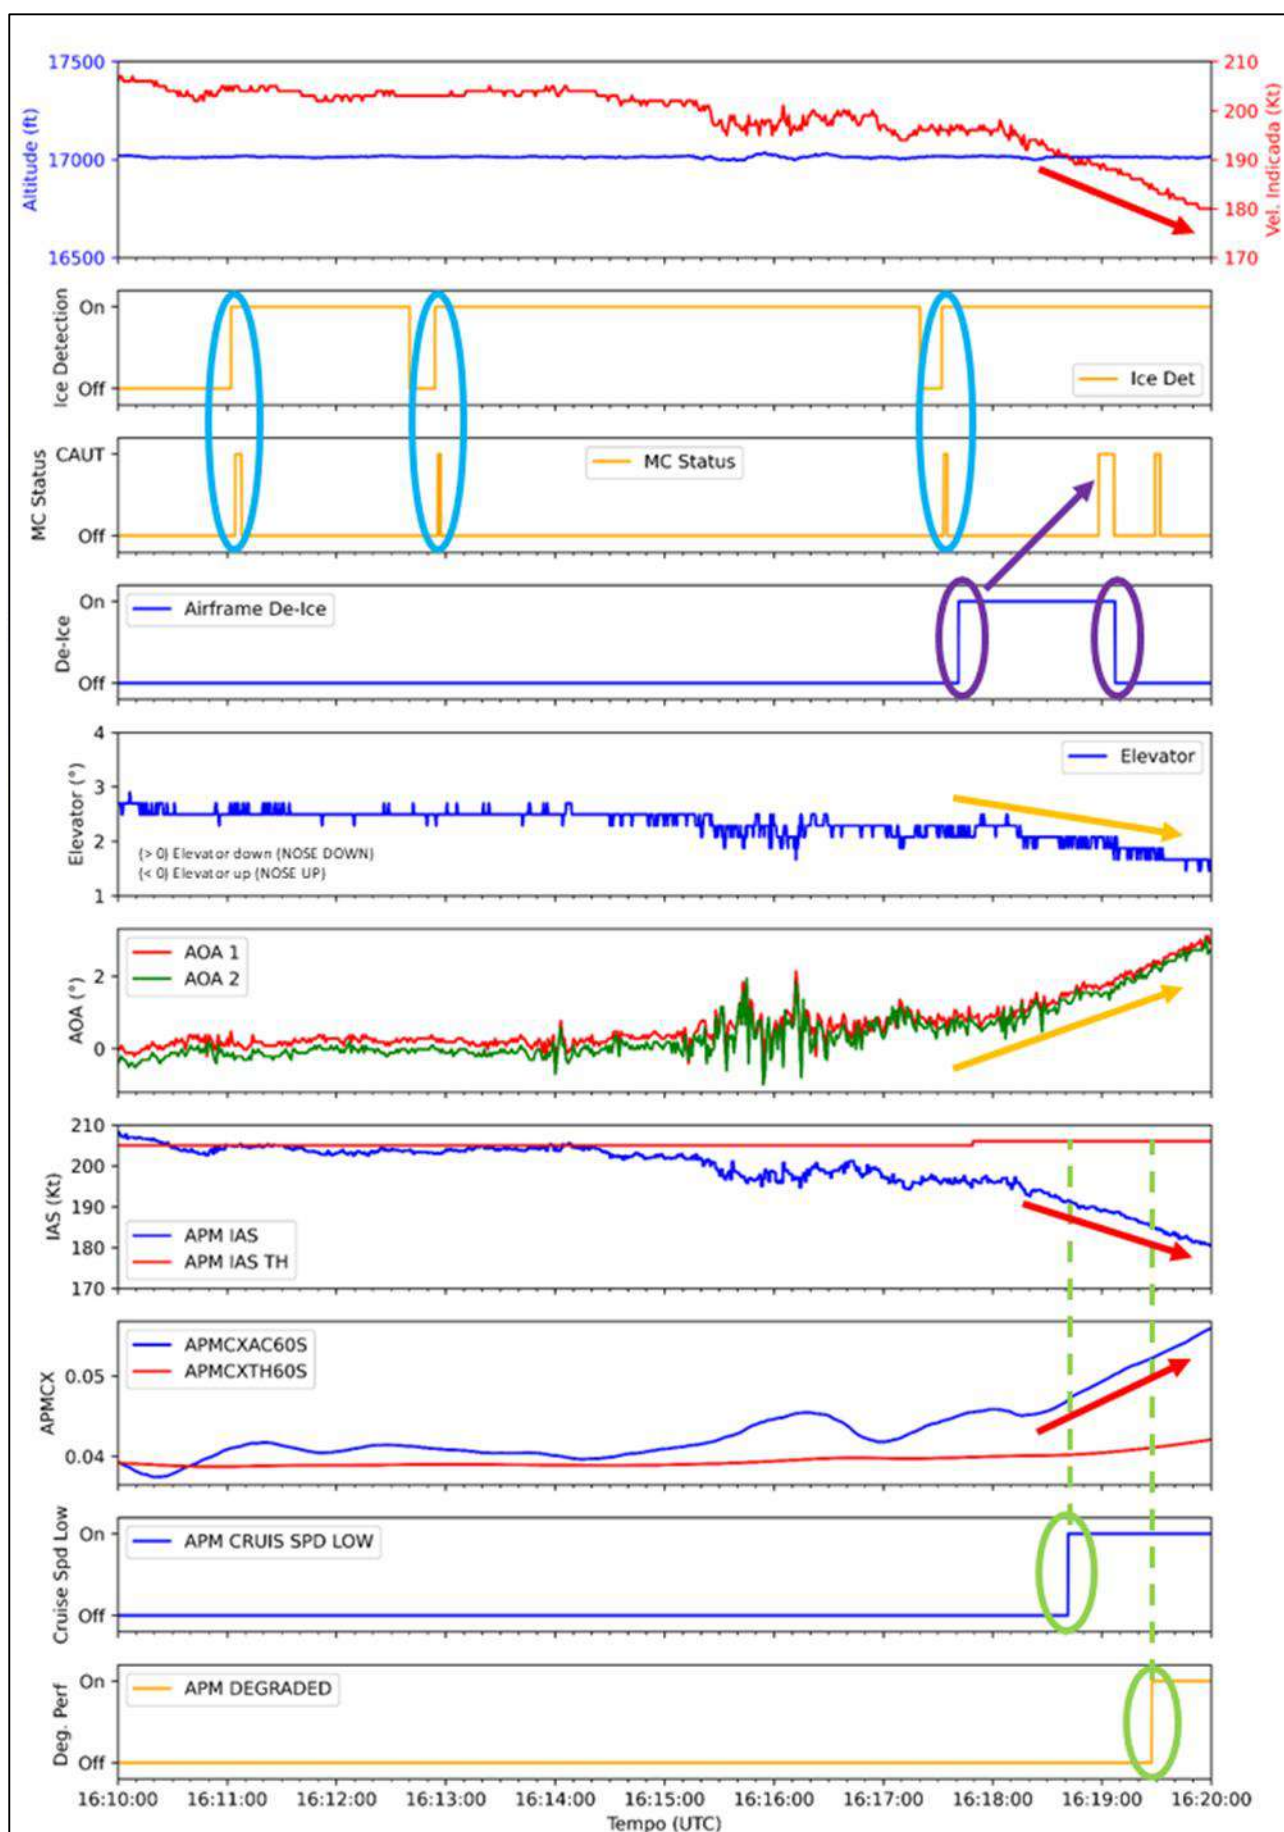
After an interval of approximately 41 minutes without detection, indications of ice accretion were again observed at three distinct moments (blue ellipses in Figure 164). These three detections, identified by the Electronic Ice Detector, were associated with three MASTER CAUTION alerts.

Figure 164 – Graph of flight data parameters highlighting the moments of ice detection, degradation of indicated airspeed, and the warnings/alerts issued by the APM during the cruise phase.

It is noteworthy that, during the approximately 6-minute interval between the three ice accretion detections, the Airframe De-Icing system remained off, while the Anti-Icing system remained active. After the third ice accretion detection, at 16:17:41 UTC, the flight crew activated the Airframe De-Icing system (first purple ellipse).

It was observed, during this cruise interval, an increase of drag calculated by the APM, and a decrease in the speed (red arrows). As a consequence, the AP commanded an elevator deflection in the nose-up direction. This deflection was intended to increase the AOA (orange arrows) in order to maintain the altitude since the ALT HOLD mode was engaged. It is important to note that, during this cruise period, there was no variation in the engine or propeller parameters.

During these interactions, at 16:19:28 UTC, with an IAS of 185 kt and the drag calculated as 27% higher than that specified by the APM, the DEGRADED PERFORMANCE alert was triggered (as indicated by the green ellipse in Figure 164), accompanied by a MASTER CAUTION alert and a single chime aural warning.

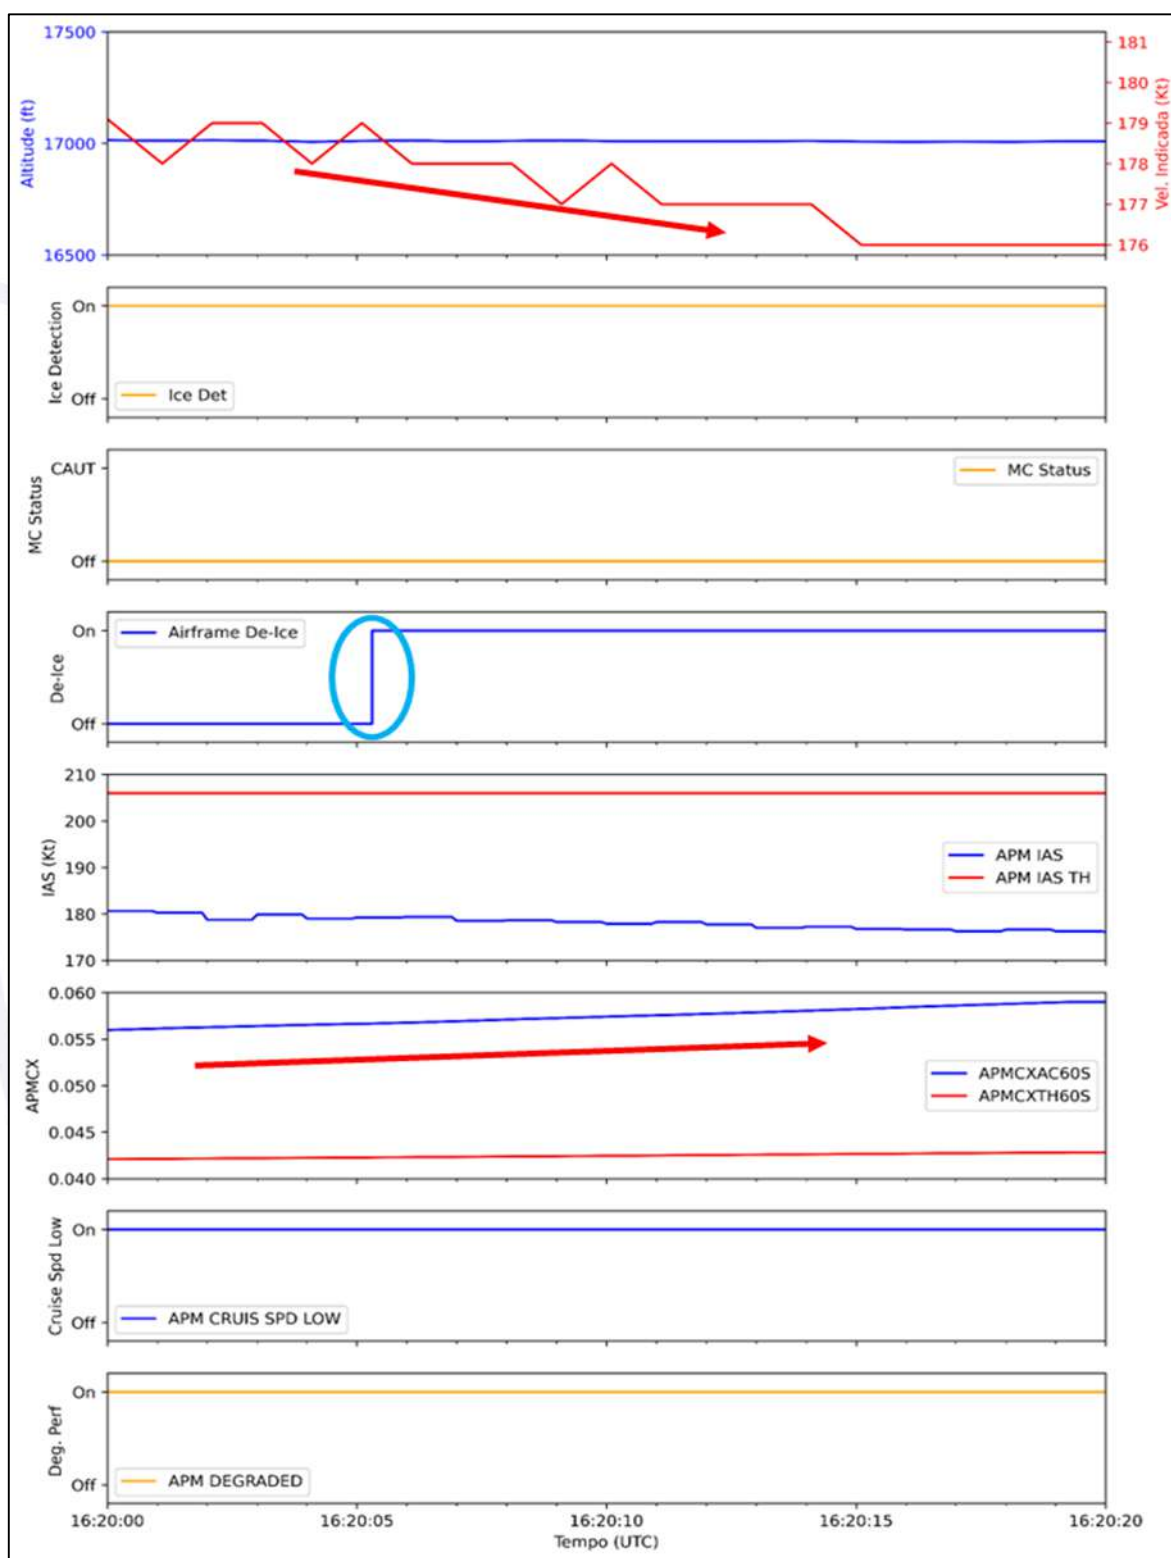
At 16:20:04 UTC, the SIC commented on the presence of “significant ice” (*bastante gelo*) and stated that he would turn on the Airframe De-Icing system. At that moment, the ICING, CRUISE SPEED LOW, and DEGRADED PERF warnings/alerts were active (Figure 166). The PIC then made a remark indicating that the Airframe De-Icing system was not functioning.

Subsequently, the Airframe De-Icing system was activated for the last time (blue ellipse) at 16:20:05 UTC, and the SIC initiated the reading and execution of the Descent Checklist, completing the task at 16:20:25 UTC. During this interval, a continuous trend of decreasing airspeed and increasing aircraft drag was also observed (red arrows of Figure 166).

Figure 166 – Graph of flight data parameters highlighting the activation of the Airframe De-Icing system following the DEGRADED PERFORMANCE alert.

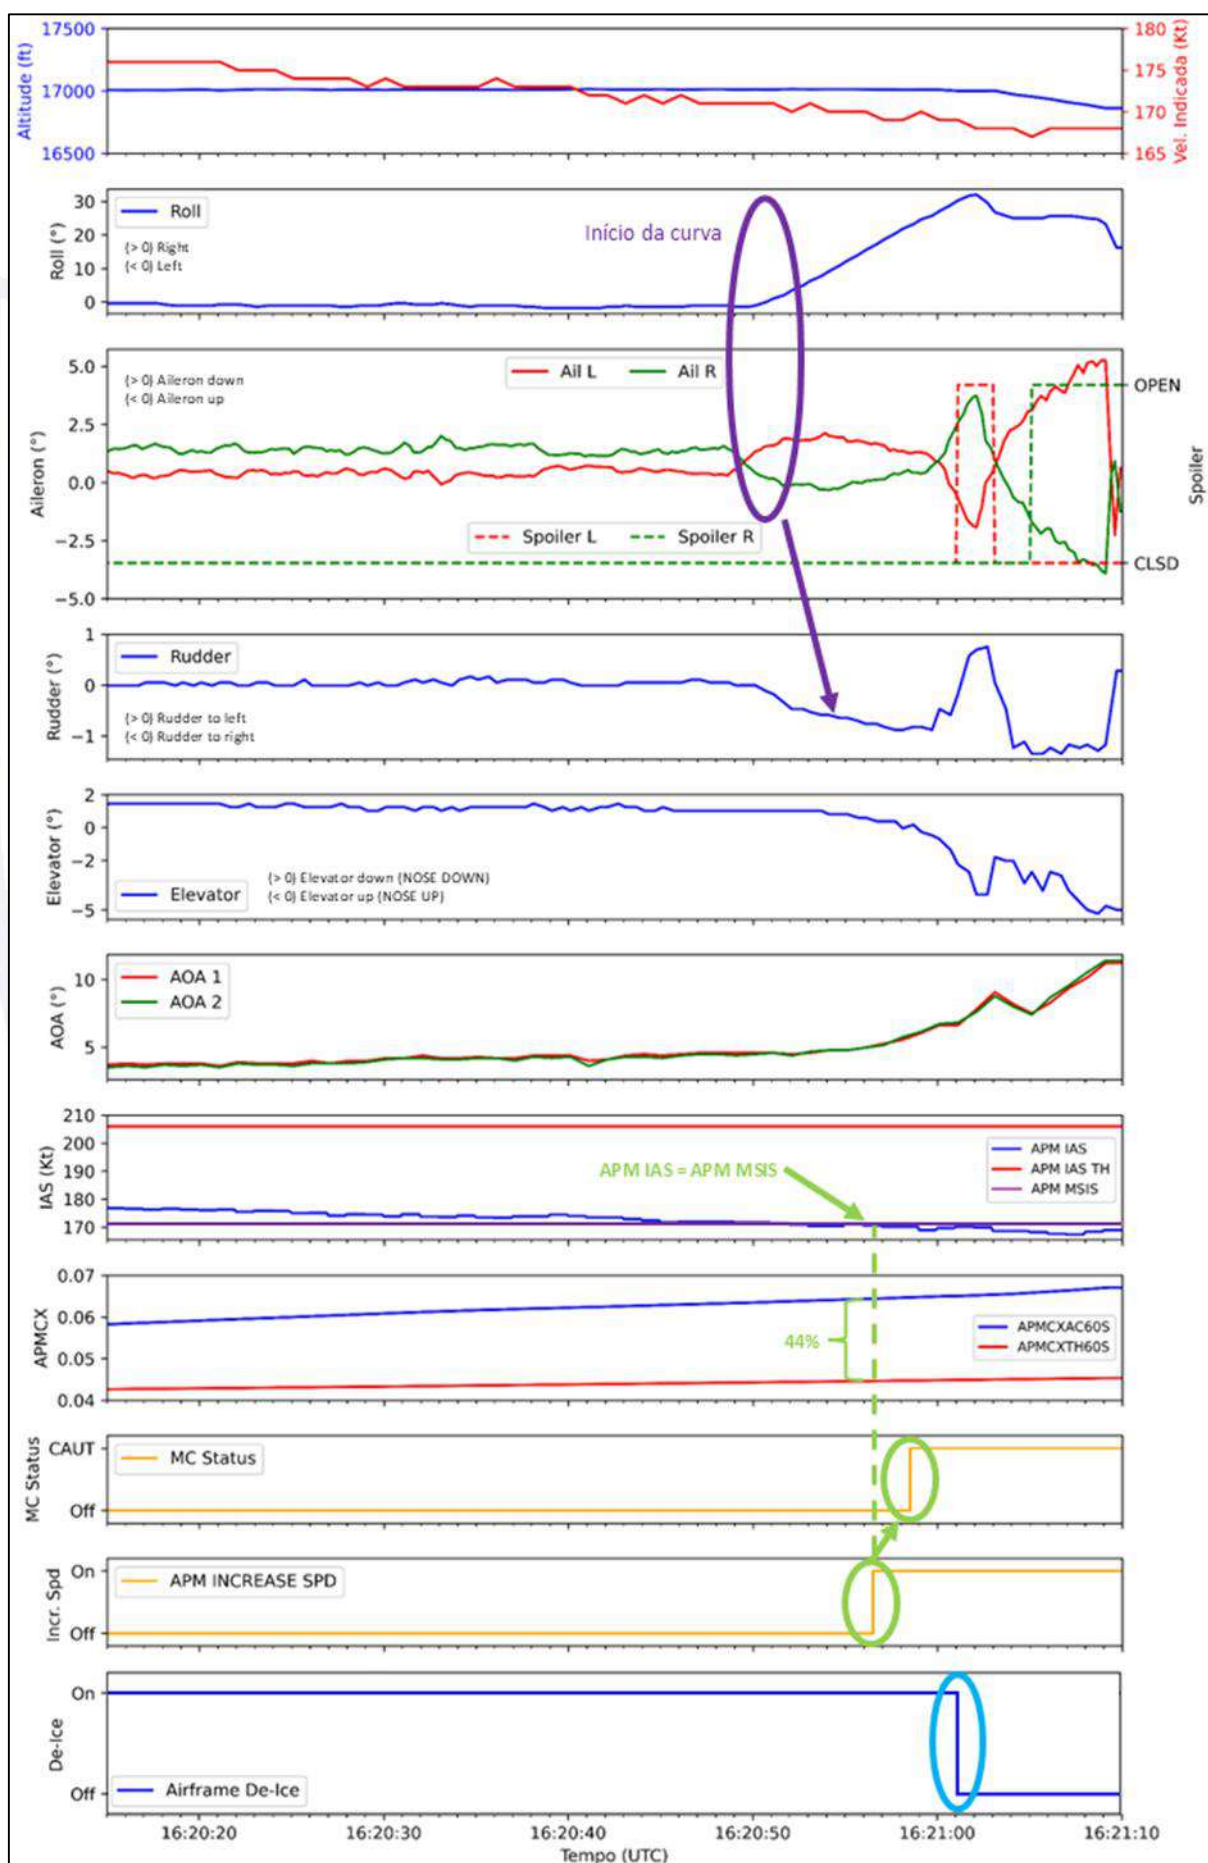
In order to execute the turn, the AP commanded aileron deflections to induce a right roll (purple ellipse in Figure 168), initiating a right bank as a result of asymmetric aileron deflection, with no initial spoiler deployment. Through the action of the YD, a slight right rudder deflection could be observed for coordination of the turn (purple arrow).

Figure 168 – Graph of flight data parameters highlighting the moments of performance degradation, the alerts issued, and the turn performed by the aircraft.

At 16:20:57 UTC, upon reaching 18° of right bank, the INCREASE SPEED alert was triggered, with the activation of a MASTER CAUTION alert (green ellipses), accompanied by a single chime aural warning, at the moment when the IAS reached the MSIS computed by the APM. At that time, the calculated drag was 44% higher than the theoretical drag specified by the APM.

The SIPAER Investigation Commission verified that the Airframe De-Icing system was turned off at 16:21:01 UTC, four seconds after the activation of the MASTER CAUTION alert (blue ellipse in Figure 168).

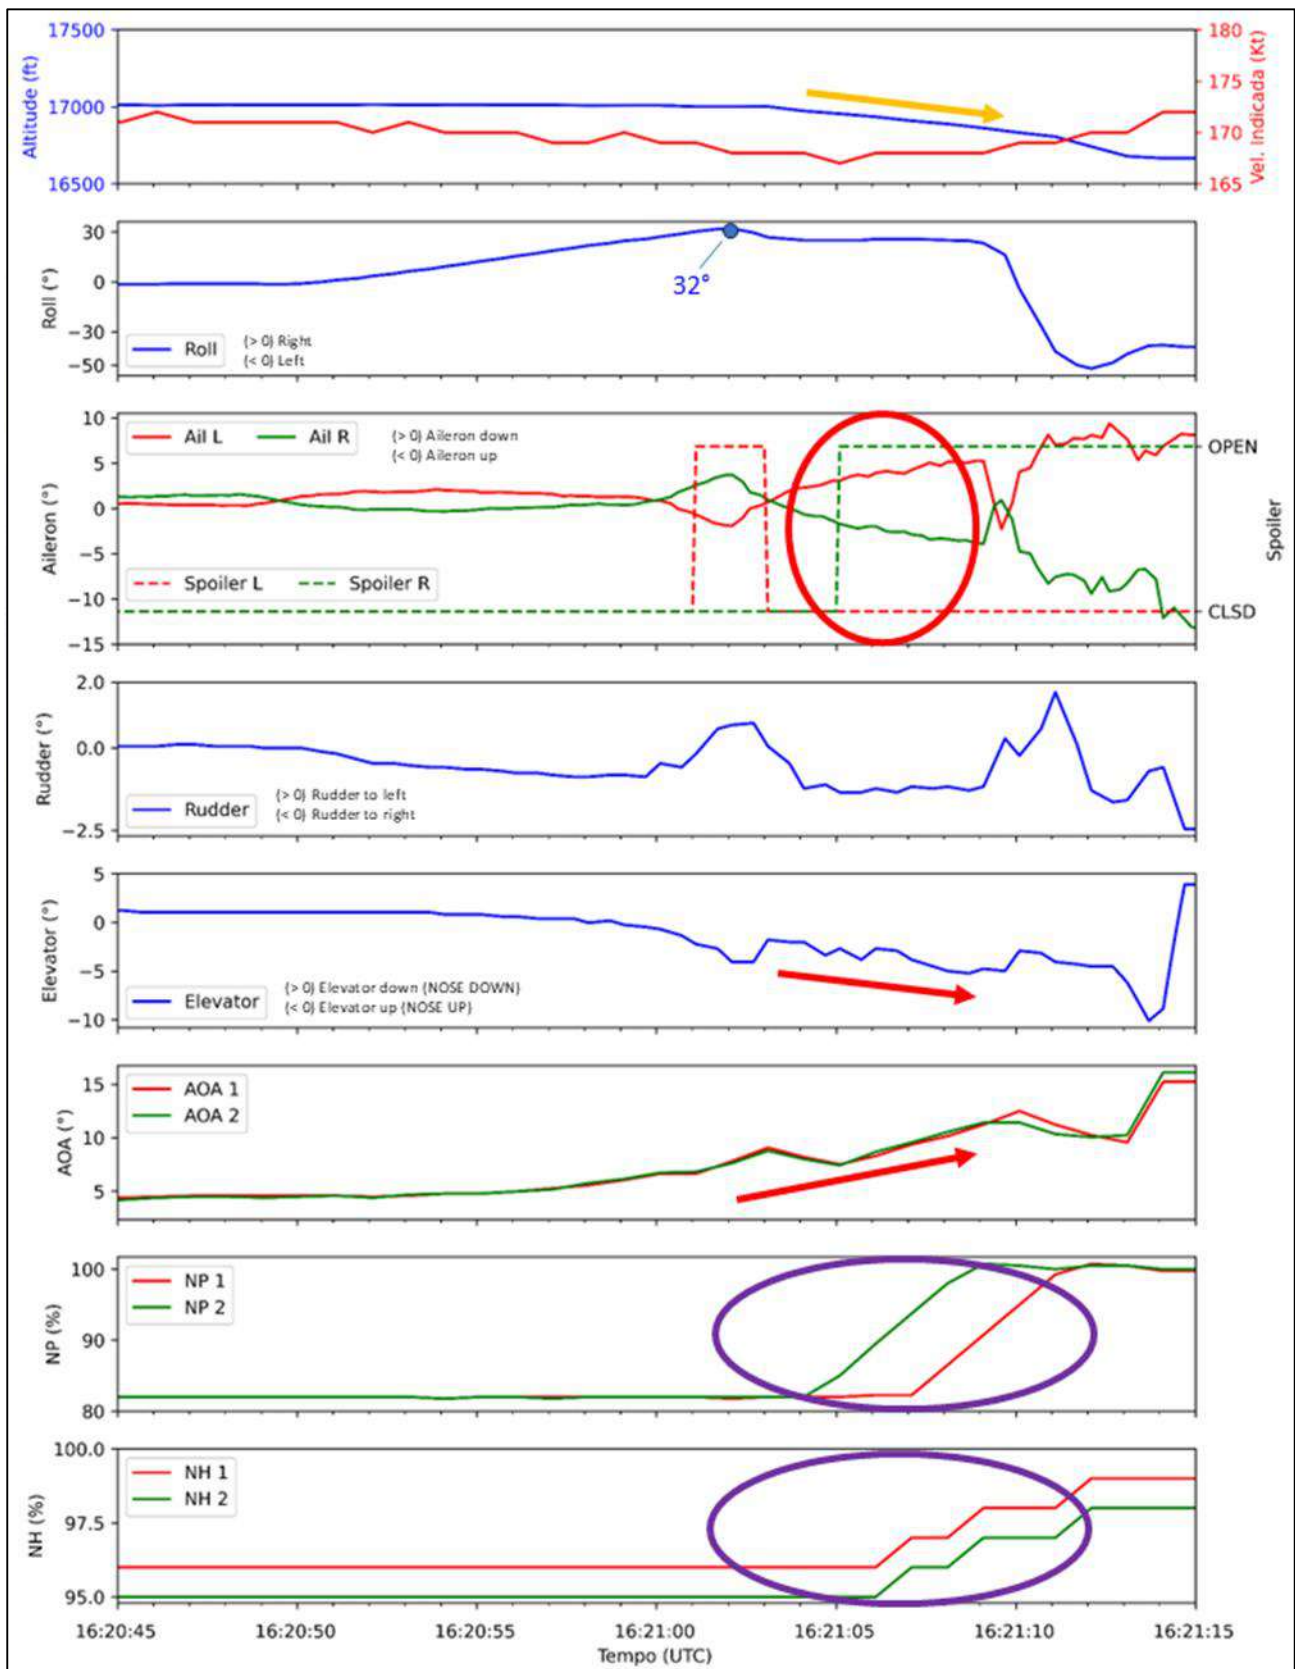
During the turn, the AP sought to achieve the bank angle prescribed for the lateral module in HIGH BANK mode (27°). During this bank angle acquisition, the aircraft reached a maximum value of 32° to the right (Figure 169).

Figure 169 – Graph of flight data parameters highlighting the AP inputs during the turn toward SANPA position.

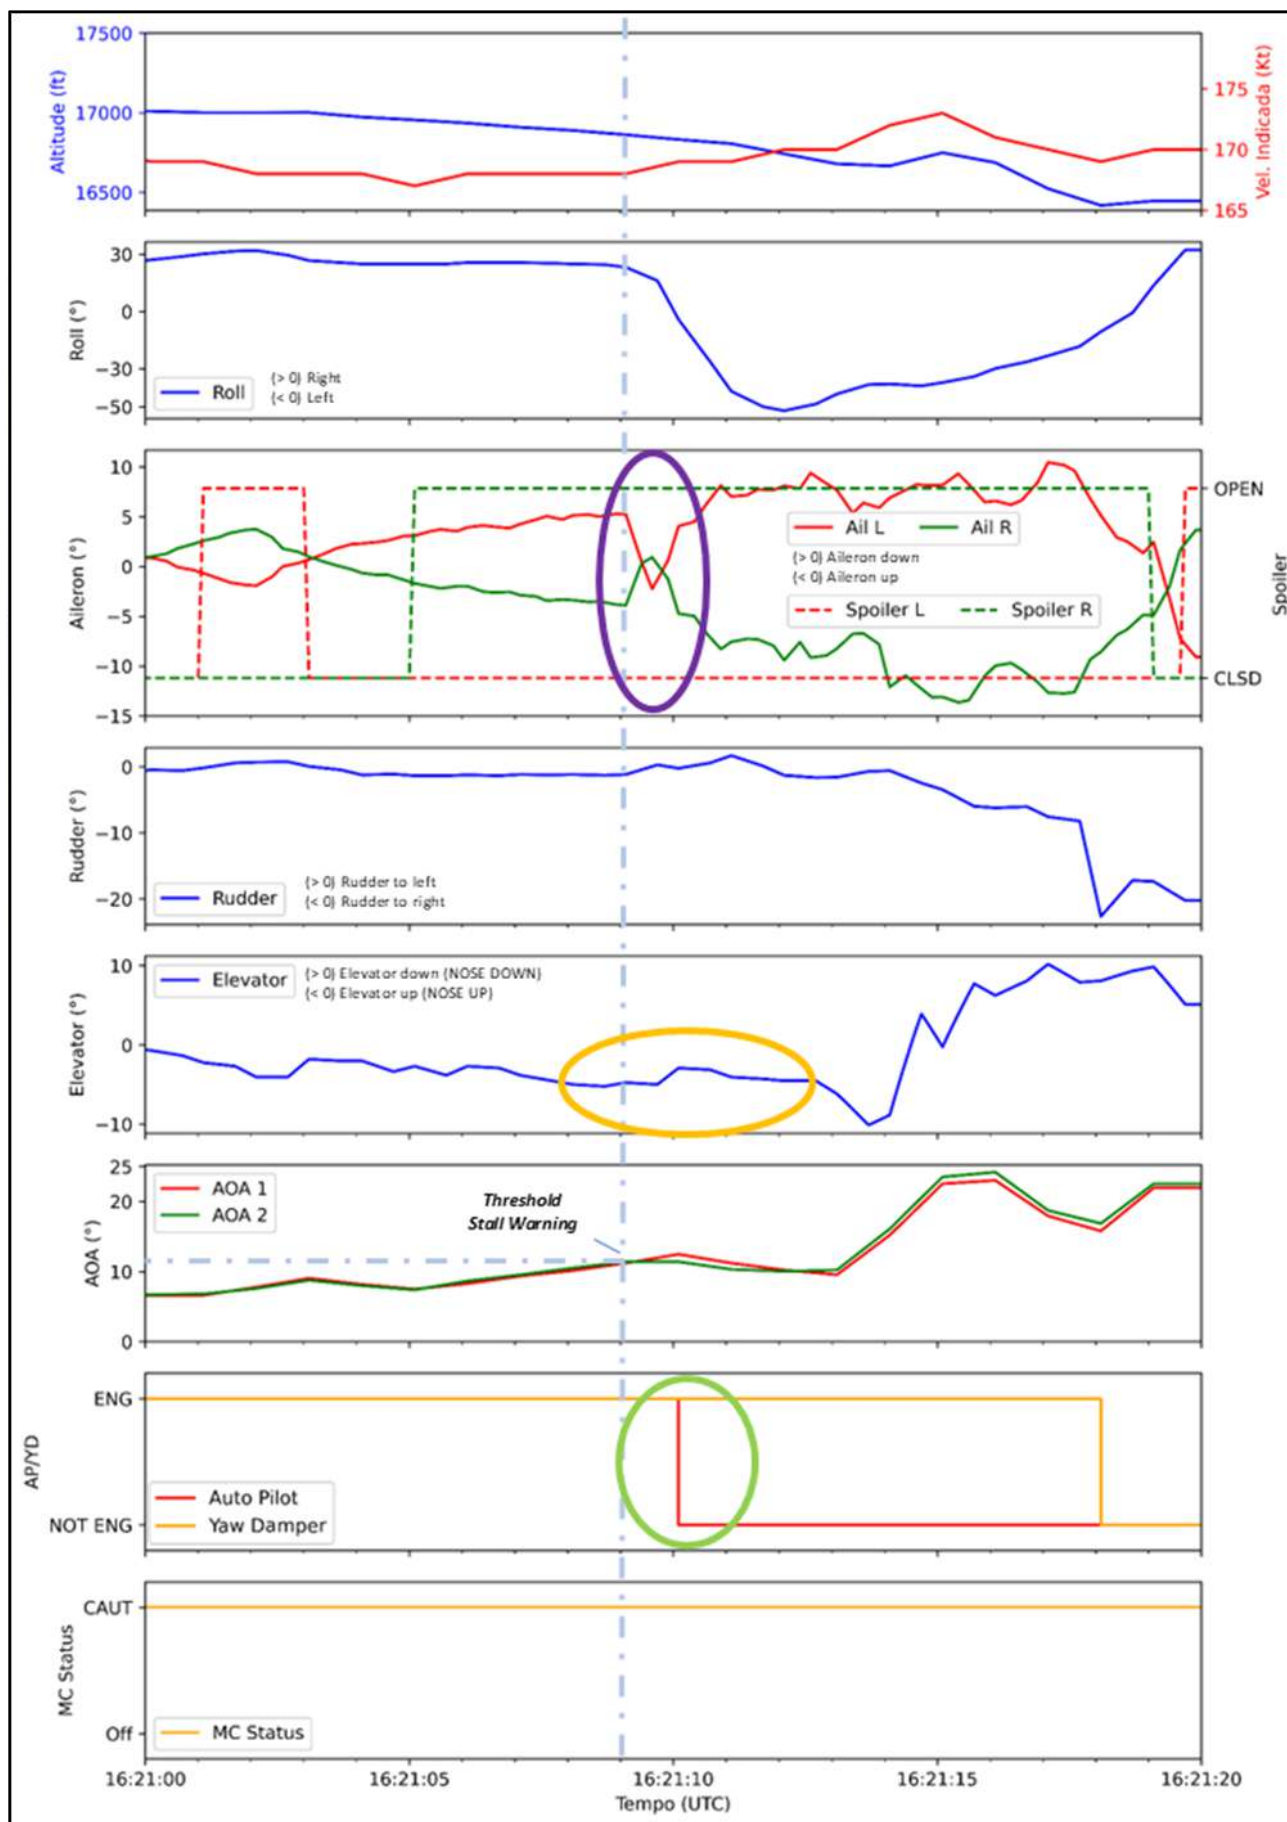
At 16:21:09 UTC, the AOA reached the activation threshold for the stall warning under icing conditions in cruise, at  $11.2^\circ$ , enabling activation of the stick shaker motors on the pilots' control columns (vertical dashed line in Figure 170).

Figure 170 – Graph of flight data parameters indicating the final moments prior to AP disengagement. The vertical baseline indicates the moment of stall warning activation.

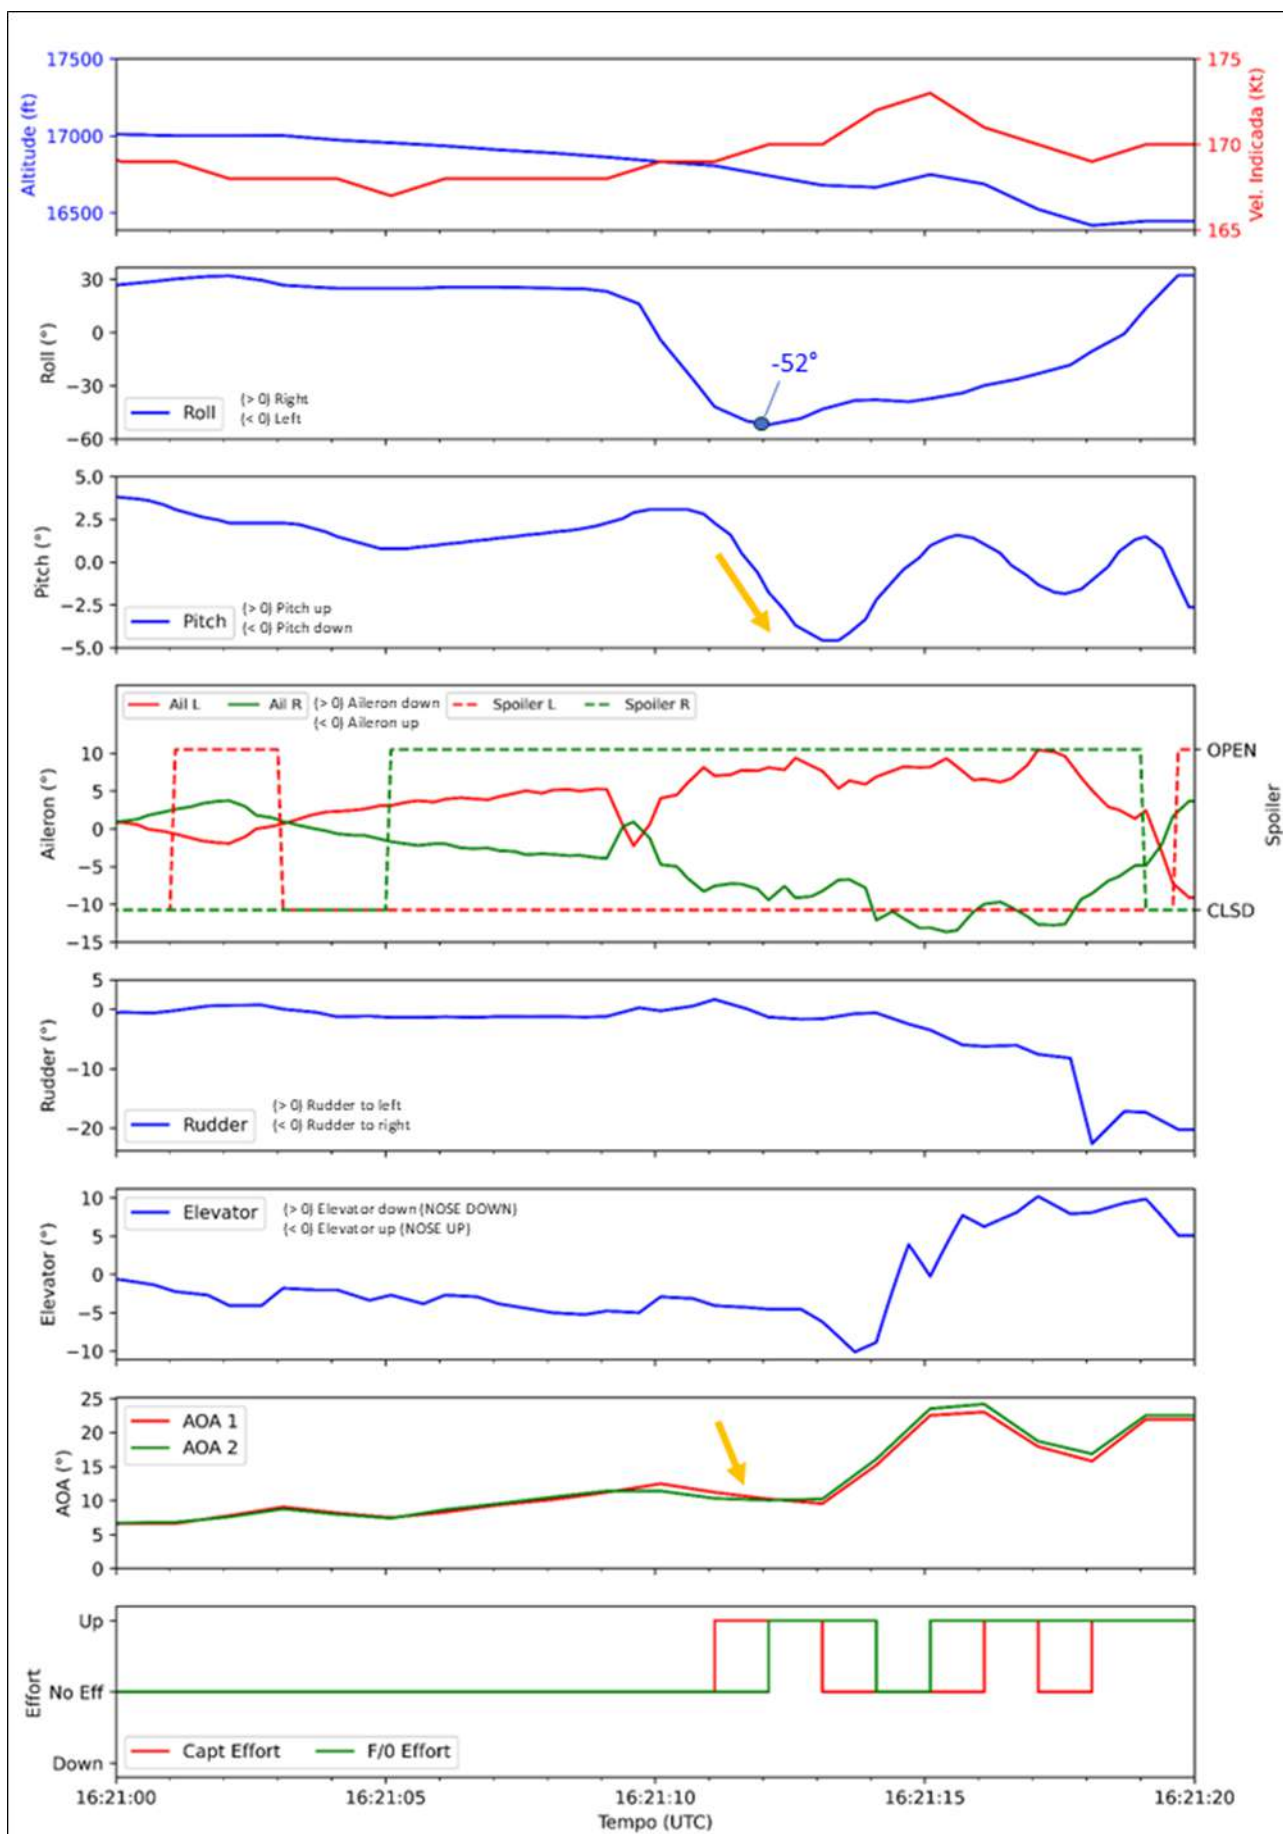
At 16:21:12 UTC, the pronounced roll to the left reached a rate of approximately 40°/s, inducing an increase in the local angle of attack of the left wing and its aerodynamic stall. At that moment, the aircraft experienced a sharp drop of the left wing, reaching a maximum bank angle of 52°, as shown in Figure 173.

Figure 173 – Graph of flight data parameters at the moment of the stall.

Due to the stall, the aircraft exhibited a natural nose-down tendency (pitch down), reaching a nose-down attitude of approximately  $-5^{\circ}$ , which led to a momentary reduction in AOA (orange arrows).

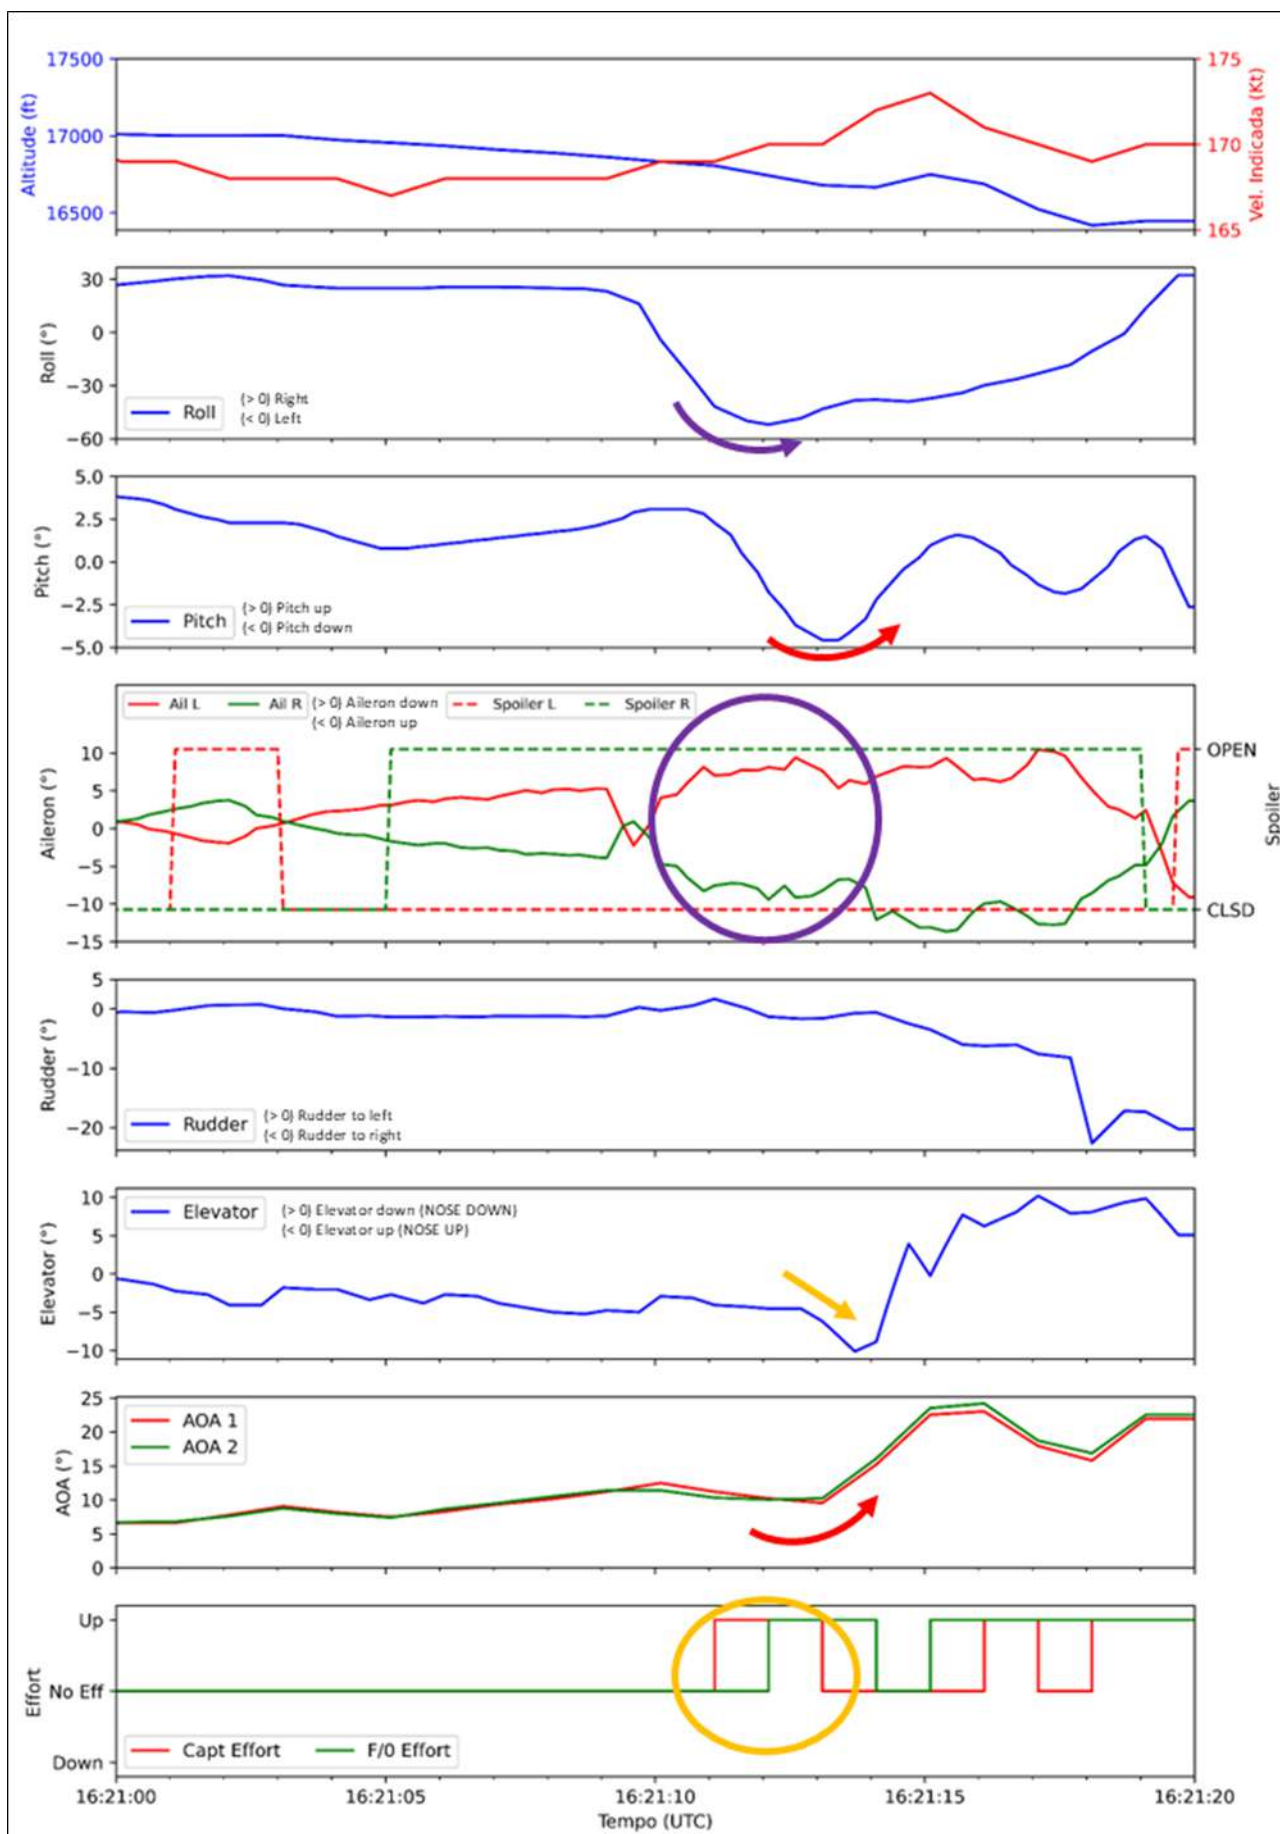
In response to the sudden drop of the left wing during the stall, the flight crew applied right control column input through nearly its full travel, which resulted, in addition to aileron movement, in the deployment of the right spoiler to increase the commanded roll rate to the right (purple ellipse in Figure 174). It was observed that this lateral control input reduced the left roll rate until its reversal, allowing the initial recovery from the wing drop (purple arrow).

Figure 174 – Graph of flight data parameters during the attempt to regain control of the aircraft, with nose-up control inputs and a right roll command.

As previously highlighted, in the pitch axis the aircraft exhibited a nose-down tendency following the stall; however, simultaneous control column inputs by both pilots were recorded, with forces exceeding 10 daN (approximately 10 kgf) in the nose-up direction (orange ellipse). The pilots' actions were contrary to the guidance established in the QRH, which calls for applying forward pressure on the control column in the event of a stall (Figure 171).
