**COMANDO DA AERONÁUTICA**  
**CENTRO DE INVESTIGAÇÃO E PREVENÇÃO DE**  
**ACIDENTES AERONÁUTICOS**

**FINAL REPORT**  
**A-116/CENIPA/2024**

**PS-VPB**

**ATR-72-212A (500)**

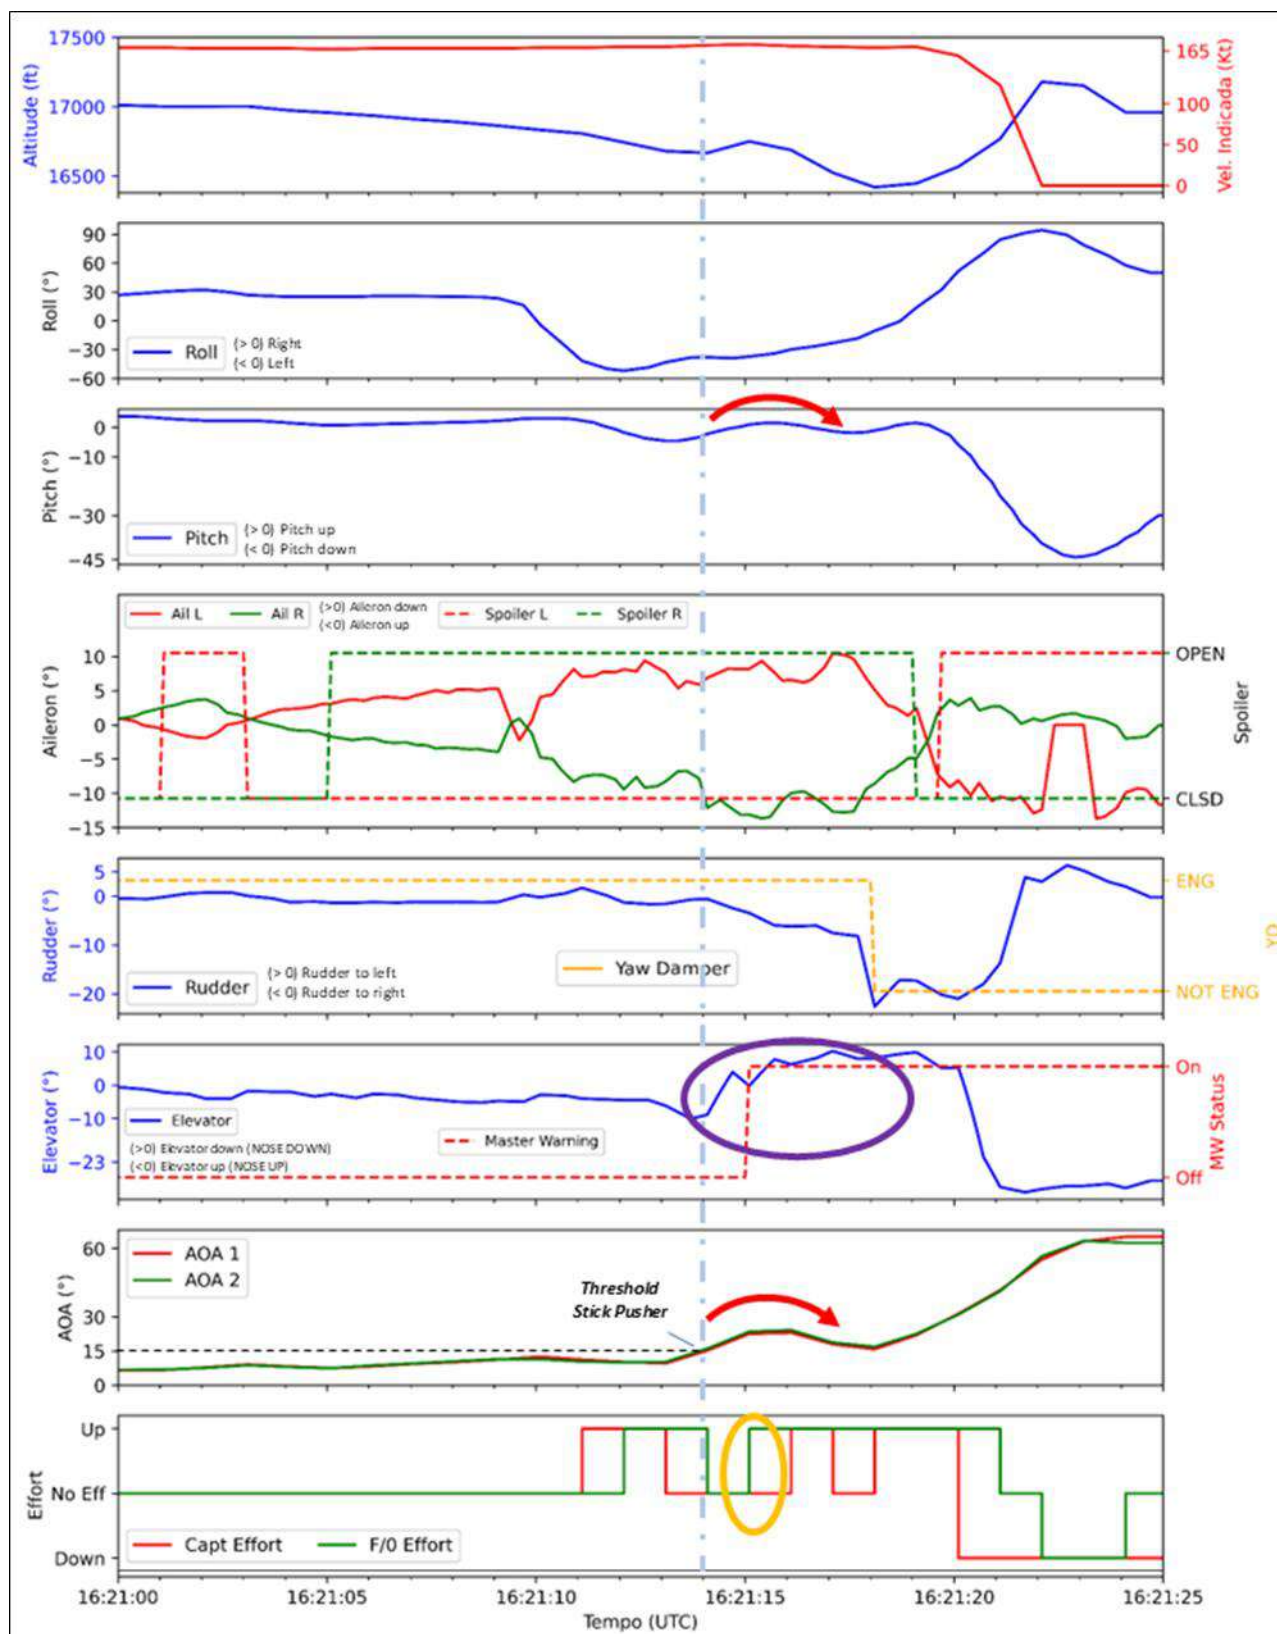
The stick pusher activation parameter was not recorded by the FDR; however, the sudden change in the left elevator position recorded by the synchro transmitter and the examinations performed as presented in section 1.16.4 indicated that the system was activated (vertical dashed line in Figure 175).

Figure 175 – Graph of flight data parameters highlighting the various indications during the time interval in which the stick pusher was activated.

This activation resulted in an effective forward movement of the control columns (purple ellipse). With the activation of the stick pusher, a reduction in longitudinal attitude was observed, along with a consequent decrease in AOA (red arrows).

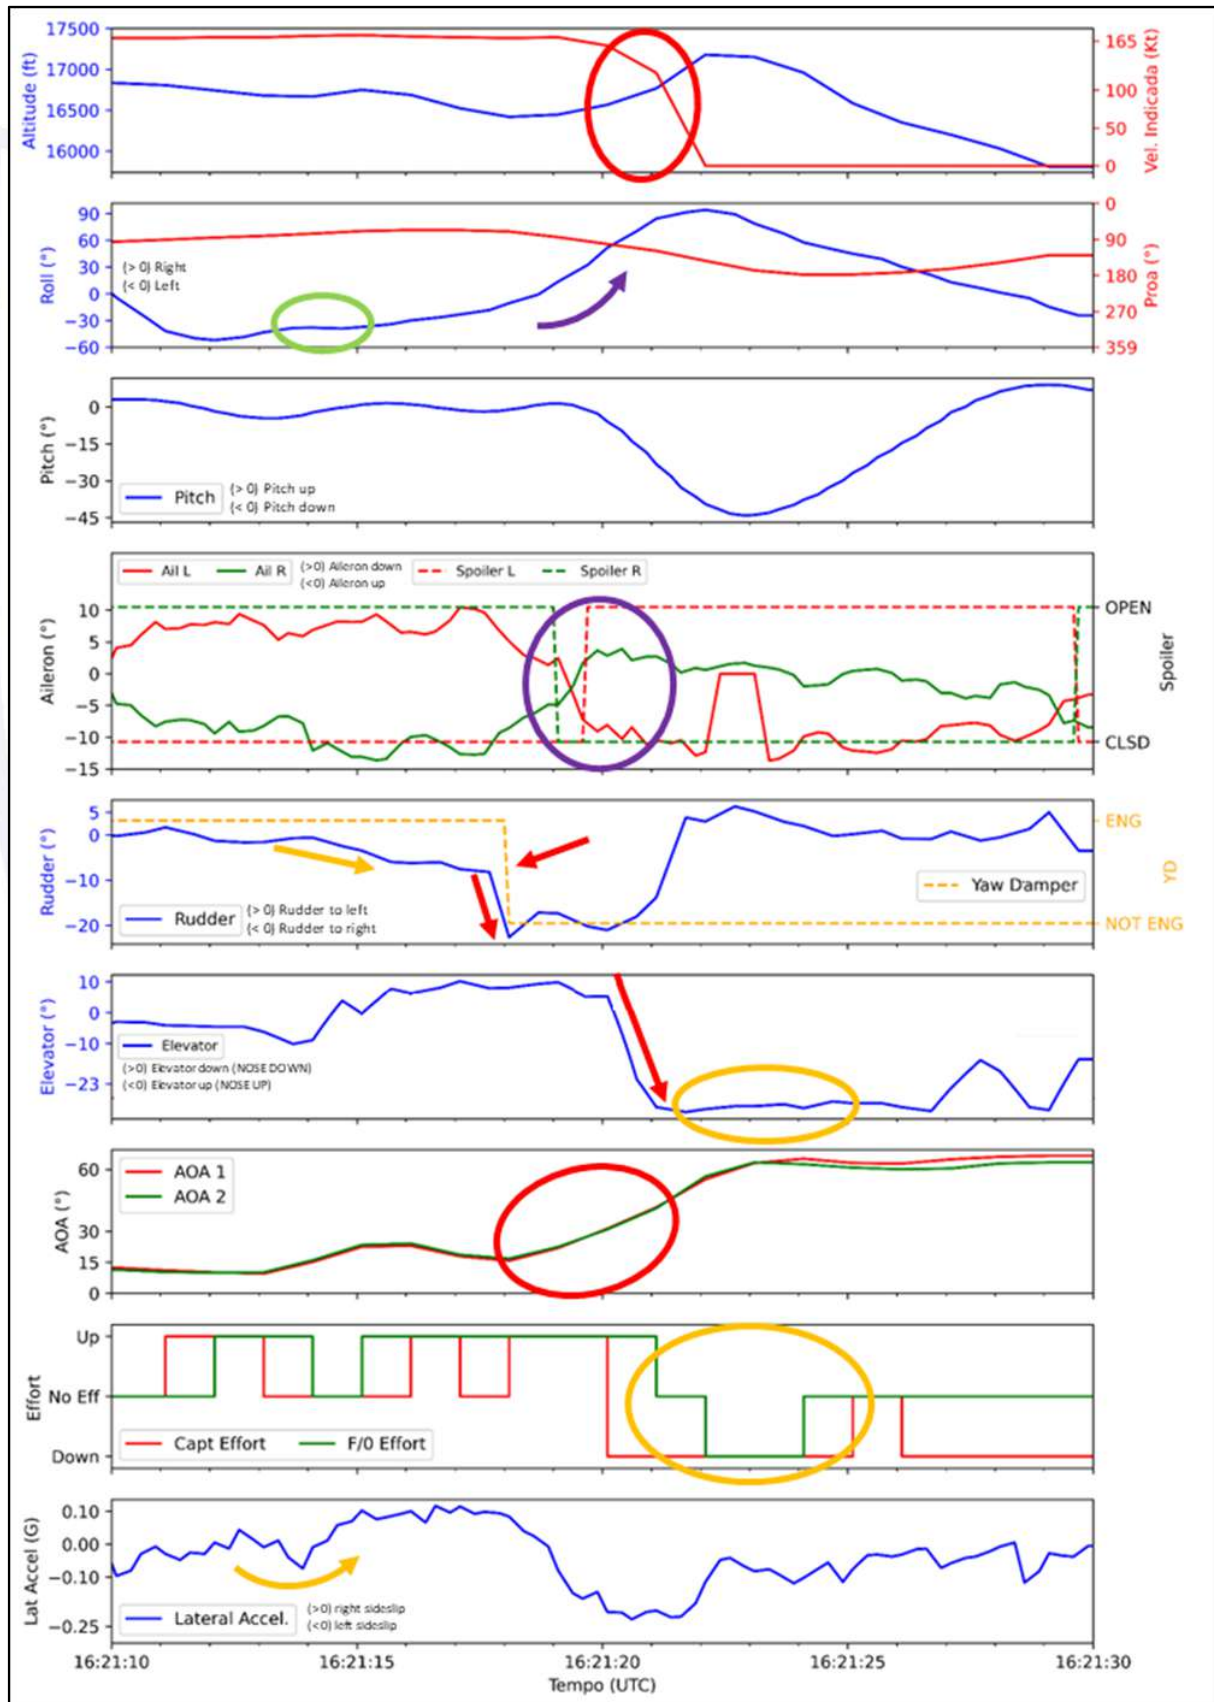
Immediately after the uncommanded roll to the left, which reached 52° of bank, flight control inputs in roll and pitch were applied, resulting in a reduction of the left bank to 38° and an increase in AOA, for approximately 2 seconds (green ellipse in Figure 176).

Upon reaching a value of approximately 8° of right rudder deflection, an abrupt movement of the rudder toward the right stop was observed, reaching 23°—equivalent to 85% of the maximum deflection of 27°—within an interval of half a second, remaining in that position for approximately 3 seconds. Subsequently, at 16:21:18 UTC, due to the sudden rudder displacement, the YD disengaged (red arrows in the Rudder parameter).

The significant rudder deflection, at a rate of 30°/s, resulted in a right yaw, which can be observed through the aircraft's lateral acceleration values and the rapid change in heading shown in Figure 176. This directional motion produced an immediate aircraft response, with a significant increase in right roll (purple arrow), at a rate close to 40°/s.

A rapid increase in AOA and a drastic reduction in speed, reaching a value of 0 kt, were also observed, even with a nose-down attitude (red ellipses). With the AOA approaching 30°, the left elevator abruptly reversed from the NOSE-DOWN position, still commanded by the stick pusher, to a NOSE-UP position close to its stop (red arrow in the Elevator parameter).

Subsequently, the aircraft entered a dive with a pitch attitude of -43°. The maximum right bank angle reached 94°. The rudder remained near a centered, neutral position, and the AOA reached values close to 63°.

At that moment, all APM alerts were deactivated. The control column force parameter recorded a period of forward (nose-down) inputs; however, no significant change was observed in the position of the left elevator (orange ellipses).

Figure 176 – Graphs of flight data parameters highlighting the initial phase of the loss of control of the aircraft.

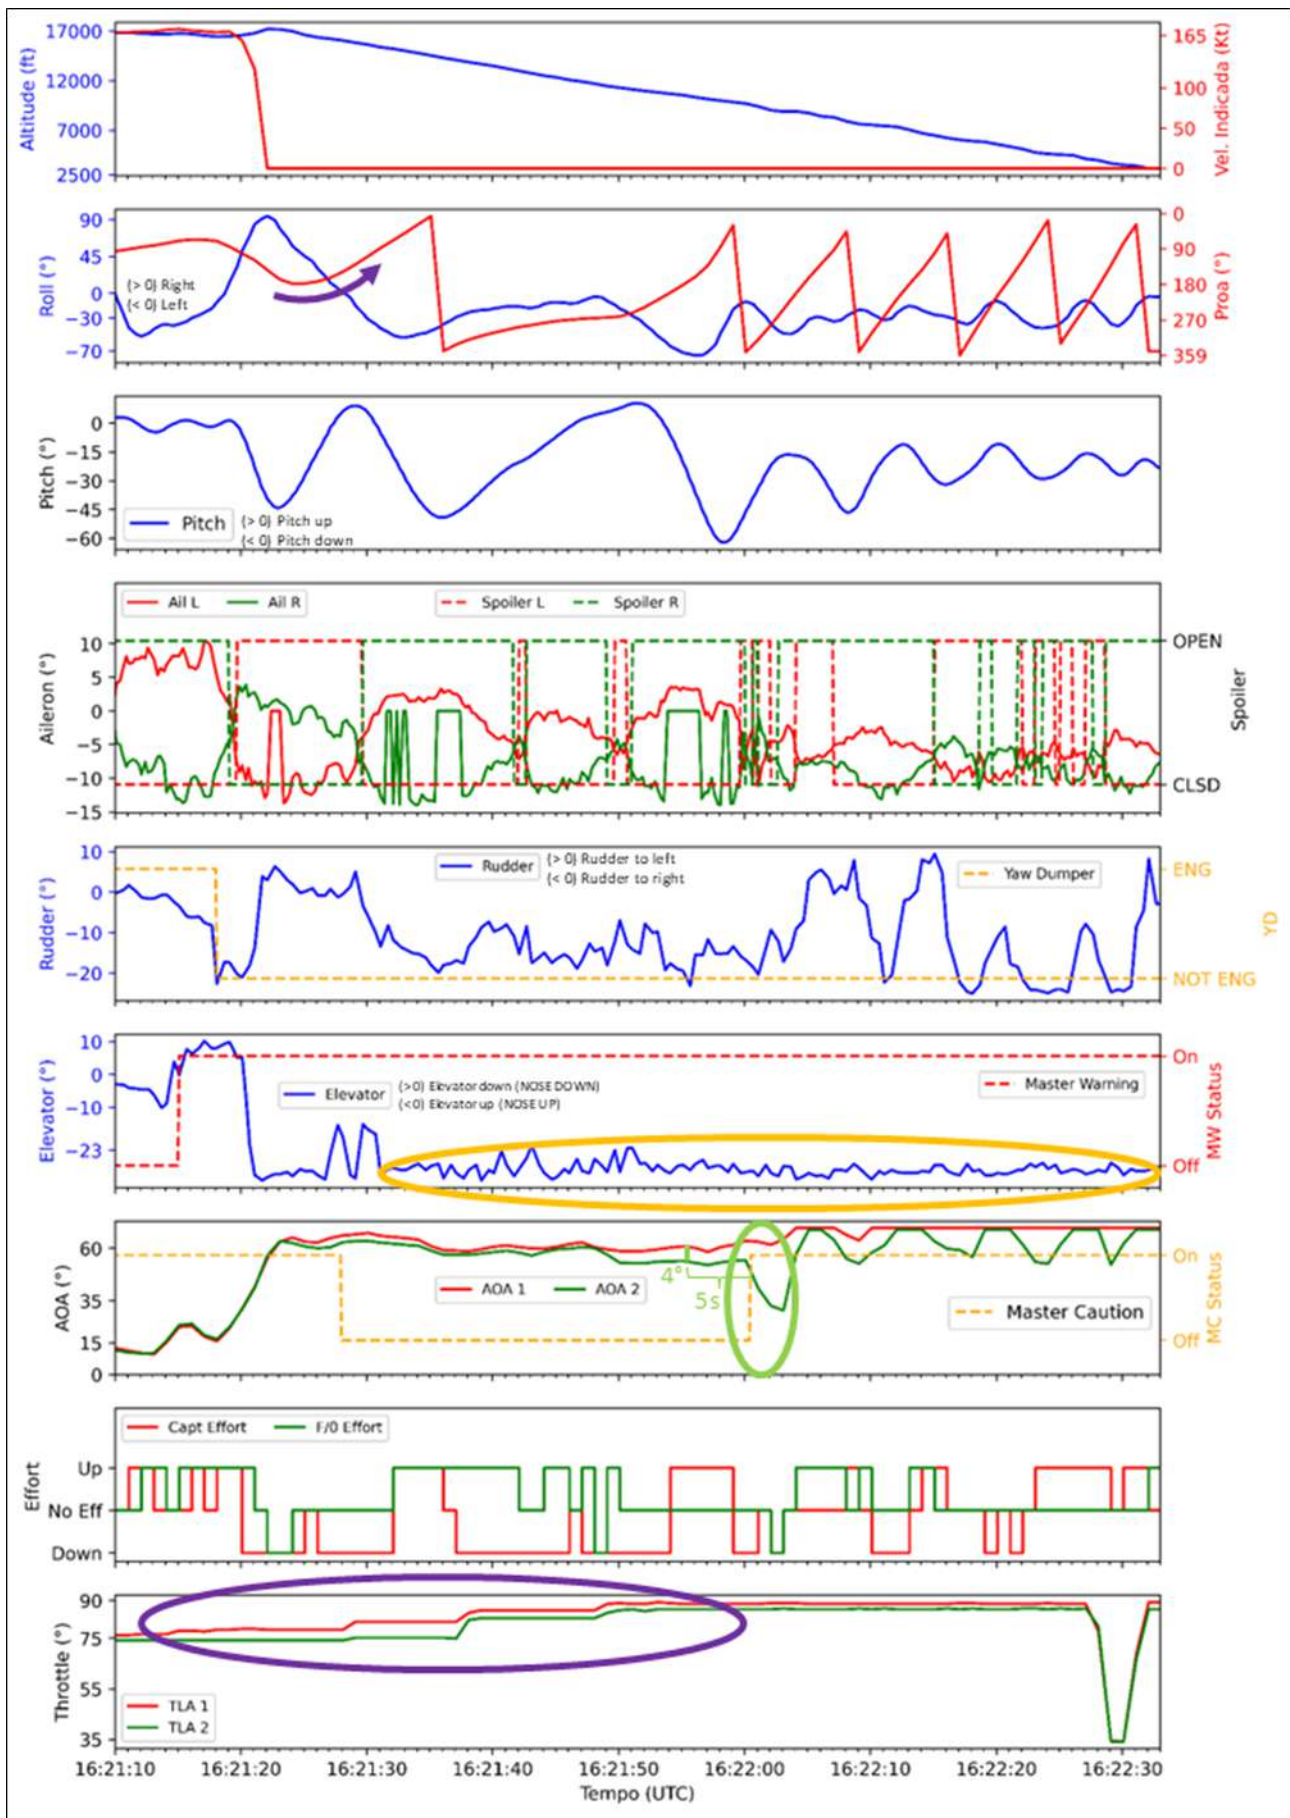
Following the sudden and abrupt right rudder deflection, a yaw and a heading change of approximately  $110^\circ$  to the right was observed. After that, the aircraft reversed the direction of rotation, now yawing to the left in a counterclockwise direction (purple arrow in Figure 177). From that point onward, the aircraft entered a left spin.

It should be noted that, as the elevators were disconnected, the FDR records related to the Elevator parameter corresponded to the position of the left elevator, which remained near the nose-up stop throughout the uncontrolled descent (orange ellipse).

It was also verified that there were throttle inputs on both engines during the initial phase of the spin (purple ellipse), as well as a recorded rudder deflection of approximately  $15^\circ$  to the right, consistent with pilot inputs intended to arrest the left rotation.

Subsequently, the pitch and roll oscillations were damped, characterizing the development of a flat spin, with an indicated angle of attack close to the mechanical stop of the AOA sensor ( $70^\circ$ ) and a rotation rate of approximately  $45^\circ/\text{s}$ . From that moment onward, with the stabilization of the rotation, no further discrepancy between the AOA sensors was identified. As a result, the stick pusher became available again until the aircraft reached 500 ft RALT, when the stick pusher was once again inhibited.

Figure 177 – Graph of flight data parameters highlighting the final moments before and after entry into the spin.

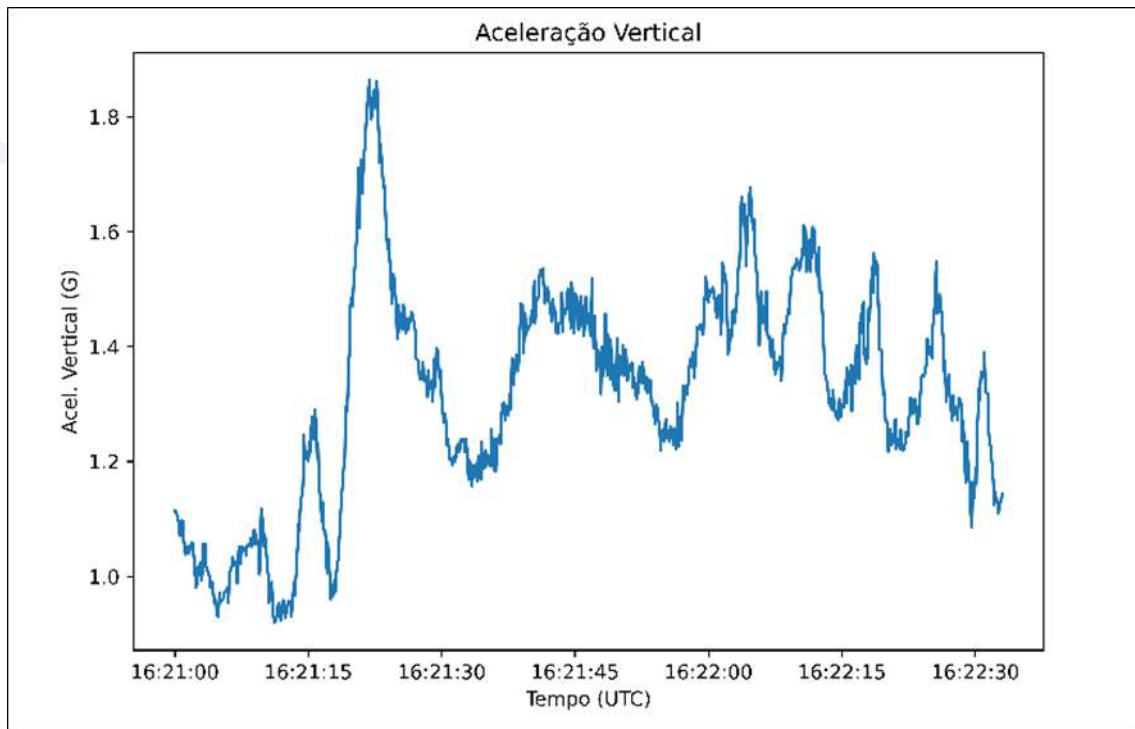
The maximum peak vertical acceleration reached approximately +1.8 g at the onset of the loss of control, followed by fluctuations between +1.2 g and +1.6 g from the aircraft lost of control until ground impact (Figure 178).

Figure 178 – Vertical acceleration data.

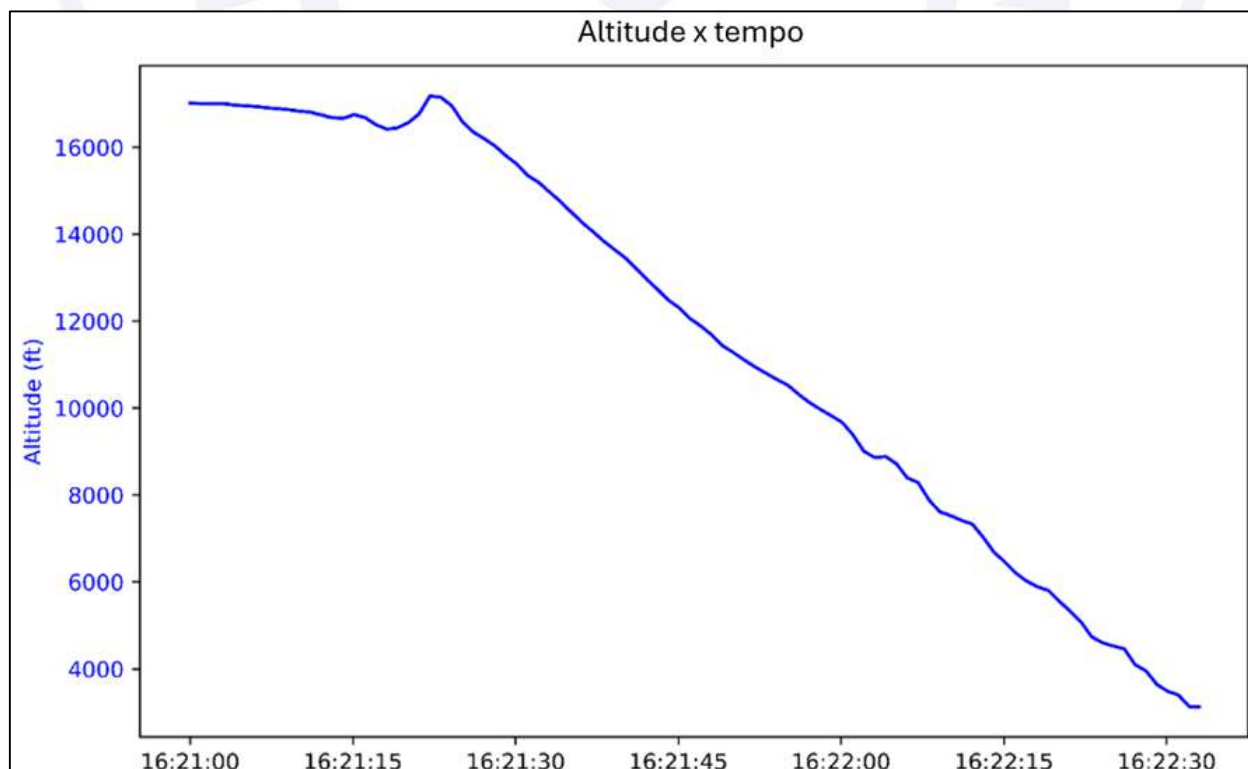
Furthermore, the aircraft exhibited an almost constant rate of descent of approximately 14,000 ft/min (Figure 179). The aircraft completed 5 left-hand spin rotations over an interval of 68 seconds, with pitch varying between +10° and -62° and left bank angles ranging from 10° to 75° until ground impact. Figure 179 illustrates this loss of altitude as a function of time (UTC).

Figure 179 – Altitude data recorded versus UTC time following the loss of control.

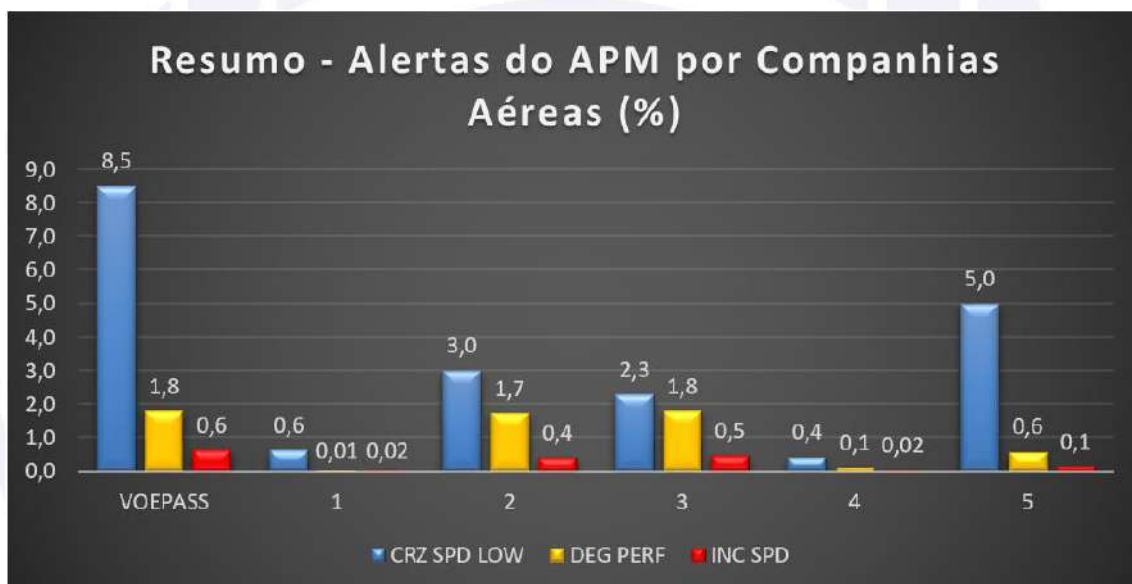
The analysis of this volume of data revealed that the company presented the highest percentage of occurrences related to APM system events. Of the 15,365 flights analyzed, 10.9% of the total presented the activation of at least one APM advisory/alert. Of this total, 8.5% presented the CRUISE SPEED LOW advisory; 1.8% the DEGRADED PERFORMANCE alert; and 0.6% the INCREASE SPEED alert, values higher than those observed among the other operators (Figure 180).

Figure 180 - Events related to the APM and percentage of CRUISE SPEED LOW (blue), DEGRADED PERFORMANCE (yellow), and INCREASE SPEED (red) advisories/alerts, comparing the company with the other operators.

The high occurrence rate of the CRUISE SPEED LOW advisory indicated that the company's aircraft were operating in cruise with indicated airspeeds averaging between 5 and 10 kt below the IAS Theoretical. These results pointed to greater operational exposure to the risk of aircraft performance degradation under icing conditions.

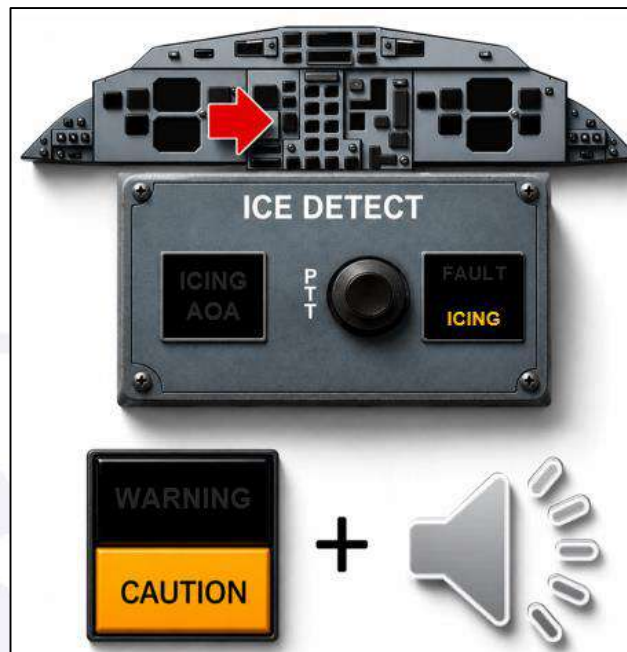
At 15:14:56 UTC, while passing approximately FL130, the Electronic Ice Detector detected ice accretion, triggering the MASTER CAUTION alert, accompanied by the single chime aural warning and illumination of the ICING light on the ICE DETECT panel (Figure 181).

Figure 181 - MASTER CAUTION alert, accompanied by the single chime aural warning, associated with the illumination of the ICING light.

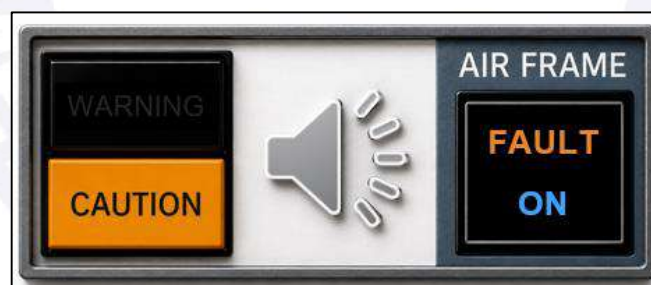
At 15:15:42 UTC, 39 seconds after activation of the Airframe De-Icing system, the MASTER CAUTION alert, accompanied by the single chime, was triggered again in the cockpit. At that moment, the MPC recorded the AIRFRAME FAULT message, associated with the operation of the right wing boots (Right Wing Boot B Fault).

Figure 182 – MASTER CAUTION alert accompanied by the single chime alarm, associated with the illumination of the ICING FAULT light.

The improper operation recorded by the MPC could have been related to a failure of the DDV found at the wreckage site near the tip of the right wing, since, based on its location, it was inferred to be the DDV corresponding to FIN 10DM, responsible for the activation of the right-wing outer boots. However, the degradation resulting from the post-impact fire made it impossible to perform any functional testing, as well as to identify elements that could indicate the operating condition of the component prior to the impact and fire exposure.

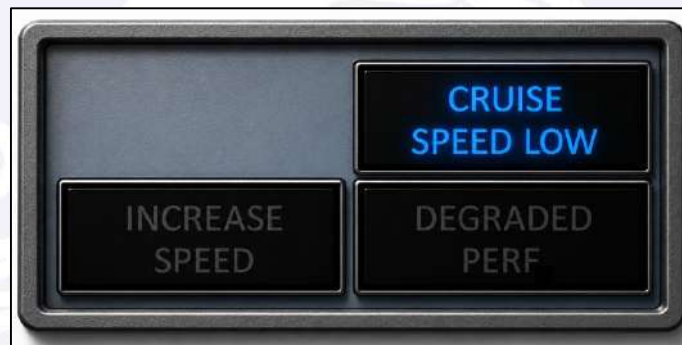
Seven distinct episodes were also identified (in addition to an eighth and last one in the final moment of the flight), in which the APM issued the CRUISE SPEED LOW alert, indicating different moments when the IAS was at least 10 kt below the theoretical speed computed by the APM and with the calculated mean drag at least 10% above the theoretical drag specified for cruise flight.

Figure 183 - CRUISE SPEED LOW alert on the left-side APM panel (PIC).

The CRUISE SPEED LOW alerts occurred during two distinct periods. The first two coinciding with ice accretion detection by the Electronic Ice Detector. The remaining five were triggered during an interval of approximately 41 minutes, in which no ice accretion was detected by the Electronic Ice Detector, indicating that, despite the absence of active detection by that sensor, the aircraft was experiencing performance degradation, possibly caused by residual ice presence or by undetected ice accretion.

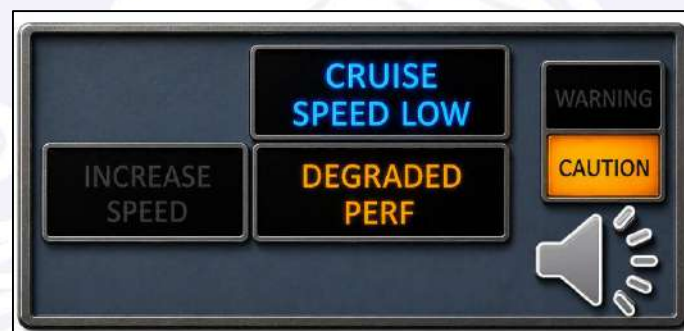
During these interactions with the air traffic control unit, with an IAS of 185 kt, decreasing at 10kt/min, and drag calculated by the APM at 27% above the expected value, the DEGRADED PERFORMANCE alert was triggered, accompanied by the MASTER CAUTION alert and the single chime aural warning. These alerts indicated a progressive deterioration in the aircraft's performance, consistent with ice accretion on the aerodynamic surfaces.

Figure 184 - DEGRADED PERFORMANCE APM alert associated with MASTER CAUTION, accompanied by the single chime aural warning.

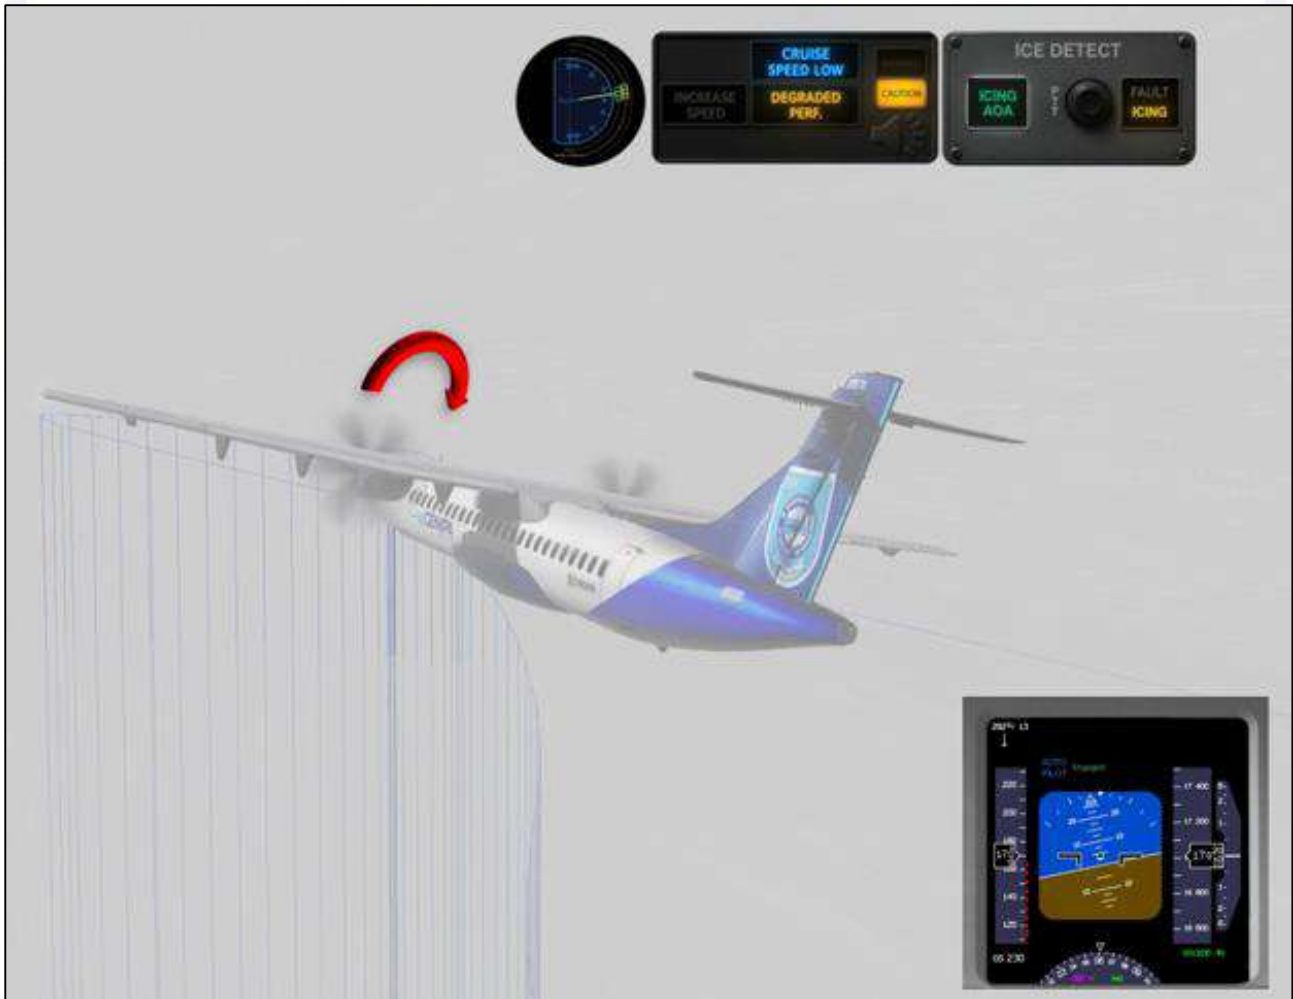
Upon reaching 18° of right bank at 16:20:57 UTC, the MASTER CAUTION alert, associated with the single chime aural warning, and the INCREASE SPEED alert were activated precisely at the moment when the IAS reached 171.1 kt, the MSIS computed by the APM for the considered aircraft weight at that instant (20,989 kg), and when the calculated drag was 44% greater than the theoretical value specified by the APM.

Figure 185 - Illustration<sup>8</sup> showing the right turn toward the SANPA position and the activation of the INCREASE SPEED alert.

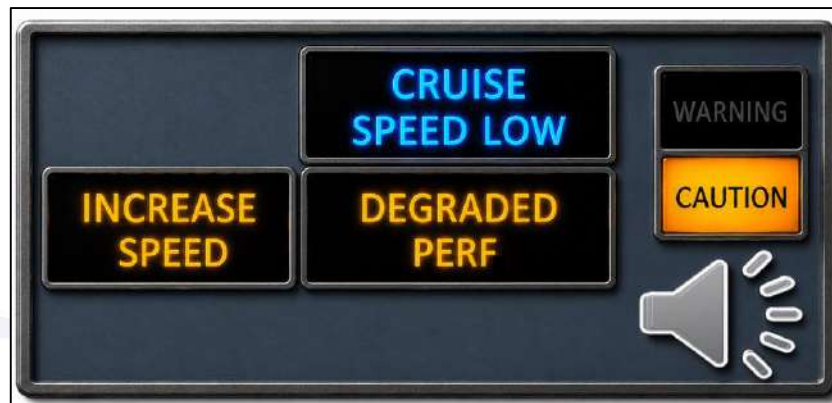
Figure 186– APM INCREASE SPEED alert, associated with MASTER CAUTION alert, accompanied by a single chime aural alert.

According to the aircraft QRH, following the activation of the INCREASE SPEED alert, the crew should seek, as a memory item, an IAS of ICING BUG +30 kt (195 kt), as well as carry out the procedures prescribed for severe icing conditions. However, based on the flight data and CVR recordings, no pilot reactions were observed toward the execution of this memory item, nor toward the performance of the procedures for the Severe Icing condition.

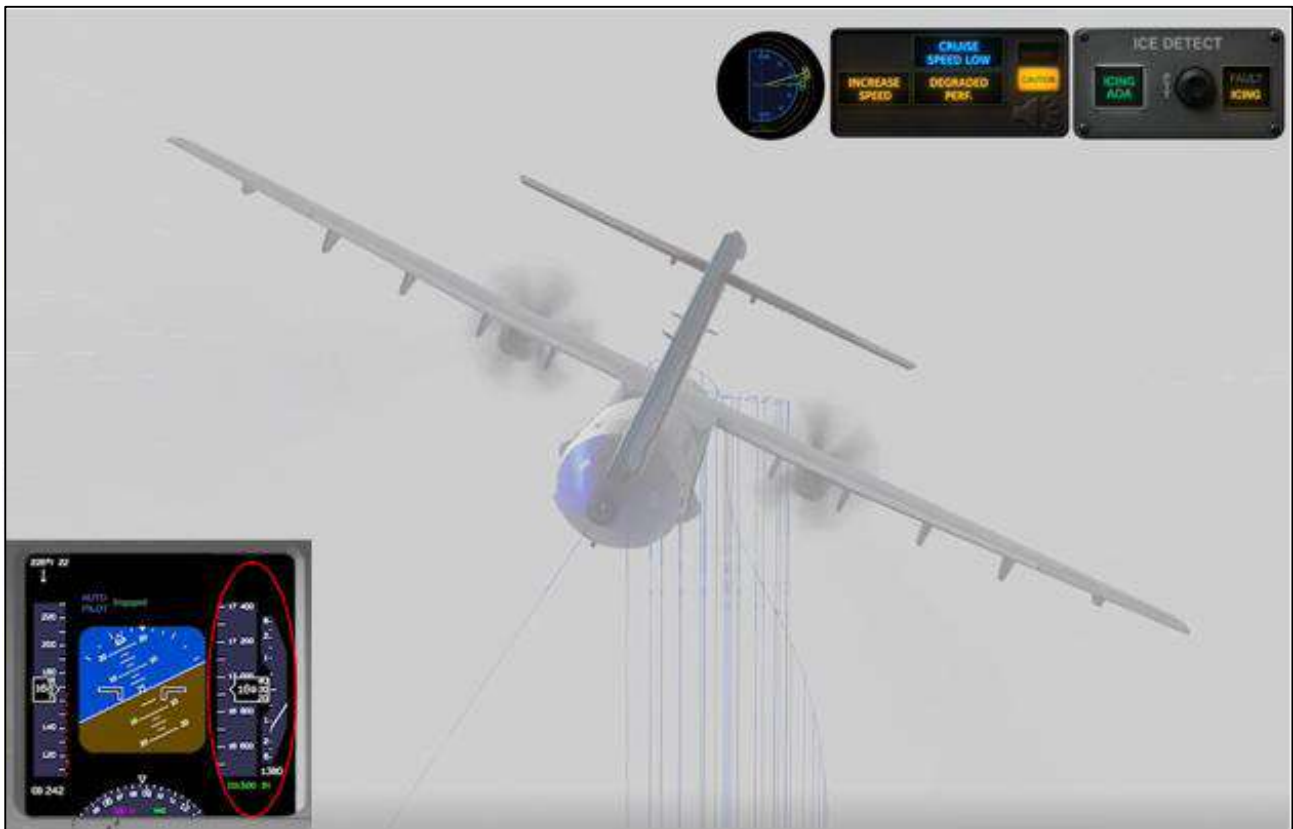
The SIPAER Investigation Commission concluded that, given the aircraft icing condition and loss of aerodynamic efficiency, the AP inputs in ALT HOLD and HIGH BANK

modes resulted in an increase in AOA, with a consequent increase in aerodynamic drag during the turn, leading to a reduction in indicated airspeed and progressive altitude loss, bringing the aircraft increasingly closer to stall condition (Figure 187).

Figure 187 - Illustration demonstrating the altitude loss during the turn due to performance degradation, with the AP engaged in ALT HOLD and the lateral bank in HIGH BANK mode.

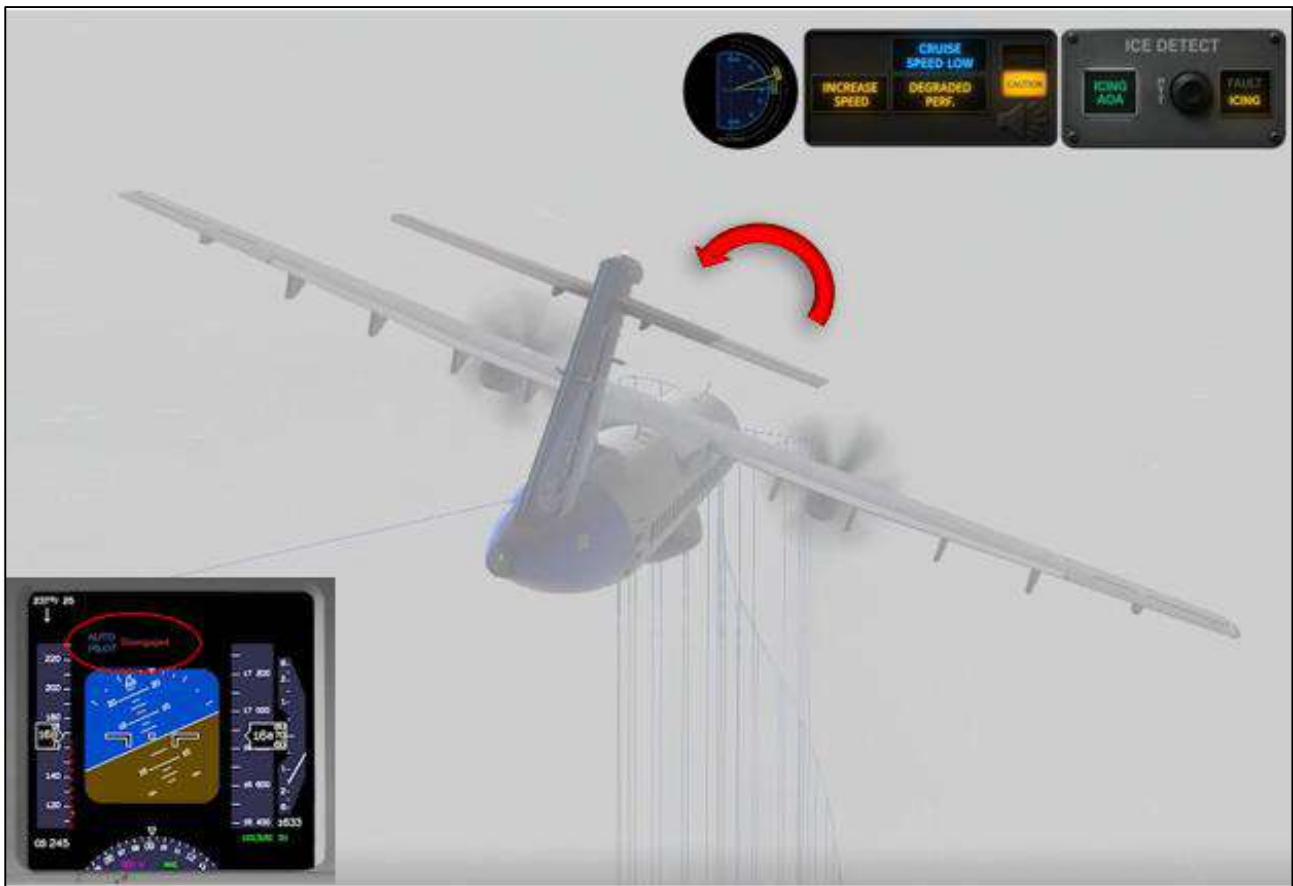
As a consequence of the stick shaker activation, the AP disengaged. As a result, lateral control of the aircraft was no longer commanded by the AP, and the ailerons exhibited an immediate tendency to return to their zero-hinge moment position (purple ellipse). Due to the aircraft's lateral stability characteristics, combined with the aerodynamic condition resulting from prolonged ice accretion, a pronounced roll rate to the left toward wings-level was induced.

Figure 188 - Illustration demonstrating the moment of stick shaker activation and AP disengagement.

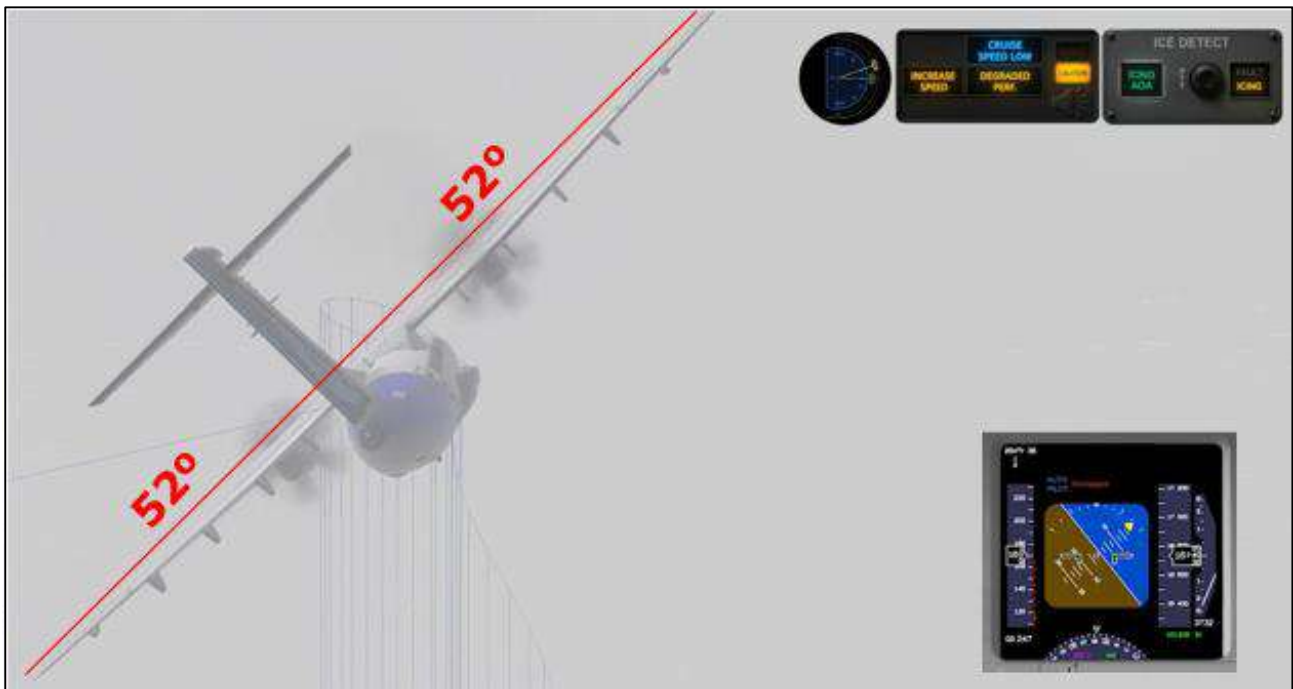
At 16:21:12 UTC, the pronounced roll to the left reached a rate close to 40°/s, inducing an increase in the local angle of attack of the left wing. This fact, combined with the ice accumulation on that surface, caused its aerodynamic stall. At that moment, the aircraft experienced a pronounced left wing drop, reaching a maximum bank angle of 52°.

Figure 189 - Illustration demonstrating the 52° bank angle following the stall.

The SIPAER Investigation Commission concluded that the stall resulted from the roll rate imposed by the sudden AP disengagement during the right turn, which generated an uncommanded roll to the left, causing an increase in the local angle of attack of the left wing that, combined with ice accumulation, led to the aerodynamic stall of that surface.

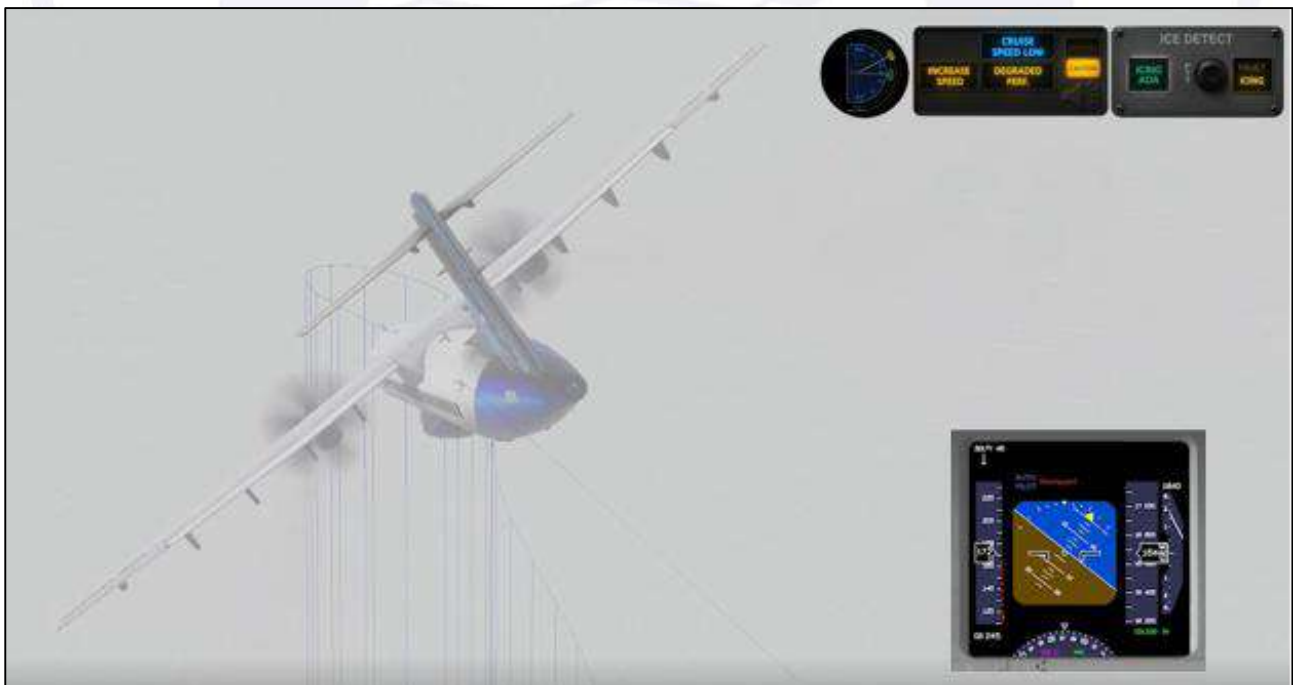
At 16:21:14 UTC, the AOA values measured by the aircraft sensors reached  $15.3^\circ$ , attaining the stick pusher activation threshold for icing conditions in cruise. At that moment, the aircraft nose was close to the horizon (approximately  $-1^\circ$  of pitch) and the aircraft was at about  $38^\circ$  of bank to the left (Figure 190).

Figure 190 - Illustration demonstrating the stick pusher activation during the reversal turn to the right.

The stick pusher activation parameter was not recorded by the FDR, but the sudden change in the left elevator position, recorded by the synchro transmitter, together with the spectral analysis of the CVR audio performed by the SIPAER Investigation Commission, indicated that the system was activated.

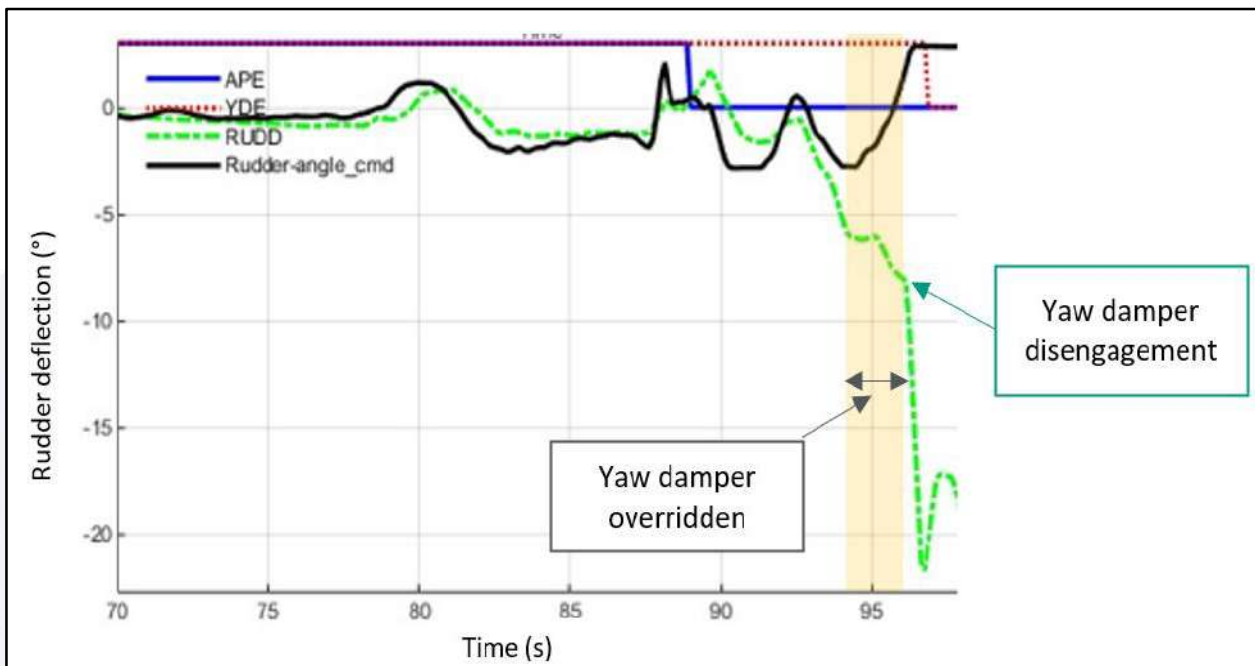
Figure 191 presents the information provided by the manufacturer. The black line represents an estimated YD response calculated by the manufacturer's software using the QAR and FDR recordings, while the green line represents the actual rudder deflection recorded during the accident flight.

Figure 191 – Illustration comparing the actual rudder position (green) with the position recalculated based on the YD software (black).

According to this hypothesis, the pilots applied right rudder pedal opposite to the left rudder command generated by the YD, as represented by the double-headed arrow in Figure 191. Consequently, the force applied through the rudder pedals overrode the YD command, resulting in the continued right rudder deflection up to approximately 8°, as shown by the green line in Figure 191.

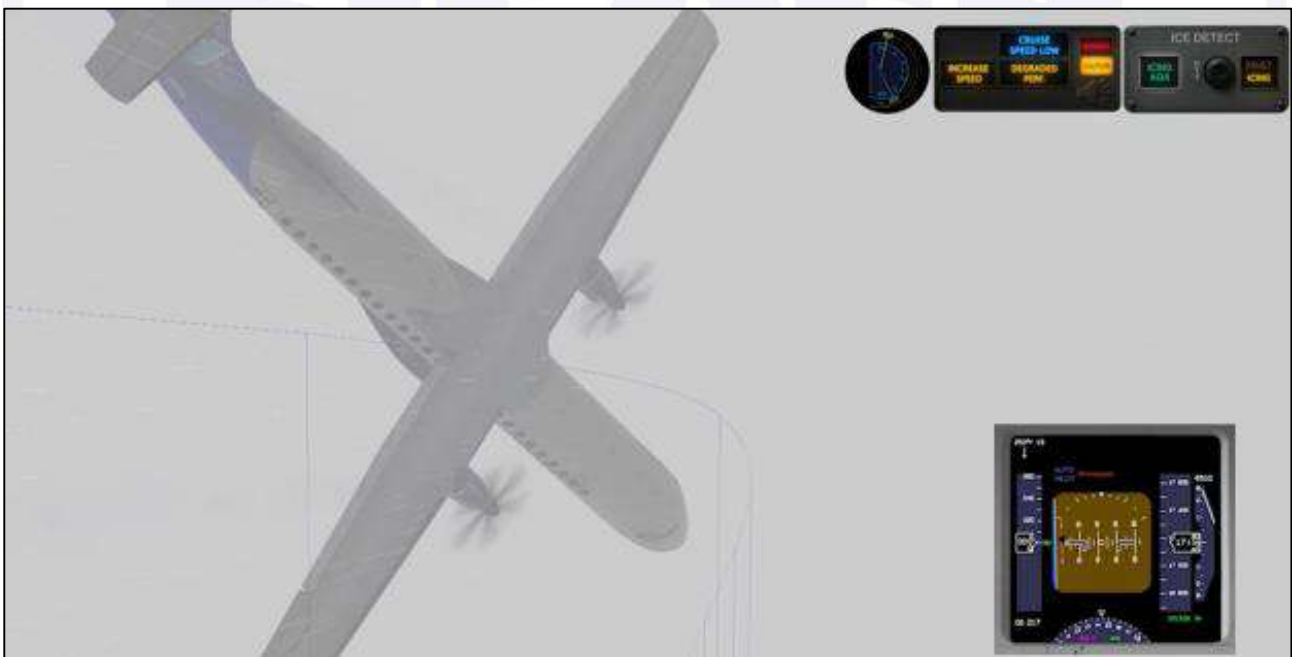
With the high AOA, aerodynamic stall of the horizontal stabilizer and elevator occurred. As a consequence, the elevators moved abruptly from the NOSE DOWN position to a NOSE UP position, near the stop, due to the upward airflow. This condition led to a rapid increase in AOA to approximately  $60^\circ$ . With this AOA magnitude, recorded at 16:21:22 (UTC), recovery of the aircraft was no longer possible and, from that moment on, the loss of control of the aircraft became irreversible.

Figure 192 - Illustration demonstrating the point of irreversibility of the accident.

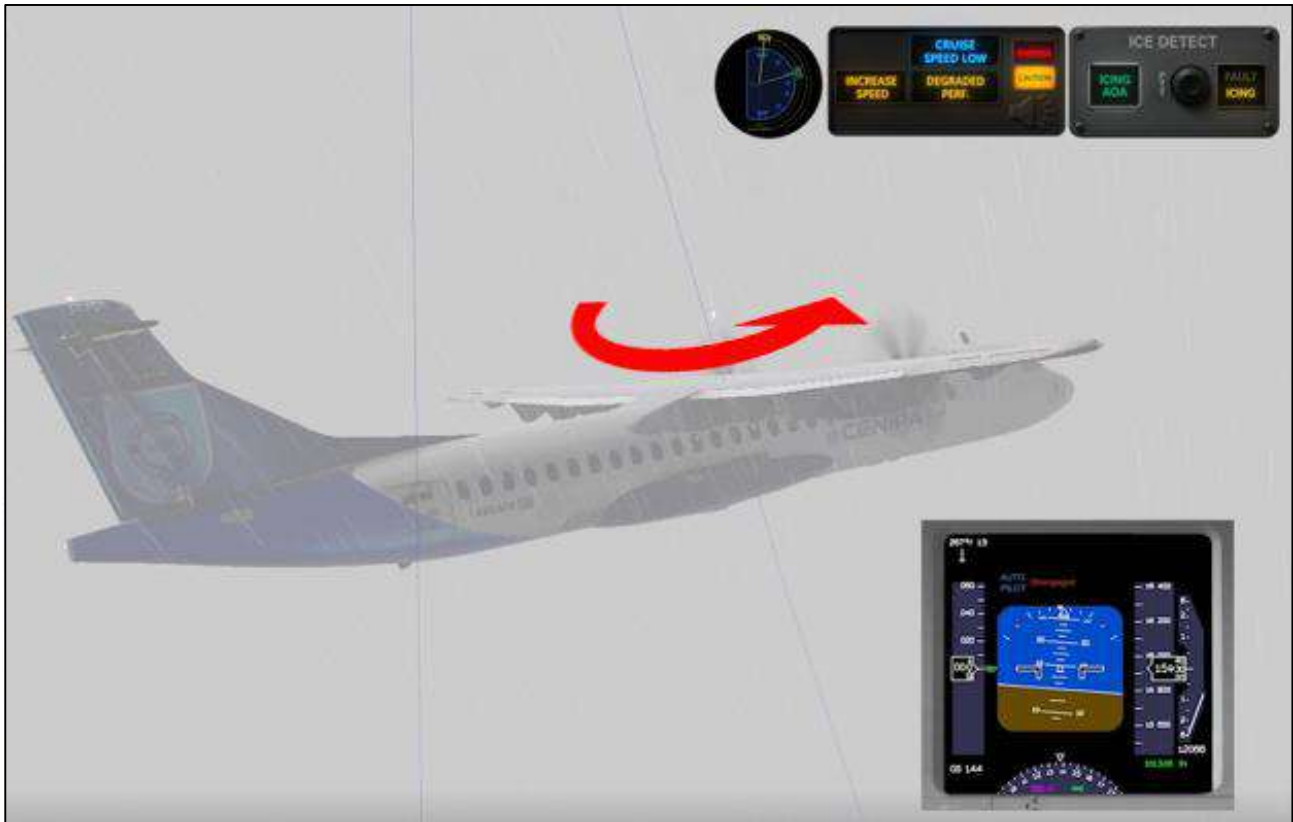
by entry into a spin to the left, with an AOA greater than  $60^\circ$  and continuous yaw maintained by the aerodynamic conditions themselves (Figure 193).

Figure 193 - Illustration demonstrating the entry into a spin with counterclockwise rotation.
