**COMANDO DA AERONÁUTICA**  
**CENTRO DE INVESTIGAÇÃO E PREVENÇÃO DE**  
**ACIDENTES AERONÁUTICOS**

**FINAL REPORT**  
**A-116/CENIPA/2024**

**PS-VPB**

**ATR-72-212A (500)**

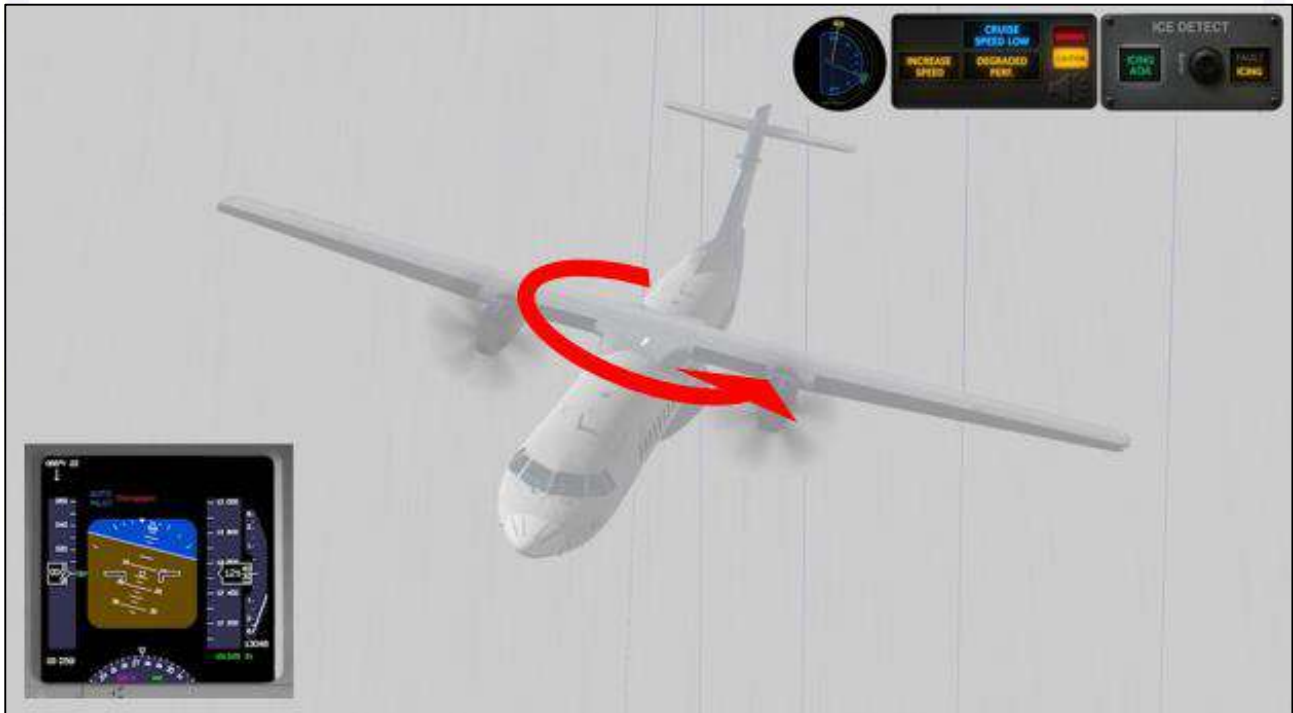
The aircraft established an almost constant rate of descent of approximately 14,000 feet per minute, completing five turns in a spin to the left over an interval of 68 seconds, with pitch variations between  $+10^\circ$  and  $-62^\circ$  and left bank angles between  $75^\circ$  and  $10^\circ$  until impact with the ground (Figure 194).

Figure 194 - Illustration demonstrating the aircraft in a flat spin.

The aircraft impacted the ground with high vertical speed and low horizontal speed, resulting in a concentrated wreckage site within an area approximately 30 meters in diameter.

The aircraft was destroyed, with crushing damage and fractures throughout its entire structure due to the high-energy impact with the ground. Following the collision, a fire occurred, increasing the degree of destruction of the aircraft.

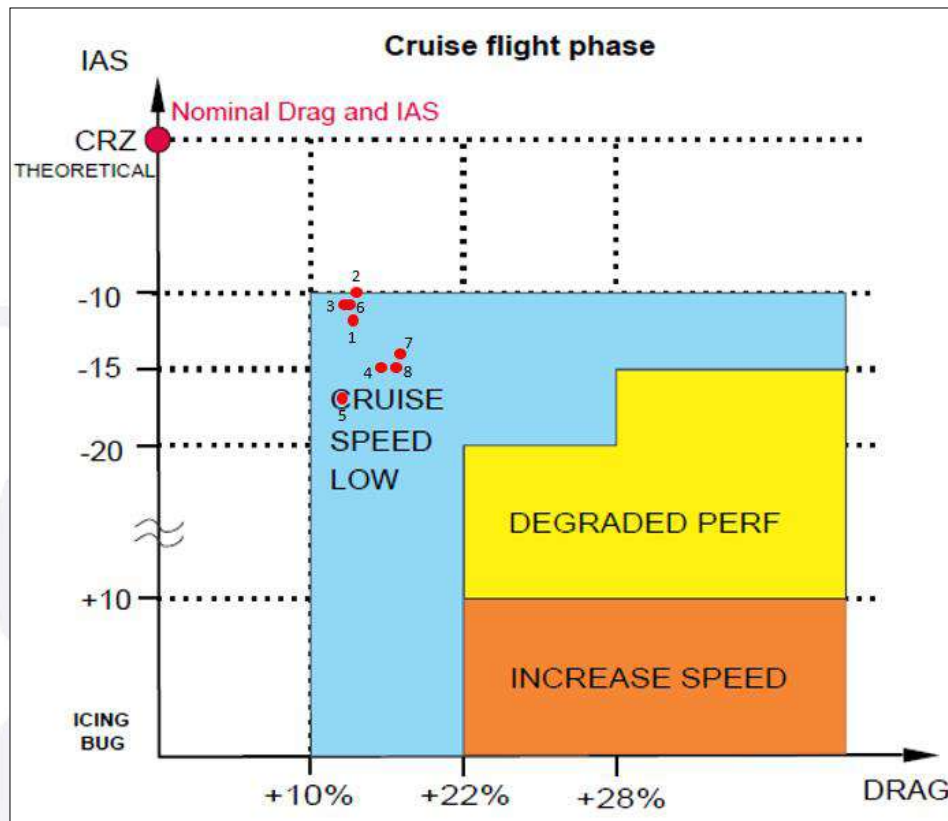
Based on the data presented in Table 4 (Conditions for activation of the APM CRUISE SPEED LOW), the plots (red dots in Figure 195) corresponding to the indicated airspeed differences (IAS-Delta\_Speed) during cruise and the percentage increase in drag (Delta\_Drag) for each of the eight CRUISE SPEED LOW ADVISORIES triggered during the accident flight were highlighted. These plots showed that those advisories were issued within their design range and in accordance with the behavior expected by the APM system.

Figure 195 - Plots of the eight CRUISE SPEED LOW advisories during the accident flight, showing airspeed differences (IAS - vertical axis) and drag percentage (DRAG - horizontal axis).

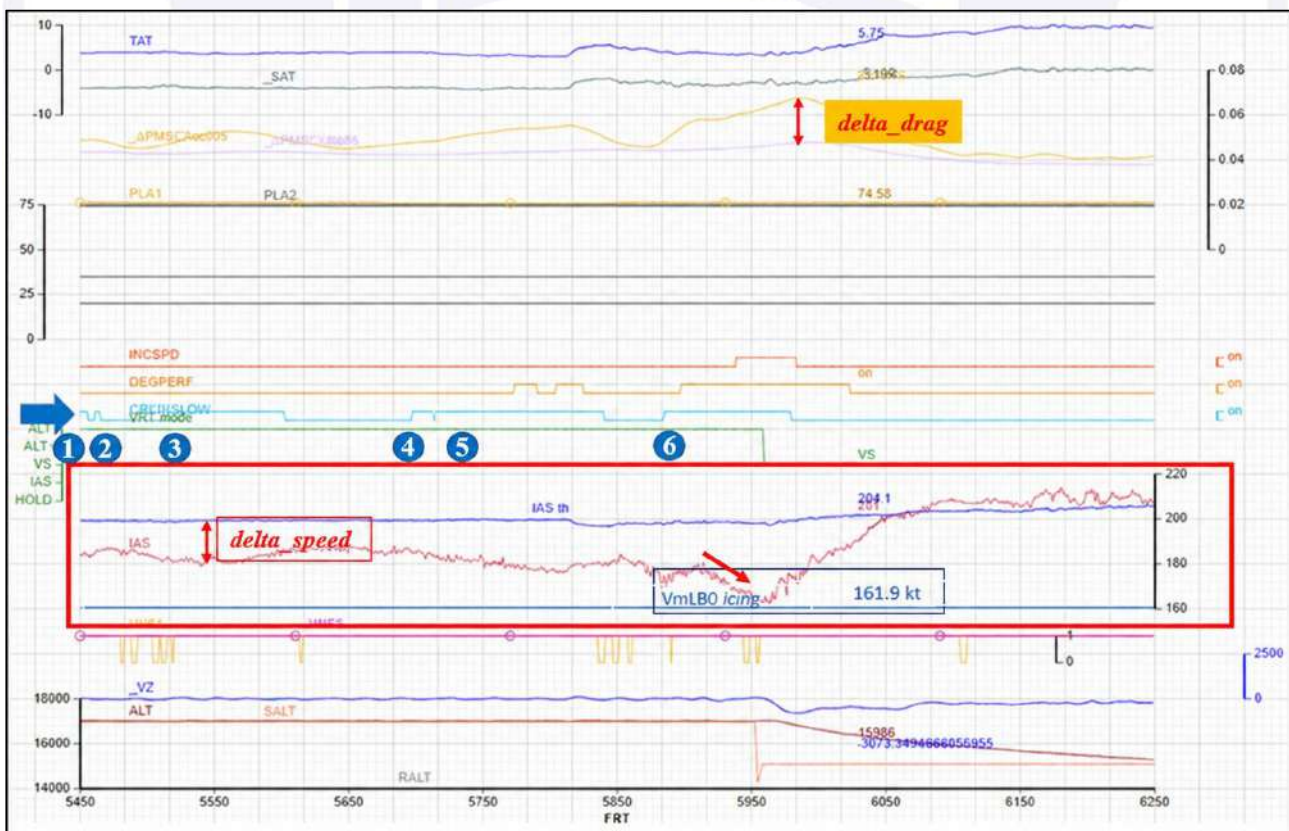
The graph containing the data from that flight highlighted a value approximately 20 kt below the reference speed (IAS\_TH) throughout the entire cruise phase, with the CRUISE SPEED LOW advisory being triggered 6 times (Figure 196). At a certain point, there was a rapid and significant degradation of IAS, consistent with a severe ice accretion condition, reaching a minimum value of 163 kt, that is, 1 kt above  $V_{MLB0icing}$  and 41 kt below IAS Theoretical (IAS th).

Figure 196 – Graphs reproduced from Figure 130 of this Report. Indication of Delta\_Speed around 20 kt throughout the entire cruise phase, with 6 activations of the CRUISE SPEED LOW advisory.

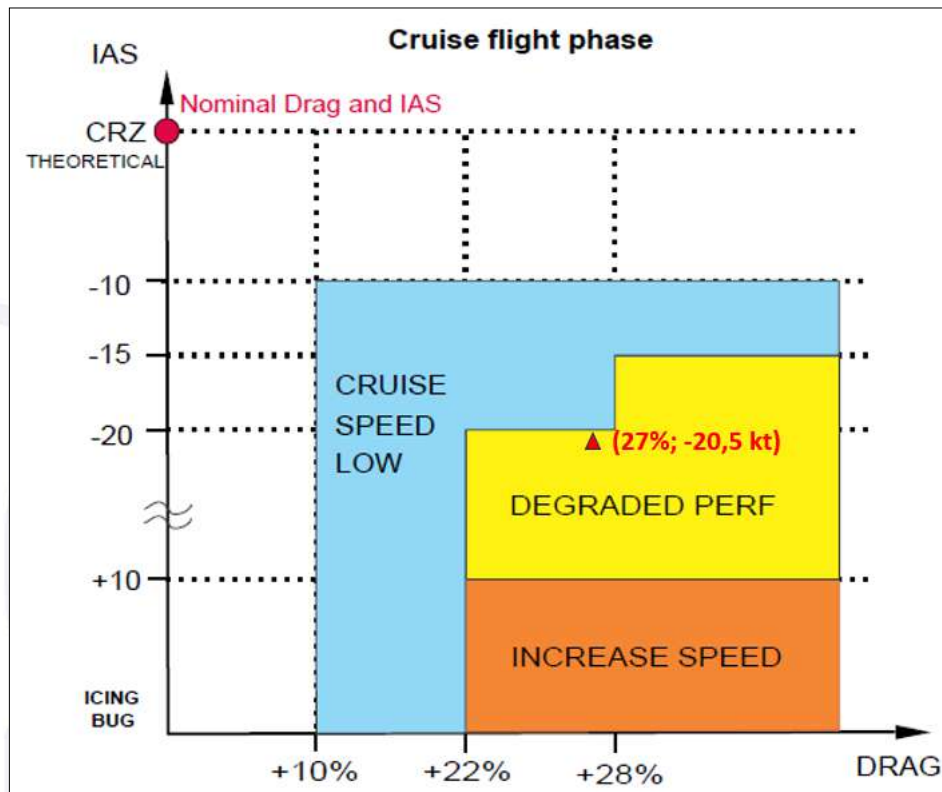
At the moment the DEGRADED PERFORMANCE alert was triggered during the accident flight, the reference speed value (IAS\_TH or APMIASTH) was 205.8 kt, while the indicated airspeed (APMIAS) was 185.3 kt. The alert was triggered when the drag difference reached 27% and the speed difference reached 20.5 kt (red arrow in Figure 197).

Figure 197 - Plot of the DEGRADED PERFORMANCE alert during the accident flight, showing speed differences (IAS - vertical axis) and drag percentage (DRAG - horizontal axis).

The SIPAER Investigation Commission identified that the 22% drag (reference drag value) was reached 28 seconds before the indicated airspeed decreased below 20 kt (reference IAS value) in relation to the drag and speed computed by the APM. The alert occurred 1 minute and 42 seconds before the stall warning and the automatic disengagement of the AP.

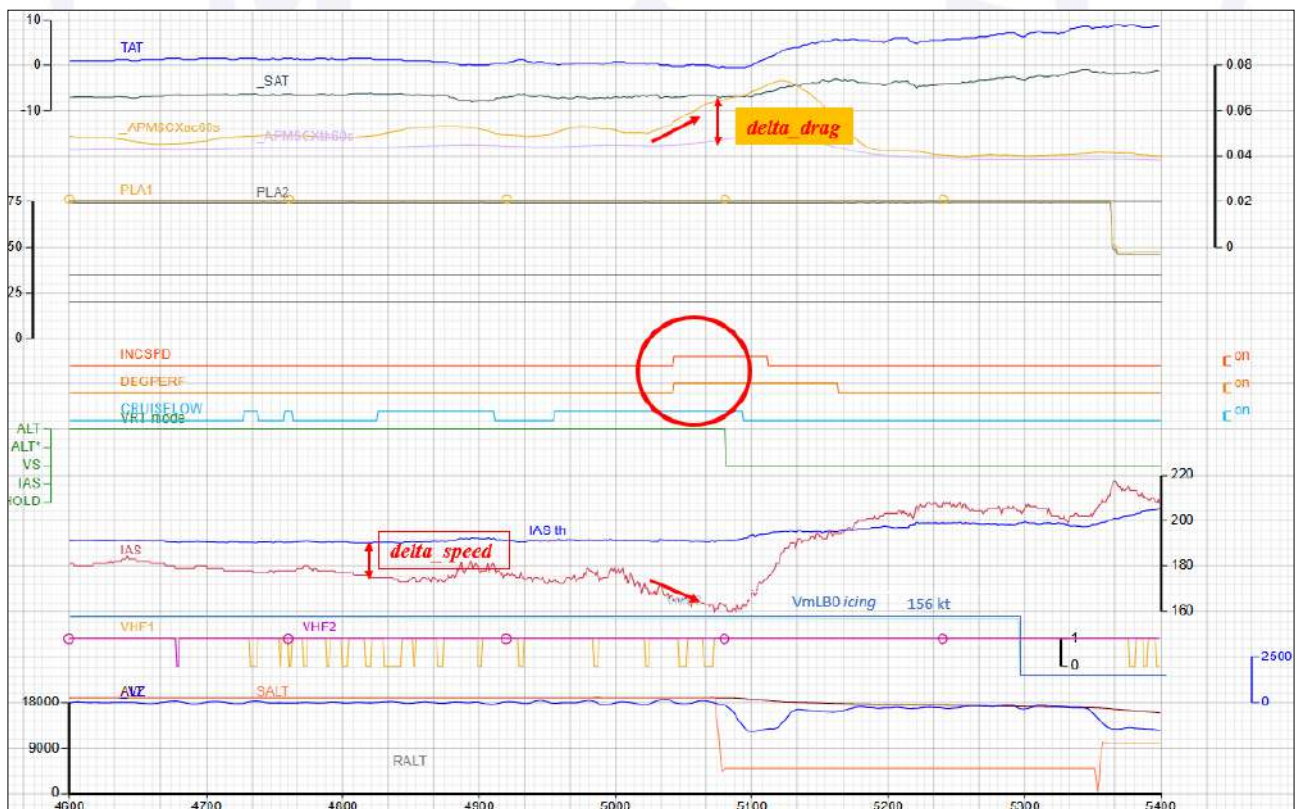
Figure 198 reproduces, as an example, the flight data graphs obtained from the operator's FDM, evidencing how the airspeed difference (delta\_speed) remained below the reference speed (IAS\_TH) throughout the entire cruise phase, and how the performance degradation conditions associated with the APM algorithm logic allowed the simultaneous activation of the DEGRADED PERFORMANCE and INCREASE SPEED alerts.

Figure 198 - Flight data graphs reproduced from Figure 131 of this Report, showing delta\_speed during the cruise phase and the simultaneous activation of the DEGRADED PERFORMANCE and INCREASE SPEED alerts following the increase in delta\_drag.

This simultaneous occurrence of the alerts could generate confusion in the flight crews' response, since both had the same classification level (Level 2 - CAUTION), despite one of them being more critical than the other from the standpoint of system design and the actions required to maintain safe flight.

Thus, the Commission concluded that a thorough evaluation by the manufacturer and the primary certification authority (EASA) was necessary in order to reassess the activation conditions of the APM alerts, so as to establish an appropriate alert hierarchy and prevent simultaneous activation.

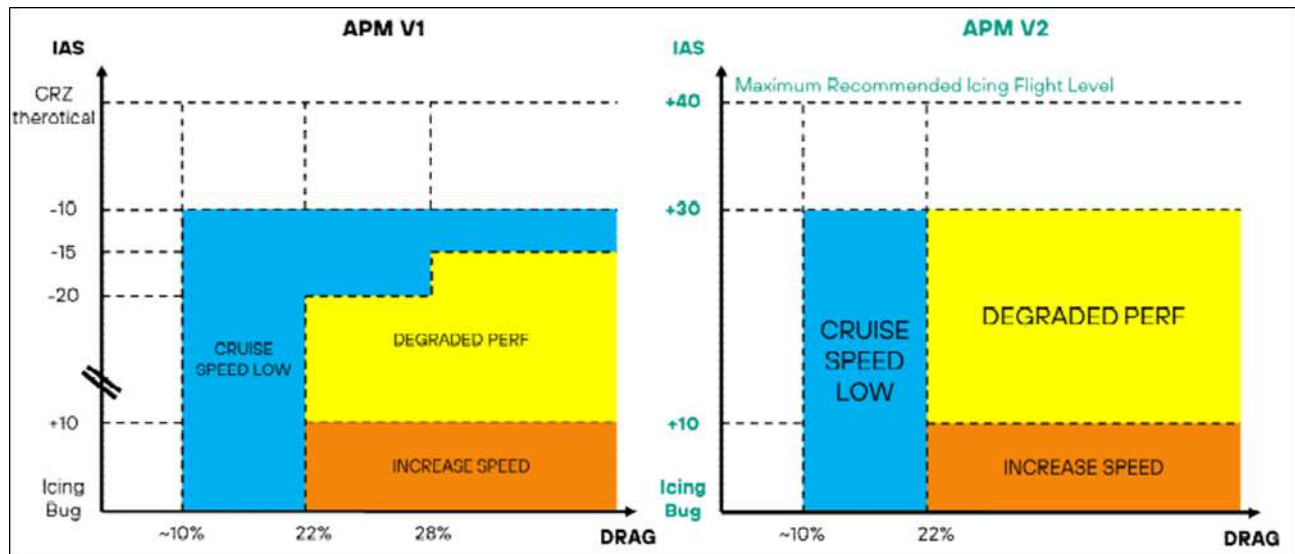
Figure 199 illustrates one of the adjustments incorporated into the V2 algorithm, indicating the elimination of the theoretical speed criterion for advisory and alert activation, such that all of them came to use VmLB0icing (ICING BUG) as the reference basis.

Figure 199 - Comparative illustration of the APM warning/alert activation regions between Versions 1 and 2.  
Source: 2025/08 Issue 1.

- 1) to reduce intermittent alert appearances (flickering), especially of the CRUISE SPEED LOW advisory, preventing messages from repeatedly appearing and disappearing and becoming trivialized by flight crews; and
- 2) to allow adequate time for procedure execution, ensuring that the flight crew would have sufficient time to complete the required actions.
