Intermediate Report (Interim Statement)

Classification: ACCIDENT

Type of Occurrence: #ICE - FORMAÇÃO DE GELO

Date: 9 August 2024
Date (UTC): 9 August 2024
Time: 16:22
City: VINHEDO - SÃO PAULO - BRASIL
Aerodrome: OUTSIDE THE AERODROME
Local: RESIDENTIAL AREA OF THE CITY
Damage to third parties: YES

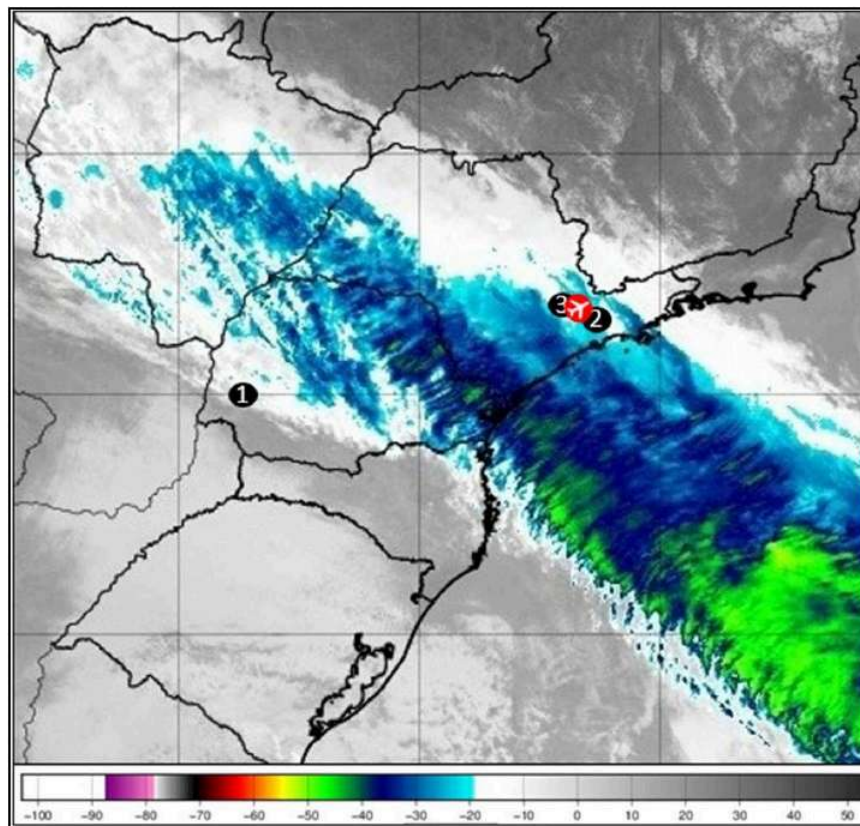
Figure 23 - GOES-16 Satellite image. Numbers show the locations of aerodromes; number "1" - SBCA; number "2" - SBGR; and number "3" - SBKP. The red circle highlights the location of the aeronautical occurrence.

As illustrated in Figure 23, clouds with tops presenting temperatures between 0°C and -35°C (light gray to dark blue tones) predominated, indicating the existence of medium altitude clouds of the altocumulus and altostratus types. The presence of Towering Cumulus (TCU) clouds was observed in scattered points and embedded in the medium cloud layer, between the east-central region of the State of *Paraná* and the south of the State of *São Paulo*, with temperatures between -35°C and -45°C (dark green to light green tones). The set of cloudiness spots shown also favored the presence of convective clouds of the Cumulonimbus (CB) type, however in isolated points of the

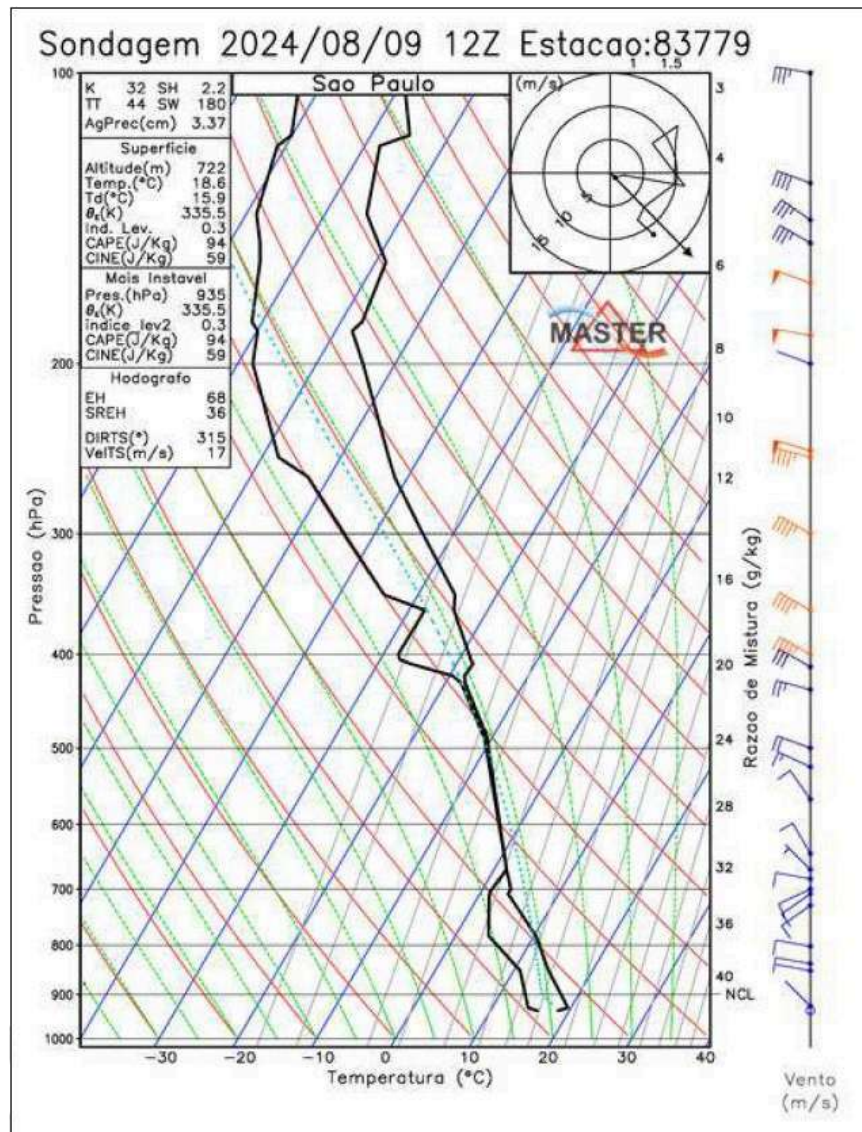
From the data obtained by the SBMT EMA, it was possible to verify that the atmosphere was very humid ($T-T_d < 2^{\circ}\text{C}$ and the mixing ratio $> 1\text{g/kg}$) at average levels, between 670 hPa (FL110) and 420 hPa (FL230), evidencing the presence of extensive cloudiness with significant thickness.

Since the air temperature only reaches the 0°C isotherm at 650 hPa (FL120), severe High Altitude Icing (HAF) occurs between FL120 and FL230. The wind at FL170 was predominantly from the West (W) with 46 kt., and the air temperature was -9°C . A maximum wind (*jet stream*) from the West at a speed of 100 kt. was identified around 250 hPa (FL340), as shown in Figure 24.

Figure 24 - Skew-T log-p diagram with winds aloft data of SBMT 12:00 UTC 09 August 2024.

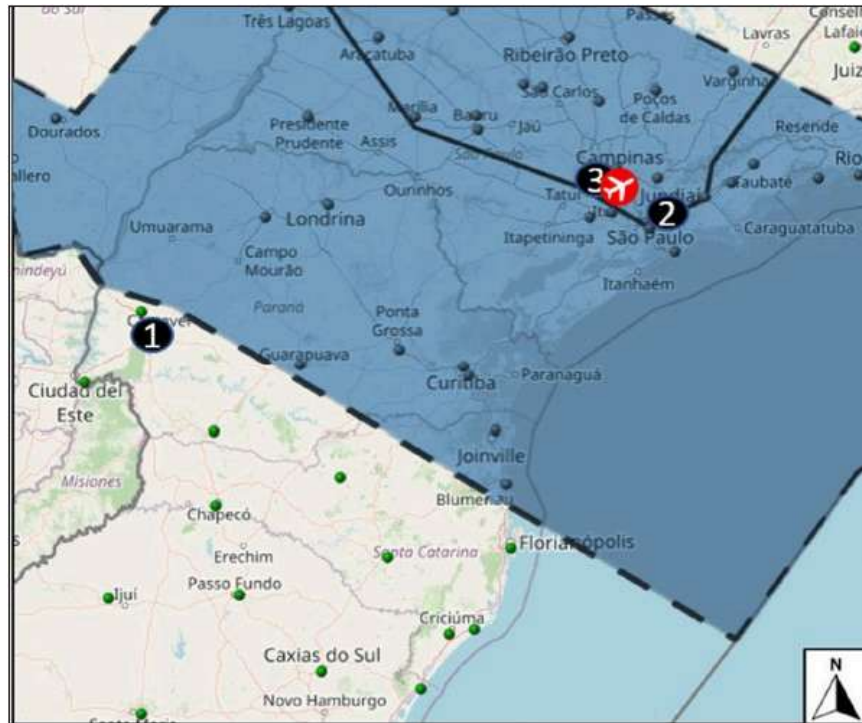
SIGMET messages related to severe-icing forecast were issued on 09 August 2024 for the Flight Information Regions of *Curitiba* (CW) and *Brasília* (BS), with validity from 15:30 UTC to 19:30 UTC (respectively, SBBS SIGMET 2 and SBCW SIGMET 9), as shown in the Figure 25 below.

Figure 25 - Areas related to the Severe Icing SIGMET message issued for FIR-CW and FIR-BS (blue hatched highlight). Numbers show the locations of aerodromes: "1" - SBCA, "2" - SBGR, and "3" - SBKP. The red circle indicates the crash site.

The referred SIGMET messages forecasted the occurrence of severe FGA (SEV ICE), with base at FL120 and top at FL210, with no apparent movement and no change in intensity, as shown below:

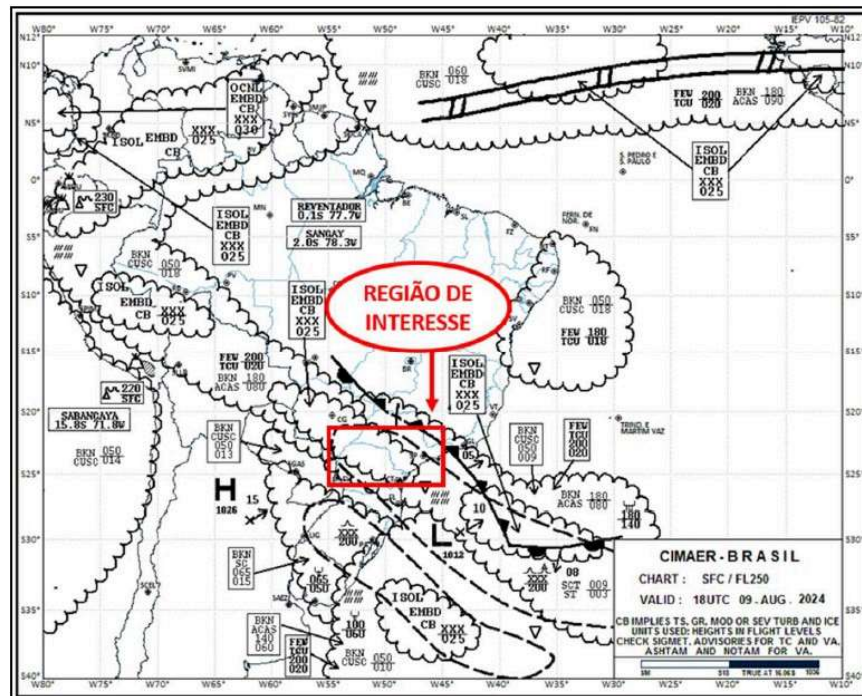
Figure 26 - 09 August 2024 18:00 UTC SIGWX from the surface to FL250. Region of interest highlighted in the red polygon.

- cold front crossing the state of São Paulo, associated with a low atmospheric pressure center of 1012 hPa located approximately at 29°S 043°W;
- TCU clouds, with base at 2,000 ft and top at 20,000 ft, covering 1 to 2 oktas sky (FEW);
