INTERNATIONAL CIVIL AVIATION ORGANIZATION

**EIGHTH TECHNICAL-
OPERATIONAL MEETING OF THE
REDDIG DIGITAL NETWORK**

FINAL REPORT

(Santiago de Chile, Chile 14 to 18 October 2019)

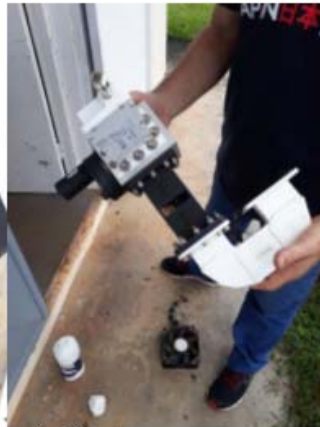
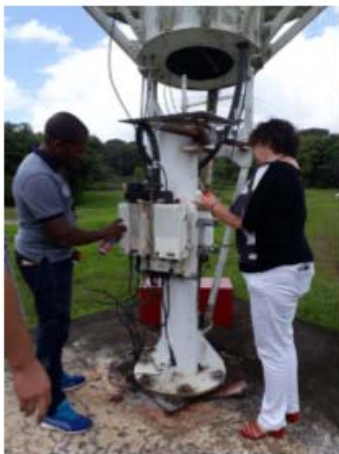
Mantenimiento componentes interior antenna (outdoor) – presencia de insectos

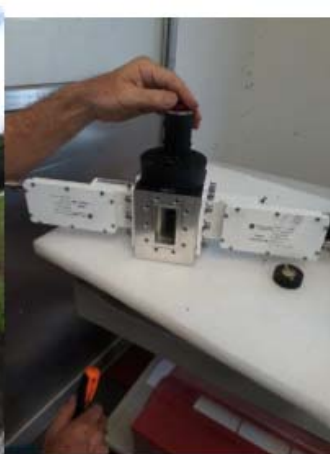
Limpieza componentes antenna

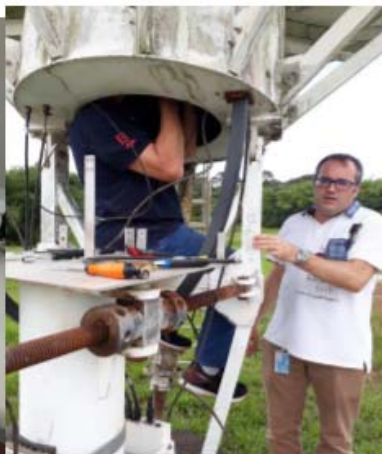
Verificación componentes Rx antenna

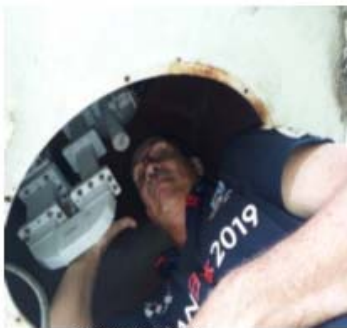
Verificación antenna

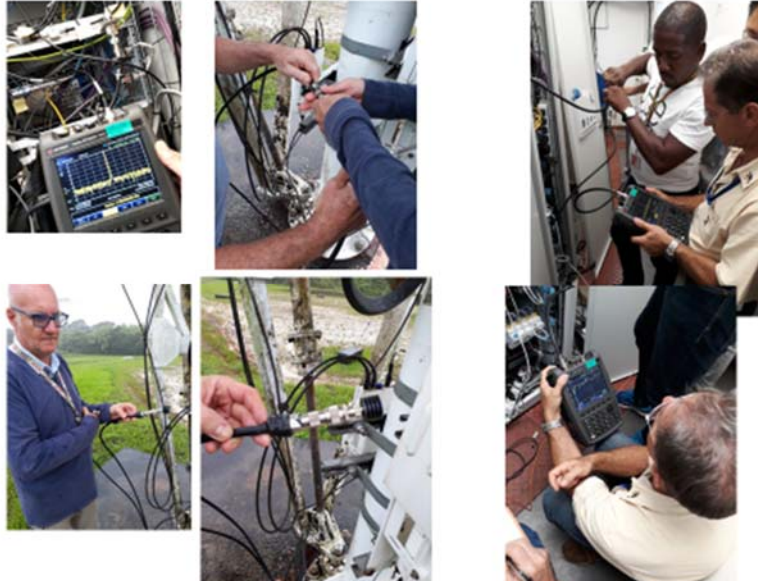
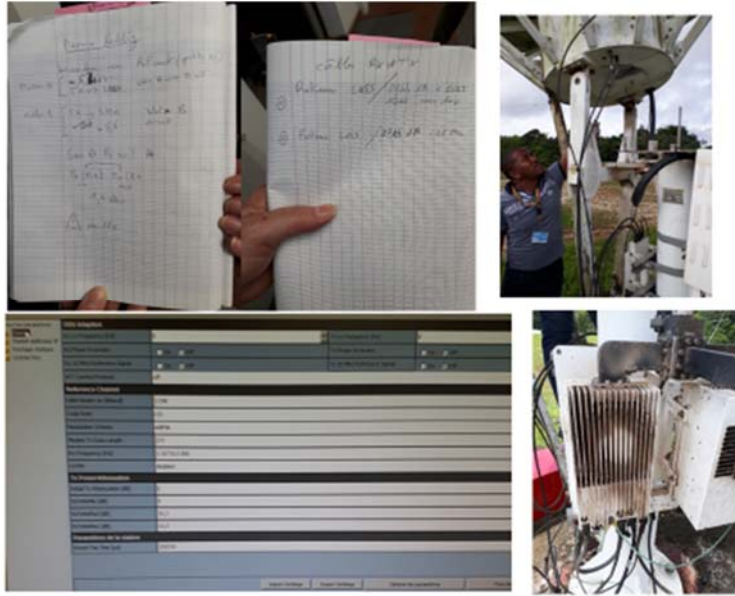
A efecto de poder verificar si la estación sufrió degradaciones por atenuaciones, se procedió a simular la inyección de una frecuencia tanto en recepción como en transmisión y la posterior lectura en las salidas de las etapas comentadas. Se registraron valores aceptables. Se hizo lo propio con los cables de transmisión y recepción que van del rack hasta la antena. Se obtuvieron resultados aceptables.

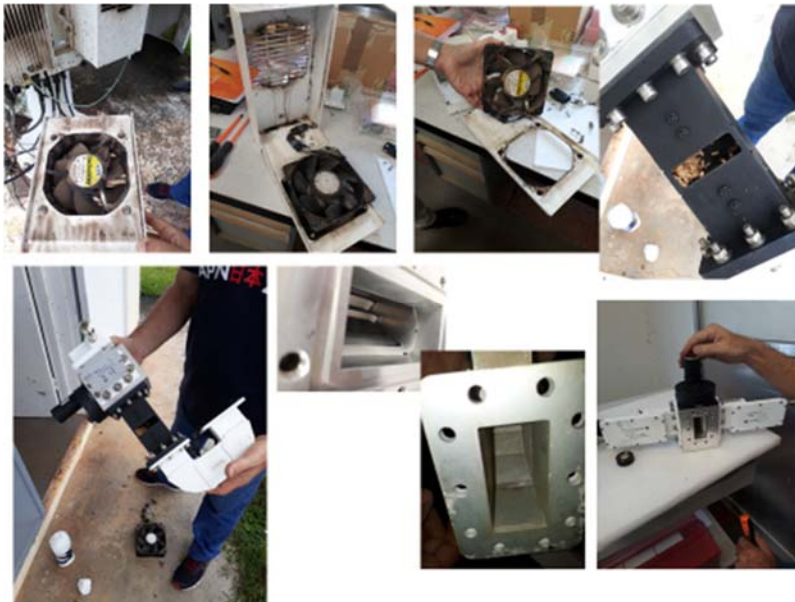
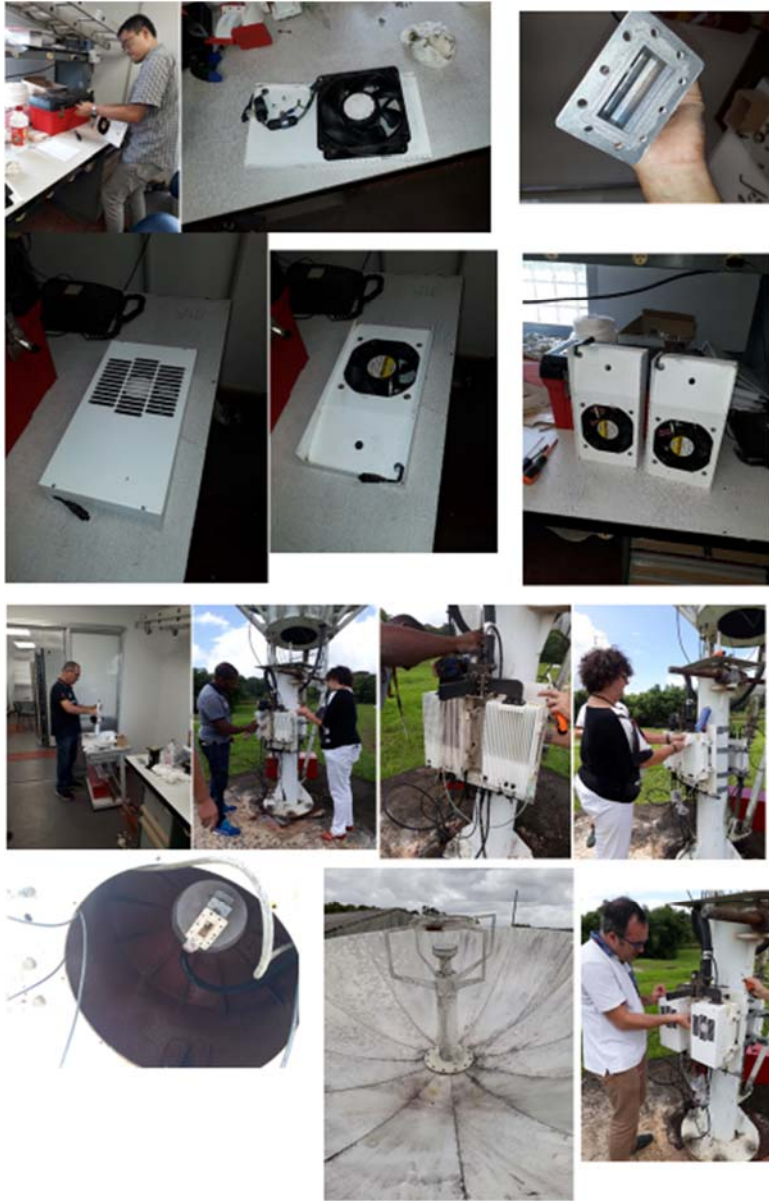
Se realizaron tareas de mantenimiento preventivo y limpieza en los IBUCs y en el plato de la antena, como también en otras partes de la estación.

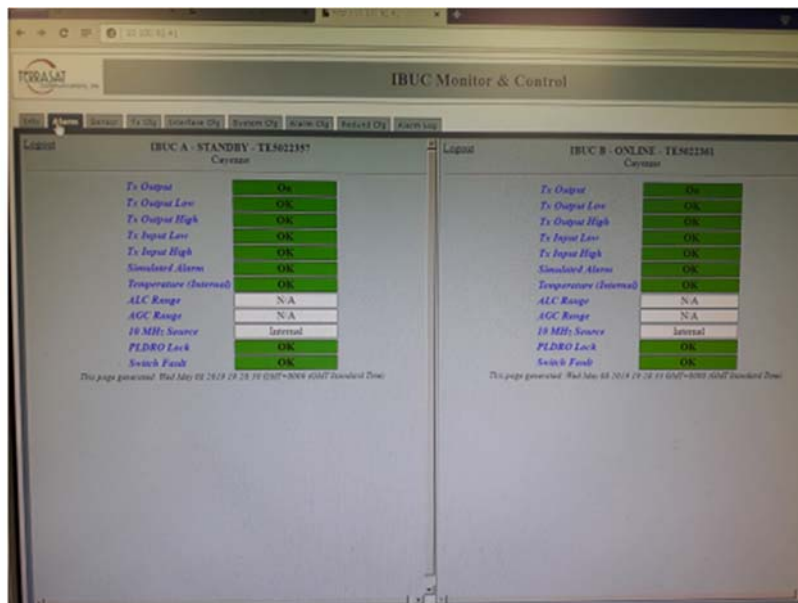
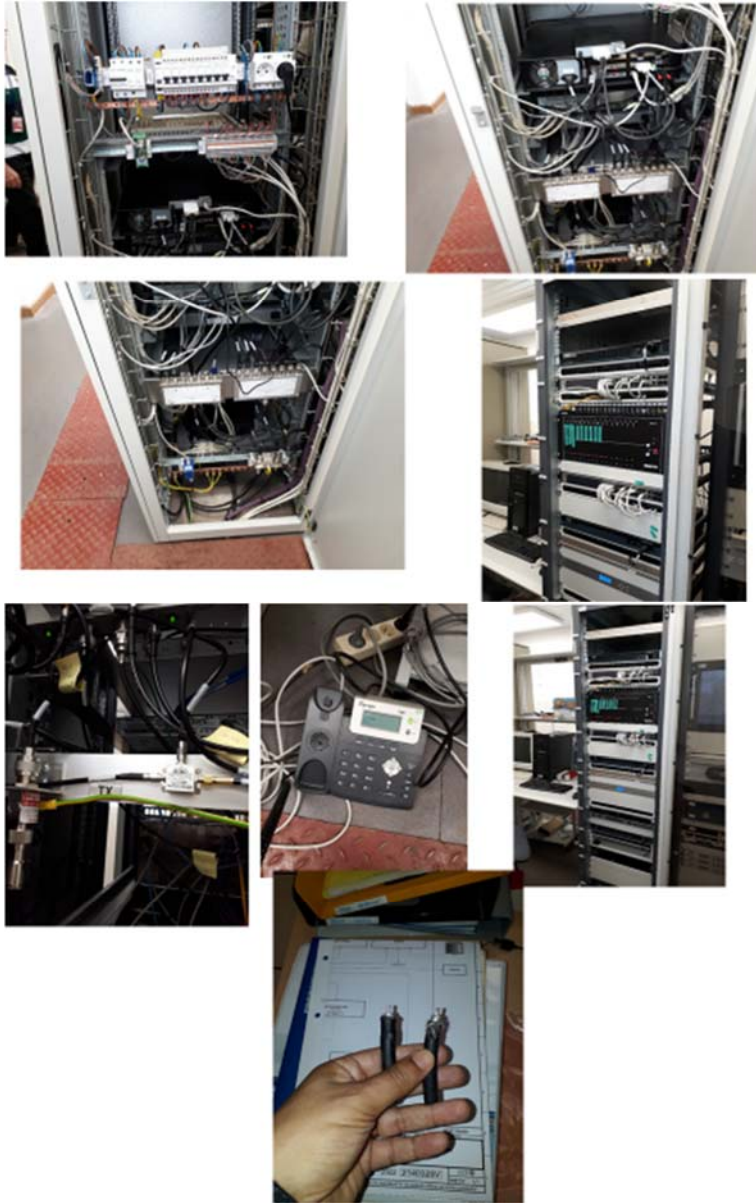
Se revisaron las configuraciones y parámetros de routers, switches, conectores, cables, circuitos DC Blocks, etc. Se hicieron mediciones de tensión y señales.

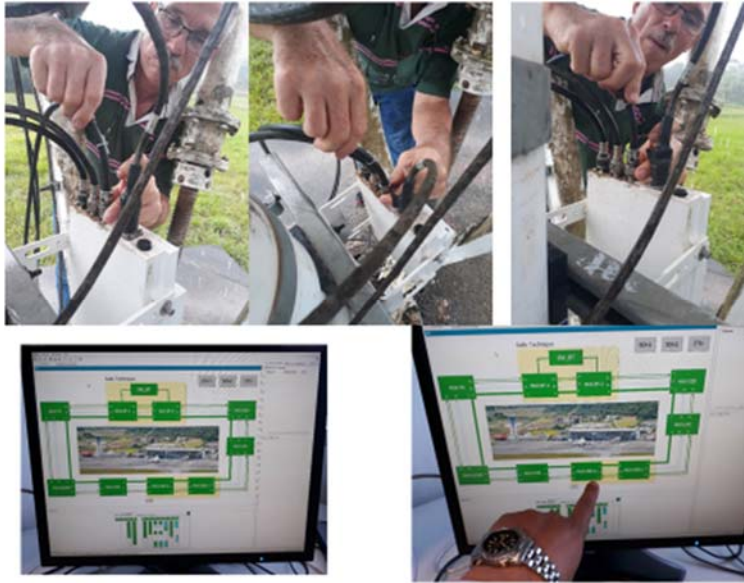
Se verificó la topología del backup terrestre, de lo cual surgió la necesidad, por parte del personal de Cayena que se analice cambiar el proveedor de última milla.

Debido a los inconvenientes que presenta uno de los módems y degradación de la performance de los amplificadores, se recomienda reemplazar uno de los módems, reemplazar uno de los amplificadores, terminar de verificar otros conectores, el Tx 1+1, el Rx 1+1, y coordinar con Intelsat para verificar como está trabajando la estación en relación al transponder satelital.
