# Bureau Enquêtes Accidents pour la Sécurité de l'Aéronautique d'État (State Aviation Safety Investigation Bureau - BEA-É) Safety Investigation Report

T-2023-22-I

| Event date: | 20 December 2023 |
| Type of aircraft | TBM 700 |

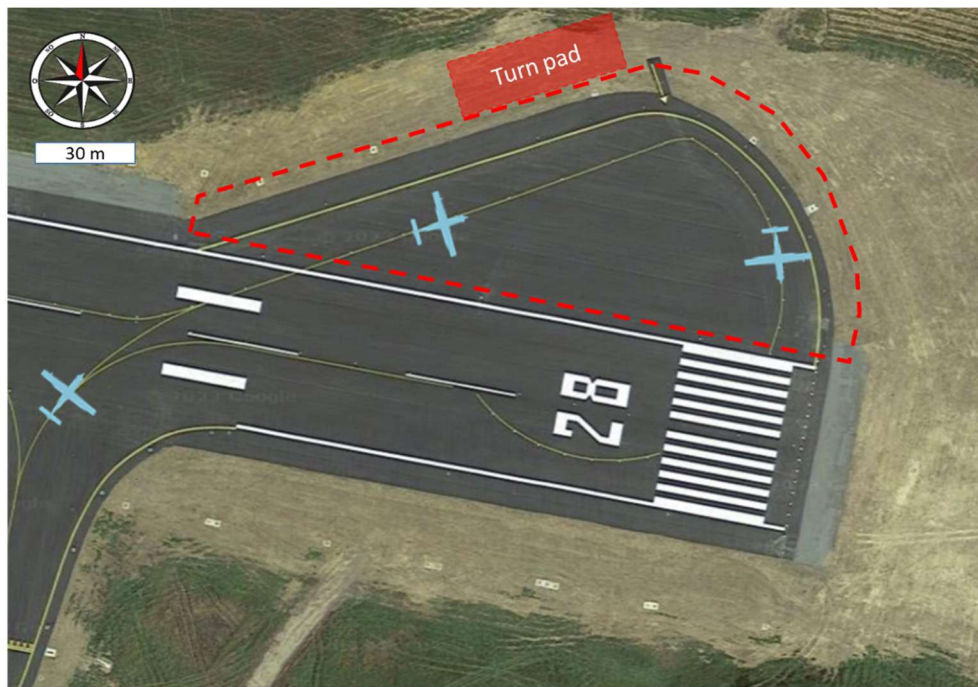
Figure 9: turn pad at the threshold of runway 28

The turn pad is a construction at the end of the airport's runway that enables aircraft to turn around. This space is essentially intended for large aeroplanes to taxi and move off to a manoeuvring area or to line up at the end of the runway before take-off. The turn pad marking complies with the applicable regulation<sup>15</sup>.

Due to its small size, the TBM 700 is not obliged to use this type of area when the runway is wide enough for it to turn around. This is the case of the 45 m-wide runway at Rennes Saint-Jacques.

During taxiing, believing he could see the figure 8 of the threshold of runway 28 to his right, the pilot flying tightened his turn thinking he was lining up on the runway centreline between the figure 2 and the figure 8, opposite a white light that he thought was the runway centreline light. The pilot was therefore the victim of a misperception that led him to make a turn that was too tight.
