REPORT

AVIATION 2026/03

***Air accident in the sea west of Sotra,
Vestland County, Norway on 28 February
2024 with Sikorsky S-92A, LN-OIJ,
operated by Bristow Norway AS***

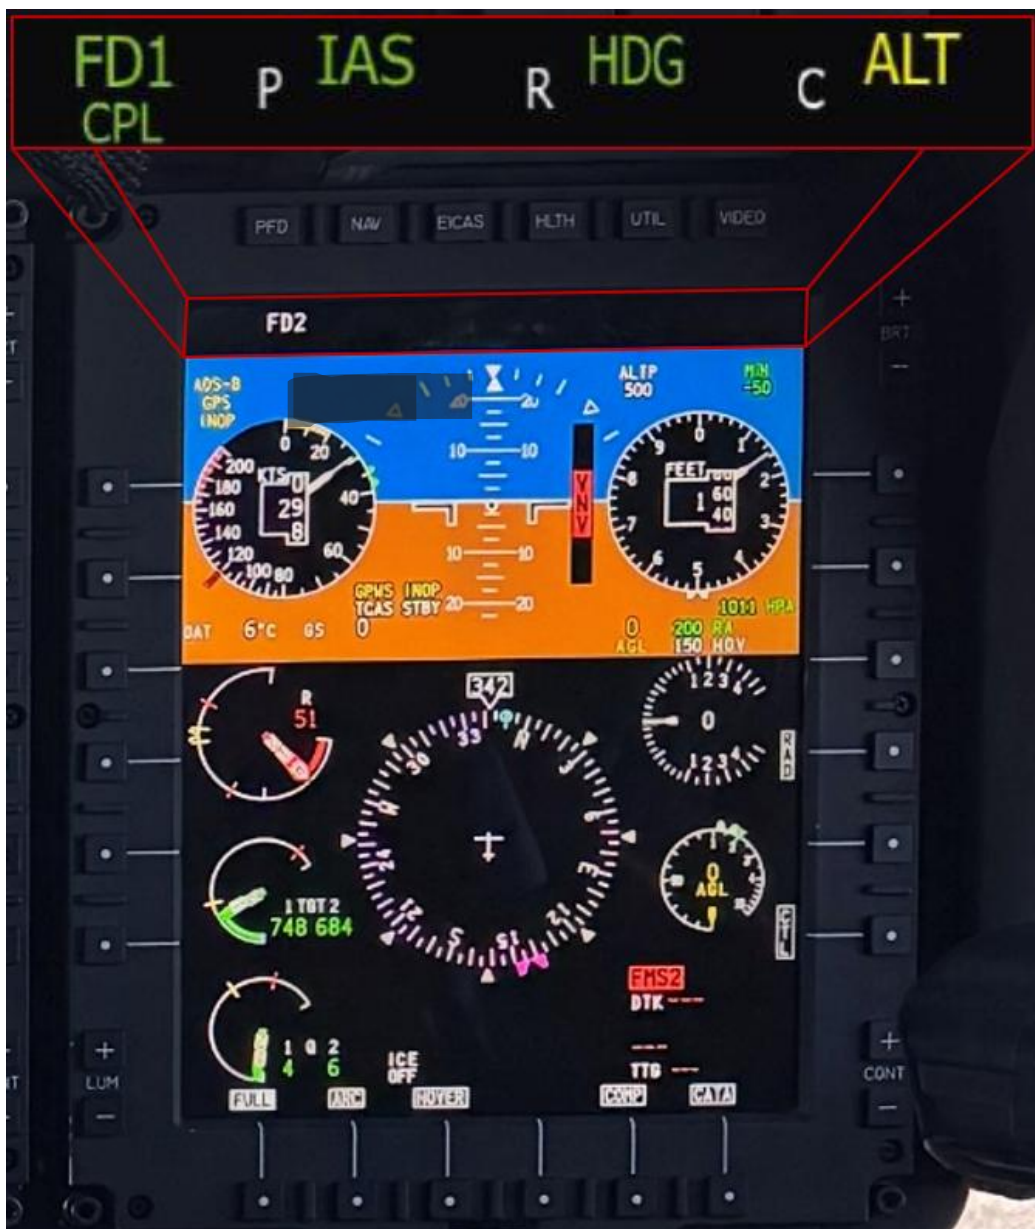
The Flight Director (FD) axis degrade is a visual cue to the pilot that a FD channel may still be coupled with degraded system performance, or the axis could be uncoupled. The FD annunciation on top of the Primary Flight Display (PFD) goes from green to yellow for the affected axis, see Figure 8. In the accident with LN-OIJ it is the pitch channel that is of interest due to the pure pitch up motion.

Figure 8: Photo of the Primary Flight Display with an illustration of a degraded collective axis (yellow ALT). A strip on the PFD with flight director annunciators is expanded and highlighted with red lines. Photo: NSIA. Illustration: Sikorsky/NSIA

As discussed in 1.6.4.3 the Flight Director provides a cue to the pilot that an AFCS axis is degraded by changing the colour of current coupled mode in that axis from green to yellow, see Figure 8. The NSIA was interested to investigate the contrast between the green and yellow at night, with the screens dimmed down. Several pilots the NSIA has talked to have stated that the colour scheme, and general layout of the Primary Flight Display (PFD) at times require extra focus to pick out details.

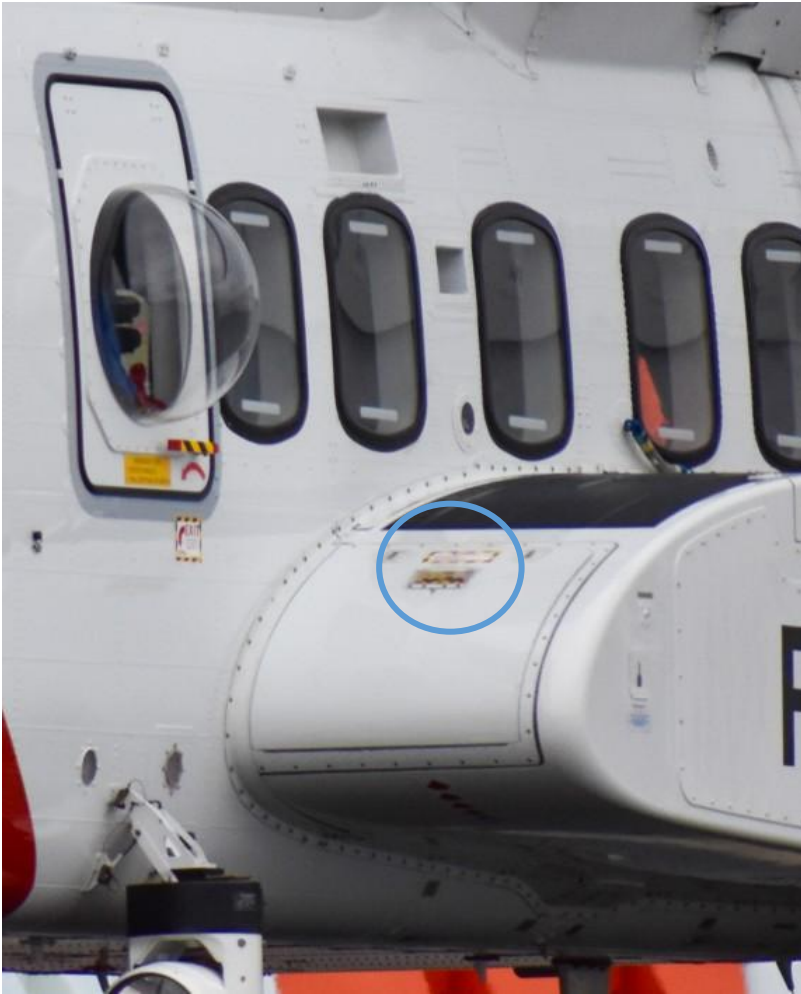
If the system cannot be jettisoned electrically, passengers can manually deploy the life rafts. Pulling the D-ring on the top front access panel of each sponson causes the rafts to inflate and deploy.

Figure 14: Picture showing the location of the D-ring, blue circle. Photo: Bristow Norway / NSIA

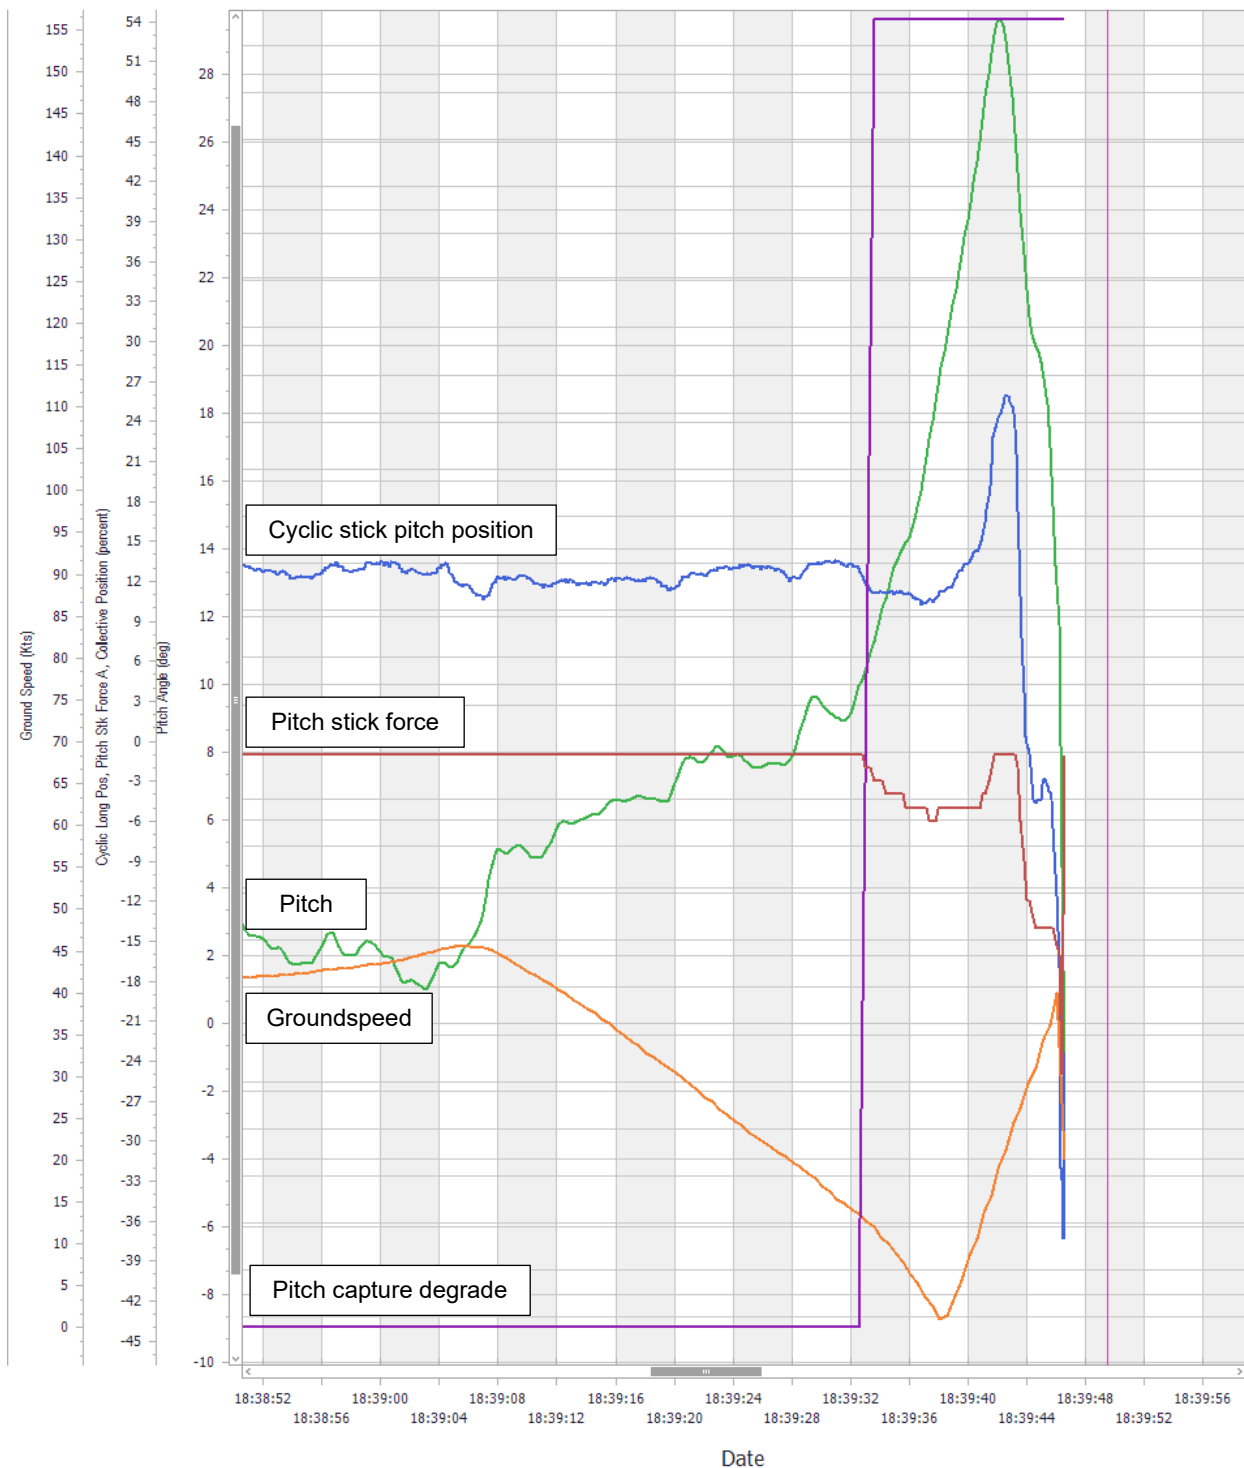
The NSIA verified that the HUMS data and FDR data were equivalent. In this report the HUMS data is shown due to superior visualisation. Figure 20 shows the pitch attitude, the cyclic stick position for pitch, groundspeed, pitch stick force and the pitch capture degrade (high is degraded) during the final deceleration of the "Mark on Top" (MOT) manoeuvre from the HUMS data. The graph spans a period of 47 seconds. All values appear normal until the helicopter starts pitching up at about 15 seconds from the end of the recording. Figure 21 shows the same parameters for the

Figure 20: The pitch angle (green), cyclic stick pitch position (blue), ground speed (orange), pitch stick force (red) and the pitch capture degrade (purple) from the HUMS data. Source: NSIA

The helicopter pitched up from 8.9° to 29.6° over a period of 10 seconds. Two seconds after the pitch up started, the FD pitch degrade was illuminated due to the stick force reaching -3%, the force reaches a maximum of -6% six seconds after the pitch up started. About a second after the pitch-up manoeuvre started, the cyclic stick moved backwards (negative, nose up), the ground speed was at this time 13.5 kt. The cyclic stick position then remained constant for 4 seconds before a forward motion is recorded (positive, nose down). The ground speed is steadily decreasing, until it reaches zero, at which point it starts increasing. HUMS cannot record negative

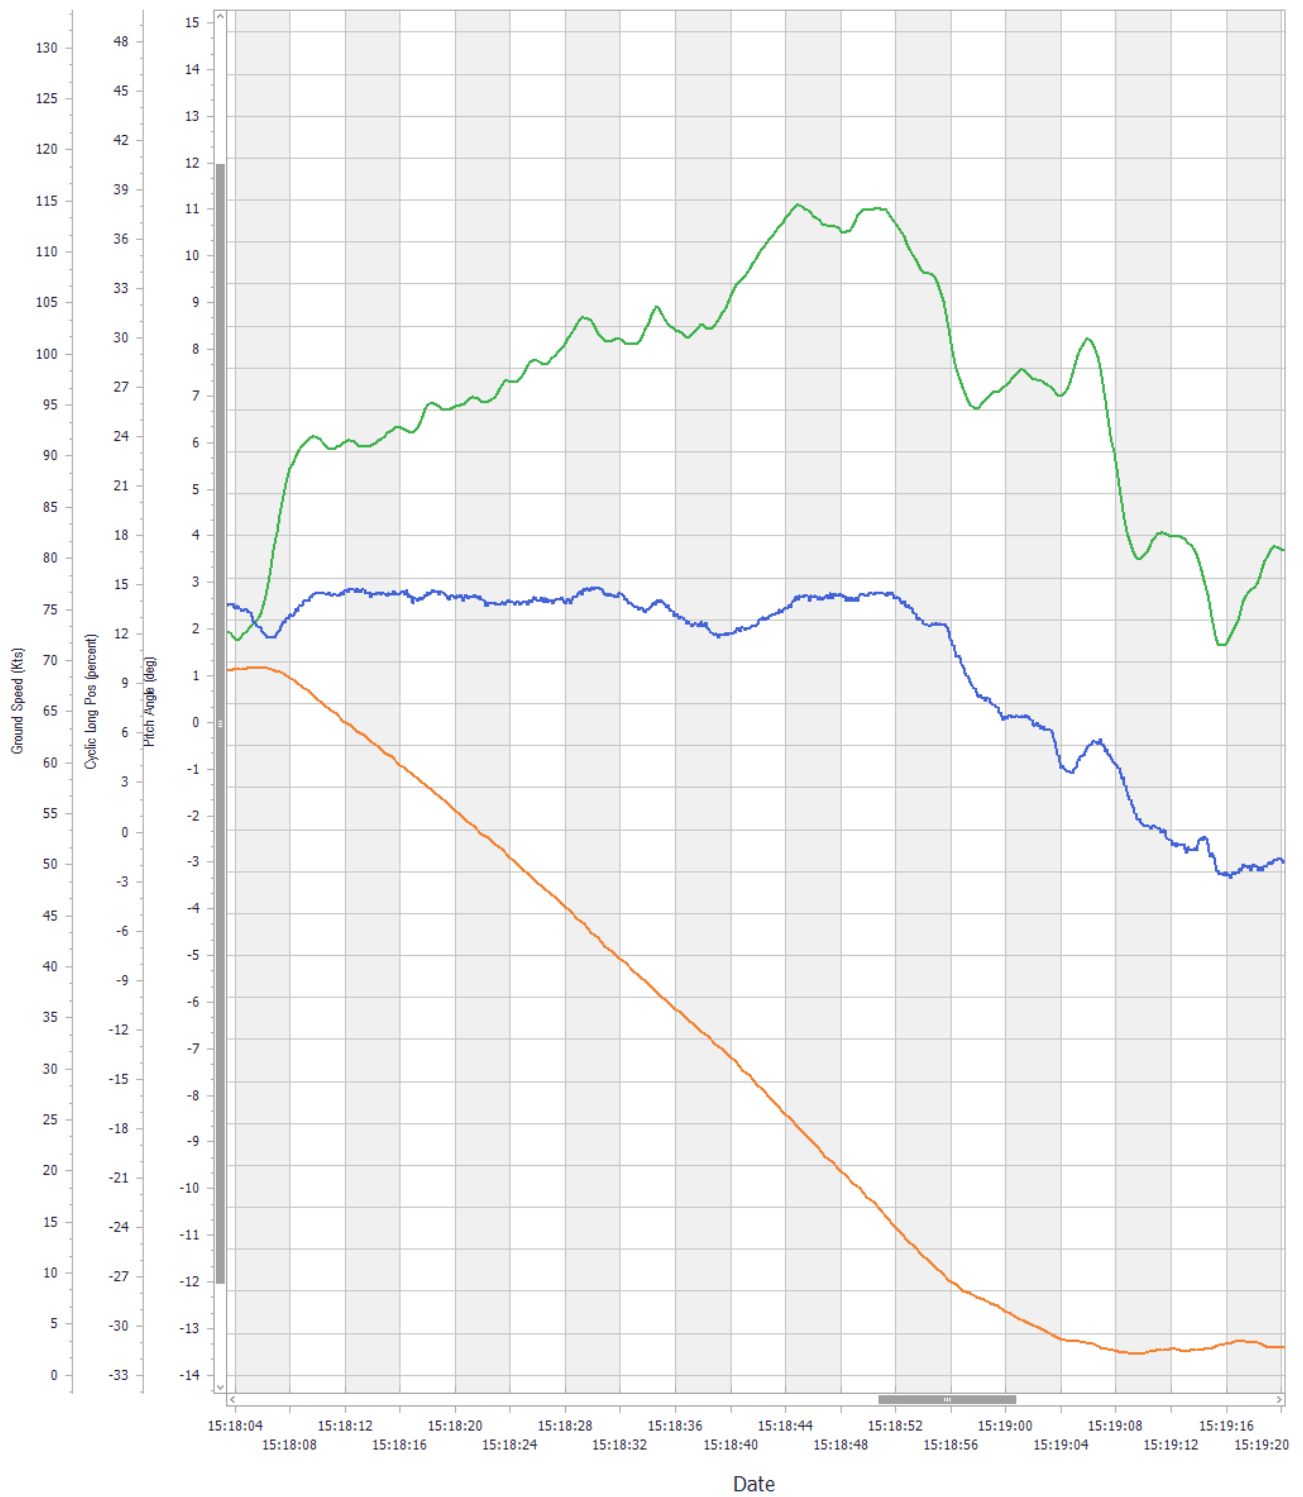
Data from the final deceleration of a MOT LN-OIJ performed on the 11 February 2024 is shown in Figure 23. This MOT completed as normal and can be considered expected behaviour. Of note is that a negative cyclic pitch trend is seen as the helicopter ground speed goes below 14.5 kt. This trend is seen in data the NSIA has collected from several flights. A comparison of cyclic position, pitch attitude and ground speed between the flight on 11 February and 28 February is provided in Figure 24. This illustration is synced to groundspeed, and shows how a normal MOT might look for LN-OIJ.

Figure 23: The HUMS data from the final deceleration of a MOT LN-OIJ performed on the 11 February 2024. Pitch (green), cyclic pitch position (blue) and ground speed (orange). Source: NSIA

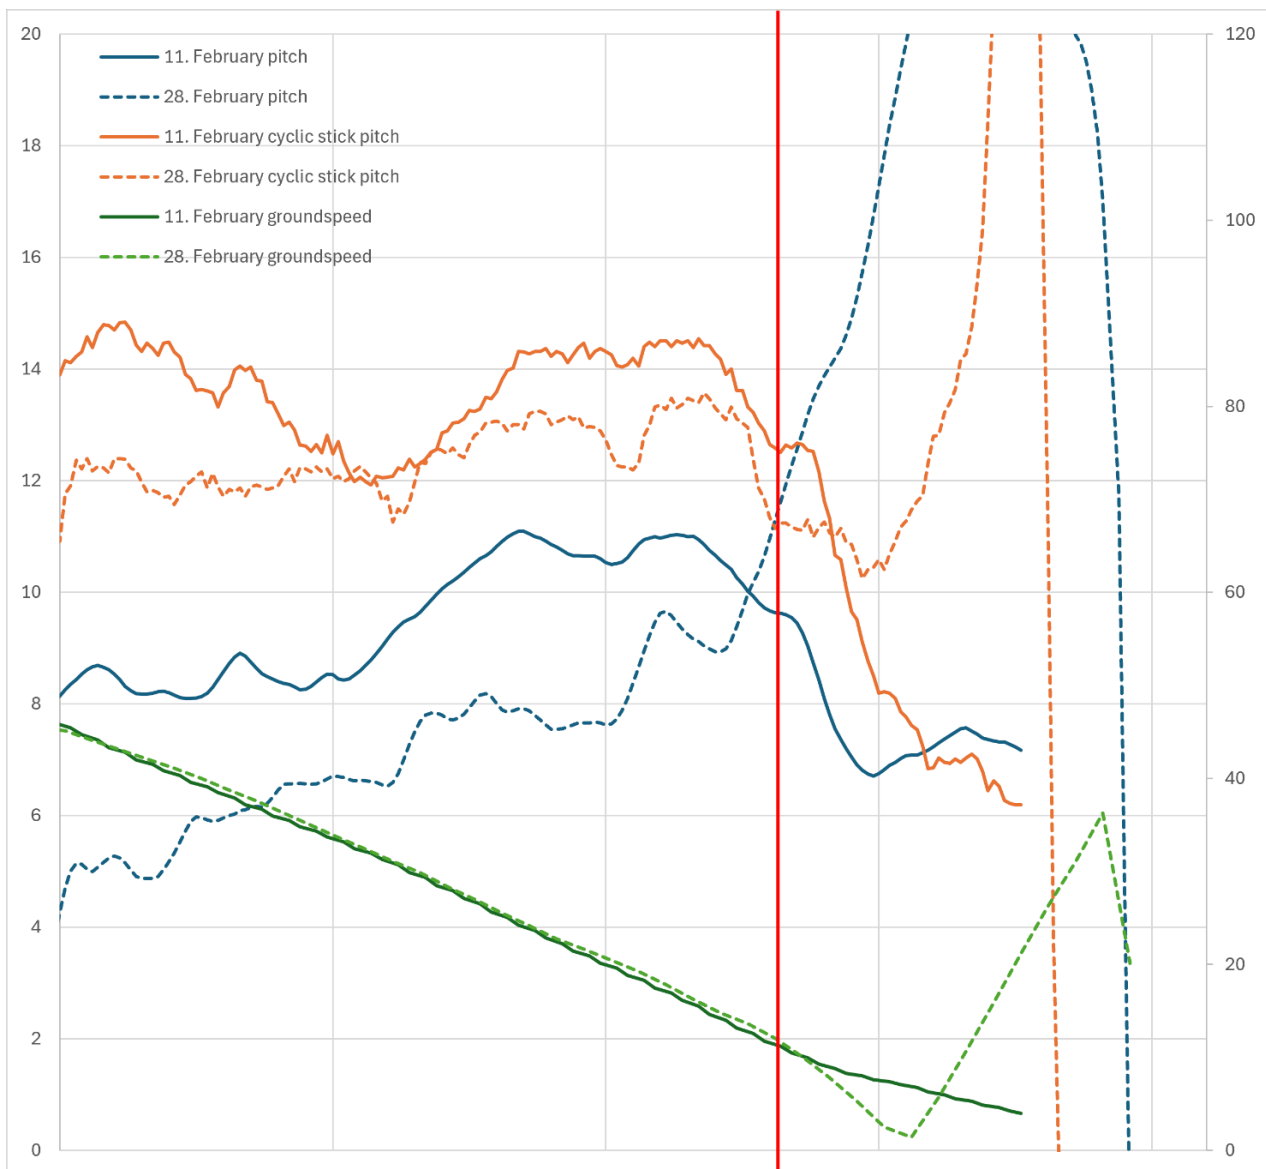
Figure 24: Comparison of the final deceleration of the MOT performed by LN-OIJ on the 11 February (solid lines) and 28 February (dashed lines). Cyclic stick pitch position is in orange; pitch is in blue (both plotted on left axis) and ground speed in green (plotted on right axis). The solid red line approximates when the pitch capture degrade occurs. Source: NSIA

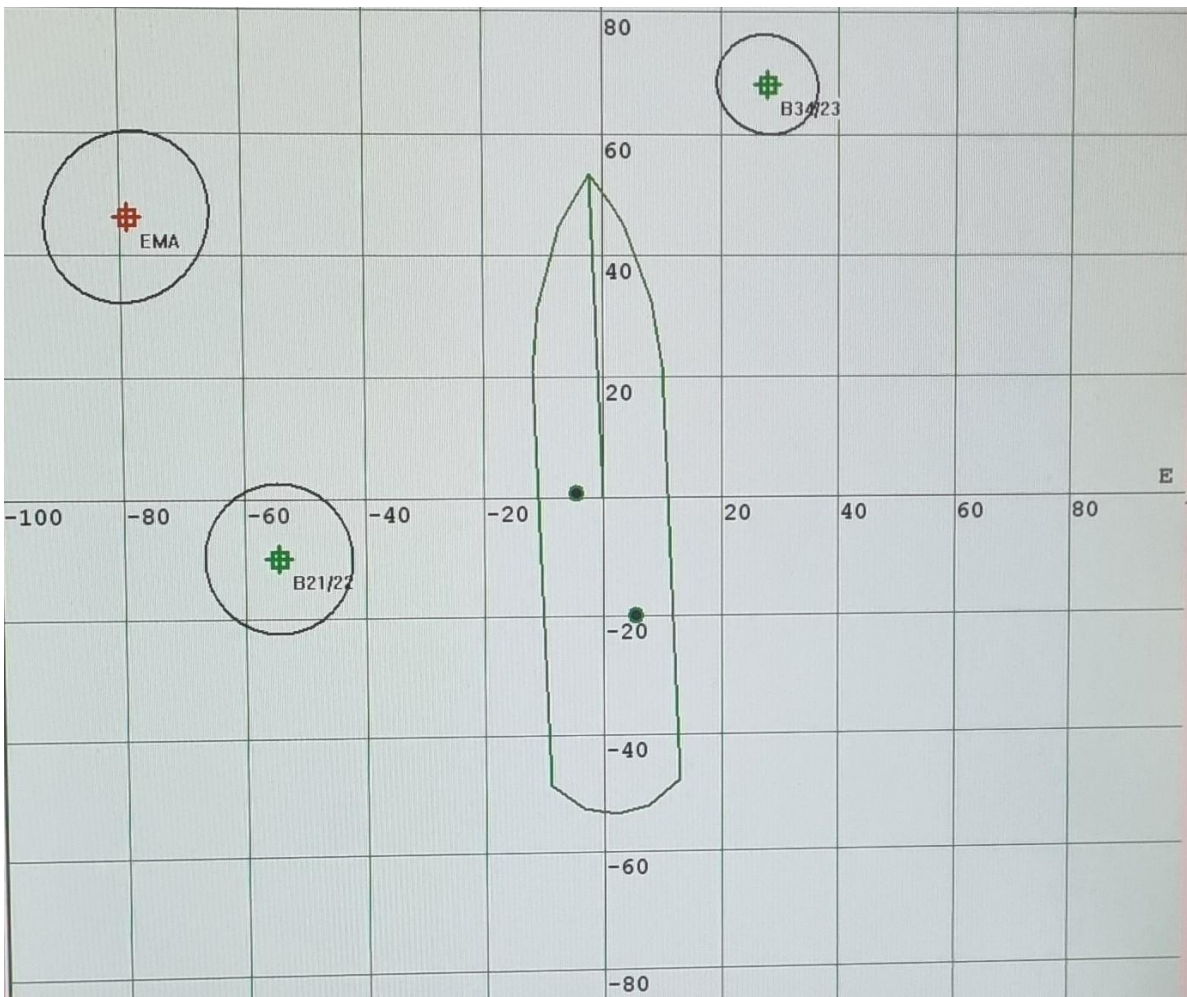
During the search, the NSIA noted that the search vessel had to be very close to the helicopter wreckage before it was detected by the DP system, and the detected signal was intermittent. During a previous search with similar equipment, the target was detected at 0.5 NM. It was also noted that the helicopter marker became clearer when the ROVs were either stationary or pulled out of the sea. This phenomenon was discussed and might indicate that the propellers on the ROVs interfered with the DP system's ability to communicate on the 37.5 kHz frequency. In addition, the helicopter wreck was largely intact, with the CVFDR still fitted inside the helicopter, which would attenuate the signal from the ULB.

Figure 25: The helicopter located by the DP system on board Normand Ocean. The two green markers are the ROV, while the red marker is the helicopter. Photo: NSIA

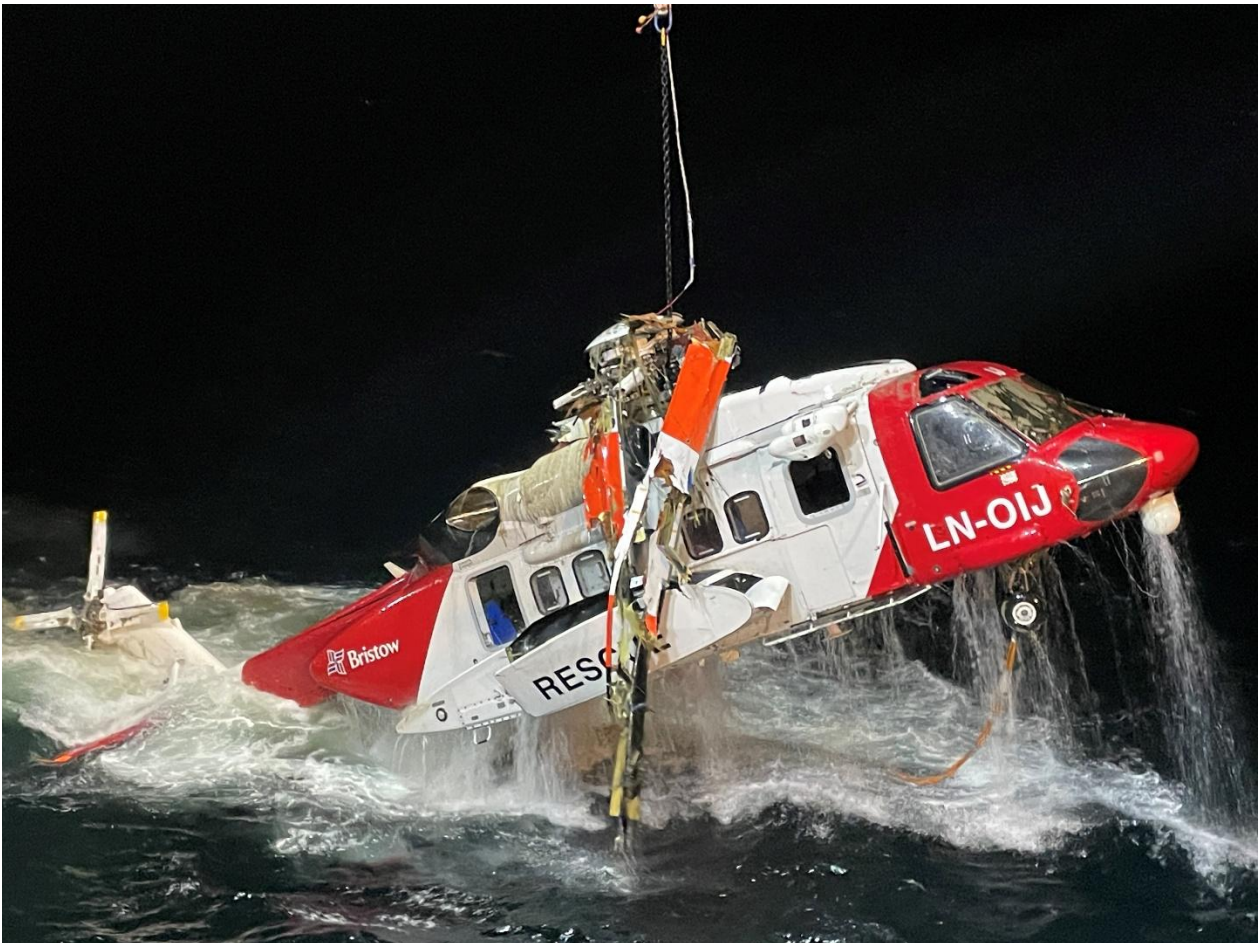
Since the helicopter was lying on its back, it was first hoisted by attaching slings on each main landing gear and on the nose gear. When the helicopter reached the surface, the vessel was rolling, making the crane boom on the port side heave significantly. The wave height was about one meter. This resulted in an uneven and jerking pull, and both main wheels were pulled loose from the gear leg, see Figure 27. To prevent losing the last attachment, the helicopter was carefully lowered down to the seabed again. Standing on its tail, a line from a second crane was attached in a way that allowed the helicopter to be lowered down to the seabed on its belly. A ROV was used to thread a chain between the main rotor mast and the pitch links. With this attachment it was possible to hoist the helicopter out of the sea, see Figure 28. The helicopter was on the deck of Normand Ocean at 0510 hrs on Saturday 2 March.

Figure 28: LN-OIJ being hoisted out of the water. Photo: NSIA

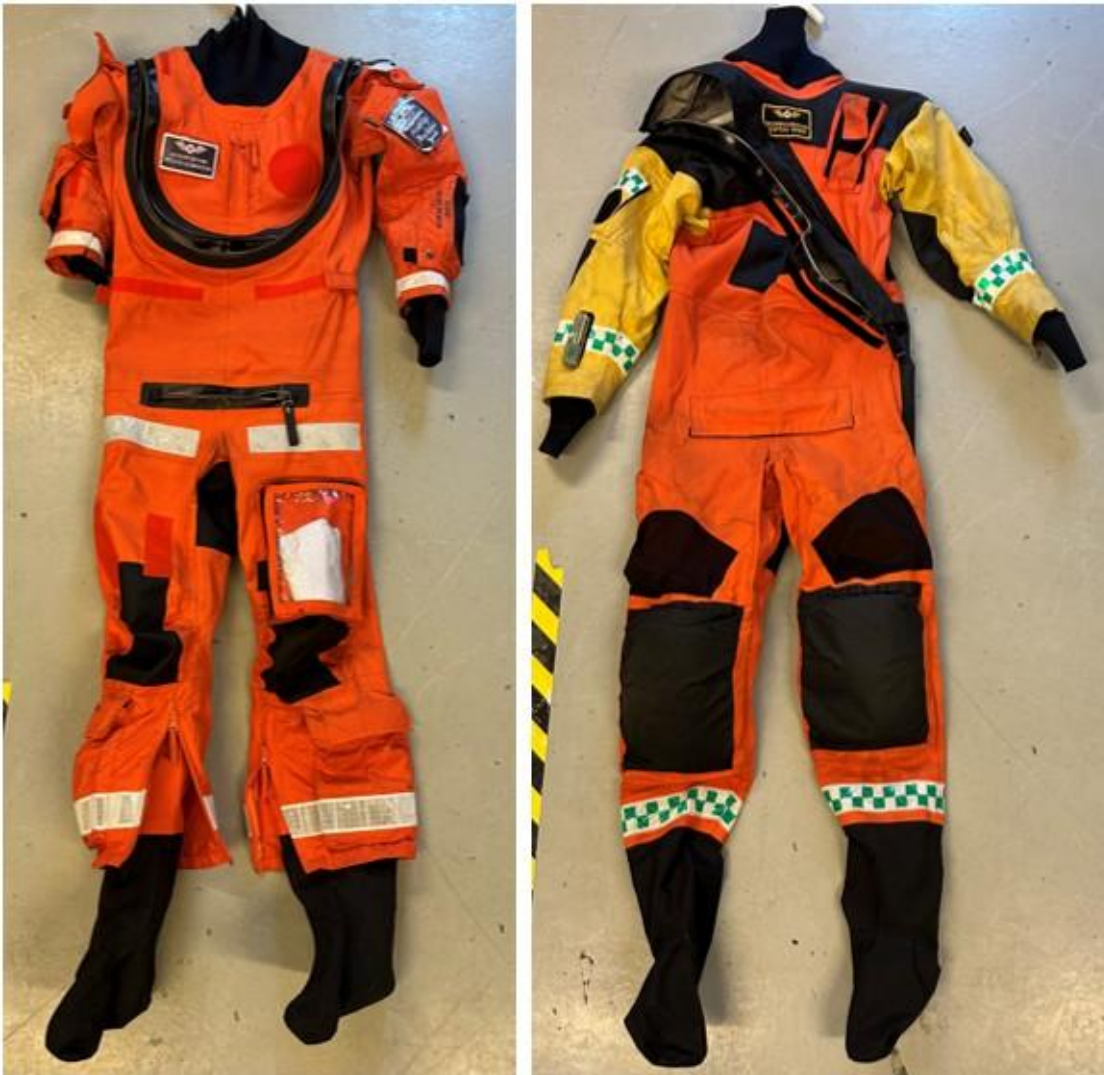
The crew used survival suits from two different manufacturers, see Figure 30. The survival suits worn by the two rescuemen were produced by Survitec. The remaining crew members had survival suits produced by Viking. Survival suits are personal to each crew member to ensure, among other things, that the rubber seals around the neck and wrists fit properly so that water does not enter the suit. Two of the crew experienced some leakage of water into the suit through the neck seal.

Figure 30: The two types of survival suits in use during the accident. The Viking PS4043 to the left and the Survitec Rescue Swimmer suit to the right. Photo: NSIA

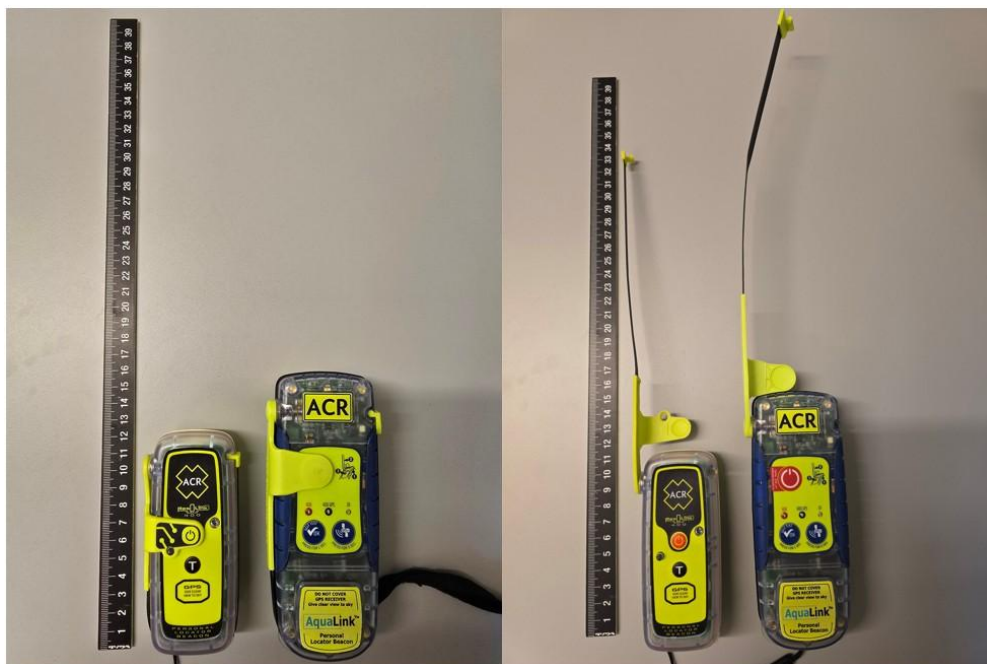
There were two different Personal Locator Beacons (PLB) used by the crew. Five of the crew members had the ACR ResqLink 400, while one had an ACR Aqualink 350, see Figure 31. Both types of PLB transmit on both 406 MHz and 121.5 MHz and can transmit GPS-position. Bristow was in the process of replacing all Aqualink 350 with the ResqLink 400. This swap occurred while the rescueman on re-training had been away from operational duty due to a loss of medical certificate, and he was less familiar with the new type.

Figure 31: The two types of PLB involved, ResqLink 400 left and Aqualink 350 right in both photos. The photo to the left shows the PLBs with the antenna stowed, and the photo on the right shows the PLBs with the antennas deployed and the red activation button is visible. Photo: NSIA

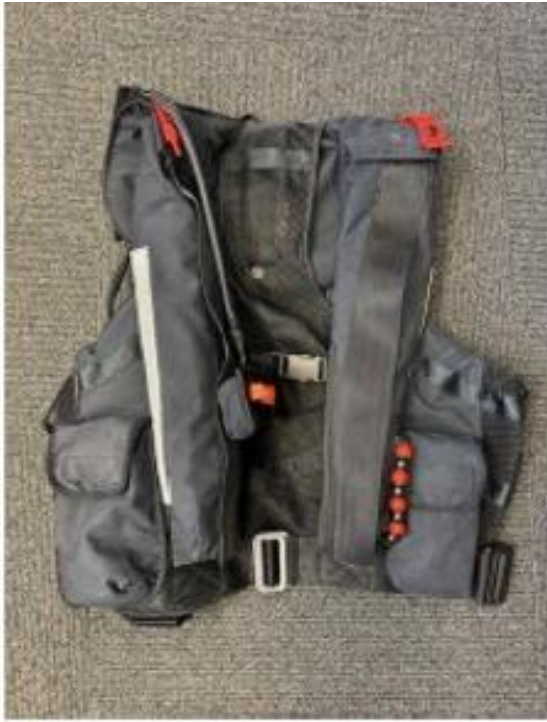
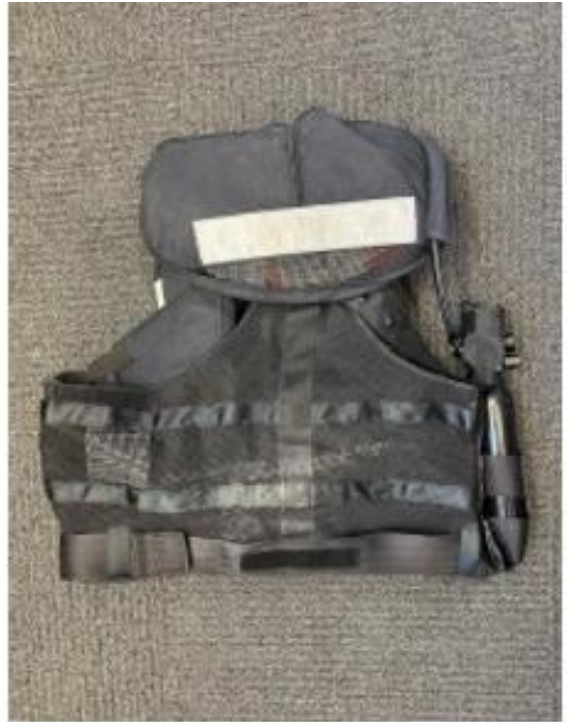
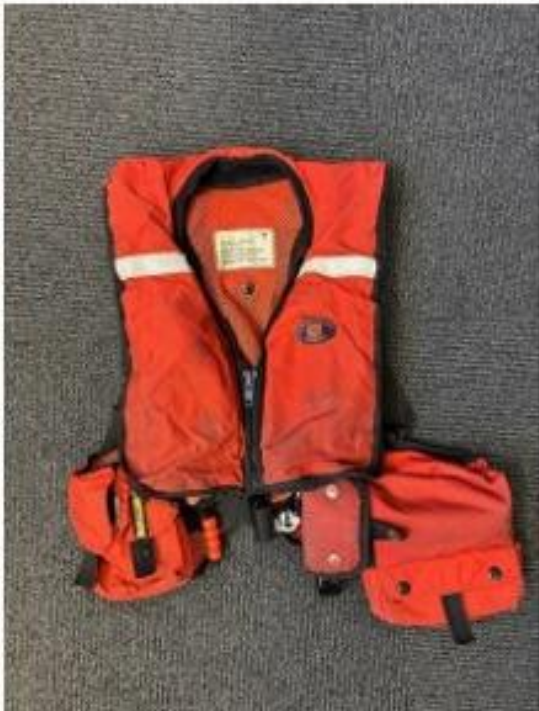
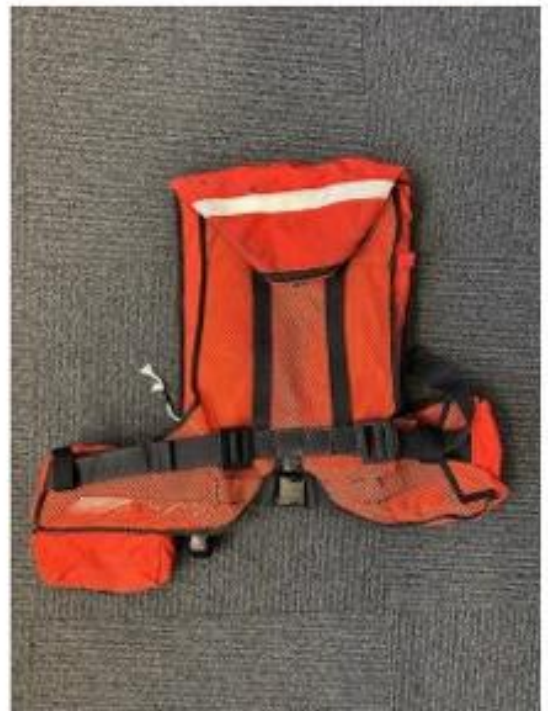
The rescueman on re-training used an LSC HSAS life jacket. The LSC HSAS is only used by rescuemen. All the other crew members used a Beaufort MK44 life jacket, see Figure 32. All life vests used in aviation must be manually inflated to provide buoyancy.

The major difference between the LSC HSAS and the Beaufort MK44, is that the latter is equipped with a light. The LSC HSAS also has a pocket with a “pengun” (a small handheld emergency flare) with 10 shots. Only one of the chambers of the rescueman on re-training’s life jacket inflated. Both gas cartridges were found pierced and empty. There were no holes or other faults with the inflation chambers and the NSIA has not been able to determine why only one chamber inflated.

Figure 32: The two types of life jacket in use. The Beaufort MK44 at the top and the LSC HSAS on the bottom. Photo: Bristow/NSIA

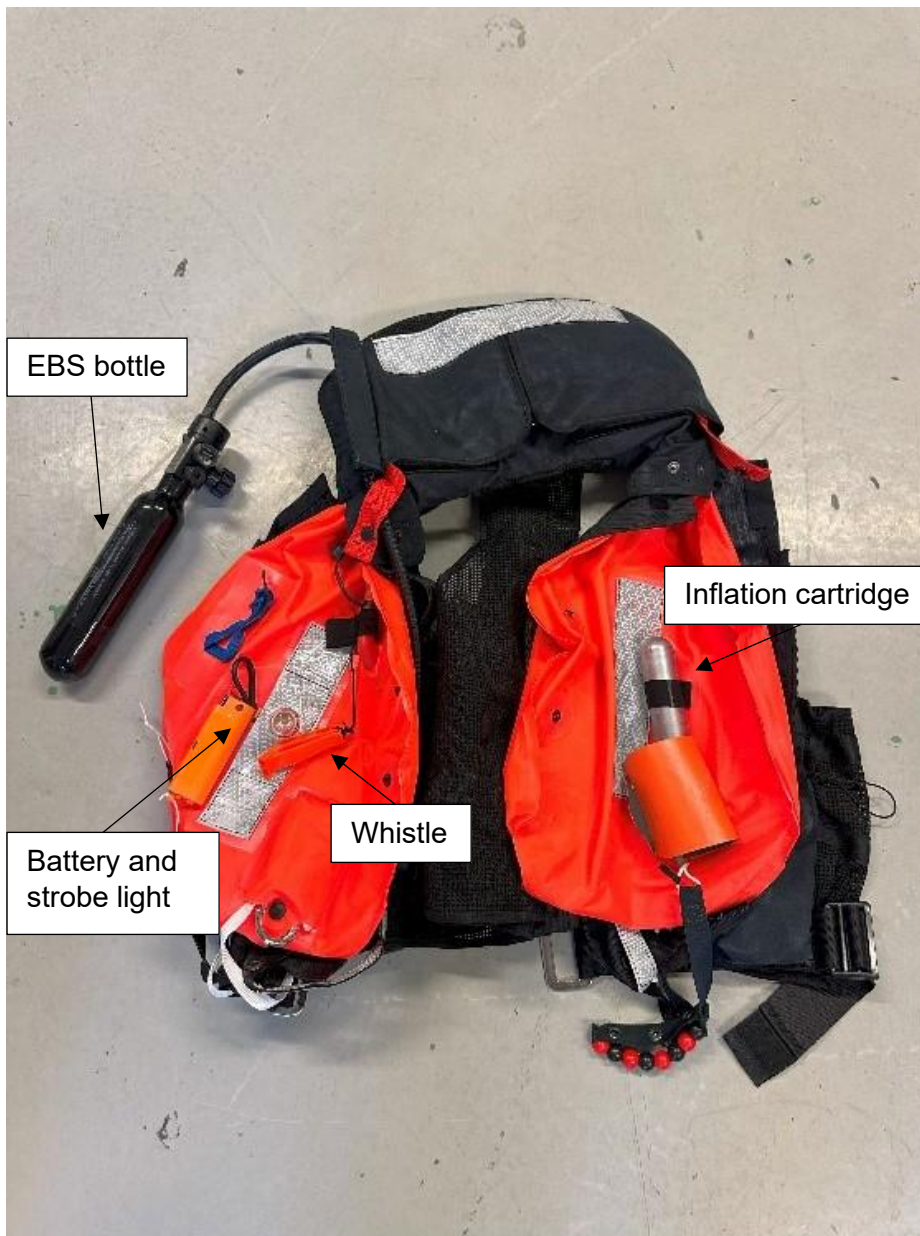
Figure 33: Life jacket type Beaufort MK44 unpacked and with equipment shown. The emergency breathing system bottle to the left in the picture. Photo: NSIA

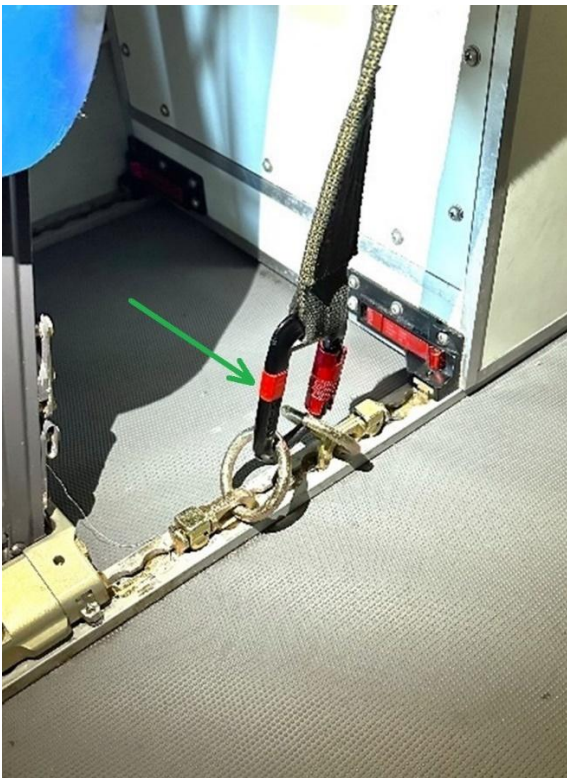
During hoisting operations, the hoist operator is normally secured using a belt with an attached lanyard, called a monkey-strap. The lanyard is attached to anchor points in the helicopter floor or ceiling via a carabiner, see Figure 34. A securing mechanism must be twisted before it can be pushed down, and the carabiner can be opened. The belt can be opened with a quick release mechanism. If they are not supposed to be hoisted, the SAR nurse also use a monkey-strap if required to enter the seatray (a rubber tray on the floor in the forward part of the cabin for collecting water after winching operations) and the door is open.

Figure 34: Lanyard secured to the cabin floor with a carabiner (green arrow). Photo: NSIA

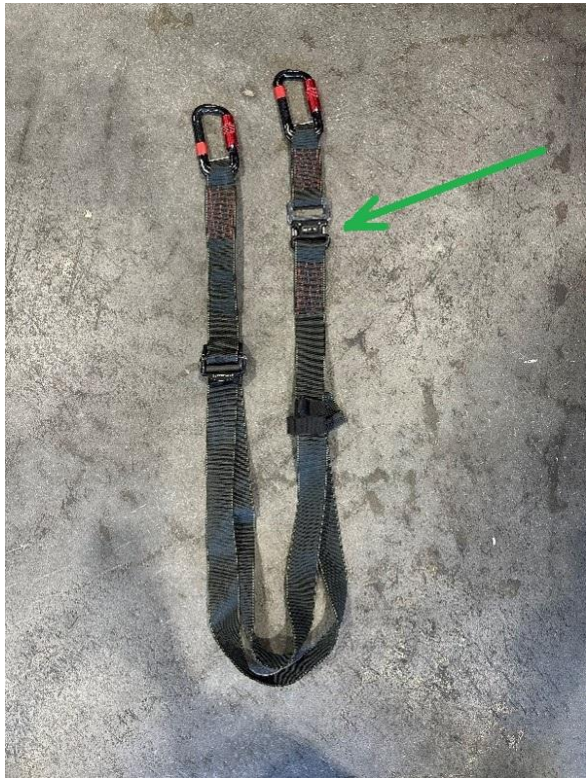
There were two types of lanyards in use at the time of the accident. Both types had carabiners in each end, while one type also had a quick release mechanism, see Figure 35. The rescueman on re-training has told the NSIA that after the accident Bristow no longer uses the lanyard without a quick release mechanism.

Figure 35: Lanyard with quick-release (green arrow). Photo: NSIA

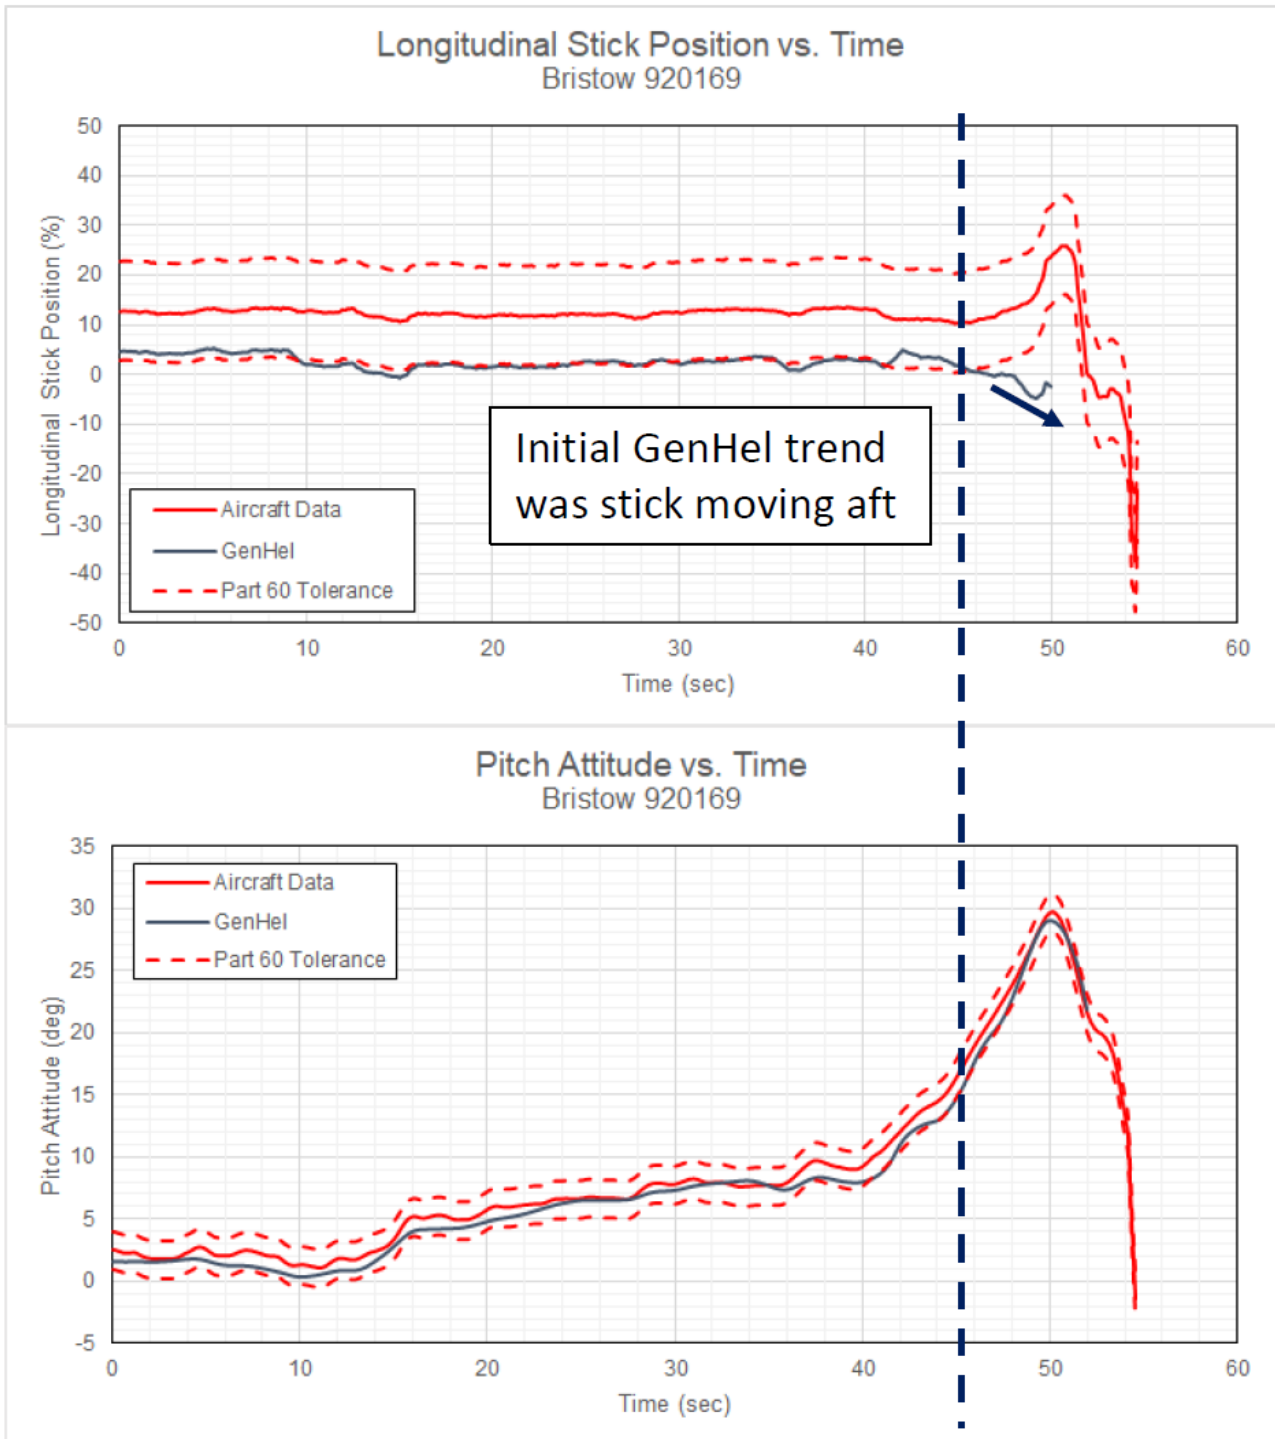
The playback showed that the GenHel model did not match LN-OIJ's pitch attitude. Excessive aft cyclic was required to get GenHel to output the same nose-up attitude seen in the accident. The aft stick movement did not only fall out of tolerance but also contradicted the trend observed in the aircraft data, see Figure 40. This indicates that the helicopter experienced more nose up pitching moment than GenHel was predicting. This discrepancy in pitching moment was investigated. Main rotor stall and atmospheric variations (i.e. wind gusts) were quickly ruled out as possibilities since they were either ineffectual or insufficient to account for the difference. This left Rotor Wake Impingement as a possible explanation for the excessive pitching moment.

Figure 40: GenHel playback analysis of pitch and longitudinal cyclic position. The solid red lines are the stick position and pitch attitude recorded by LN-OIJ. The dashed red lines are the tolerance bands from FAA Part 60. The grey lines are the outputs from the GenHel model. At around time $t=45$ it can be seen that to recreate the pitch attitude from the accident the cyclic has to move out the tolerance band and is also moving opposite to the recorded data. Source: Sikorsky/NSIA

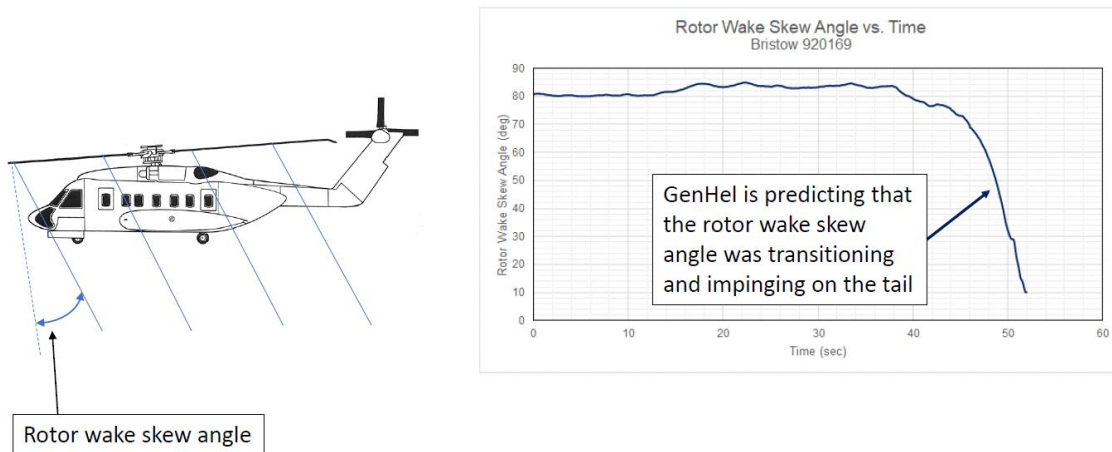
Main rotor wake impingement is when the main rotor wake affects the empennage aerodynamics. It is most pronounced during translational lift where the helicopter is transitioning between low and high-speed flight and vice versa. GenHel modelling of the main rotor wake impingement primarily relies on the rotor wake skew angle. By making the GenHel model follow the pitch attitude in the aircraft data, the rotor wake skew angle could be extracted, see Figure 41.

Figure 41: Definition of and estimation of the Rotor Wake Skew angle from the accident. Source: Sikorsky/NSIA

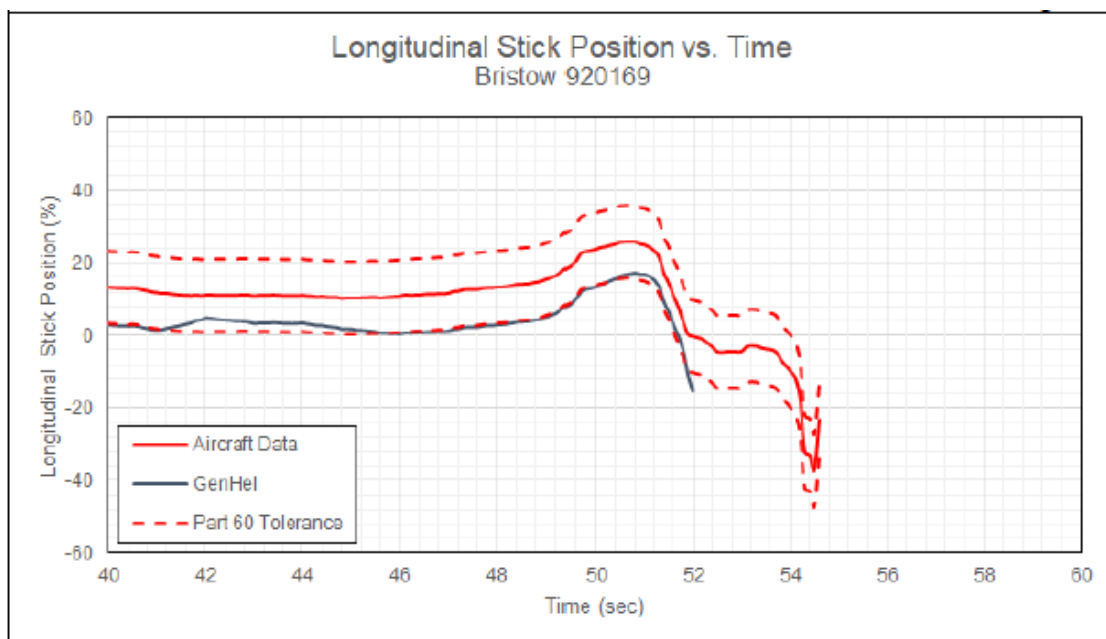
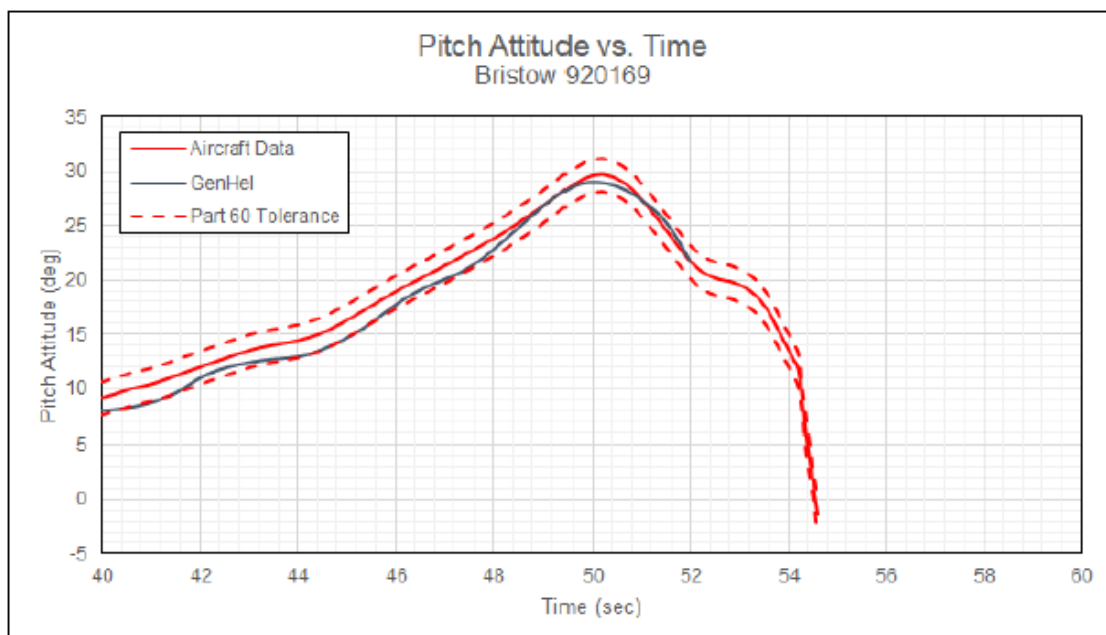
Since GenHel models main rotor wake impingement, the initial playback results suggested that the magnitude of the effect was being underpredicted by the model. Consequently, the main rotor-on-empennage interference maps in GenHel were adjusted to attain the additional pitch up moment such that the playback matched, see Figure 42.

After tuning main rotor-to-empennage interference maps in the GenHel model to better match the playback result, it was important to determine if the changes were reasonable. Based on the analysis it was concluded that when LN-OIJ reached ~20° nose up, the main rotor wake started to impinge on the horizontal tail. This resulted in an increased nose up pitching moment. Although the

increased nose up pitching moment was counteracted by moving the longitudinal stick forward, the aircraft experienced an additional 10° increase of pitch attitude to ~30° before the aircraft pitch attitude started to reduce. This behaviour is synonymous with what would be expected when moving through translational lift.

Figure 42: The result of the tuning of the main rotor-to-empennage maps. Source: Sikorsky/NSIA
