REPORT

AVIATION 2026/03

***Air accident in the sea west of Sotra,
Vestland County, Norway on 28 February
2024 with Sikorsky S-92A, LN-OIJ,
operated by Bristow Norway AS***

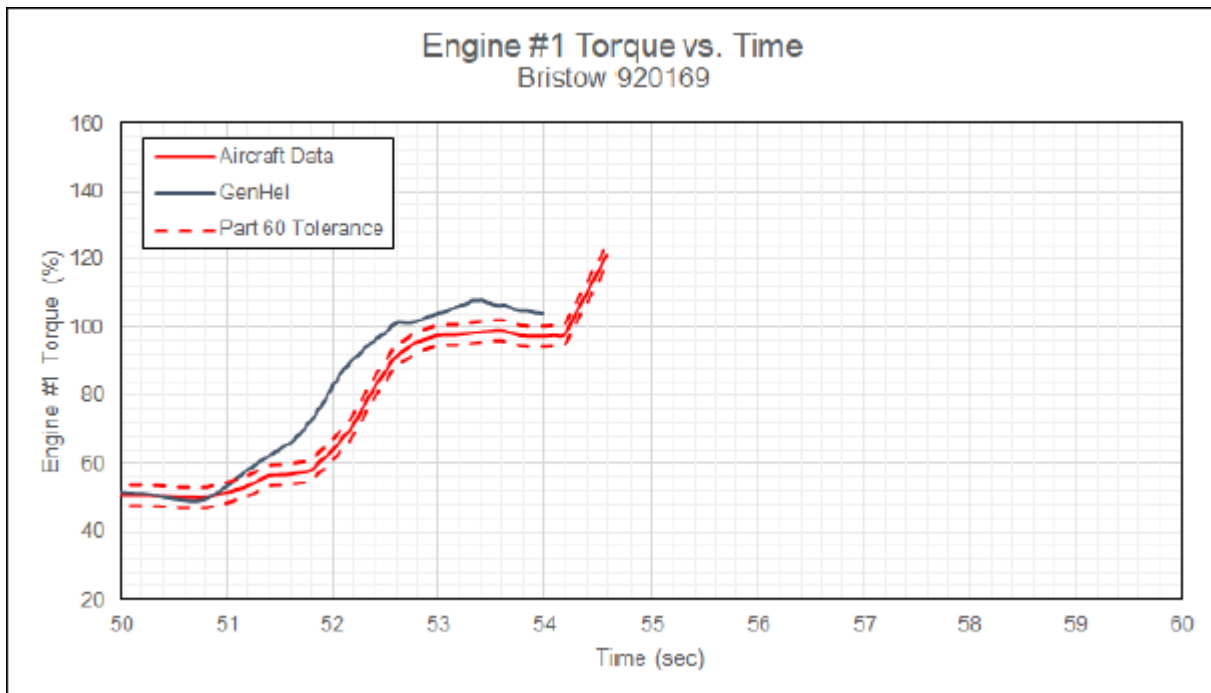
Shortly after the aircraft recovered from the 30° nose up condition (around t=50) the engine torque correlation between the GenHel S-92A model and the aircraft data diverged. Engine torque correlation had been quite good during the playback until this point was reached. An example of this divergence is presented in Figure 43 below.

Figure 43: The recorded and GenHel predicted engine torque. The solid red line is the engine torque recorded by LN-OIJ. The dashed red lines are the tolerance bands from FAA Part 60. The grey line is the outputs from the GenHel model. Source: Sikorsky/NSIA

The engine torque divergence indicated that the aircraft had experienced a reduction in main rotor thrust. The GenHel model was not predicting the same reduction in main rotor thrust. It was suspected that this was a result of the aircraft entering Vortex Ring State (VRS). VRS is an aerodynamic state where a toroidal vortex forms around the main rotor of the helicopter and drastically reduces the lift. For VRS to occur three conditions must be present.

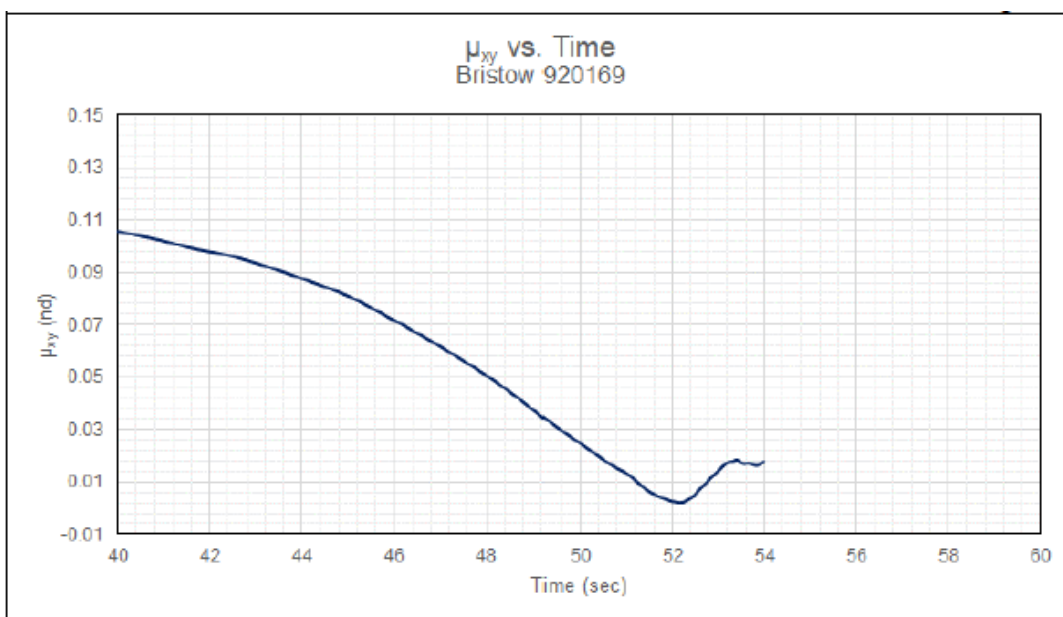
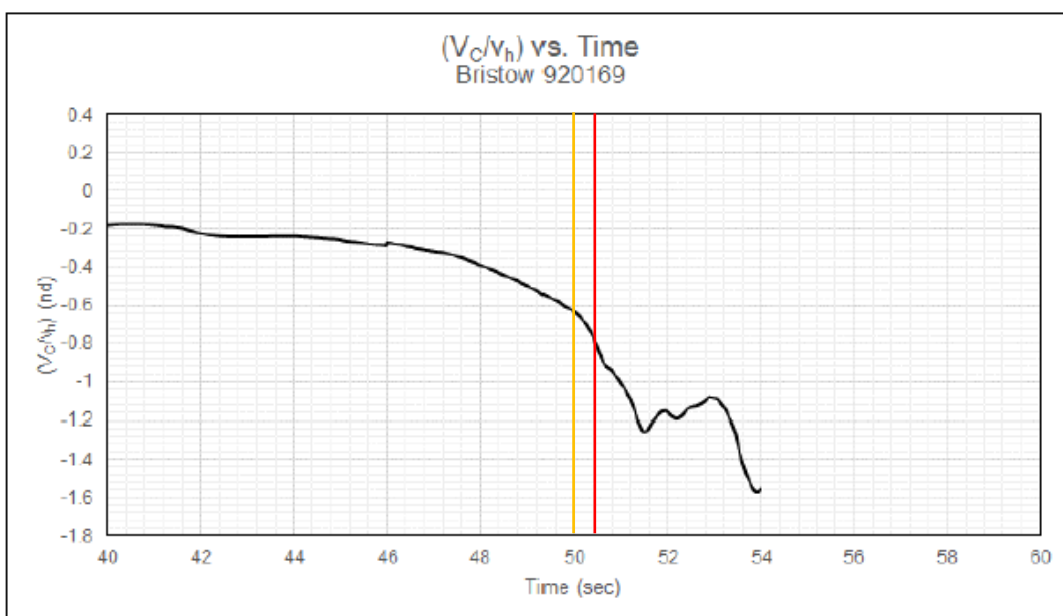
As can be seen from Figure 45 the conditions for entering VRS is satisfied at time 50 seconds when the climb velocity to hover induced velocity ratio becomes less than -0.6. The Full VRS boundary is then crossed around half a second later as that value becomes less than -0.8.

Figure 45: The advance ratio in the x-y plane and climb velocity to hover induced velocity ratio. The orange line marks when the helicopter crossed the VRS onset boundary, while the red line marks when the helicopter crossed the full VRS boundary. Source: Sikorsky/NSIA

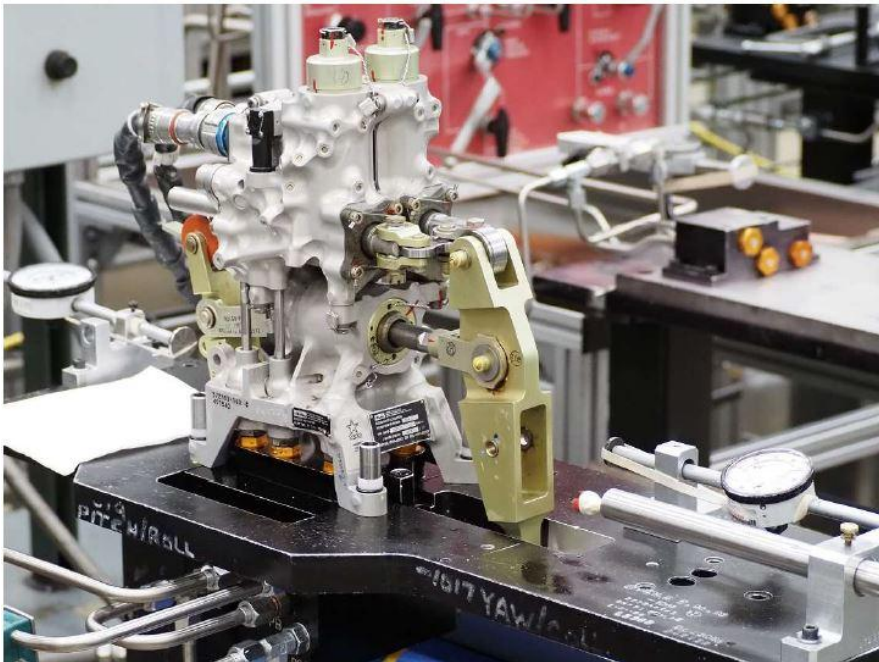
The SAS1 and SAS2 did not pass electrical acceptance test criteria, but there was no evidence of a short or an open circuit. No functional anomalies were observed during hydraulic bench tests that would preclude SAS and boost function, see Figure 46. During disassembly of the boost portion of the servo it was observed to have only wear from service. The SAS portion of the servo was disassembled to a lesser degree. Oil samples taken from the unit were outside the acceptance criteria, but not to a degree that it could hamper normal operation.

A contact mark between the input link and the SAS housing cutout was cleaned with cloth. A tactile check of the contact mark using a soft metal scribe revealed no evidence of a wear step on either

the input link or the housing cutout. A slight change in surface profile was felt on the housing cutout, but no discernible change in surface profile was felt on the contact mark. This was considered not to hamper normal operation.

Figure 46: The pitch boost/SAS servo installed on the hydraulic test bench at Parker Aerospace.
Photo: NTSB/NSIA

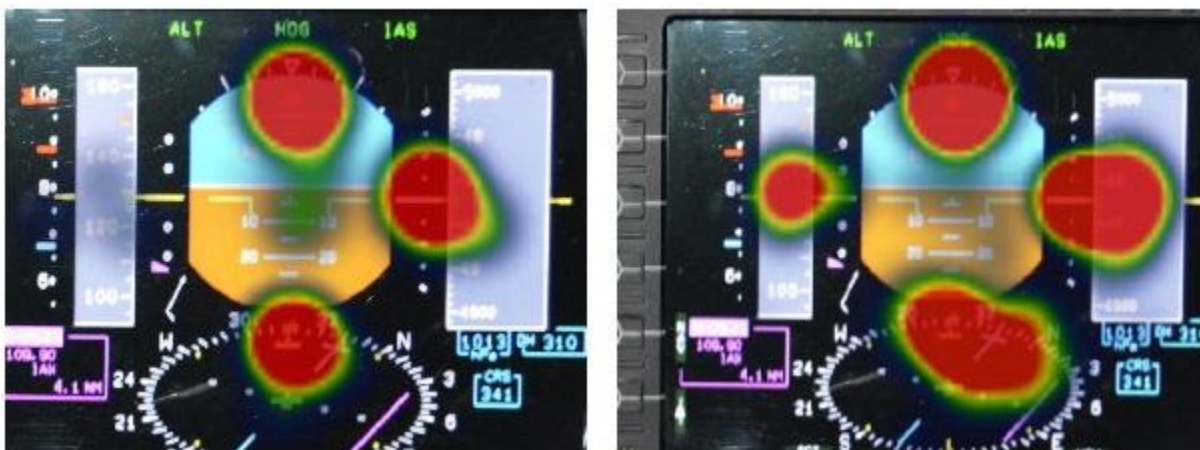
HeliOffshore has in the period 2015–2022 conducted research³⁶ into pilot monitoring of flight systems in the offshore rotary wing industry. The research show that it is not uncommon for pilots (across different domains, helicopter types and countries) to prioritise other cockpit instruments than the attitude indicator (AI). The findings are irrespective of experience. Instead of the classic T-scan that is taught to pilots, see Figure 50, where the main area of focus is the AI while referencing the instruments around it (speed, altitude, heading) many pilots develop a scan pattern that does not include the attitude indicator, see Figure 51 and Figure 52.

Figure 51: Two of the scanning patterns the research found. The instrument panel is from an Airbus EC225 helicopter. The circles indicate where the pilot is looking, larger circles mean more time spent looking at that area. Source: HeliOffshore/NSIA

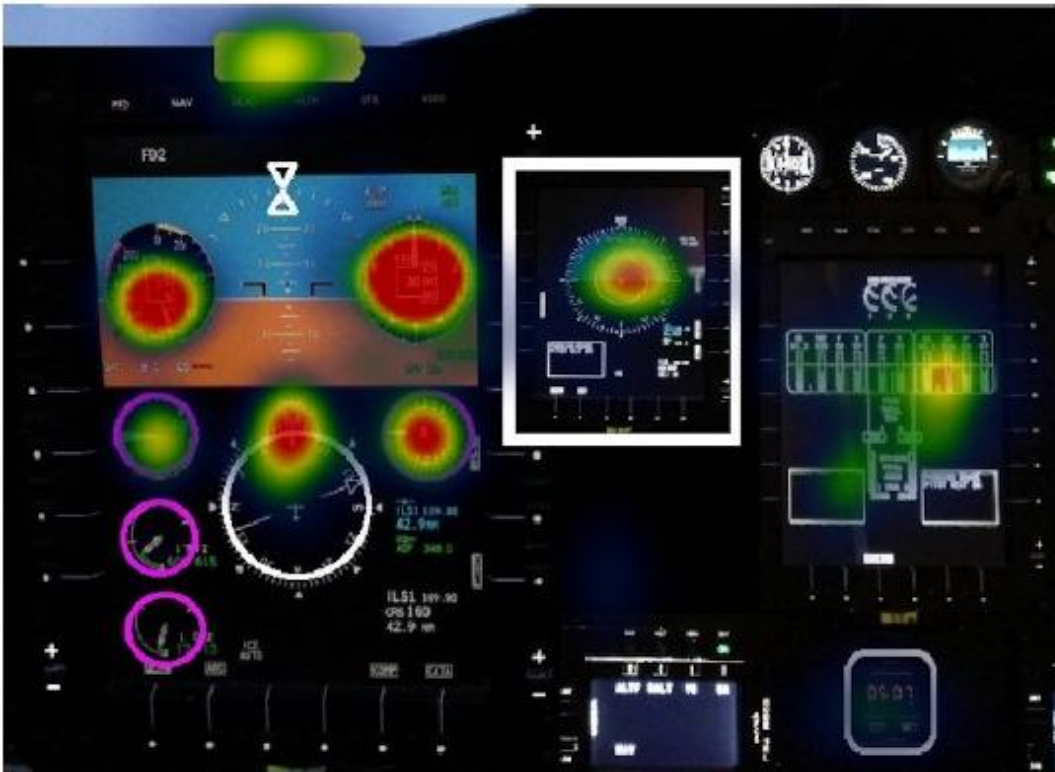
Figure 52: One extreme example of absence of AI monitoring from the research. Dwell time heat map for an 85-second period representing uncoupled flying by a PF between 450 ft and 1,200 ft. The instrument panel is from a Sikorsky S-92A. Source: HeliOffshore/NSIA
