Runway excursions on take-off involving Airbus A330-323, 9M-MTL, and Boeing 787-9, VN-A819

Melbourne Airport, Victoria, on 7 and 18 September 2023

ATSB Transport Safety Report

AO-2023-043

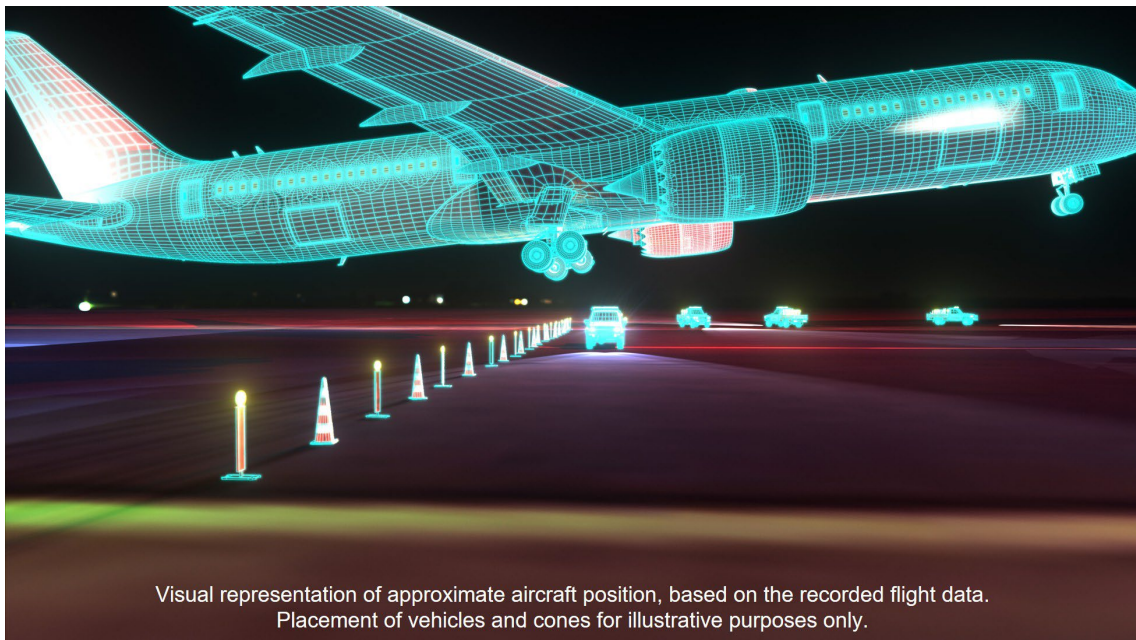
Visual representation of approximate aircraft position, based on the recorded flight data.
Placement of vehicles and cones for illustrative purposes only.

The jet blast from each aircraft impacted runway unserviceability lights, works lights and marker cones at the works limit. Personnel were active in the works area at the time of both occurrences however none were physically injured as a result. There was no damage to either aircraft, or injuries to passengers, and both continued with their planned flights.

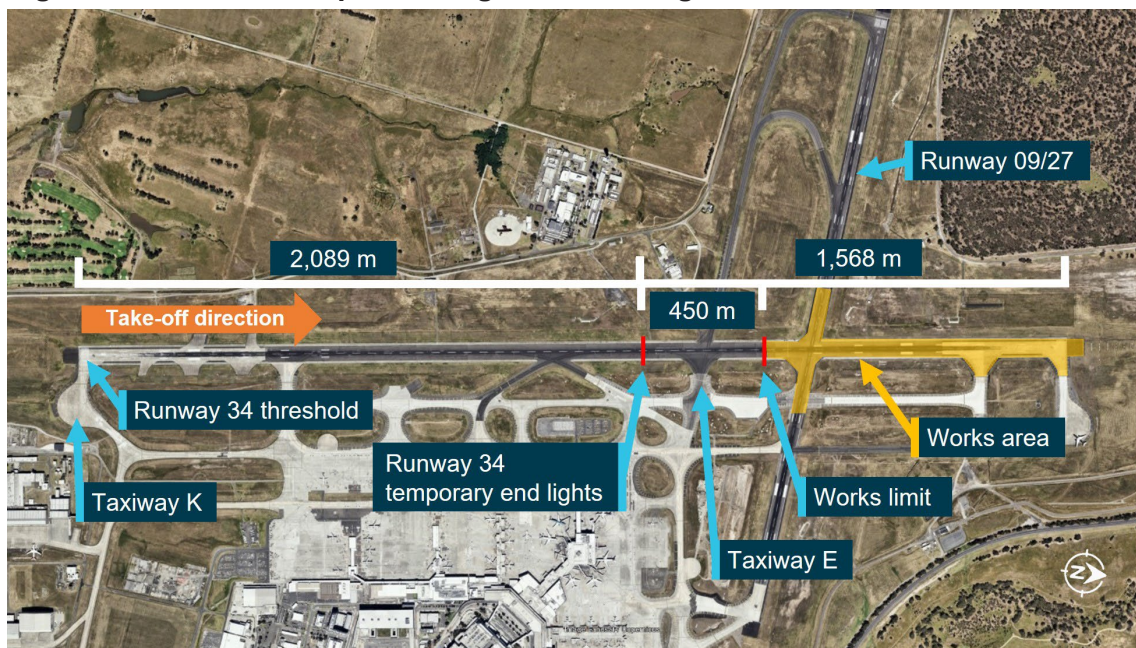
Figure 1: Melbourne Airport arrangement relating to the occurrences

Within an 11-day period in September 2023, the ATSB received 2 notifications of runway excursions by scheduled passenger air transport aircraft during take-off at night from runway 34 at Melbourne Airport, Victoria. Runway 34, which was normally 3,657 m long, had been temporarily shortened each night for runway resurfacing works in progress (WIP), leaving 2,089 m available for take-off (Figure 1). Both occurrences were in darkness (past the end of astronomical twilight¹ with the moon well below the horizon) in otherwise good visibility conditions.

The works were divided into 16 stages, with stage 8 of the works concerning the intersection of runways 16/34 and 09/27. The works plan involved closure of runway 09/27 and, to maintain an operational runway during the works, the runway 16 threshold was displaced, shortening the length of runways 16 and 34 (Figure 1).
