Final Report

B777-300ER, 9V-SWM Turbulence Event over Myanmar

21 MAY 2024

TIB/AAI/CAS.231

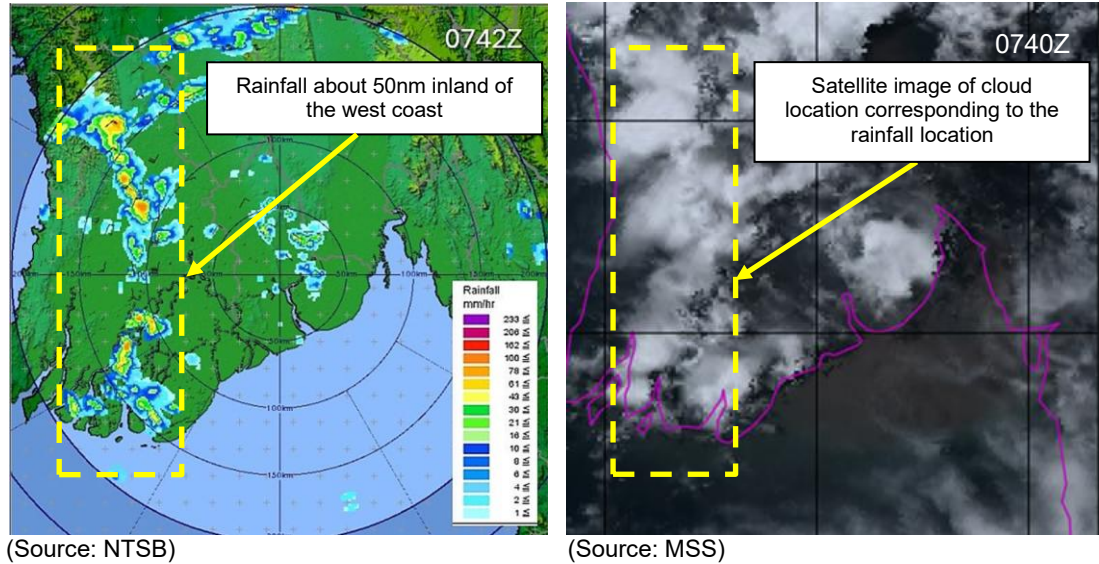
Figure 13: Ground WXR image (left) of rainfall and satellite image (right) inland of the west coast of Southwest Myanmar at 07:42 and 07:40 respectively

1.6.4.1 In a meteorological report provided by the US National Transportation Safety Board (NTSB) to the investigation team, a Yangon ground WXR image at 07:42 was included. The WXR image depicts rainfall over Southwest Myanmar (see the left image in **Figure 13**). It shows that there was rainfall about 50nm inland of the west coast of Southwest Myanmar. The right image in **Figure 13** shows the satellite image at 07:40 depicting the cloud location corresponding to the rainfall image.

- (a) There were groups of clouds in Southwest Myanmar, including towering cumulus clouds⁴³ (TCU) about 50nm inland from the west coast of Southwest Myanmar (see paragraph 1.6.4.1) (hereinafter referred to as Cloud A.) There was rainfall associated with the TCU (see **Figure 13**). According to MSS' analysis of the satellite data, the cloud-top height in this area, from 07:40 to 07:50, was stable and was between 45,000ft and 52,000ft, which was above the aircraft cruising altitude. As mentioned in paragraph 1.6.3, the flight crews of the four aircraft then flying in the vicinity had similar observations.

2.3.1 As mentioned earlier, the investigation team believes that there was widespread cloud coverage in Southwest Myanmar, including TCU and rain clouds, around the time the occurrence aircraft was flying through the area. The Yangon WXR images (see **Figure 13**) shows rainfall, ranging from 1 to 100mm/hr, in the area about 50nm inland of the west coast of Southwest Myanmar. According to the WXR OEM, their WXR can detect rainfall above 0.7mm/hr which would be painted on the NDs. These clouds were within the detection range of the WXR. Yet, the flight crew told the investigation team that the NDs of the occurrence aircraft did not show any weather returns. Summarised below are the flight crew's observations on the NDs:

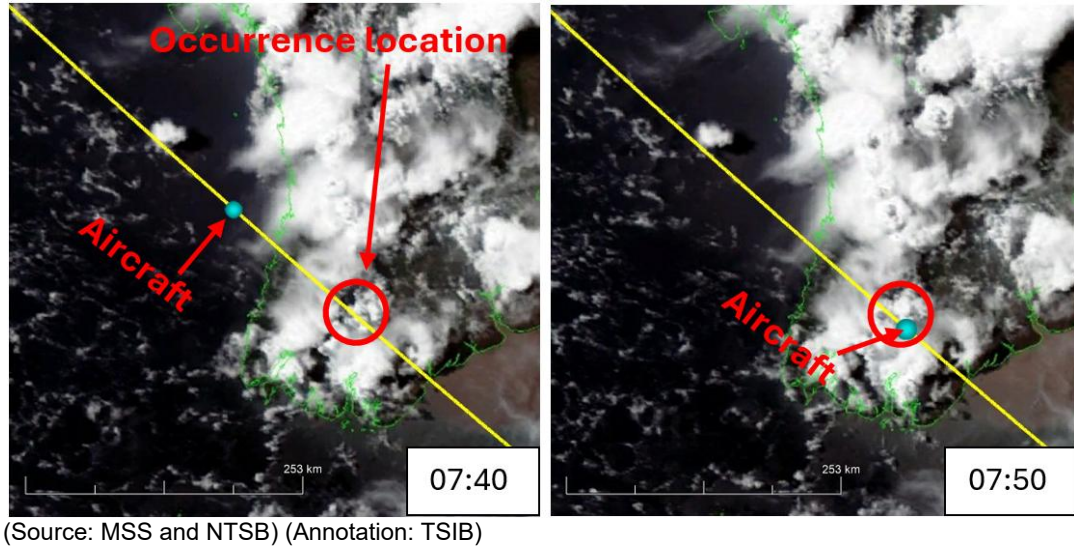
Figure 14: Occurrence aircraft location and cloud conditions

1.6.4.2 NTSB and the Meteorological Service Singapore (MSS) also provided Himawari-9 satellite images at 07:40 and 07:50 (see **Figure 14**). These images show the weather over Southwest Myanmar at 07:40 and 07:50 (the turbulence incident occurred at about 07:49). It is to be noted that these satellite images provide only top-down views indicating the cloud coverage of the highest clouds. They do not provide information on the clouds' vertical profile (e.g. what is under the cloud tops, whether there are empty spaces under the layer clouds, and how low are the cloud bases).

1.6.4.3 The investigation team noted from **Figure 14** that there were widespread clouds in the following two areas over Myanmar:

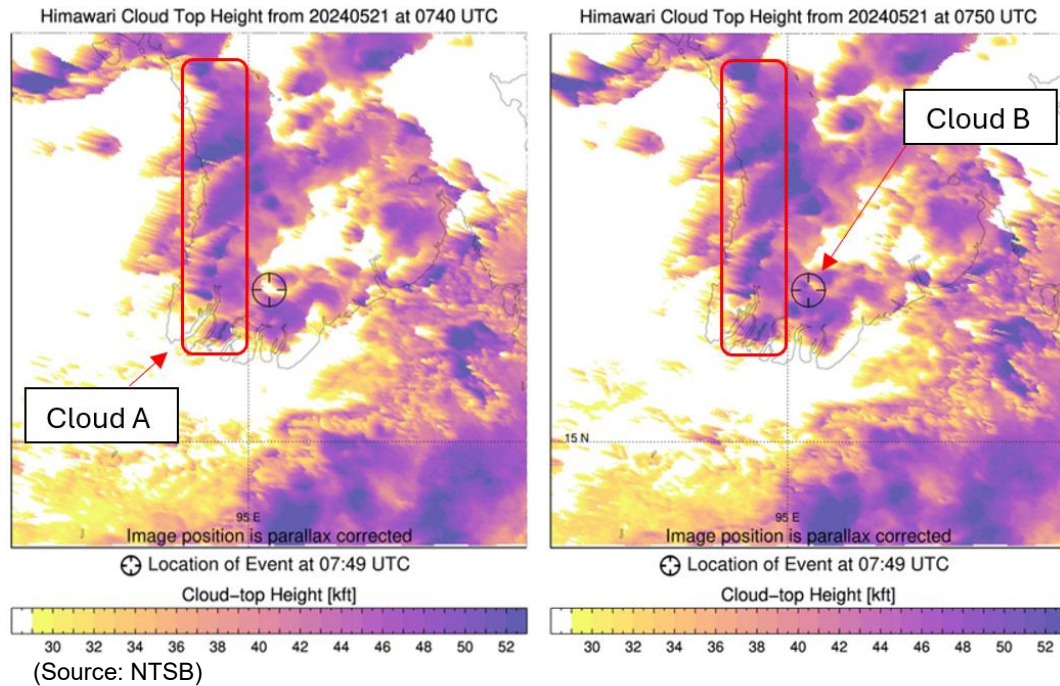
Figure 15: Himawari cloud-top height images at 07:40 and 07:50

1.6.4.4 NTSB also provided Himawari cloud-top height images at 07:40 and 07:50 (see **Figure 15**). These images show that there were clouds in the west coast of

Southwest Myanmar, although, according to **Figure 13** above, there was no rainfall in the west coast. Similar to the satellite images, cloud-top height images do not identify the type of clouds that are covering an area and they do not provide information on the clouds' vertical profile.
