Air Accidents Investigation Branch

Aircraft Accident Report No: 6/2007 (EW/C2005/05/03)

Synopsis

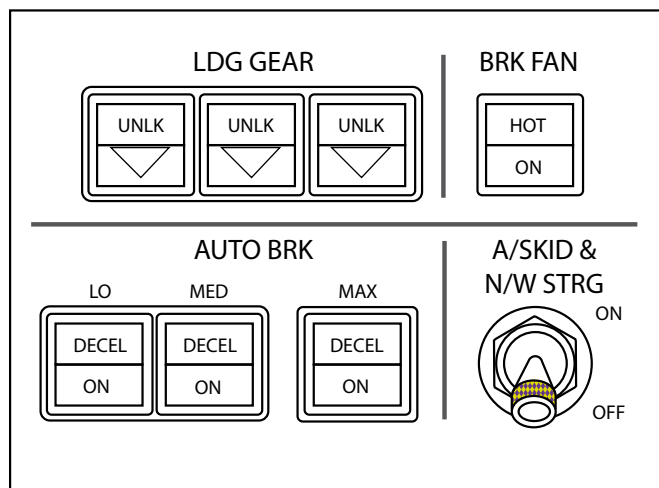
Figure 2

Flight deck controls consist of left and right brake pedals for each pilot, an autobrake control panel and an A/SKID & N/W STRG (Anti-skid and Nosewheel Steering) On/Off switch (Figure 2) on the forward panel and a parking brake switch on the centre console. The flight deck brake pedals drive resolvers (with a left and a right channel) that convert pedal displacement into four parallel electrical signals. In Normal braking mode these pass to the BSCU as the pilots' manual braking commands.

AutoBrake Selection and A/SKID & N/W STRG
Switches

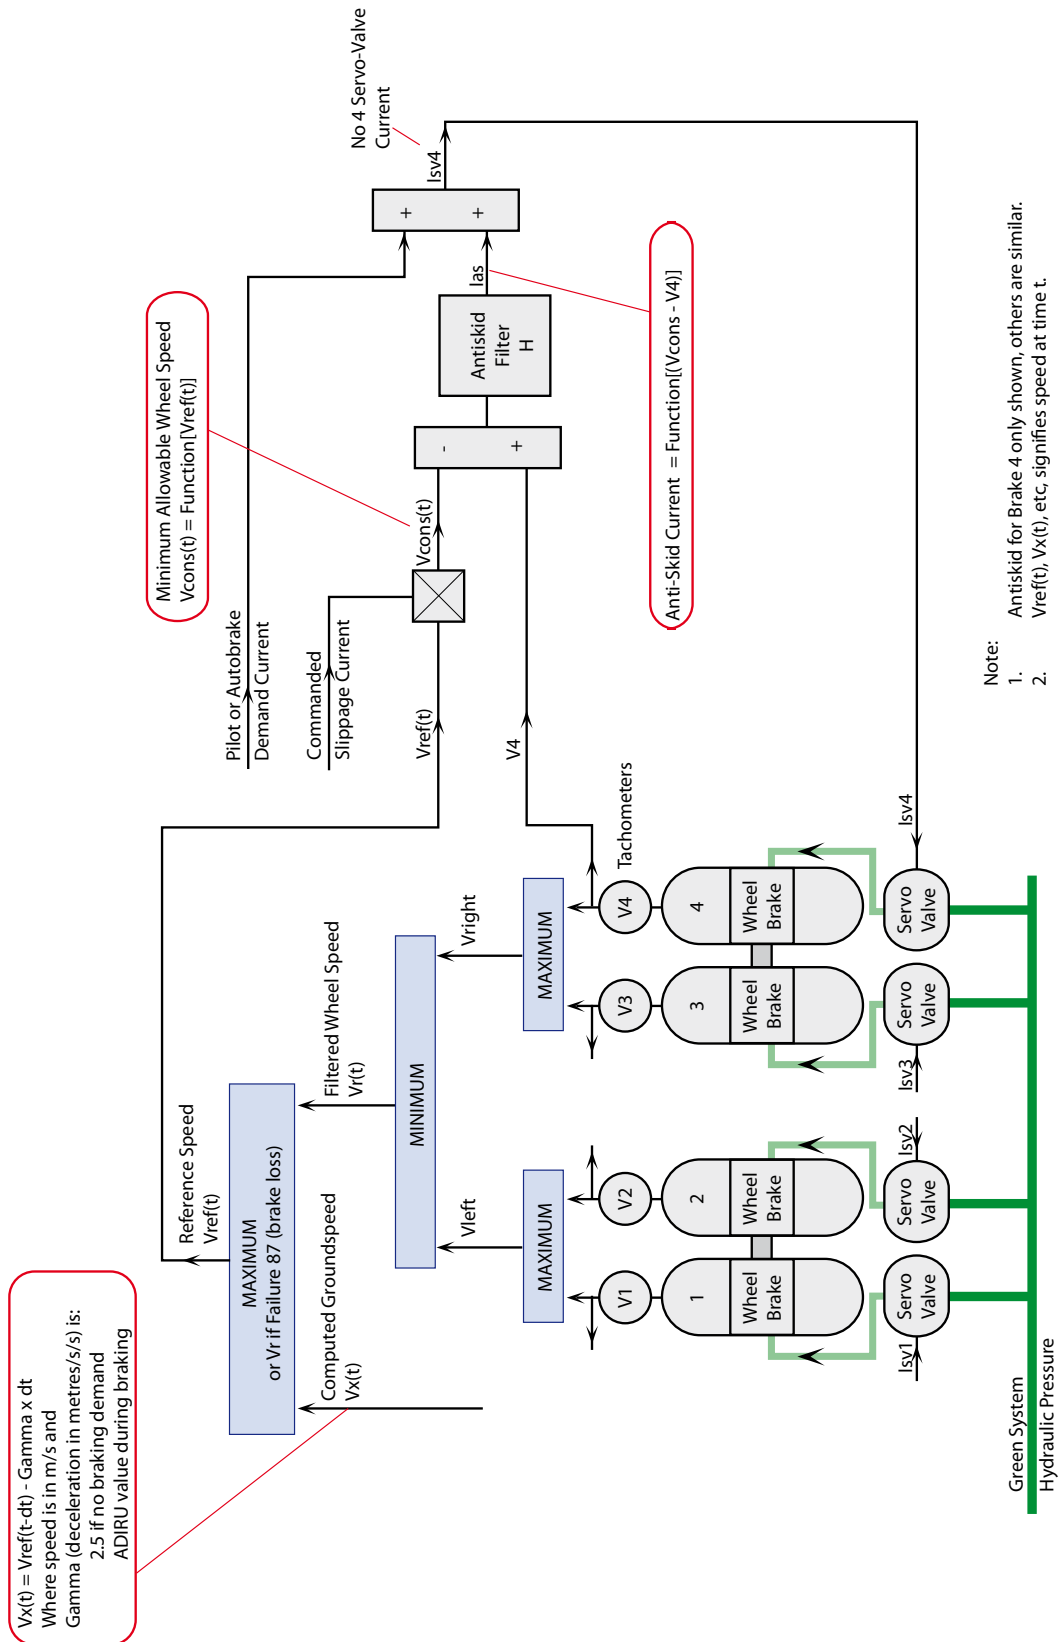
Tachometer signals, indicating wheel rotation rate, are converted to a groundspeed via multiplication by a nominal tyre rolling radius. The maximum groundspeed signal from the pair of wheels on each MLG is determined (Figure 3), to give a V_{left} and a V_{right} value, and the minimum of these two values is taken as the filtered wheel speed, V_r . This logic would prevent V_r from being affected by a single erroneous tachometer signal.

Figure 3
 A320 Wheel Braking System Schematic

It was reported that the electrical noise that could be generated in the tachometer signal by driveshaft resonance (see paragraph 1.18.2) tended to have a significantly asymmetric nature. This asymmetry could prevent it from being adequately suppressed by BSCU electrical filters intended to limit noise transmission. It appeared that the resultant excessive electrical noise passing into the BSCU could be interpreted as a higher individual wheel speed (V_1 , V_2 , V_3 or V_4 , see Figure 3) than was in fact the case.

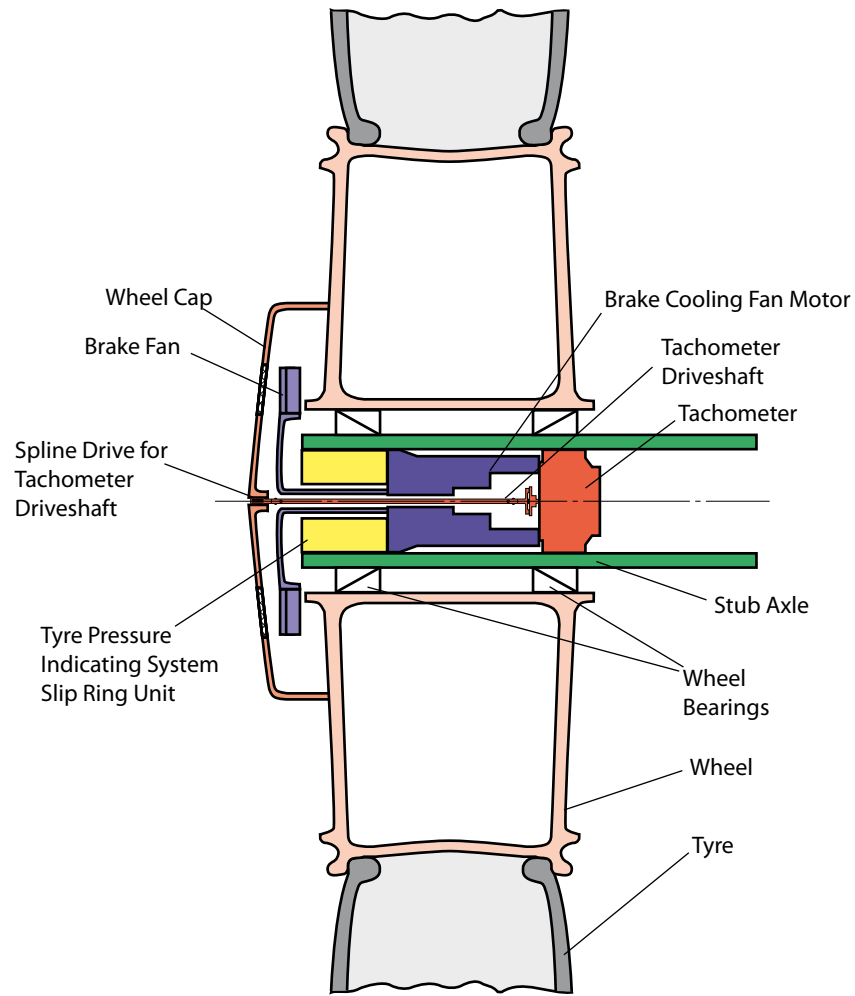
The tachometer for each mainwheel is located in the respective wheel stub axle (see Figure 4) and connected to the wheel by a driveshaft and the wheel cap (sometimes called the ‘debris guard’).

Figure 4
Mainwheel Assembly
