**AERONAUTICAL ACCIDENT**  
**INVESTIGATION AND PREVENTION CENTER**

**FINAL REPORT**  
**A – N° 67/CENIPA/2009**

**AIRCRAFT**          **PR - MBK**

**MODEL**             **AIRBUS A-320**

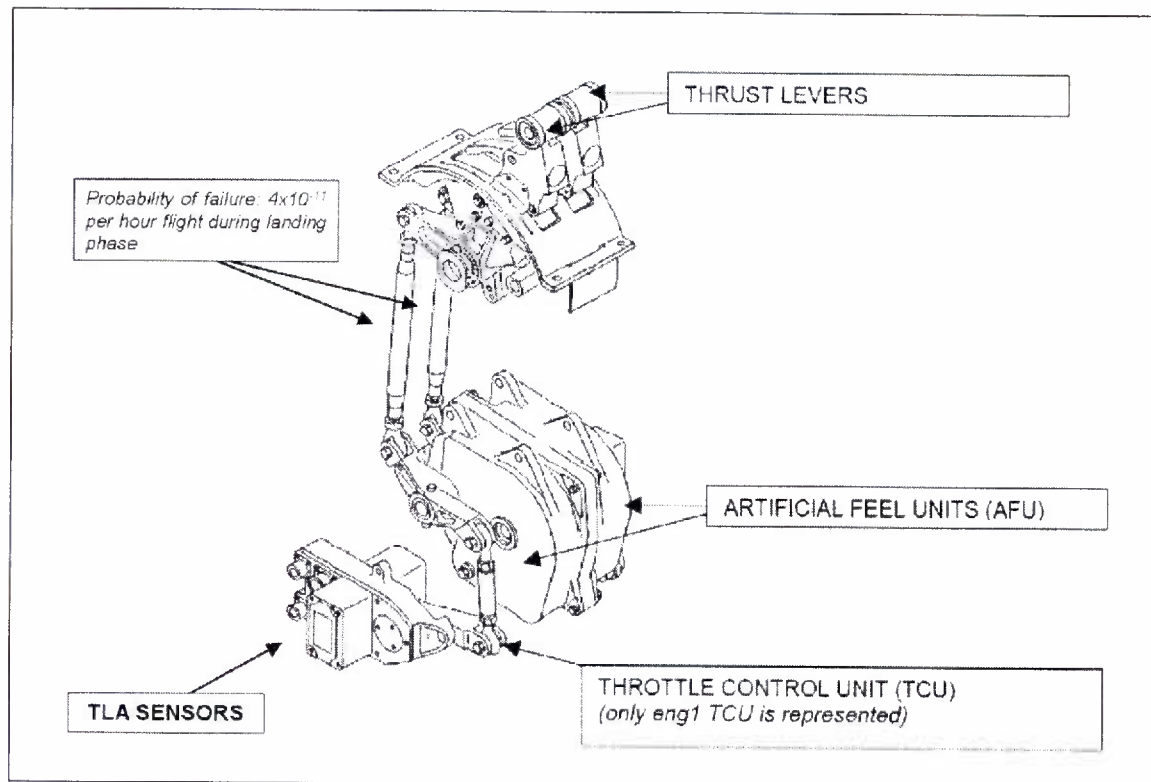
Figure 5 - Scheme of the power control system.

Exams were made in the wreckage of the Artificial Feel Units (AFU) with the purpose of verifying the existence of failures in their quadrants and gears, as well as marks that could confirm the relative position of the thrust levers at the moment of the impact, considering the possibility of a failure of the mechanism that connects the thrust levers to those units.

According to information provided by the aircraft manufacturer, the probability of a failure of the mechanism that connects the thrust levers to the AFUs is  $4 \times 10^{-8}$  per flight hour, and the probability of the failure to occur at the moment of the landing is  $4 \times 10^{-11}$  per flight hour. The sensors that record the position of the thrust levers in the flight data recorder (FDR) are located in the AFUs and not directly in the thrust levers.

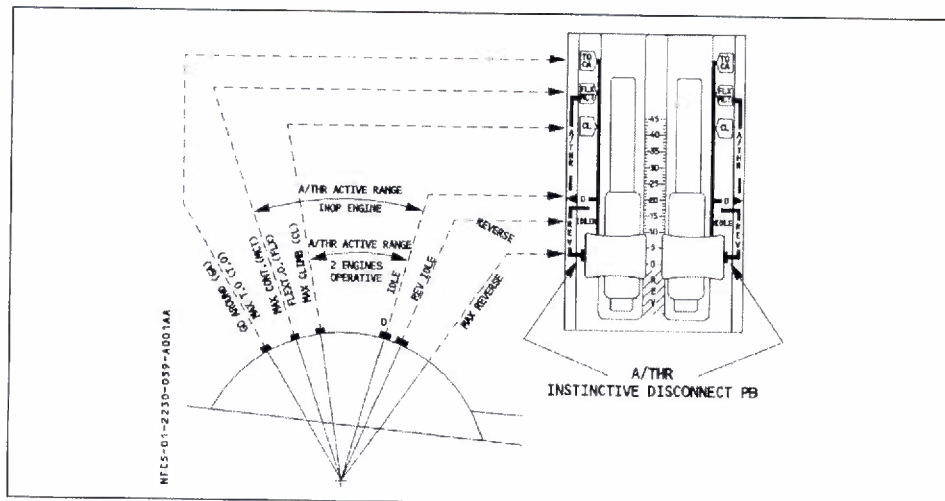
Figure 8 - Positions of the thrust levers.

The power control system of the Airbus A-320, shown in the figure 8, has 5 positions for the levers: "TOGA" (Takeoff/Go-around), "FLX/MCT" (Flex Takeoff/Maximum Continuous Thrust), "CL" (Climb), "IDLE" (Zero Thrust) and "REV" (Reverser). These positions are defined by means of detents, and correspond to the following TLA values:

The autothrust system works from the "IDLE" up to the "FLX/MCT" positions. Basically, when the autothrust system is active, it automatically controls the power, which may vary from "IDLE" up to the limit determined by the lever positioning, that is, "CL" or "FLX/MCT" – so as to maintain a speed or vertical variation rate previously selected by the pilot.

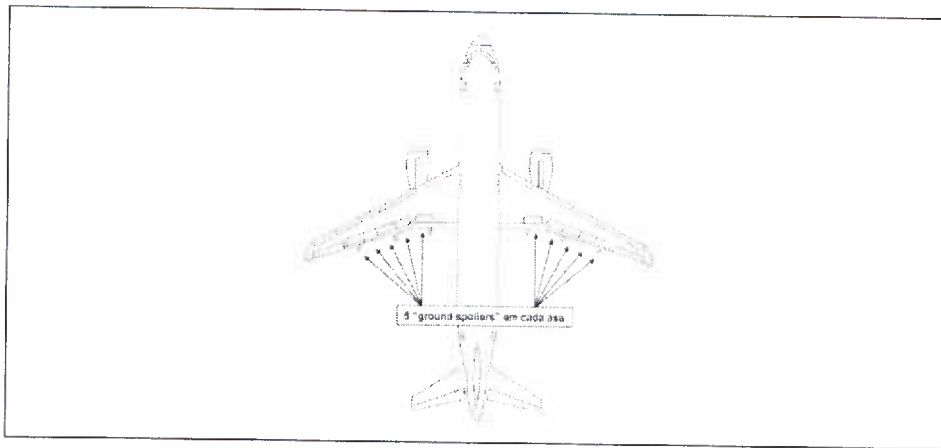
Figure 9 - Ground spoilers: five in each wing.

The A-320 has five spoilers on each wing (figure 9), which open automatically after landing. The spoilers are devices installed on the upper part of the wings whose objective is to reduce lift and increase the aerodynamic drag. During the landing, the device is activated, significantly reducing lift and allowing for a more efficient braking. Consequently, the landing distance of the aircraft is quite reduced.

The automatic ground spoiler function causes the spoilers to open automatically, as soon as the main gears touch the ground, provided the thrust levers are at the "IDLE" position. If one lever stays at the "CL" position during the landing, it deactivates the actuation of the ground spoilers, significantly reducing the aircraft braking capability (between 45% to 50%).
