## **Final report A-019/2008**

Accident involving  
a PILATUS PC6-B2H4  
Turbo-Porter aircraft,  
registration EC-JXH,  
in Lillo (Toledo),  
on 30 May 2008

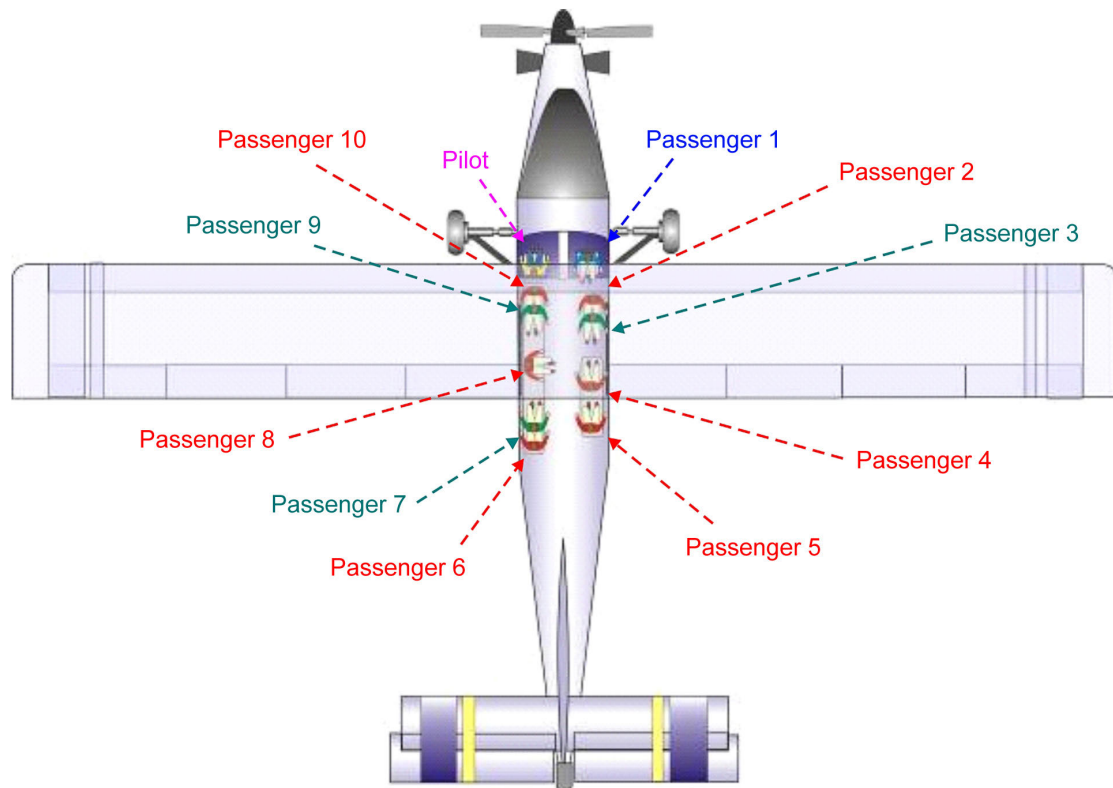
**Figure 6.** Positions of the occupants

Figure 6 shows the seating arrangement in the airplane, as reported by the occupants. The passengers are numbered clockwise, starting with the one seated next to the pilot (passenger 1). There was a small bench on the right side of the airplane where passengers 4 and 5 were seated. Passengers 2 and 3 were on the floor. There was a longer bench on the left side where the other five passengers were seated.

In any event, for the weight and number of passengers on the airplane, small variations in their locations could cause the center of gravity to shift outside the flight envelope.

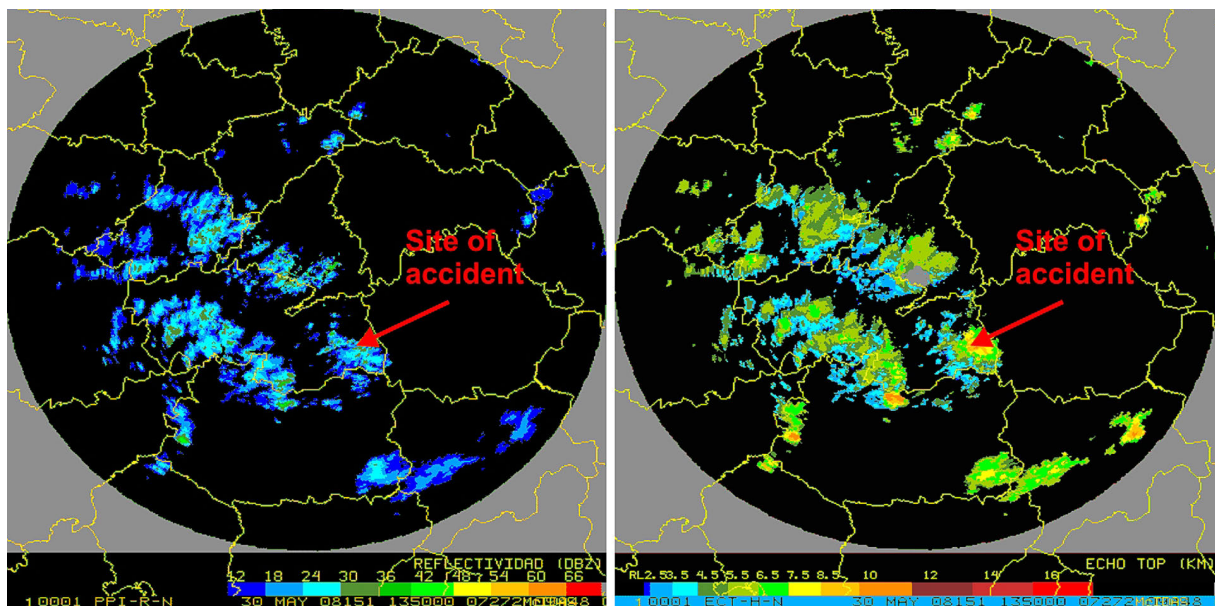
Figure 8. Reflectivity and Eco Top maps for 15:50

The reflectivity and Eco Top images in figure 8 show, respectively, the type of precipitation in the area at the time of the accident (light) and the altitude of the clouds (between 5 and 10 km).

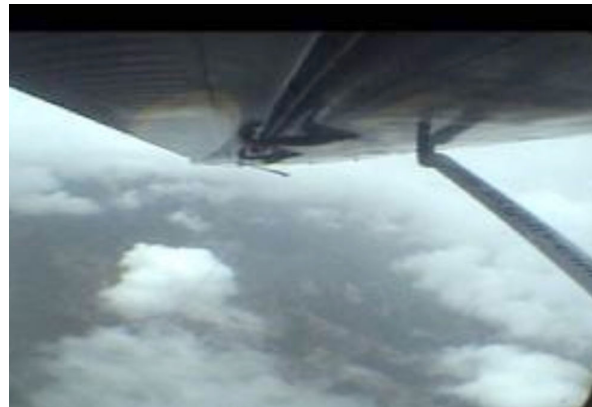
**Figure 9.** View from inside

One of the parachutists was recording during the climb on a camera mounted on his helmet (figure 9). Later, during the fall, the camera turned on inadvertently when he hit his head as he was ejected from the airplane, so part of the fall was recorded. The footage shows the atmospheric situation described above, with abundant clouds (figures 10 and 11).

Two of the passengers who were making their first tandem jumps reported that during the climb, they could see numerous clouds around them from their respective positions inside the airplane.
