**Air Accidents Investigation Branch**

**Report on the accident to  
Eurocopter EC225 LP Super Puma, G-REDU  
near the Eastern Trough Area Project (ETAP)  
Central Production Facility Platform  
in the North Sea  
on 18 February 2009**

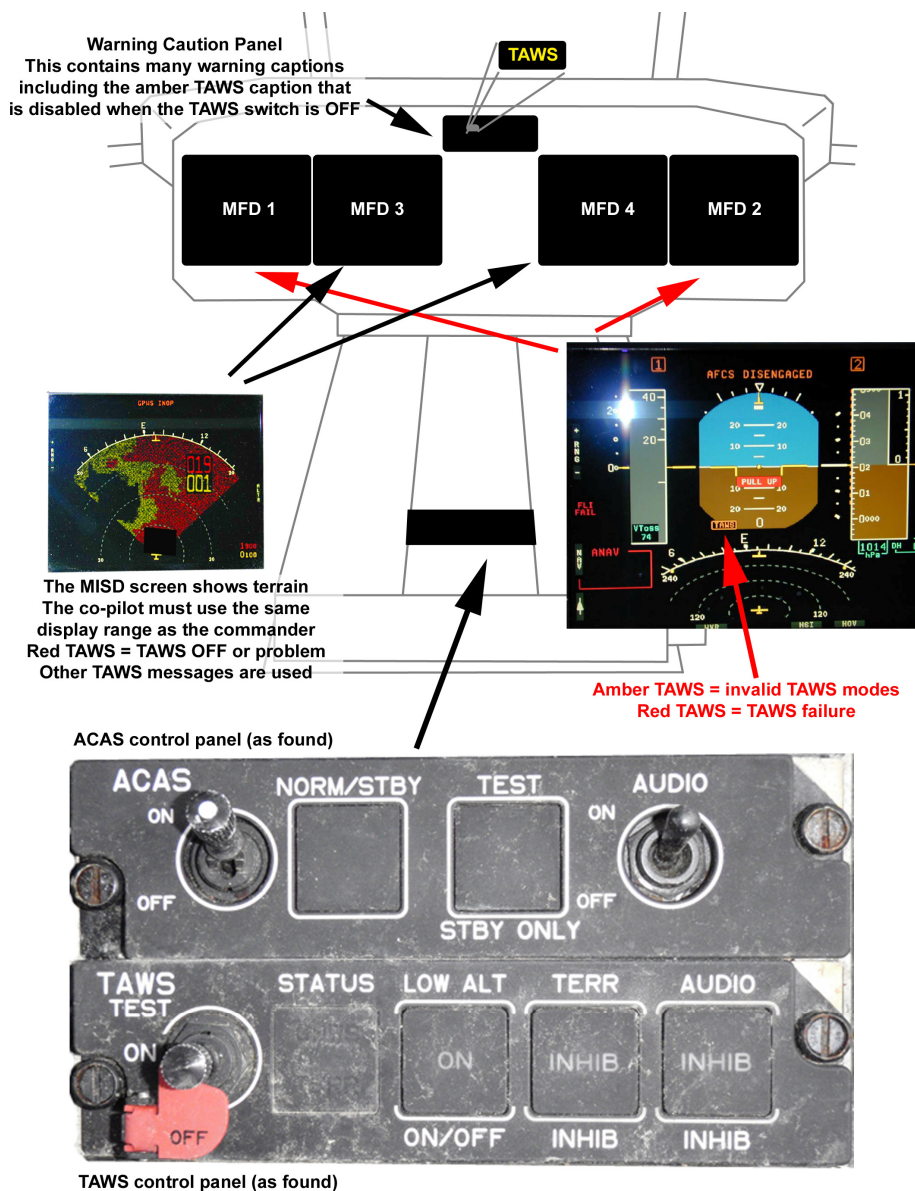
### Figure 4

## TAWS and ACAS control panels and TAWS indications

Figure 4 in Section 1.6.8.1 includes a photograph of the TAWS and ACAS control panels as they were found when the helicopter was recovered from the sea. The control panel switches for both systems were found in the ON position; the TAWS switch guard was in place.

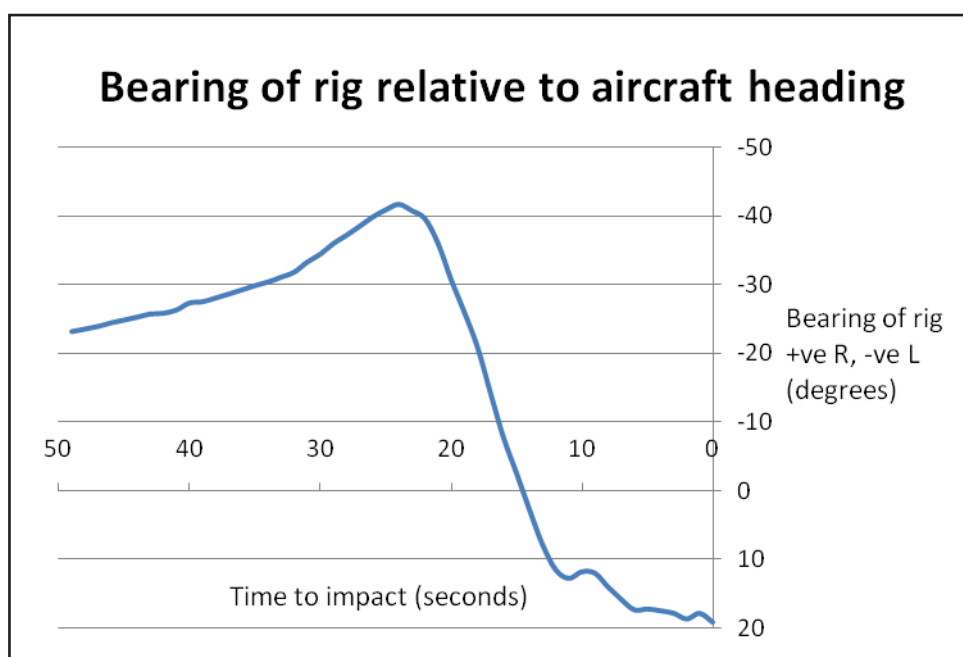
**Figure 2**

Direction of platform in relation to aircraft heading. At 25s before impact the pilots would have seen the lights of the platform at about 42 degrees to their left. Following the turn the platform would have appeared about 15 degrees to their right.

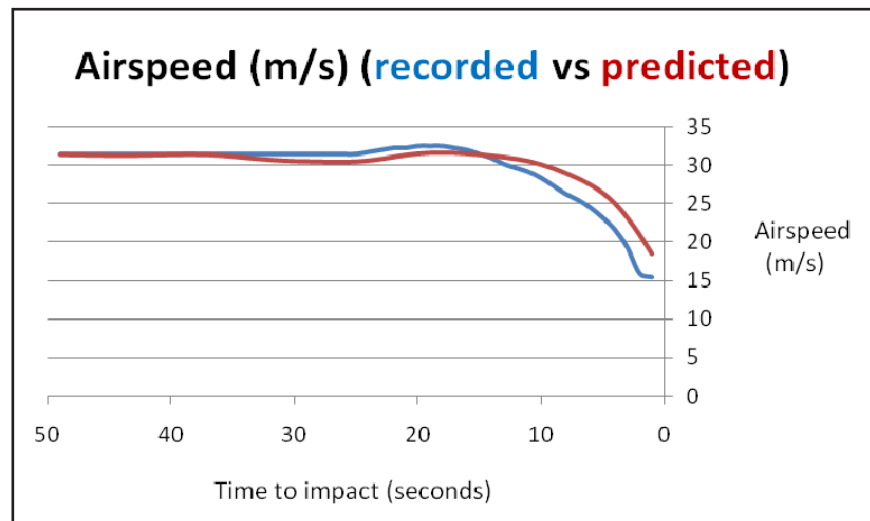
**Figure 3**

Comparison of recorded airspeed with values derived from corrected pitch attitude.

A comparison of actual versus calculated airspeed is shown in Appendix B Figure 3. There is reasonable agreement between predicted and actual airspeed given the errors associated with the integration of forward acceleration to derive airspeed, the 0.25 degree resolution of the pitch record and the sensitivity to small changes in subtracted offset. The validation of this relationship provides the justification for the use of the corrected rather than the recorded pitch attitude in the subsequent analysis.

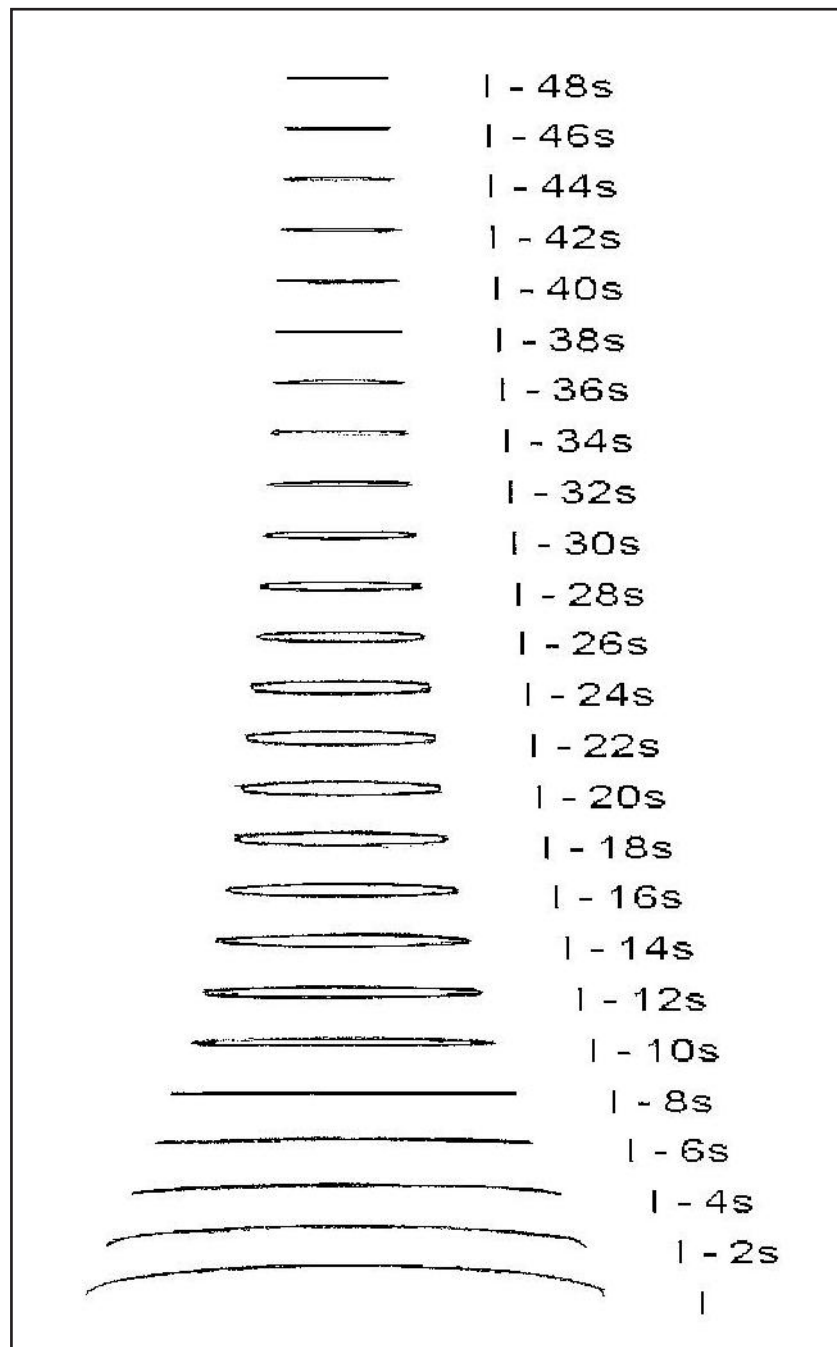
**Figure 5**

A knowledge of the aircraft height above the sea and distance from the platform allows calculation of the glideslope to the helideck. It also enables a calculation of what the crew might have been able to see of the green lights around the periphery of the helideck on the approach to the platform. A sequence at 2s intervals from I-48s of the helideck appearance is shown in Appendix B Figure 5. This shows that the ellipse of lights on the periphery of the helideck would have appeared most 'open' at 20s before impact when the aircraft was turning on to the final approach, some 820m from the platform. From 8s before impact the aircraft was below the height of the helideck and the lights of the further edge of the helideck would no longer have been visible.

The likely appearance of the helideck at 2s intervals from 48s before impact. The side-to-side subtended angle of the helideck is as it would have been seen by the pilots if this figure is viewed at a distance of 70cm from the eye.
