# Final Report

On the accident on **1<sup>st</sup> June 2009**  
to the **Airbus A330-203**  
registered **F-GZCP**  
operated by **Air France**  
**flight AF 447 Rio de Janeiro - Paris**

Bureau d'Enquêtes et d'Analyses  
pour la sécurité de l'aviation civile

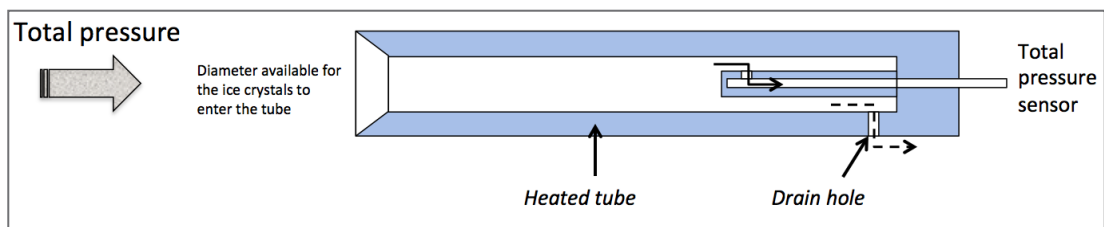
Figure 8: Pitot probe diagram

In the presence of ice crystals, there is no visible accretion of ice or frost on the outside, nor on the nose of the probe, since the crystals bounce off of these surfaces. However, the ice crystals can be ingested by the probe air intake. According to the flight conditions (altitude, temperature, Mach) if the concentration of crystals is greater than the capacity for de-icing of the heating element and evacuation by the purge holes, the crystals accumulate in large numbers in the probe tube.

As soon as the concentration of ice crystals is lower than the de-icing capacity of the probe, the physical barrier created by the accumulation of crystals disappears and measurement of the total pressure becomes correct again.

Experience and follow-up of these phenomena in very severe conditions show that this loss of function is of limited duration, in general around 1 or 2 minutes.

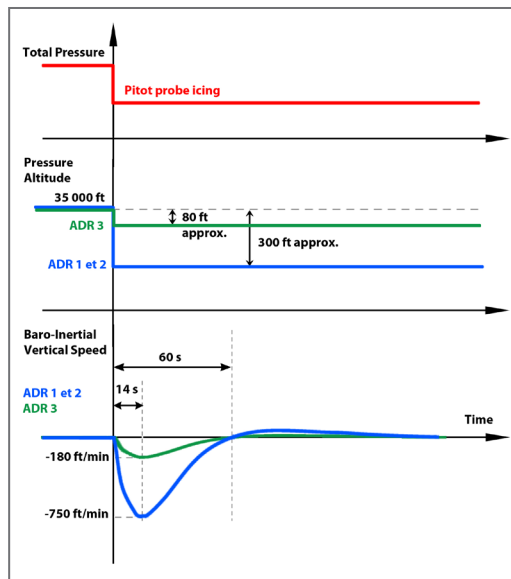
Figure 10: Effect of a drop in total measured pressure on pressure altitude and vertical speed

The first consequence of a drop in measured total pressure is a drop in the Mach and the CAS. The drop in Mach leads to a drop in standard altitude due to the correction of the measured static pressure. This drop is different according to the ADR under consideration: in the flight conditions of the event, it is of the order of 300 to 350 ft for the ADR 1 and 2 and of 80 ft for ADR 3.

The drop in indicated standard altitude also causes a transient variation in Vzbi. Just as the drop in standard altitude is lower for ADR 3 than for ADR 1 and 2, the variation in Vzbi is lower for ADR 3 than for the two others, as illustrated by the graph below:

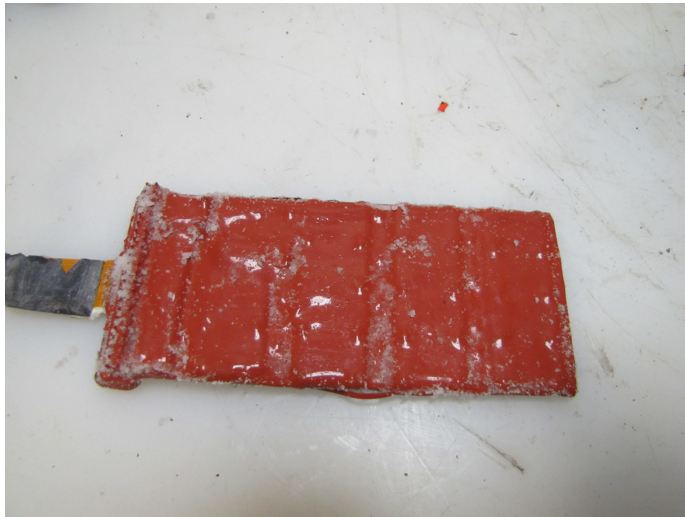
Figure 19: FDR memory board

The memory board was cleaned. Visual inspection did not reveal any damage to the board. The board was placed in an oven for 36 hours in order to remove the moisture in the components and the printed circuit board. The impedance measurements that were then made on the input connector were in accordance with the measurements made on reference units.

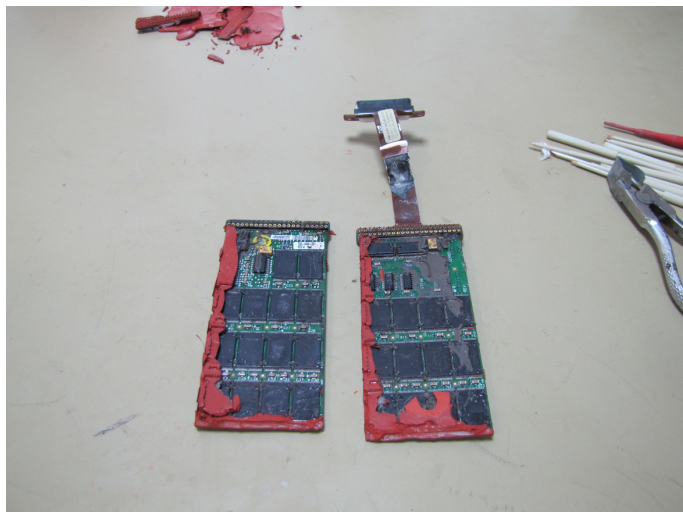
Figure 23: CVR memory boards before cleaning

Visual inspection of the boards revealed damage: a capacitor and a resistor were cracked on one of the boards; two decoder-type components were damaged on the other board.

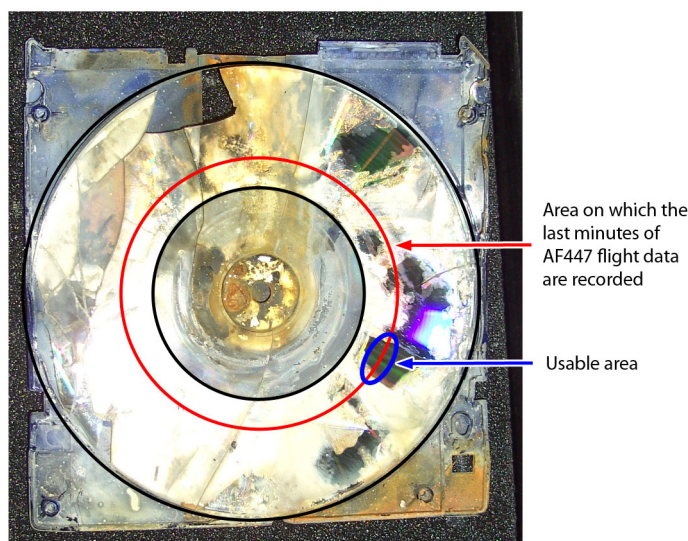
Figure 29: Optical disk showing the location of the readable zones

This computer is an unprotected parameter recorder used for flight analysis purposes by the operator. The data was recorded on a magneto-optical disk which was removed from the computer. The disk was so badly damaged that it was impossible to use traditional reading methods. It was therefore examined in collaboration with the solid-state physics laboratory at Paris-Sud University, and in conjunction with the manufacturer, Thales.

Readable zones were identified. The only zone likely to contain flight data was analysed. It relates to one second of information recorded every 100 seconds. Very little information could thus be recovered, and this data did not supplement the elements recovered by other means. The examination was therefore terminated after this feasibility study.

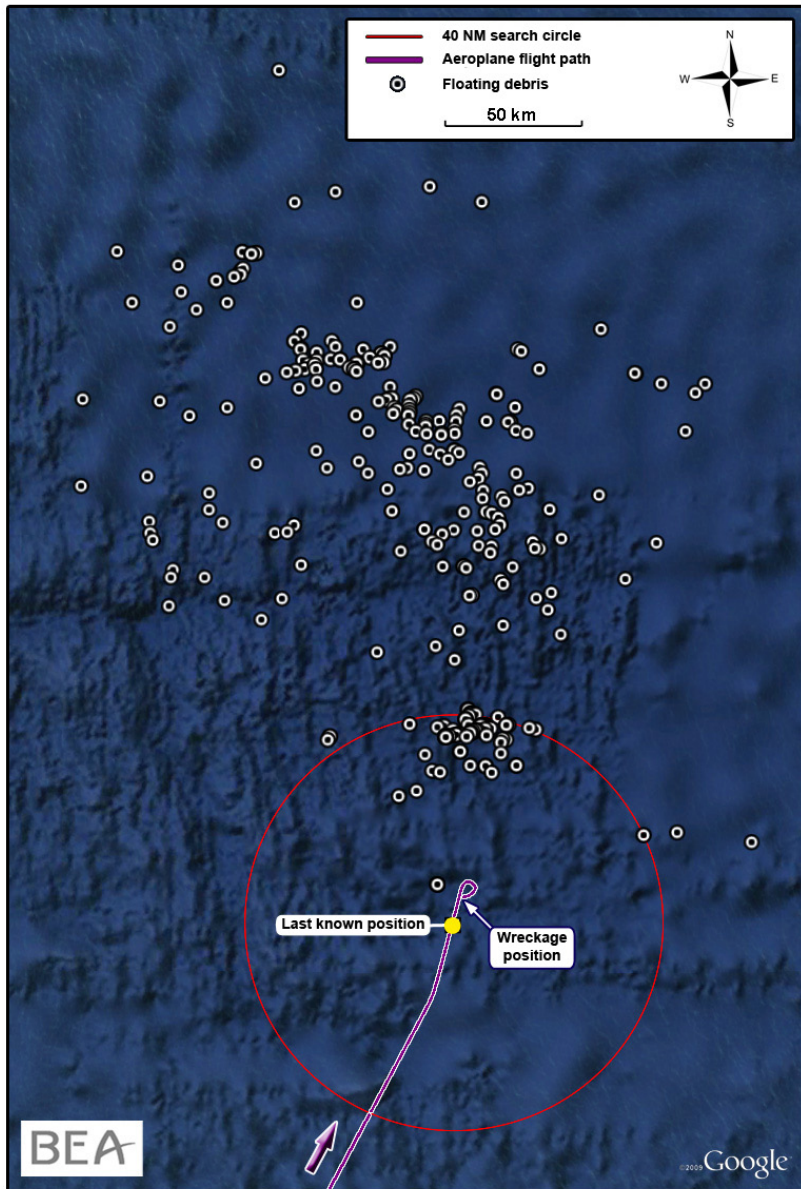
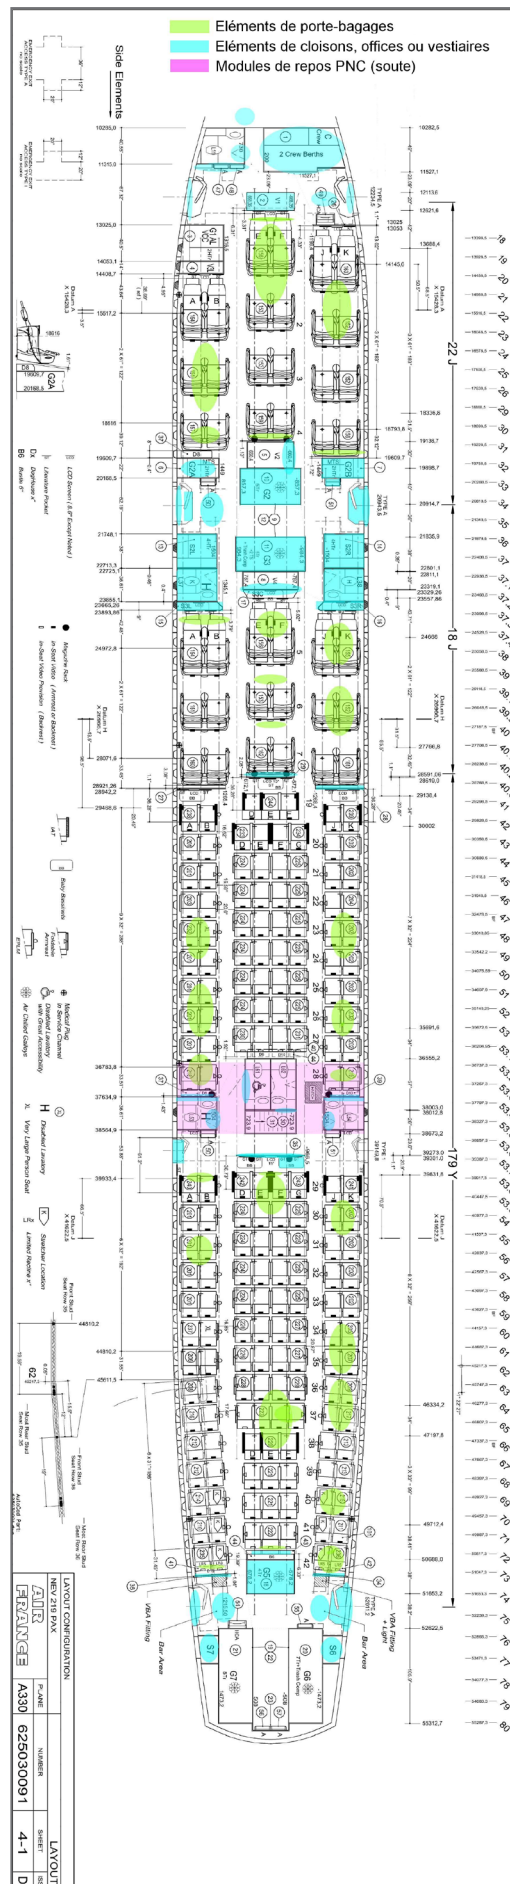
Figure 34: Position of the cabin part debris recovered in relation to the aircraft layout

Most of the parts found were low-density honeycomb or composite material parts.

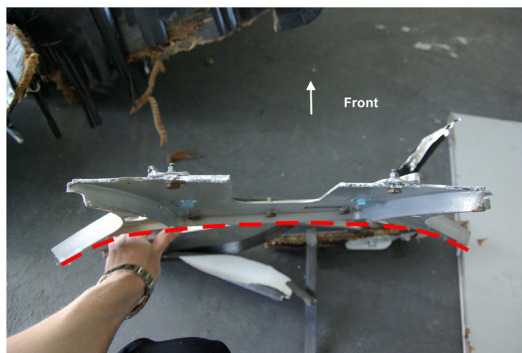
Figure 36: Luggage rack fitting deformed towards the front Toilet door (L54)

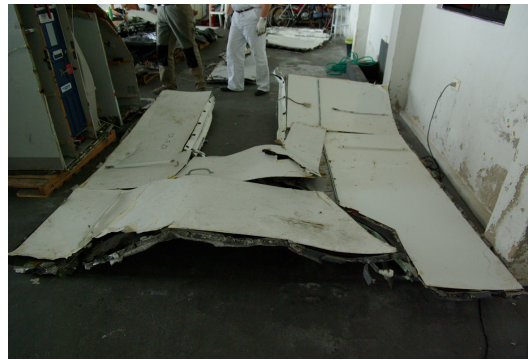
The wall fragments were crumpled. The reconstitution of the ceiling showed it was bent downwards and the floor bent upwards.

These deformations were symmetrical on the left and right sides with respect to the aircraft centreline.

Figure 39: Ceiling of the LDMCR:  
with top-downwards deformation

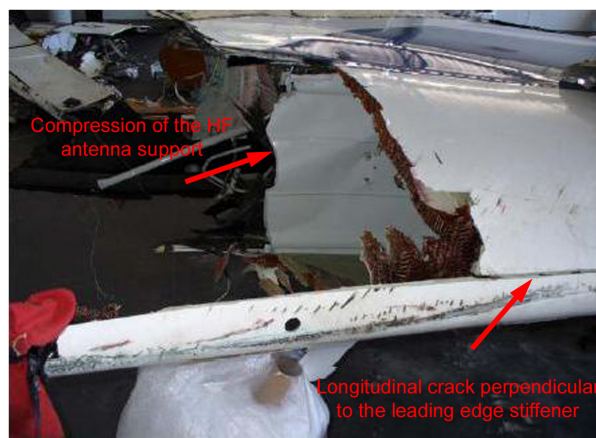
Figure 46: HF antenna support

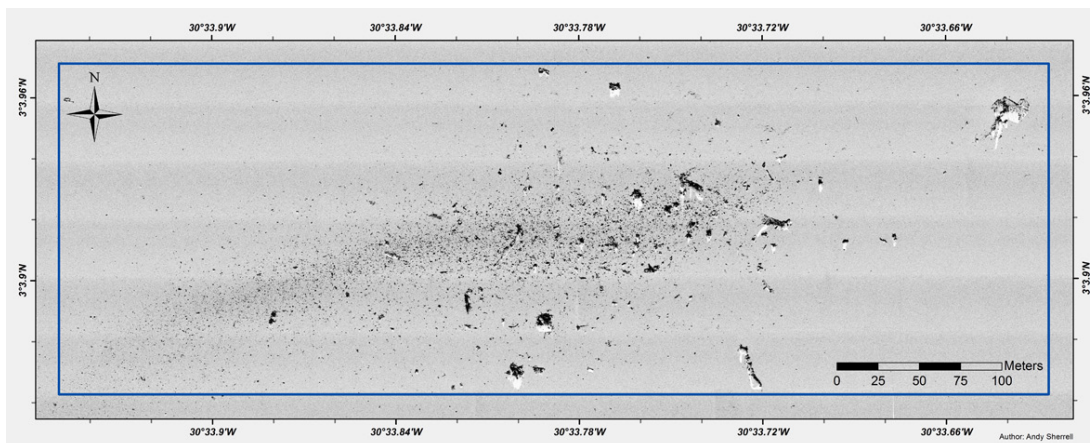
The densest debris (central section, engines, APU, landing gear) was found to the east of the site and the lighter debris to the west.

Outside the main area of 600 metres by 200 metres, a rear left fuselage panel containing eleven windows and around seven metres long was found approximately two kilometres south-west of the area. Part of the lower surface of the trimmable horizontal stabiliser was also found slightly to the south-west of this area.

Figure 55: Sonar Images of the debris field

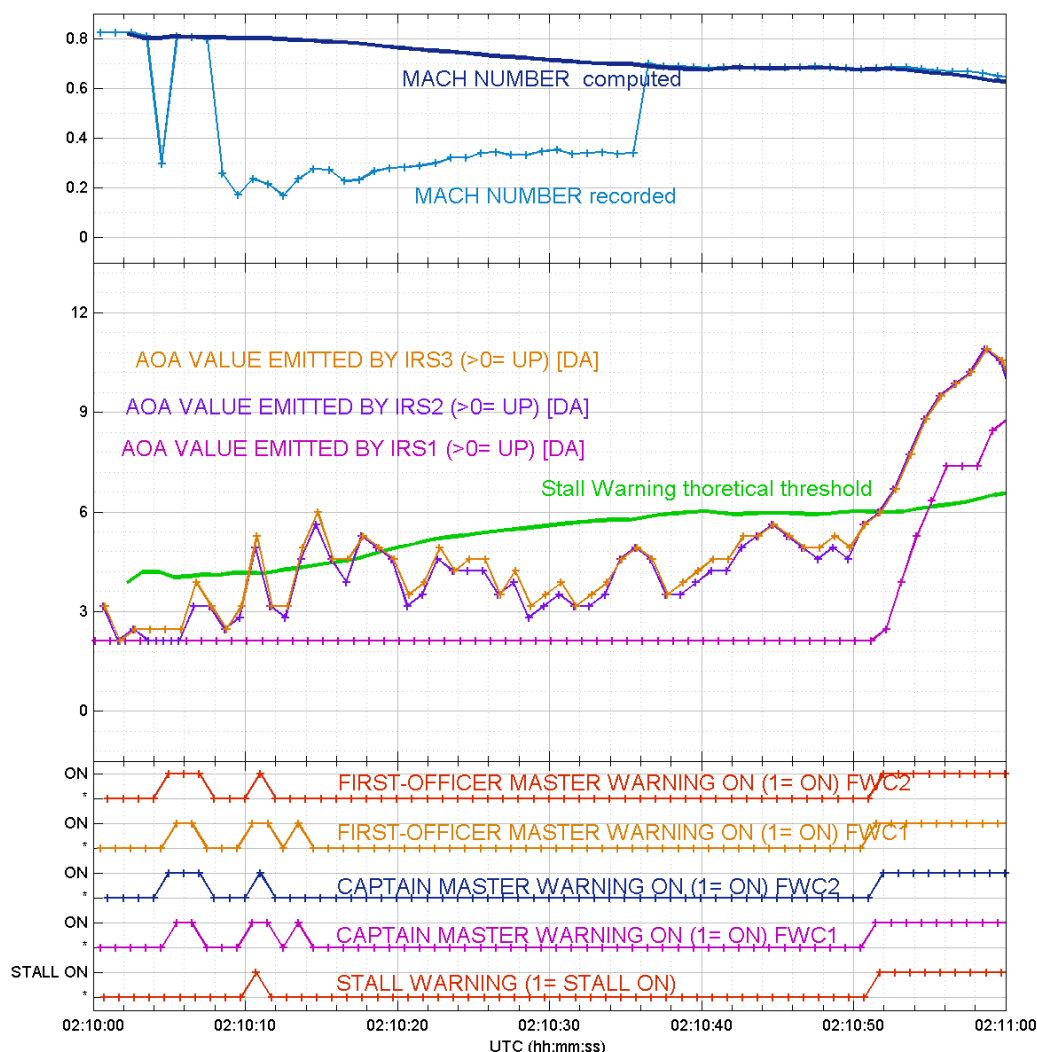
The graph below shows the change in the three recorded angles of attack as a function of time, in addition to the theoretical threshold at which the stall warning was triggered. This threshold was determined from a Mach value that was itself calculated from ground speed, wind and static temperature parameters. Comparison of this calculated Mach with the recorded Mach shows a good correlation.

Figure 62: Evolutions of recorded angles of attack and of the stall warning trigger threshold

The activations of the warning picked up by the CVR were identified as occurring at between 2 h 10 min 10.4 and 11.3 and between 2 h 10 min 13 and 13.4. The short duration of activation did not make it possible to detect it from the "Stall warning" parameter, but the FWC 1's "Master warning" parameters were triggered on one point at this time. However, this warning should have continued until about 2 h 10 min 15.5, and then have been triggered again between 2 h 10 min 17 and 19. The disabling of this warning was probably due to the fact that, between 13.4 and 15.5 and then between 17 and 19, and possibly at other times, the three Mach values were abnormally low (three Pitot probes iced up). The warning triggering threshold then suddenly increased to values of about 10°, much greater than the recorded angles of attack, which led to the warning stopping.

The stall warning triggered again ten times after 2 h 11 min 45; a correlation was noted between this triggering and a pitch-up input by the PF on two occasions, between 2 h 12 min 52 and 2 h 12 min 57 then between 2 h 13 min 52 and 2 h 14 min 02.

Note: the behaviour of the angle of attack 1 was slightly different from that of the two others ("lazy" behaviour) . Though the cause of this difference could not be established, it had no effect on the functioning of the systems.

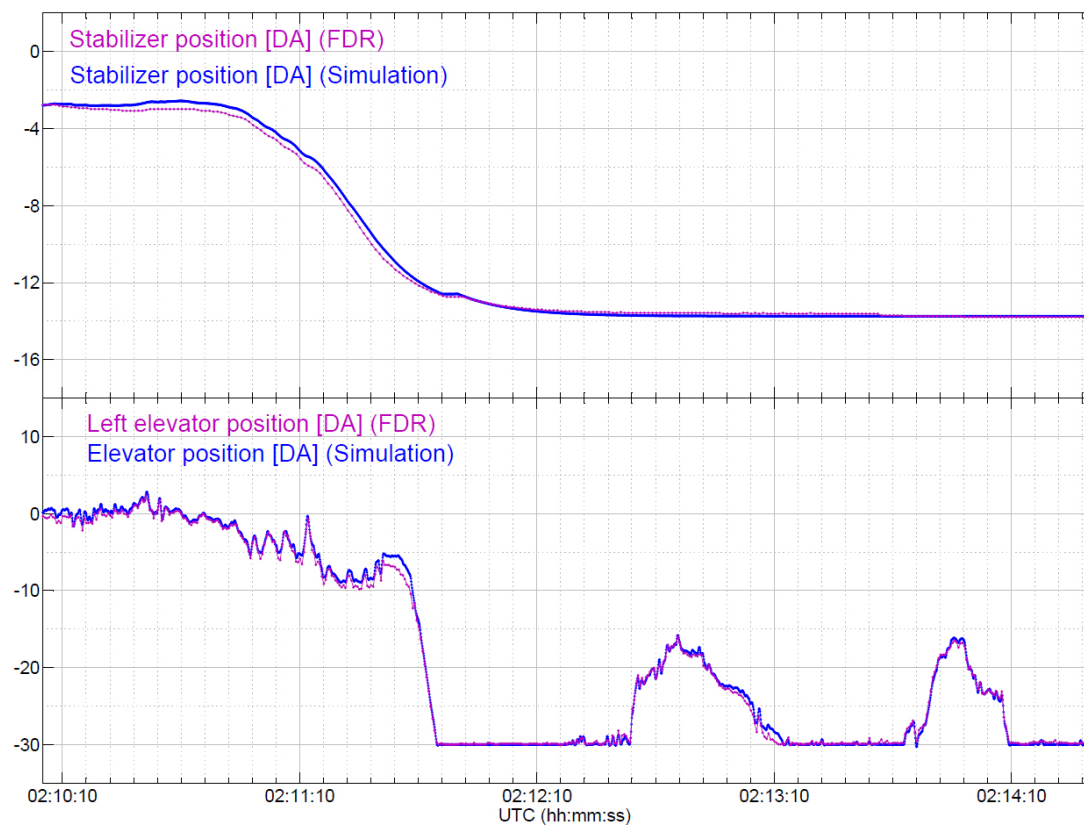
A simulation of the operation of the flight control computers was undertaken, which involved recalculating the movements of the elevators and of the trimmable horizontal stabiliser (THS) based on pilots' inputs and compared the results against FDR parameters. This simulation was continued up until the end of the flight. The recalculated deflection angles for the elevators and the PHR are consistent with the parameters recorded.

Figure 63: Comparison between the recorded positions of the elevator and THS and the simulation

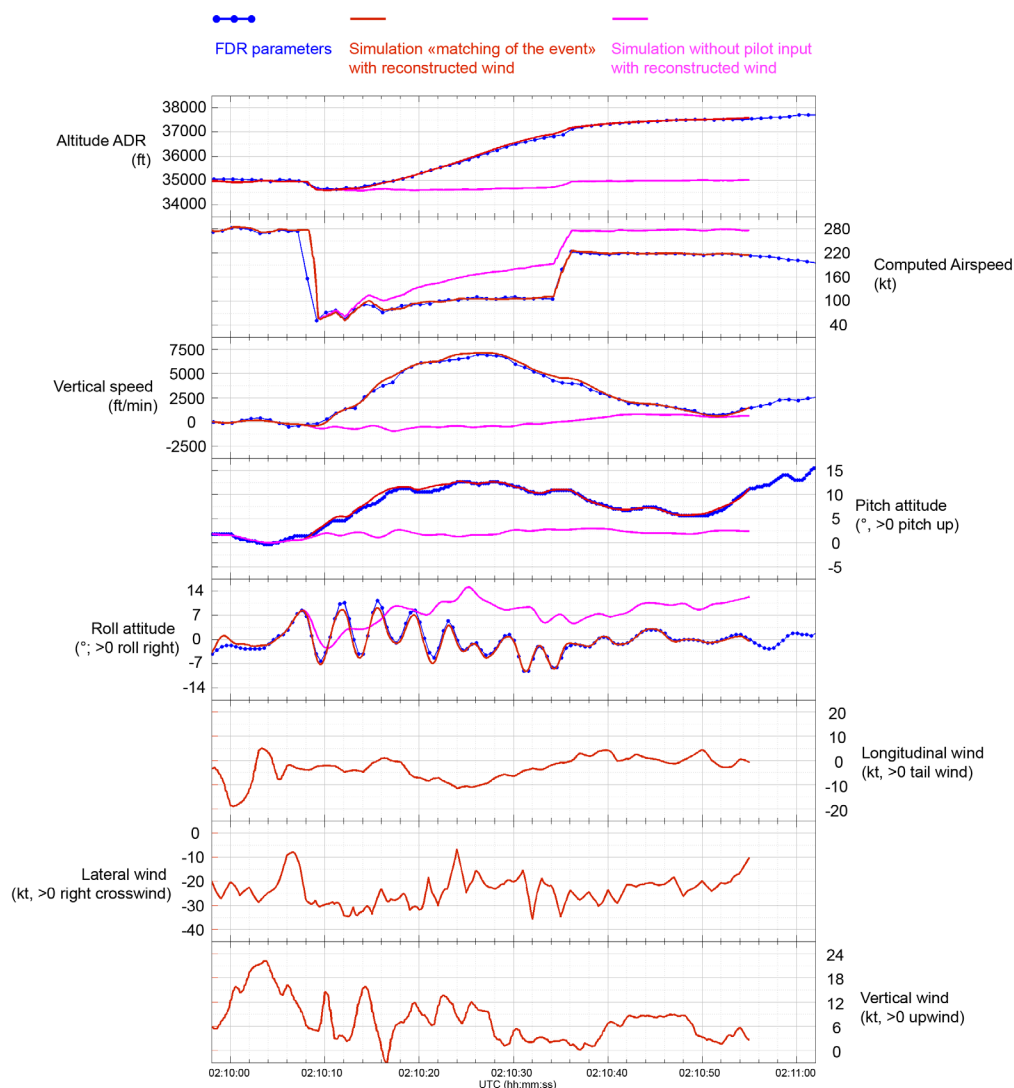
- ❑ From about 15 seconds before disconnection, the autopilot countered aerological disturbances whose intensity would be defined as "light" on the ICAO scale (variations in vertical acceleration of less than 0.5 g);
- ❑ When the autopilot disengaged, a concomitant lateral gust caused the aircraft to depart from its flight path with a roll to the right;
- ❑ The subsequent roll movements resulted from the inputs by the PF;
- ❑ The aircraft's movements in the longitudinal axis were primarily due to the inputs by the PF, with the exception of small variations due to the aerology (variations in normal acceleration of about 0.2 g);
- ❑ The turbulence eased as from about 2 h 10 min 30 s;
- ❑ With no PF inputs, the aircraft would have gradually rolled further to the left but the variations in pitch attitude and altitude would have been small.

Figure 64: Comparison between recorded parameters and the simulation

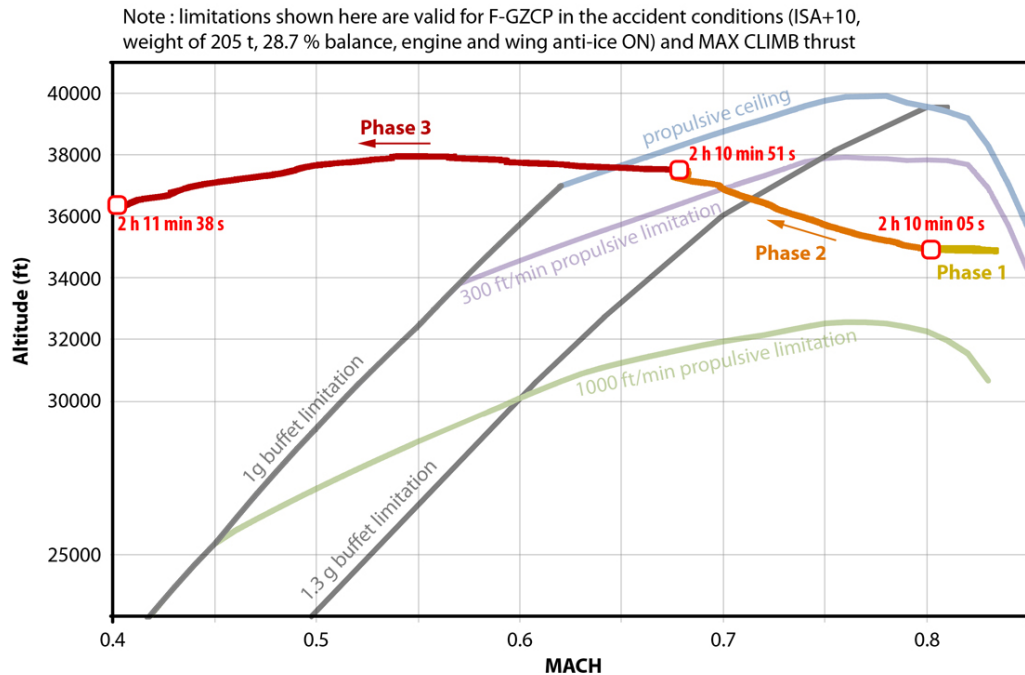
Figure 65: Flight envelope

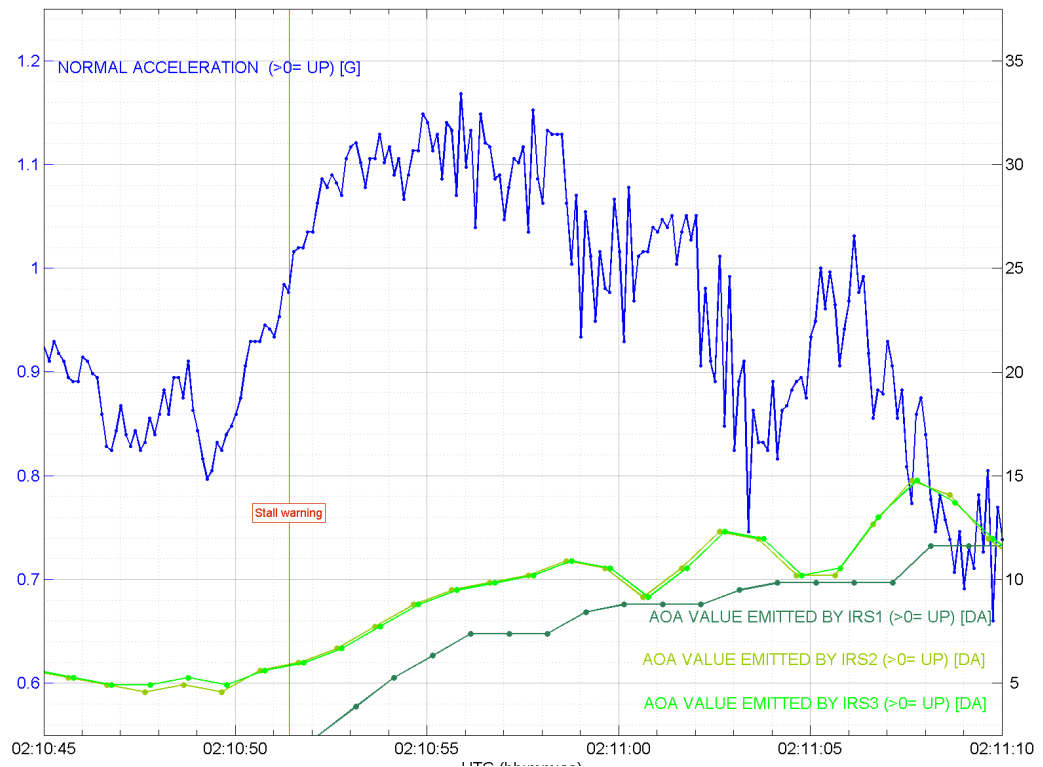
At 2 h 10 min 51, when the aircraft was at about 37,500 ft and still climbing, the stall warning was triggered (see 1.16.3.2). A change in the recorded normal acceleration behaviour was demonstrated from 2 h 10 min 53, at an angle of attack about 1 to 2 degrees greater than the warning activation threshold.

Figure 66: Evolution of normal acceleration recorded at the time of activation of the stall warning

This modification of the behaviour resulted in the appearance of a high frequency component of an amplitude increasing to up to about 0.1 g peak-to-peak, and with a signature that is very different from a turbulence signature of aerological origin. Furthermore, there is a noise on track 1 of the CVR, at about 2 h 10 min 55, which may be the impact of the microphone striking a panel, heard at a stable frequency.

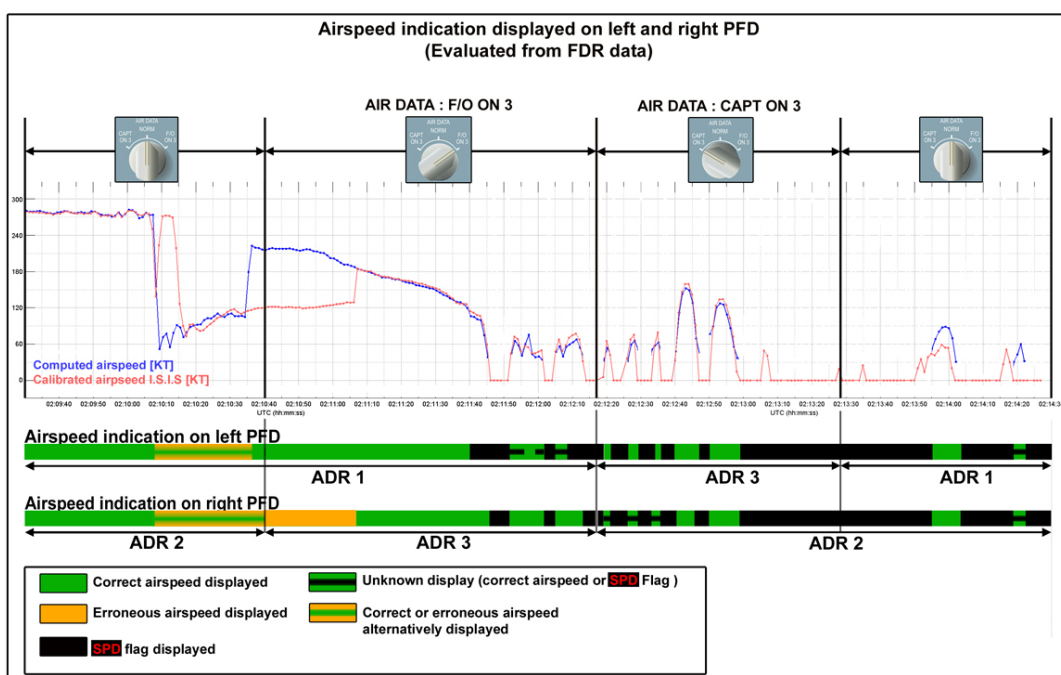
Analysis of the FDR data made it possible to determine, for each PFD, the time periods when the CAS was displayed as well as the corresponding ADR source.

Figure 67: Speed displays on the PFD

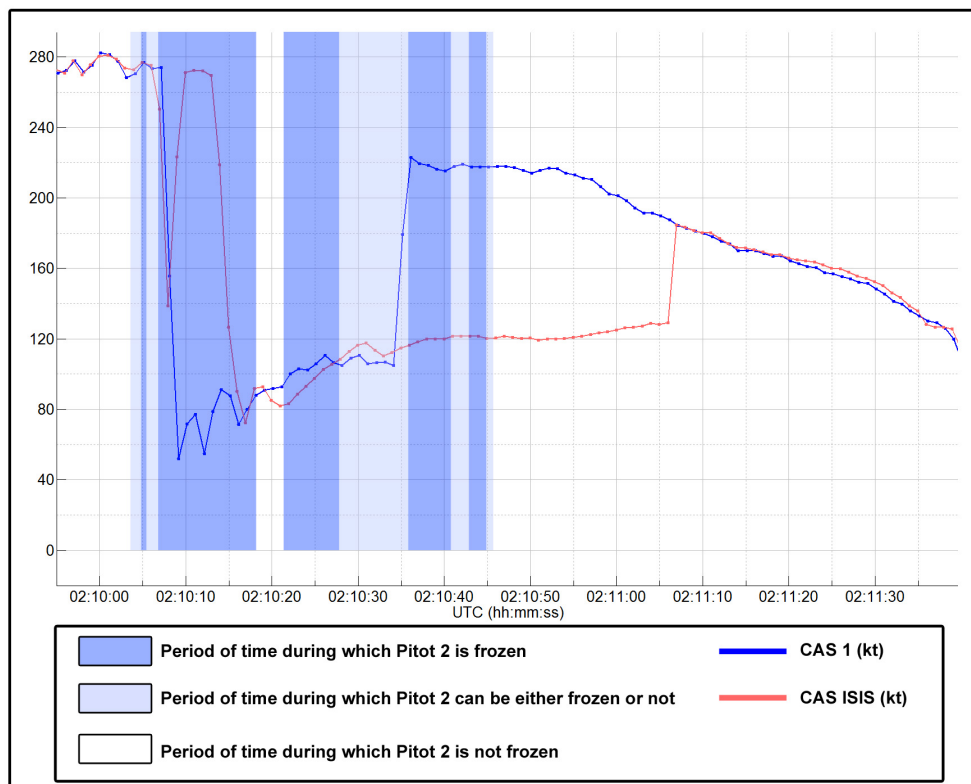
Between these two moments, the Pitot probe on the copilot's side certainly unfroze, at least temporarily.

Two icing profiles were established, one in which the Pitot probe remained frozen for the longest period of time and the other for the shortest period of time. It was not possible to determine which of the two profiles was more likely. Consequently, the evolution of the CAS displayed on the right PFD is partially known for the period from 2 h 10 min 3.5 to 2 h 10 min 46, as the following graph illustrates.

Figure 68: Evolution of the 3 CAS

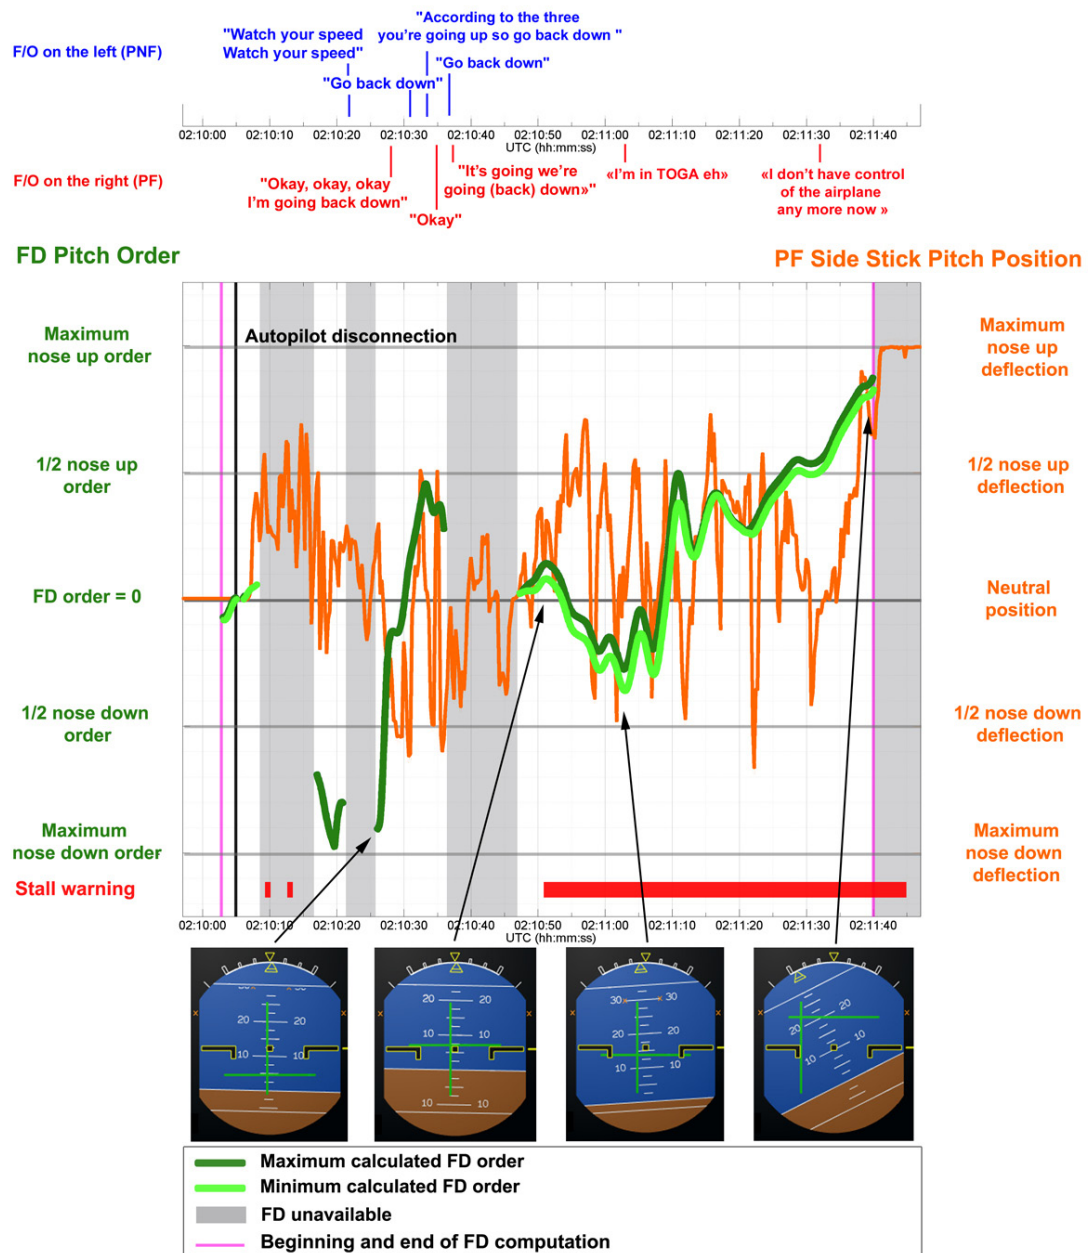
The following graph represents the maximum and minimum positions of the FD crossbars displayed between the disconnection of the autopilot and 2 h 11 min 40, as well as the longitudinal inputs made by the copilot on his sidestick:

Figure 69: Evolution of FD crossbars

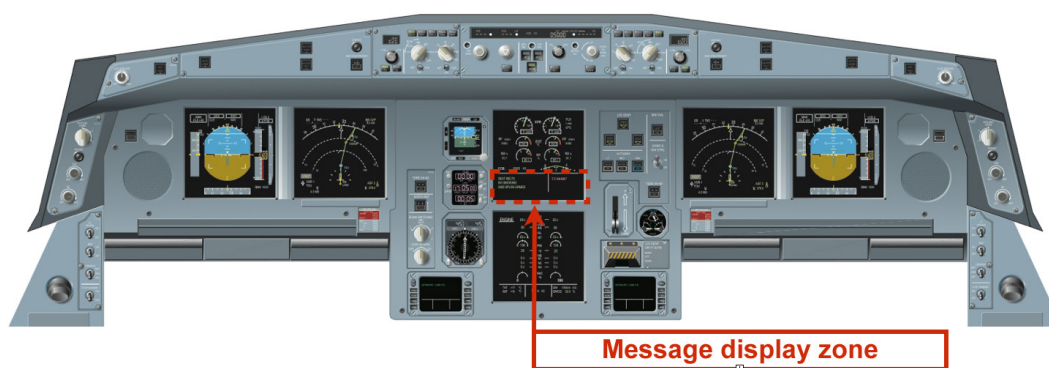
Figure 70: Position of the area where ECAM messages are displayed

Seven lines are available on the ECAM for the display of messages. If the number of lines required to display all the messages exceeds this number, a green arrow pointing downwards appears to indicate that other messages of lower priority have not been displayed. To make them appear, the crew must process the first messages, then clear them. It is not possible to know if any of the crew members cleared one or more ECAM messages during the event, however, no announcement to this effect was made.

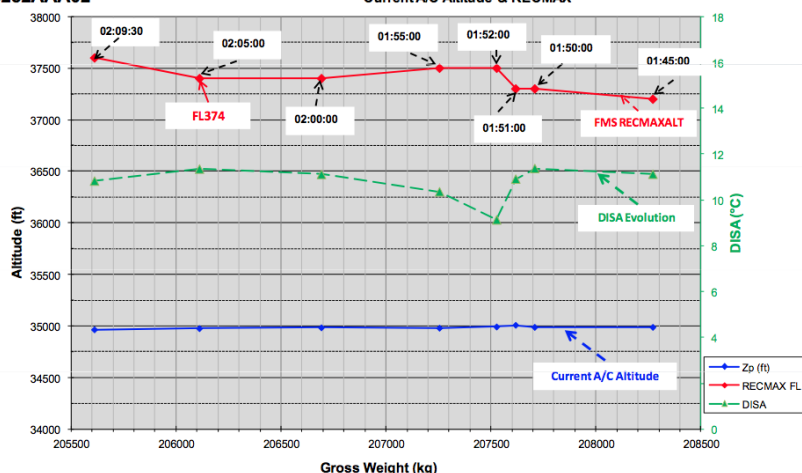
Figure 72: Evolution of the REC MAX (simulation) Source Airbus

The optimal flight level (OPTI) was recalculated using the information from the flight plan and the cost index used at Air France (80). This calculation indicated that the OPTI was about 37,000 ft flying over ORARO point, increasing in the same order of magnitude as the REC MAX.

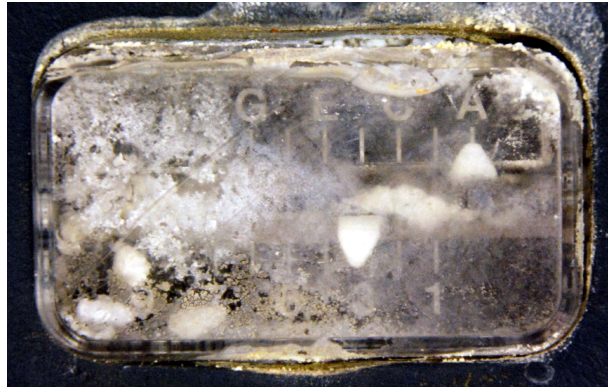
Figure 83: Dial indicating armrest position

The shoulder straps, the left lap belt and crotch belt were recovered detached. Examinations showed that on impact the left lap belt and crotch belt were locked and that the shoulder straps were not.

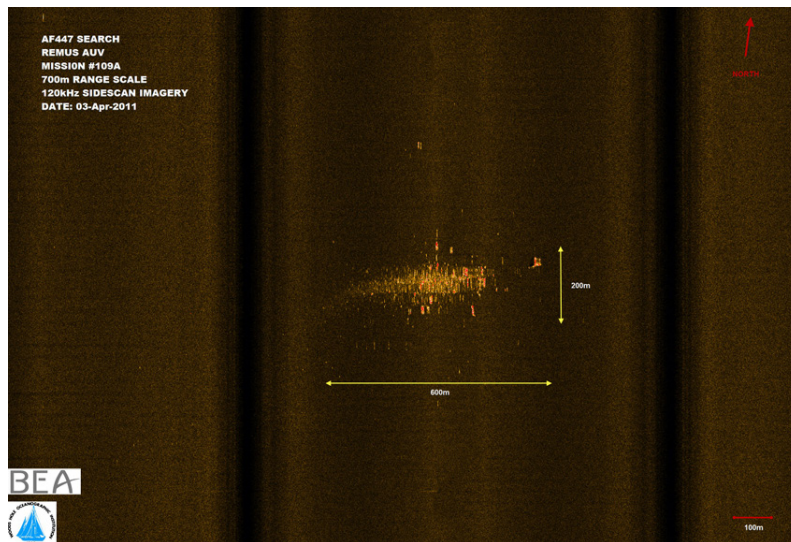
The wreckage was discovered on 2 April 2011 with the aid of the REMUS AUV's side scan sonar adjusted to a frequency of 120 kHz and a 700-metre range.

Figure 92: General view using sonar imaging: 120 kHz, range of 700 m

The first passage brought to light a concentration of backscattered data over an area of around 600 metres by 200 metres.

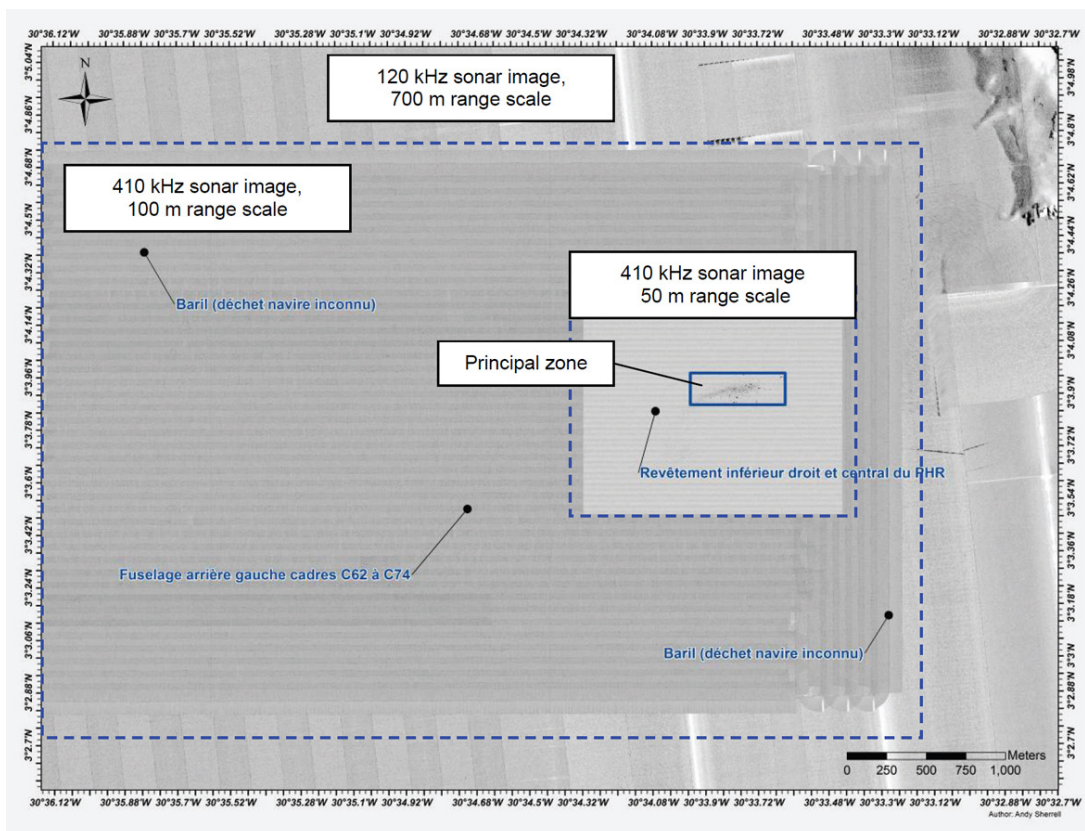
Figure 97: Overlay of sonar images taken with various settings:

During phase 4, the area was scoured several times by the REMUS AUVs with different sonar settings to make sure that no possible debris, located beyond the main zone, was forgotten. This exploration made it possible to localize a part of the fuselage about two kilometres from this zone as well as objects such as oil drums that did not come from the aircraft (see the following figure). The initial imagery was subsequently enhanced by high resolution 410 kHz sonar images at various range scales.

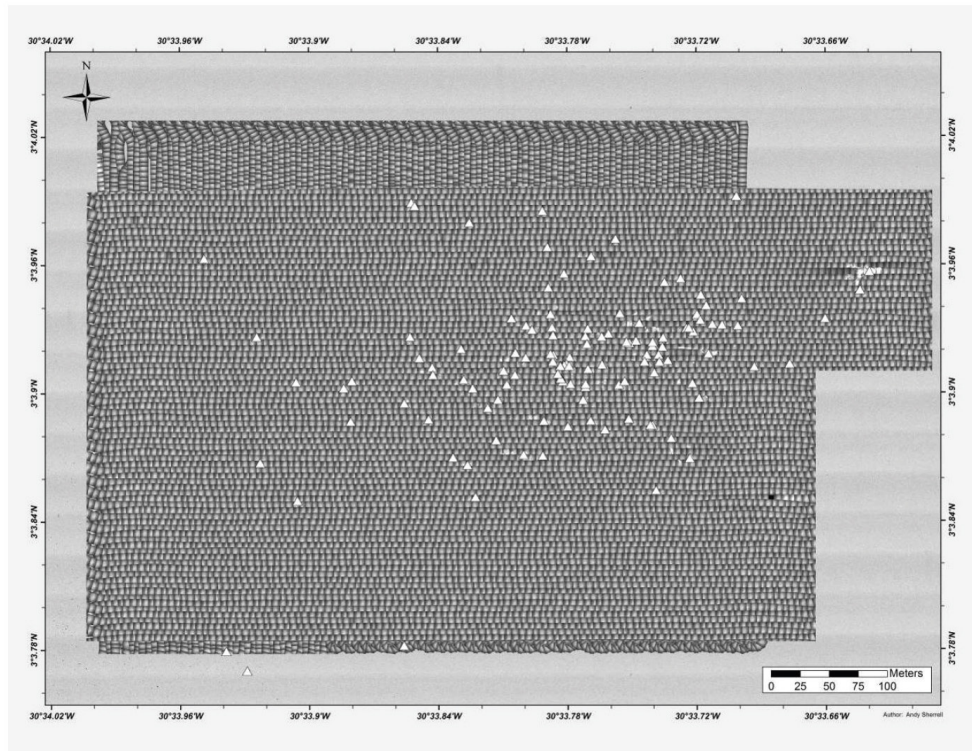
These photographs enabled the first chart of the wreckage site to be produced in mosaic form (see diagram below).

Figure 98: Visualisation of the photo mosaic obtained with REMUS AUV images and the aeroplane debris identified by using the REMORA ROV
