# FINAL REPORT AIRCRAFT SERIOUS INCIDENT

**Smoke in flight deck and cabin, engine  
shut down and an emergency landing**

**M-01409/AIG-09**

**Boeing 757-200**

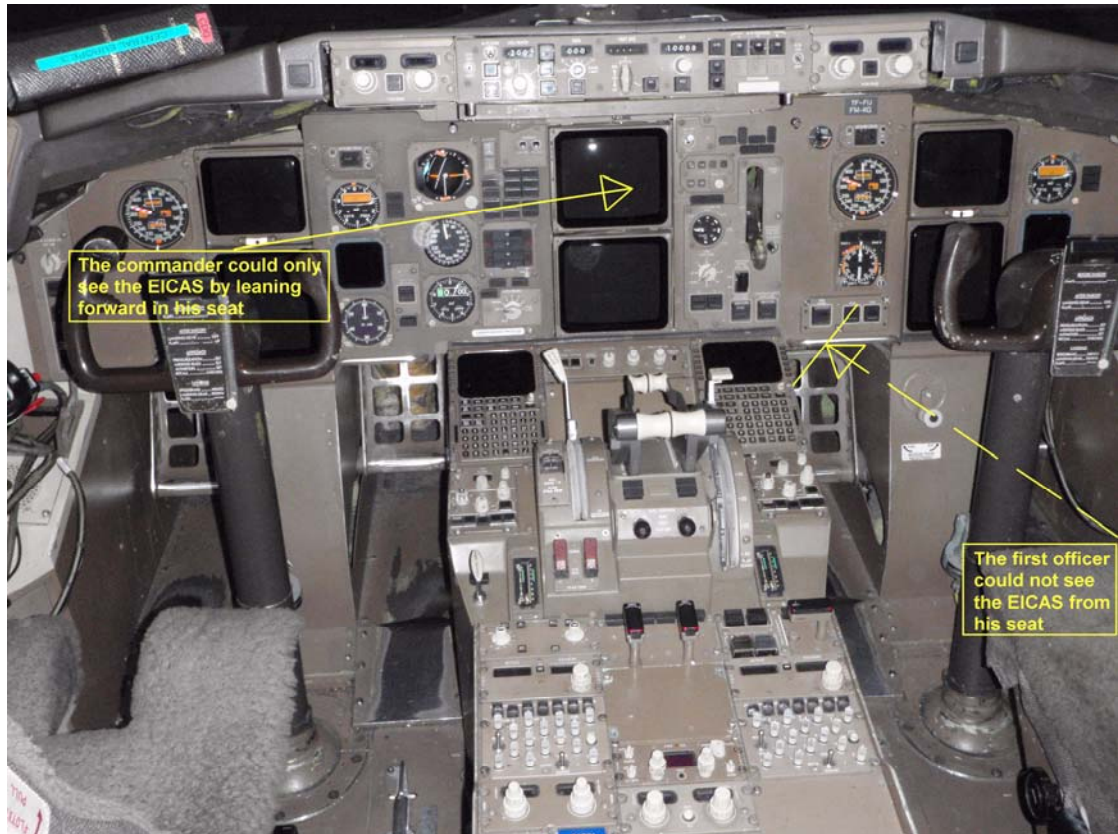
Seventeen seconds after the smoke was initially noticed in the flight deck, the flight crew advised London ATC that they had smoke in the flight deck. At this time, the smoke had intensified rapidly and the flight crew had difficulty seeing the instruments on the control panels as well as each other. A few seconds later, three loud bangs were heard by the flight crew coming from an engine as it most likely surged<sup>4</sup>. Due to the dense smoke, by leaning forward in his seat, the commander was barely able to recognize on the EICAS<sup>5</sup> in the centre control panel that the parameters for engine #1 (LH engine) were irregular and its EGT<sup>6</sup> was rising. At this time the first officer did not see the EICAS due to the thickness of the smoke and had difficulty seeing the control panels that were a bit closer and directly in front of him. See Figure 1.

Figure 1 – View of the EICAS panels (commander leaning forward in his seat)

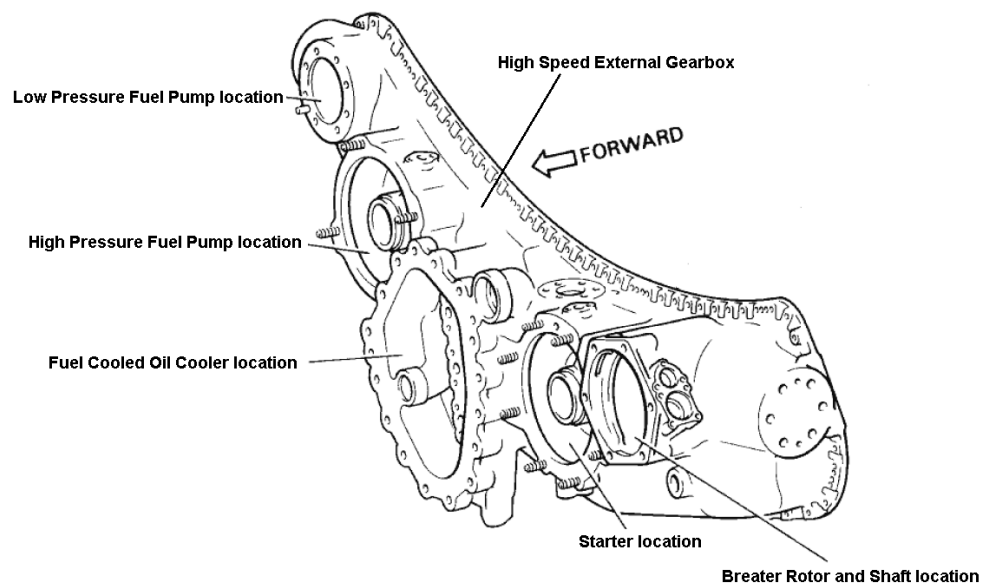
Several subcomponents installed on the high speed external gearbox, were also inspected as part of the investigation. See Figure 8.

Figure 8 – The high speed external gearbox and the locations and its subcomponents
