***Final report RL 2012:21e***

**Serious incident on 16 of January 2010 to  
aircraft EP-IBB at Stockholm/Arlanda  
Airport, Stockholm county, Sweden**

Ref.no. L-02/10

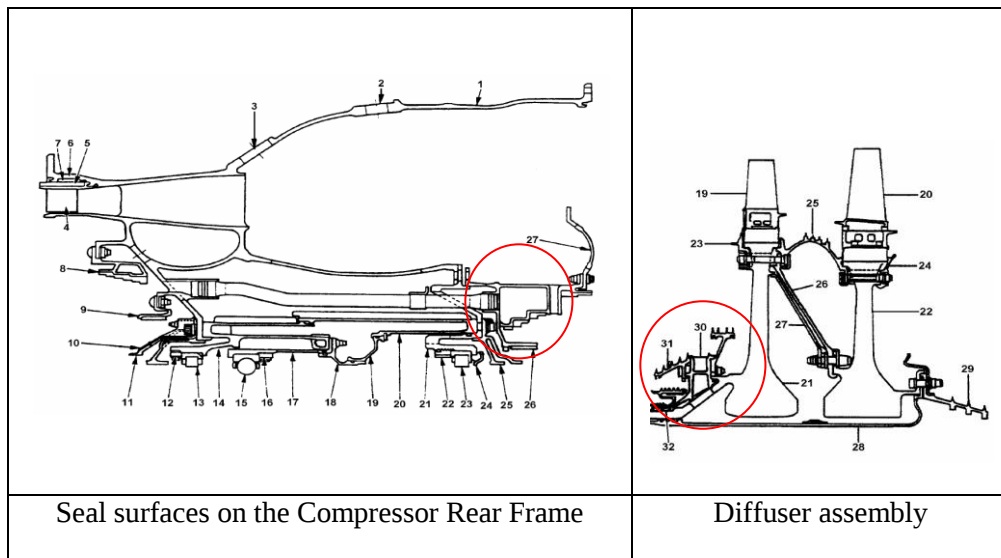
Fig.12. Diffuser Assembly and Compressor Rear Frame.

If the aft air seal separates, seal debris which enters the core flowpath in addition to the loss of pressure balance will result in an engine stall event by the result of the disruptive core airflow. In the investigated incident, the separated debris which entered the core flowpath resulted in significant downstream damage which resulted in high exhaust gas temperature (EGT) and loss of fan speed (N1 system) from the LPT blade damage.

In the drawing below, a red circle marks the static seal surfaces on the Compressor Rear Frame and the rotating Diffuser Assembly on the High Pressure Turbine.

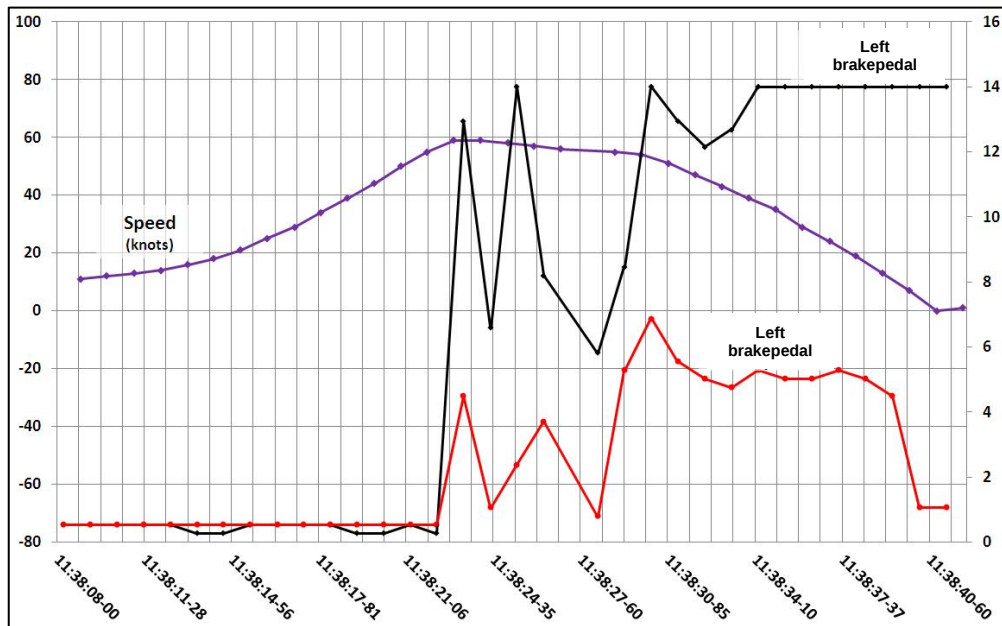
Fig. 21. Brake pedal angles.

The recording of the brake pedal angles has been secured, for the right and left pedals, respectively. The pedals for right and left pilot are mechanically interconnected, which means that it is not possible to determine which one of the pilots has pressed down any of the brake pedals. Only the joint brake angle has been recorded. The brake pedal angles are presented in Fig. 21 below. A value of 14 represents the maximum displacement.

From the diagram in Fig. 21, it can be noted that the recorded pedal displacements follow each other at different levels during the sequence, where the right pedal has been recorded with values corresponding to around half of the value for the left pedal.

Maximum displacement has been recorded from the left brake pedal during the final phase until the point when the aircraft stops. During this phase, the value from the right pedal decreases and approaches zero when the aircraft stops.

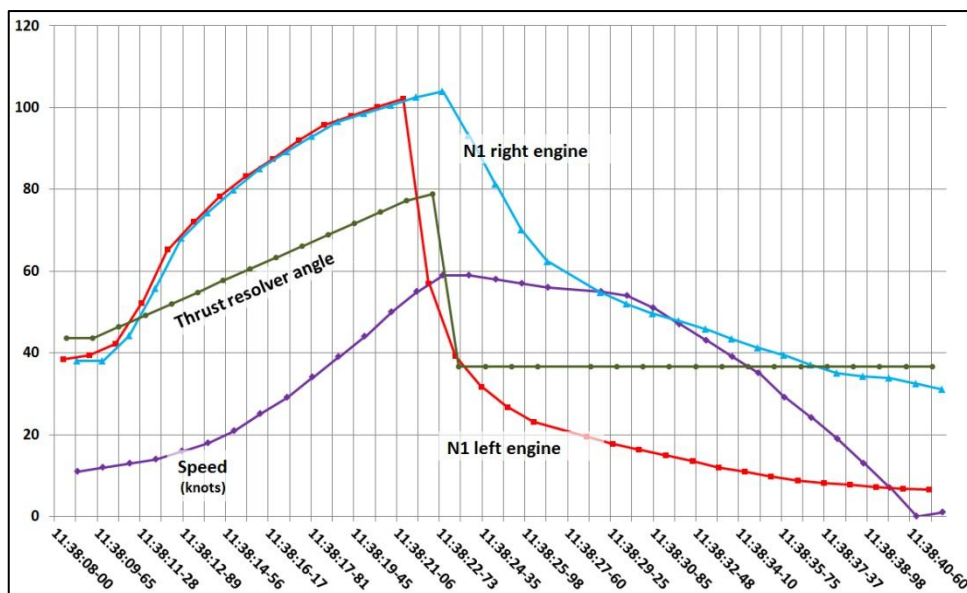
Fig. 22 Rpm N1, throttle angle, aircraft speed.

The engines' rpm N1, thrust lever angle, and the speed of the aircraft are presented in Fig. 22 below. The red line represents the left engine, i.e., the engine that failed.

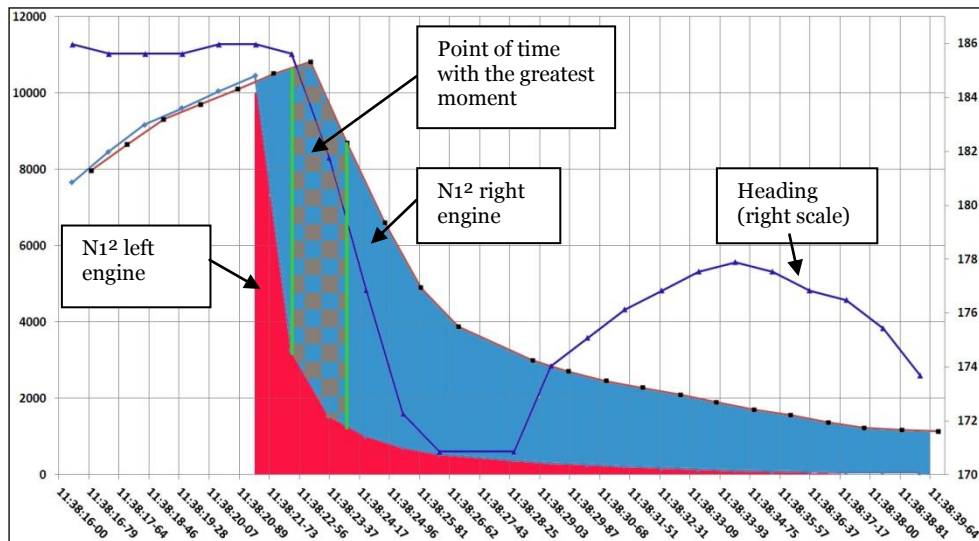
Fig. 23. Illustration of the energy from the engines.

Fig. 23 also shows N1 for the left and right engines, though it is the square of N1 that is presented as this better represents the amount of energy developed by the engines. The red area represents the energy output of the left engine from the loss of engine power until the aircraft was close to a standstill. The blue area represents the energy output of

the right engine over and above that of the left engine, i.e., the energy which contributed to the yawing moment of the aircraft.

The greatest yawing moment was at the time when the right engine's rpm was at its highest, i.e., when the thrust lever angle was reduced to minimum and the right engine's rpm began to decrease. Between 38:22.34 hrs and 38:23.84 hrs, the yawing moment was greatest, followed by a rapid decrease as the right engine's rpm decreased. This area is marked as a checked area in Fig. 23 below.

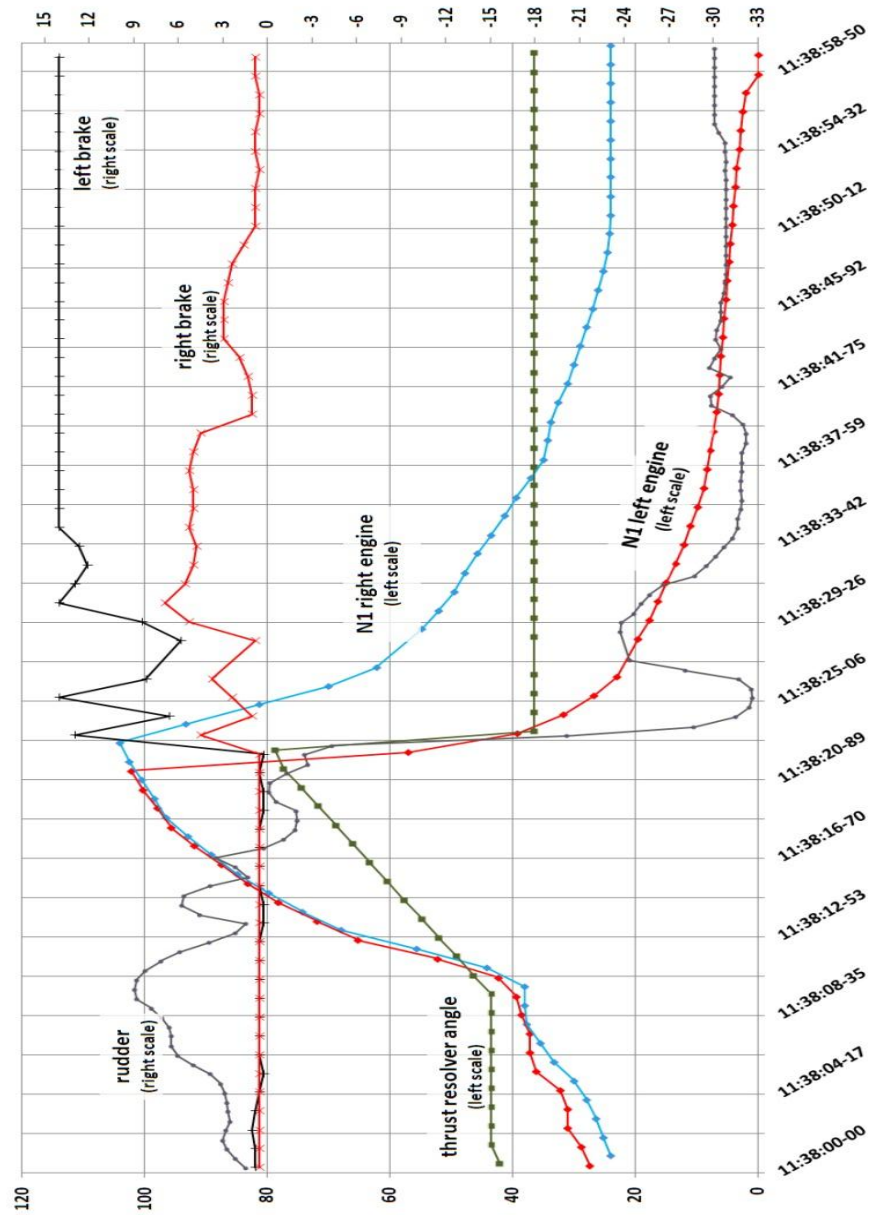
Fig. 24. Data from the FDR.

The enlarged diagram overleaf – Fig. 24 – illustrates the times with raw data from the FDR at the time of the loss of engine thrust itself, from 38:21 to 38:25. The first point on the N1 line is also the highest point (102.25%).

Among other parameters which could be noted from the FDR readouts, it can be seen that aileron was applied (the steering wheel on the steering column was moved to the right),

and that the steering column was pulled back a little. These actions were initiated when the aircraft had already begun the veer to the left.

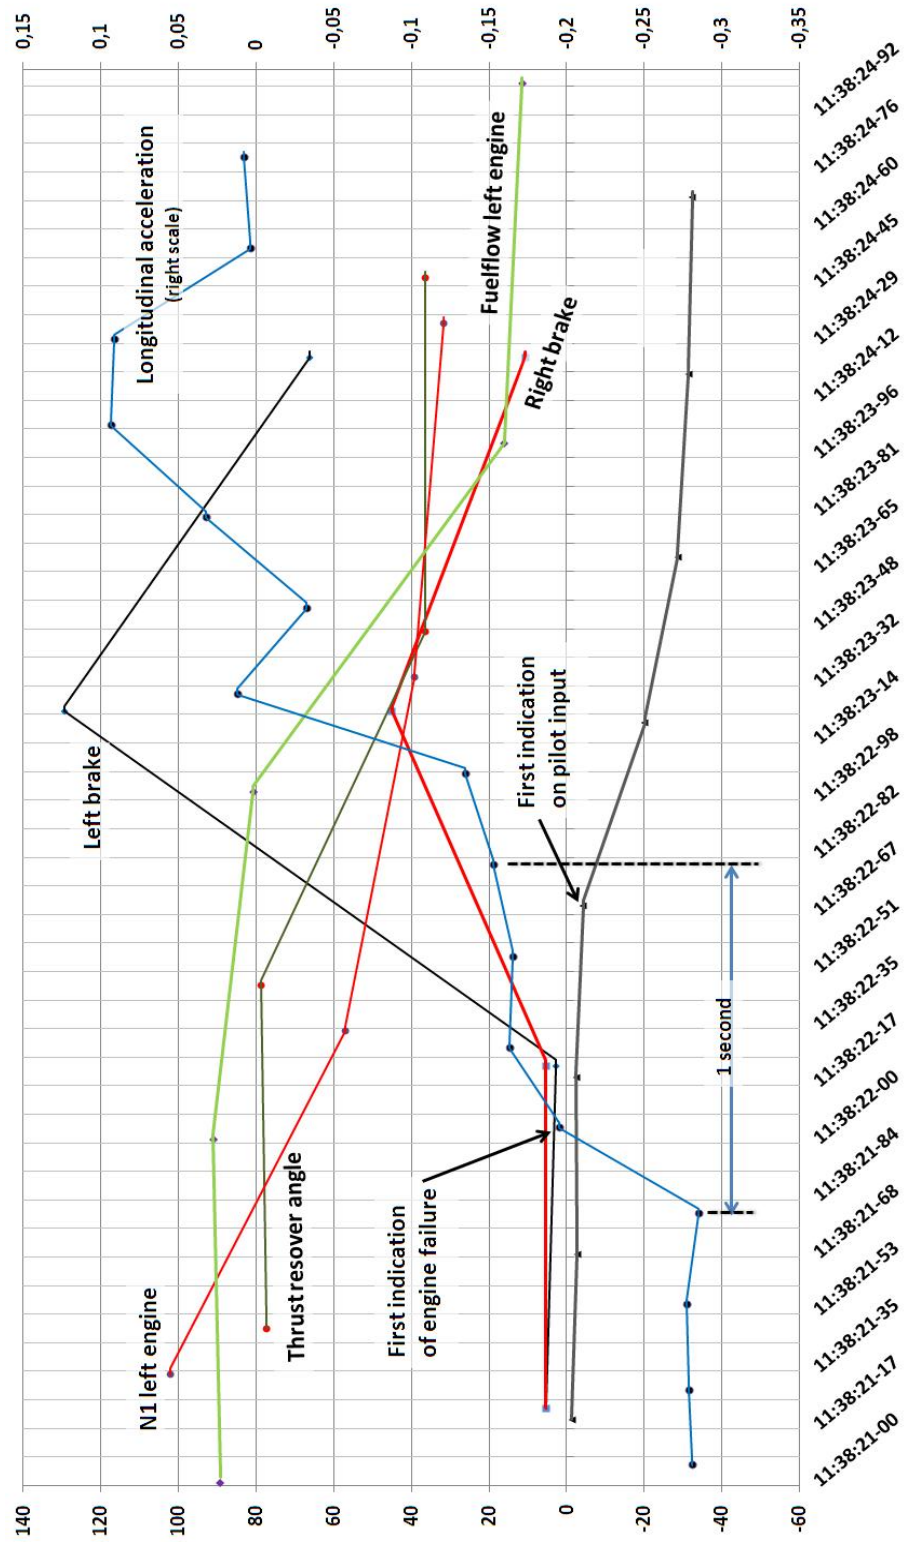
Fig. 25. Data from the FDR.

The pilots' reaction to the loss of engine thrust can be seen in the thrust lever angle, rudder and the brake pedal angles. The pilots' reaction begins at 38:22.18 hrs at the earliest (rudder) and at 38:22.68 at the latest (rudder position recorded at 2 Hz, i.e., two times per second). At 38:22.18 hrs, the rudder passes  $-20^\circ$  (turn right). The first value recorded when the brake pedals had begun to be used is at 38:23.25 hrs (they are recorded at 1 Hz). The left brake pedal was at that point depressed at around 92% of maximum displacement, and the right pedal at around 29%. The thrust lever angle is recorded at 1 Hz, and at 38:22.46 hrs, the thrust lever positions were still unchanged. At 38:23.46 hrs, the thrust levers had been retarded down to ground idle. The sequence can be seen in Fig. 25.

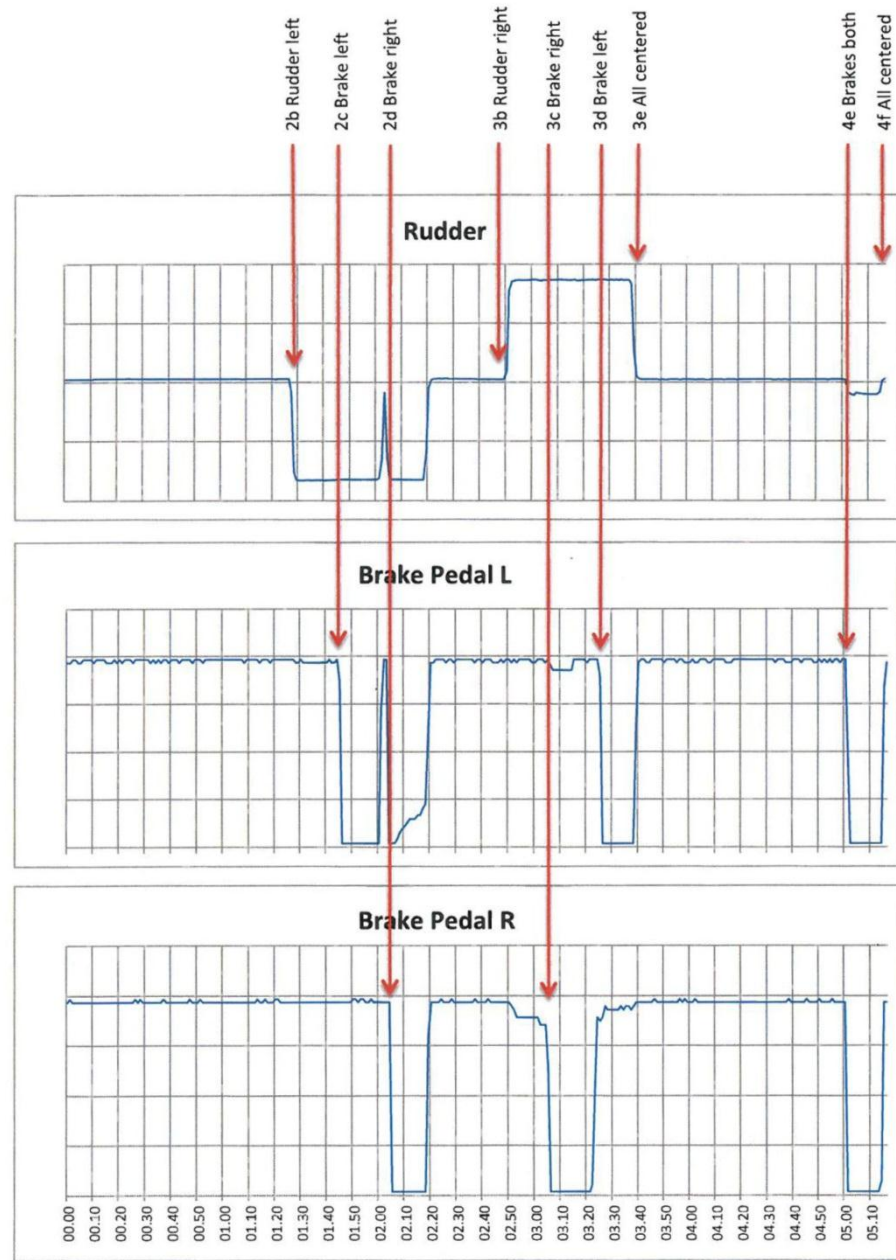
Fig. 26. Section of a graphical presentation of the data recorded during testing. Terms on the upper edge refer to SHK's test schedule. The bottom scale represents a time axis.

When the recorded data were extracted, it was established that there were no malfunctions or deviations, compared with the original recordings from the incident. Upon full displacement of left and right brakes, the corresponding maximum values had been recorded in the FDR. In the illustration above, it can also be understood that full brake displacements were registered irrespective of whether the rudder pedals were in left, right or neutral position. All recorded values corresponded fully to the movements and manoeuvres carried out by the test persons in the cockpit.

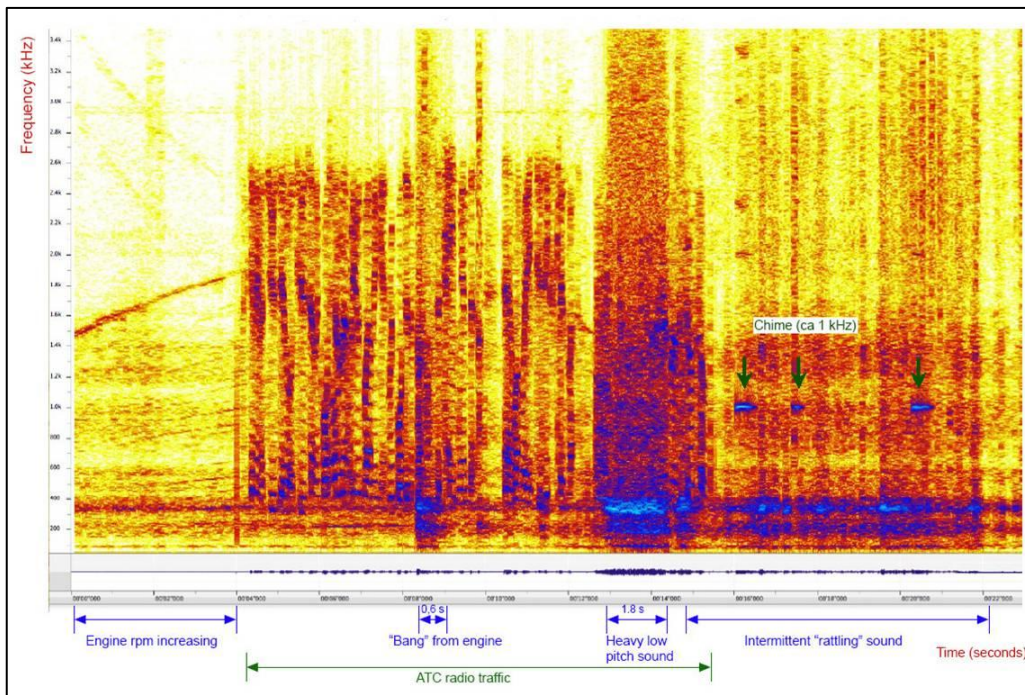
Fig. 27. Sonogram from channel 2 of the CVR. Graphics: Magnic AB.

The sonogram describes how sound can be visualized in the frequency plane, with time on the horizontal axis, where in addition to the “bang”, the low-frequency sound recorded approximately 4.5 seconds after the engine failure can also be noted.

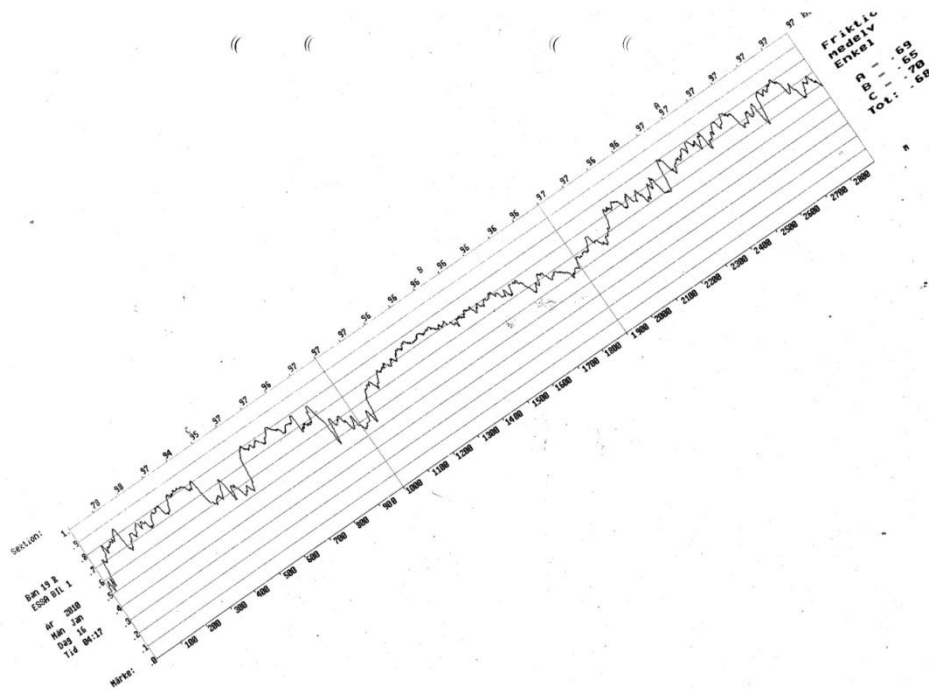
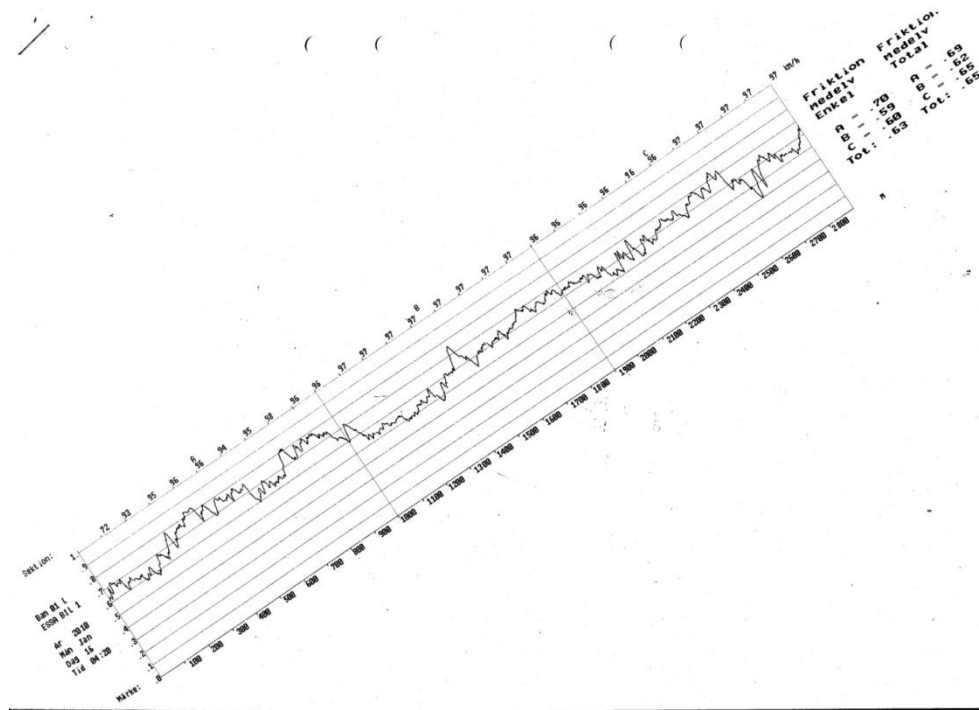
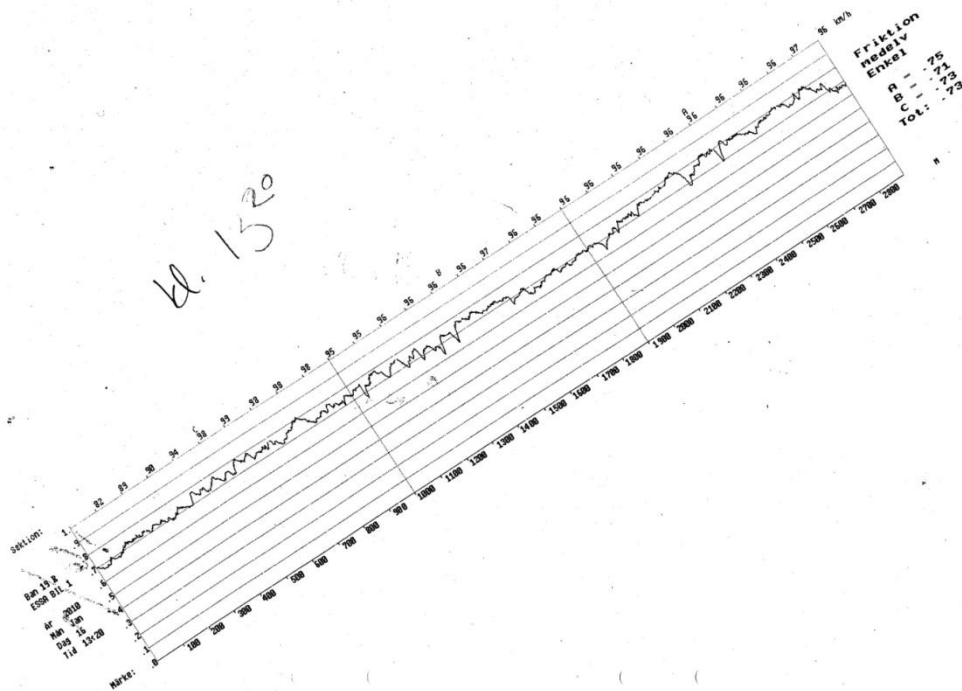
Fig. 31. Friction measurement at 04.17 hrs on runway 19R.

Fig. 32. Friction measurement at 04.20 hrs on runway 01L.

Fig. 33. Friction measurement at 13.20 hrs on runway 19R.

Approximately 35 minutes after the incident, a new friction measurement was carried out on runway 01L/19R, Fig. 33. This friction measurement shows generally higher values, 75, 71 and 73 for the respective sections and a mean value of 73. The difference between the highest and lowest friction values was on that occasion approximately 19.

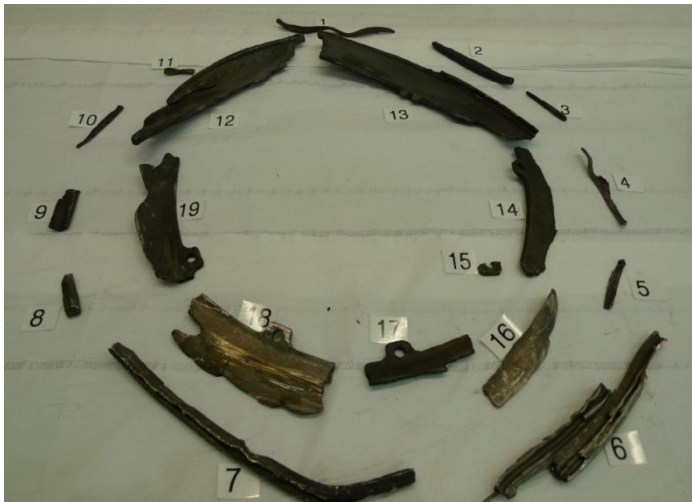
Of the parts analysed, it was discovered that the majority had secondary damage and that the sequence of failure on the diffuser aft air seal was the primary damage in a sequence of failure that is unknown at this time. LHT concluded that the seal came loose due to micro cracks in the nine attachment lugs that hold the seal against the diffuser. The attachment lugs are to have come loose, and the ring to have expanded radially outwards and come into contact with the stationary honeycomb seal. See Fig. 42.

Fig. 42. Fragments of the diffuser aft seal analysed by LHT.  
Photo: LHT.

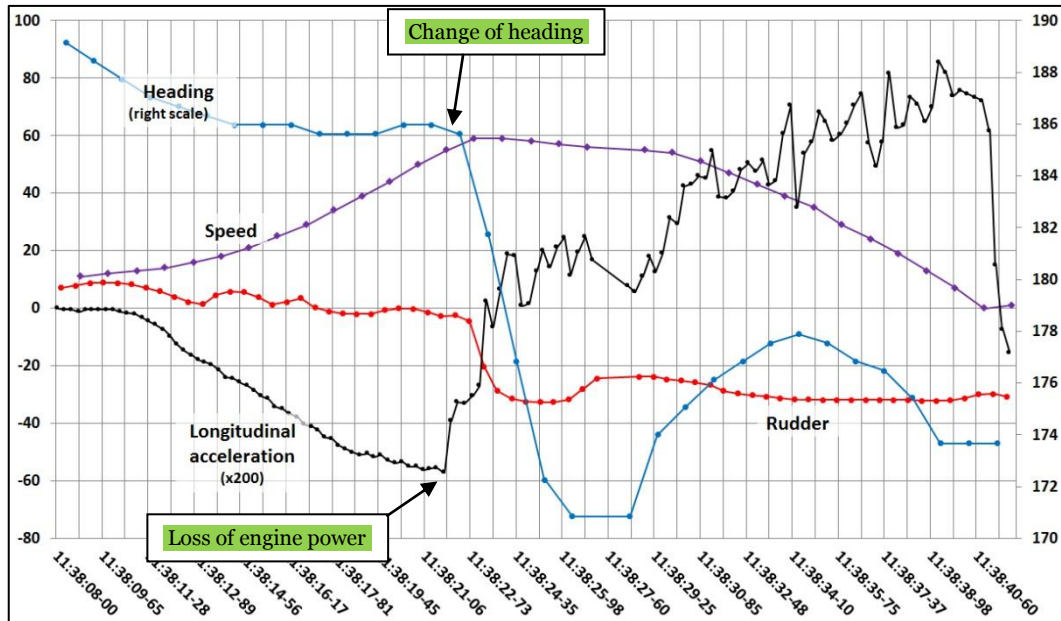
Fig. 53. Data from the FDR. (See also fig. 19.)

Apart from the remaining kinetic energy in the engine’s rotating fan, the loss of power took place extremely fast. In the space of only two seconds, the thrust was reduced to approximately 50% and after a further two seconds to approximately 10%. This has been

Following evaluation of the available parameters, SHK has chosen to use the decreasing acceleration as an indicator of the point in time of the engine failure. According to this parameter, the point in time of the engine failure can be established at 38:21.9 ( $\pm 0.12$  seconds). Apart from the higher frequency at which the values were recorded, this parameter can be verified in comparison with other data from the engine. In other words, the time of the engine failure has been determined as the point in time when the acceleration decreases due to reduced thrust from the left engine.

However, because the rudder deflection (see Fig. 53) is a pilot induced reaction to the change of heading, the latest point in time for the change of heading cannot be after the latest time of the rudder deflection. This reduces the possible interval for the change of heading to have taken place to between 22.46 and 22.68.

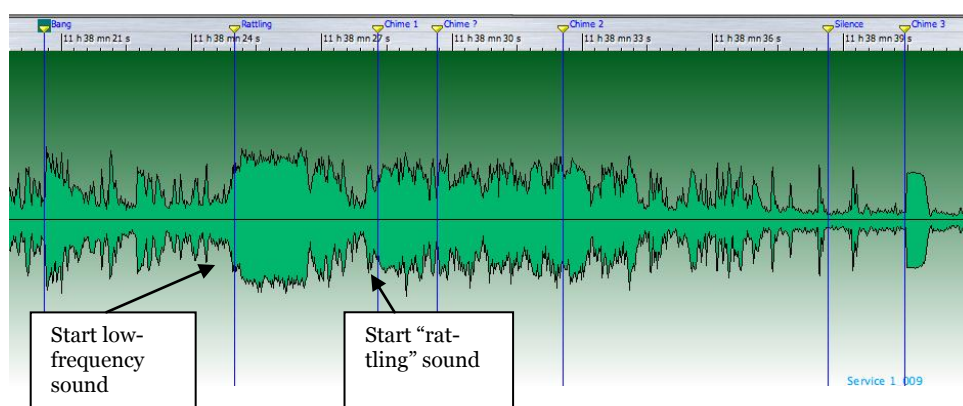
Fig. 54. Audiogram of parts of the incident. Graphics: Magnic AB.

At 26.5, a loud, low-frequency sound is recorded, which continues until 28.3. This sound is probably caused by the commander activating the nose wheel steering via the steering wheel at this point in time and turning the nose wheel to its maximum displacement angle. The increasing angle results in the nose wheel being more or less transverse against

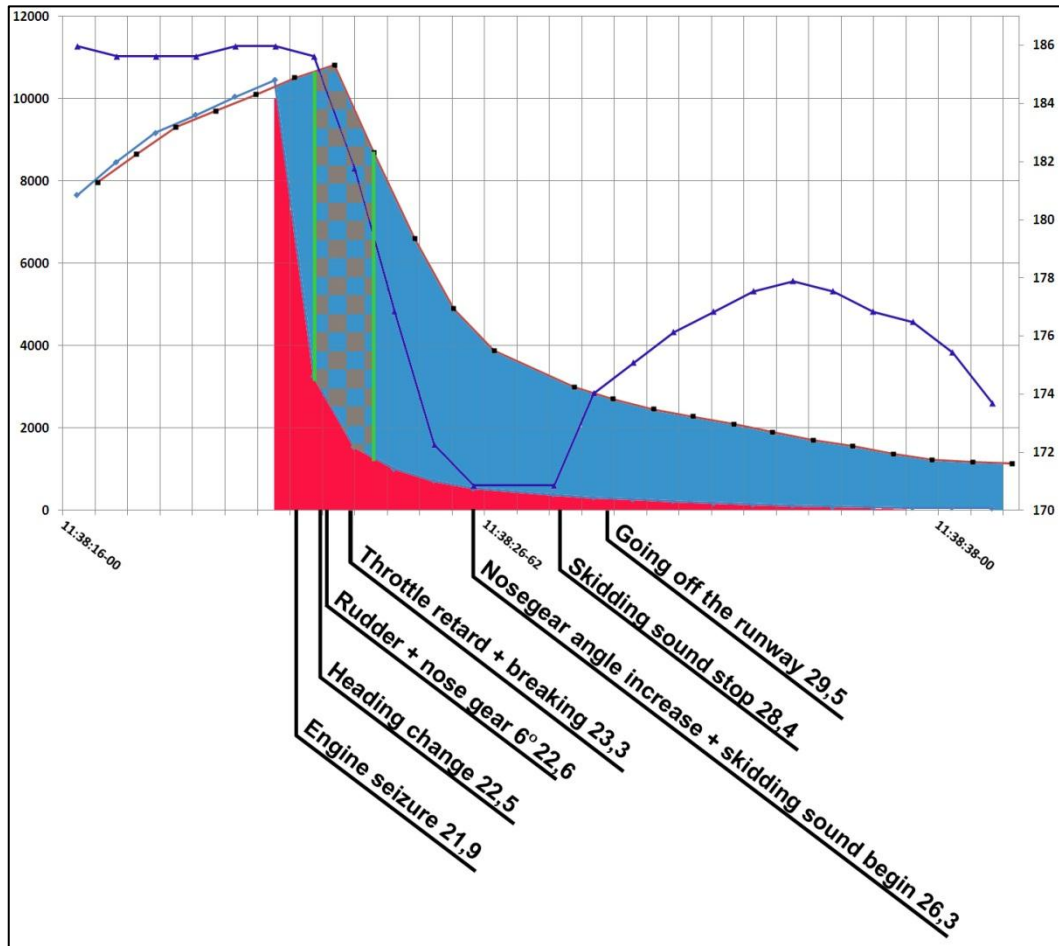
Fig. 56. Illustration of the energy from the engines including timeline. See also fig. 23.

In the diagram in Fig. 56, relevant data from the FDR, with the area of high yawing moment inserted, has been combined with the analysed timeline of the incident. The diagram shows clearly that the force from the excess moment from the situation of asymmetric thrust almost immediately produced the veer.

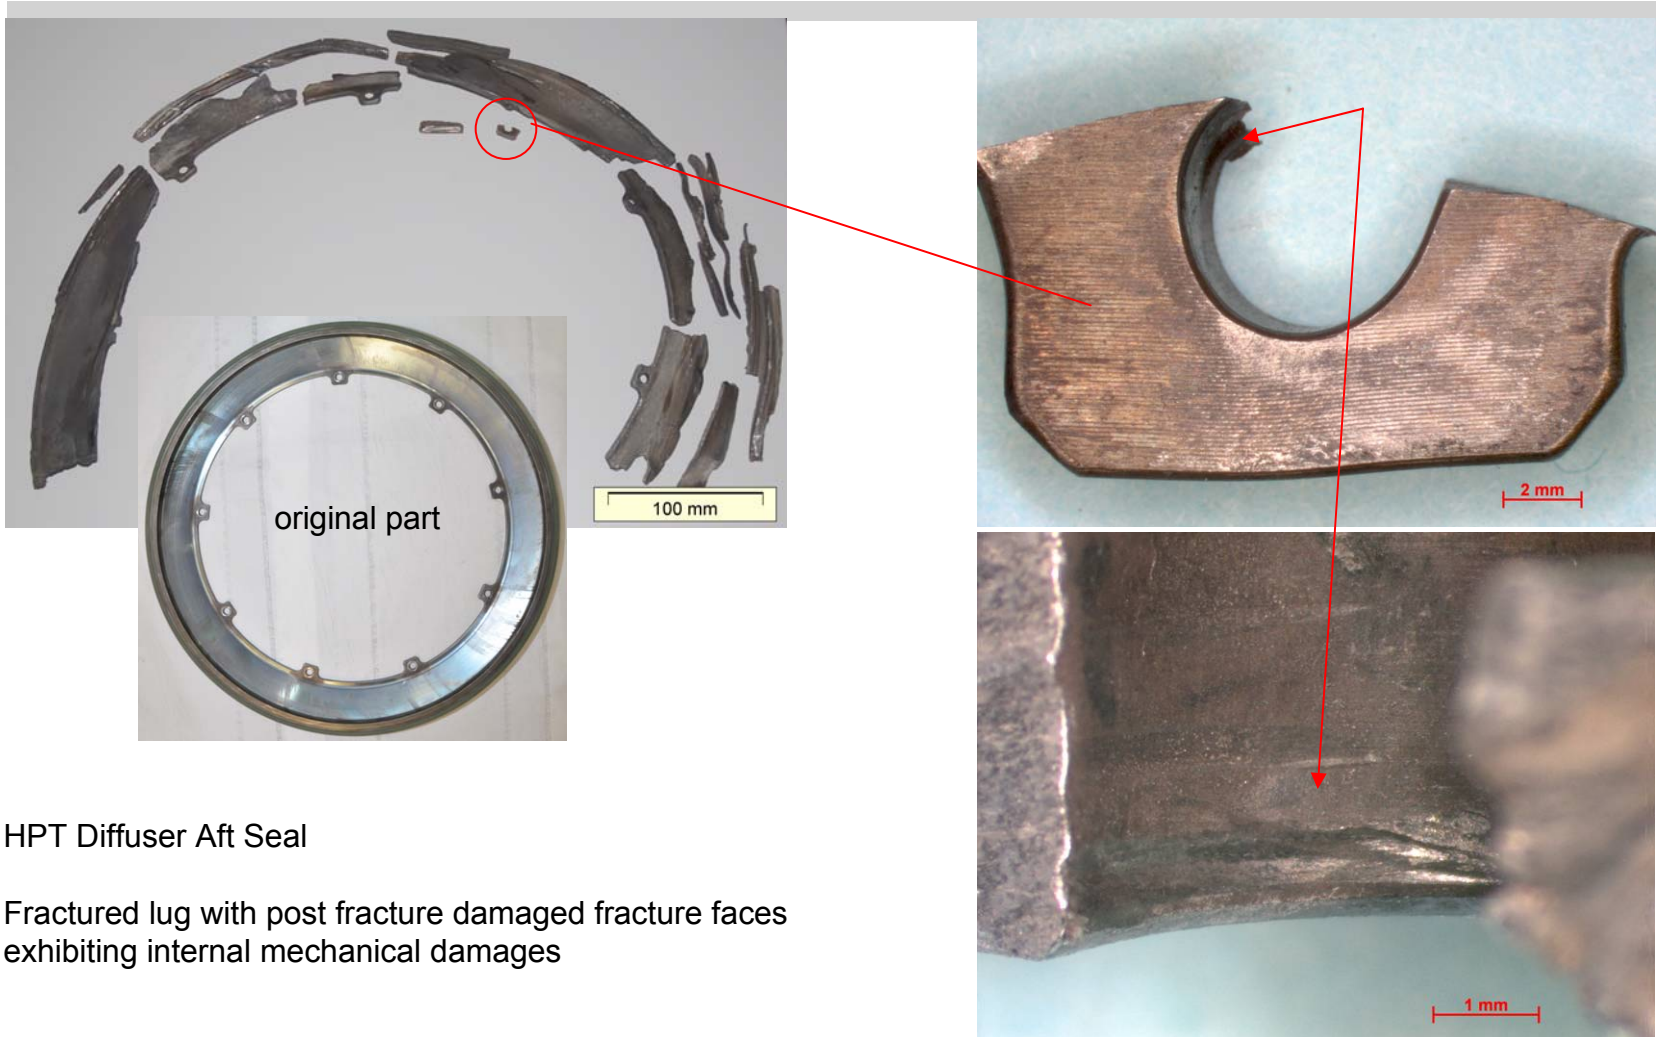
HPT Diffuser Aft Seal

Fractured lug with post fracture damaged fracture faces exhibiting internal mechanical damages

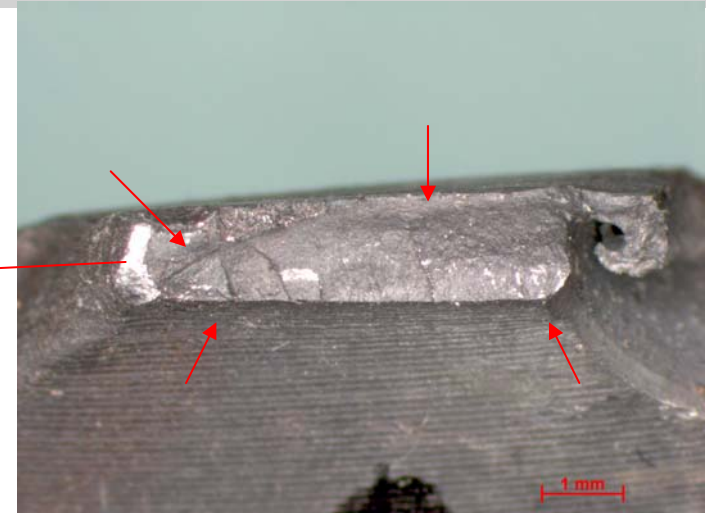
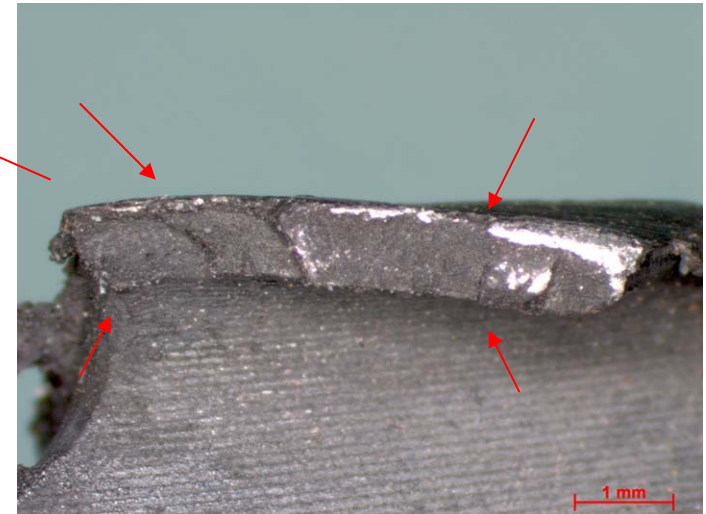
HPT Diffuser Aft Seal

Fractured lug with fatigue fracture indications

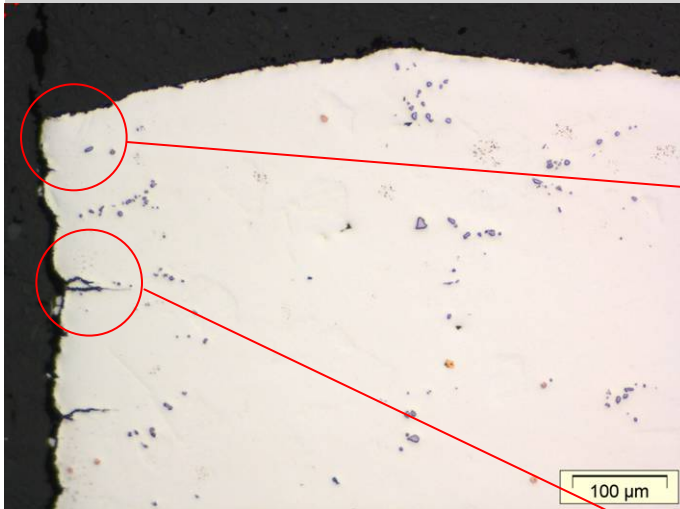
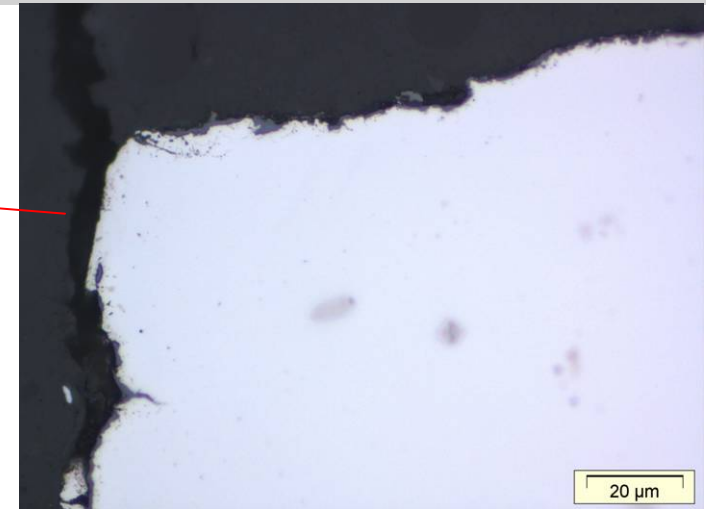
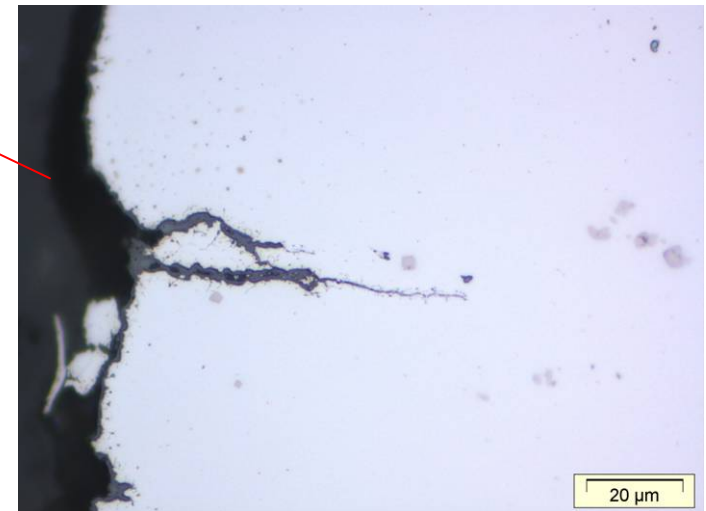
HPT Diffuser Aft Seal

Lug fracture origin exhibiting thermal fatigue and secondary thermal fatigue cracks next to fracture origin

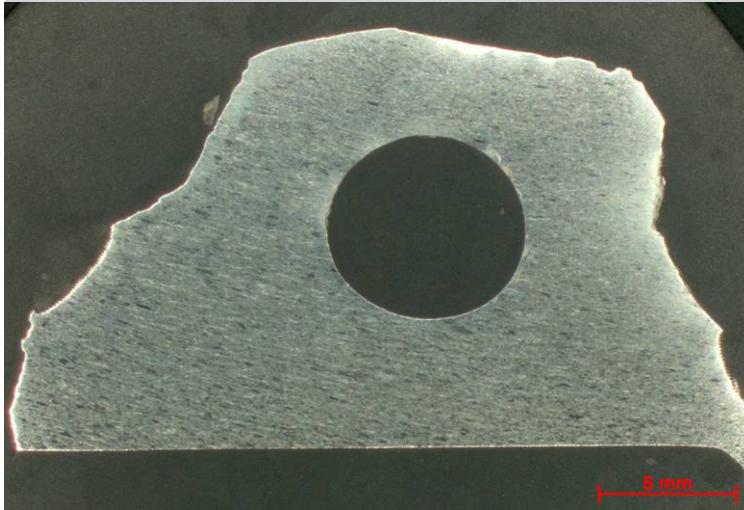
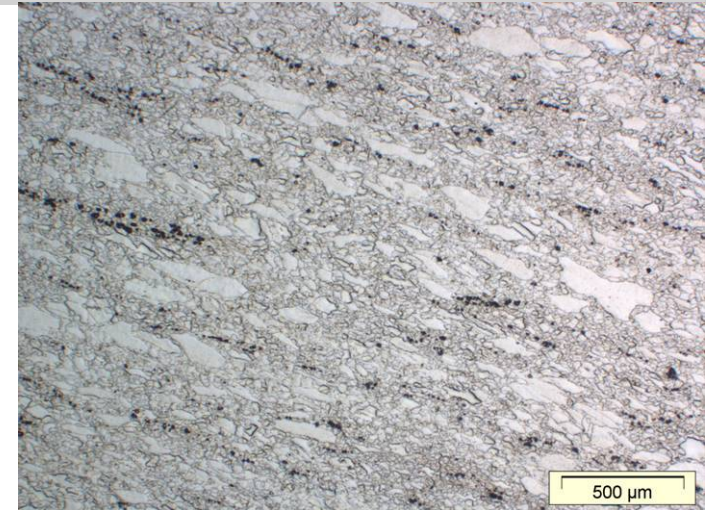
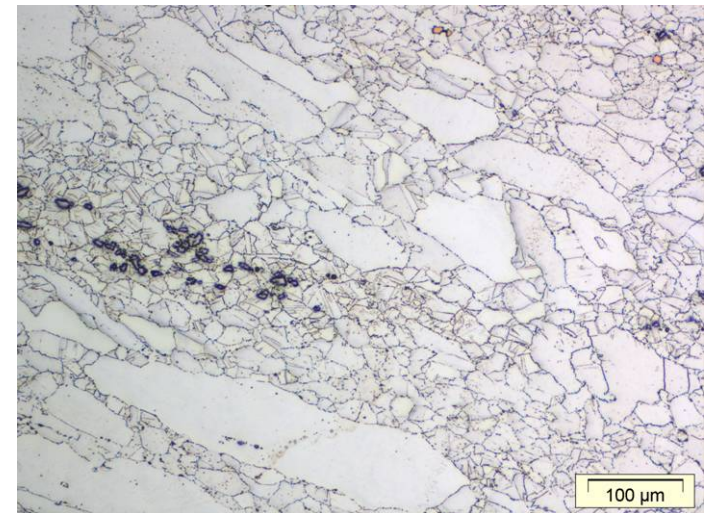
HPT Diffuser Aft Seal

Slightly ovalized seal lug (top left)  
and general microstructure (right)

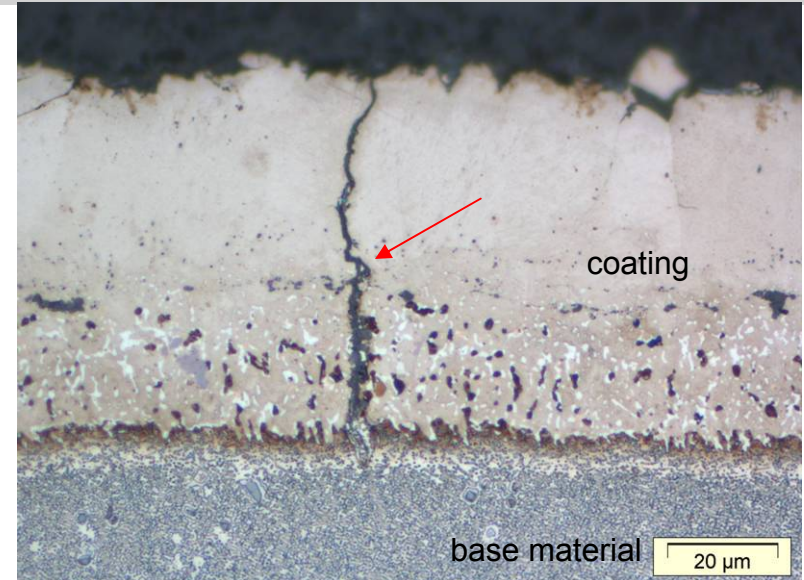
### HPT Blade

Fractured blades (top left), fracture face of blade airfoil (bottom left) and oxidized / sulfidized crack through the airfoil coating (top right)

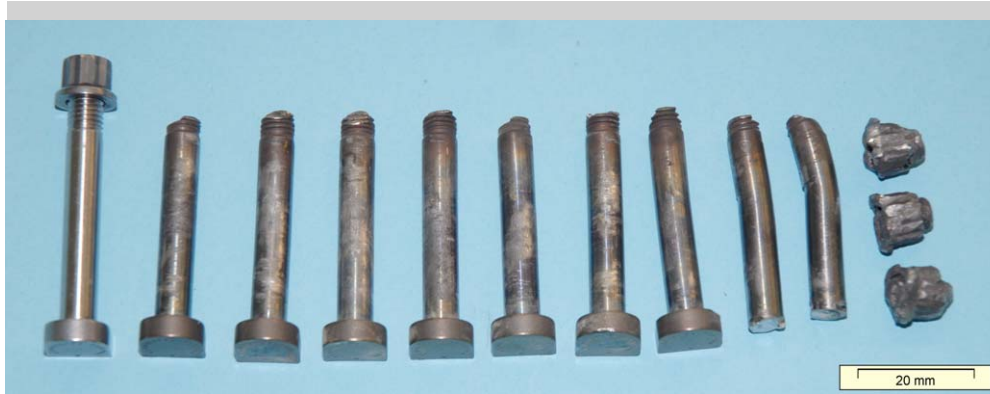
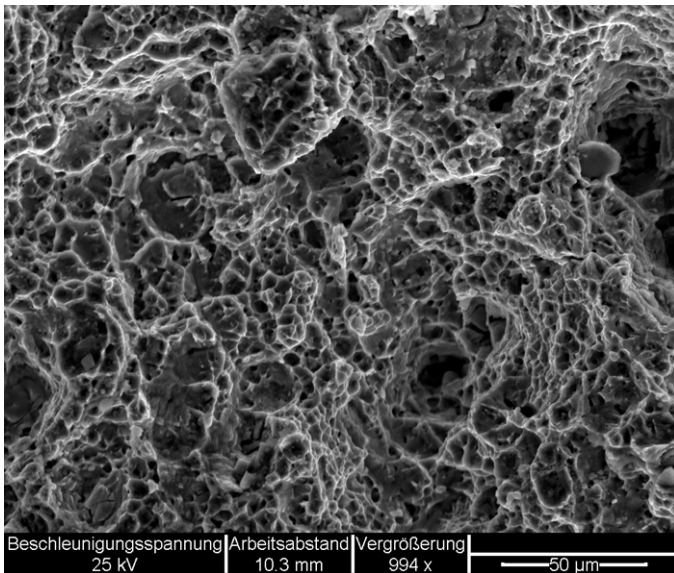
Ring Bolt

Fractured ring bolts (top), typical fracture face (top right) and SEM view depicting the ductile structure of the fracture (bottom left)

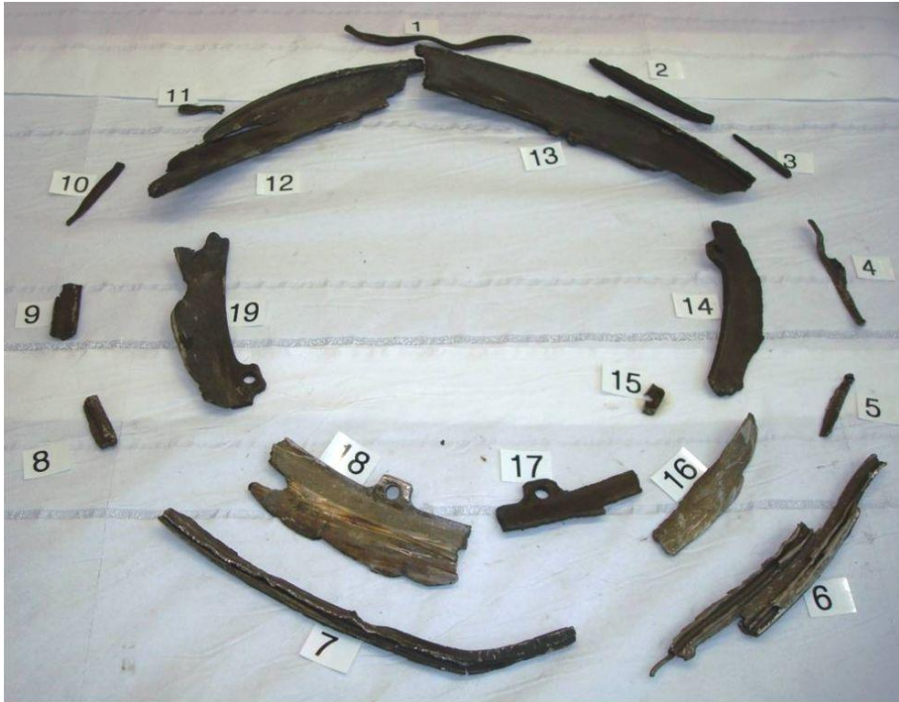
Photo No 2. LHT photo showing Diffuser Aft Seal fragments.

Pieces 4, 5, 9, 10 and 11, on photo no 2, are not believed to come from the Diffuser Aft Seal, based upon visual appearance and geometry.

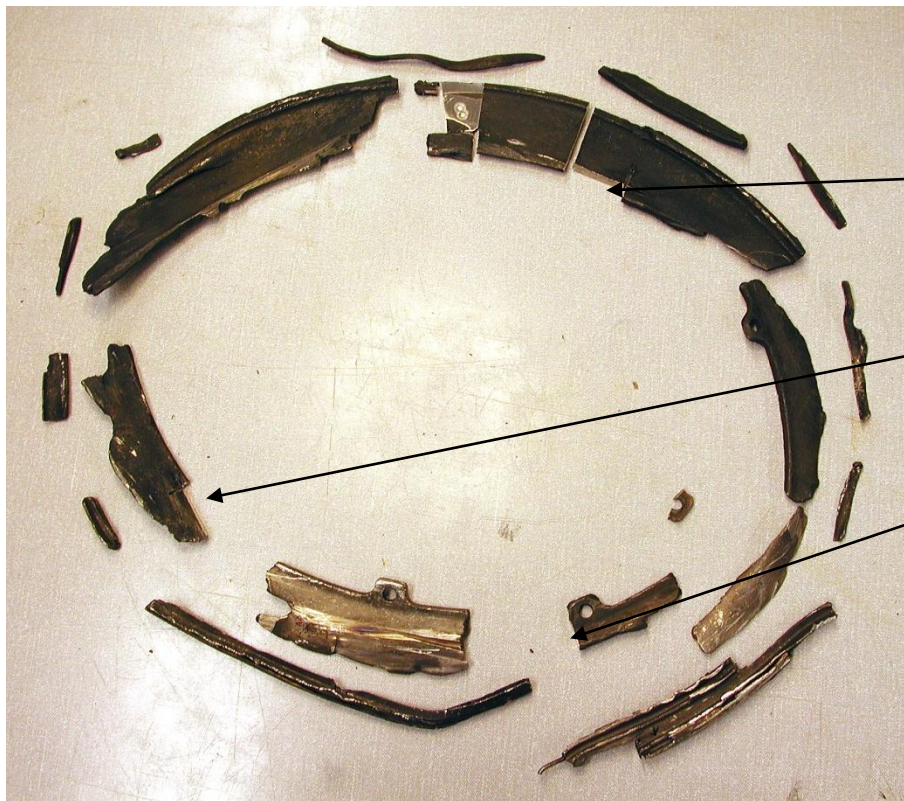
Photo No 3. All of the fragments were received. LHT have cut sections from No 13, 17 and 19.

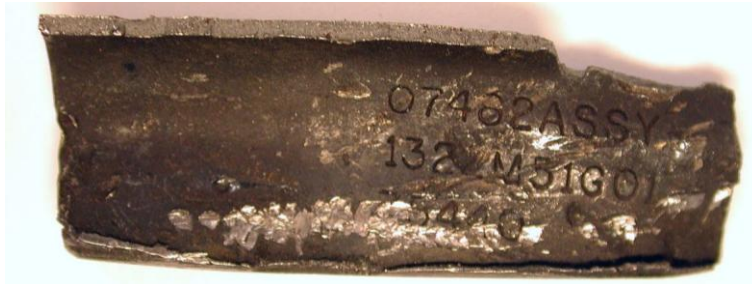
Piece No 9 is confirmed by GE Aviation to be a HPT Stage 1 Nozzle air cover baffle.

Photo No 4. Piece no 9, HPT Stage 1 Nozzle air cover baffle.

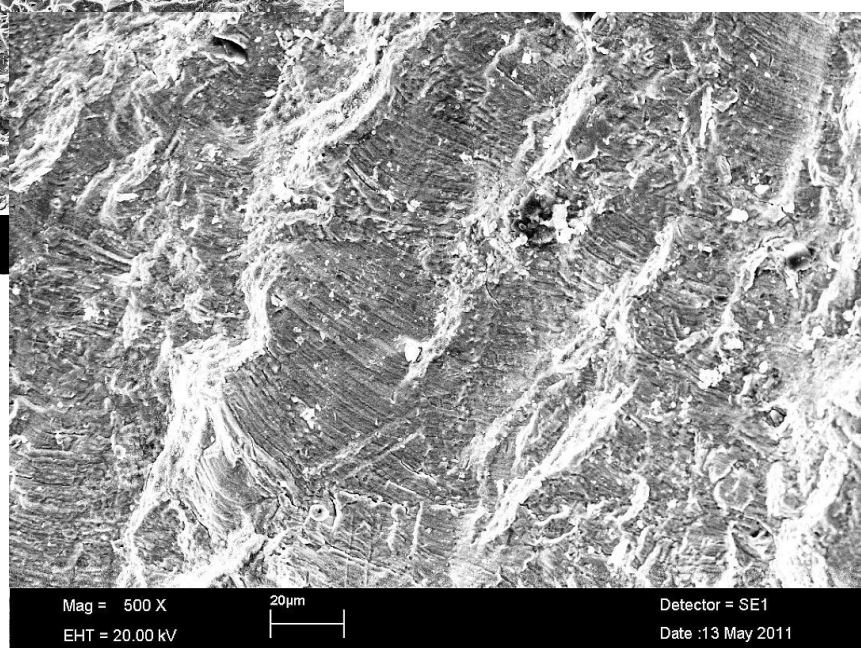
Photo No 11. Fatigue striations in a comparatively oxide free surface.

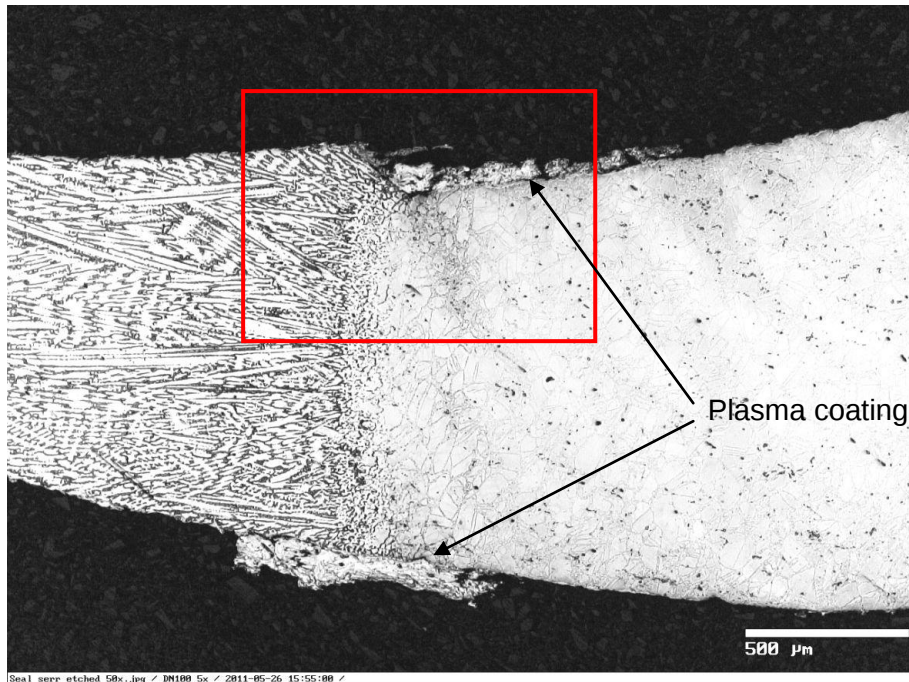
Photo No 14. Higher magnification of the dabber weld interface.

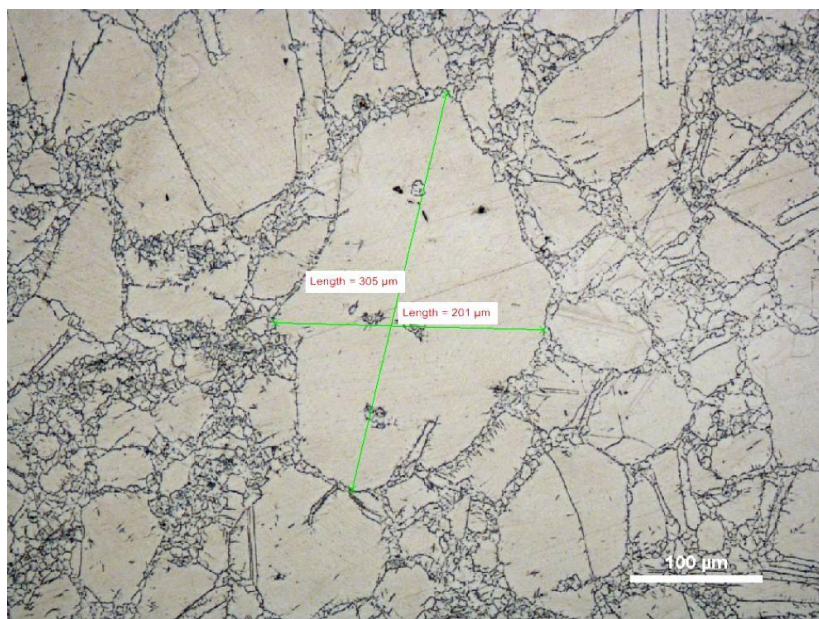
Photo No 18. The grain size of the seal tooth base material, about 3 mm from the weld interface, was evaluated per GE C50TF37 CL B per ASTM E 112.

Duplex, necklace structure is not permitted according to the requirements.  
The largest grain in photo No 18 is 0.30 x 0.20 mm which is not permitted.
