## **Report IN-010/2010**

Incident occurred on 14 May 2010, to aircraft Boeing 737-800, registration EI-DYX, operated by Ryanair during approach to Valencia Airport (LEVC), Spain

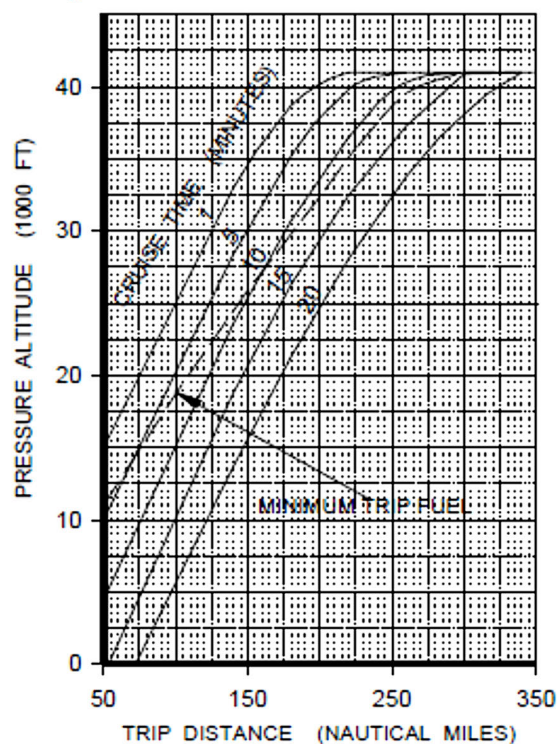
## Short Trip Cruise Altitude

Boeing's Flight Planning and Performance Manual (FPPM) includes a graph for short distances that can be used to calculate fuel consumption for short-distance flights as a function of various parameters such as weight, altitude, wind and temperature. The graph also outputs the optimal, or lowest consumption, level (see figure). For a distance of 103 NM, the minimum fuel curve corresponds to an altitude of 18,000 ft.
