**Investigation Report on the Accident to**

**Ethiopian 409 – Boeing 737-800**  
**Registration ET-ANB**  
**at**  
**Beirut - Lebanon**  
**on**  
**25<sup>th</sup> January 2010**

***Presented by the IIC on 17<sup>th</sup> January 2012***

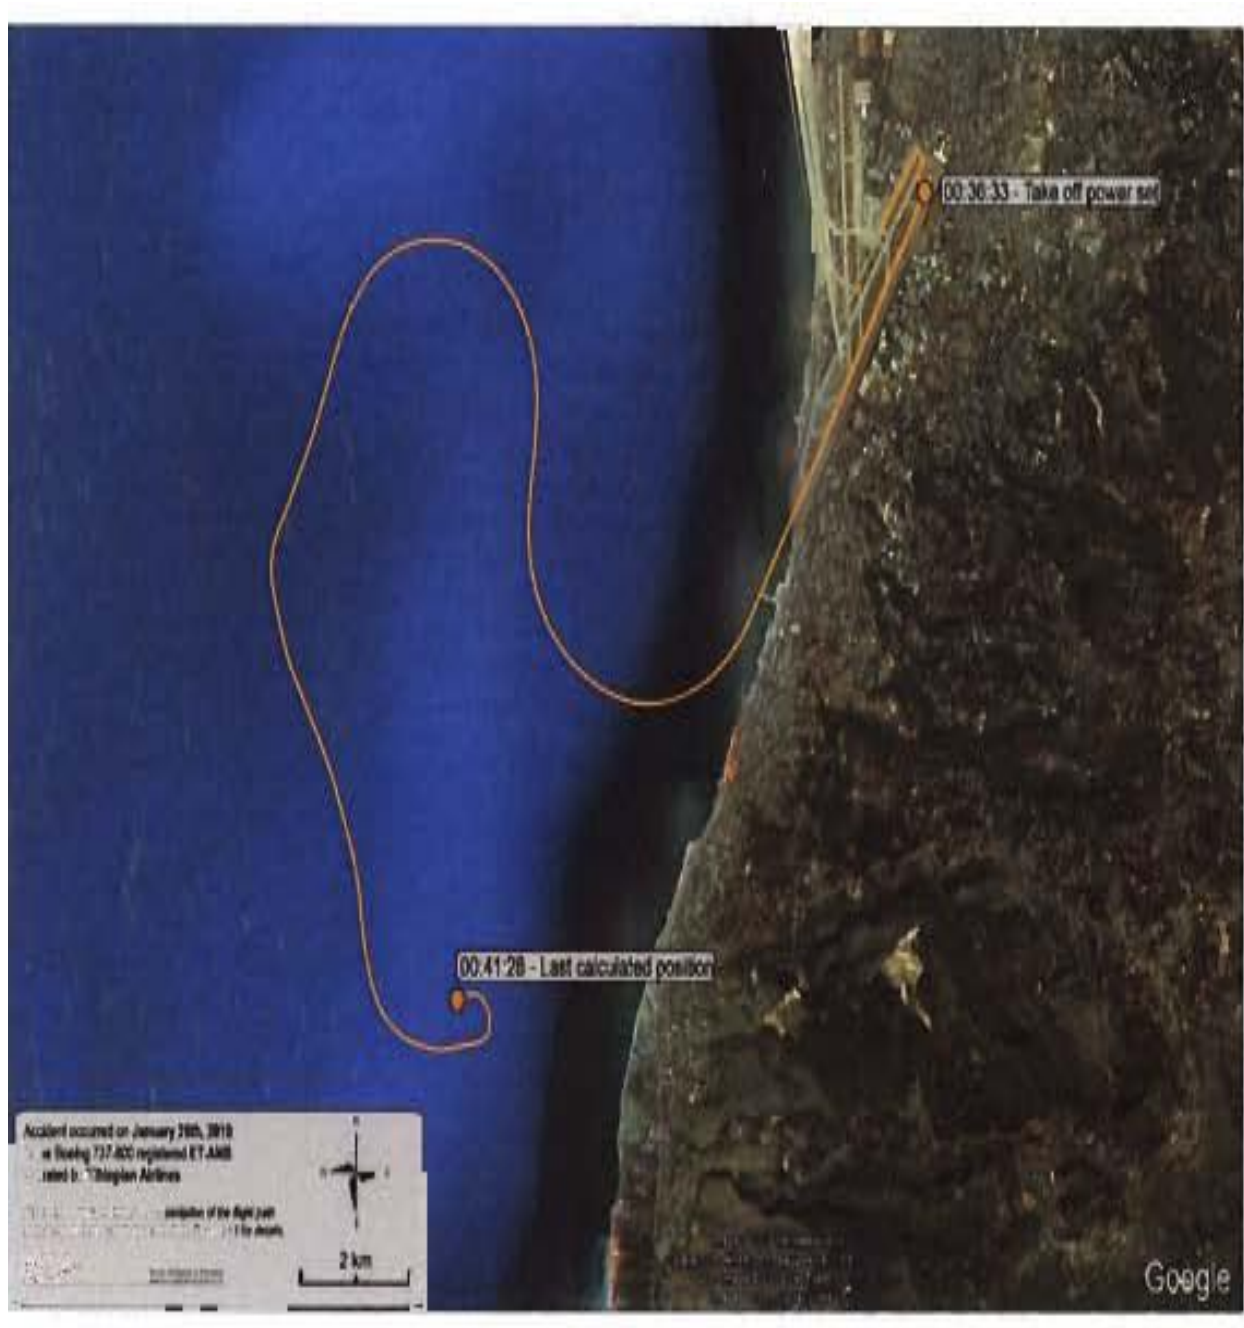
**Figure 1: ET 409 horizontal tracks**

The following two figures developed by the French Bureau d'Enquêtes et d'Analyses (BEA) reproduce the entire flight horizontal and vertical tracks as derived from the DFDR data:

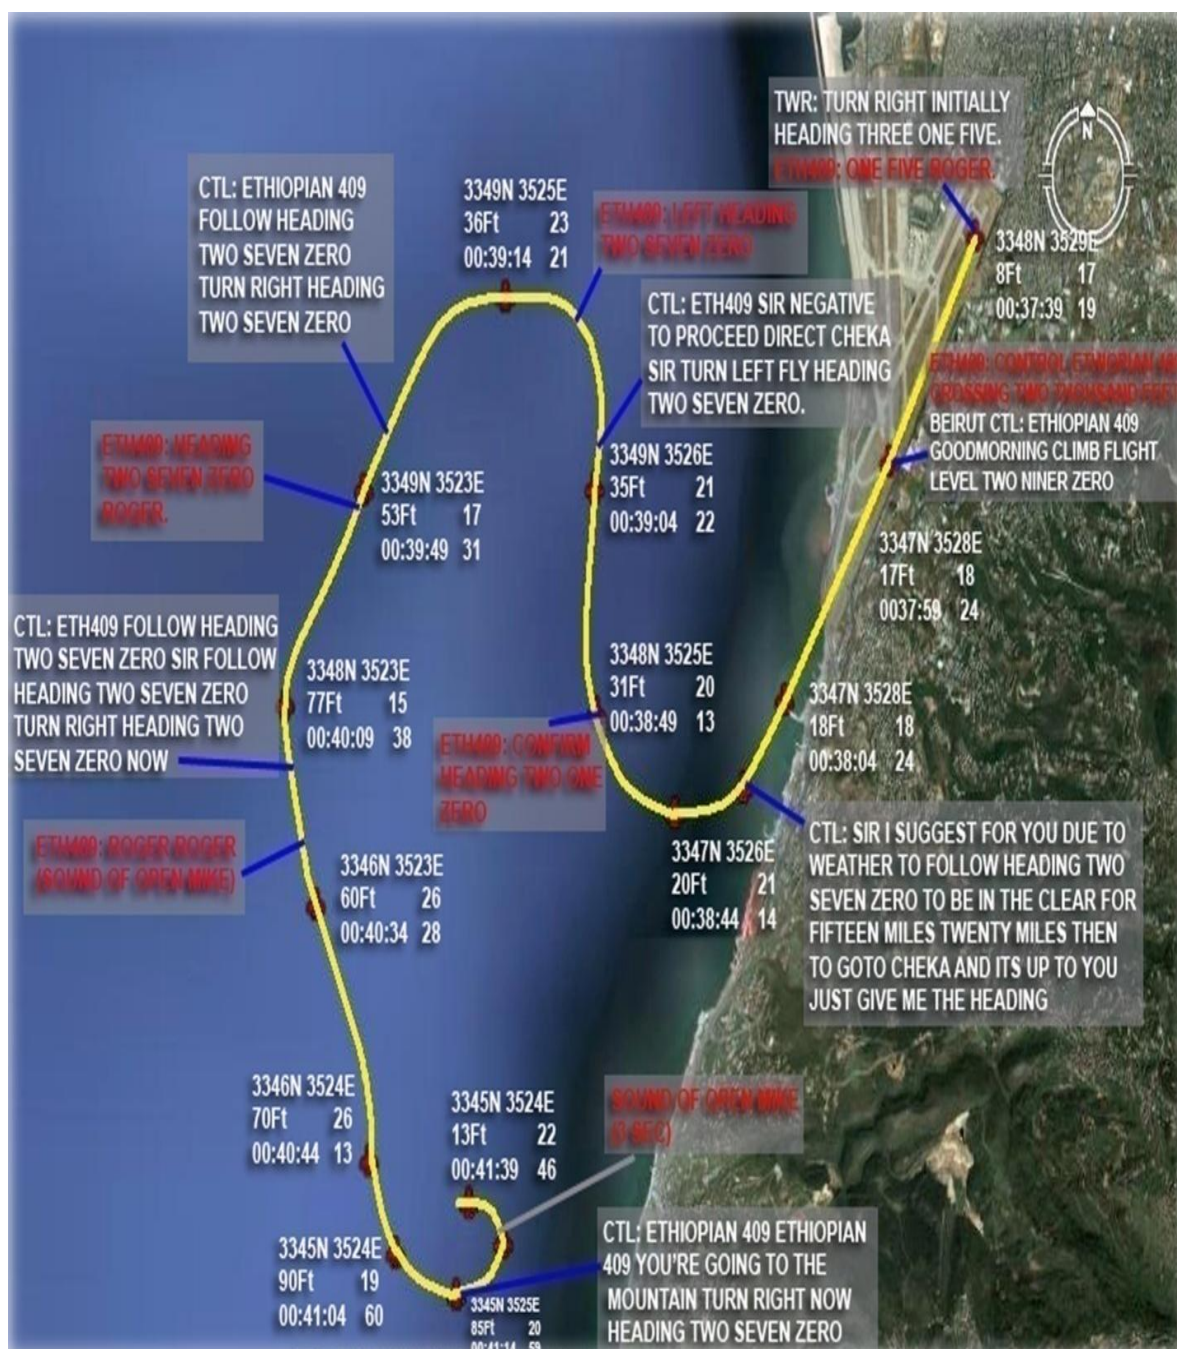
**Figure 10: ET 409 Radar Tracks with ATC transcripts**

Prior to the retrieval of the CVR and DFDR data, a reconstruction of ET flight path was carried out by the Lebanese CAA IT technician in synchronization with the ATC transcript data. This is shown in figure 10 below.

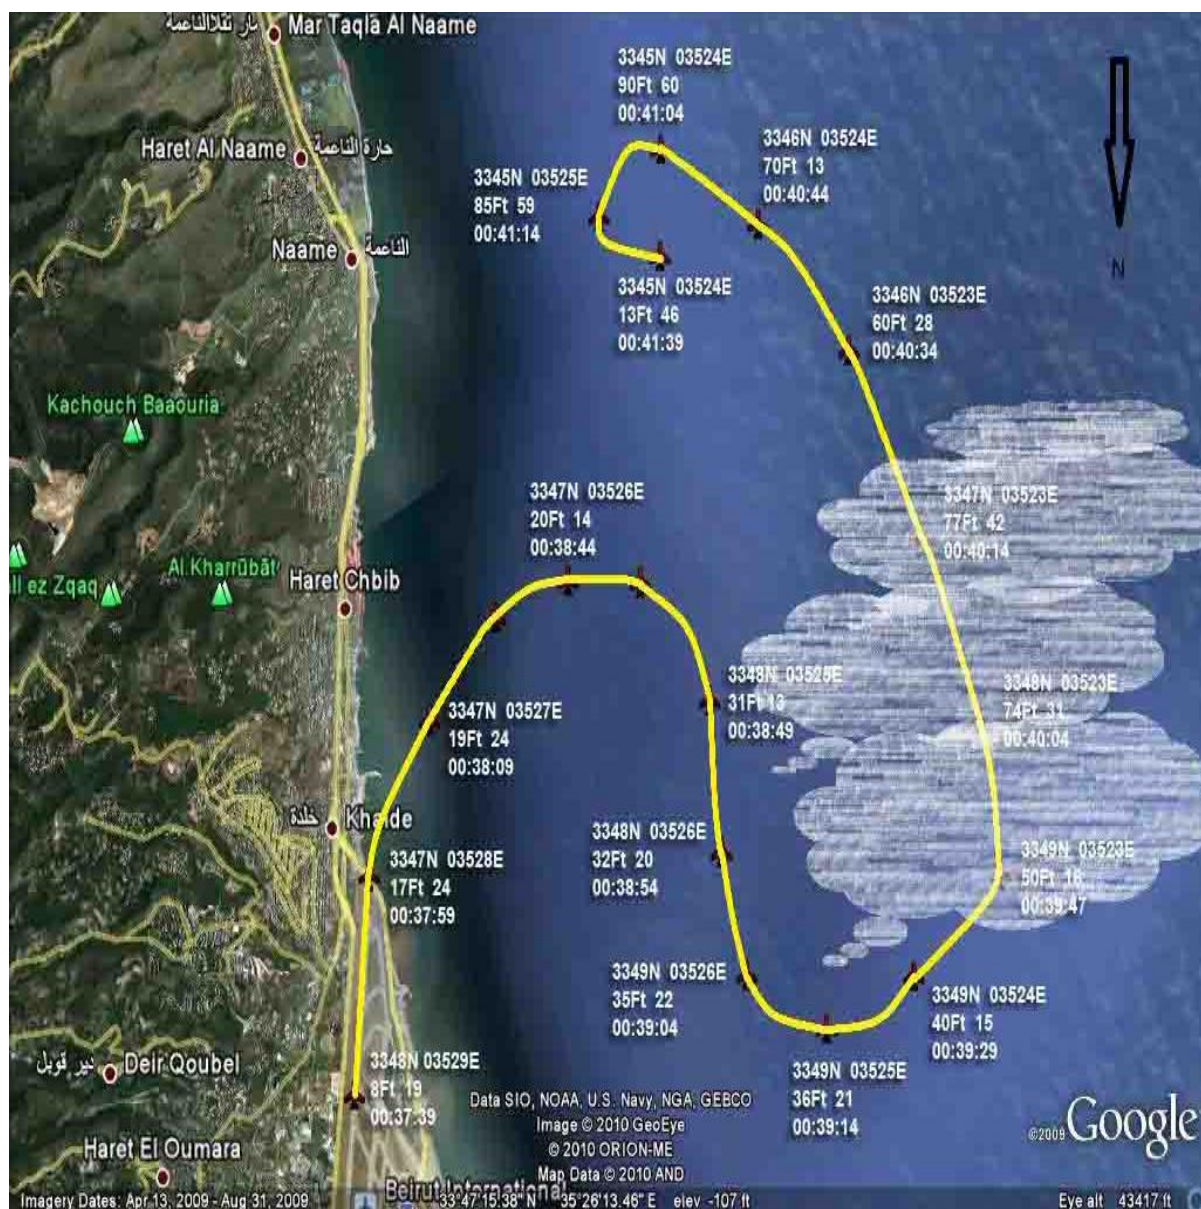
**Figure 11: ET 409 Radar Tracks with cloud information**

Further reconstruction of ET flight path was later on carried out by the Lebanese CAA IT technician in synchronization with the meteorological office at BRHIA and the ATC weather data. This is shown in figure 11 below.

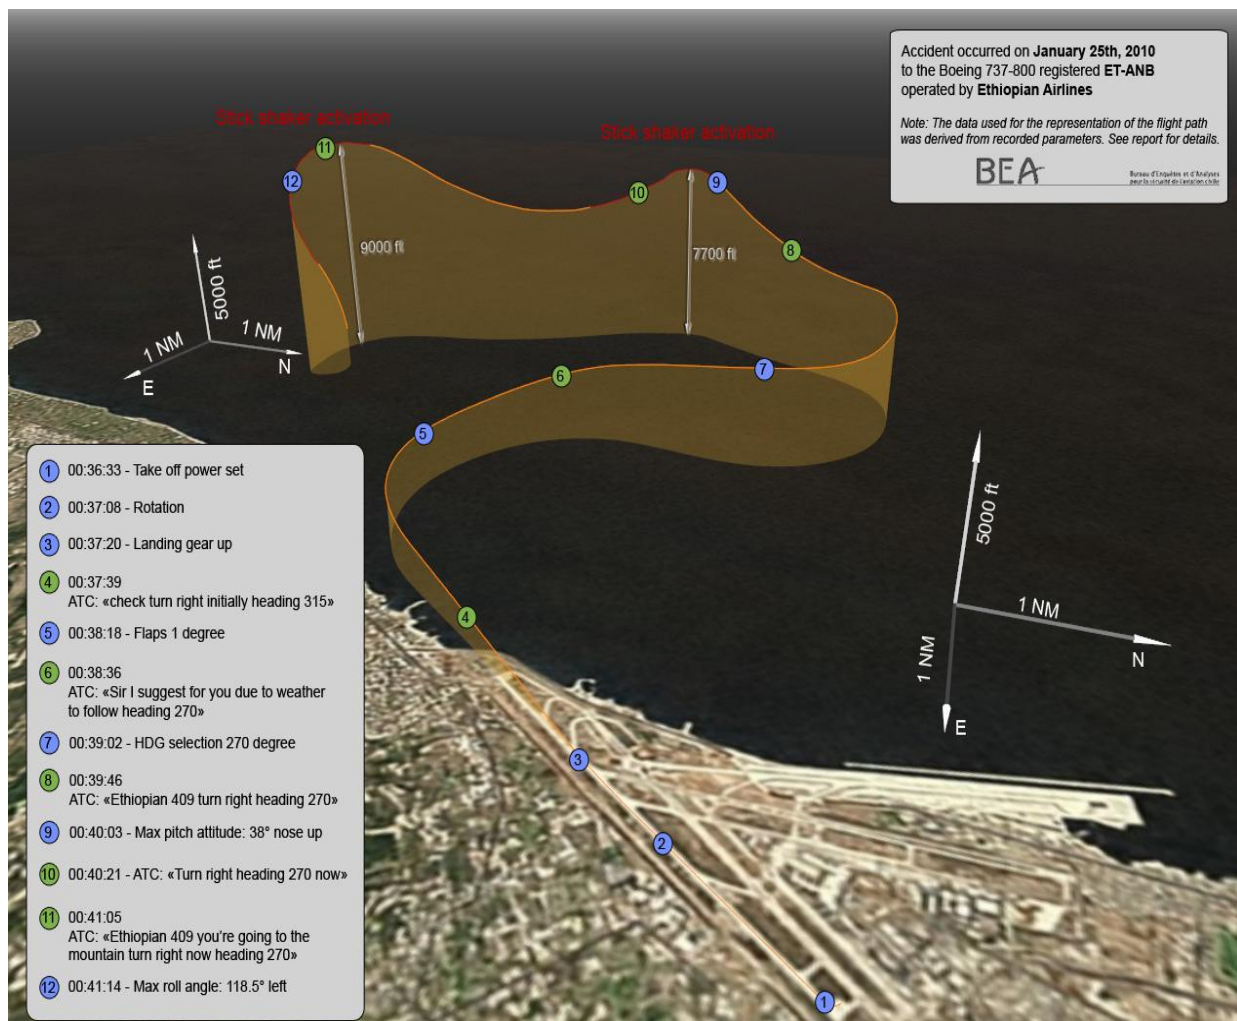
A reconstruction of ET horizontal and vertical track were developed by the BEA based on the data retrieved from the DFDR recording. These reconstructions are incorporated as Figure 1 and Figure 2 of this report. The following Figure 12 reproduces in 3D the flight profile associated with the major events points.

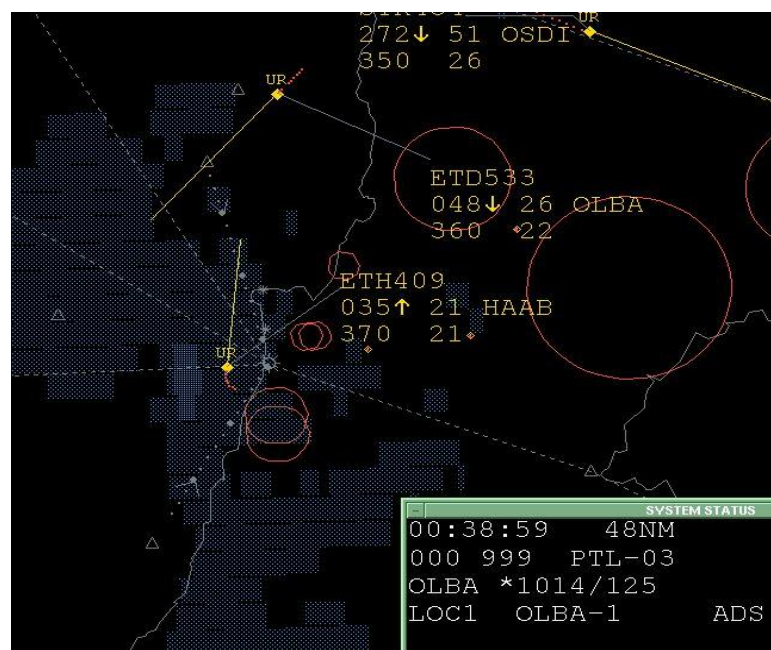
**Figure 16: Radar Snapshot at 00:38:59**

Therefore the ATC controller who thought that the aircraft, which was now more than 45° right of the cleared to heading, had misunderstood the Tower amended clearance to fly heading 315° v/s fly direct Chekka. So he immediately issued a clearance to turn left heading 270°, which was acknowledged by the crew. Figure 16 below reproduces the snapshot of the radar picture displayed in front of the controller when the aircraft reached a heading of 003°. The captain was heard on the CVR reading back in the cockpit the correct heading and the F/O was recorded setting it on the MCP and confirming his action as per the SOP call-out.

Beyond that point, the ATC controller was unaware of the problems the crew had to control the aircraft, especially that no particular call indicating such difficulties was received, and all the clearances issued to the crew were read back in a calm and relaxed voice, with the exception of the last non-standard “roger, roger” call back transmitted by the F/O one minute prior to the crash and the open microphone sound he got as a reply to the last instruction the flight crew could have heard around 20” prior to the crash.

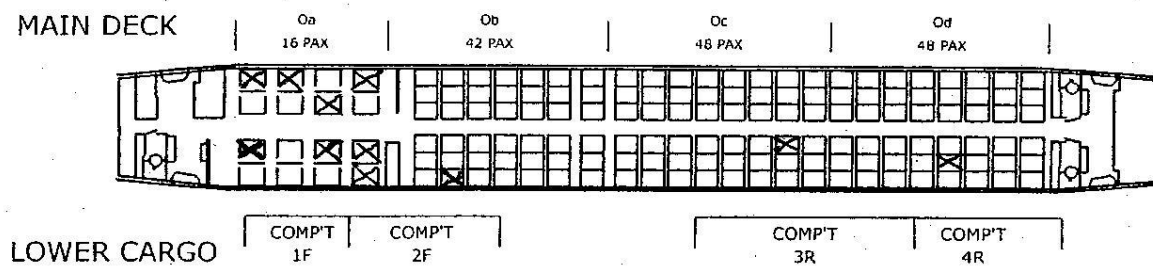
**Figure 18: Airplane Map**

**N.B.** Seats marked with an X are the seats were of the passengers whose bodies were recovered on day 1. Two out of these passengers were children under 5 years of age.

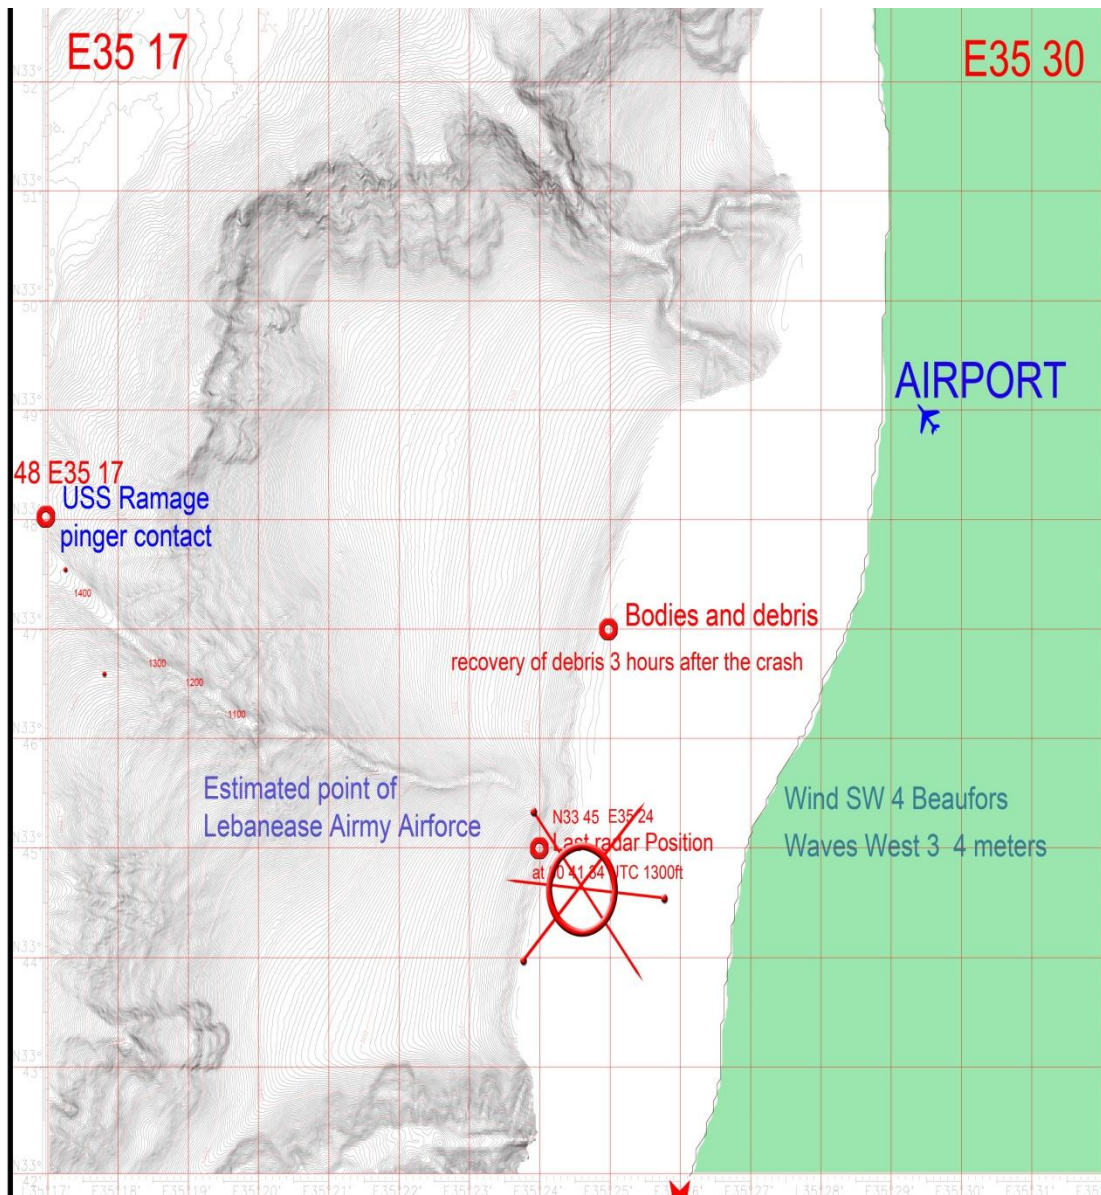
Attachment IV: Location nn of DFDR v/s Pinger Signal received by the USS Ramage

Finally, the controversy created by the signal picked by the USS Ramage was the result of the presence of a sea valley between the point where that signal was picked up and the point which was identified later by the French experts and where the wreckage was found. That allowed the sonar equipment on the USS Ramage to pick a signal which was 10 Km away through an adjusted sonar equipment (refer to Attachment IV).
