**AIRCRAFT ACCIDENT REPORT 2/2013**

**ACCIDENT INVESTIGATION DIVISION**

**Report on the accident to Airbus A330-342  
B-HLL operated by Cathay Pacific Airways Limited  
at Hong Kong International Airport, Hong Kong  
on 13 April 2010**

**Hong Kong  
July 2013**

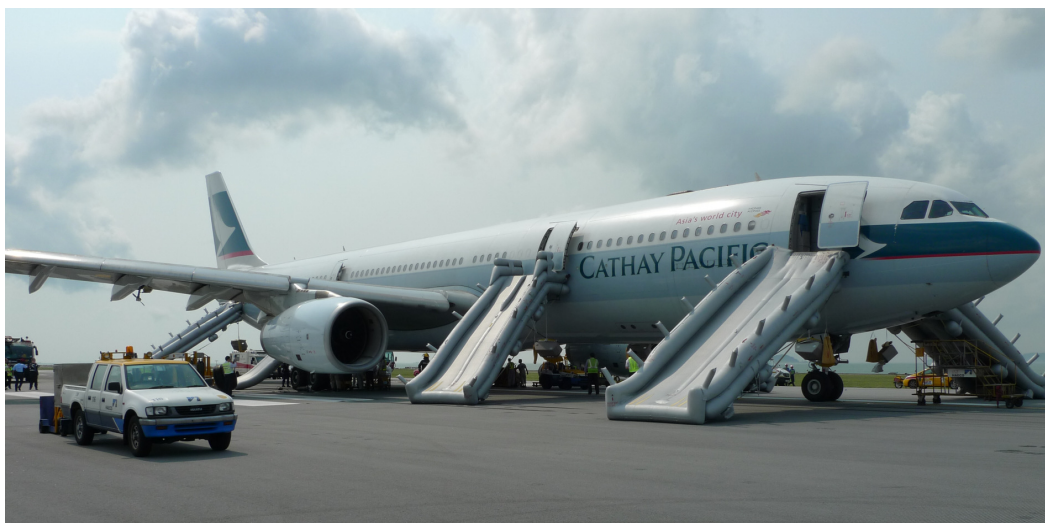
e. All eight emergency exits doors were used after the cabin crew had confirmed the absence of fire or smoke outside the exits. Exit doors L1, R1 and R4 were each attended by two cabin crew members, and the remaining five exit doors were each attended by one cabin crew member. Some passengers took their cabin bags along and did not follow the cabin crews' instruction to leave their bags behind before jumping onto the slides. The whole evacuation was completed in about two mins and 15 seconds. The Commander, the co-pilot and the ISM walked through the cabin to make sure there was no one left inside the aircraft before they left.

**Figure 2: All Emergency Evacuation Slides were deployed**

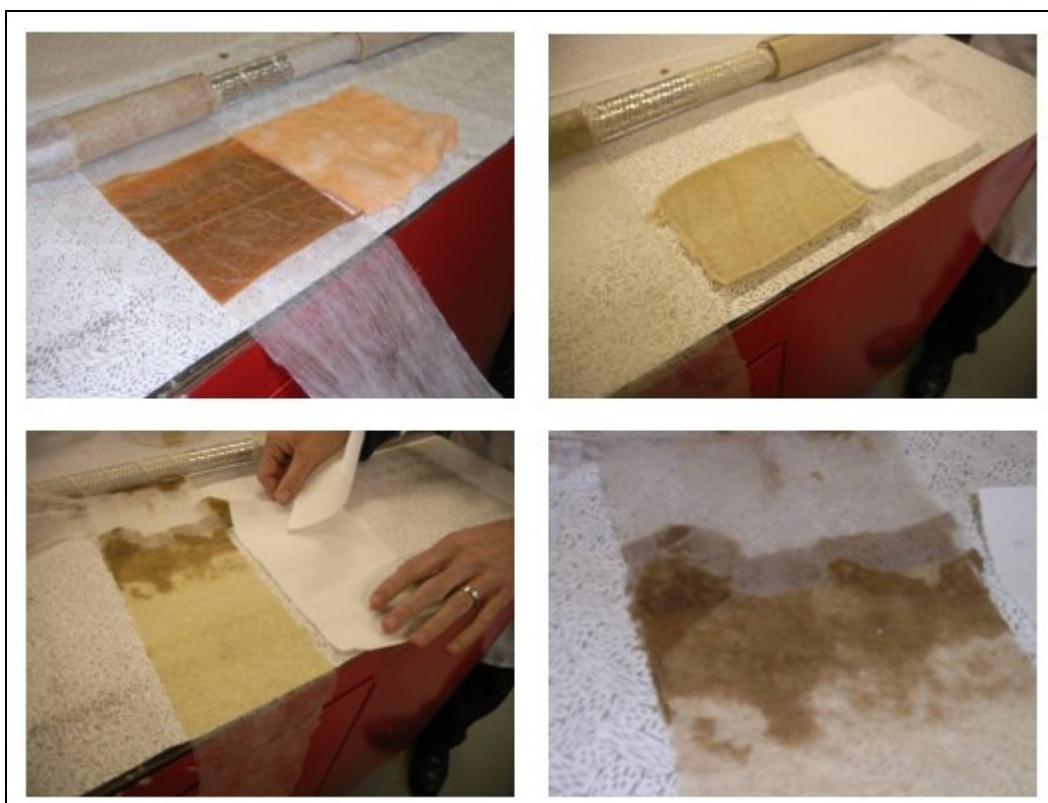
**Figure 32: Dissecting one of the event filter monitors**

d. Examination of the dissected filter monitors revealed that the construction of the accident filter monitors was identical in terms of media type to a recently manufactured element, and that the SAP layers had been exposed to water. There was very little evidence of dirt trapped in the media layers. Isolated SAP spheres were found in one filter monitor (see Figure 33). No SAP sphere was identified in the new pristine filter monitor when it was dissected and examined by using similar technique.

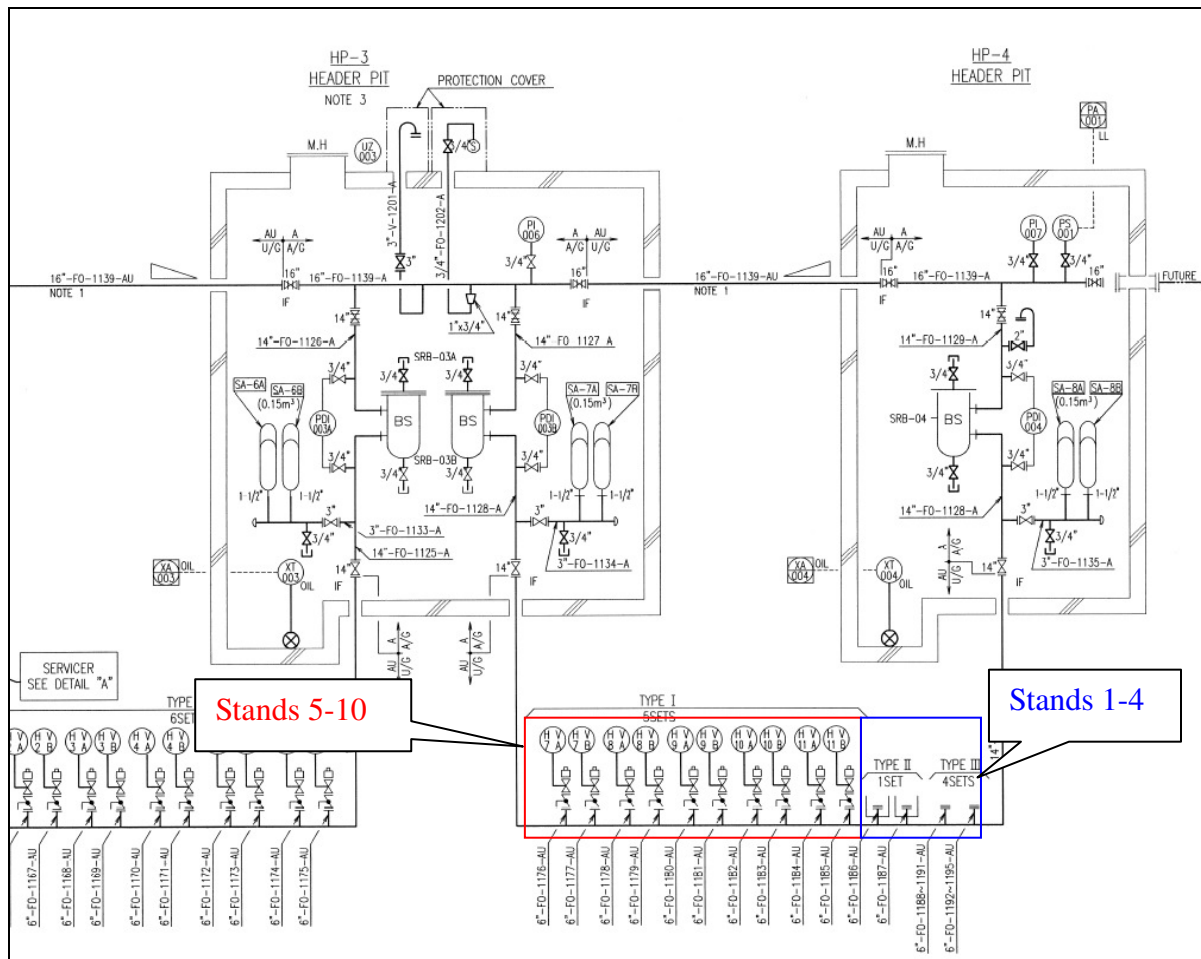
a. The WARR facility at the time of the accident was constructed under Surabaya Airport Construction Project and opened in 2006. The fuel hydrant system was part of the project. The specification of the project was detailed in the 2001 contract document (No. LN/130/2001), including the fuel hydrant system, which was detailed in drawing reference U-AD-FS-GFU-000. The hydrant for parking Stand No. 8 where the accident aircraft had the fuel uplifted was part of an “into-plane” refuelling ring circuit that supplies fuel to Stands No. 1 to No. 10. In 2006, only Stands No. 5 to No. 10 were opened as operational parking stands. A piece of vacant grass land adjacent to the operational stands was reserved to be the future locations of Stands No. 1 to No. 4. The hydrant refuelling circuit layout of WARR is shown in *Appendix 13* and the portion affected by the extension work is highlighted in Figure 51 below.

**Figure 51: WARR hydrant refuelling circuit before the Extension Work**

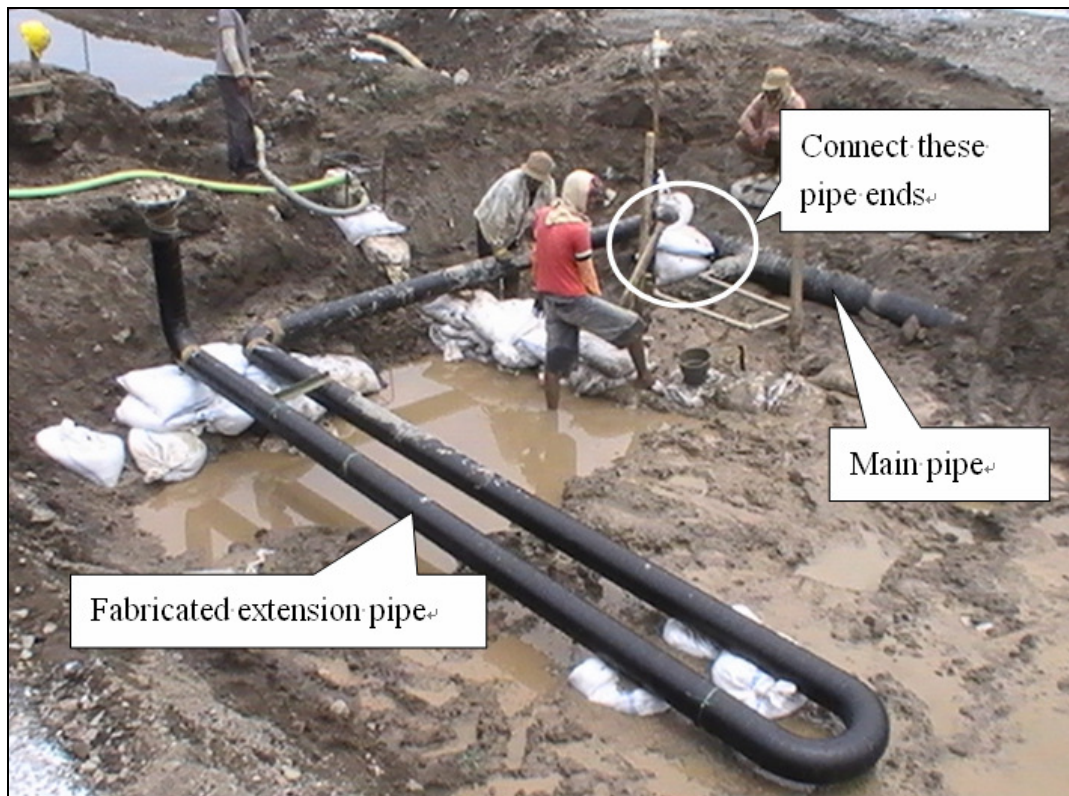
**b.** Before the "tie-in", the affected hydrant circuit was isolated and emptied to prepare for the connection of the extension pipe. During "tie-in" process, a fabricated 6" diameter extension pipe was transferred to the site on the day of connection. For each of the eight connections, the existing 6" diameter end pipe fitted onto the 14" diameter distribution pipe was cut open by hand sawing. The open end was blanked to be air tight with a "cap seal", and a "gas free" test of the open end was performed. The edge of the 6" pipe opening was grounded to create a bevel edge for subsequent joining by electric arc welding. The interior was swab cleaned by canvas or leather ball per specification. The fabricated extension pipe was then positioned and welded to the 6" diameter end pipe. According to the contractor, this "tie-in" process usually took 3 to 4 hours to complete. From the photos taken during the "tie-in" process (Figure 54), the work site was in a recess with water puddles, probably caused by recent rainfall, and with a drain pump to remove the water puddles in the work area.

**Figure 54: The tie-in process to connect the fabricated extension pipe to the main distribution pipe**
