## **AIR ACCIDENT INVESTIGATION SECTOR**

## **AIR ACCIDENT INVESTIGATION REPORT**

**Uncontained Cargo Fire Leading to Loss of Control  
Inflight and Uncontrolled Descent Into Terrain**

Boeing 747-44AF  
N571UP  
Dubai  
United Arab Emirates  
03 September 2010

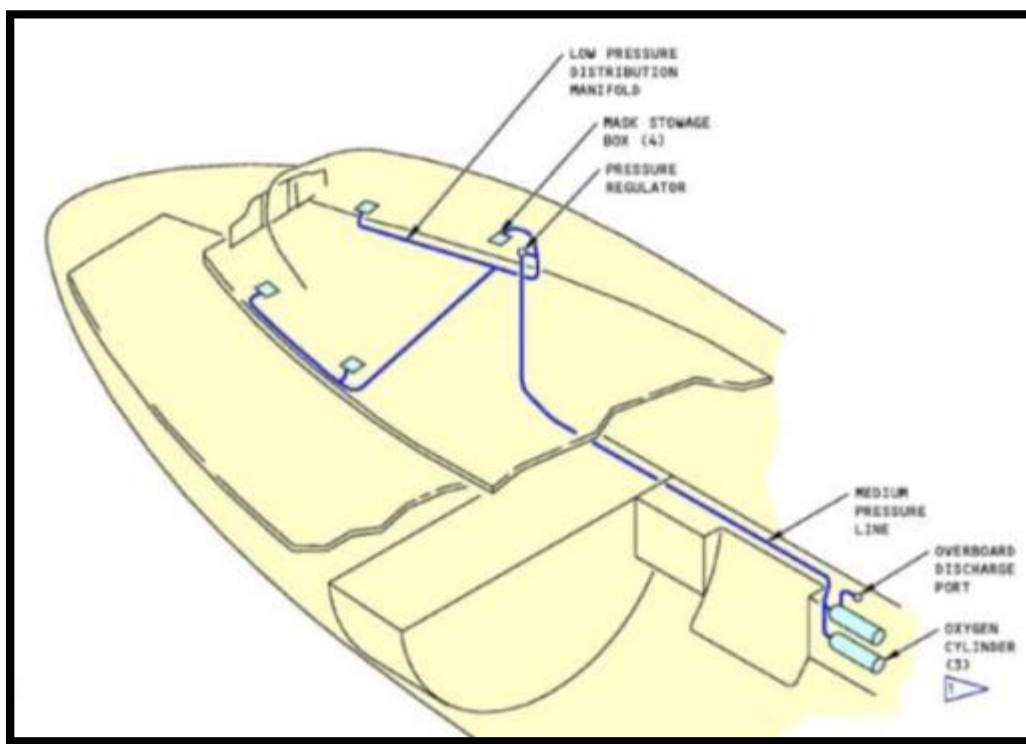
Figure 9 Crew Oxygen Bottle Location

The frangible disc safety release device will rupture when the bottle pressure is between 2500 and 2775 psig. This will allow the oxygen to escape into an overboard discharge line, emptying the bottle. Boeing estimated that this will occur if the bottle exceeds 94°C/ 200°F for a full bottle described above.

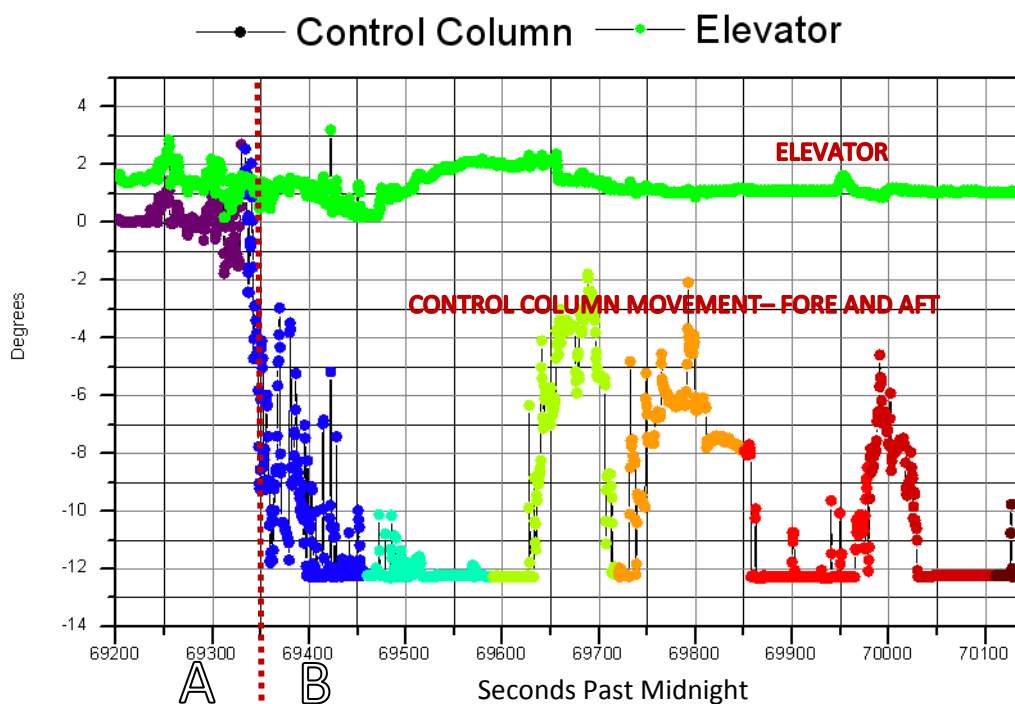
Figure 18 control synchronization/desynchronisation

The PF made a series of pitch inputs which had a limited effect on the descent profile; the descent is arrested temporarily. There then followed a series of rapid pitch oscillations. These were not phugoid oscillations, these were commanded responses where the elevator effectiveness decreased rapidly as the airspeed decayed and the elevators could not compensate for the reduced thrust moment from the engines to maintain level flight in a steady state. This was due to the desynchronisation of the control column inputs and the elevators.

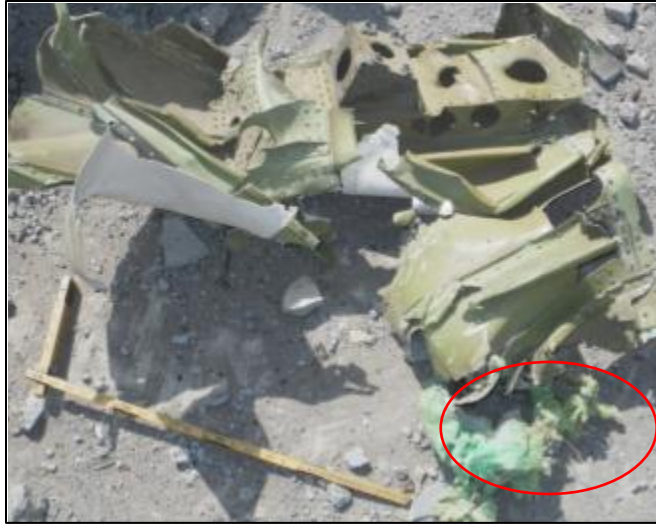
Photo 14 Portion of nose door (upper)

This portion of nose door was from the upper portion of the door on the left hand side approximately between stations 160 to 200. This piece exhibited some localized discoloration of primer shown circled above.

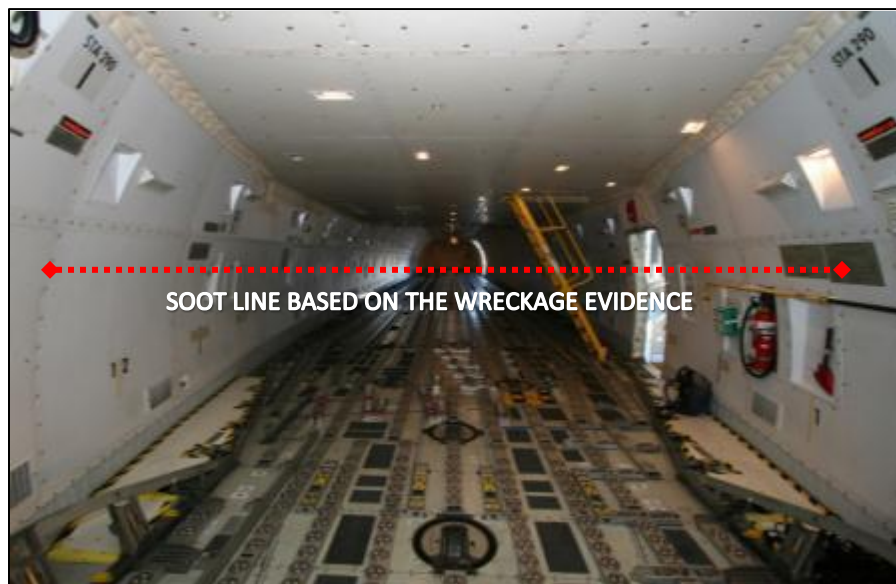
The demarcation of sooting on the stairs suggests a smoke layer extending to the height shown by the dotted line in photo 17 below.

Photo 17 Exemplar interior showing stairs to the flight deck and a dotted line showing the level of the smoke layer

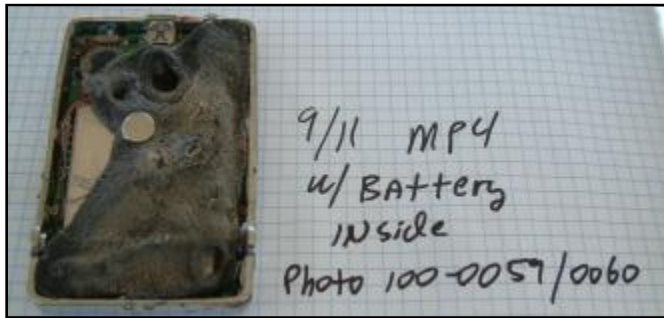
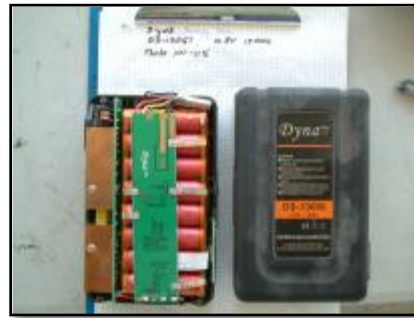
Personal electronic device with battery inside [LH]/Lithium-ion battery pack [RH]

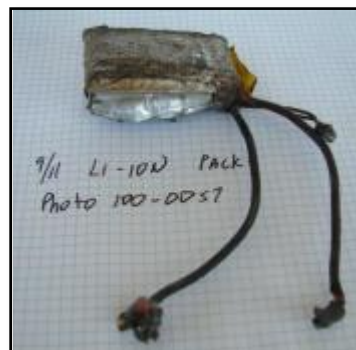
Lithium-ion battery packs - LH and RH

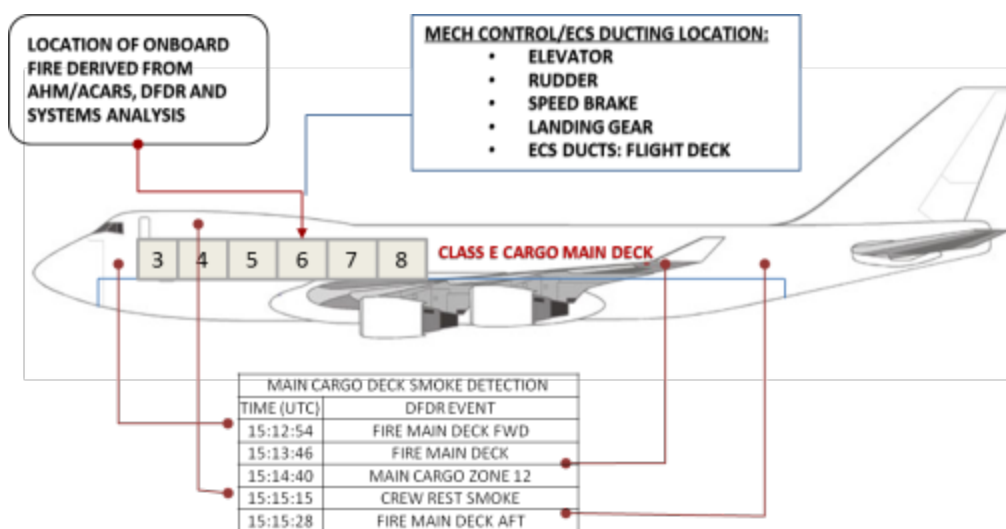
Figure 28 Fire Warning - Crew Alerts

As detailed in other sections of this report, a cargo fire originating on the main cargo deck breached the cargo compartment liner, severely damaging the control cable support trusses, oxygen system and other essential systems impairing the ability of the crew to safely operate the aircraft for the duration of the flight from the time of the first fire indication.

Due to the cargo compartment liner failing to operate as an effective fire and smoke barrier, the supernumerary and cockpit areas filled with continuous smoke. The smoke did not abate for the duration of the emergency.

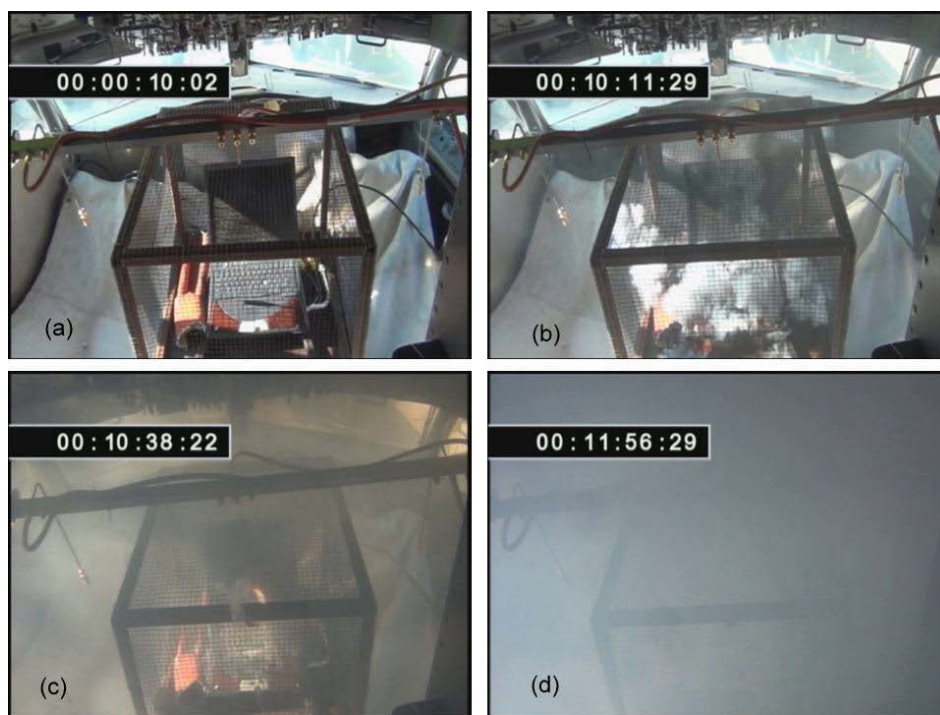
Picture 5 - Loss of pilot vision - ensuring pilot vision in the presences of continuous smoke.

In this accident, the smoke was continuous and of sufficient density and rate of flow to prevent viewing the flight displays, radios panels and the view outside the cockpit.

As an indication of the smoke in the cockpit problem, the pictures below are of an FAA test of an EFB1/Laptop battery fire. The test is a good indication of the lack of visibility encountered when a cockpit is full or filling with smoke.<sup>59</sup>

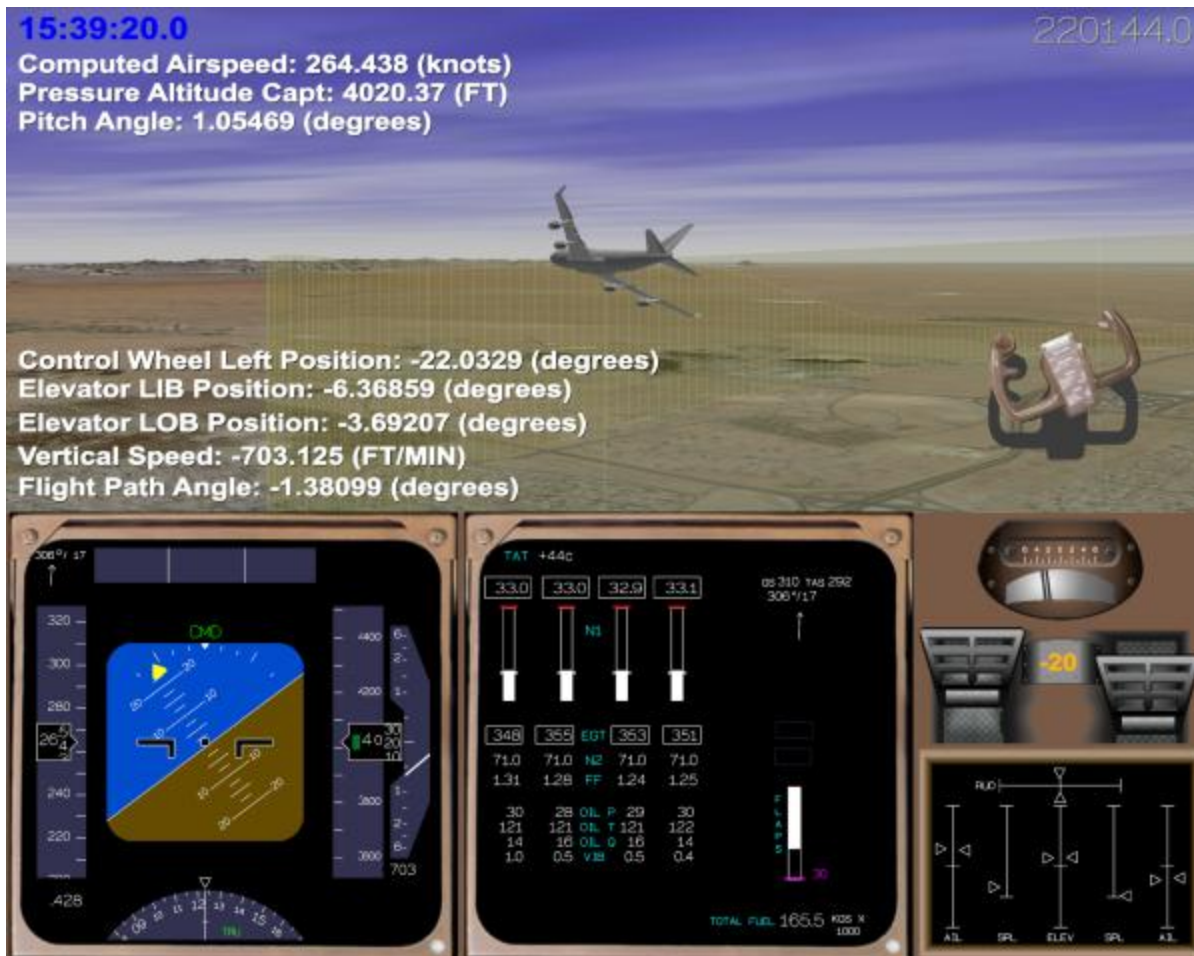
Figure 43 - GPWS: Bank Angle Warning - 15:39:19 UTC

The aircraft rolls rapidly to acquire the new selected heading, reaching a max right bank angle of 37.5 degrees, before rolling wings level.

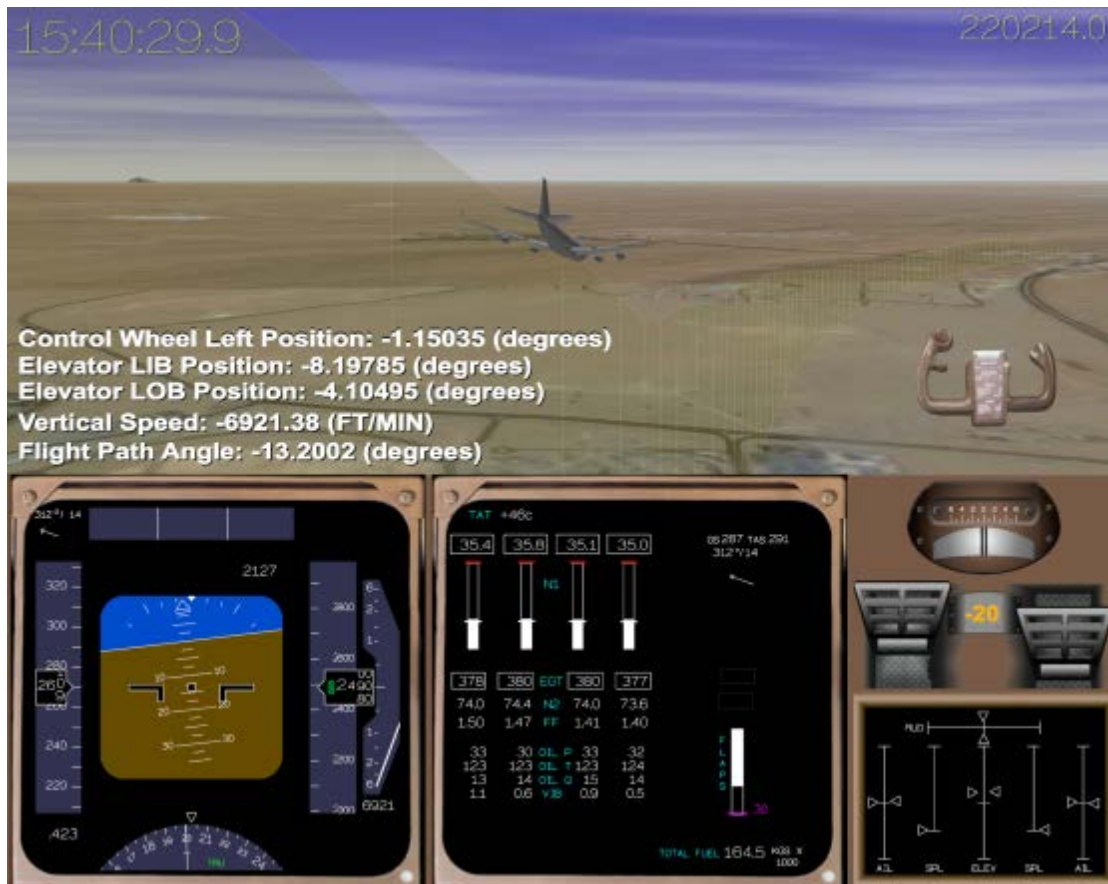
Figure 44 - 15:40:30 UTC Descent Towards Nad Al Sheba

The aircraft responds to the control inputs from the PF and the rate of descent is reduced. There follows a series of pitch oscillations as the control inputs are made. The effect of the inputs on the controllability decrease as the airspeed decreases.

It is possible that the steep descent angle of  $-14^\circ$  may have caused a weight shift forward of some of the remaining cargo, moving the CG forward. This in combination with the reduced throttle setting and reduction in the thrust moment, could cause the aircraft to pitch nose down if uncorrected.

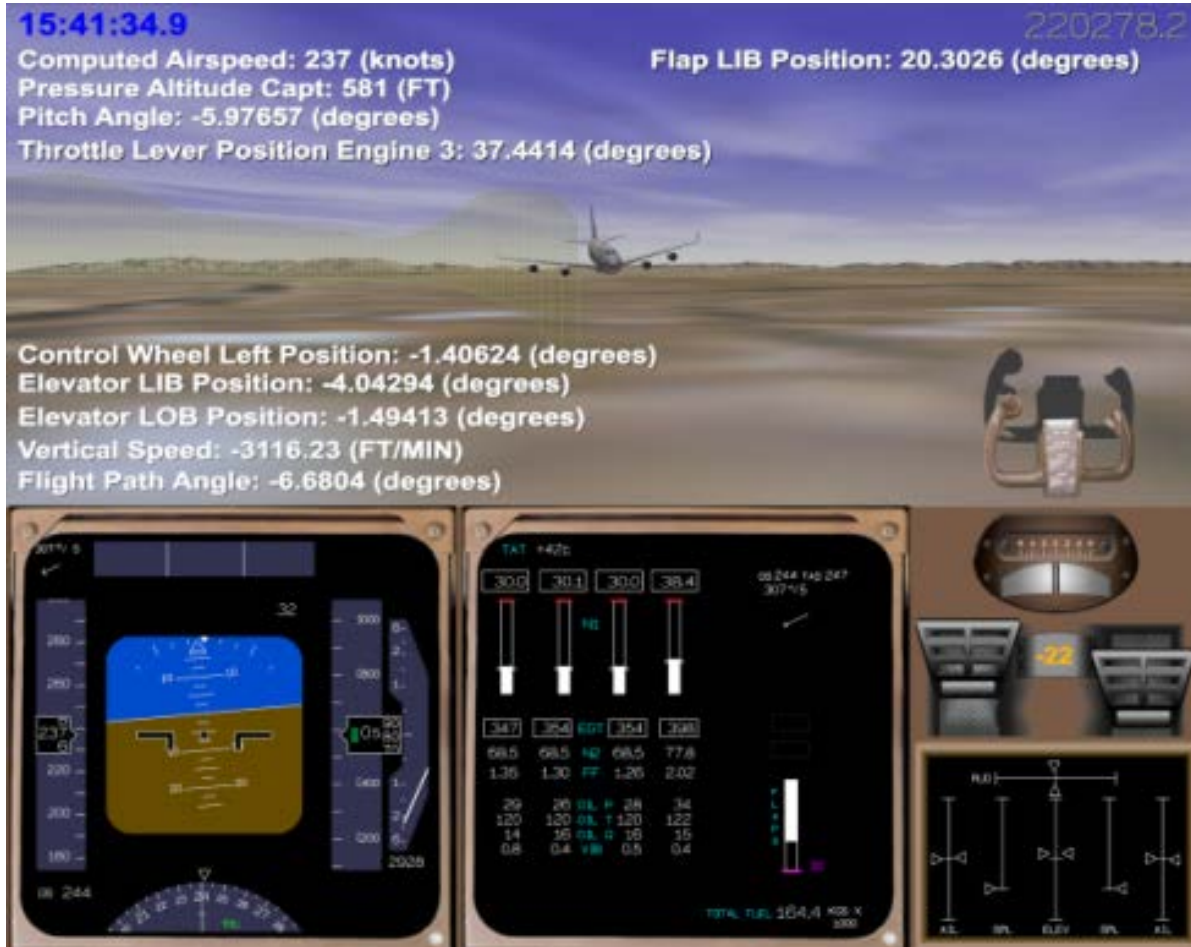
The collision with the terrain is now inevitable.

Figure 47 - 15:41:30 UTC - LOC-I/Loss Of Control In Flight/Data Ends

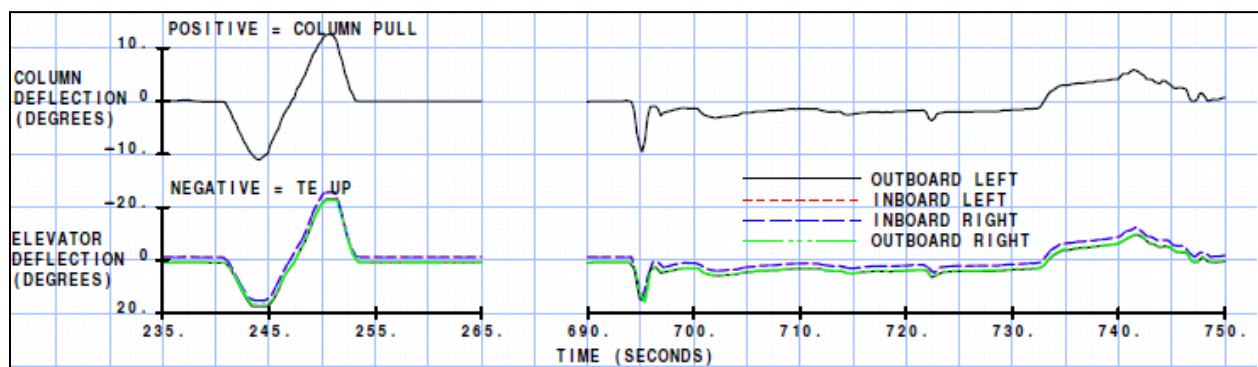
Figure 49 Column sweep and take-off rotation

Column sweep and take-off rotation display the normal relationship between column and elevator. If the tension is below the allowable tolerance, the column and elevator will no longer be consistent.

Following the initial fire warnings the column moved nose-down with no corresponding change in elevator deflection (left plot Fig. 49 above).

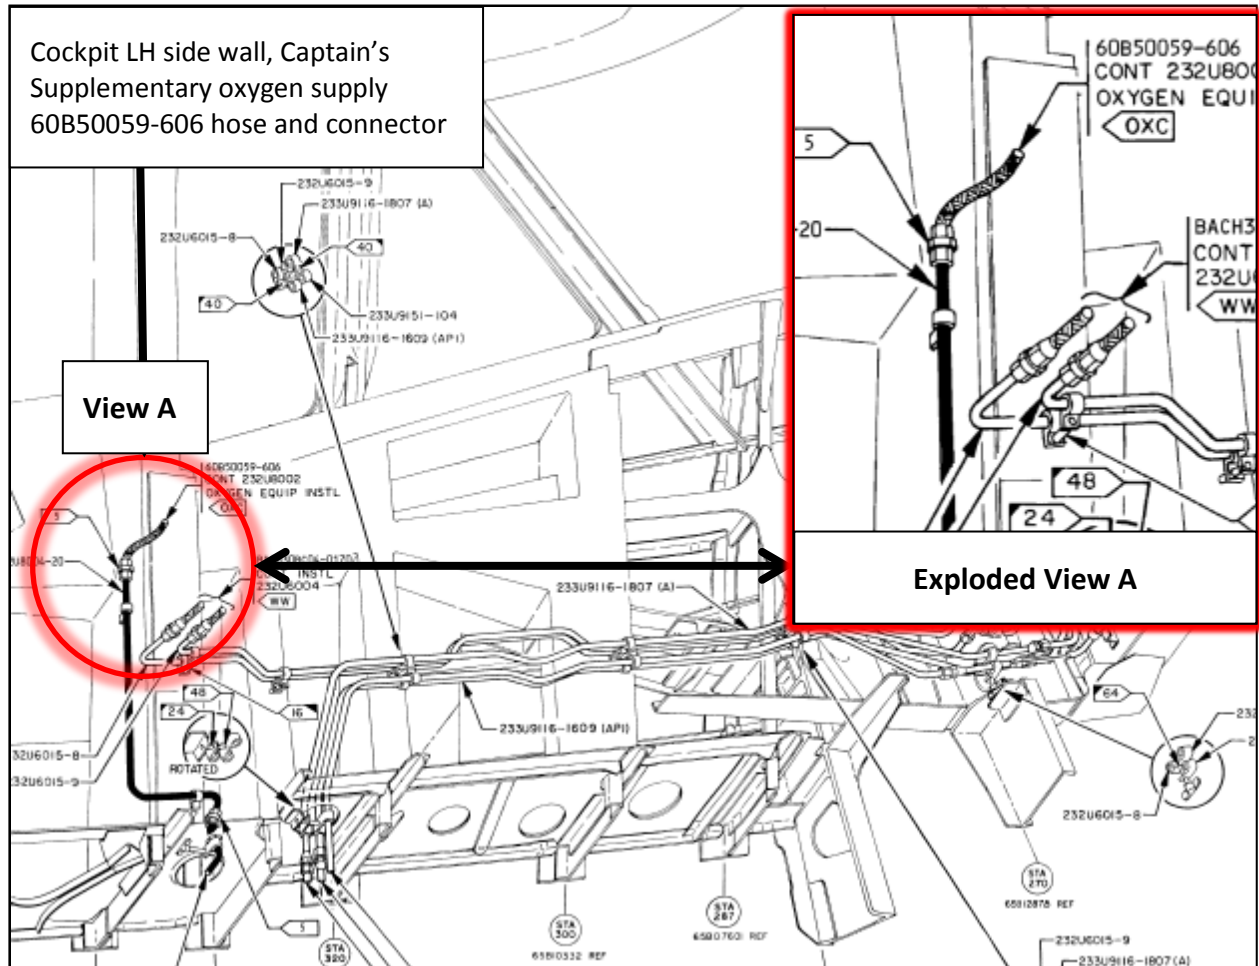
Figure 61 - View on cockpit LH sidewall - Captains supplementary oxygen supply hose and connector

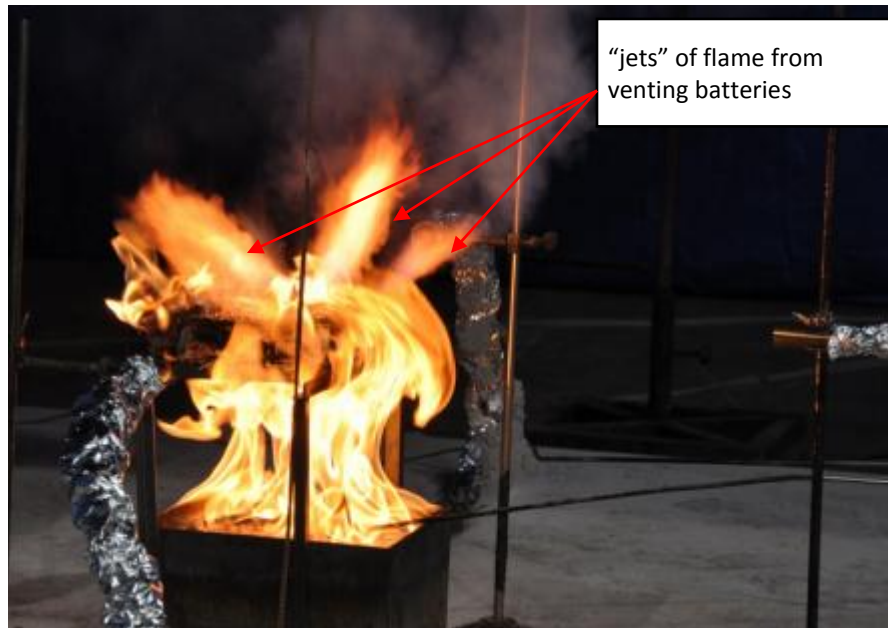
Due to the violent nature of the battery case venting and combustion of the electrolyte, some of the batteries (or battery components) were liberated from the charred packaging and propelled several feet, landing onto the floor. Some of these projectiles continued to burn upon landing.

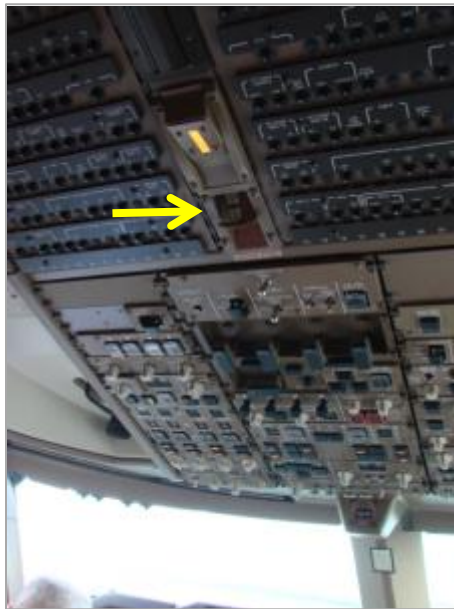
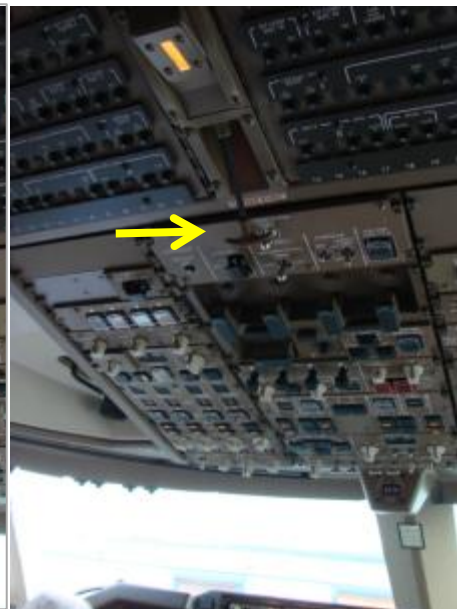
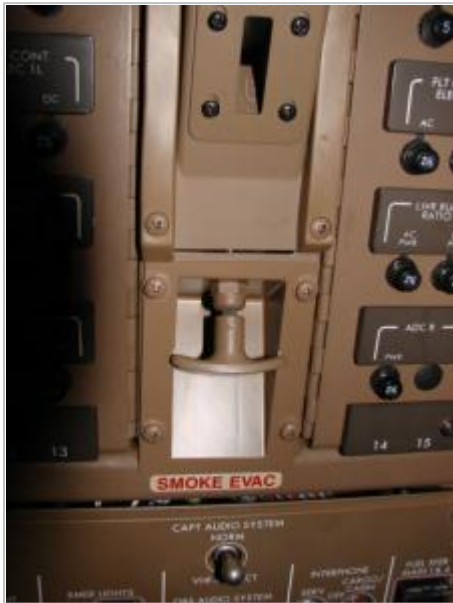
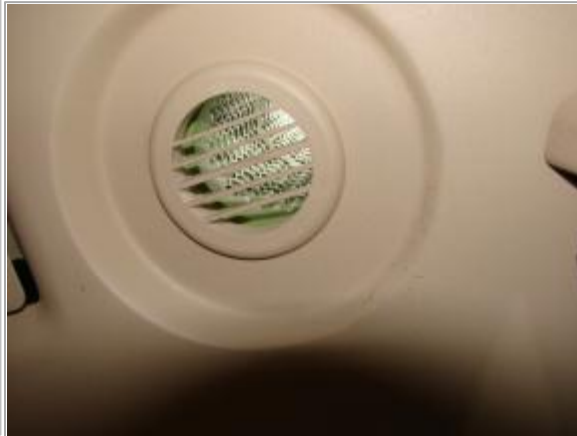
captain called for the fire main deck checklist. No emergency was declared and no turn was initiated. The FIRE MN DK FWD checklist was begun at about 1:32 (1 minute and 32 seconds into the scenario). When pilot #1 removed his oxygen mask from its container, the cord was tangled and delayed donning. Two minutes and 15 seconds into the scenario, an emergency was declared with ATC (air traffic control). The flight was cleared to descend to FL250 and initiated a right turn toward ANC. Although “smoke” was declared by the instructor, it was not heard by the flight crew and no acknowledgement was made. When the main deck cargo fire arm switch was armed, packs 2 and 3 were automatically turned to ‘off’. It was unclear to the observers who was designated the PF because pilot #1 switched the altitude in the mode control panel. The flight crew was again informed that the cockpit was full of smoke at 4:18 into the scenario. The flight crew donned smoke goggles. It took about 16 seconds for the crew to don their smoke goggles. The flight crew descended to FL100. At time 5:30, the flight crew was unable to see their instruments due to smoke in the cockpit. This was simulated by failing the displays and covering the backup display. The captain pulled the smoke handle, however, no checklist was used to make this decision.

Figure 97: Smoke Evacuation Handle      Figure 98: Smoke Evacuation Handle (pulled)

Figure 99: Smoke Evacuation Handle      Figure 100: Smoke Evacuation Port (cockpit ceiling)

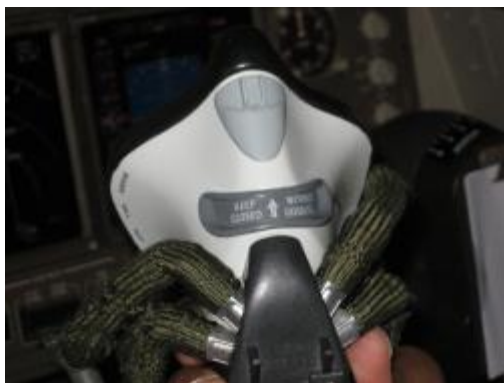
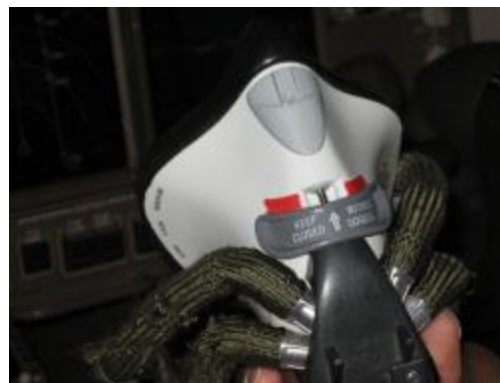
Figure 101: Smoke vent valve selector (closed)      Figure 102: Smoke vent valve selector (open)

The pilots involved in the exercise indicated that with the smoke goggles donned, it was difficult to find the switch to clear the goggles of smoke (see figures 9 and 10) and one stated “it was “awkward”.

The pilots did not believe they would have thought to clear the goggles if they had not practiced it before the scenario. Pilot #1 stated that it was a misconception that the goggles should fit snugly. He said they were designed to be loose so that the goggles could be cleared of smoke. The instructor informed the crew that they should have completed the smoke fire and fumes checklist prior to completing the smoke removal checklist. Asked who would be in charge of communicating with ATC, both pilots indicated that the PM would do this.

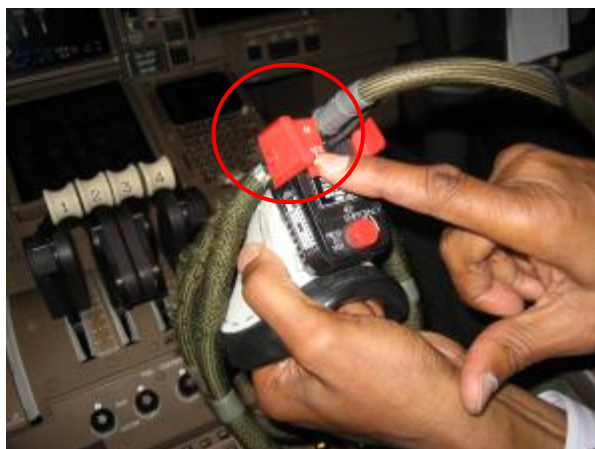
Figure 106: 100% Selector Switch on Oxygen Mask

The pilots in the exercise did not know about preflight maintenance of O2. Regarding the different oxygen levels of the oxygen mask (see figure 10), “Normal” was a mix of ambient air and oxygen and the higher you get, the more O2 that was introduced, “100%” was 100% oxygen and “emergency” was positive pressure and 100% oxygen.

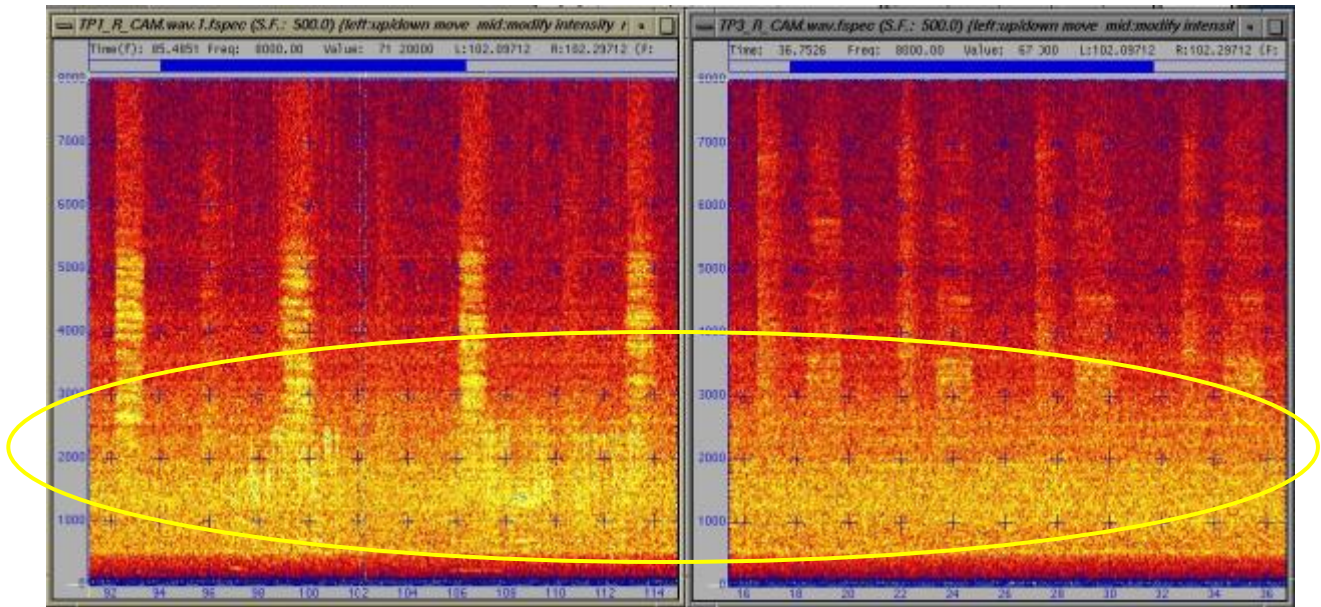
Figure 109 - Spectrogram of CAM - Test points 1 and 3, During Flight

In flight, this characteristic is much more difficult to discern, due to the background ambient noise in the cockpit. The area highlighted in Figure 108 shows the background noise during flight is too loud to see the lower frequency range of the inspiratory noise. As a result, this characteristic was not suitable to differentiate between mask modes.

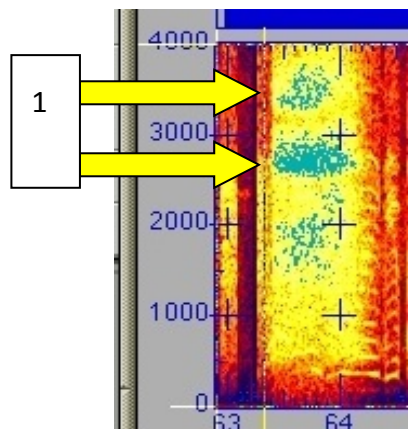
Figure 110 – Spectrogram of Inspiratory Noise from Mask Microphone Audio

The auditory review of the mask microphone audio revealed that the breath noises did not sound significantly different between the two mask modes. However, the sound spectrum analysis found a unique characteristic in the audio that differentiates one mask mode from the other. Figure 109 shows a spectrogram of the inspiratory noise from a single breath, as recorded from the oxygen mask microphone.

The audio from the mask microphones exhibits characteristic “bands” of energy during inspiratory breaths (light blue regions labeled 1 and 2 in Figure 109). These bands are a concentration of relatively higher sound energy within certain frequency ranges. The height of the bands (range of frequency) and total number of bands seems to vary, and may be affected by the overall loudness of the breath sound itself. However, two of these bands are present in all segments of audio that were examined (labeled 1 and 2 in Figure 109). The unique characteristic is the “center” frequency of Band 2. The band height (total frequency range) can vary, but the center of the band appears to be unique to the mask mode. In
