Air Accident Investigation Unit Ireland

SYNOPTIC REPORT

**Boeing, 737-8AS, EI-EMH/EI-EKK
LINK 2, Dublin Airport, Ireland**

7 October 2014

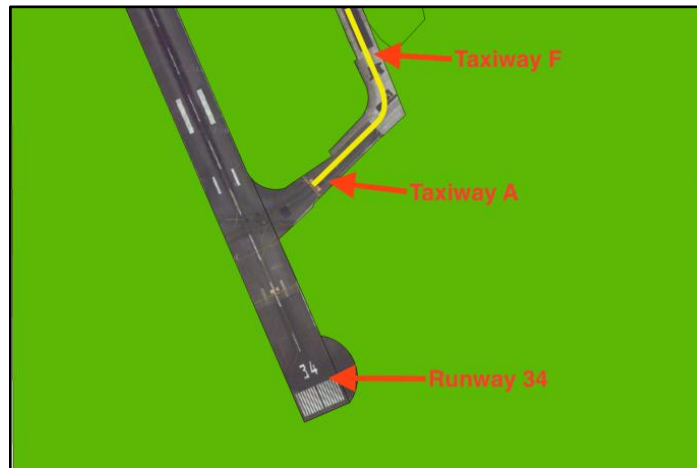
Graphic No. 4: RWY 34 with Taxiway A

Graphic No. 4 shows RWY 34 prior to the development of RWY 28 (pre-1989) and the new Pier 4. TWY F led directly to TWY A, which was the normal access onto RWY 34. Aircraft entered the runway approximately 200 m north of the threshold, and those requiring full length would backtrack to a turning circle at the RWY 34 threshold.

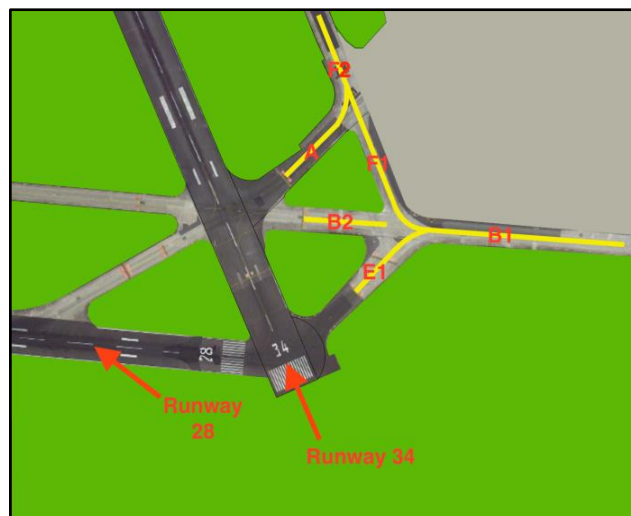
Graphic No. 5: New RWY 28 with TWY access through F2/F1/E1

The threshold of RWYs 28 and 34 was accessed by TWY F1 and E1. TWY B, parallel to RWY 28, was constructed, crossing RWY 34 abeam TWY A and intersecting the vertex of F1 and E1 (**Graphic No. 5**).

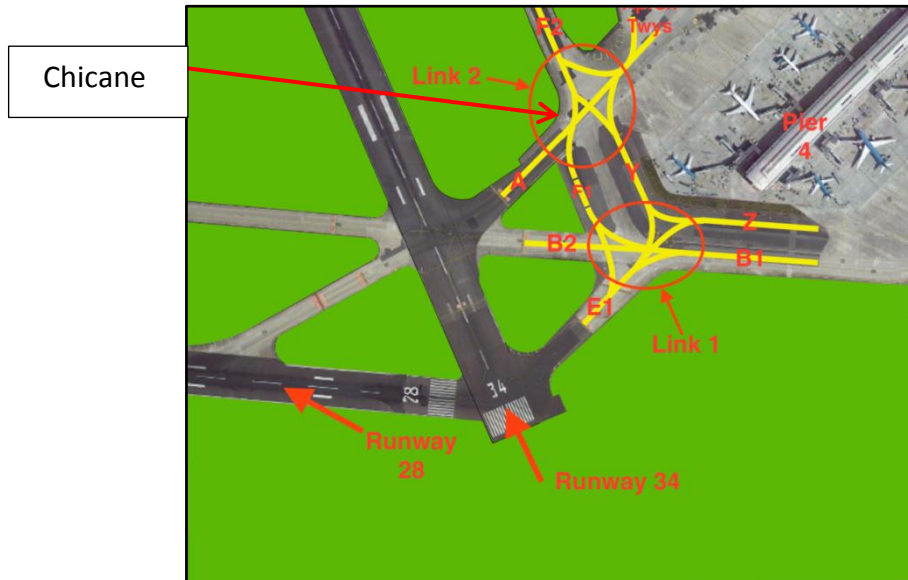
Graphic No. 6: Taxiway formation LINK 1/LINK 2

These changes resulted in the introduction of a chicane taxiway centreline formation from TWY F2 through LINK 2 to TWY F1 and the shortening of TWY F1 to 20 m (**Graphic No. 6 and No. 7**). It should be noted that TWYs Y and Z had been withdrawn from service prior to the subject event.

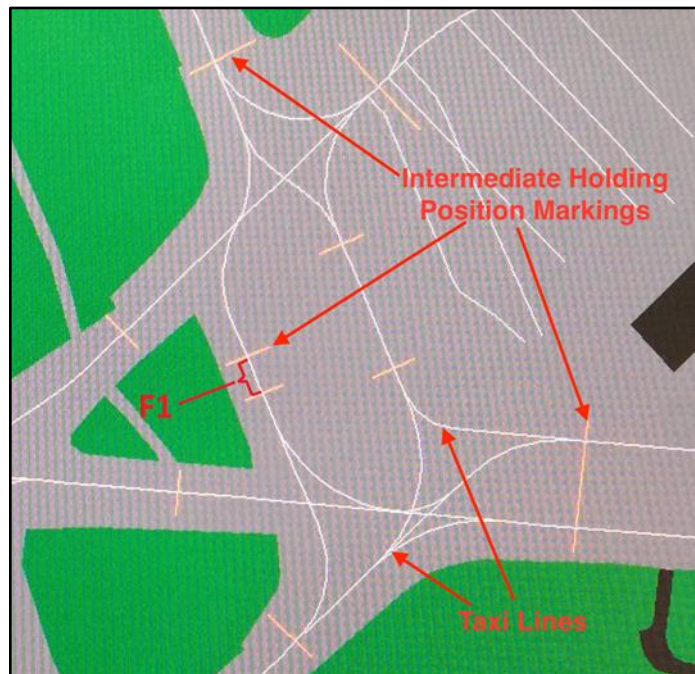
Graphic No 7: Intermediate Holding Position Markings LINK 1/LINK 2

Graphic No 7 represents a close-up of the LINK 1/LINK 2 area with the IHPMs, taxi lines, and TWY F1 shown.

TWY F1 is a short taxiway, connecting LINK 2 to LINK 1. It is bounded at either end by an IHPM, one between F1 and LINK 1 and the other between F1 and LINK 2. TWY F1 measures 20 m in length. When an aircraft taxis in a southerly direction on F1, and stops at the southern IHPM between F1 and LINK 1, there is sufficient clearance for aircraft up to Category E¹¹ to taxi from TWY B2 onto LINK 1.

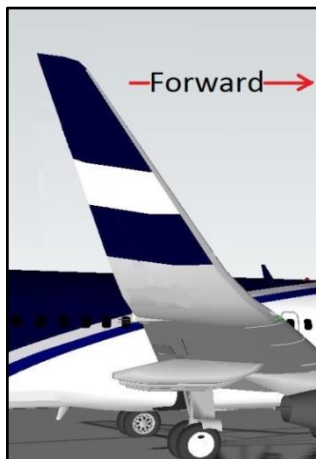
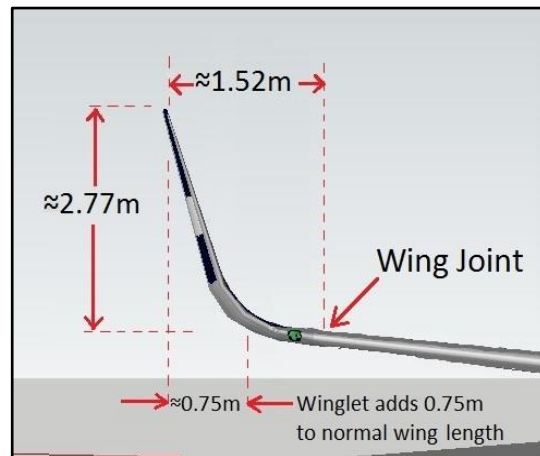
Figure No. 1: Side view of Winglet. **Figure No. 2:** View of Winglet from leading edge.

For aircraft such as the occurrence aircraft and aircraft of similar configuration, the addition of winglets does increase the wing dimensions of the aircraft. However, they do not extend upwards perpendicular to the horizontal plane, but rather extend upwards, backwards and outwards from the wing itself. Specific to the occurrence aircraft type, the winglet extends the wing by 1.52 m from the wing joint, adds 0.75 m to the normal wing length and rises to a height of 2.77 m above the wing (Figures No. 1 and No. 2).

The increase in height is significant as it extends above the height of the aircraft's horizontal stabiliser (Graphic No. 9). Prior to the introduction of winglets, wingtips would have had sufficient vertical clearance to pass underneath the horizontal stabilizer of the same aircraft type.

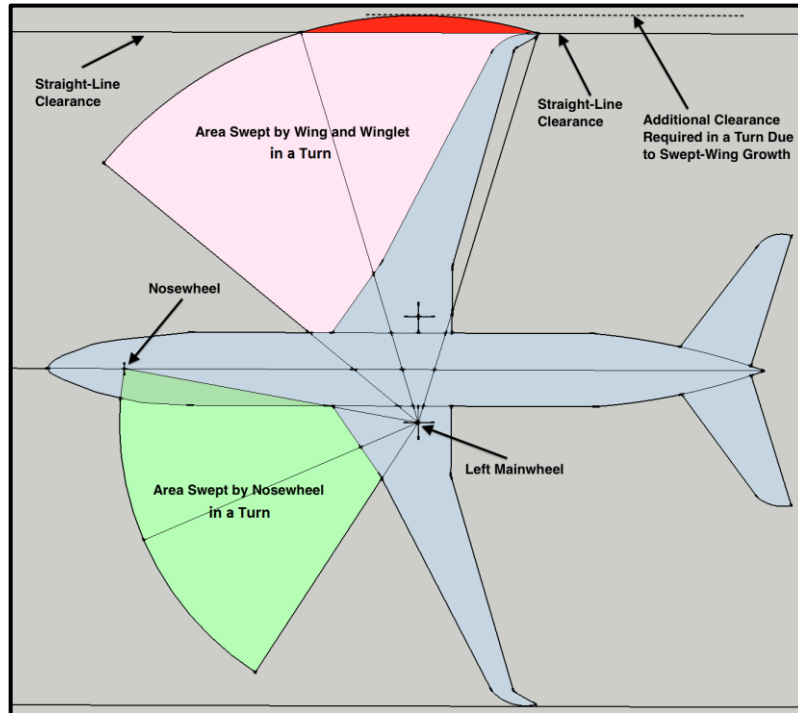
Graphic No. 10: Turning radius 'wing creep' depicted in red

Most modern transport aircraft have swept wings which are subject to a phenomenon known as 'swept wing growth' or 'wing creep'. This occurs during a turn when the wingtip describes an arc greater than the normal wingspan due to the geometry of the aircraft and the arrangement of the landing gear (**Graphic No. 10**).

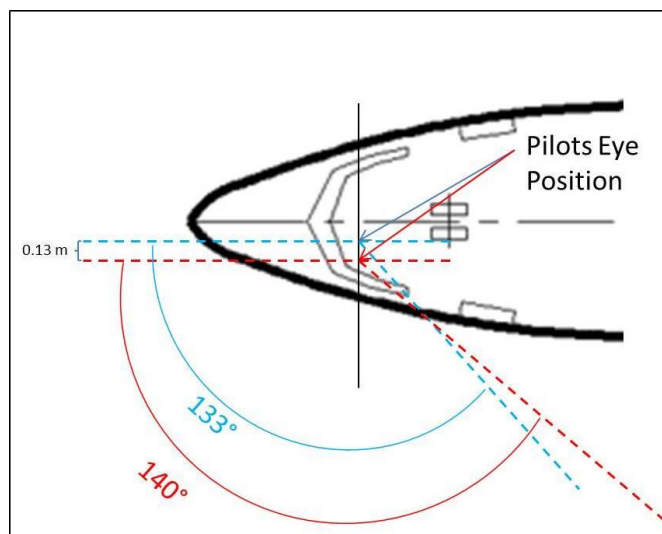
Graphic No. 11: Cockpit visual angles in the horizontal plane

Specific to the occurrence aircraft type and while seated in the left-hand seat, the visual angle in the horizontal plane through the pilot's normal eye position and looking towards the wingtip is 133°. If the pilot moves his head 0.13 m outboard of the normal pilot's eye position the visual angle in the horizontal plane increases to 140° (**Graphic No. 11**).
