## Final report on aircraft accident

Case number: **2015-089-F-026**

Description: **Aircraft collided with the ground during a training flight**

| Factual information | |
|---|---|
| <b>Aircraft type:</b> | Tecnam P2002JF |

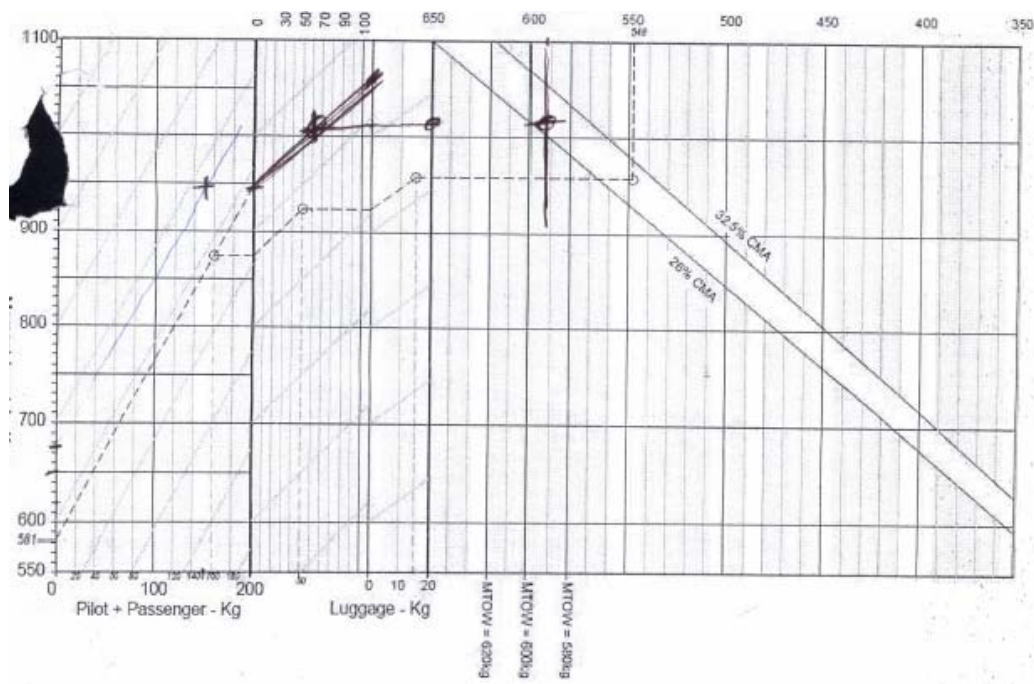
Figure 2: Weight & Balance calculations for the accident flight

When analysing the Weight and Balance sheet that was filled out prior to the flight, some discrepancies were found regarding the weight of the Instructor and the Student, as well as regarding the calculation for possible fuel quantity and the weighing report from the manufacturer.

During the investigation, the combined weight of the Instructor and the Student was found to be 169 kg, 19 kg more than the weight listed on the Weight and balance sheet used while preparing for the flight.

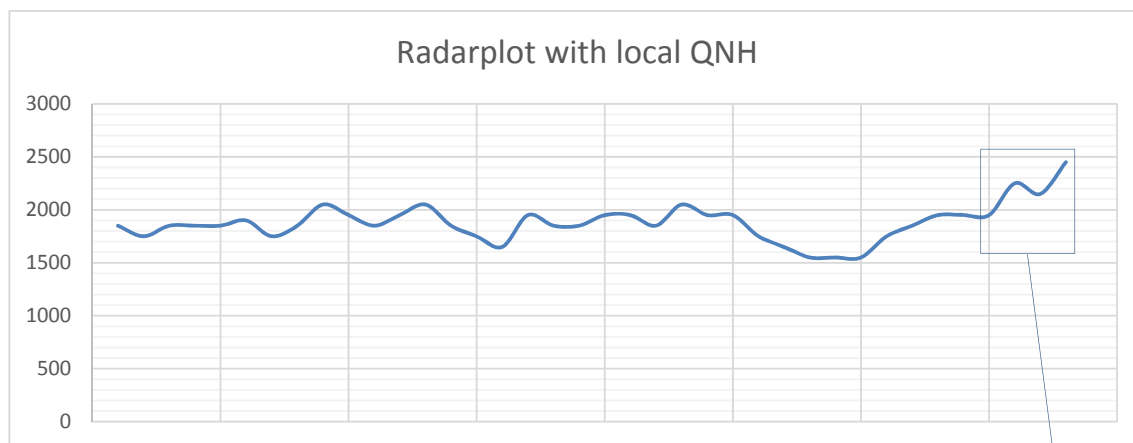
Figure 5: The aircraft's altitude, based on local QNH

The following chart demonstrates the altitude during the last ten minutes of the flight, corrected for local QNH (988 hPa).

According to the last four recorded radar signal, the aircraft was flown from approx. 1950' to 2250' and then from 2250' to 2150' and then from 2150' to 2450'<sup>7</sup>, which was the last recorded radar signal.

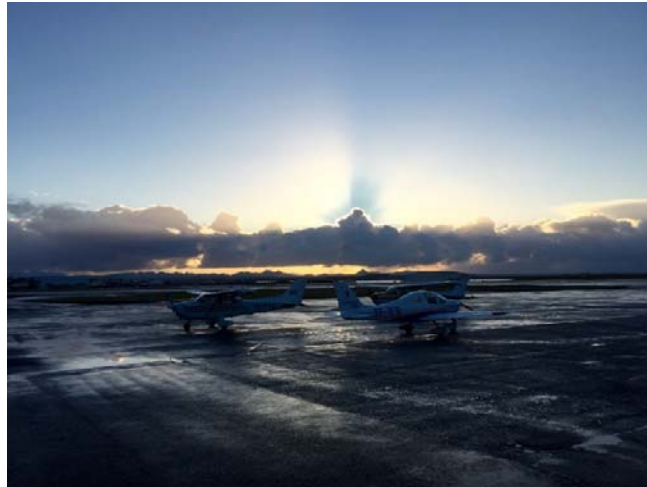
Figure 12: Picture taken towards training area MIÐSVÆÐI

A report from the MET Office for VFR conditions was published the same day at 11:30 where it was stated that the cloud base in the south of Iceland would be broken at 1.500 to 2.000 feet. Widely there would be embedded CB's<sup>15</sup> with limited visibility in showers and snow showers, improving as the day progressed. The picture above was taken at BIRK at

15:04 on the day of the accident towards the MIÐSVÆÐI training area.

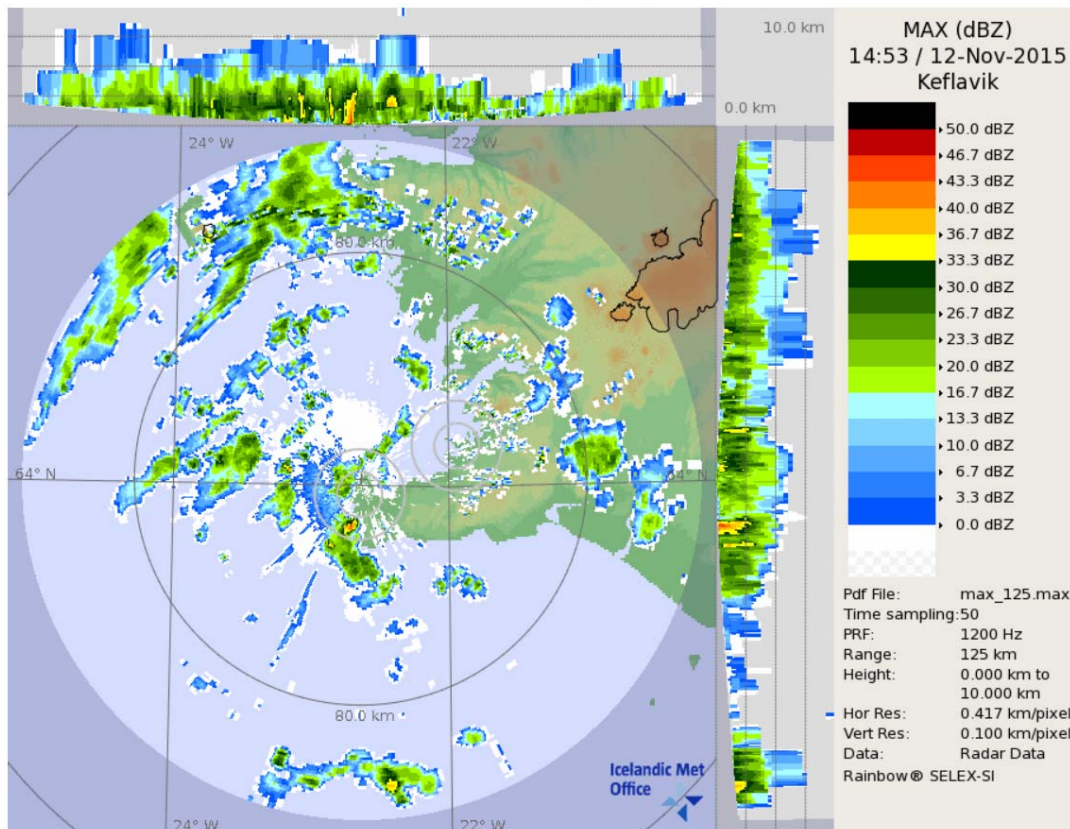
Figure 13: Precipitation in the accident area around the accident time

Figure 13 shows the reflectivity detected by the weather radar at Miðnesheiði, in the vicinity of BIKF. The radar detects particles of size large enough to precipitate. The weather radar did not detect precipitation in the accident area around the accident time. However, the image clearly shows snow showers in the vicinity indicating convective conditions.

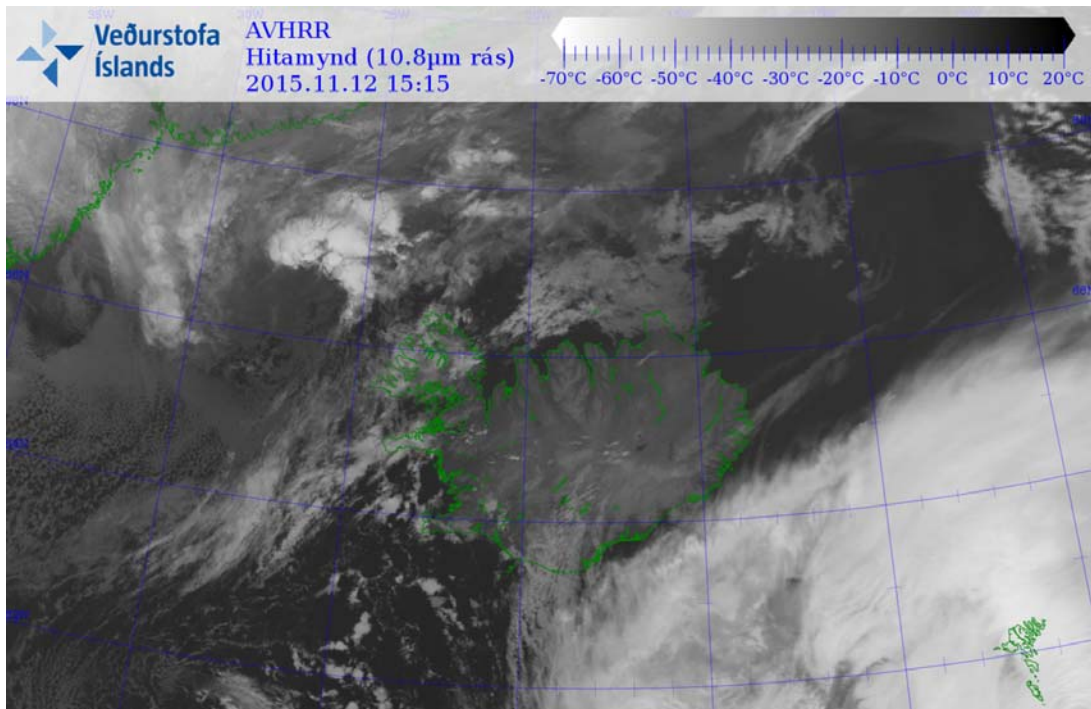
Figure 14: Clouds in the area around the time of the accident

The satellite image in Figure 14 shows no clouds in the region at 15:15, about 32 minutes after the accident.

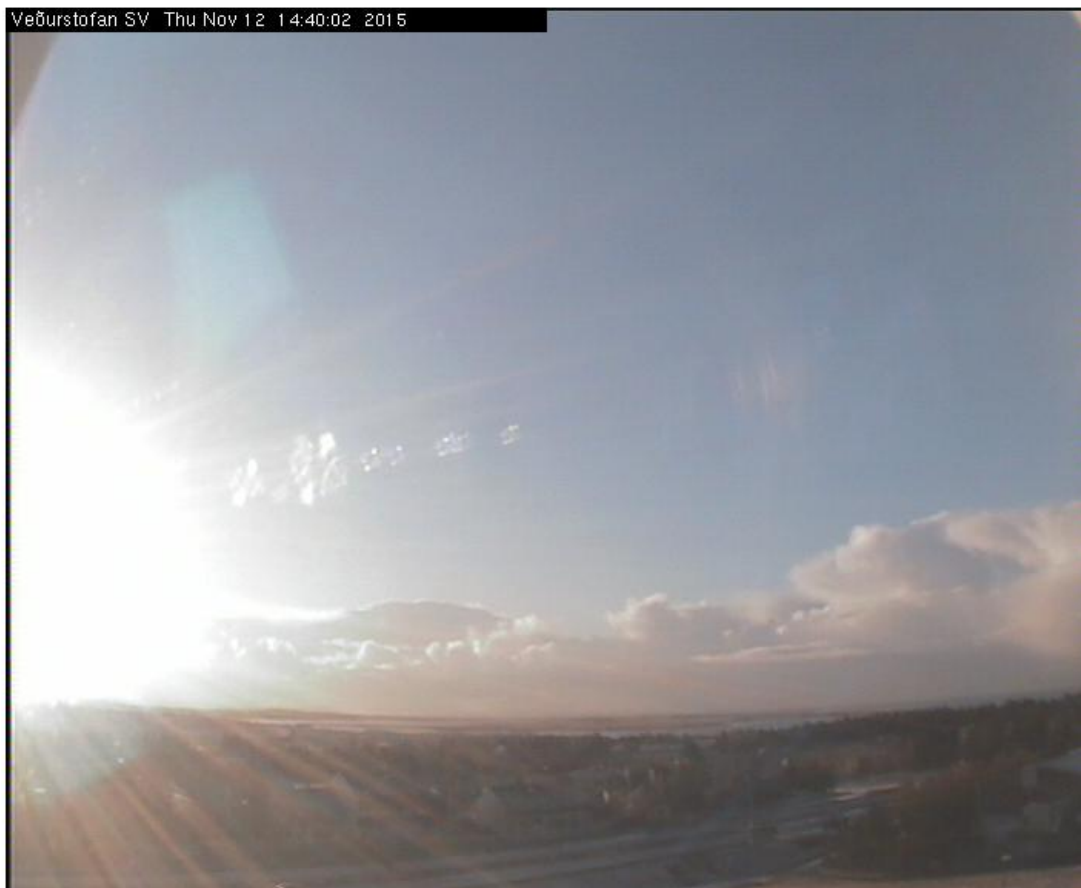
Figure 15: View from the MET Office towards the accident area around the time of the accident

As can be seen in Figure 15, the sun was shining and low in the sky around the time of the accident. The last plotted heading of the aircraft was towards the sun (see Figure 15 and Figure 16), possibly interfering with the pilots' instrument reading.

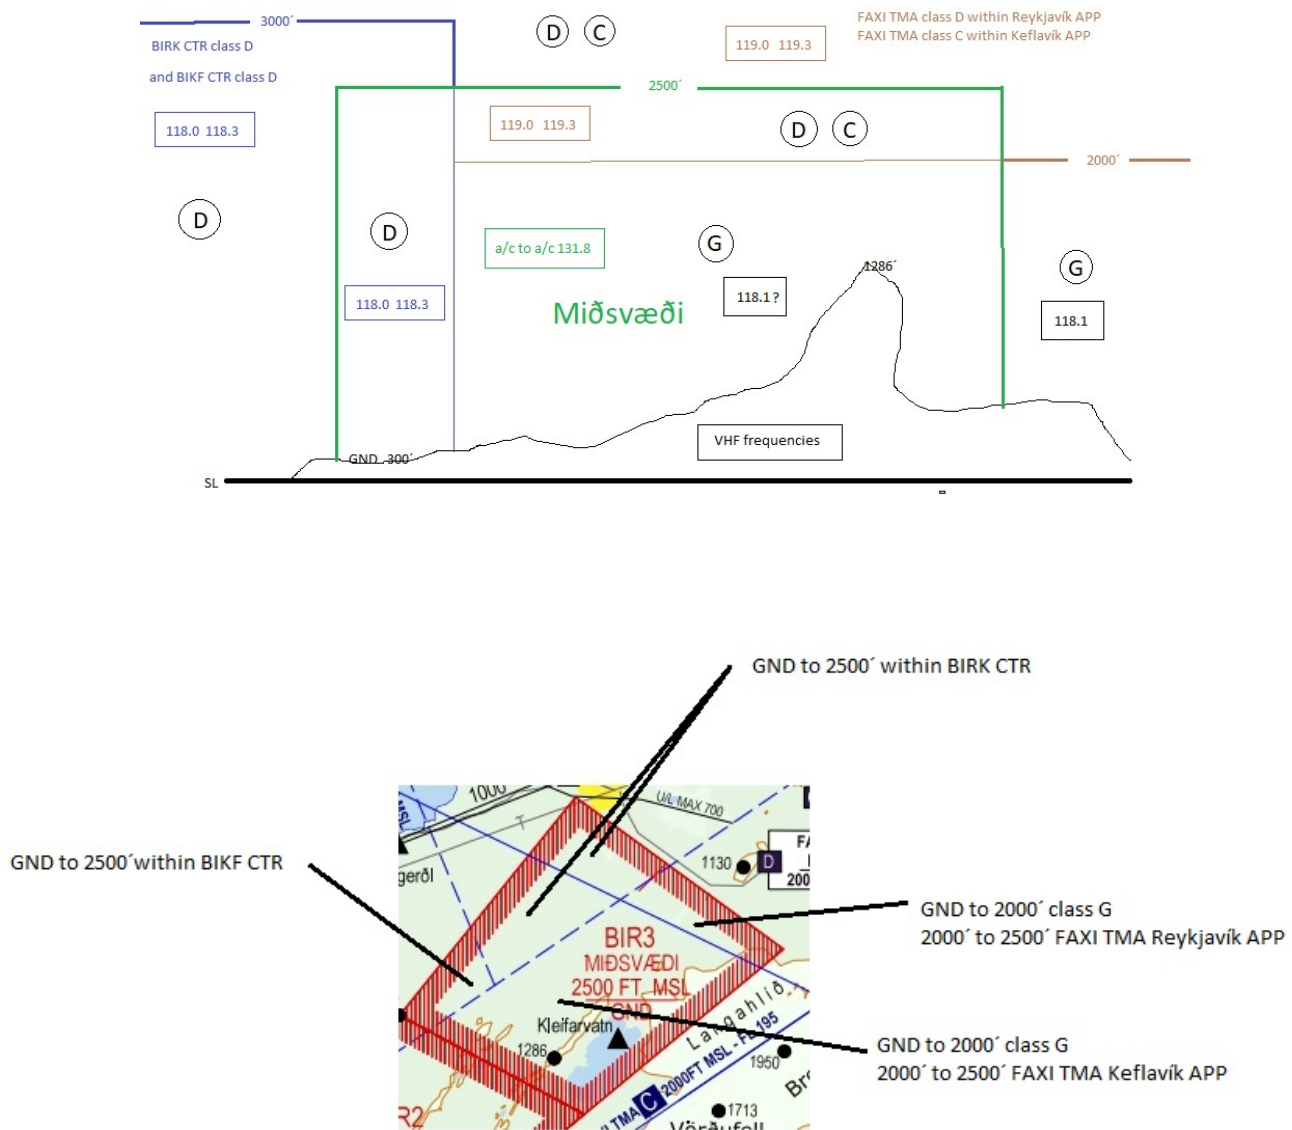
Figure 19: MIÐSVÆÐI

There are three different airspace classes<sup>17</sup> at MIÐSVÆÐI, Class C, D and G depending on the location from time to time.

The investigation revealed that the area is more complicated than other training areas and in case of higher altitude needed (above 2500' MSL) the pilots need to contact either one of two approach control units, i.e. BIRK Approach and BIKF Approach. Due to this, some instructors use other training areas for higher altitude

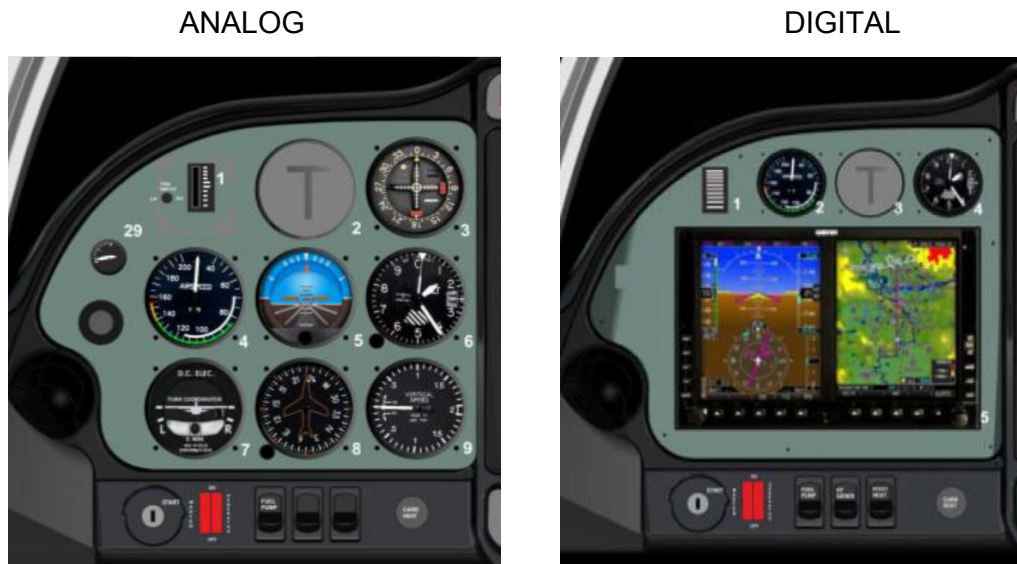
Figure 31: The difference between analog and digital panels

Figure 31 demonstrates the difference between the analog and the digital panels of the Tecnam P2002JF. At the digital configuration there are also some analog instruments as a standby instruments.

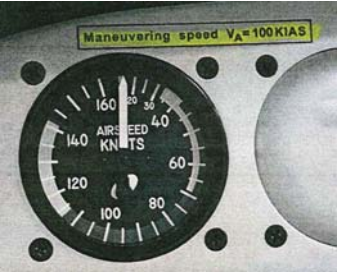
| Tecnam P2002-JF Flight Manual | Aircraft |
|---|---|
| <div data-bbox="365 441 878 506" data-label="Text"> <p>MANEUVERING SPEED <math>V_A = 96</math> KIAS</p> </div> | <p data-bbox="976 317 1235 348">100 KIAS in aircraft</p> |

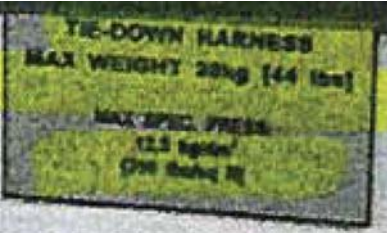
| Tecnam P2002-JF Flight Manual | Aircraft |
|---|---|
| <div data-bbox="370 1003 873 1224" data-label="Text"> <p>FASTEN TIE-DOWN NET<br/>MAXIMUM WEIGHT 20 KG<br/>MAX. PRESS 12.5 kg/dm<sup>2</sup></p> </div> | <p data-bbox="976 863 1360 894">Tie-Down Harness in aircraft</p> <div data-bbox="976 1161 1247 1318" data-label="Text"> <p>TIE-DOWN HARNESS<br/>MAX WEIGHT 20kg [44 lbs]<br/>MAX SPEC. PRESS:<br/>12.5 kg/dm<sup>2</sup><br/>[256 lbs/sq ft]</p> </div> |
