# Misaligned take-off from Runway 24, Amsterdam Airport Schiphol

*The Hague, November 2018*

# GENERAL OVERVIEW

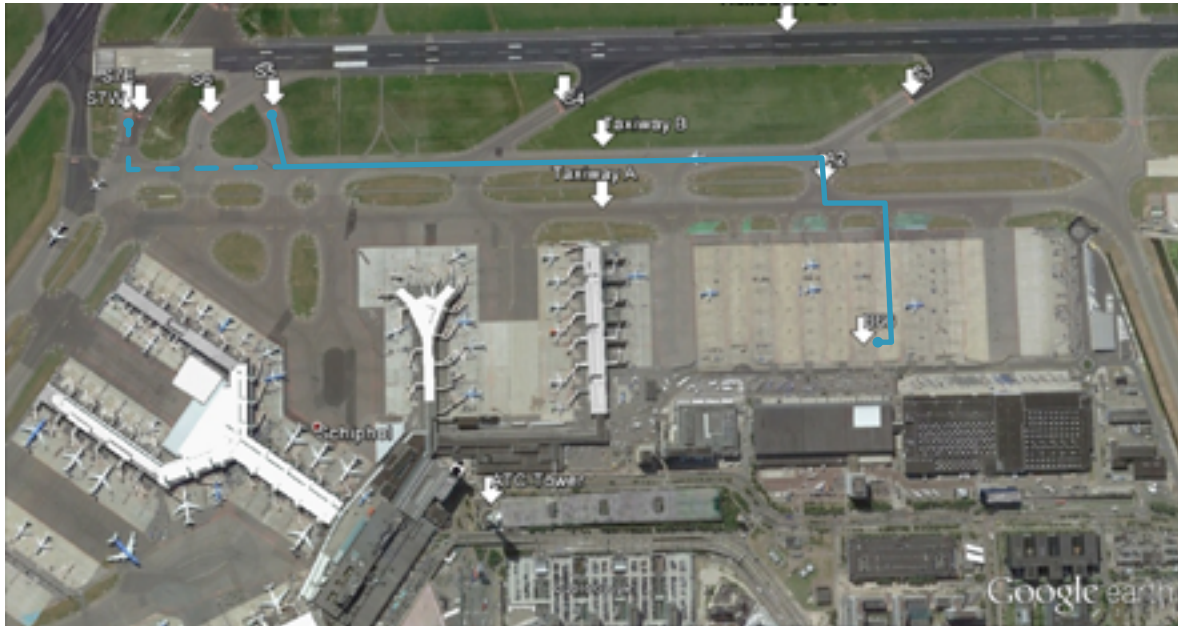
At 17.15 hours start-up clearance was requested and approved. At 17.20 hours taxi clearance was obtained and the flight crew was instructed to taxi via taxiway A to taxiway B, using intersection A2 and S7 for take-off from Runway 24. An overview of the intended taxi route is depicted in Figure 1 (blue dashed line).

Figure 1: Overview of the relevant part of Amsterdam Airport Schiphol with the parking stand, taxiways and Runway 24 together with a rough representation of the intended (blue dashed) and actual taxiing track (blue). (Photo: Google Earth)

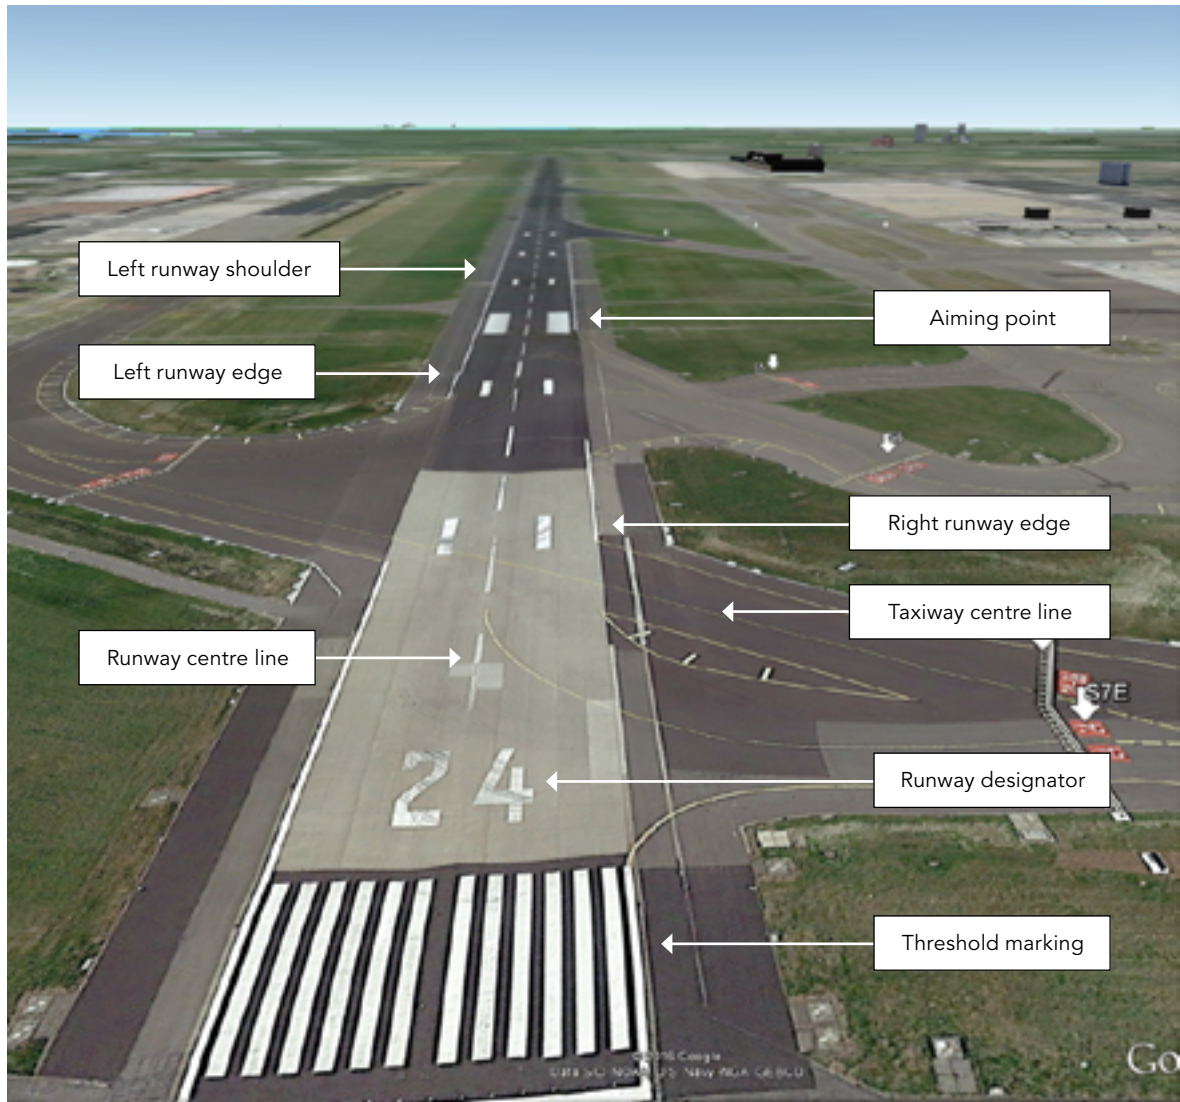
Figure 4: Runway marking definitions. (Photo: Google Earth)

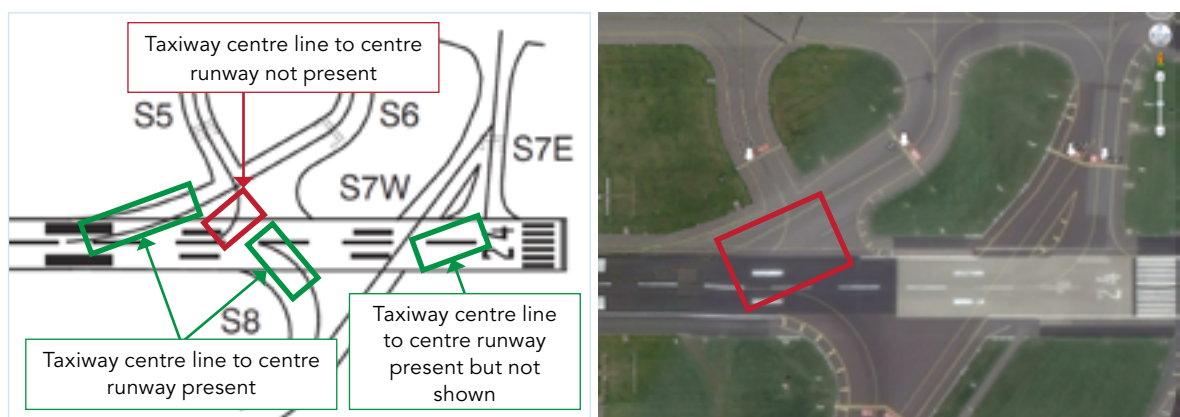
Figure 5: Taxiway B and Runway 24 with Exit S5 - S8 and taxiway centre line marking (reference). (Photo: Google Earth)

In the Integrated Aeronautical Information Package (AIP) for Amsterdam Airport Schiphol, a situation chart is published for runway 06/24. While conducting the investigation, it was found that the situation as depicted on the chart did not correspond with the actual layout of Amsterdam Airport Schiphol. Figure 5 (left) indicates that the taxiway centre line should be continuous and leading towards the runway centre line. However, from Figure 5 (right) it becomes evident that in reality the taxiway centre line is interrupted at the runway side line marking. On 26 April 2016 the investigation team of the DSB informed Air Traffic Control the Netherlands (LVNL) of the discrepancies between the published charts and actual taxiway centre line markings on Runway 24. In response, the relevant maps were updated to be correctly presented in the latest AIP publication.

As can be seen from Figure 5, a centre line marking leading from taxiway S6 to the centre line of Runway 24 is present. In contrast to S6, S5 does not have a centre line marking leading to the centre line of Runway 24. The centre line marking that is present on S5 is discontinued at the right-hand edge line of Runway 24.

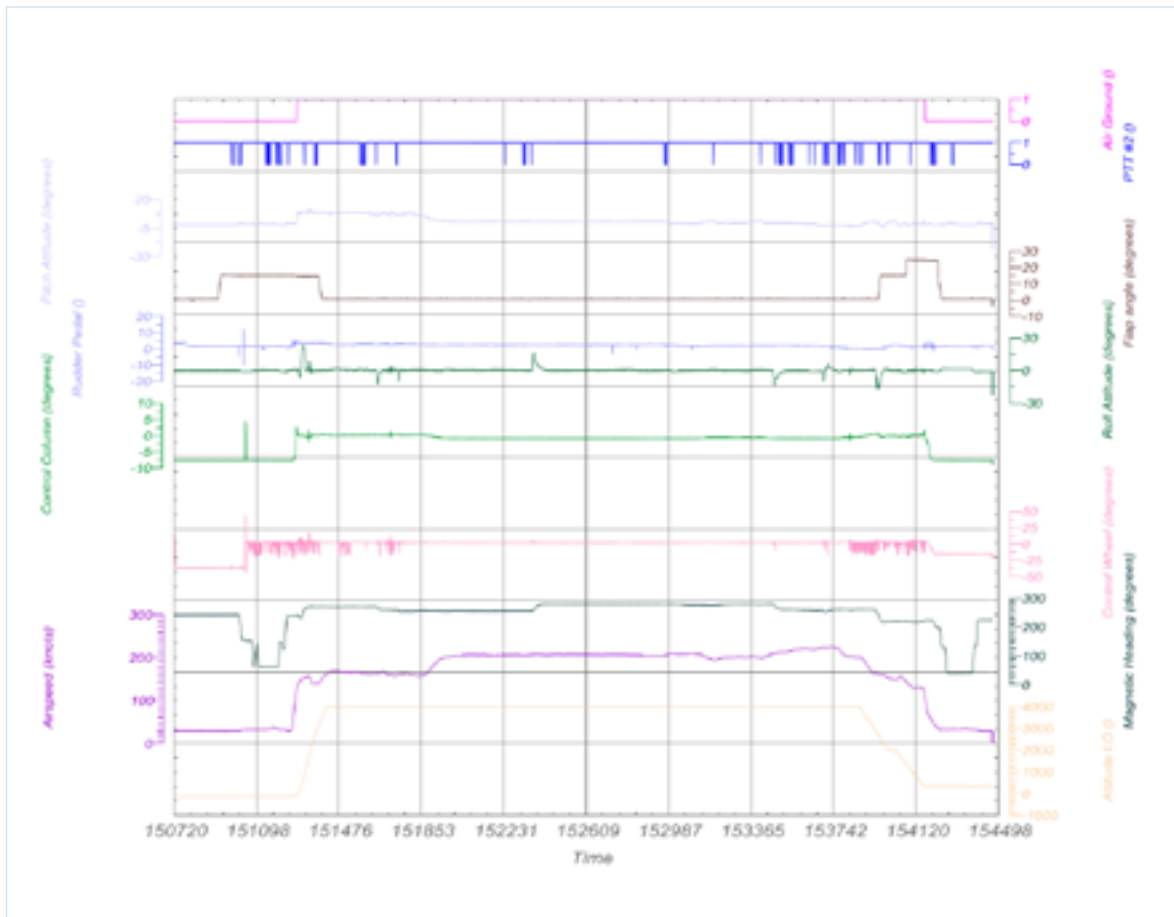
Figure A1: Overview of the Euler angles, aircraft state and control related parameters for the duration of the flight.
