# Air Accident Investigation Unit Ireland

## FORMAL REPORT

**ACCIDENT**  
**Fairchild Aircraft Corporation**  
**SA 227-BC Metro III, EC-ITP**  
**Cork Airport, Ireland**  
**10 February 2011**

**AAIU Report No: 2014-001**  
**State File No: IRL00911013**  
**Report Format: Formal Report**  
**Published: 28 January 2014**

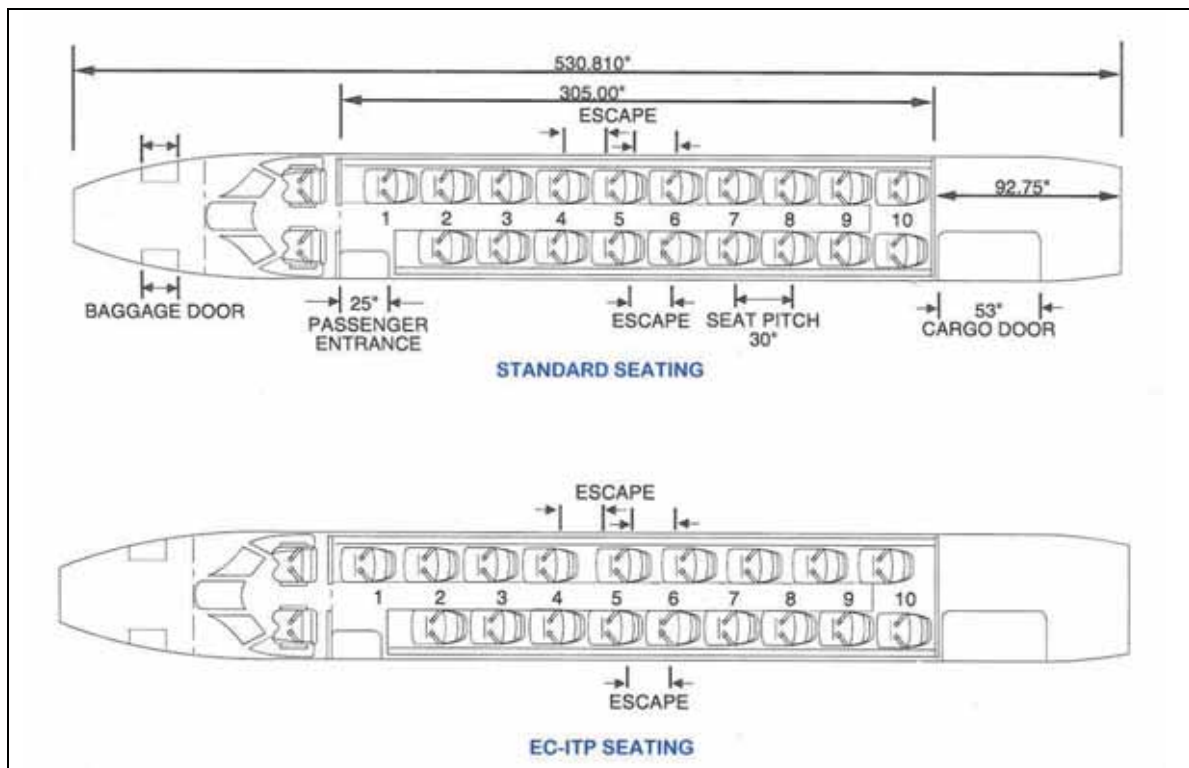
The seat pitch on the right-hand side commenced at 20 inches with a pitch of 38 inches provided adjacent to the aft emergency (escape) exit at the position of seat 5R. Seats behind 5R to the aft bulkhead were arranged with a pitch of 33 inches (**Figure No. 4**).

**Figure No. 4:** Standard 19-seat passenger layout and non-standard 18-seat layout as found on EC-ITP (*adapted from SA 227 AFM*)

AFS personnel removed all but two of the passenger seats to gain access to the casualties. In most cases the aisle-side seat legs were cut; some of the seats were forcibly wrenched free resulting in twists and fractures to the seat legs. Following recovery of the wreckage to the AAIU facility, the seats were examined. The Investigation compared the cut and fractured seat legs on the removed seats and established the location of each passenger seat in the cabin prior to the accident. The examination revealed a non-standard layout and seat pitch on the right hand side of the aircraft (**Figure No. 4**).

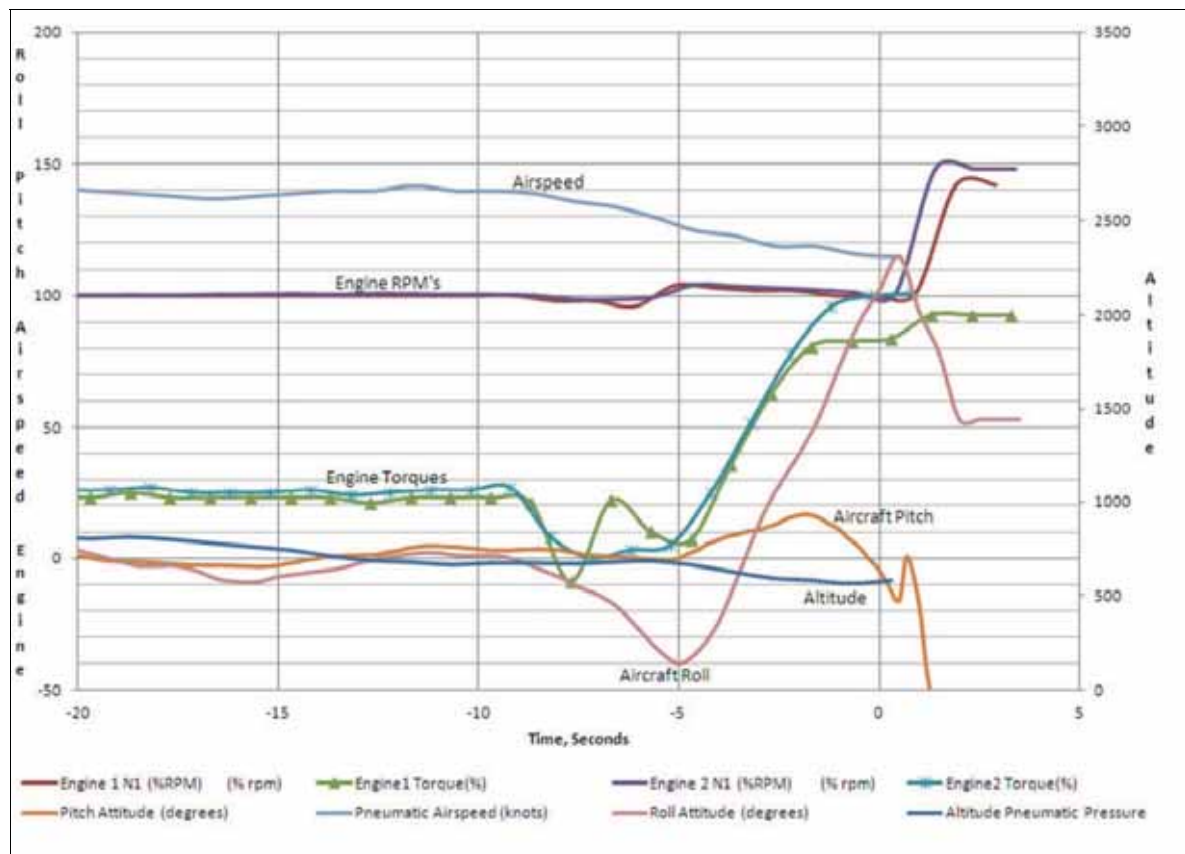
The graph in **Figure No. 5** shows the final 20 seconds of relevant parameters recovered from FDR data. Aircraft heading, not shown for clarity, was consistent with the roll readings. Until approximately 9 seconds before impact, the indicated airspeed recorded by the FDR was consistent with engine power settings and expected aircraft performance. The first significant event was a reduction of delivered engine torque from both engines, commencing approximately 9 seconds before impact, accompanied by a decrease in airspeed.

**Figure No. 5:** FDR data for final 20 seconds of recording

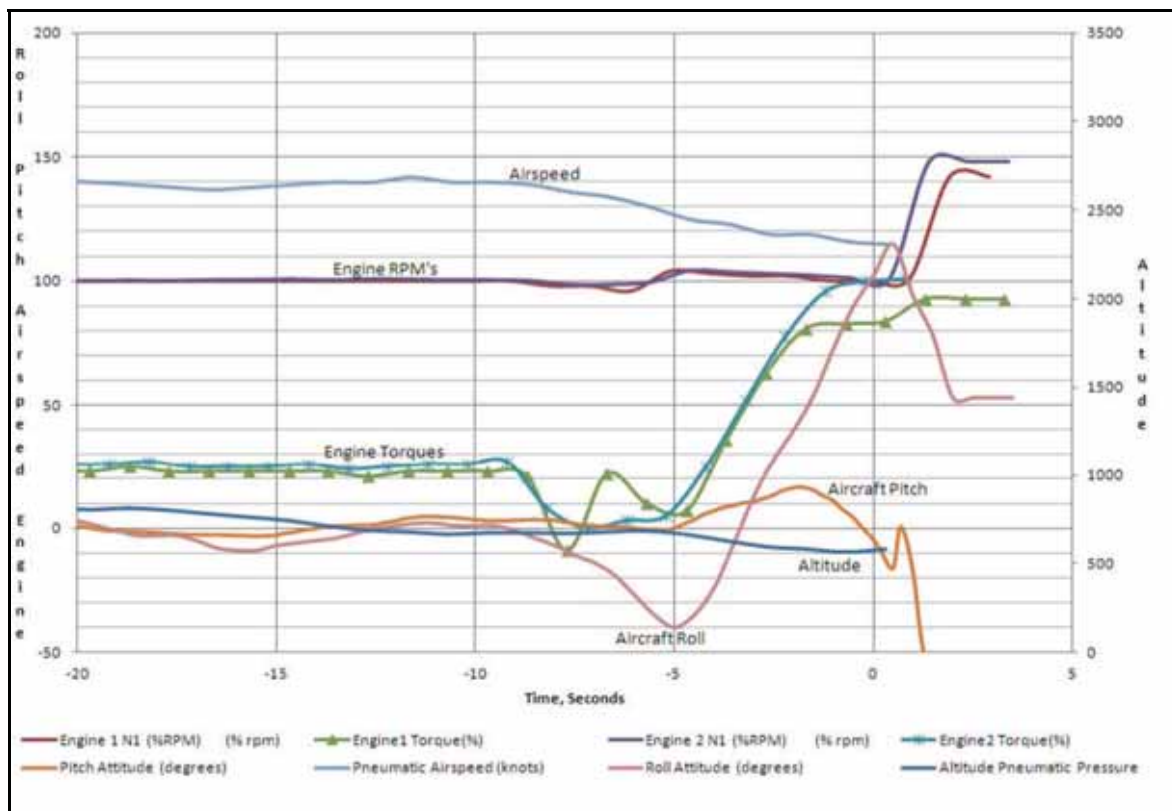
Relevant FDR parameters for the final 20 seconds of the flight are illustrated in **Figure No. 5a** (this is a reproduction of **Figure No. 5** to assist the reader).

**Figure No. 5a:** FDR Data for final 20 seconds of recording

Effect (3) is evident at several times in the recorded data. During the period from -20 to -10 seconds (**Figure 5, 5a**), engine No. 2 torque was generally approximately 4% higher than that for No. 1 engine. During the time when the data indicates the power levers were brought below the Flight Idle stop (Beta range), the FDR recorded a minimum torque value of -9 % for No. 1 engine, while the minimum recorded torque value for No. 2 engine was 0%.

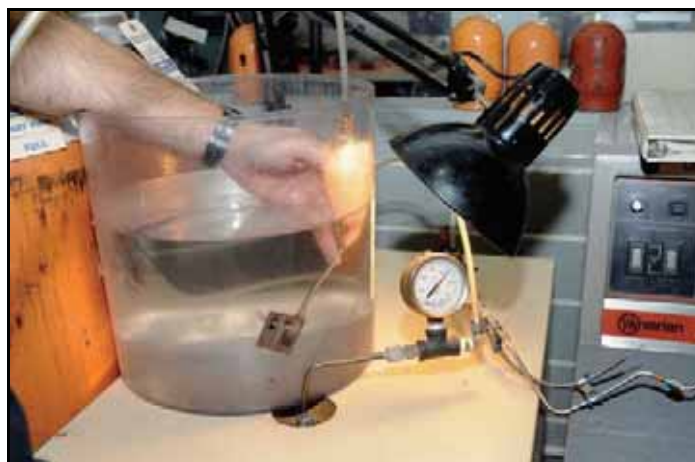
The  $P_{T2}/T_{T2}$  sensor was cut midway in the capillary tube to isolate the bellows from the probe to determine which end may be breached. Each half was pressured using helium, then dunked into a tank of Stoddard Fluid (MIL-F-7024 type II) (**Photo No. 3**).

**Photo No. 3:**  $P_{T2}/T_{T2}$  leak check test

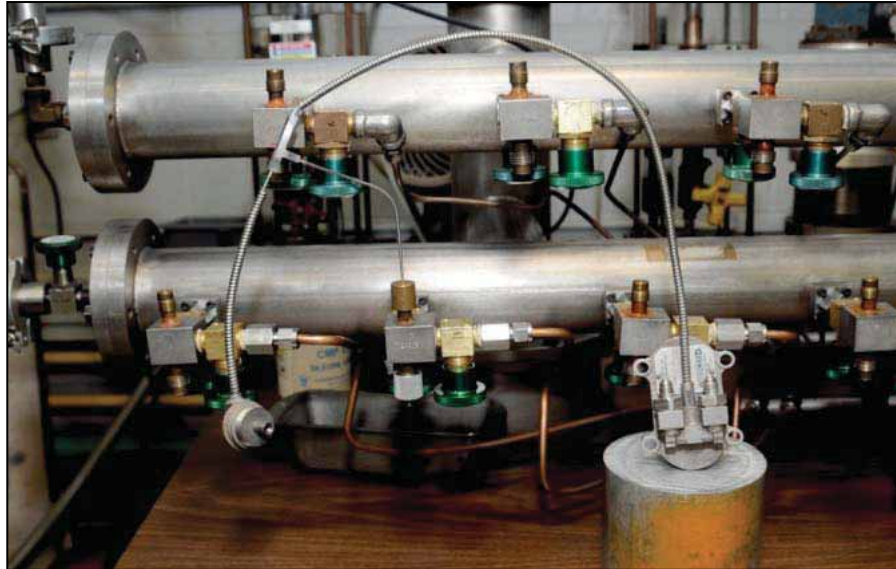
The modified  $P_{T2}/T_{T2}$  sensor was then put under vacuum to draw any air trapped out the system and then it was filled with N-butyl alcohol (**Photo No. 7**).

**Photo No. 7:** pressurizing the  $P_{T2}/T_{T2}$  sensor to determine leak rate

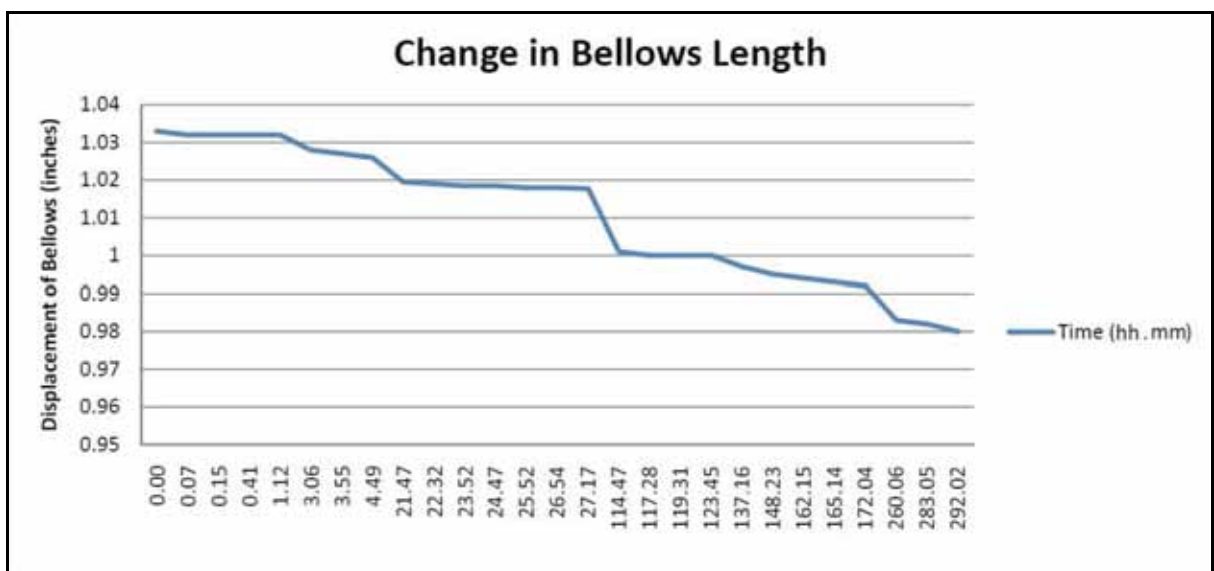
A 15-pound load was then applied to the bellows that simulates the load it would experience when attached to the engine. Under this load, the bellows displacement was measured to be 1.33-inches. The loss of internal pressure (bellows displacement) was monitored and recorded as a function of time (**Plot 1** and **Table 1**). The following displacements and times were recorded:

**Plot 1:** Bellows Length Change vs Time

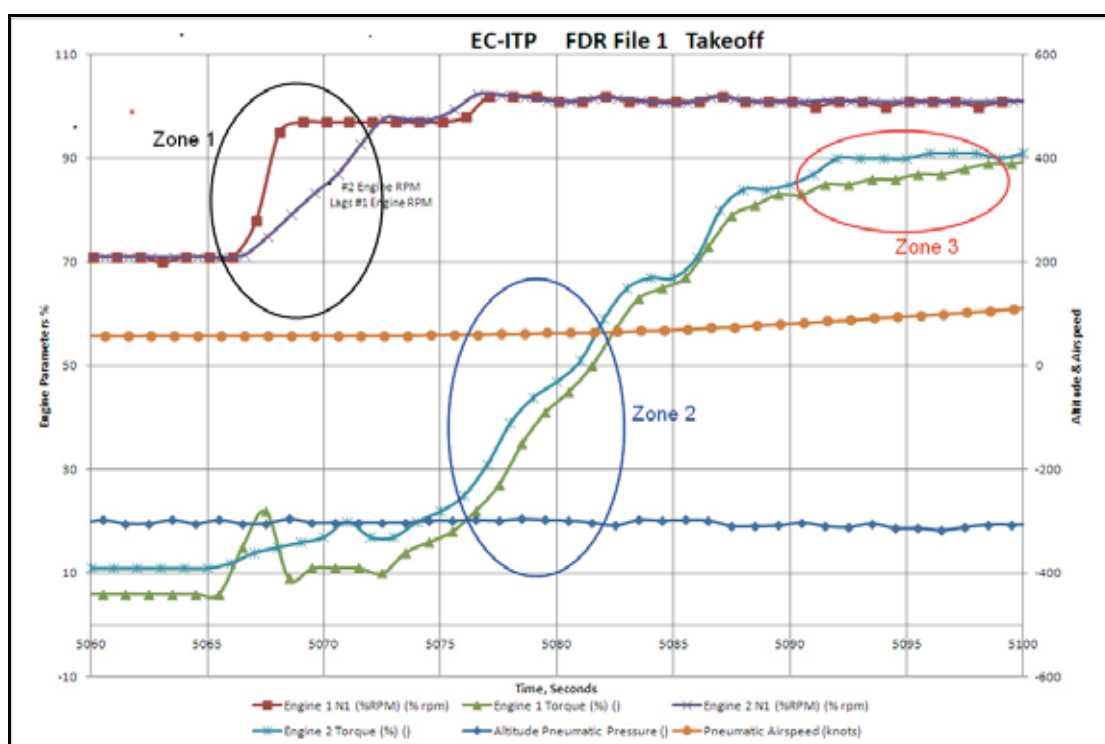
**Figure No. 1** shows FDR recorded parameters from EC-ITP on a take-off several weeks before the accident flight indicating that the  $P_{T2}/T_{T2}$  anomaly existed at that time.

**Figure No. 1:** Previous Take-off FDR Parameters

In Zone 1, the two curves show the engine speeds measured in RPM for the No. 1 engine (red) and the No. 2 engine (purple). The curves show that when the speed levers were advanced from Low RPM to High RPM in preparation for take-off and the engine speeds increased from 70% to approximately 97%, the speed response of the No. 2 engine lagged behind that of the No. 1 engine by approximately 5 seconds.

The effects of this on EC-ITP can be seen in Zone 2 of **Figure No. 1**, where the engine torques increase as the power levers are advanced. Since, during this phase of engine operation, the fuel flow to engine No. 2 is higher due to the low temperature signal being transmitted by the shortened bellows, the torque of engine No. 2 advances ahead of that of engine No. 1.

This effect can be seen in Zone 3 of **Figure No. 1** where the engine torques are settling close to take-off values, the torque achieved by engine No. 2 is several percentage points greater than that for engine No. 1.

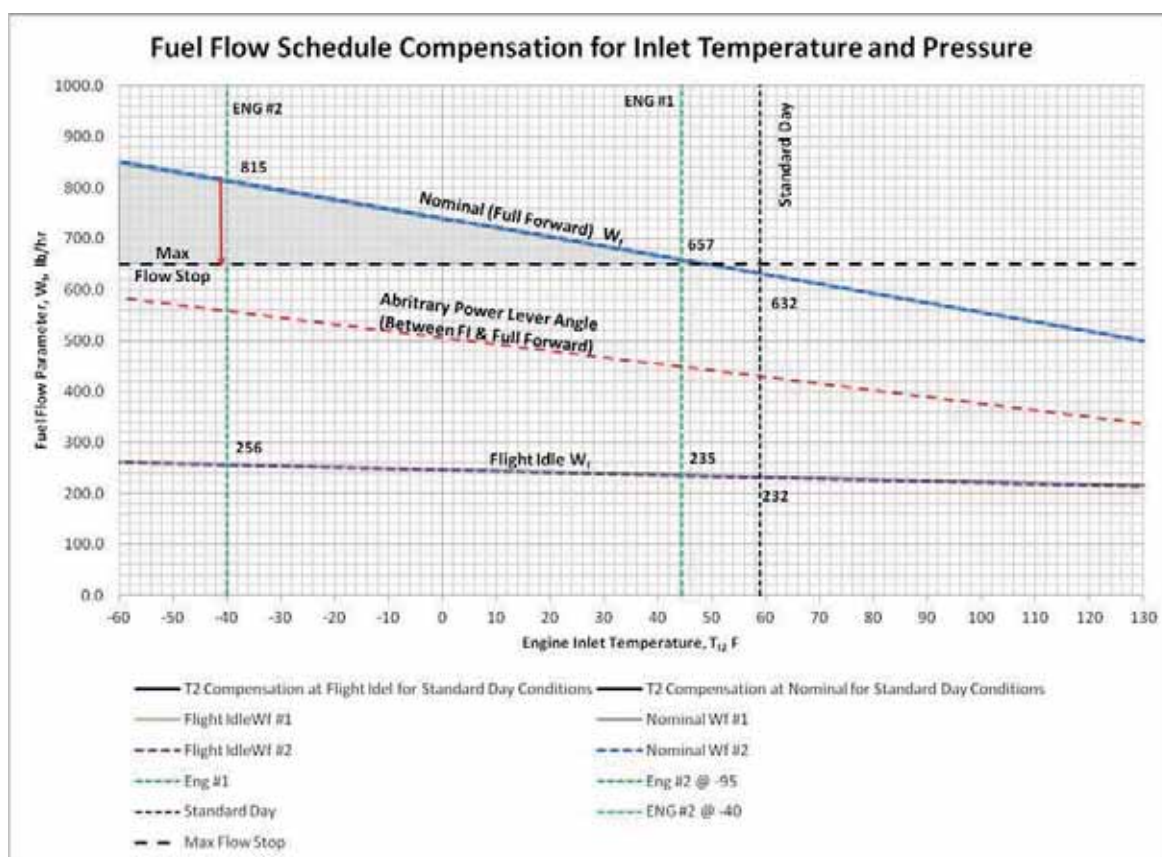
As the power lever is moved from Flight Idle to full forward, which is illustrated at an arbitrary power lever position by the dashed red line, there is a proportionally higher fuel flow to the No. 2 engine than to the No. 1 engine.

**Figure No. 2:** Fuel Flow Schedule Compensation (Source Honeywell)

Thus, as the power levers are advanced for take-off, the effect of a shortened bellows is to increase the fuel flow to the engine on the side with the shortened bellows, i.e. the No. 2 engine on EC-ITP.

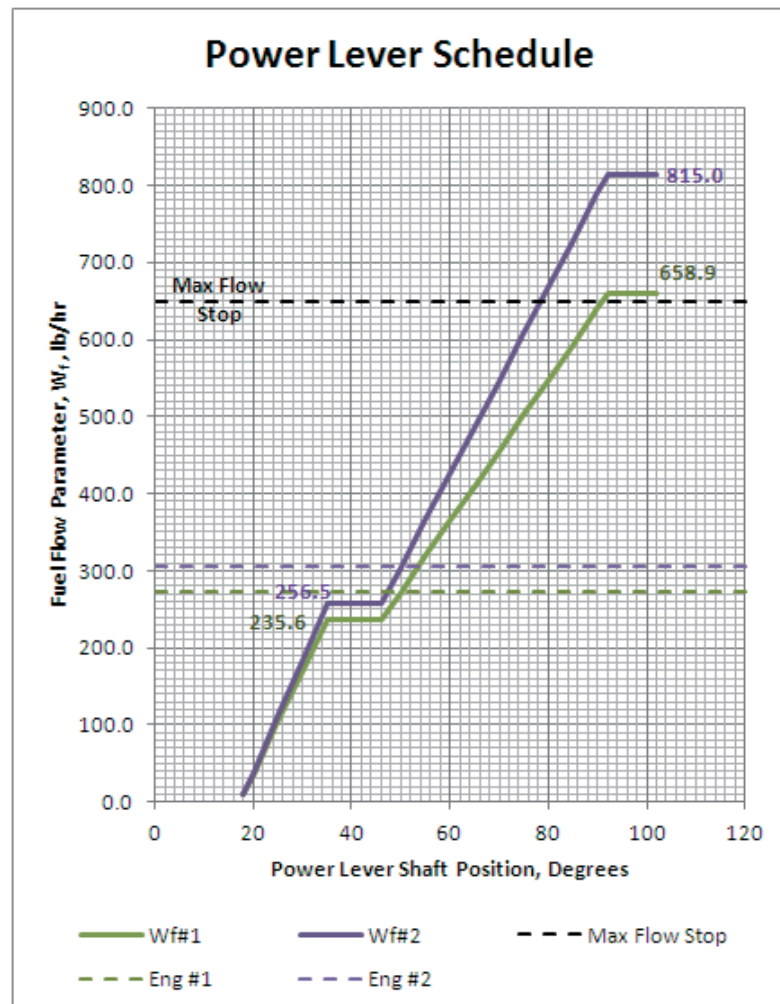
**Figure No. 3** shows the comparative power lever schedules for the two engines on EC-ITP. The power lever position fuel flow schedule for engine No. 1 is shown in green, representing compensation for the correct inlet temperature as sensed by the normal  $P_{T2}/T_{T2}$  sensor. The schedule for engine No. 2 (in purple), shows fuel flow against power lever position compensated for the negative temperature bias being transmitted from the  $P_{T2}/T_{T2}$  sensor with the shortened bellows. It can be seen that, for a given power lever angle, No. 2 engine fuel flow is higher than that for No. 1 engine.

**Figure No. 3:** Power Lever Schedule for EC-ITP Engines (*Honeywell*)

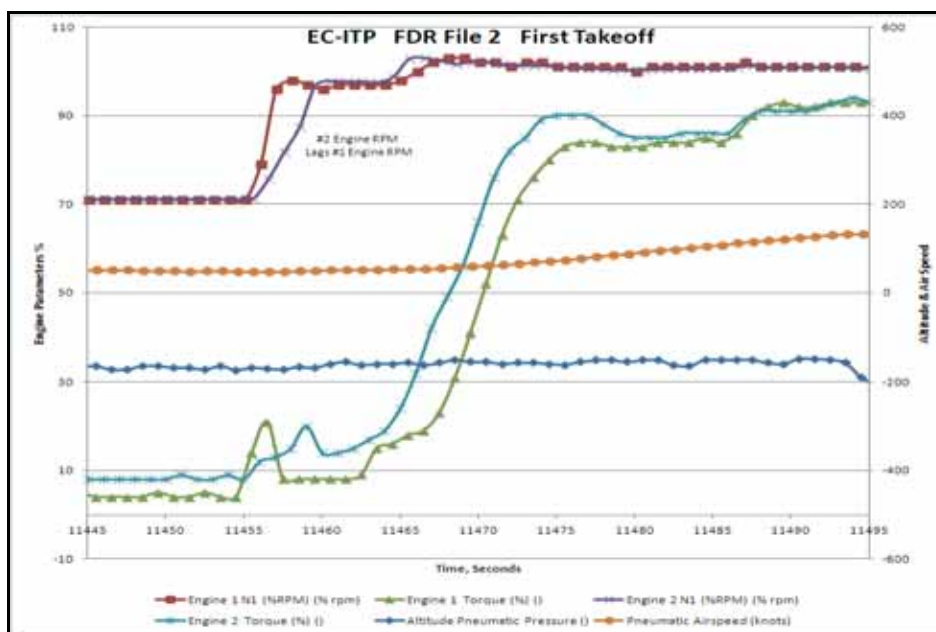
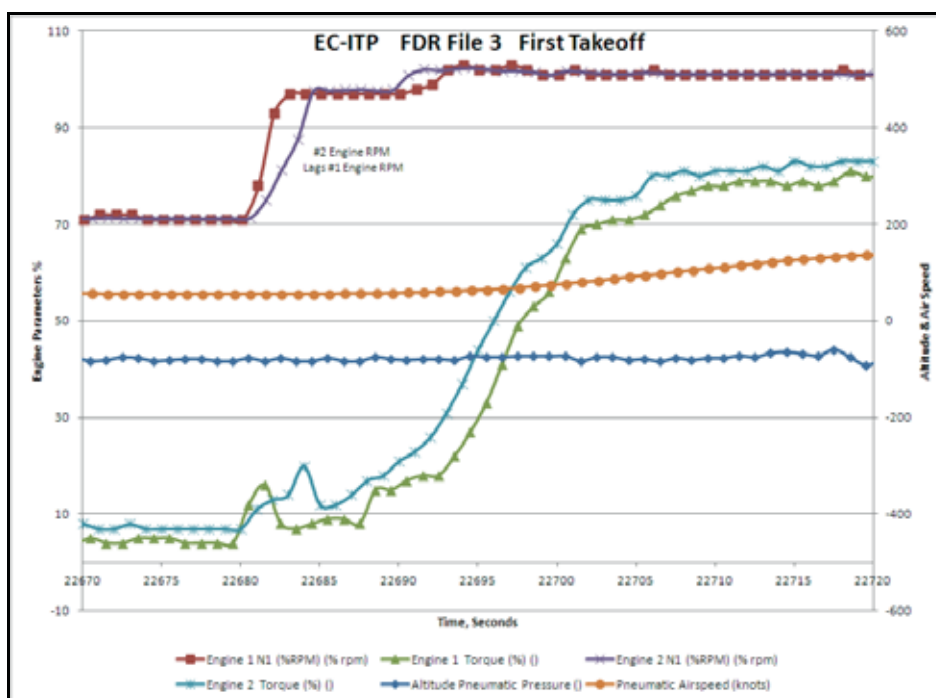
**Figure No. 4** and **Figure No. 5** present FDR data for two further take-offs made by EC-ITP some weeks before the accident flight. Similar characteristics are seen, in that the engine No. 2 RPM lags that of engine No. 1 as the speed levers are advanced in each case. Also, the torque achieved by engine No. 2 advances ahead of that achieved by engine No. 1 and, particularly as seen in **Figure No. 5**, the No. 2 engine torque remains higher than that of No. 1 engine as the aircraft speed increases during its take-off run.

**Figure No. 4:** Sample of take-off FDR parameters weeks prior to accident

**Figure No. 5:** Additional sample of take-off FDR parameters weeks prior to accident

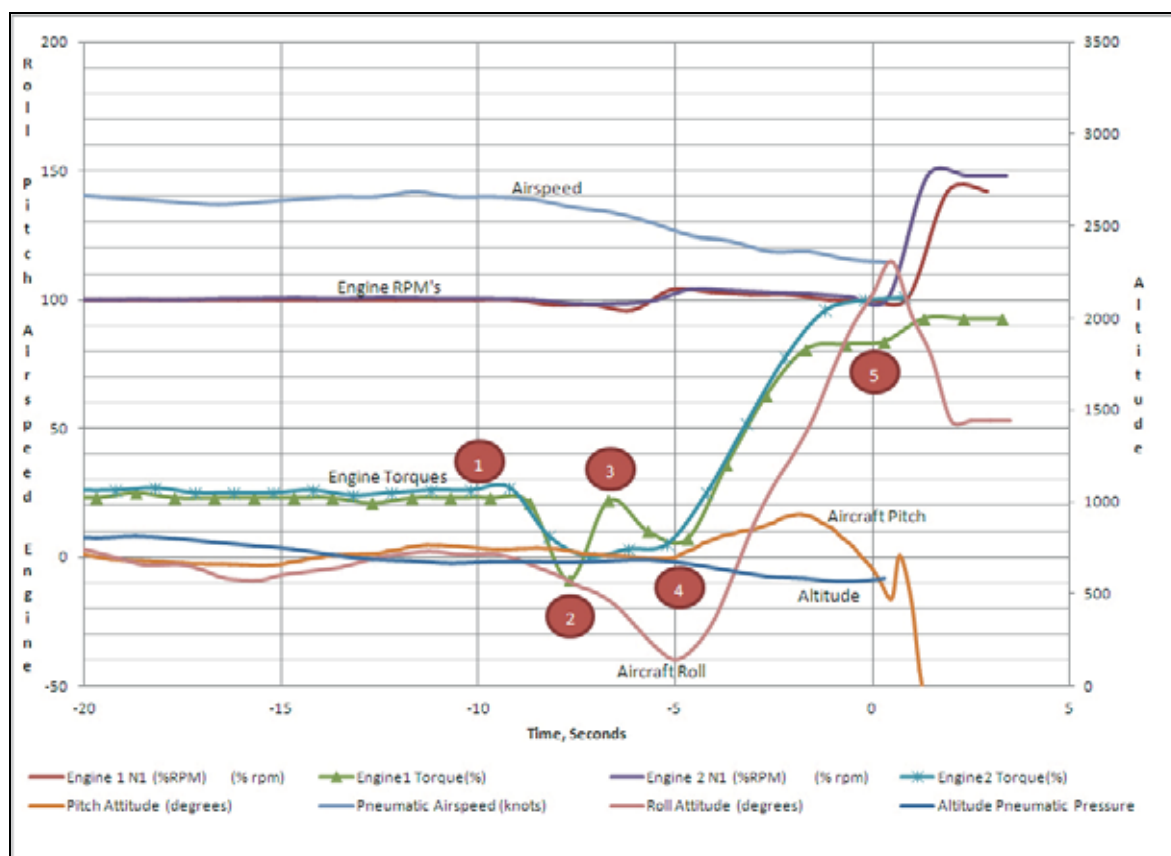
**Figure No. 6:** FDR Parameters during final approach (accident flight)

**Figure No. 6** illustrates various FDR parameters recorded during the accident sequence. The x-axis represents time measured in seconds with the “0” point representing a time approximately one second before commencement of the impact sequence, when the values of recorded parameters became unreliable.

The data shows that, as the aircraft descended towards the runway during the time period from -20 secs to approximately -9 secs, the engine torque for the No. 1 engine was recorded at values generally in the range 21 to 23% while that for the No. 2 engine was in the range 25 to 27%. During this period, the engine speeds were recorded as 100% for No. 1 engine and at values in a range between 100.0% and 100.7% for No. 2 engine. These values are illustrated in **Figure No. 6** from the left hand axis until a time just after datapoint 1.

**Table No. 1** sets out the values, either recorded or interpolated from the FDR data, for the five datapoints shown in **Figure No. 6**.

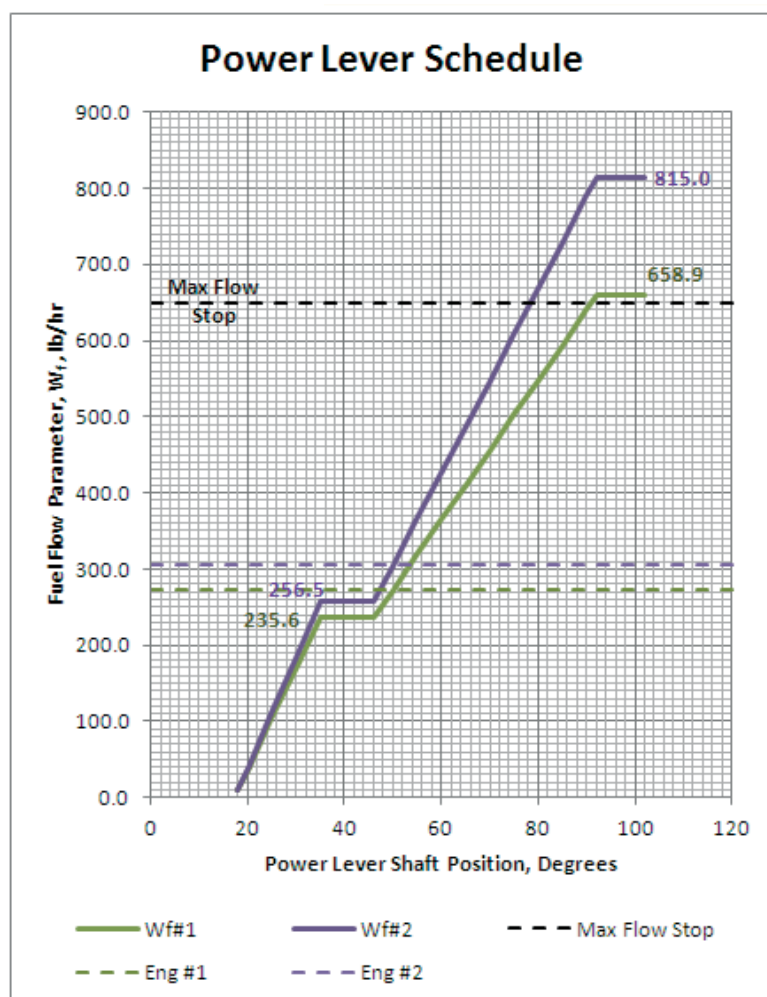
**Figure No. 7:** Fuel Flow/Power Lever Angle (PLA) Curves

All of the above calculations take no account of the effects of the shortened  $P_{T2}/T_{T2}$  sensor bellows height and the consequent negative temperature bias. In order to calculate the power lever angle at those data points where the fuel flow was on the respective power lever schedule, it is necessary to use the curves shown in **Figure No. 7** (which is a reproduction of **Figure No. 3**) and takes into account the effects of the shortened bellows.

In this figure, the curve of fuel flow (Wf#1) against PLA for the No. 1 engine, is shown in green while that for the No. 2 engine is shown in purple. If each of the fuel flow figures shown in **Table No. 3** is brought across to the applicable curve in **Figure No. 7**, then the equivalent power lever angles for each point can be derived. This data is shown for engines No. 1 and No. 2 in **Tables No. 4** and **No. 5** respectively.

In summary, the data indicates that at datapoint No. 1, both power levers were in the PLA range 50° to 52°. At datapoint No. 2, the torques and engine speeds for both engines are seen to decrease, with a corresponding reduction in computed fuel flow. From the Fuel Flow/PLA curve shown in **Figure No. 7**, it can be seen that both power levers were now at angles in the range 31° to 33°, i.e. they were both at an angle below (or behind) the Flight Idle gate.

Similarly, if the computed fuel flow figure for No. 2 engine of 305.9 lb/hr at datapoint 4 is inserted into the appropriate curve in **Figure No. 7**, a power lever angle of approximately 50° is derived. Again, since the OSG was active and was restricting the fuel flow to this figure, it can be stated that the power lever angle was probably greater than 50°.

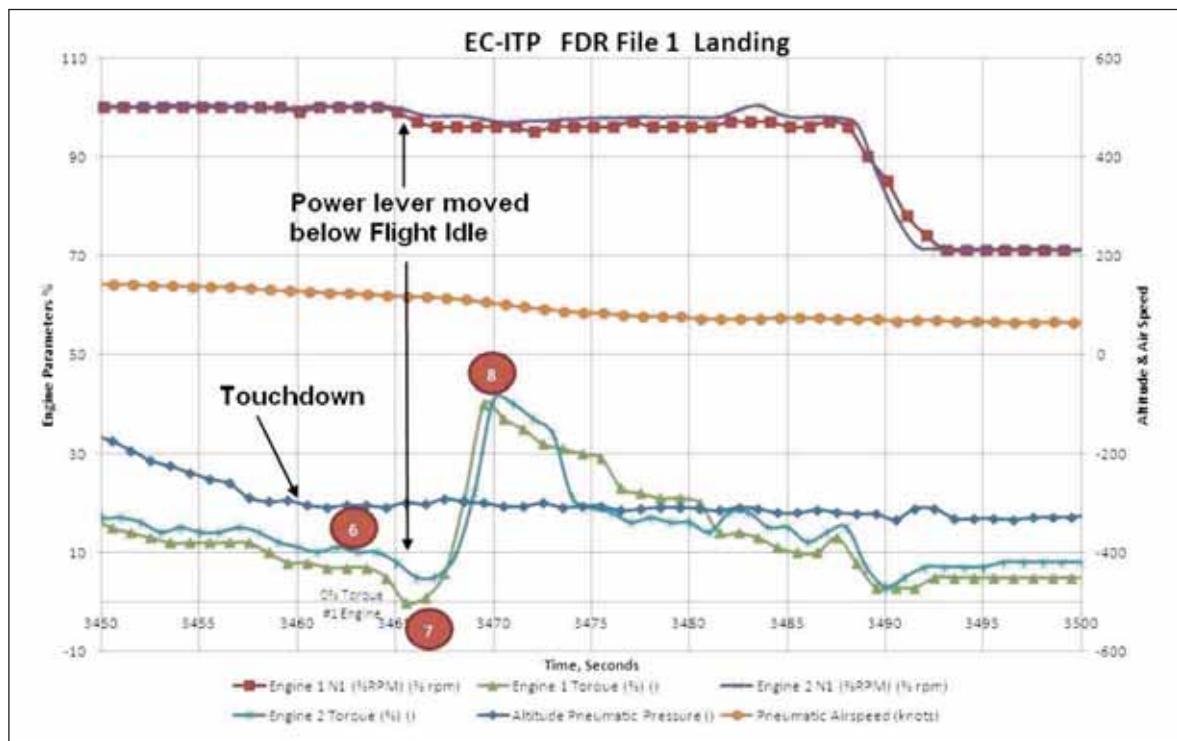
**Figure No. 8:** FDR Data from Previous Landing

The Investigation looked at a landing which had been made by EC-ITP at a Spanish airport several weeks before the accident, and for which FDR data was available. **Figure No. 8** illustrates the FDR data for this landing in similar format to that shown for the accident. Time in seconds is shown on the x-axis while the various engine parameters along with altitude and airspeed are shown on the y-axis. The touchdown occurred at FDR time reference 3460.

A similar analysis was carried out for this landing, and the manufacturer's computer model was used to calculate the fuel flows at datapoints 6, 7 and 8 as shown in **Figure No. 8**. The data is shown for the No. 1 engine in **Table No. 6** and for No. 2 engine in **Table No. 7**.

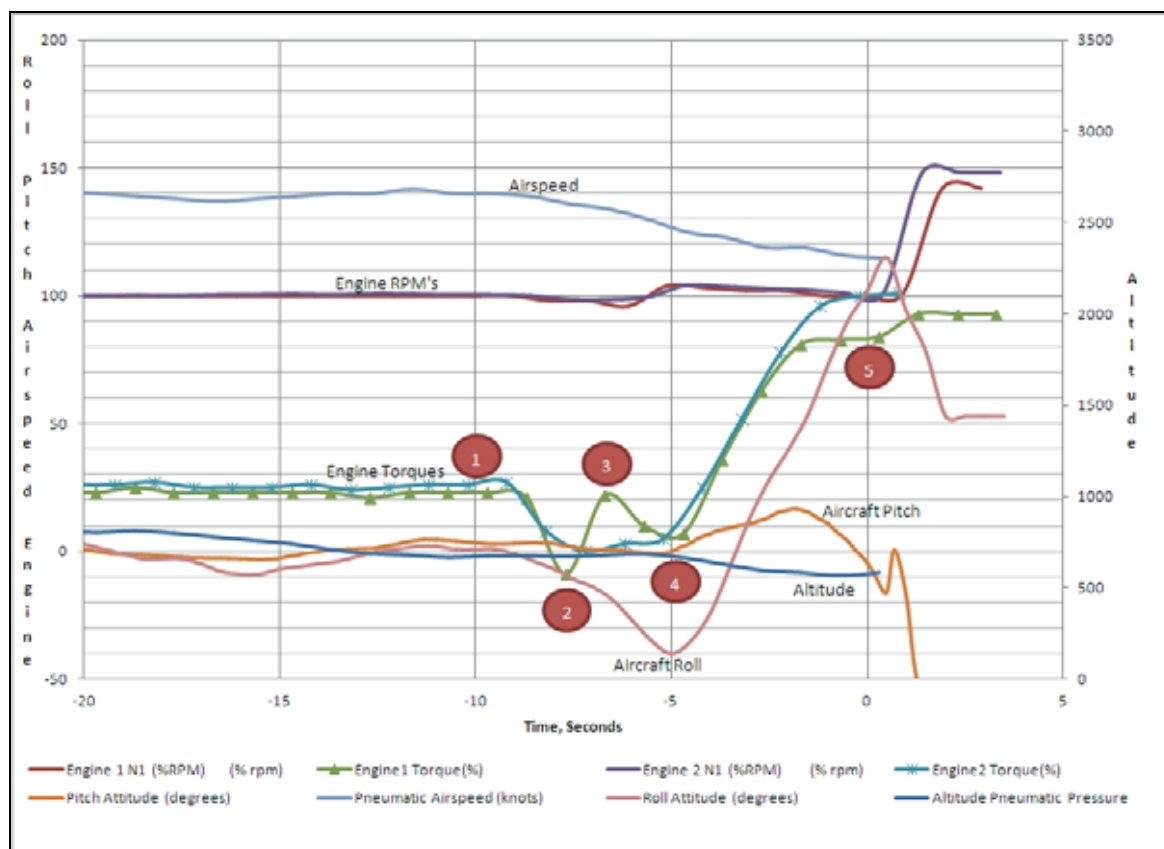
**Figure No. 9:** FDR Parameters during final approach (accident flight)

Regarding the final approach and the time period from -20 seconds to approximately -9 seconds, the engine torque for the No. 1 engine was recorded at values generally in the range 21 to 23% while that for the No. 2 engine was in the range 25 to 27%. During this period, the engine speeds were recorded as 100% for No. 1 engine and at values in a range between 100.0% and 100.7% for No. 2 engine, **Figure No. 9**.
