Air Accident Investigation Sector

- Final Report –

AAIS Case N°. AIFN/0002/2012

Attempted Takeoff from Runway Edge

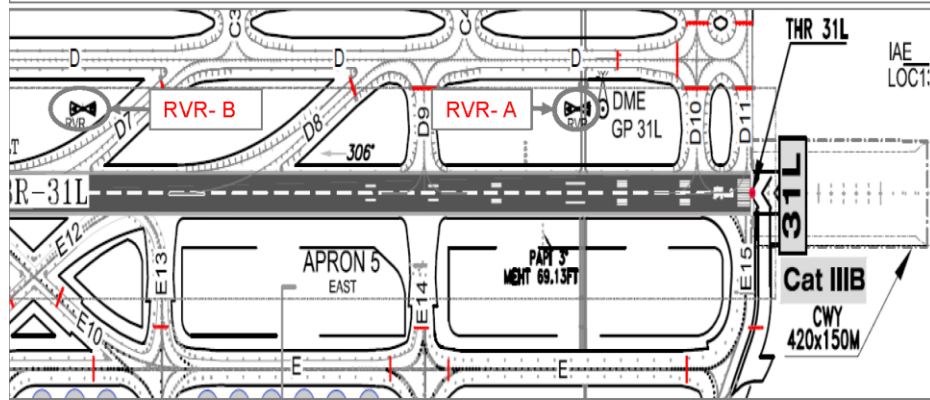
Figure 9. RVR A location

The location of RVR A is approximately 350m away from the 31L threshold, as shown in figure 9. When the Commander said that he could not see during the taxi after stop bar E15, the Aircraft was approximately 425m from RVR A.

RVR- A is located approximately 350 meters from 31L Threshold. At the point the Commander said he could not see, RVR- A to the Aircraft was approximately 425 meters.

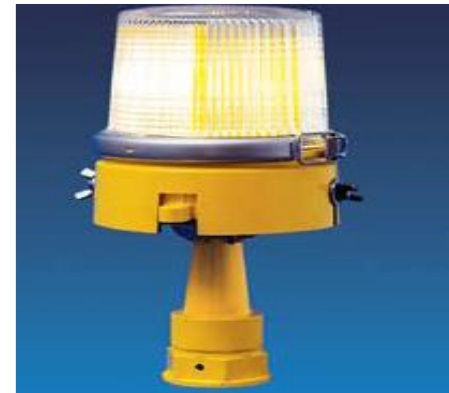
Figure 11. Runway edge lamp

The runway edge lamps, spaced at 60m, feature an omnidirectional component for circling guidance. They are 30mm in height and are mounted above the runway surface. It is designed to withstand the heaviest jet blast with a minimum number of parts. There is an inner lens and the outer dome remains clamped to the upper body for fast re-lamping as it is only necessary to undo two wingnut-screws. The light inside the lamp is a precision quartz halogen bulb which is pre-focused and accurately positioned in the lower body. Stability of the lamp is normally ensured through attachment to heavy material such as concrete. Levelling and aiming in azimuth of the lamp are performed using a specialized aiming device. The lamp is designed to be frangible in case of impact.

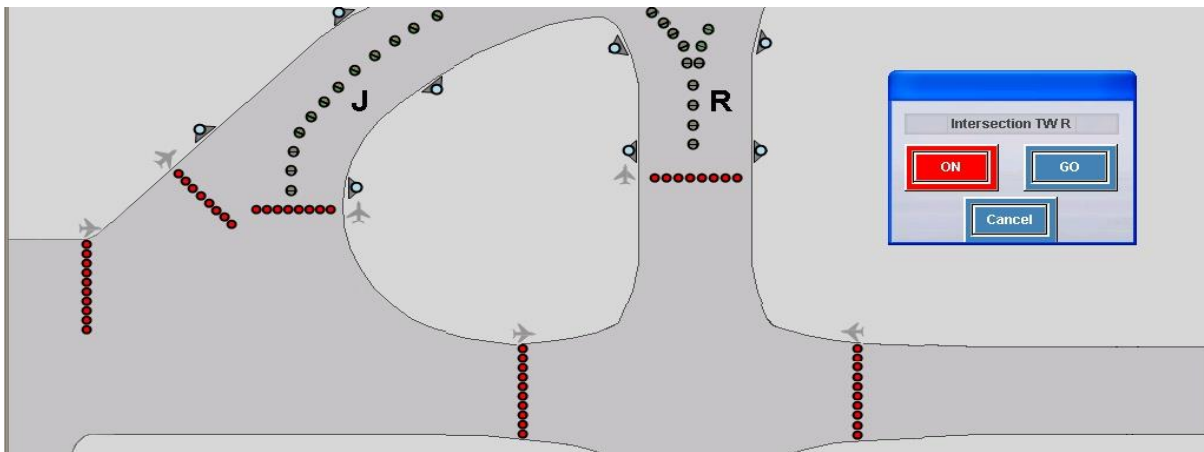
Figure 13. Viewing an intersection stop bar

For the Incident flight, when the ATCO wanted to operate the E15 stop bar, he had to touch the stop bar indicator in the screen which would have popped up the page shown in figure 13 indicating that the stop bar is ON and the green lead-in lights are OFF. Initially the ON button was red indicating that the stop bar was ON. Additional selectable options are ON, GO and CANCEL.

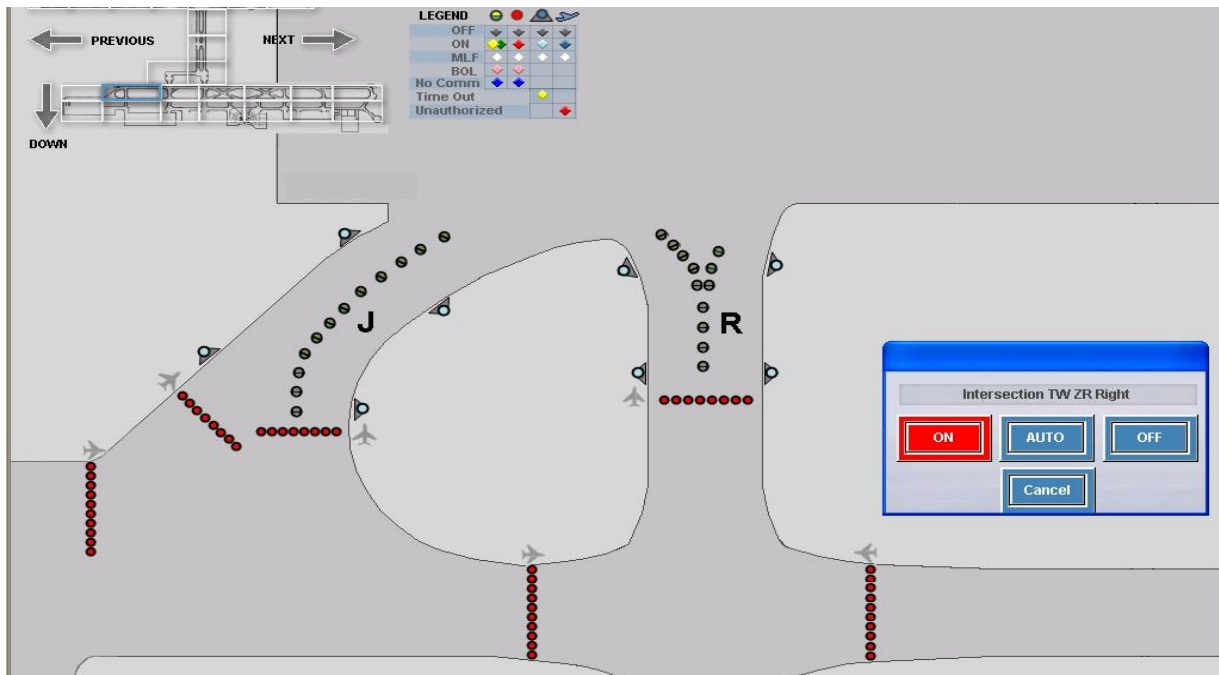
Figure 16. Activating a timed intersection

If the system was set to automatic, figure 16, the difference was that the stop bar would have turned back ON when either the Aircraft passed the second sensor 17/7, or a period of 45 seconds had elapsed since the command to GO was issued.
