# Runway excursion involving Boeing 737, VH-VUI

Darwin Airport, Northern Territory | 6 December 2016

**ATSB Transport Safety Report**  
Aviation Occurrence Investigation  
AO-2016-166  
Final – 15 May 2019

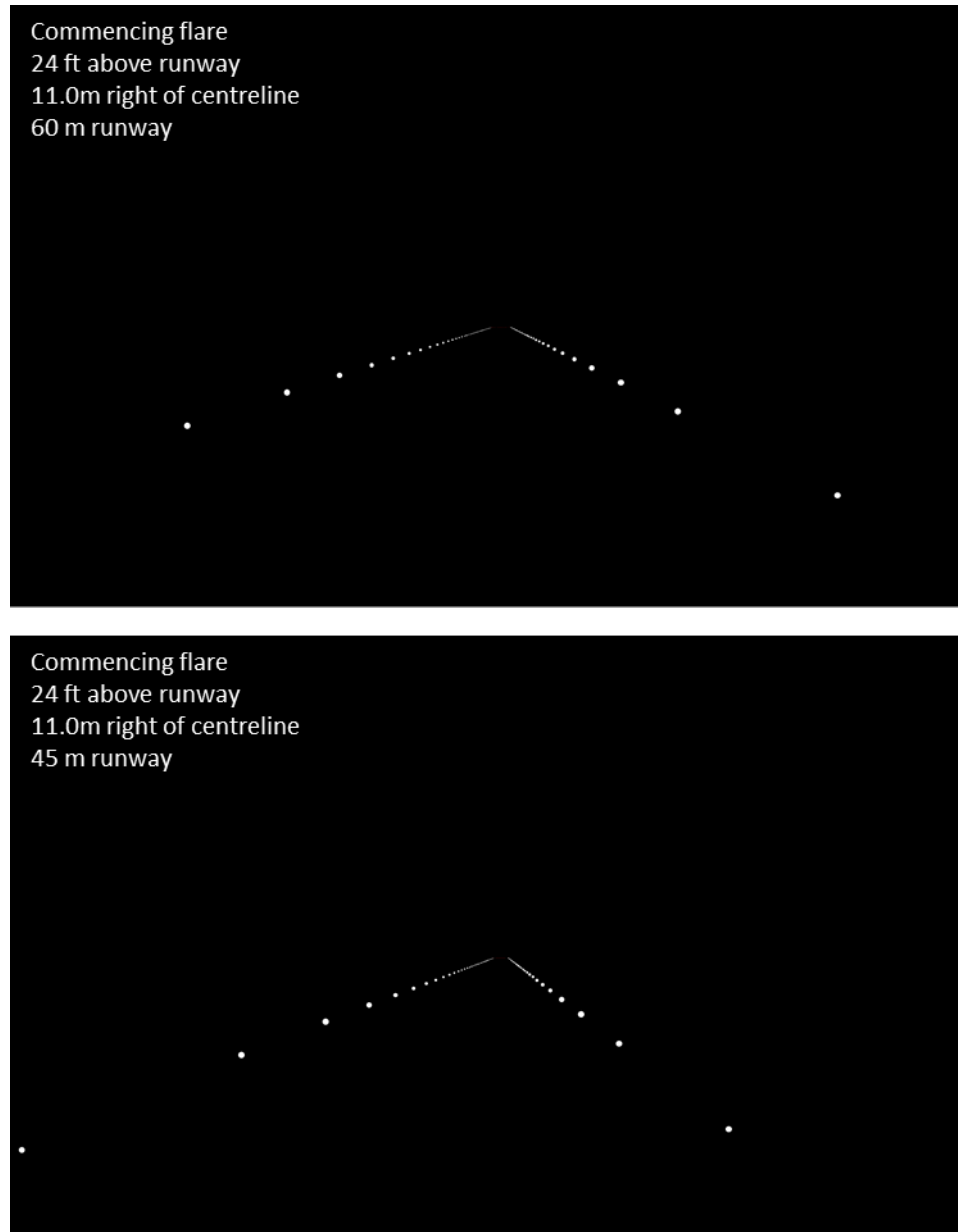
**Figure A5: Simulated approaches to runways of different widths, without centreline lighting**

Figure A5 compares a 60 m wide runway without centreline lighting (top) with a 45 m wide runway without centreline lighting (bottom). In both cases, the aircraft is 24 ft above the ground, 11.0 m right of centreline. The relative asymmetry of the two rows of lights is much easier to detect for the 45 m runway than the 60 m wide runway.
