**Accident** to Fokker 27-500  
registered **I-MLVT**  
on 25 October 2013  
during initial climb from Paris-Charles de Gaulle Airport

## Loss of a propeller blade then part of the left engine during initial climb, in-flight turn back, emergency landing

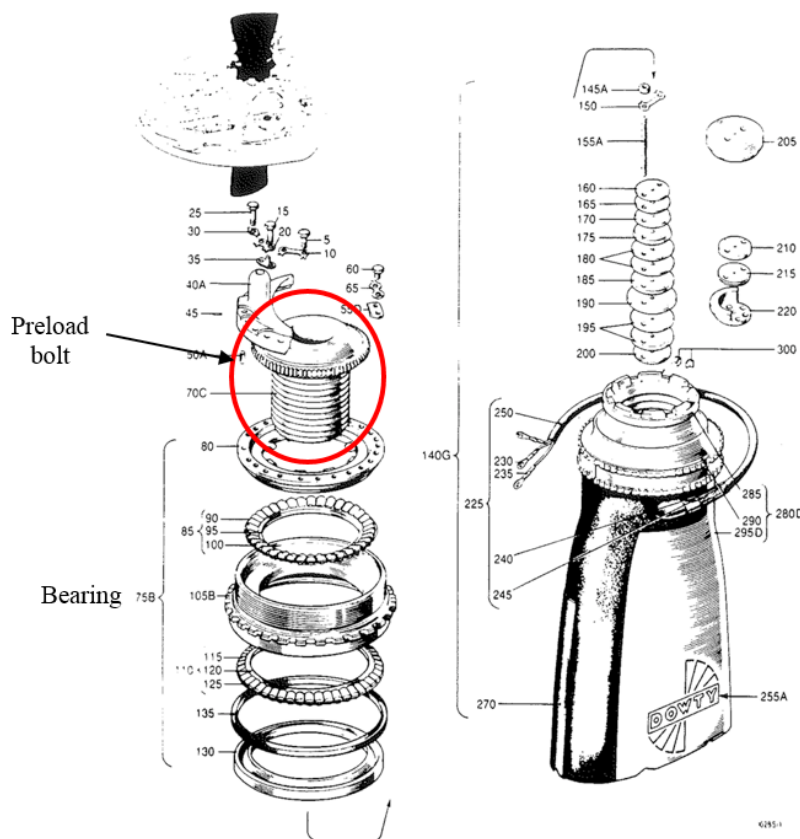
Figure 1: Exploded view of a propeller blade root, taken from the propeller OHM<sup>(3)</sup>

Each blade comprises a profile and a root, which in turn is made up of a bearing and a pre-load bolt. The bearing allows the blade to rotate in the hub, which is how the pitch is changed. The bolt is used to assemble and pre-load the bearing. The bolt tightening operation is described in the OHM. It requires the use of a hydraulic bench on assembling and disassembling the blade.

When the blade is assembled, before attachment to the hub, the OHM requires the bearing to be pre-loaded to an extension value within a certain specified range. Bearing extension is obtained by tightening the blade pre-load bolt. If the bearing extension is within the recommended range, this means that the bolt and bearing have been pre-loaded to an optimum degree, and this limits the in-service loads on the bolt.
