FINAL REPORT

Investigation of a serious incident on 30.06.2015 with FALCON F900 aircraft, registration marks VP-CGD, and EMBRAER 170 aircraft, registration marks SP-LDK, started in the controlled air space of the Republic of Romania and realized in the controlled air space of the Republic of Bulgaria.

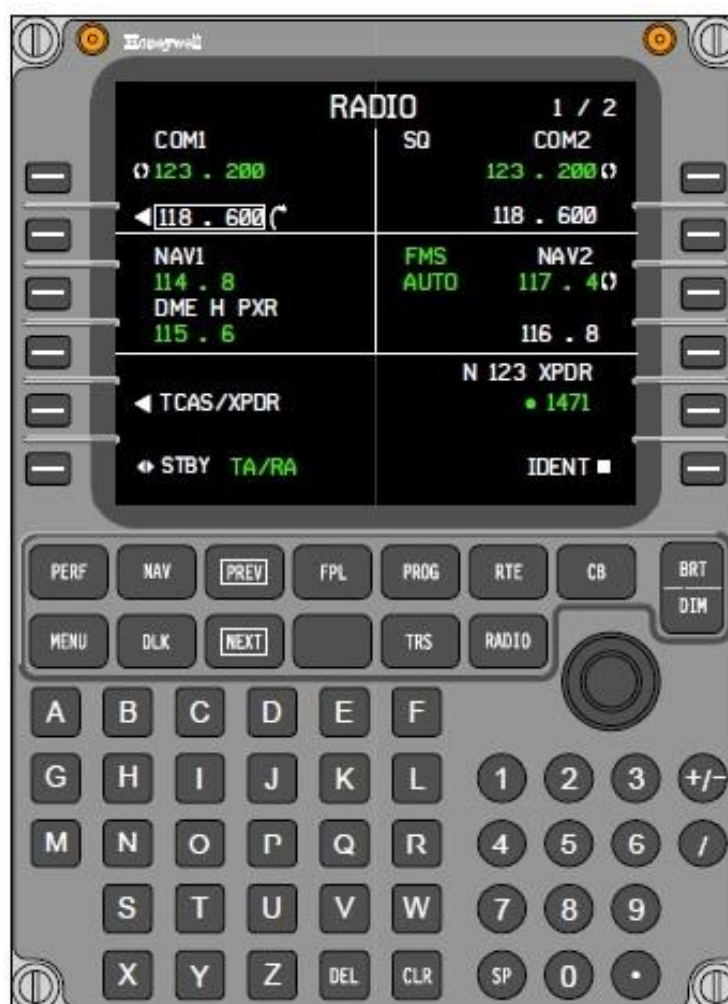
Fig. 8

The transponder system of Embraer-170 aircraft is controlled by two MCDUs (Multifunction Control Display Units) located on the Engine Start Panel (see Fig. 8).

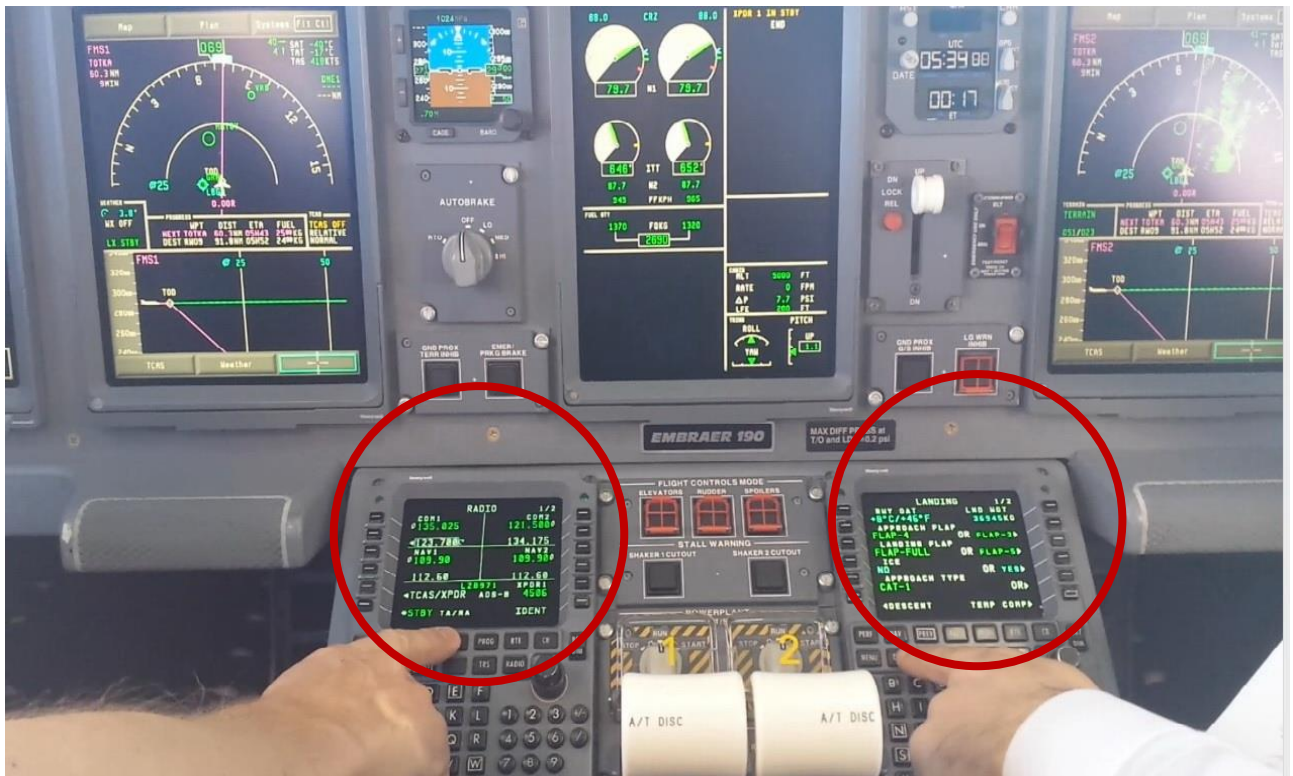
Fig. 9

The one MCDU is located on the right side of the Captain Pilot Flying, and the other one is located on the left side of the First Officer, as seen on Fig. 9.

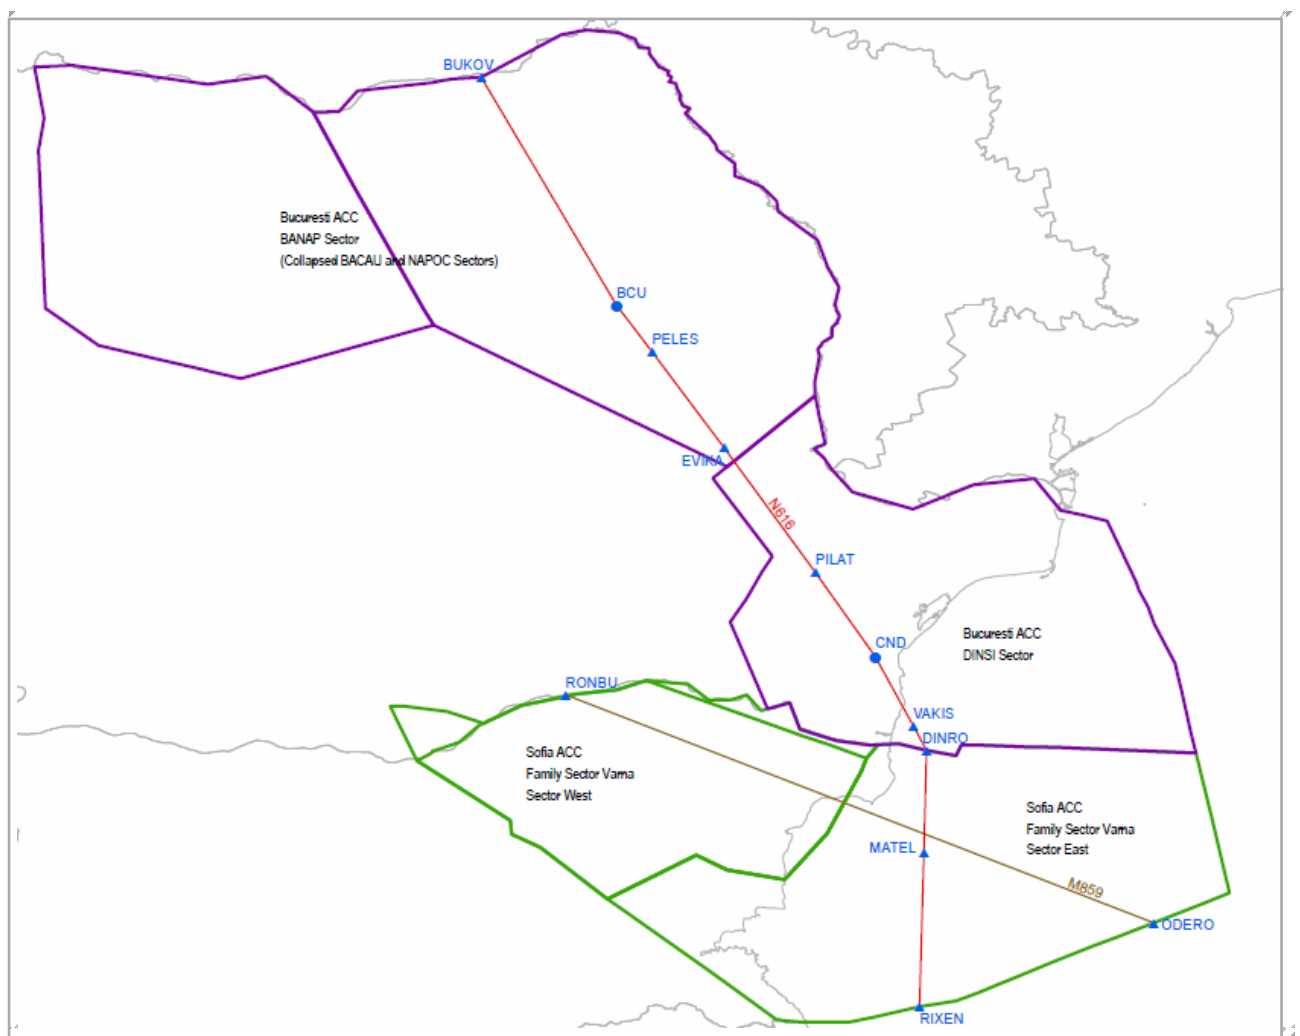
Fig. 12

The division of the air space into sectors is exhibited on Fig. 12.
