FINAL REPORT

on
investigation of a serious incident, realized on 11.03.2018 with B737-400 aircraft, registration marks TC-TLC, operated by TAILWIND AIRLINES AO, in a flight on route Antalya - Zurich over the territory of Republic of Bulgaria.

BULGARIAN AIRCRAFT ACCIDENT INVESTIGATION UNIT

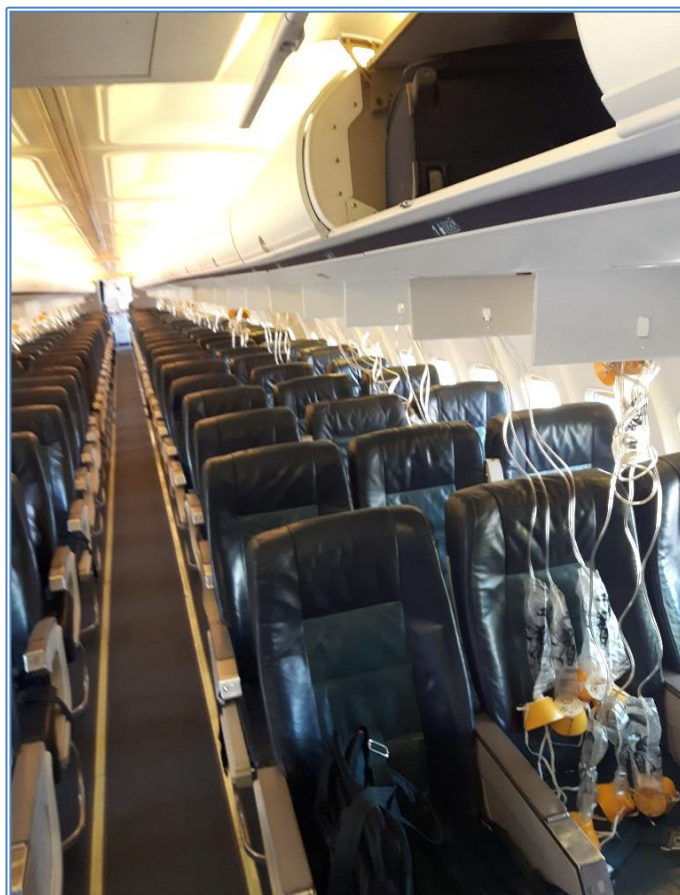
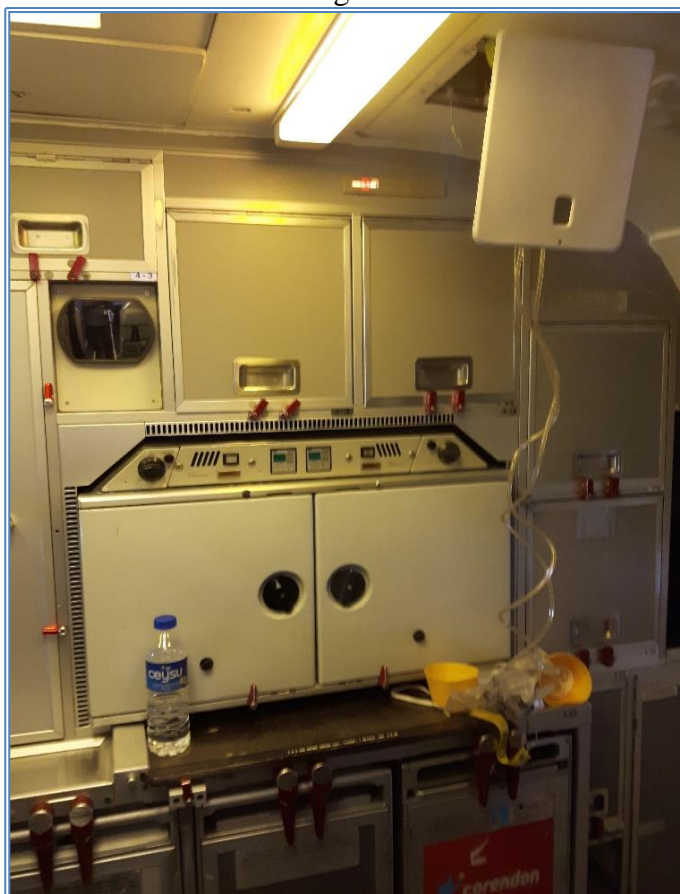
During the inspection of the aircraft after realization of air occurrence no damages on the airframe: The external condition of the airplane is visible from the photos shown in Enclosure 1. All oxygen masks in the passenger cabin were activated, Fig. 9 and 10 of Annex 1. A QAR memory card with flight parameters was downloaded. An inspection of the cabin pressure control system performed by CAMO of AO has revealed a failure of the outflow valve gasket

The passenger oxygen system automatically supplies oxygen masks to passengers and cabin crew when the cabin pressure falls below altitude values equivalent to 14000 ft. The oxygen is supplied from chemical oxygen generators after the oxygen mask is pulled down by the user. The masks can also be lowered by a switch located on the front upper panel in the cockpit. On the pictures on Fig. 9 and 10 of Enclosure 1 the lowered mask may be seen in the passenger cabin and in the galley.

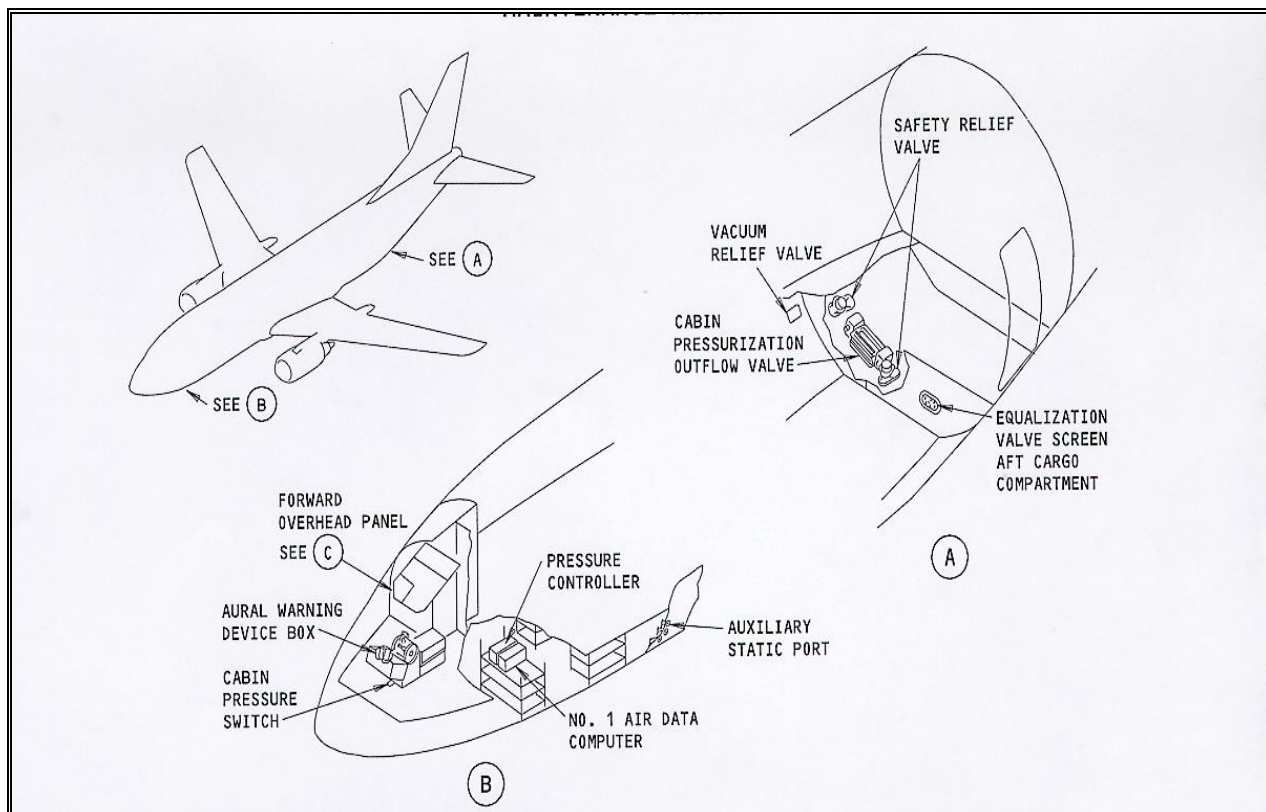
Fig. 11.

The air conditioning system, Part 21, in accordance with the unified classification system might be considered as consisting of four subsystems for: distribution, pressurization control, cooling and temperature control. The change of the cabin pressurized altitude, a basic feature for the serious incident under investigation, is related to the operation of the pressure control system. It provides in the pressurized compartments of the aircraft up to altitude of 28000 ft maximum overpressure of $7,45 \pm 0,1$ psi and at altitudes over 28000 ft maximum overpressure of $7,8 \pm 0,1$ psi. On the Fig. 11 of Enclosure 1 a layout of the pressurization control system components is shown.
