# Accident Investigation Final Report

**State File Number:** A13940723EPMNE  
**Type of Occurrence:** Accident  
**Date of Occurrence:** Oct. 15<sup>th</sup> 2015  
**Place of Occurrence:** Near Mehrabad Airport  
**Aircraft Type:** B747-300  
**Registration:** EP-MNE  
**Operator:** Mahan Air

Date of Issue: 10 Oct 2016

**Final Report**

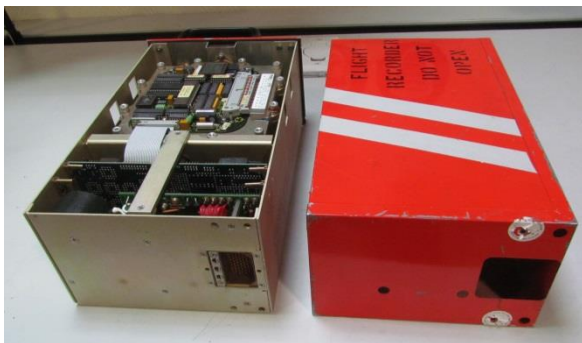
Fig 1 – CVR opened

A visual inspection was performed. No physical damage was found. The technical seals were still in place and intact. It was decided to perform a direct readout.

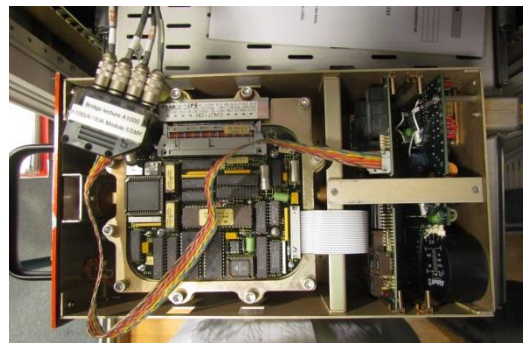
Fig 2 – CVR download

The download was successful. Four audio files with duration of 31 min 54 s were retrieved:

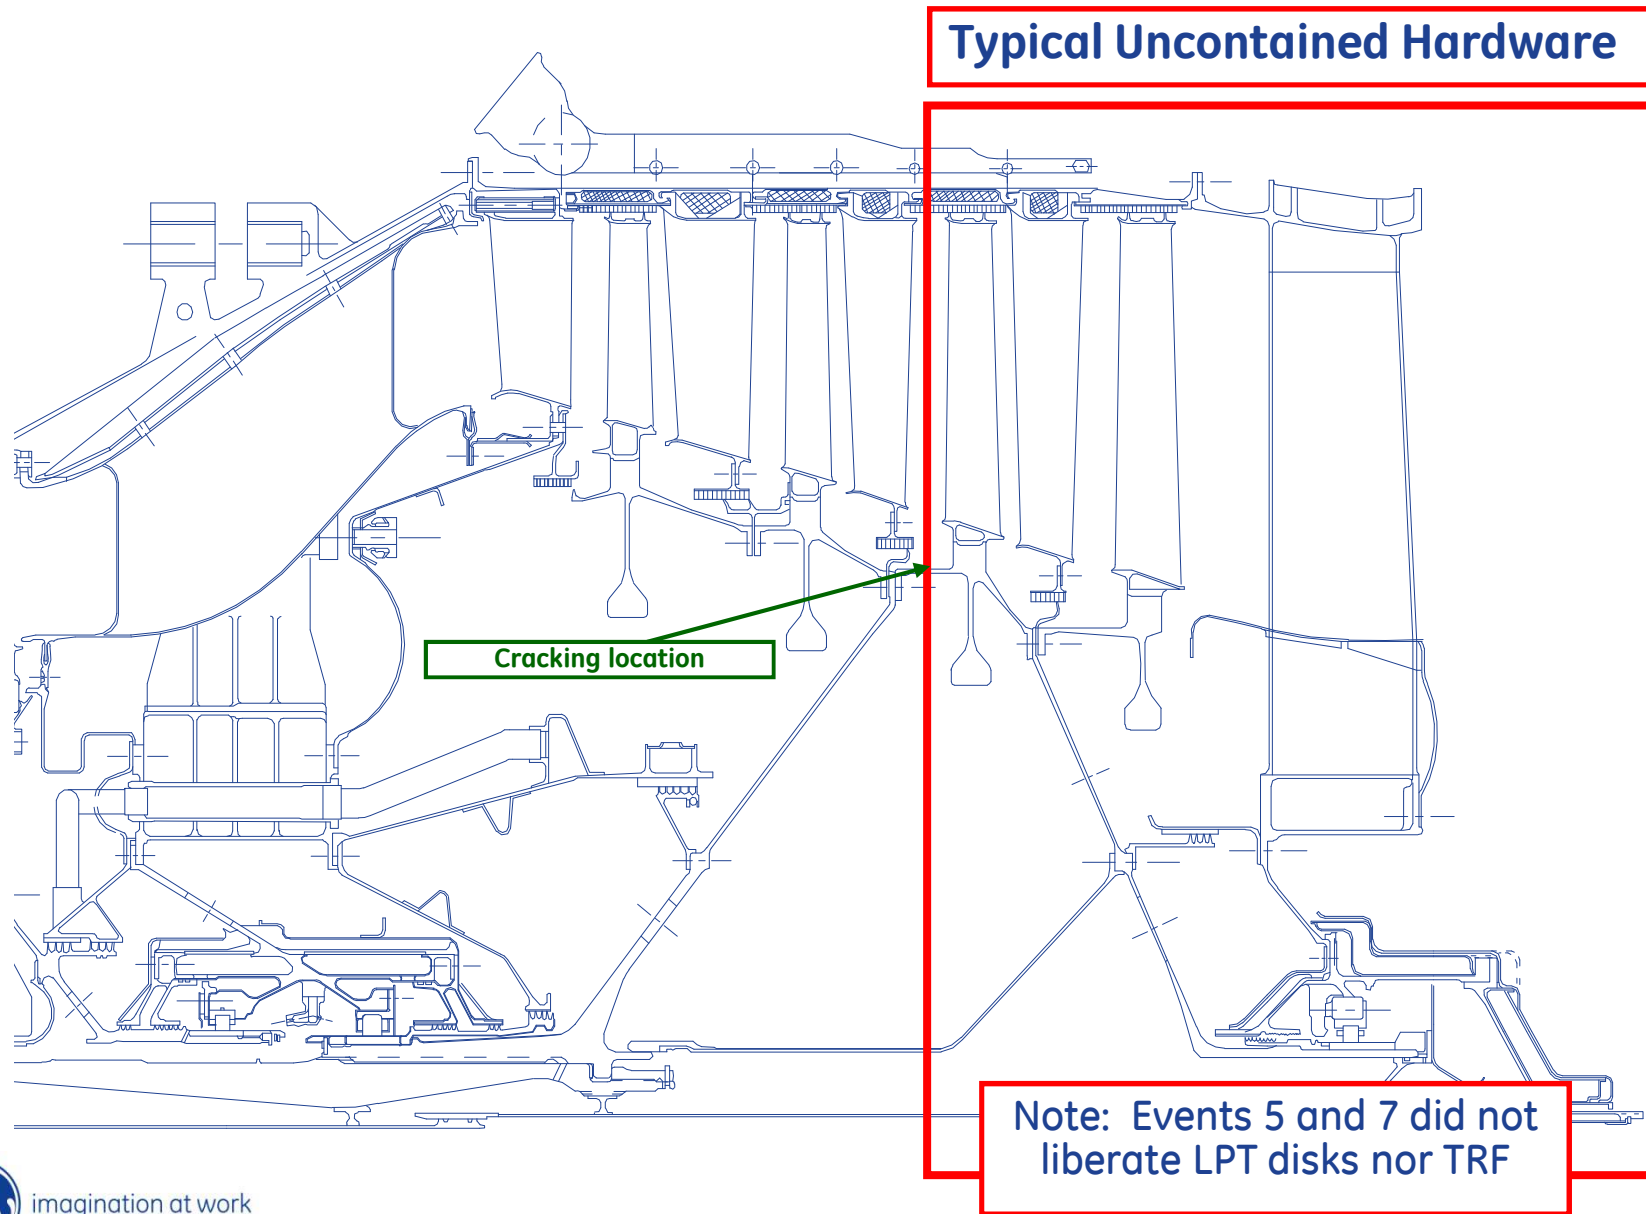
# *LPT Separation*

High HPTR imbalance causes secondary vibratory damage in the LPTR

HCF crack initiates/propagates in LPT S3 disk forward spacer arm

Continued engine operations can lead to 360° crack and separation of LPT
