## **INTERSTATE AVIATION COMMITTEE**

#### **FINAL REPORT**

| Type of aircraft | Airplane, Boeing 737-500 (53A) |
| Registration | VQ-BBN (Bermuda) |

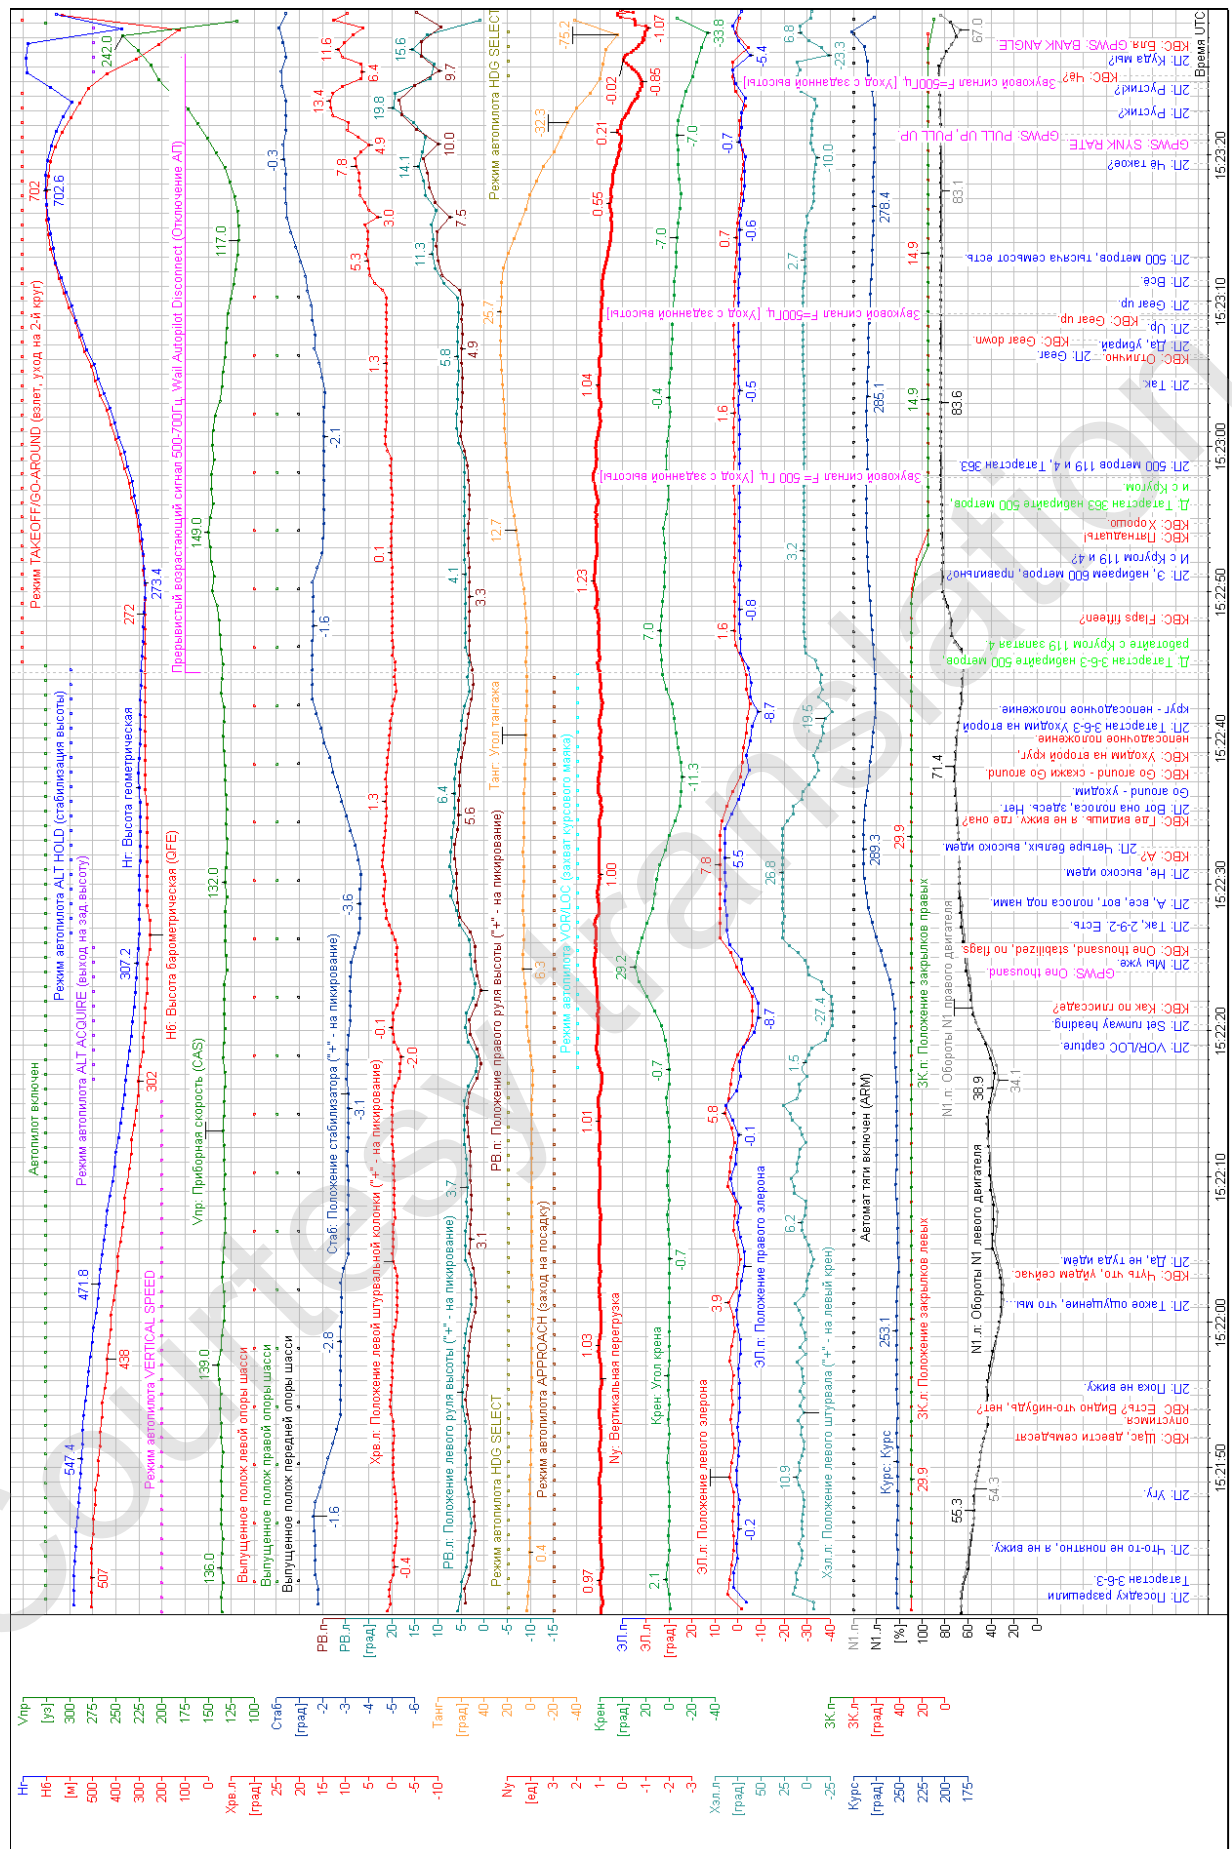
Figure 12 Boeing 737-500 VQ-BBN Flight Data for 17.11.2013 (final segment)

- The FDR contained data of 34 flights of the Boeing 737-500 VQ-BBN (approx. 61 hours of records) including the accident flight record;
- The Boeing 737-500 VQ-BBN FDR was operative on the flight of November 17, 2013 and recorded analogue data in full compliance with the list of Boeing 737-500 recordable parameters as well as event signals compatible to the their generation conditions.

After they received the clearance the crew engaged the V/S mode (selected vertical speed 1200 fpm) to descend to 270 m (900 ft) height which was selected on the MCP and maintained by the A/P until the go-around (Figure 12).

At 15:22:45 the crew engaged the TO/GA mode to go-around. As the TO/GA mode was engaged the A/P used for the approach was automatically disengaged as per design and the FD mode was active during the following flight (Figure 12).

The analysis of the trigger conditions for Altitude alert as well as ALT ACQ and HDG SEL signals at 15:23:25 (Figure 12) revealed the following: As the go-around was initiated the selected altitude was approx. 900 ft. After climbing to approx. 1200 ft the Altitude alert was triggered which meant they left the selected altitude. The next Altitude alert triggering occurred during the climb at an altitude of approx. 2000 ft and then it was triggered for the third time during the descent, as the aircraft was passing the altitude of approx. 1400 ft. This means that during the climb the crew reset the selected altitude to approx. 1700 ft (according to the go-around pattern). It can be concluded that the crew changed the selected altitude when they were already past it. This conclusion is drawn from the fact that the TO/GA mode was still engaged during the climb. The disengagement of the TO/GA mode (as the ALT ACQ and HDG SEL were engaged and thrust decreased) occurred only during the descent when crossing the altitude of approx. 1700 ft from above, which is compatible with the autoflight system logics – in TO/GA mode the selected altitude is captured from above only when the aircraft crosses it, while it is captured well in advance from below (during the climb). This was confirmed by the simulator experiments.

The PIC started active control inputs during landing gear retraction after the speed had fallen to 125 kt with pitch angle more than 25 degrees nose up. The control column was pushed nose down for approx. 1/3 of the travelling distance from the trimmed position (Figure 12). The actual altitude above runway level was approx. 2000 ft/600 m at that time and kept increasing with a vertical speed of over 4000 fpm (20 m/sec).

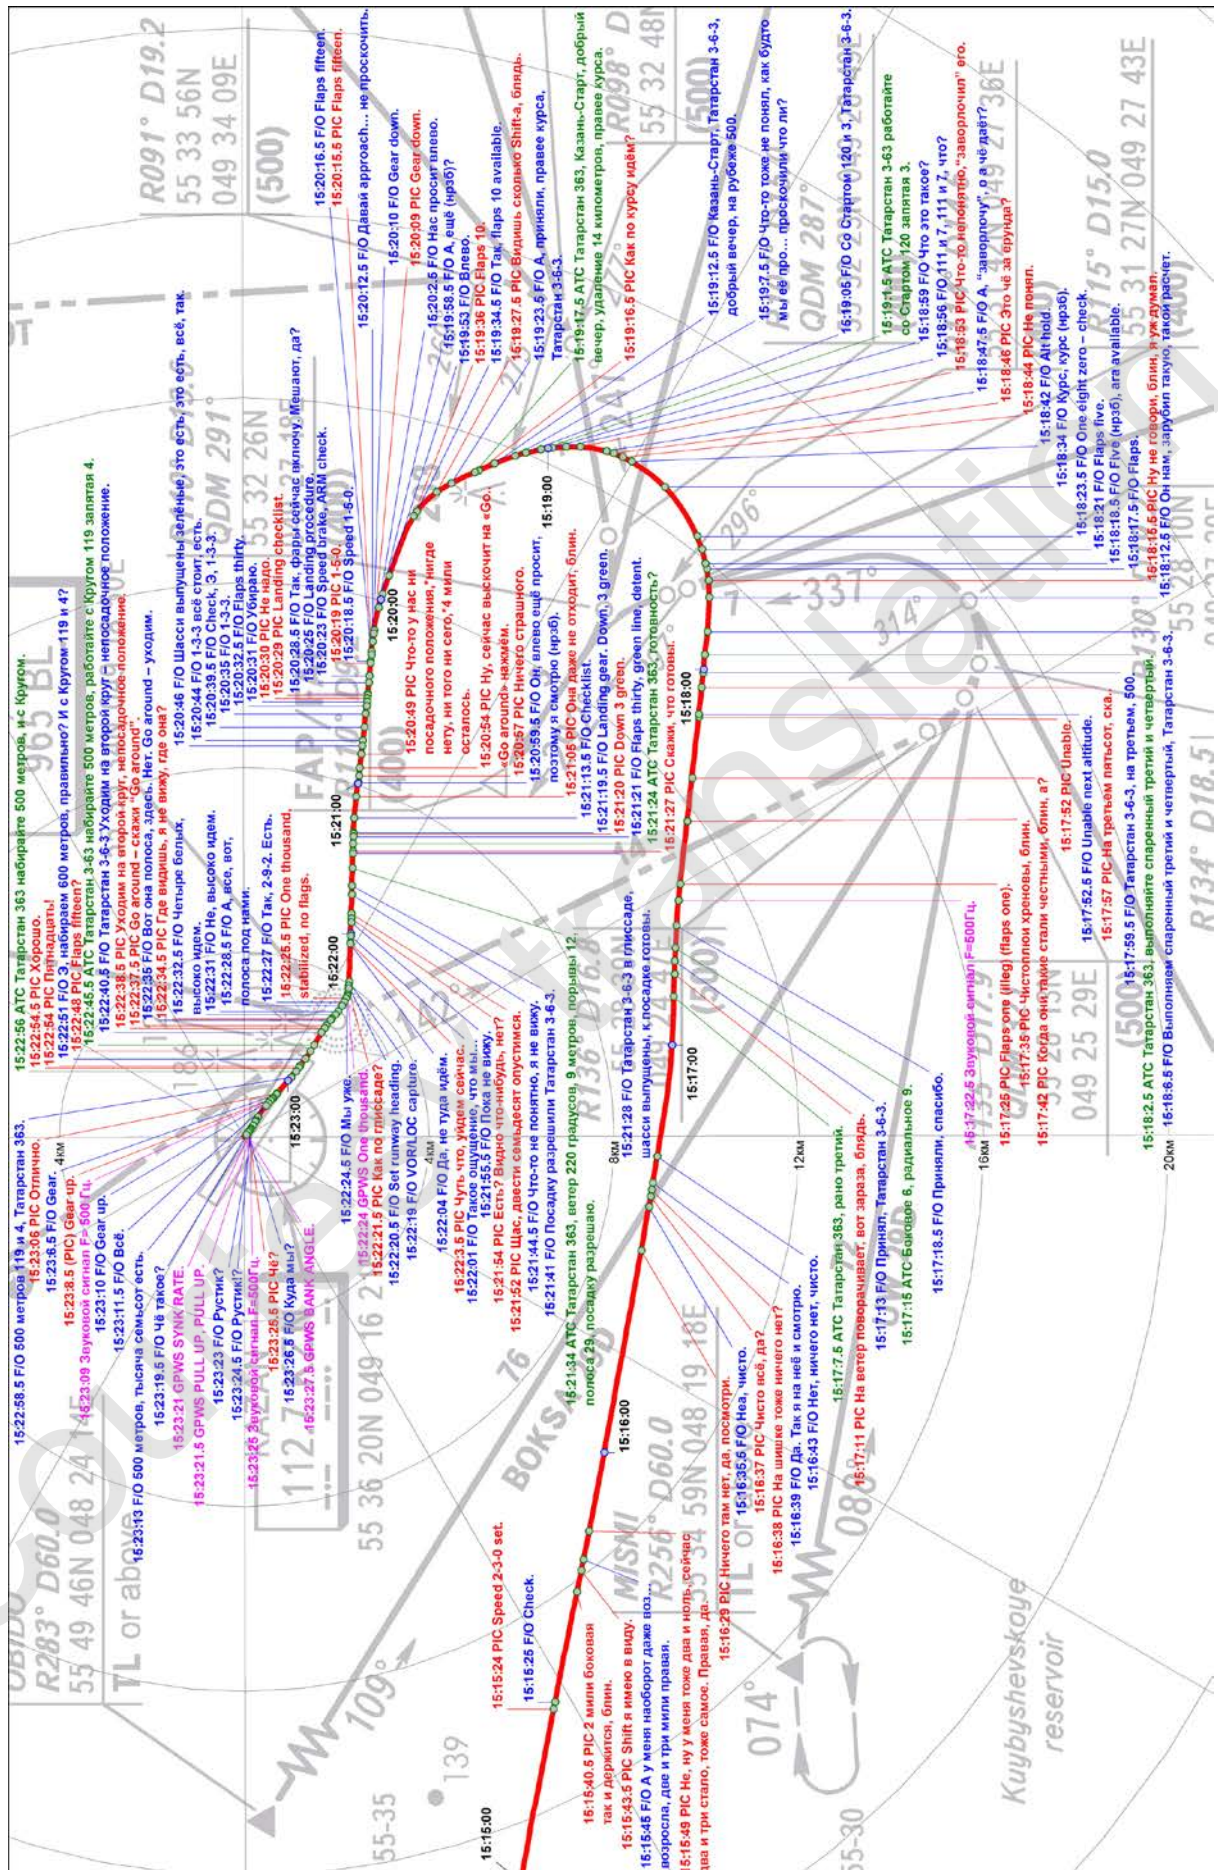
Figure 15 Boeing 737-500 VQ-BBN flight path on 17.11.2013 near Kazan Airport (there is a gap on the STAR pattern from the base turn point to MISMI waypoint, MISMI position is out of scale)

heading change was not enough either. The aircraft was approaching the base turn parallel to the standard approach pattern (Figure 15 and Figure 81).

After the crew informed the ATC on reaching the base turn point they were cleared for base and final turn. Actually the turn was initiated at 15:18 in the HDG SEL mode before the aircraft reached the altitude of 500 m with a significant deviation from the STAR pattern (Figure 15 and Figure 81), that the ATC could have seen on the radar, and the crew could have seen that using the VOR/DME.

The turn was completed with a significant “overtake” (Figure 15 and Figure 81). The cockpit communication analysis revealed that the crew was not completely aware of their position with regard to the approach pattern, which is confirmed by the following dialogue between the PIC and the FO at 15:18:46:

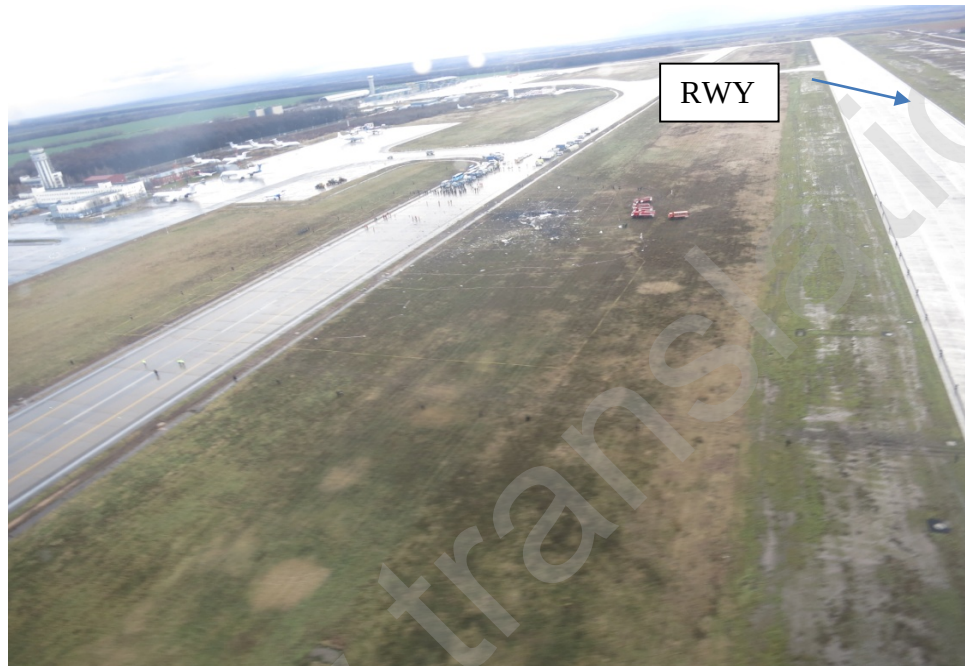
**Figure 16 Accident site general view from opposite to the flight direction**

The aircraft was approaching to land with magnetic heading 292 degrees. The accident occurred at the airfield of Kazan International Aerodrome between the runway, main taxiway, Taxiway C and taxiway B (Figures 16 and 17). The airport is located in the plain. The runway threshold elevation is 125 m for heading 292 degrees, and 106 m for heading 112 degrees. The elevation at the accident site is 115 m.

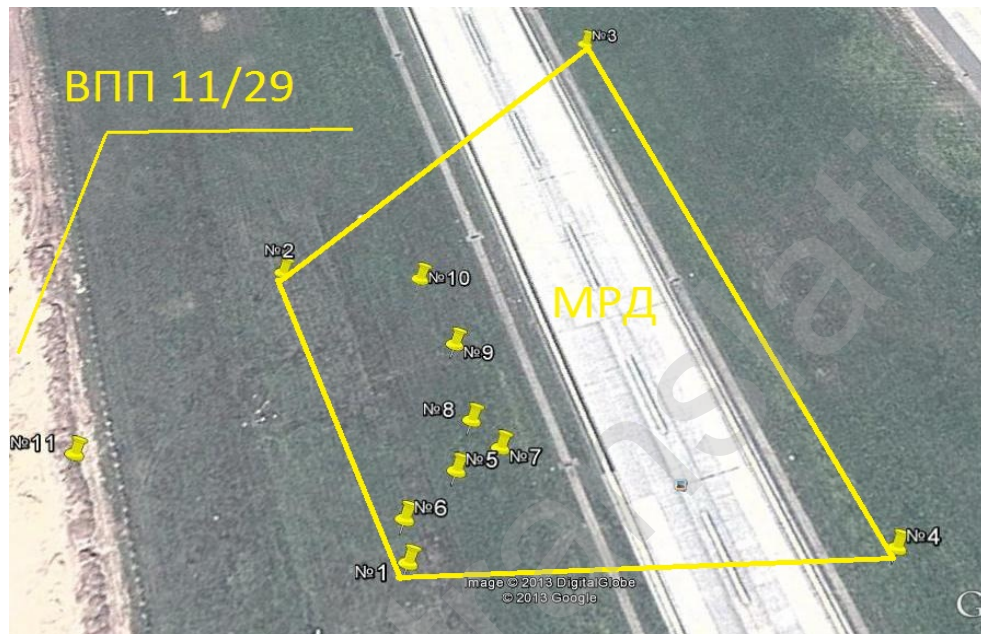
**Figure 18 Wreckage plot**

The aircraft impacted the ground between the runway in use (RWY 29) and the main taxiway at point 5 (Figure 18) (N55°36.5291' and E49°16.6111'). The wreckage spread area was

The largest structural fragments are marked with points 5 through 11.

The accident site examination revealed that the aircraft impacted the ground with a large nose down pitch angle. This is determined by the nature of the crater (Figure 18), as well as engine position being almost vertical in the ground.

After the impact the fuselage was destroyed with the tail cone detached (Figure 20), the latter being found 20 m ahead of the impact point in the direction where the aircraft was heading (point 8, Figure 18).

Forty meters ahead of the tail cone fragment in the flight direction (point 9, Figure 18) a rudder fragment was found (Figure 21).

At distance of 120 m from the first impact point and 25 m from the right edge of RWY 29 (runway in use) (point 11, Figure 18) a red fire extinguisher bottle was found (Figure 22). This fragment was the closest one to the runway.

The runway examination made immediately after the accident revealed no aircraft marks or fragments on the runway and beyond the fragment spread area (Figure 18). Thus, there were no signs of uncontained inflight damage.

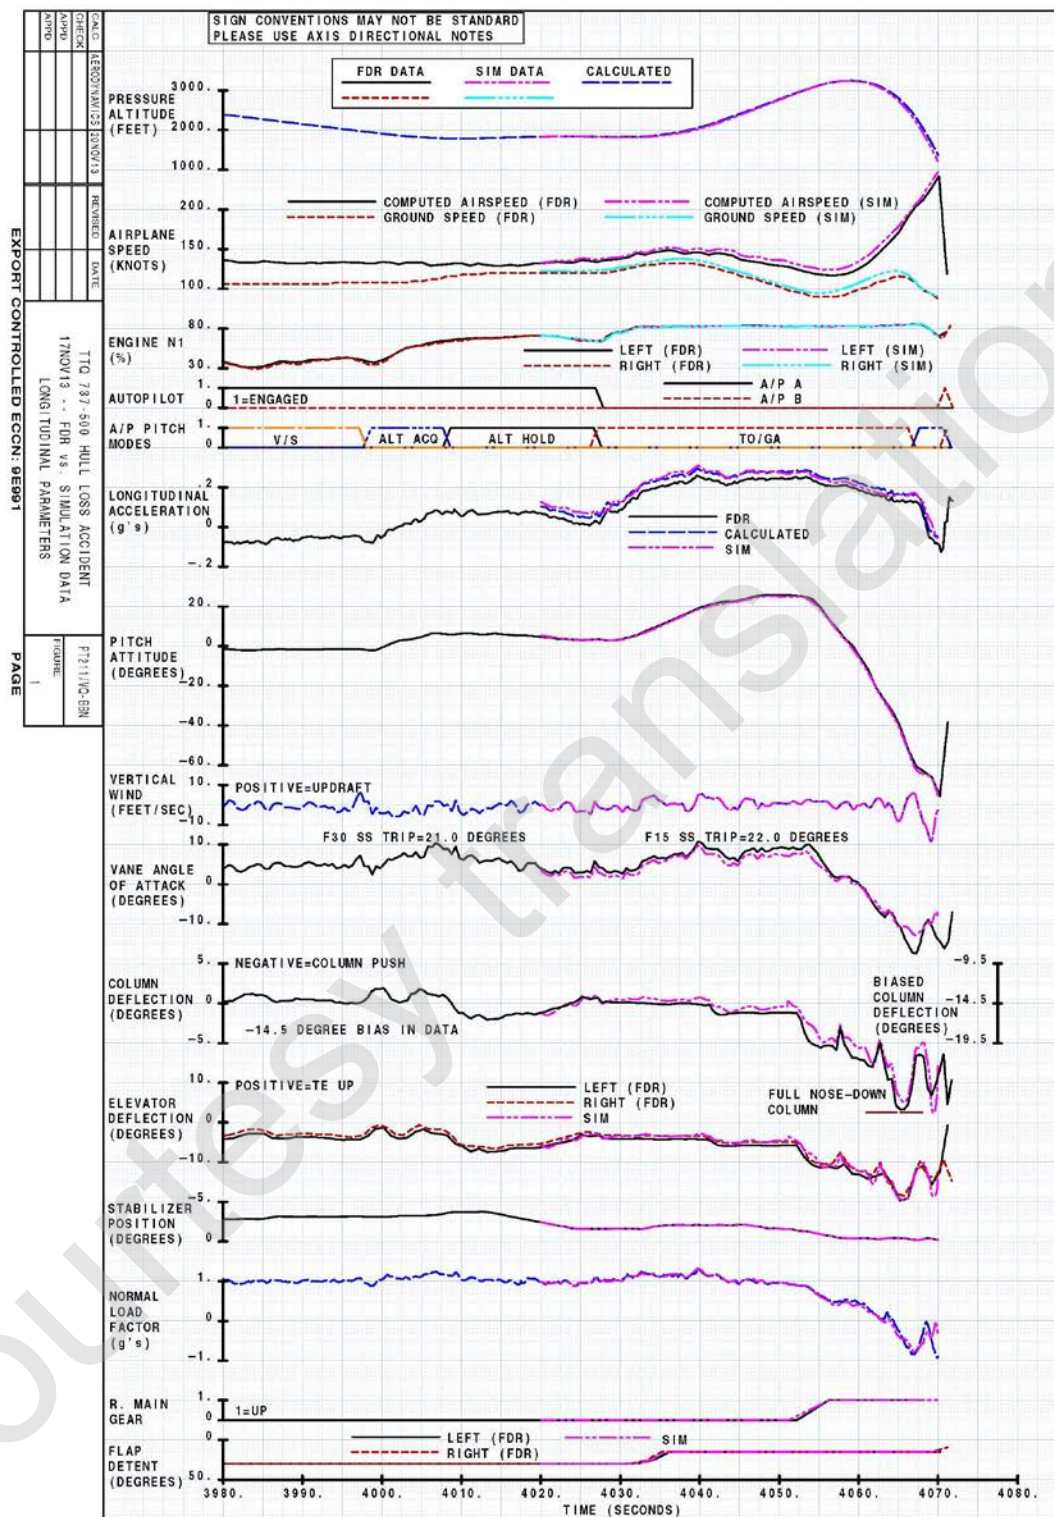
Figure 23 Simulation data (longitudinal parameters)

The analysis of the simulation match results shows that before the aircraft reached significant negative angle of attack values (about 5 to 7 seconds before the impact) the calculated data were well consistent with the FDR records for the flight controls (column, wheel and pedal deflections) as well as for the control surfaces (aileron, elevator and rudder deflections) respectively. Thus it can be concluded that during the final flight segment the aircraft movement corresponds to registered control inputs, actual engines power and actual wind profile. The stability and controllability parameters were well consistent with the type design. No additional external forces (windshear, icing) were affecting the aircraft. The flight control system including the elevator was operating as per design. During the emergency situation development the angle of attack values exceeding the threshold level for stick shaker activation were not achieved.

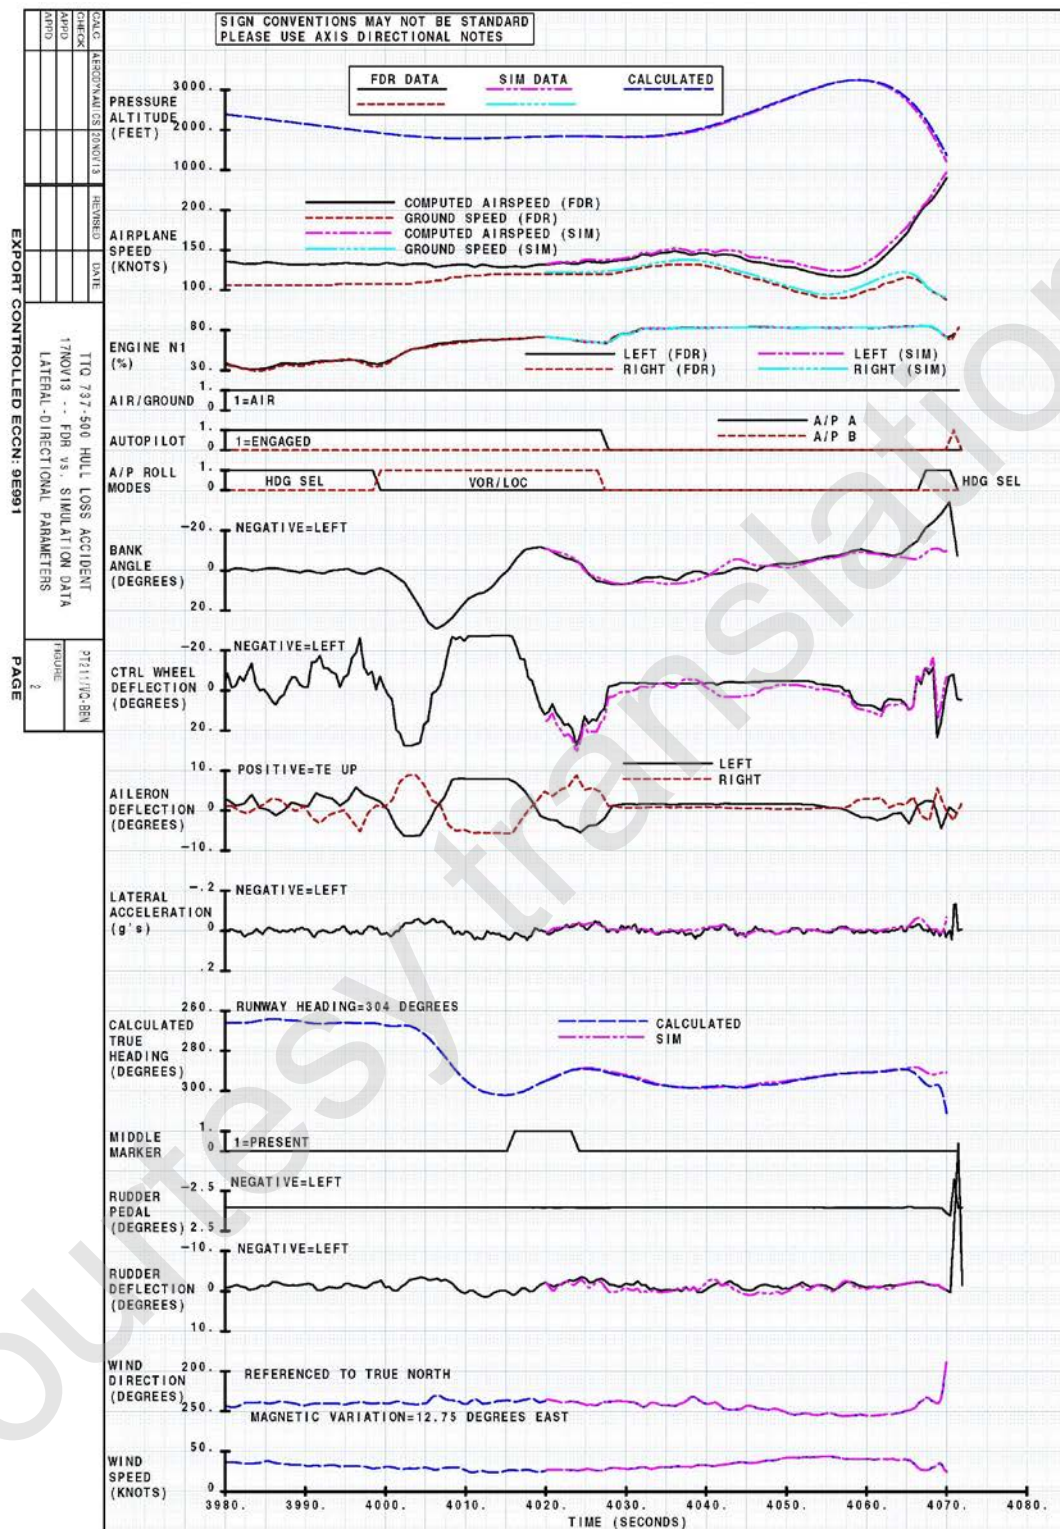
Figure 24 Simulation data (lateral-directional parameters)

**Note:** *Simulated control wheel position necessary to create registered bank angle values began deviating from the recorded values starting at 5 to 7 seconds before the impact. This difference is caused by the fact that the negative values of angle of attack experienced by the accident airplane exceeded the angle of attack range of the simulation lateral/directional aerodynamic coefficient data tables.*

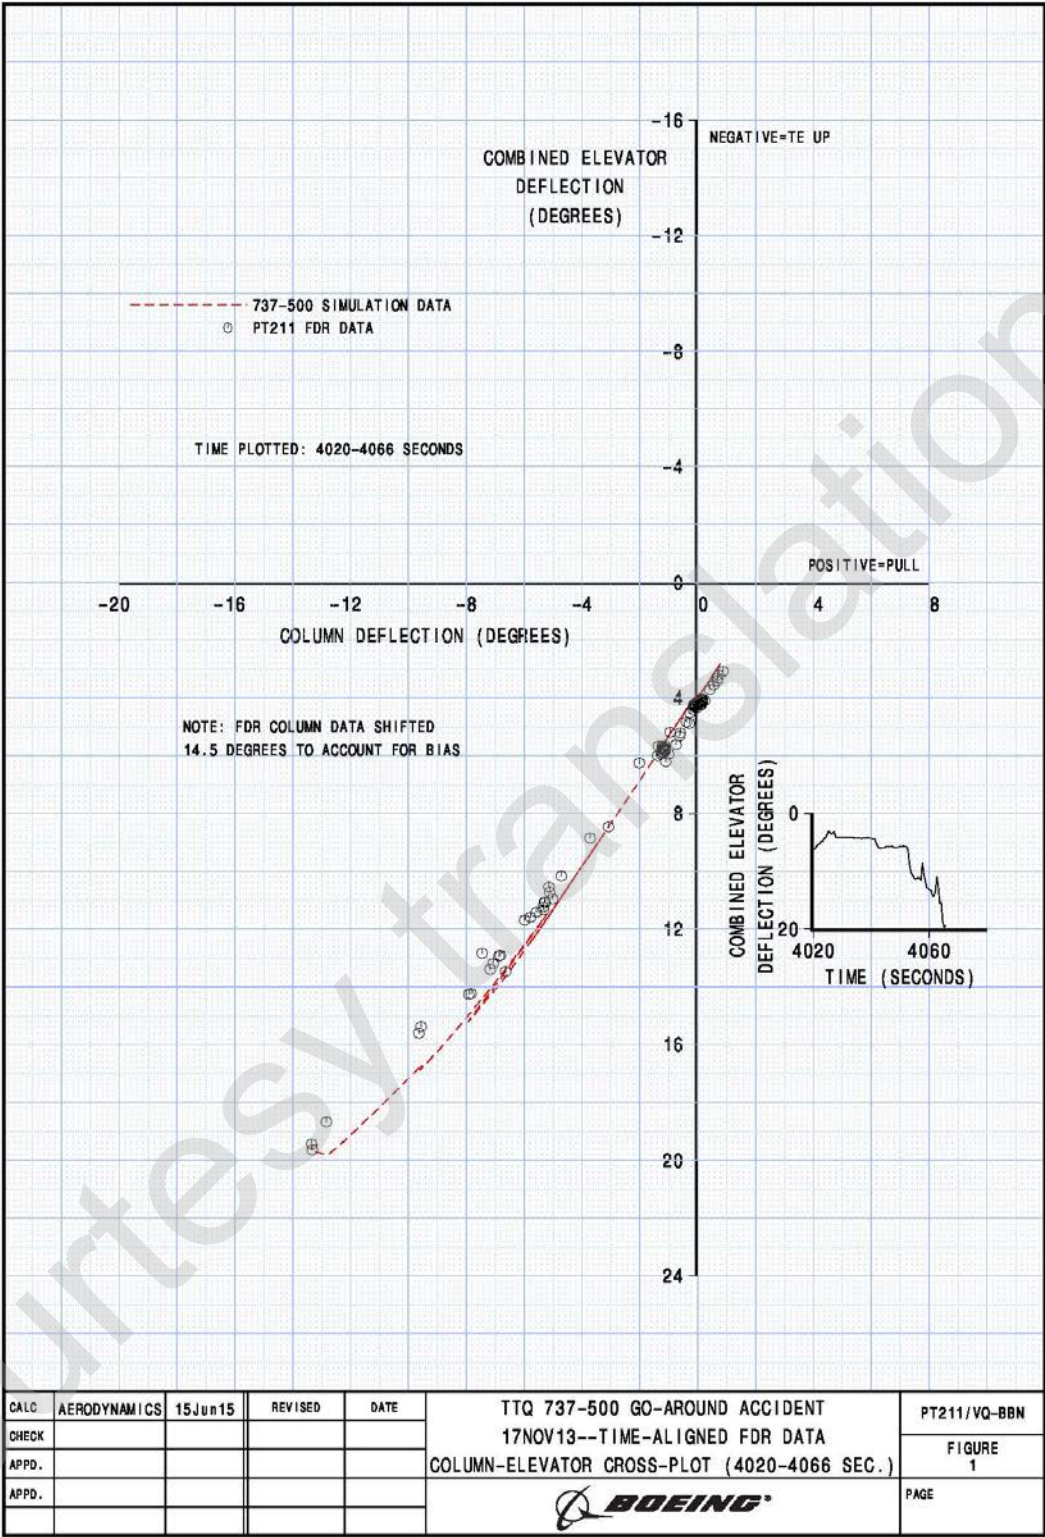
Figure 25 Column-Elevator cross-plot

An additional chart was created to correlate elevator deflections to the column inputs (Figure 25). The same Figure contains data calculated as a result of the simulation. The Figure shows that both the values and curve slope are well consistent, which confirms the normal operation of the flight control system without any extra resistance, that means without any jamming or seizure (no extra column forces that would have led to linkage extension resulting in inconsistency of the calculated and recorded elevator deflections at the same wheel position, see also 1.18.7).

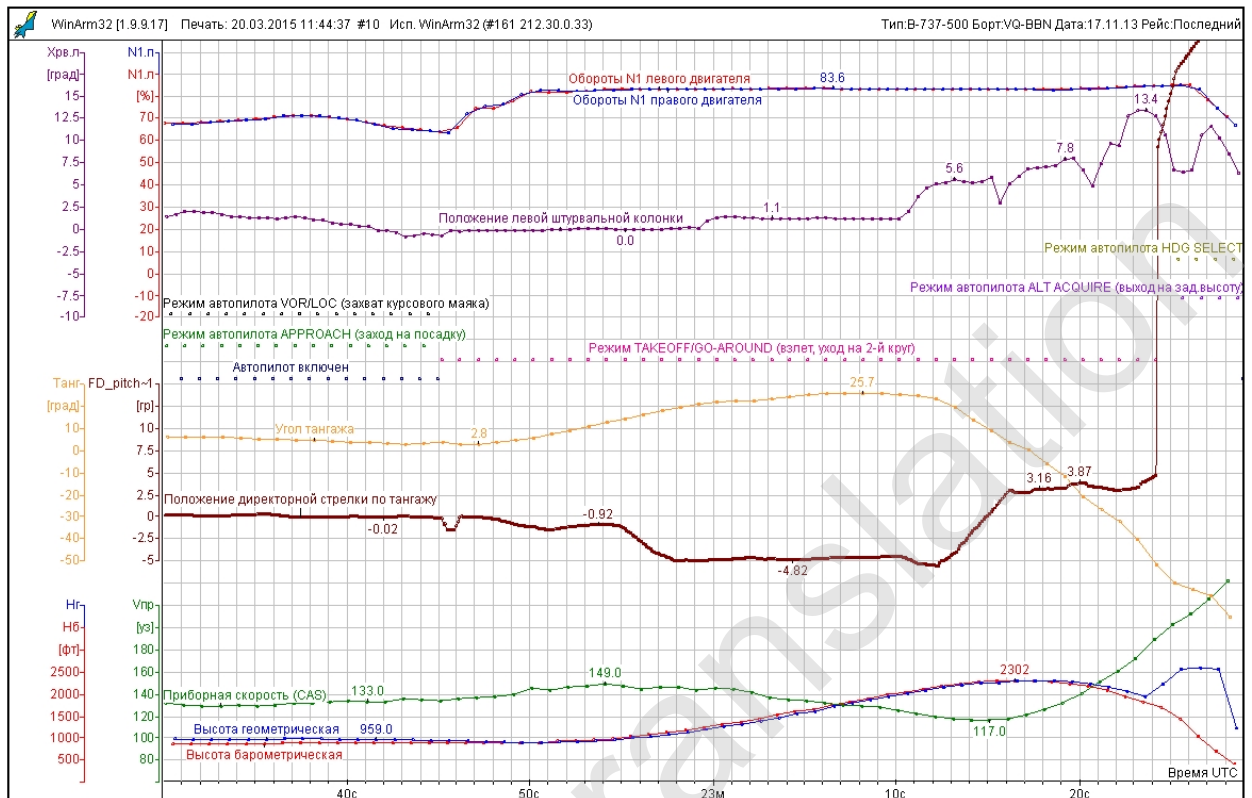
Figure 27 EADI FD pitch bar position simulation

The EADI pitch FD bar position during the go-around was also simulated (Figure 27). The “null” value corresponds to the situation when the pitch bar is at the aircraft symbol position.

There is one more peculiarity of the FD pitch bar indication in TO/GA mode. Its deflection value is limited (roughed sensitivity) to prevent the aircraft from PIO. This is clearly visibly in the reconstruction of the pitch FD bar position in the accident flight, made by the Boeing Company (Figure 27). The plot reveals that despite the significant deviations from the required flight profile and/or climb speeds, the FD pitch bar position did not exceed  $\pm 5\text{-}6^\circ$  when the TO/GA mode was engaged. The pitch bar position reached the highest limit only after the mode transition to ALT ACQ.

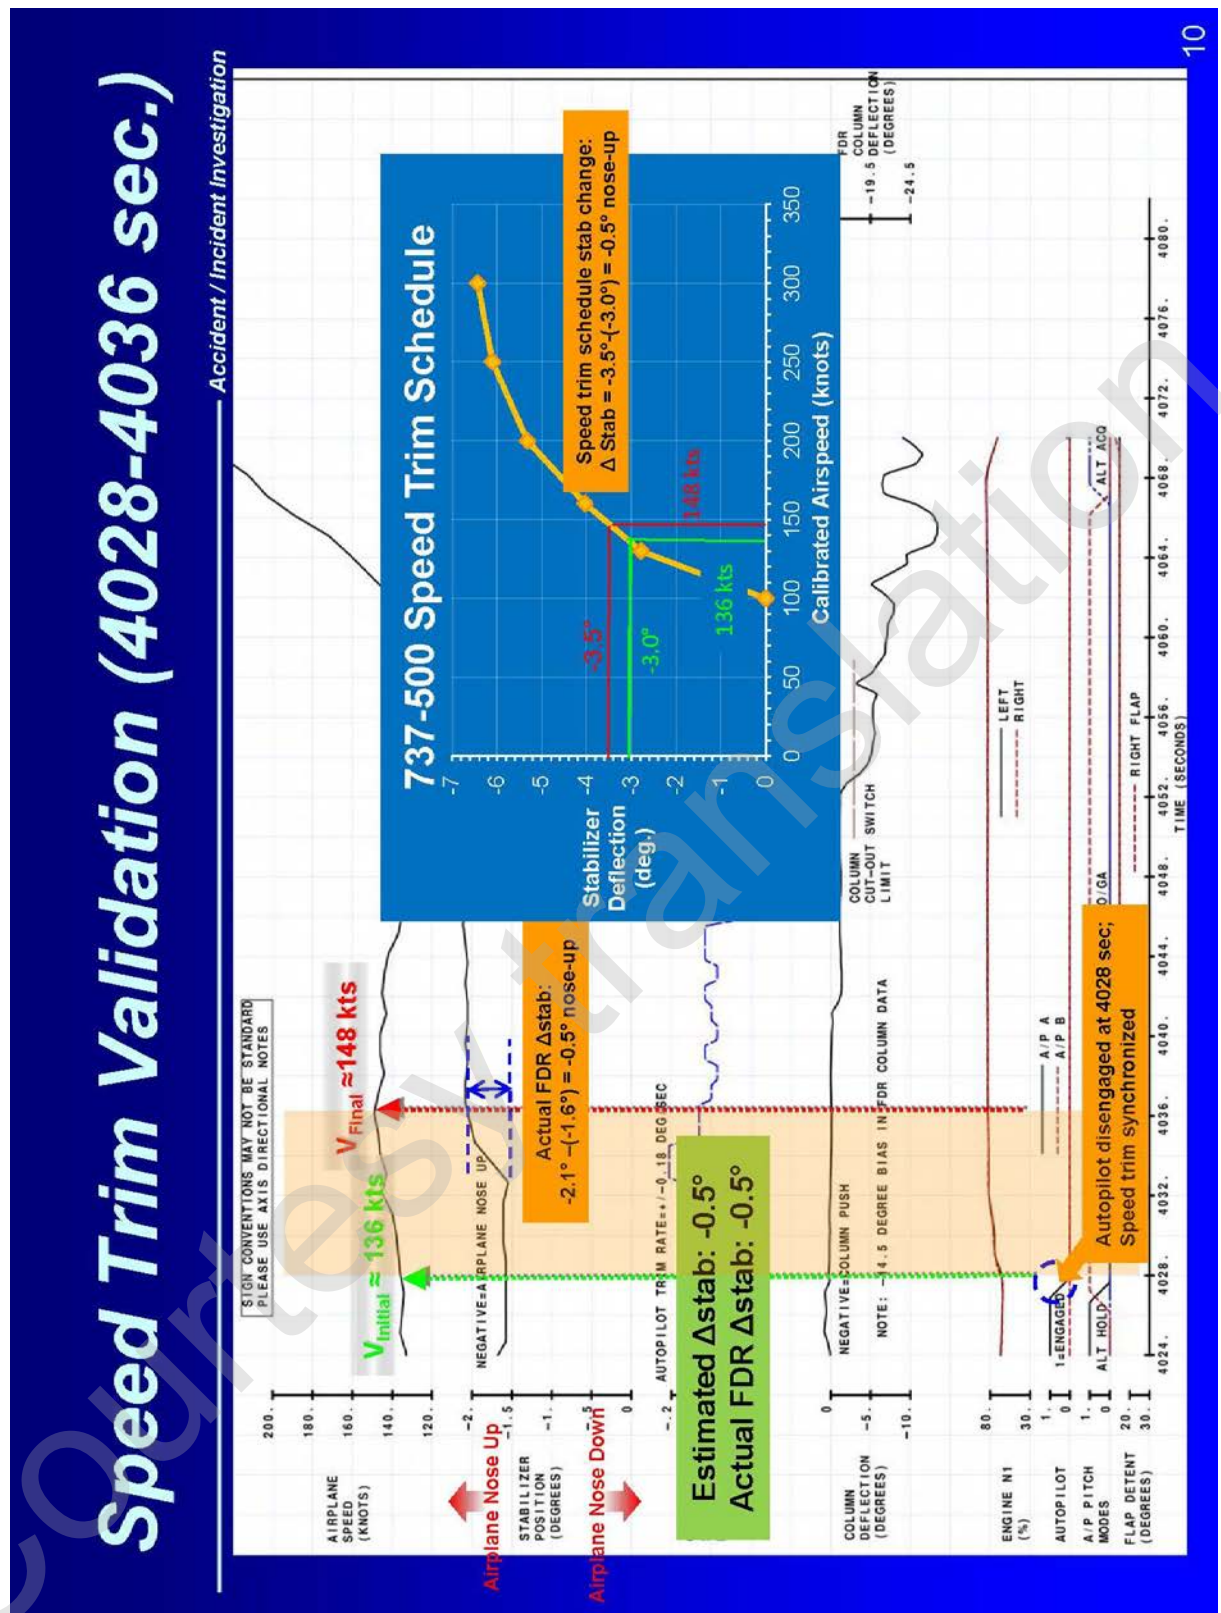
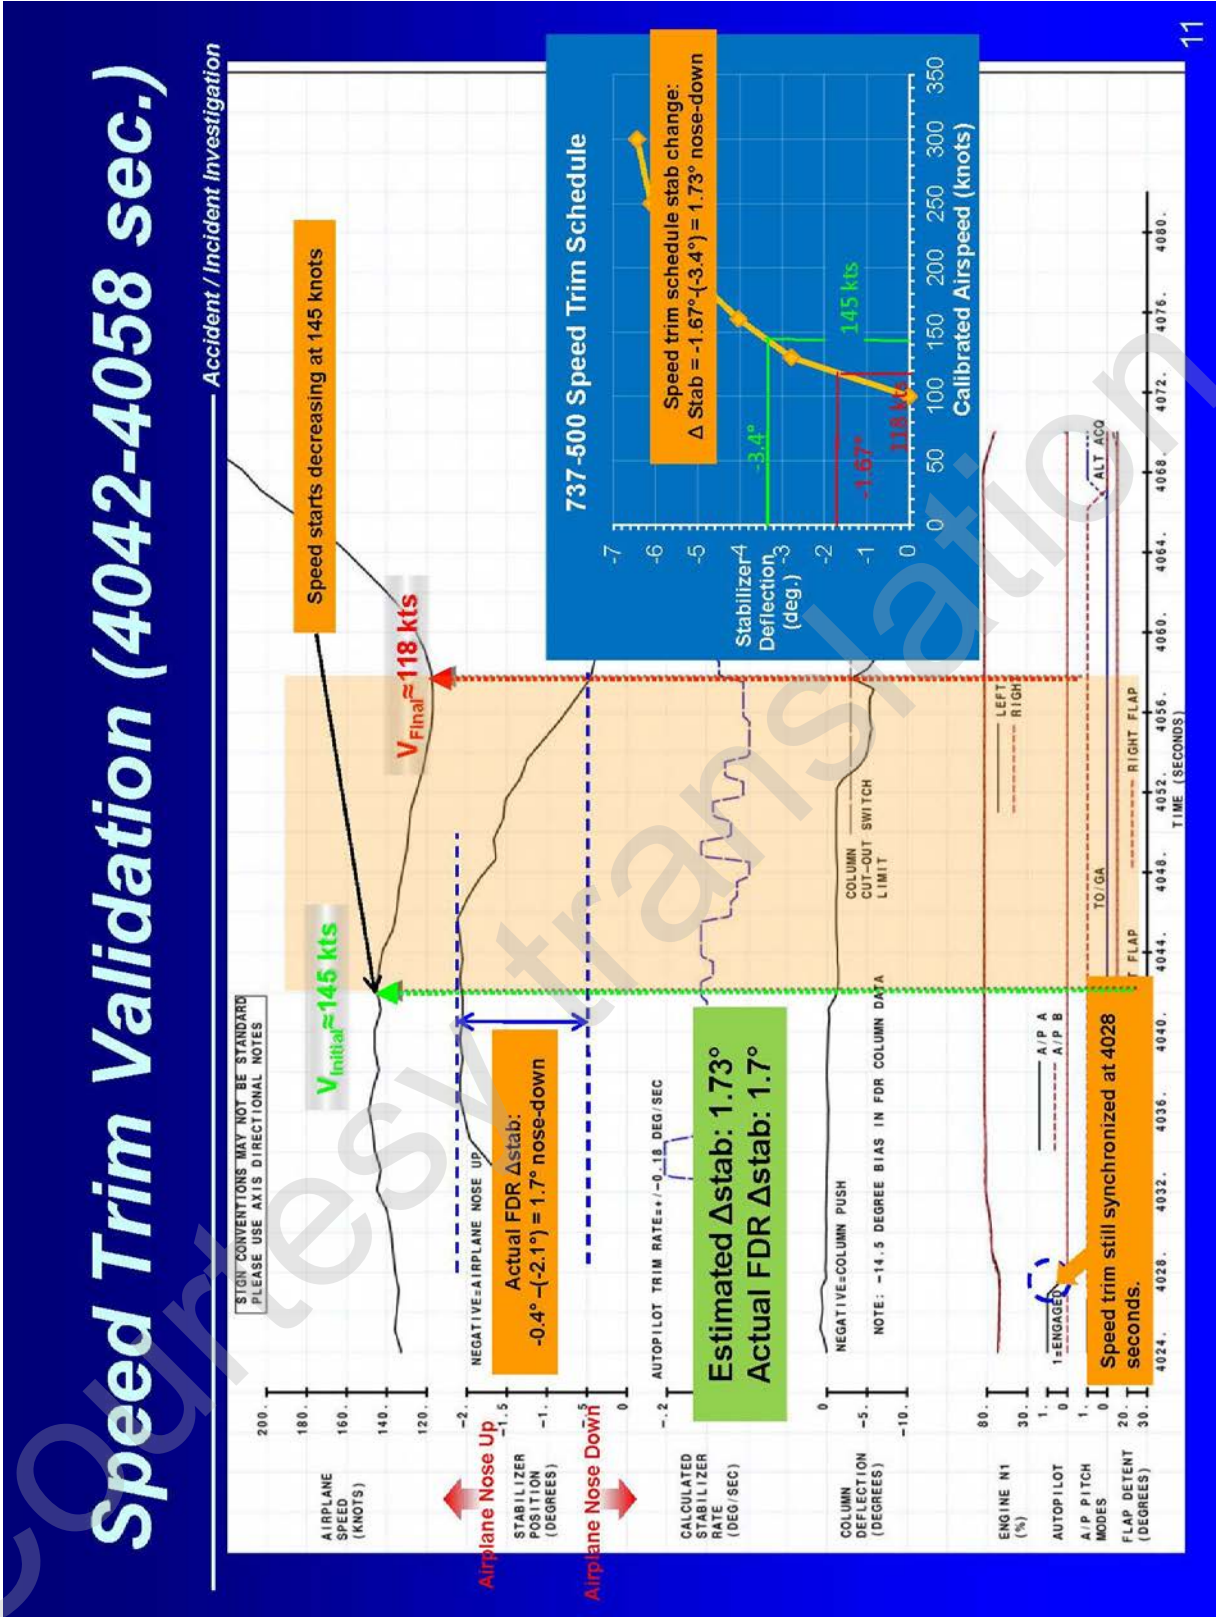
Figure 30 STS validation (15:23:00 – 15:23:16)

Figures 29 to 31 show the three specific segments of the final flight stage. In the first segment (Figure 29) as the airspeed increased from 136 knots to 148 knots the stabilizer made an increment 0.5° nose up deflection, which corresponds to the value determined by the chart on Figure 28. In the second segment (Figure 30) as the airspeed decreased from 145 knots to 118 knots the stabilizer made an increment 1.7° nose down deflection, which also corresponds to the value determined by the chart on Figure 28. In the third segment (Figure 31) despite the extensive airspeed increase the stabilizer did not deflect nose up as the crew deflected the column nose down to a value exceeding the threshold value, which deactivated the STS as per design.

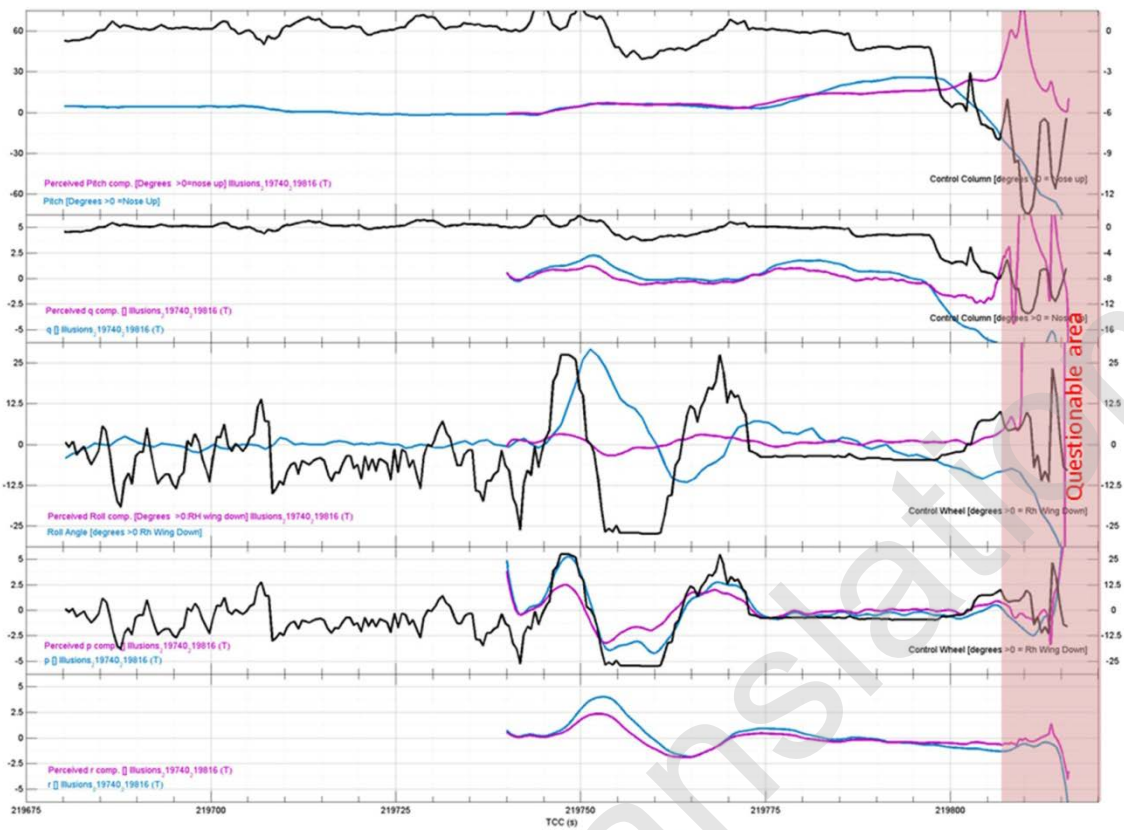
**Figure 32 BEA Sensorial Modelling Results**

The applied model has a number of limitations. The modelling results require verification when the actual pitch is greater than 25 degrees or lower than -15 degrees and could not be used when the normal acceleration is lower than 0 G (negative load factor). The abovementioned conditions are applicable to the 9 last seconds of the flight (Figure 32, see the red area)<sup>15</sup>.

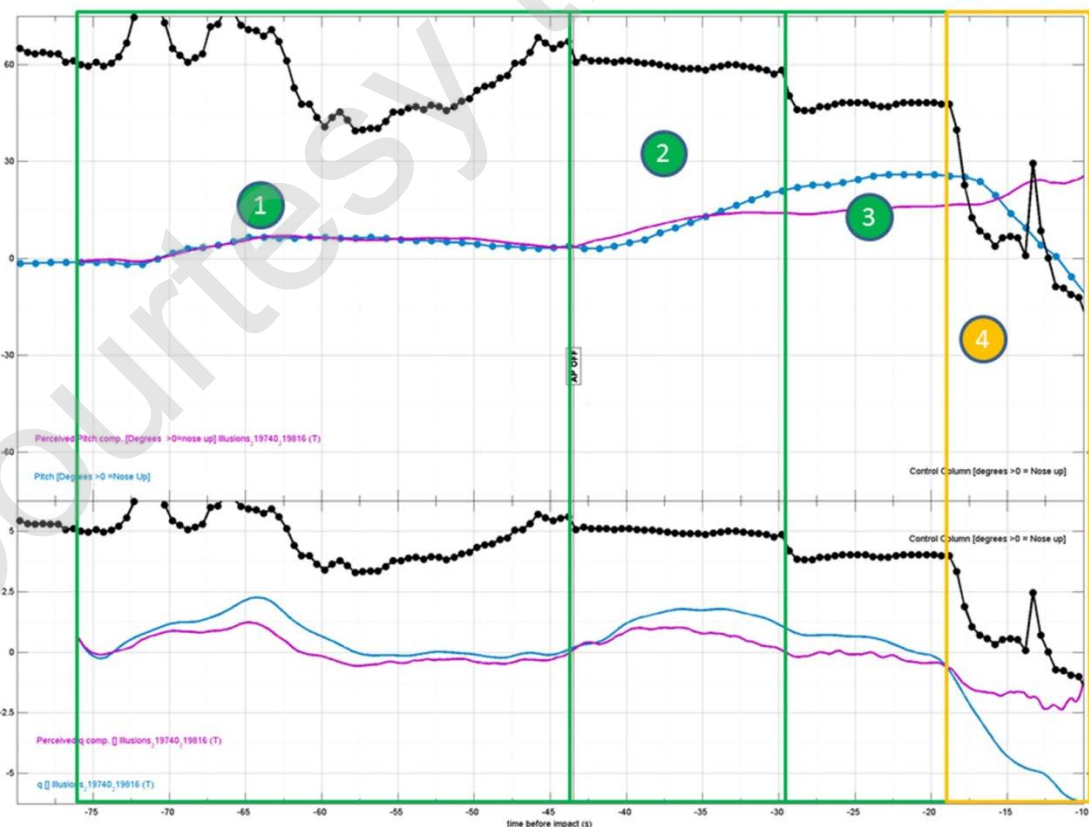
**Figure 33 BEA Sensorial Modelling Results (cont.)**

The pitch component parameters are plotted in Figure 33. Four zones are designated.

In zone 1 the actual and perceived pitch angles were quite similar. The autopilot was engaged during this segment.

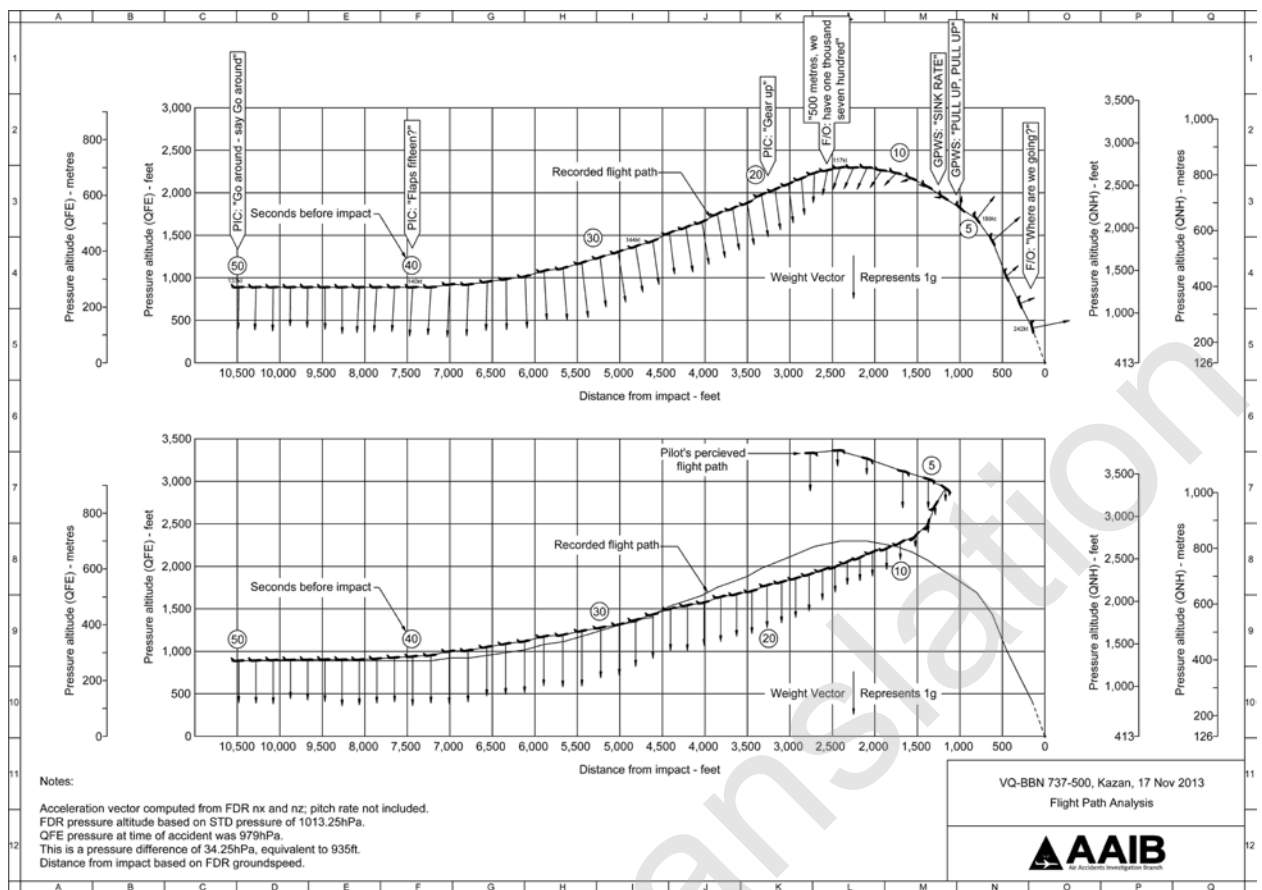
Figure 34 AAIB UK Sensorial Modelling Results

The AAIB UK also assessed the probability of somatogravic illusions effect on the pilots during the go-around. During the research they used a method successfully applied during some other investigations. Based on the calculations a chart was built (Figure 34) that shows the probable effect of the illusions.

The modelling led to a conclusion that provided the pilots did not monitor the flight instruments in due manner they could have experienced the so-called “inversion” illusion during a change from climb to descent and during descent, which could have forced the PIC to apply nose down pitch control to correct the perceived pitch angle increase (sensed “looping” flight path).

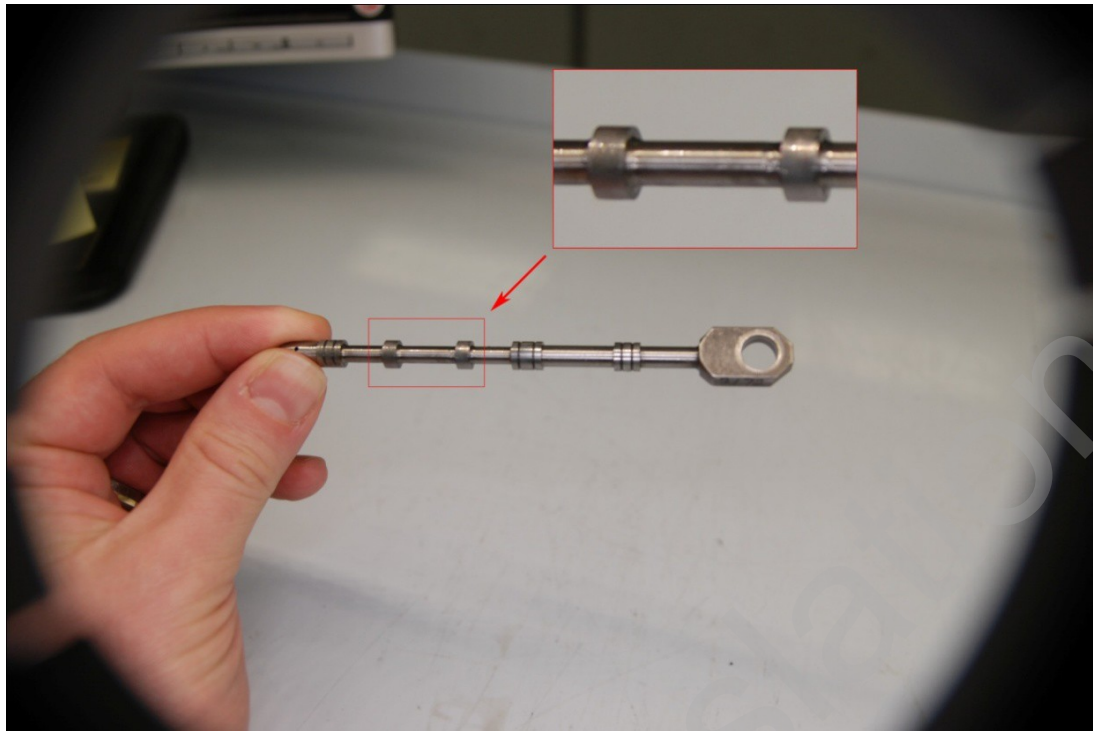
**Figure 66 RH control valve primary slide**

The first feature is different design of the RH and LH control valve primary slides. Two of the RH control valve primary slide lands have no balance grooves (Figure 66). While the LH control valve primary slide has those balance grooves (Figure 67).

Similar differences were revealed on the bypass valve slides. The absence of balance grooves may lead to increased friction forces and more extensive wear. According to the designer's explanation both types of slide design are acceptable. This is explained by the fact that balance grooves were added to slide design over time and are now considered the industry standard, though
