## **INTERSTATE AVIATION COMMITTEE**

#### **FINAL REPORT**

| Type of aircraft | Airplane, Boeing 737-500 (53A) |
| Registration | VQ-BBN (Bermuda) |

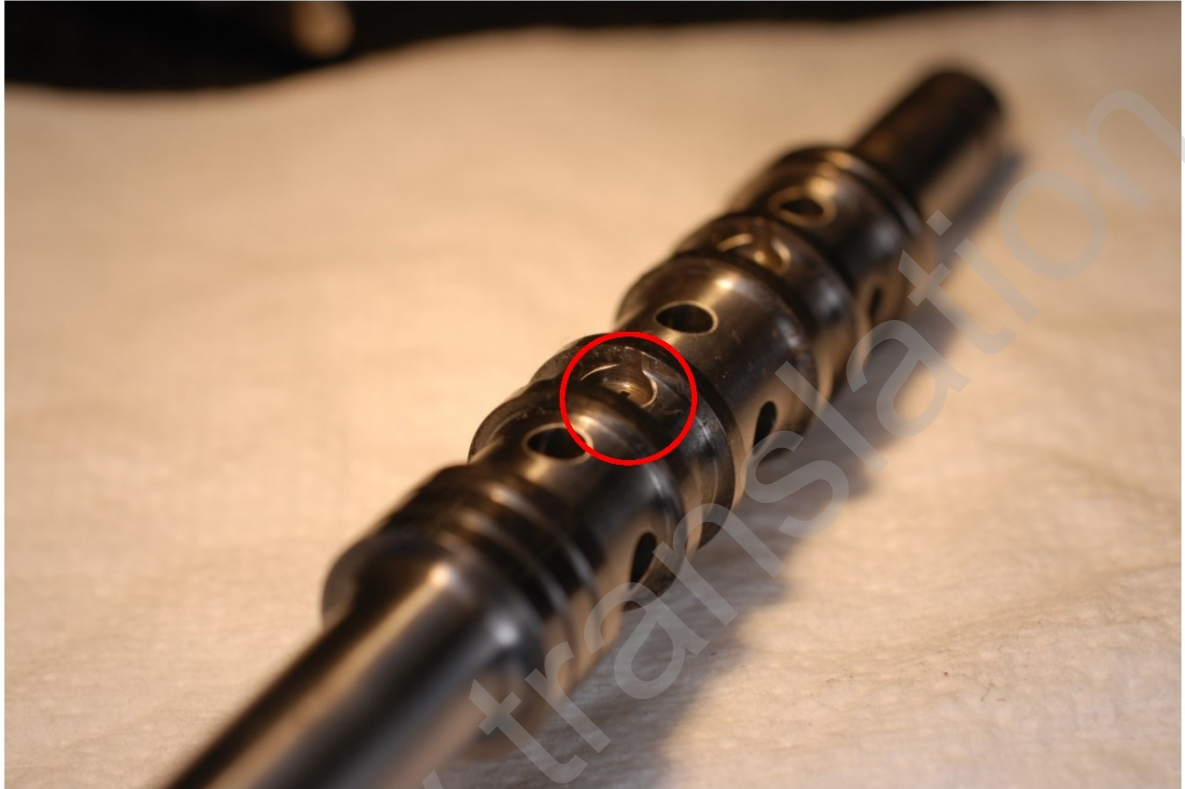
The second feature is the edges deformation on lands of the RH control valve secondary slide (Figures 68 and 69).

**Figure 68 RH control valve secondary slide land edge deformation**

Such feature is a result of the manufacture of the recessed hole in the secondary slide. The features were measured and were determined to be within the tolerance requirements of the applicable drawing. It was also noted that the side of the land edge that was deformed is non-critical non-metering edge side.

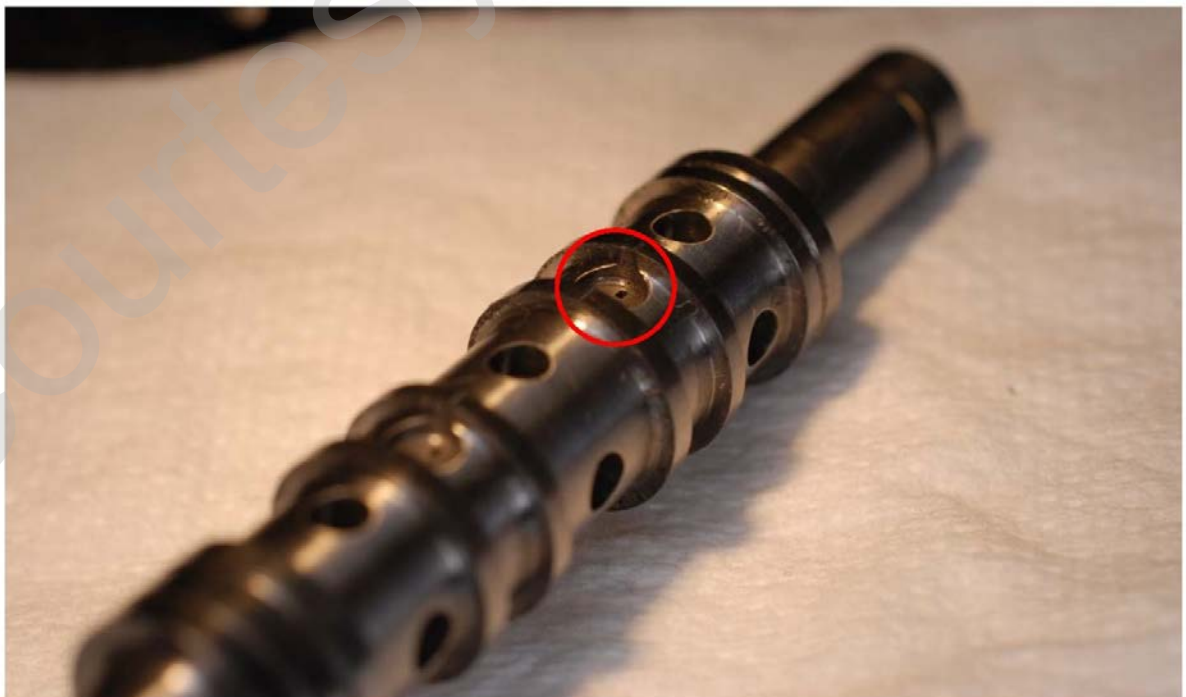
**Figure 69 RH control valve secondary slide land edge deformation**

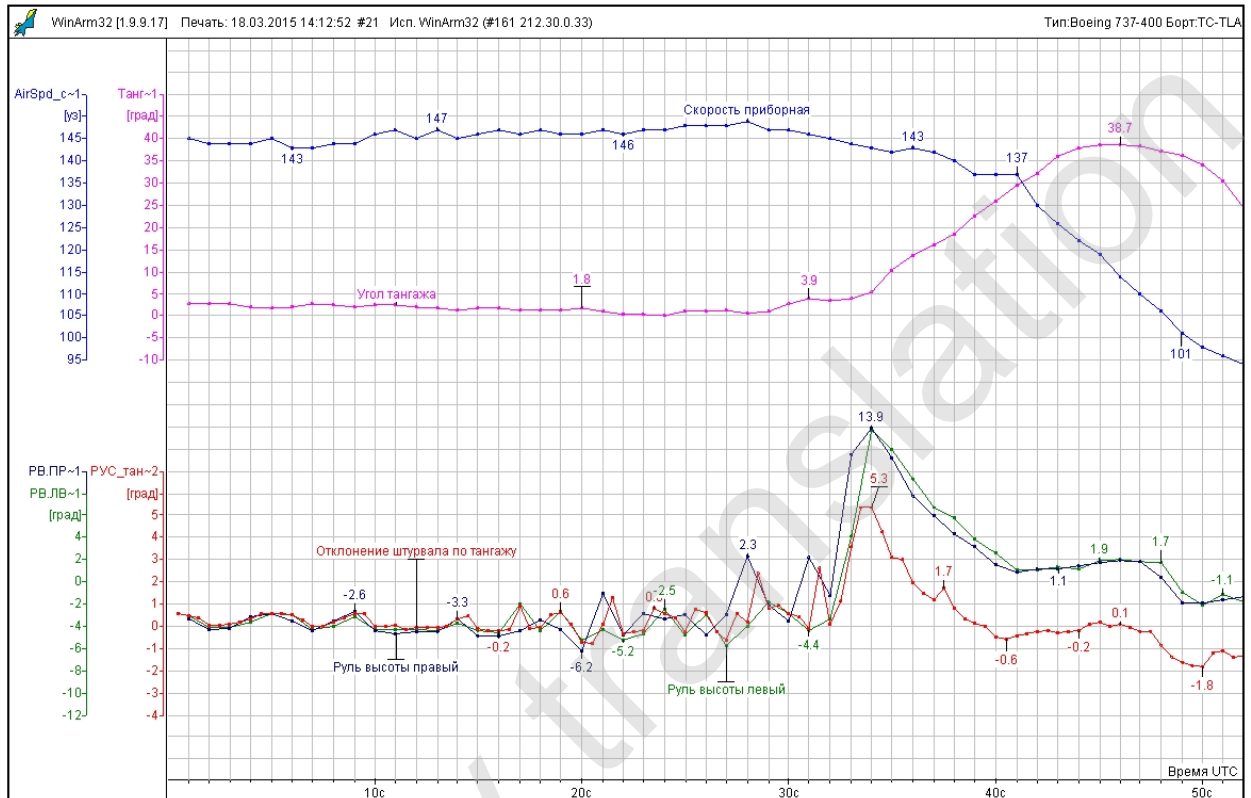
The FDR record analysis (Figure 71) revealed that the significant column input forces applied by the crew led to control linkage extension. This is revealed by comparing the column and elevator positions before and after the jam. The same column position corresponds to different elevator deflection angles.

**Figure 71 Boeing 737-400 TC-TLA Flight Parameters**

Figure 71 contains the FDR record for the Turkish event. Apparently the significant column input forces while the control linkage was jammed led to cable (control linkage) extension. This is revealed by comparing the column and elevator positions before and after the jam. The same column position refers to different elevator deflection angles.

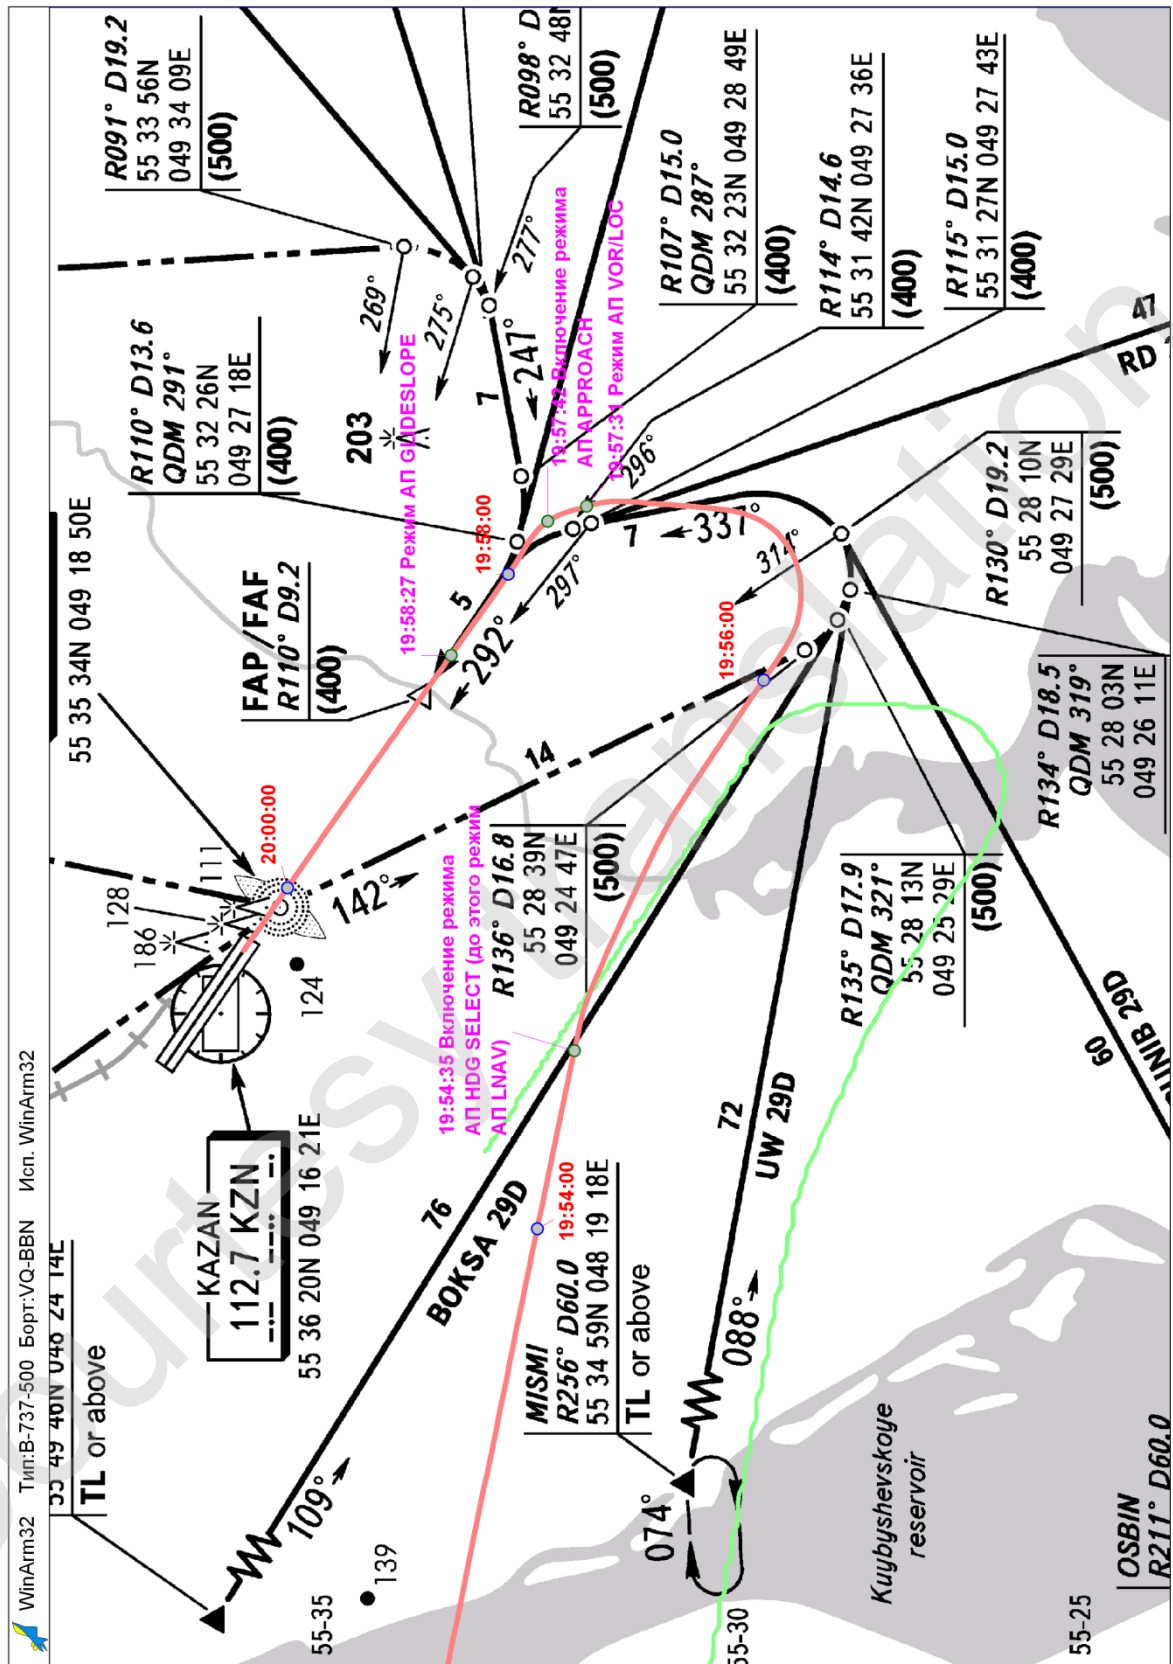
Figure 76 Boeing 737-500 VQ-BBN Flight Parameters, October 17, 2013

- during all approaches the crew engaged the VOR/LOC in due time, which ensured the aircraft intercepted the localizer in automatic mode;
- the flight path in Figure 76 is similar to the accident flight path from the MISMI waypoint to the disengagement of the L-NAV mode. After the L-NAV mode was disengaged and the HDG SEL mode activated the crew made a corrective turn right to intercept the base turn entry point with acceptable accuracy.

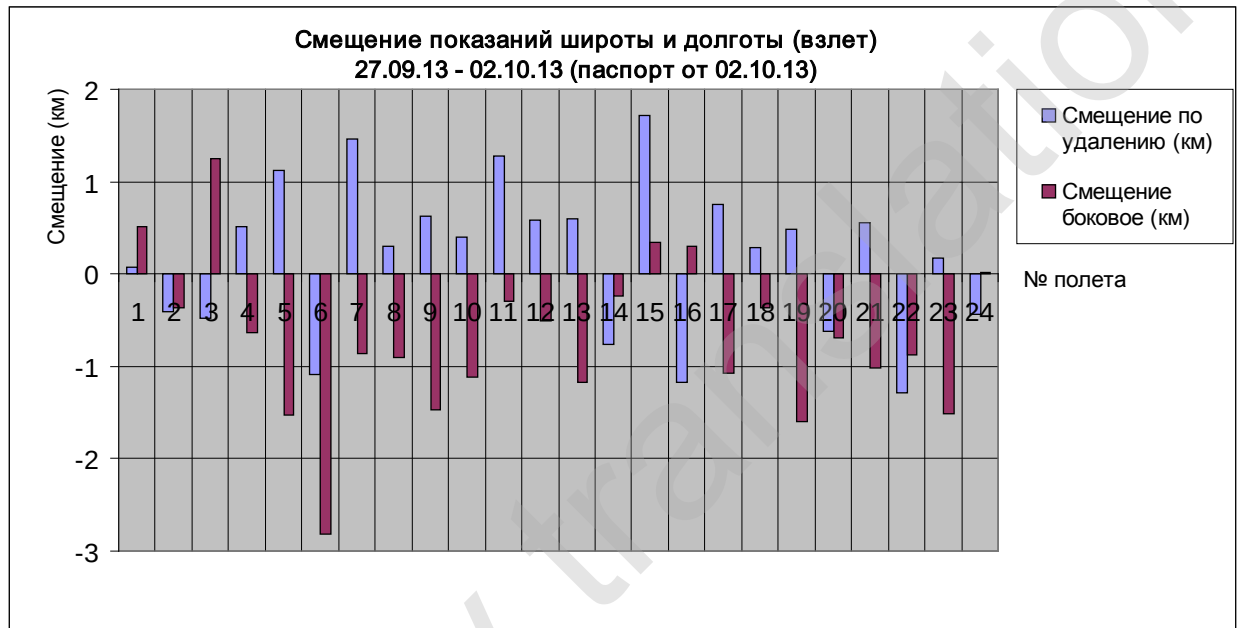
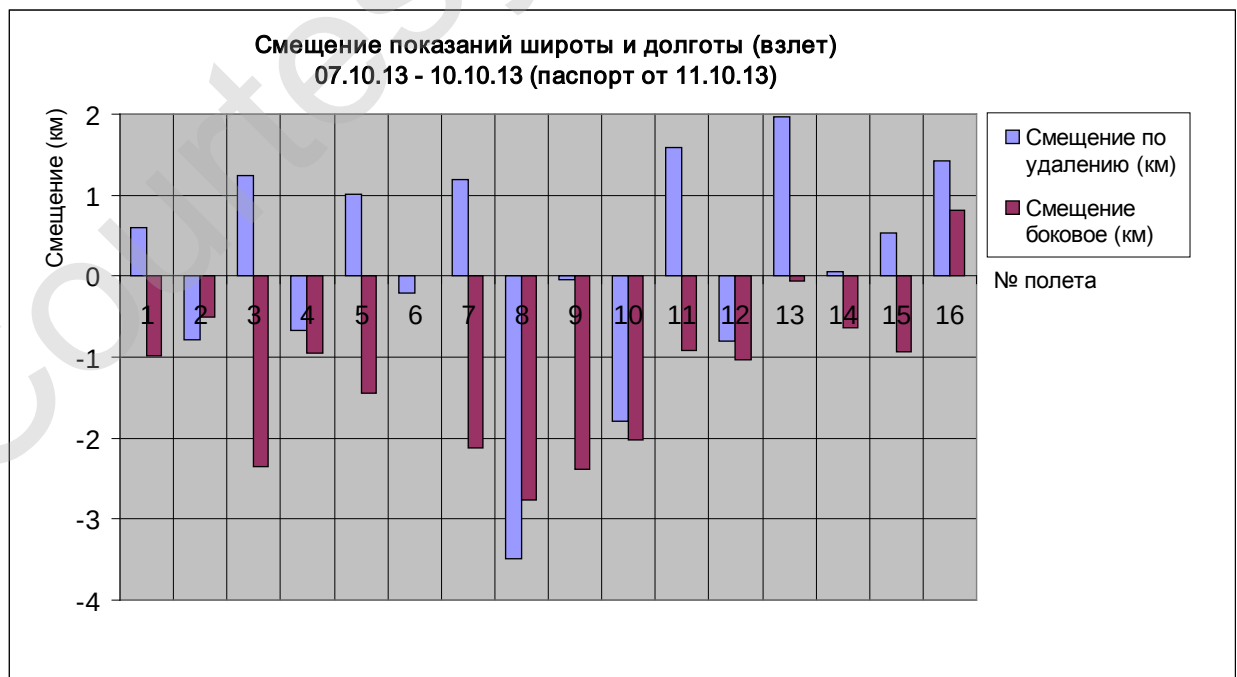
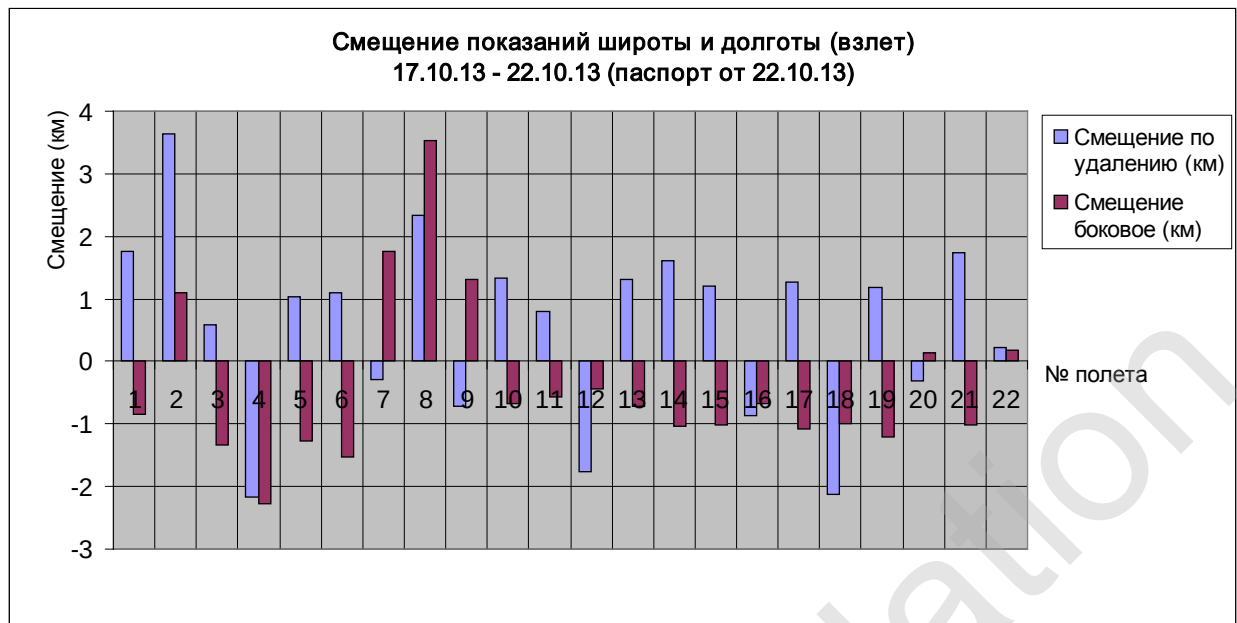
To analyze how the airline's crews perform the IRS alignment procedure before flights, 62 flights were analyzed that were conducted by different crews within September 27 to October 22, 2013. Figures 78 to 80 below show the deviations of the actual aircraft position at the start of the takeoff roll from the IRS position. The provided charts show that in the majority of flights there was significant deviation of the actual position from the IRS position, meaning the coordinates entered by the crews during the IRS alignment were not accurate enough.

Figure 78 IRS map shift during takeoffs on September 27 to October 2, 2013

Figure 79 IRS map shift during takeoffs on October 7 to October 10, 2013

Figure 80 IRS map shift during takeoffs on October 17 to October 22, 2013

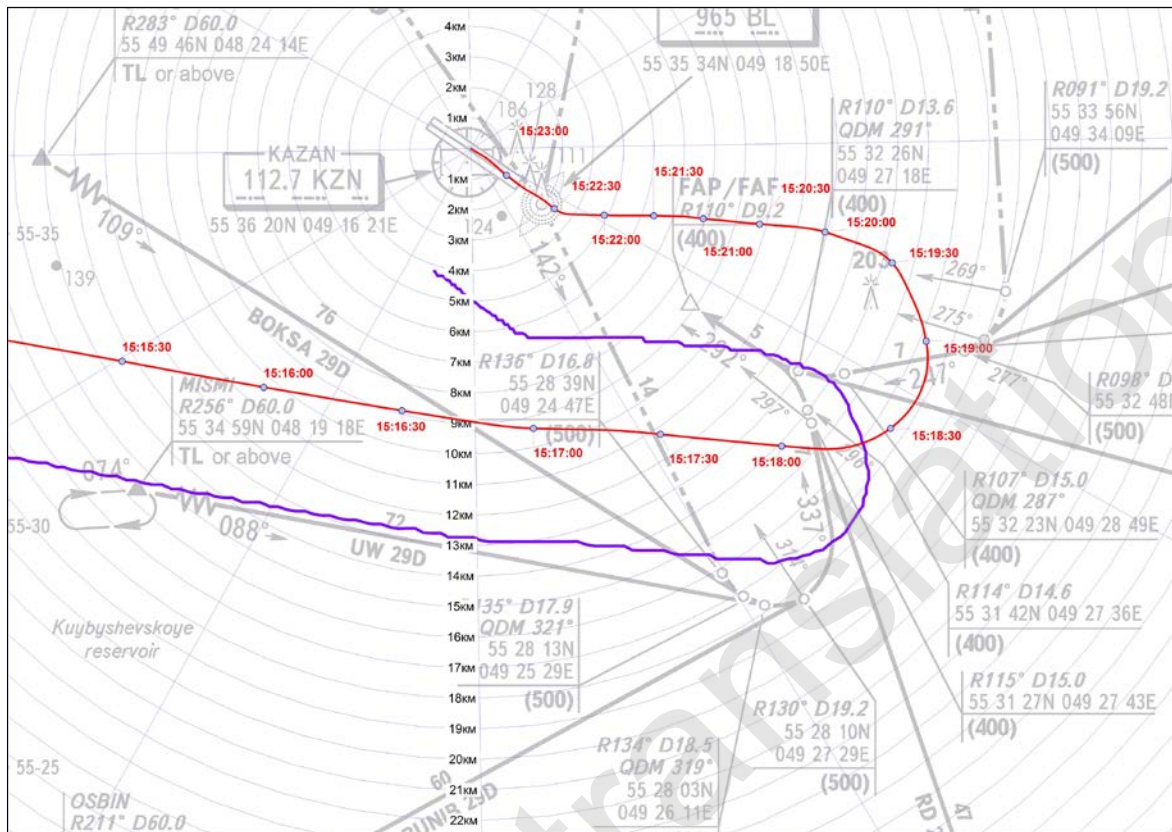
heading change was not enough either. The aircraft was approaching the base turn parallel to the standard approach pattern (Figure 15 and Figure 81).

**Figure 81 Actual flight path (red) and FDR (IRS) flight path (blue). There is a gap between the base turn and MISMI waypoint, the location of MISMI WP is out of scale**

After the crew informed the ATC on reaching the base turn point they were cleared for base and final turn. Actually the turn was initiated at 15:18 in the HDG SEL mode before the aircraft reached the altitude of 500 m with a significant deviation from the STAR pattern (Figure 15 and Figure 81), that the ATC could have seen on the radar, and the crew could have seen that using the VOR/DME.

The turn was completed with a significant “overtake” (Figure 15 and Figure 81). The cockpit communication analysis revealed that the crew was not completely aware of their position with regard to the approach pattern, which is confirmed by the following dialogue between the PIC and the FO at 15:18:46:

By the time the aircraft reached the approach pattern the map shift on the left IRS was approx. 4 km (Figure 81) southwards (i.e. the actual flight path was to the north of that recorded by the FDR)<sup>40</sup>.

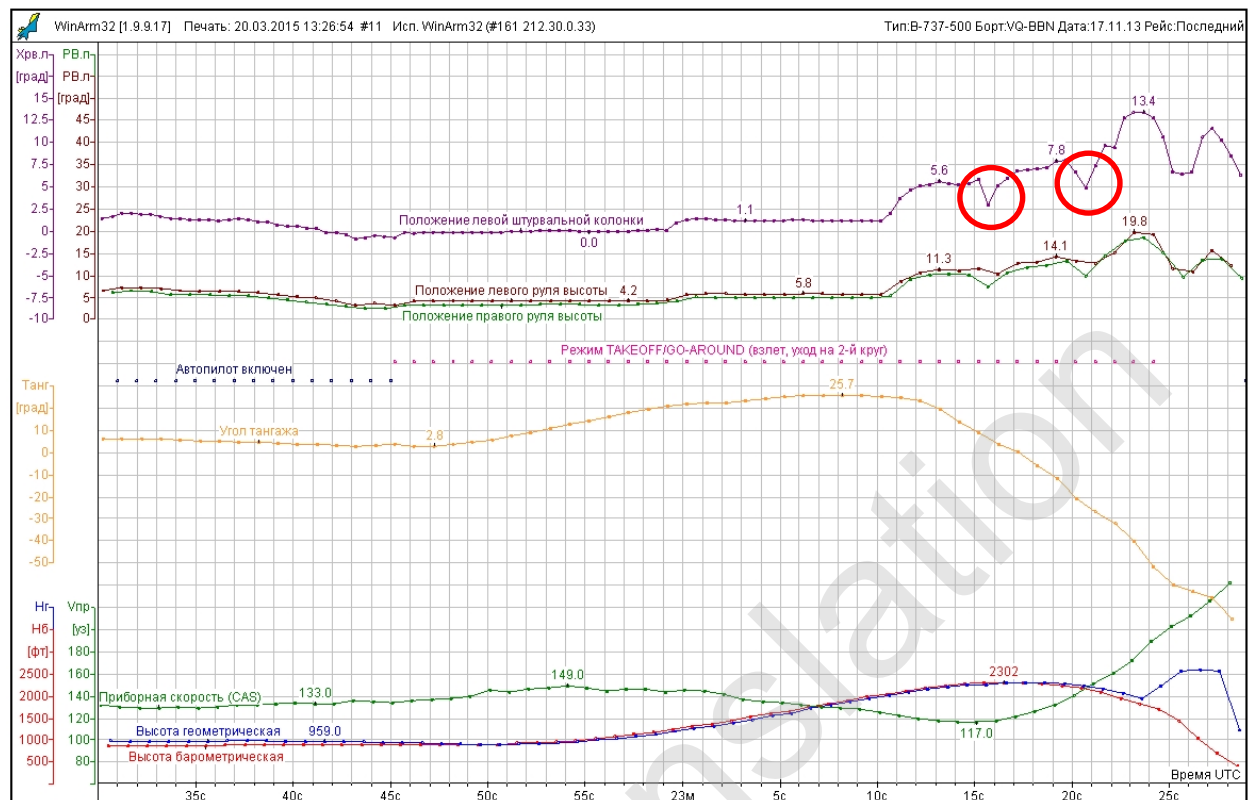
When analyzing the accident circumstances and recorded flight data (intensive nose up pitching during the final flight segment and no nose up control inputs) some of Rosaviatsya experts that were involved in the investigation had an opinion that there could have been no nose up control inputs because the elevator control linkage has been jammed partly and could not be moved nose up. As an argument they pointed to some remarkable peaks on the column and elevator deflection records (Figure 83, circled).

**Figure 83 Longitudinal parameters during the final segment of the accident flight**

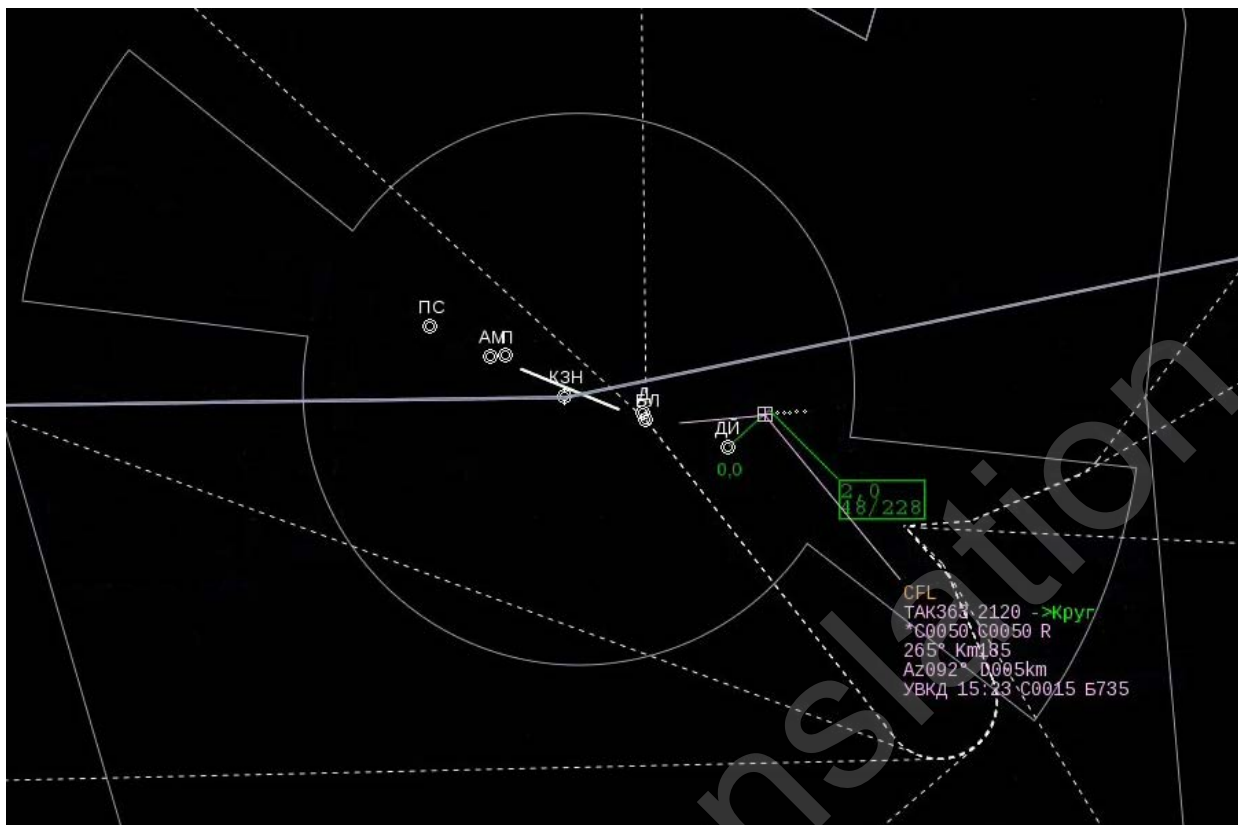
The ATC officer cleared them for landing, although he could see it on the radar that the aircraft was not stabilized (Figure 84): the distance from the localizer was about 5 km, according to Galaktika ATM automation complex, the altitude was 500 m according to the aircraft information tag without any tendency to descend (the descent symbol was not present in the tag) and the aircraft was offset to the right of the landing track. It would have been a more appropriate decision for the ATC officer to inform the crew on their actual position at least and recommend to go around.

**Figure 84 Radar printscreen at the time of the landing clearance providing**
