The Aircraft Accident Investigation Board of the Islamic Republic of Iran

Flight PS752 Accident Investigation

Final Report

Crash of Ukraine International Airlines Flight PS752

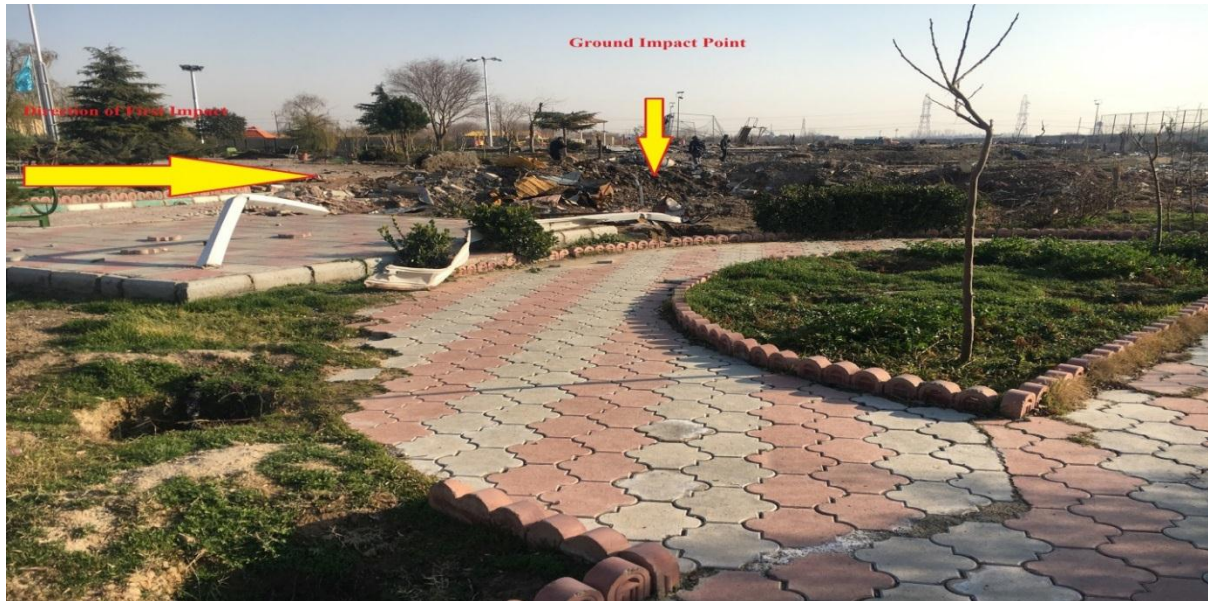
Figure 7- The first ground impact of the aircraft

Shortly after the transponder stopped transmitting signals, the aircraft heading was changed to the right and after turning, headed toward the airport. The aircraft lost its altitude gradually and after passing by Khalaj Abad residential area impacted a gazebo roof in a recreation park with the position $35^{\circ}33'45.4''\text{N}51^{\circ}06'11.3''\text{E}$ and then hit the ground (Figure 7).

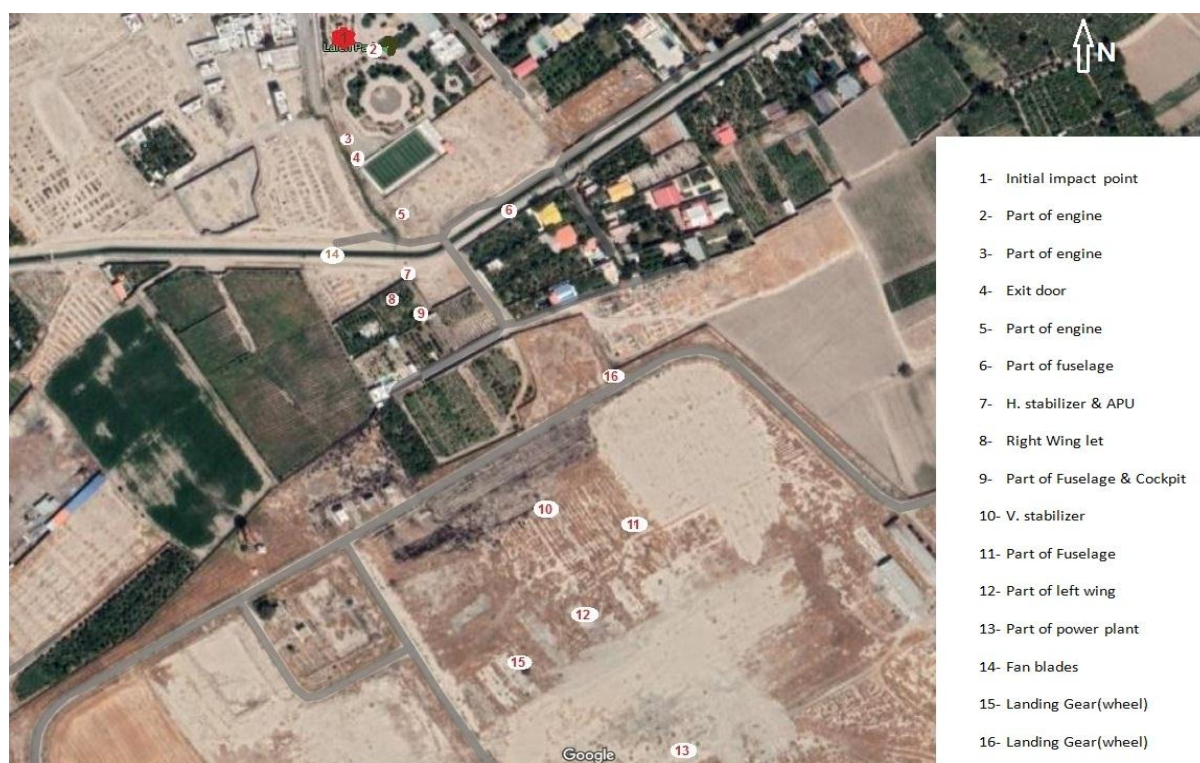
Figure 8- An overview of the aircraft parts distribution

The impact with the ground created a large hole in the park, then the fuselage distanced from the ground and went on to a soccer pitch, hit its fences, passed by a water canal, again hit walls of private gardens and disintegrated completely as shown in Figure 8. The evidence and pieces gathered from the aircraft at the main accident site showed that the aircraft still maintained its relative integrity before impacting the ground. Interviews with eyewitnesses along the flight path confirmed this as well.

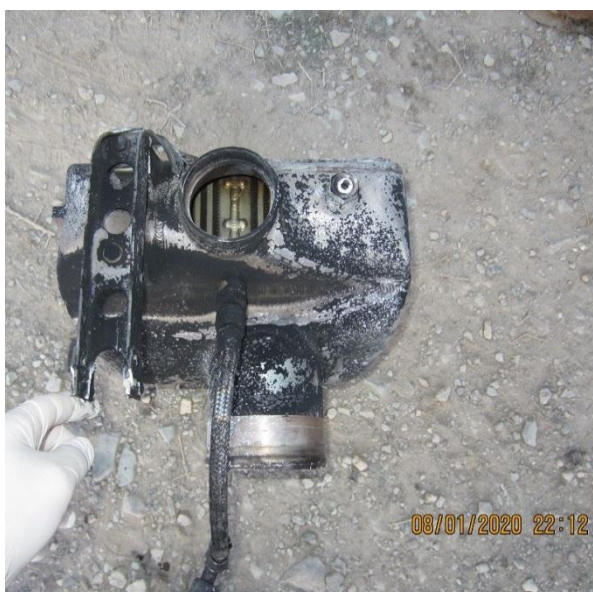
Figure 10- A part of air conditioner found on ground before crash site

While flying past a village called Boke near Shahriar, some skin pieces belonging to the aircraft wing back end surfaces (Figure 9) were detached and found on the ground at position $35^{\circ}35'55''\text{N}$, $50^{\circ}59'00''\text{E}$. Some small pieces and a piece of the air conditioning system (Figure 10) were found at position $35^{\circ}35'53''\text{N}$, $50^{\circ}59'43''\text{E}$, about 10 kilometers before the crash site, which was collected by the locals in residential complexes and delivered to the respective rural council.

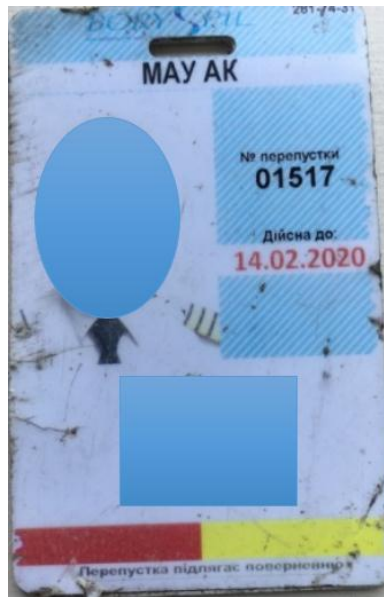
Figure 15- Instructor pilot's ID card

An ID card related to instructor pilot was found at the crash site without any signs of burns (Figure 15).

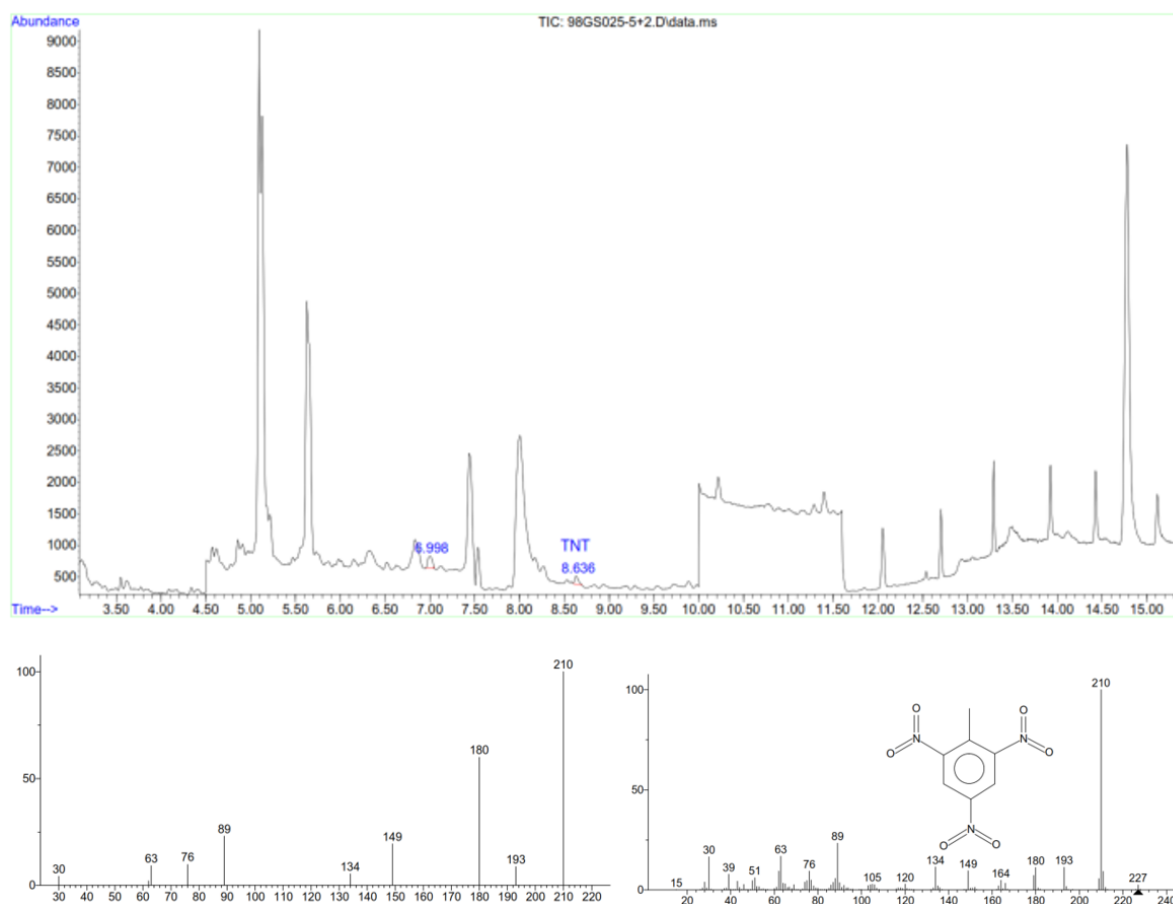
Figure 28- Gas chromatography–mass spectrometry; GC-MS, of aircraft wing skin piece

Based on the results yielded through GC/Mass chemical analysis, the existence of Trinitrotoluene (TNT) explosives with a chemical formula C₇H₅N₃O₆ was confirmed in the aircraft wing skin, which was found before the crash site. (Figure 27)

Gas chromatography–mass spectrometry; GC-MS of this piece can be seen in Figure 28.

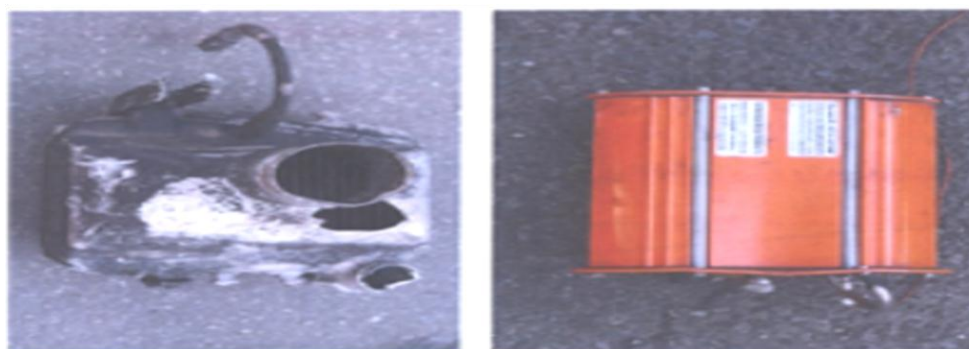
Figure 29- Pieces on which the explosive test was done

By sampling the air conditioning system and the two ELT pieces of the aircraft (Figure 29) and performing gas-chromatographic-mass spectrometry on each of the parts, the presence of negligible amounts of Dinitrotoluene (DNT) with the chemical formula $C_7H_6N_2O_4$ was proven.

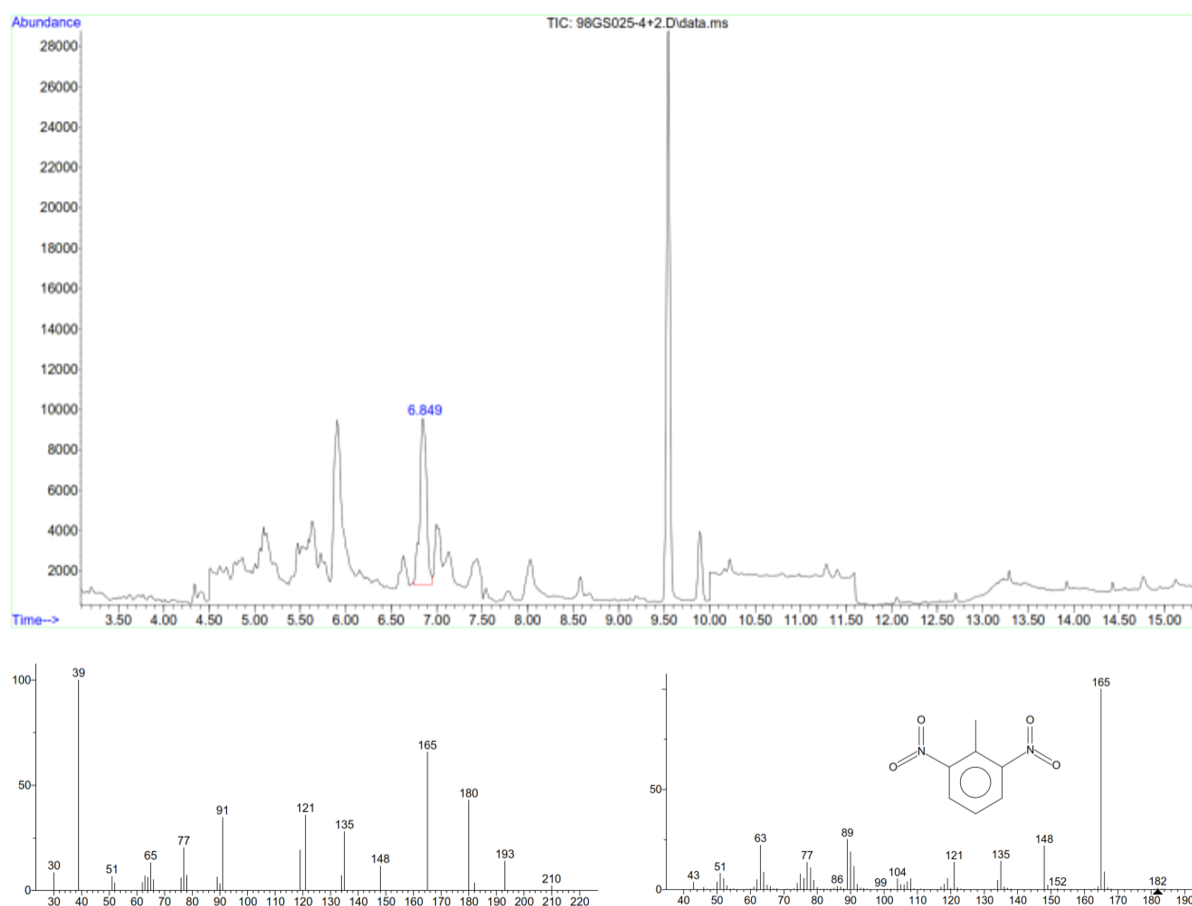
Figure 30- The GC-MS of the ELT and heat exchanger

The GC/Mass chemical analysis spectrum of the above samples can be seen in Figure 30.

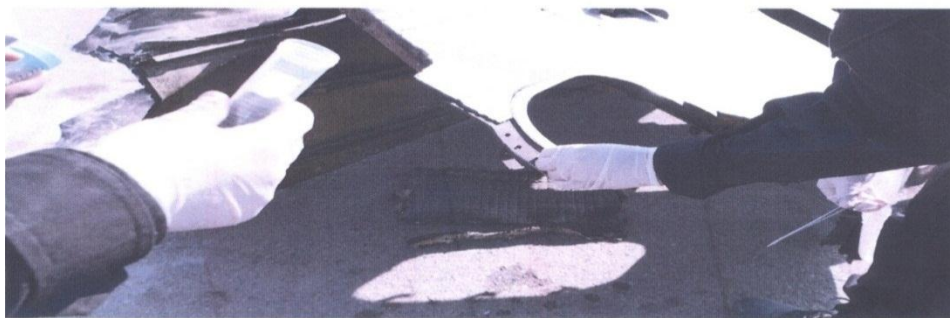
Figure 31- The interior of part of the aircraft cabin window pieces on which the explosive test was done

According to the spectrometry obtained from the interior part of the aircraft cabin window (as shown in Figure 31), the presence of more explosive Trinitrotoluene (TNT) was detected (Figure 32).

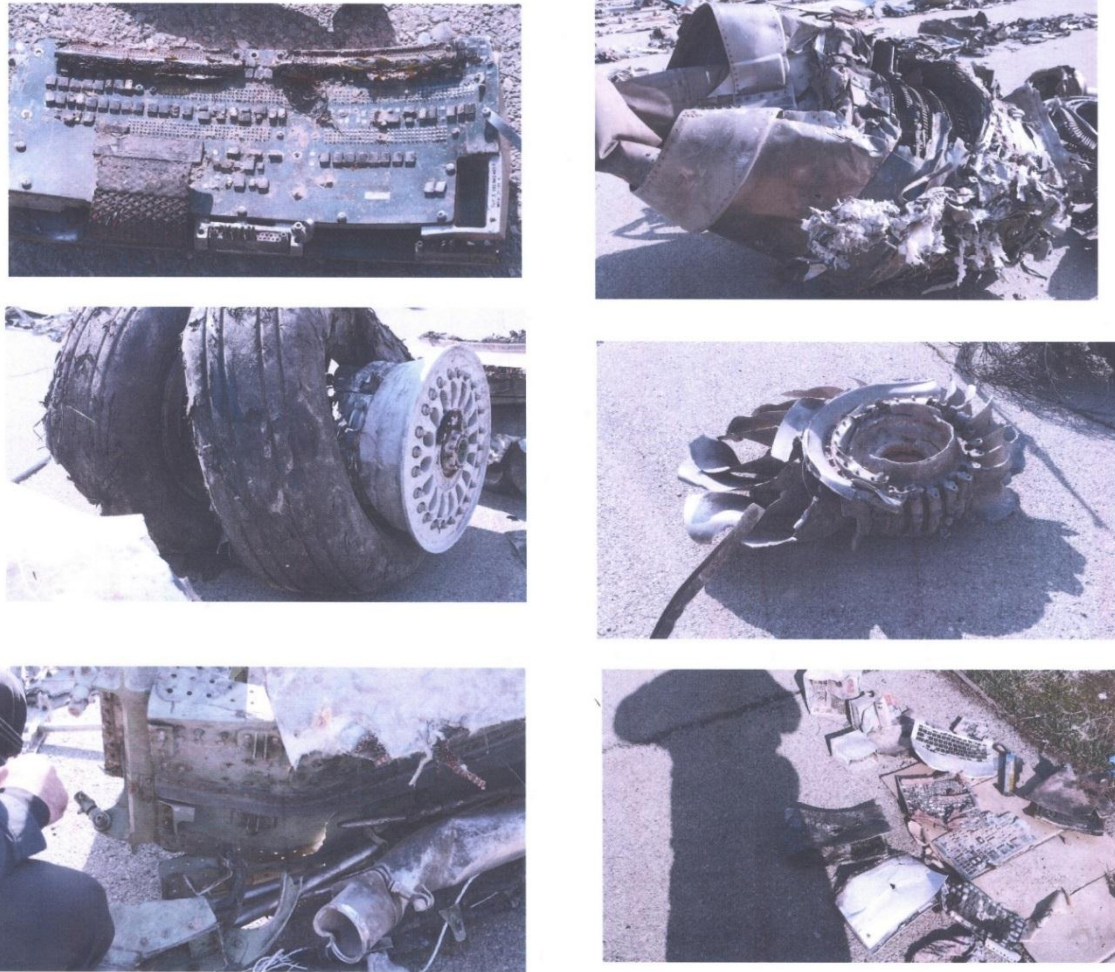
Figure 33 -Some of the aircraft parts free from explosives

It should be noted that no explosive contamination was observed in the samples taken from the engines and other aircraft pieces or the objects inside the passenger cabin (Figure 33).

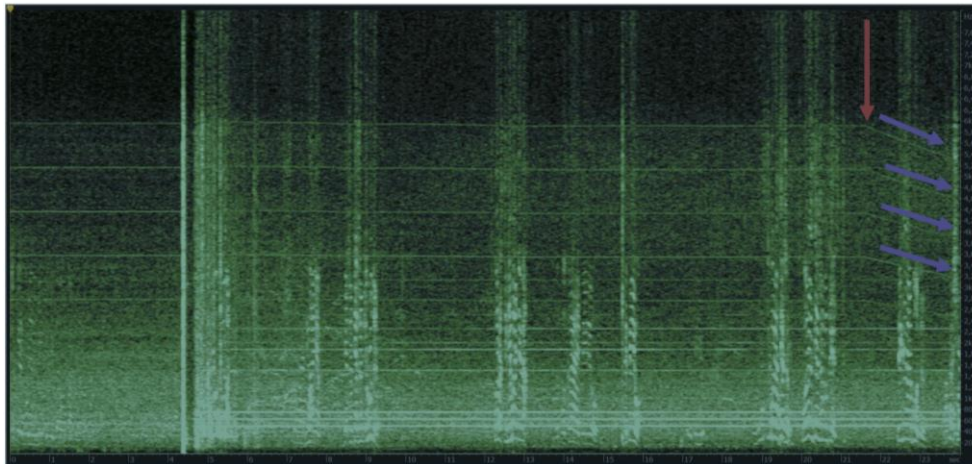
Figure 40- Drop of frequencies recorded in CVR. Photo:BEA

A drop of frequencies began 2.445s before the end of CVR recording.

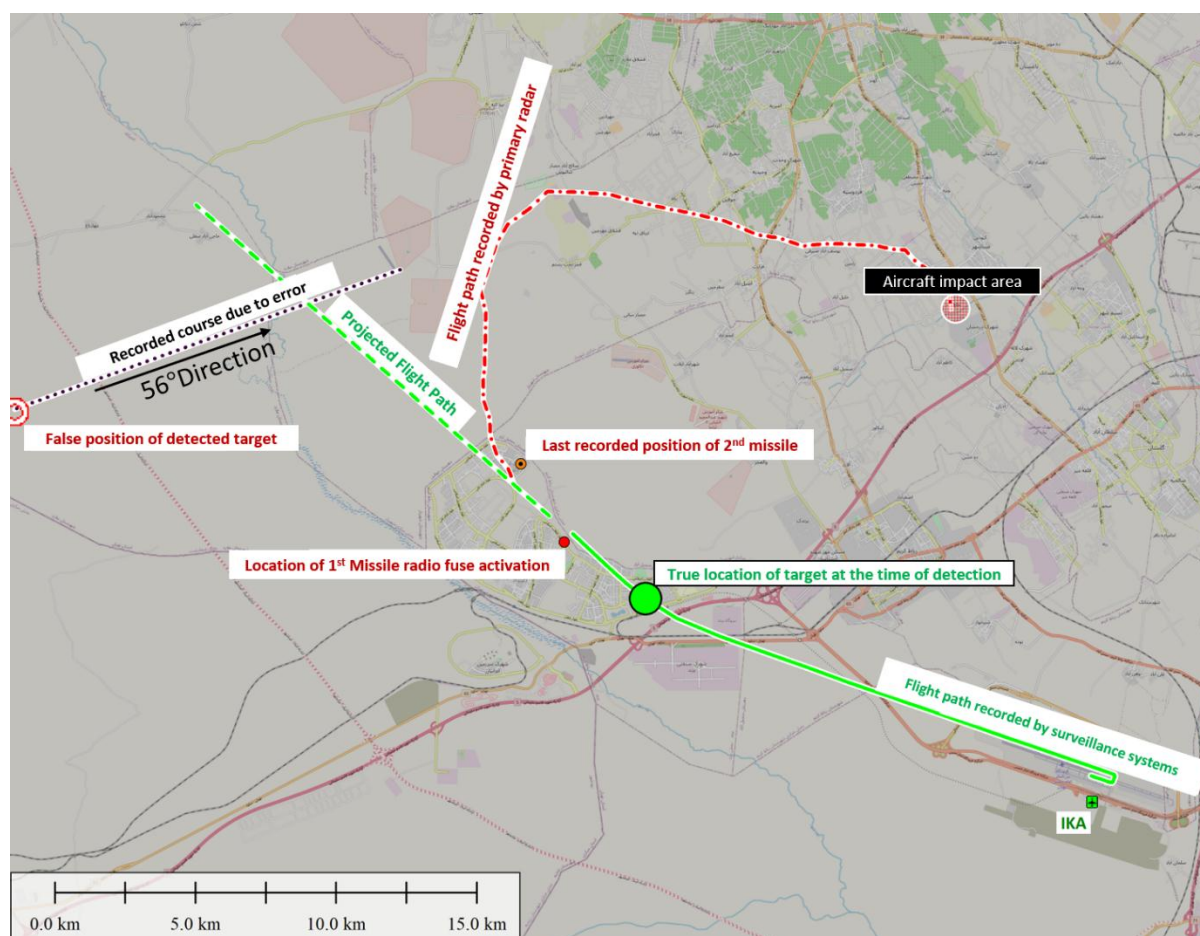
Figure 41- The location of key events in missile launch

At 06:15:22, the last communication between the second missile and the defense system was recorded in a place close to the aircraft route. After that, the defense system showed a message indicating the strike had failed, with the aircraft clearing from the radar lock-on after some time.

Figure 41 depicts the trajectory and true location of the aircraft, wrong detected position and locations related to the activation of the missiles.

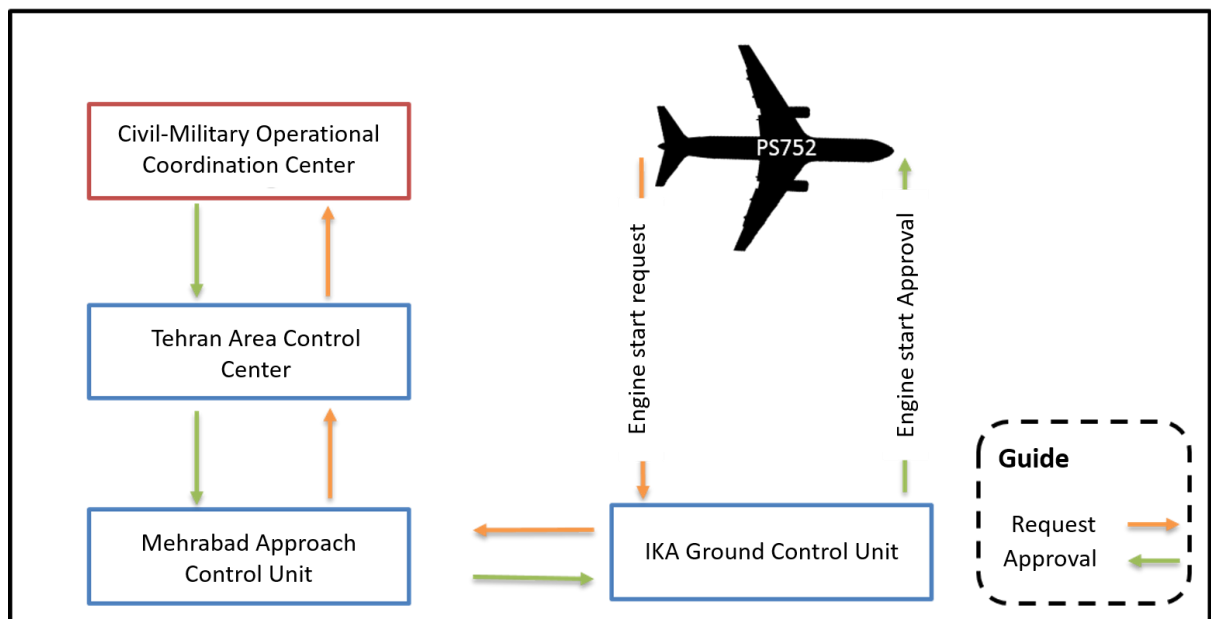
Figure 47- Civil-Military coordination structure at the operational level at the time of the accident

Civil- Military coordination at the time of flight PS752 is illustrated in Figure 47. In this figure, the communication lines between IKA ATC unit, Mehrabad approach unit, Tehran ACC and CMOCC are shown.

Review of evidence regarding flight PS752 showed that the plan had been implemented and the air traffic control had issued the clearance for engine startup after making coordination with the air defense sector.

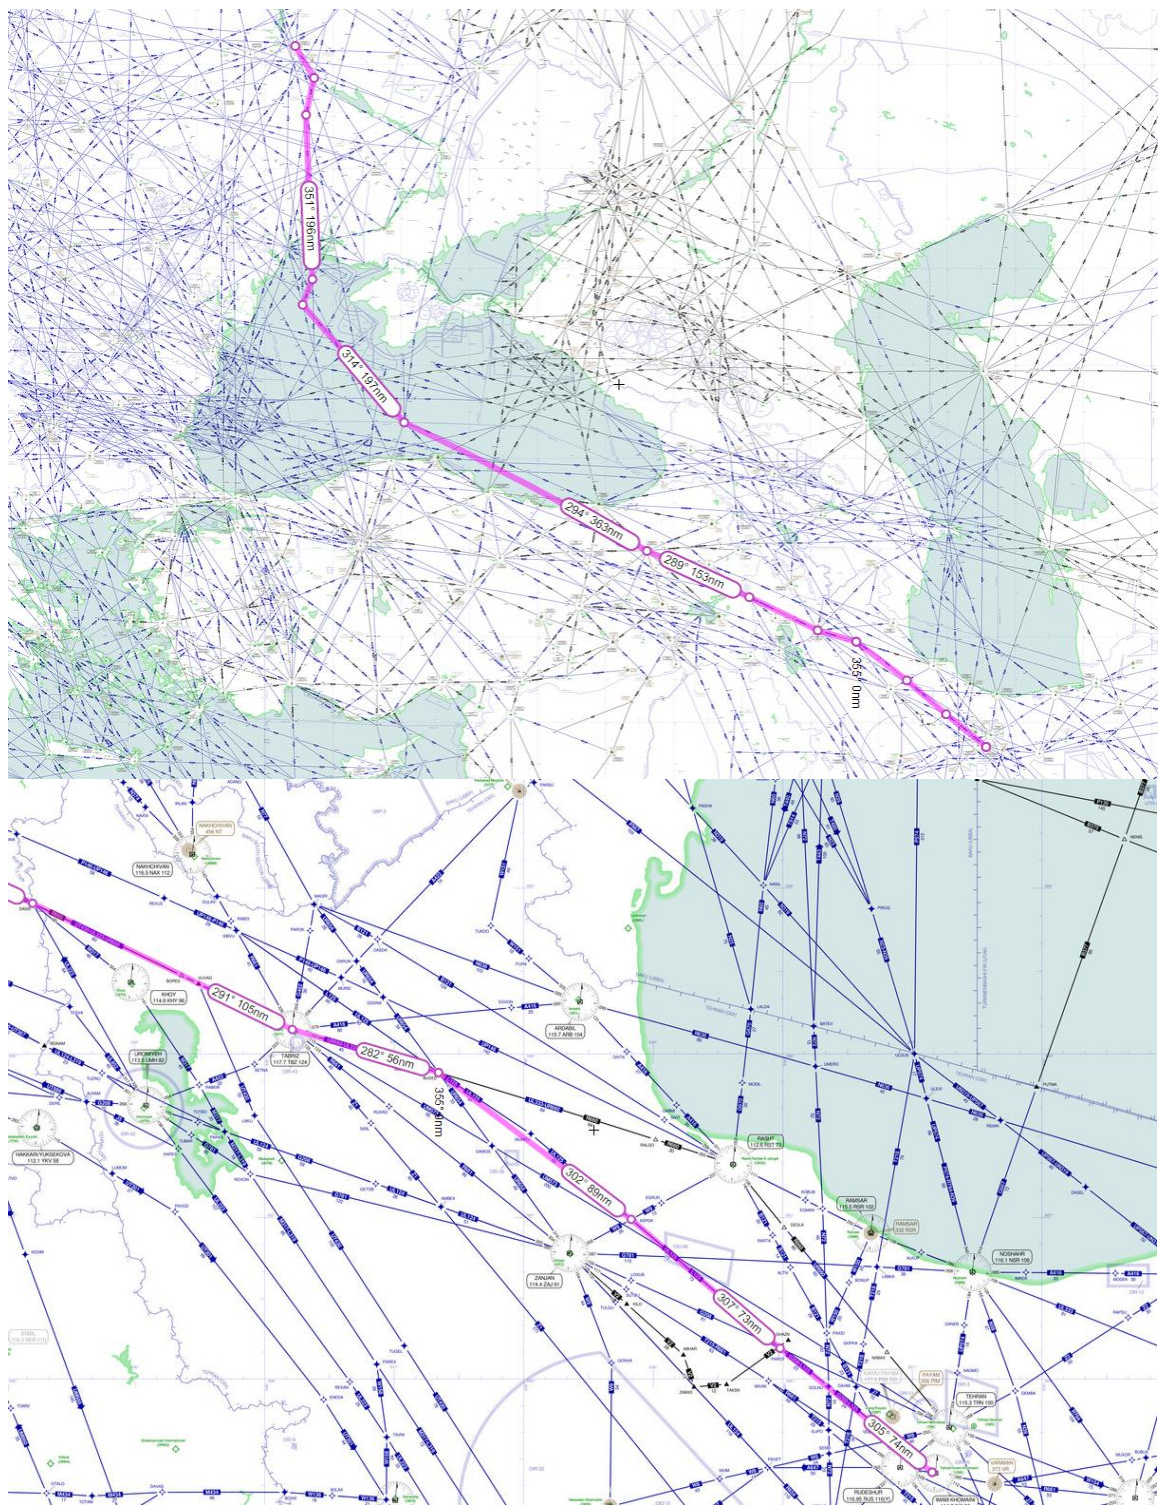
Figure 48- PS752 planned route

Also, the flight PS752 plan had been sent to the military sector, and the CMOCC had been receiving the civil surveillance radar information including the very flight specifications. Considering the location and time of the PS752 takeoff as well as its trajectory to leave Iran FIR, which was not in the limited areas in west of FIR (Figure 48), the measures envisaged in the risk reduction program from this perspective had also been implemented according to the plan.

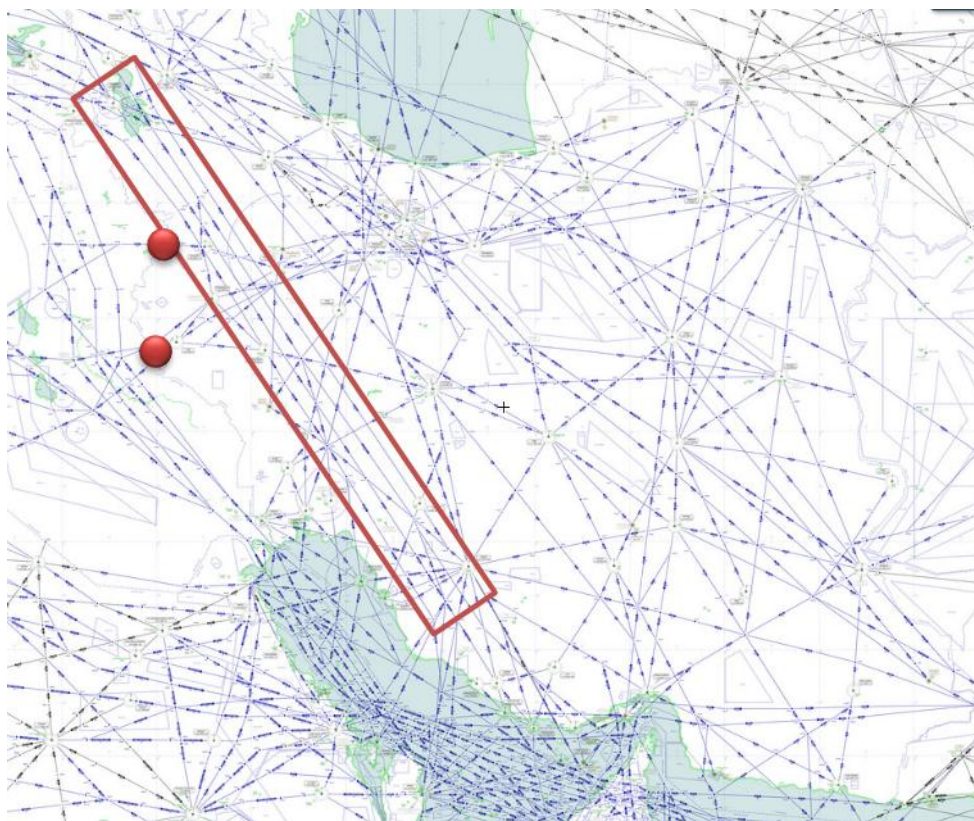
Figure 49- The scope of Iran west routes and exchange points between Tehran and Baghdad FIRs

The planned measure to clear the four parallel routes in the west of the country had been carried out. The radar observations showed that at the time of the accident, the clearance of four parallel routes No. UT430, M317/L319, UL223 and UT 331 of the transit traffic in the west of Tehran FIR near Iraqi border (Figure 49) had been carried out and there was no flight in this area.

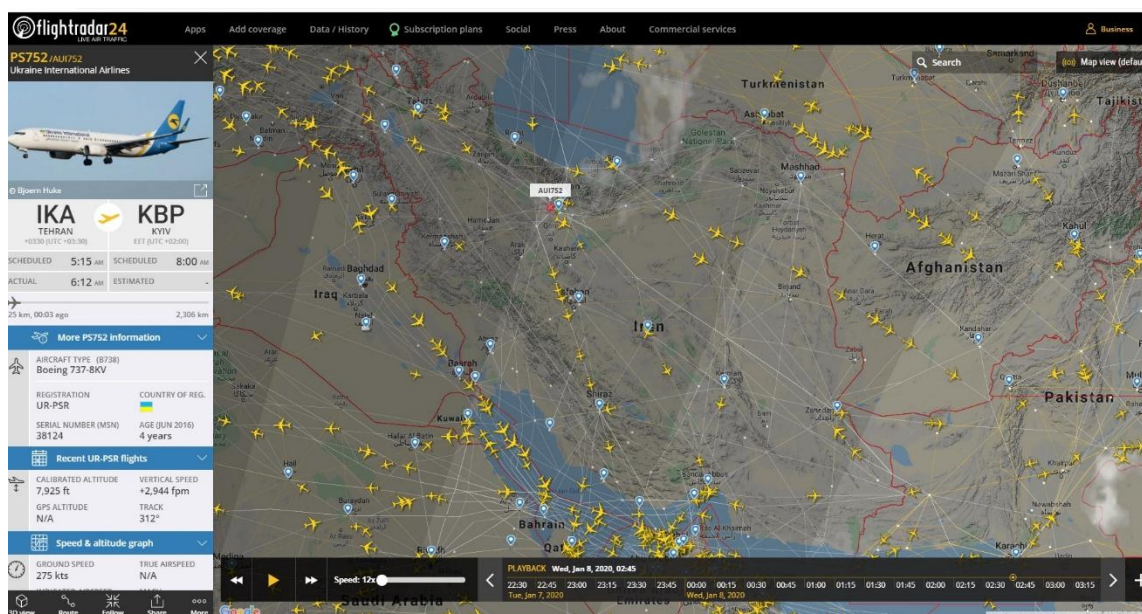
Figure 50- Transit flights status in the west of Iran FIR at PS752 takeoff time (source: FlightRadar24)

The observable flight information on these routes corresponds to the one recorded on Internet sources (Figure 50).

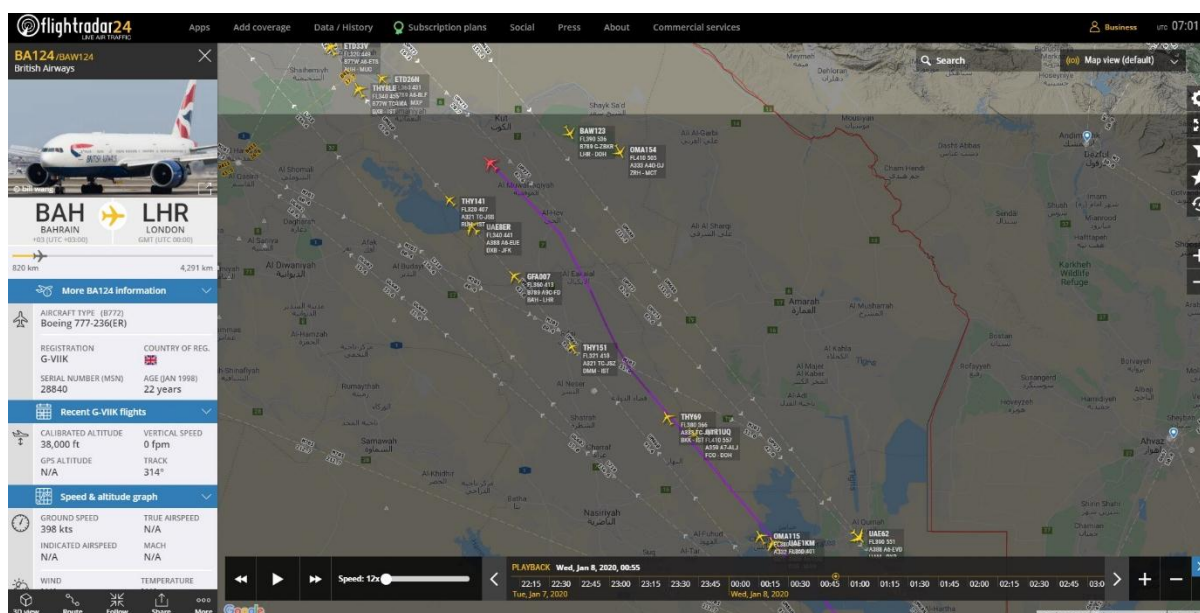
Figure 53- BAW124 whose entry into the Iranian airspace was denied due to the suspension of traffic exchange between Tehran and Baghdad FIR

It was also observed that at 04:11 Iraq ACC requested their counterpart in Iran to accept the entry of British Airways flight BAW124 into the Iranian airspace. This was, however, denied due to the restriction imposed on the traffic exchange between the two countries -Iran and Iraq (Figure 53). Such a negative response was in line with the planned preventive measures.

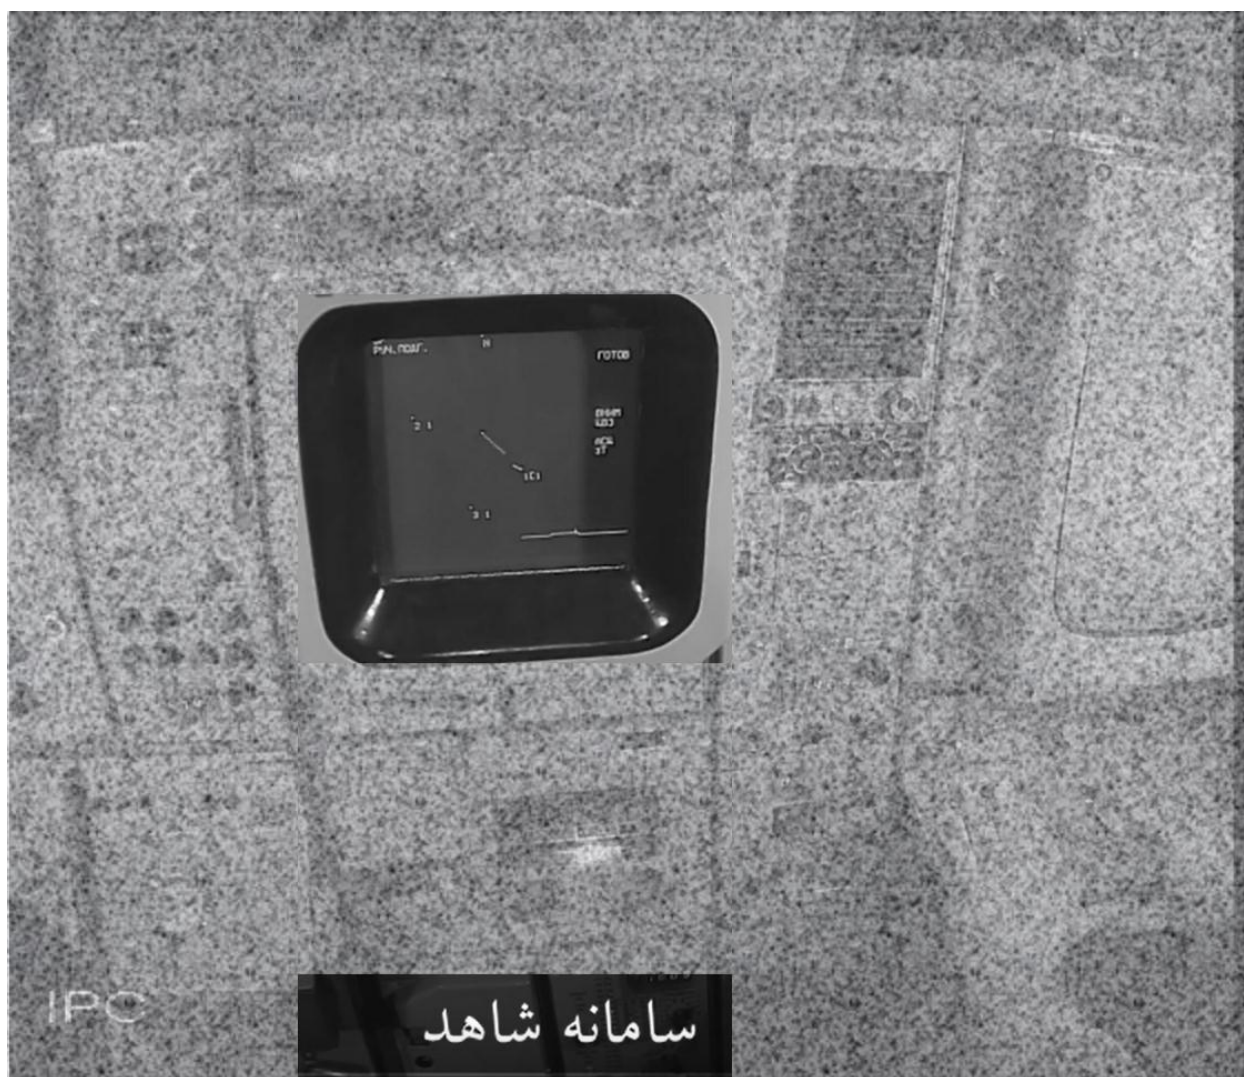
Figure 54- The target direction in the reference ADU in the simulation with correct North alignment

The simulation also indicated that the aircraft flight operation did not play a role in the occurrence of the error made by the air defense unit operator. In the two times of simulation, the reference unit operators detected the aircraft from the IKA direction (Figure 54), while the main unit operators detected it approaching from the western area (Figure 55).

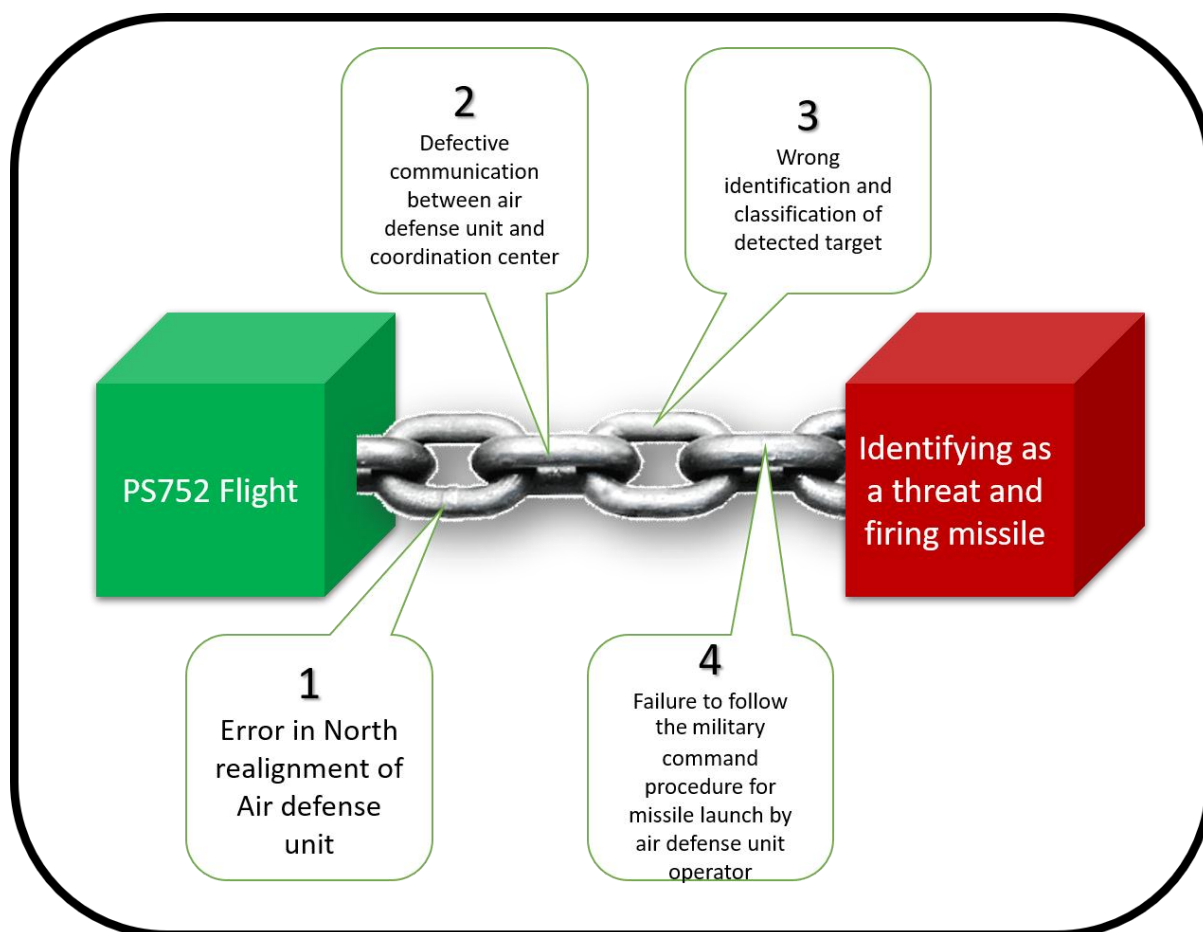
Figure 56- The chain of events leading to firing missile at PS752

The target specifications were announced to the command center, but the message was never relayed. Without receiving a go-ahead or response from the command center, he came to identify the target as a hostile one and fired missile at the aircraft against the procedure planned.

The chain of events observed by the investigation team leading to firing missile at PS752 is illustrated in Figure 56.

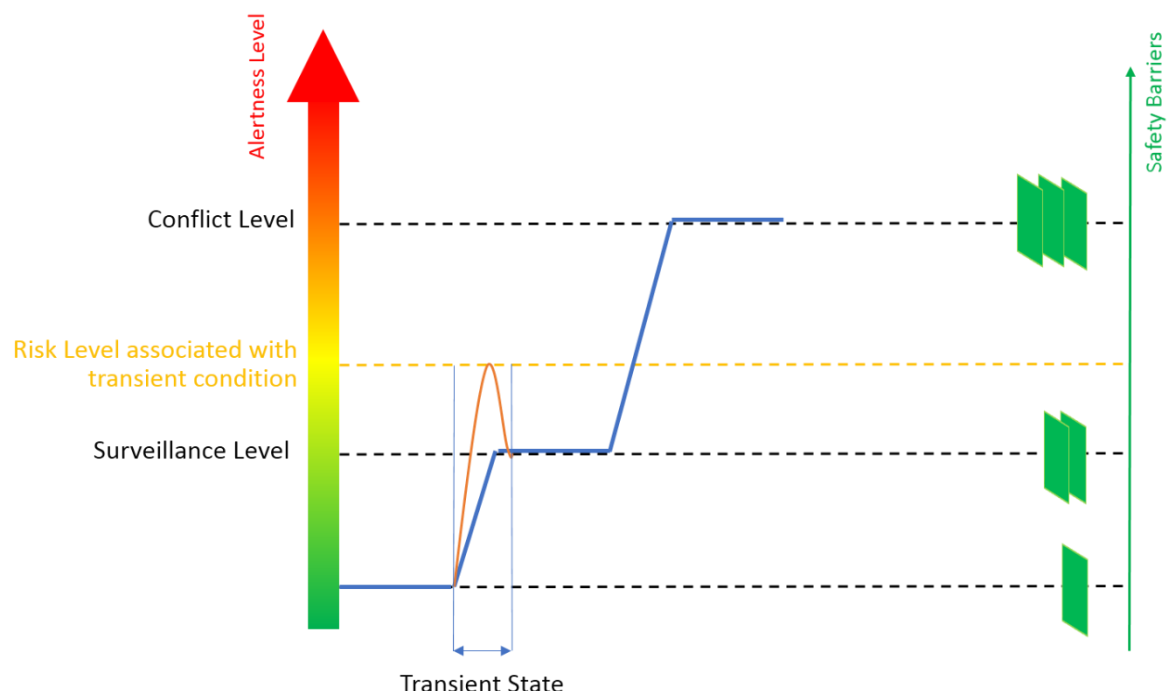
Figure 57- Alertness levels and risk in transient condition

In PS752 accident case, taking into account that the prevailing conditions rapidly changed at about 02:00, it is likely that at the time of the accident, the transition time was not finished yet and this transient condition contributed to human errors and the existing hazards within the whole system.
