SERIOUS INCIDENT

Aircraft Type and Registration:	DHC-8-402, G-FLBE	
No & Type of Engines:	2 Pratt & Whitney Canada PW150A turboprop engines	
Year of Manufacture:	2009 (Serial no: 4261)	
Date & Time (UTC):	14 November 2019 at 1950 hrs	
Location:	In-flight from Newquay Airport to London Heathrow Airport	
Type of Flight:	Commercial Air Transport (Passenger)	
Persons on Board:	Crew - 4	Passengers - 59
Injuries:	Crew - None	Passengers - None
Nature of Damage:	Aileron cable broke	
Commander's Licence:	Airline Transport Pilot's Licence	
Commander's Age:	51 years	
Commander's Flying Experience:	8,778 hours (of which 5,257 were on type) Last 90 days - 150 hours Last 28 days - 33 hours	
Information Source:	AAIB Field Investigation

Synopsis

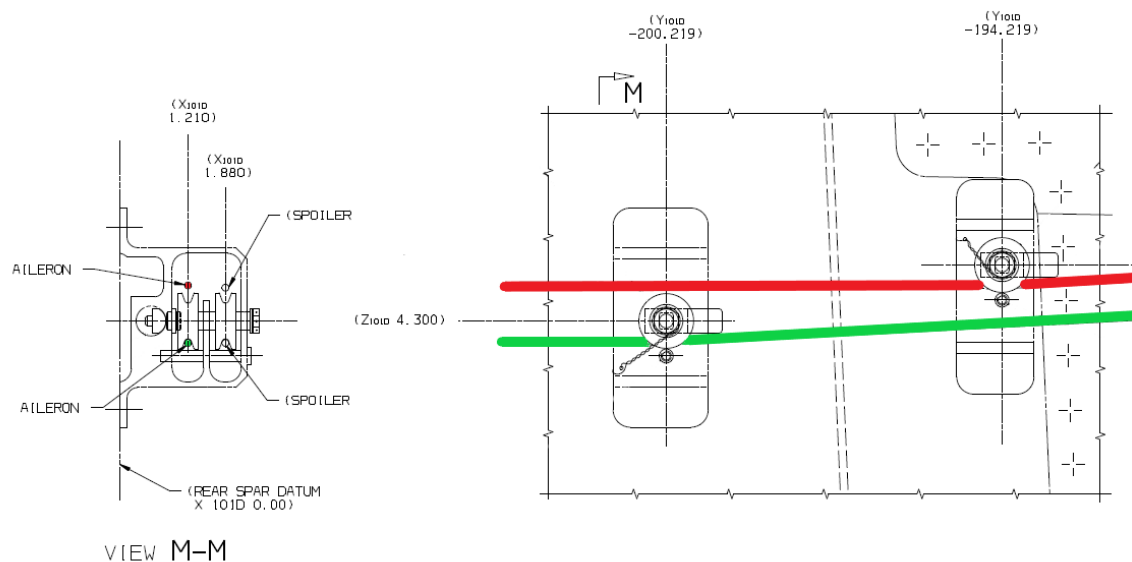
Figure 2

Post-flight examination revealed that the lower left aileron cable broke just outboard of the engine where it passed over a pulley to accommodate a change in the wing dihedral (Figure 1). There was no other damage to the aircraft.

Immediately outboard of the engine, small pulleys direct the cables by approximately three degrees to accommodate a change in the wing dihedral. The spoiler cables are routed aft of the aileron cables (Figure 2).

Pulley and cable arrangement to accommodate a change in the wing dihedral

The lower left aileron cable failed where it passed over a pulley mounted on the rear wing spar. The pulley was found to rotate freely on its bearing.

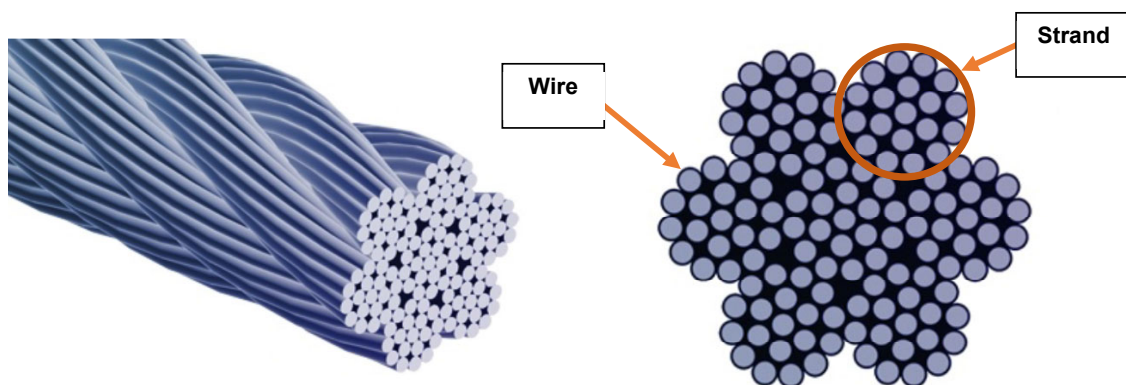
Figure 3

The control cables have a diameter of $\frac{1}{8}$ inch and are constructed from 7 strands, each consisting of 19 wires. Six of the strands are wound concentrically around a central strand (Figure 3).

Construction of the control cable
