## **INTERSTATE AVIATION COMMITTEE**

#### **FINAL REPORT ON RESULTS OF INVESTIGATION OF ACCIDENT**

| Type of aircraft | ATR72-201 aeroplane |
| Registration | VP-BYZ, Bermudas |

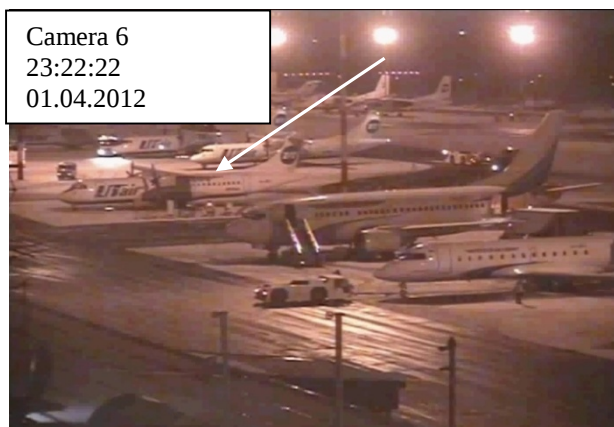
**Figure 15.** ATR 72 VP-BYZ A/C arrived to Roschino AD on 01.04.2012 at 17:43 and was put to stand 3

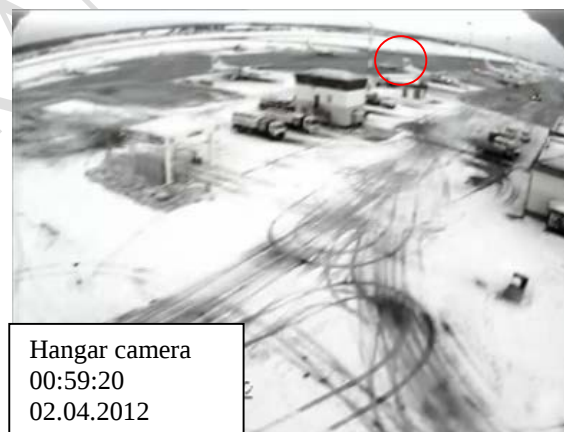
**Figure 18.** De-/anti-icing vehicle has arrived to the ATR 72 VP-BYZ A/C

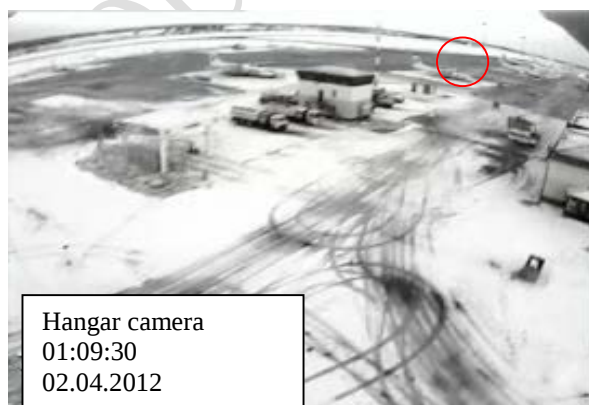
**Figure 19.** De-/anti-icing vehicle is leaving

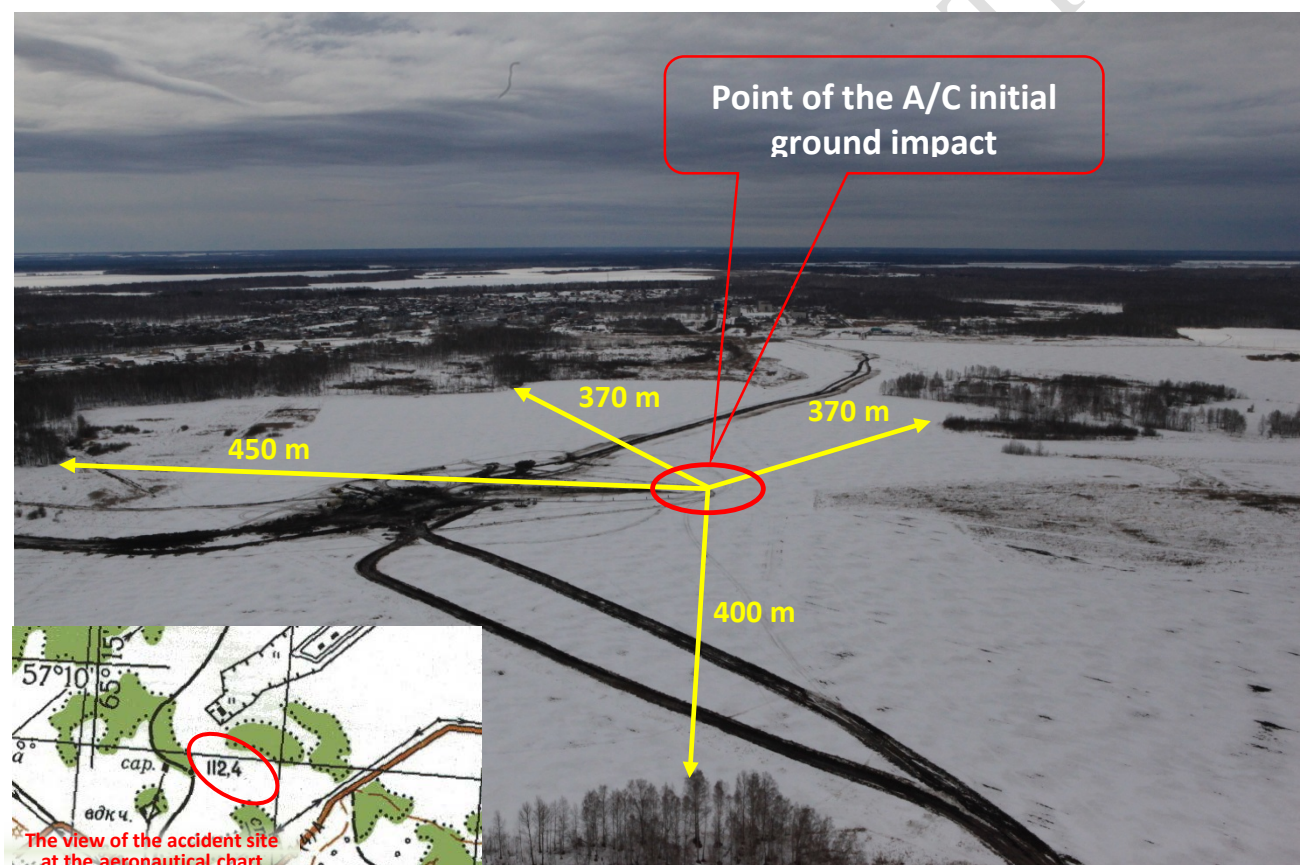
Figure 29. The accident site positioning with relation to the reference points

The Tyumen (Roschino) AP is located in the flat area and its RWY 21 exit threshold elevation is 103.9 m. The area where the accident occurred is a flat ground (at the moment of accident it was covered with snow,  $H = 30\text{--}34$  cm) with some adjoining blocks of birch forest with trees' height of 15-20 m (Figure 29). The terrain elevation in the area of the accident is 110 m.

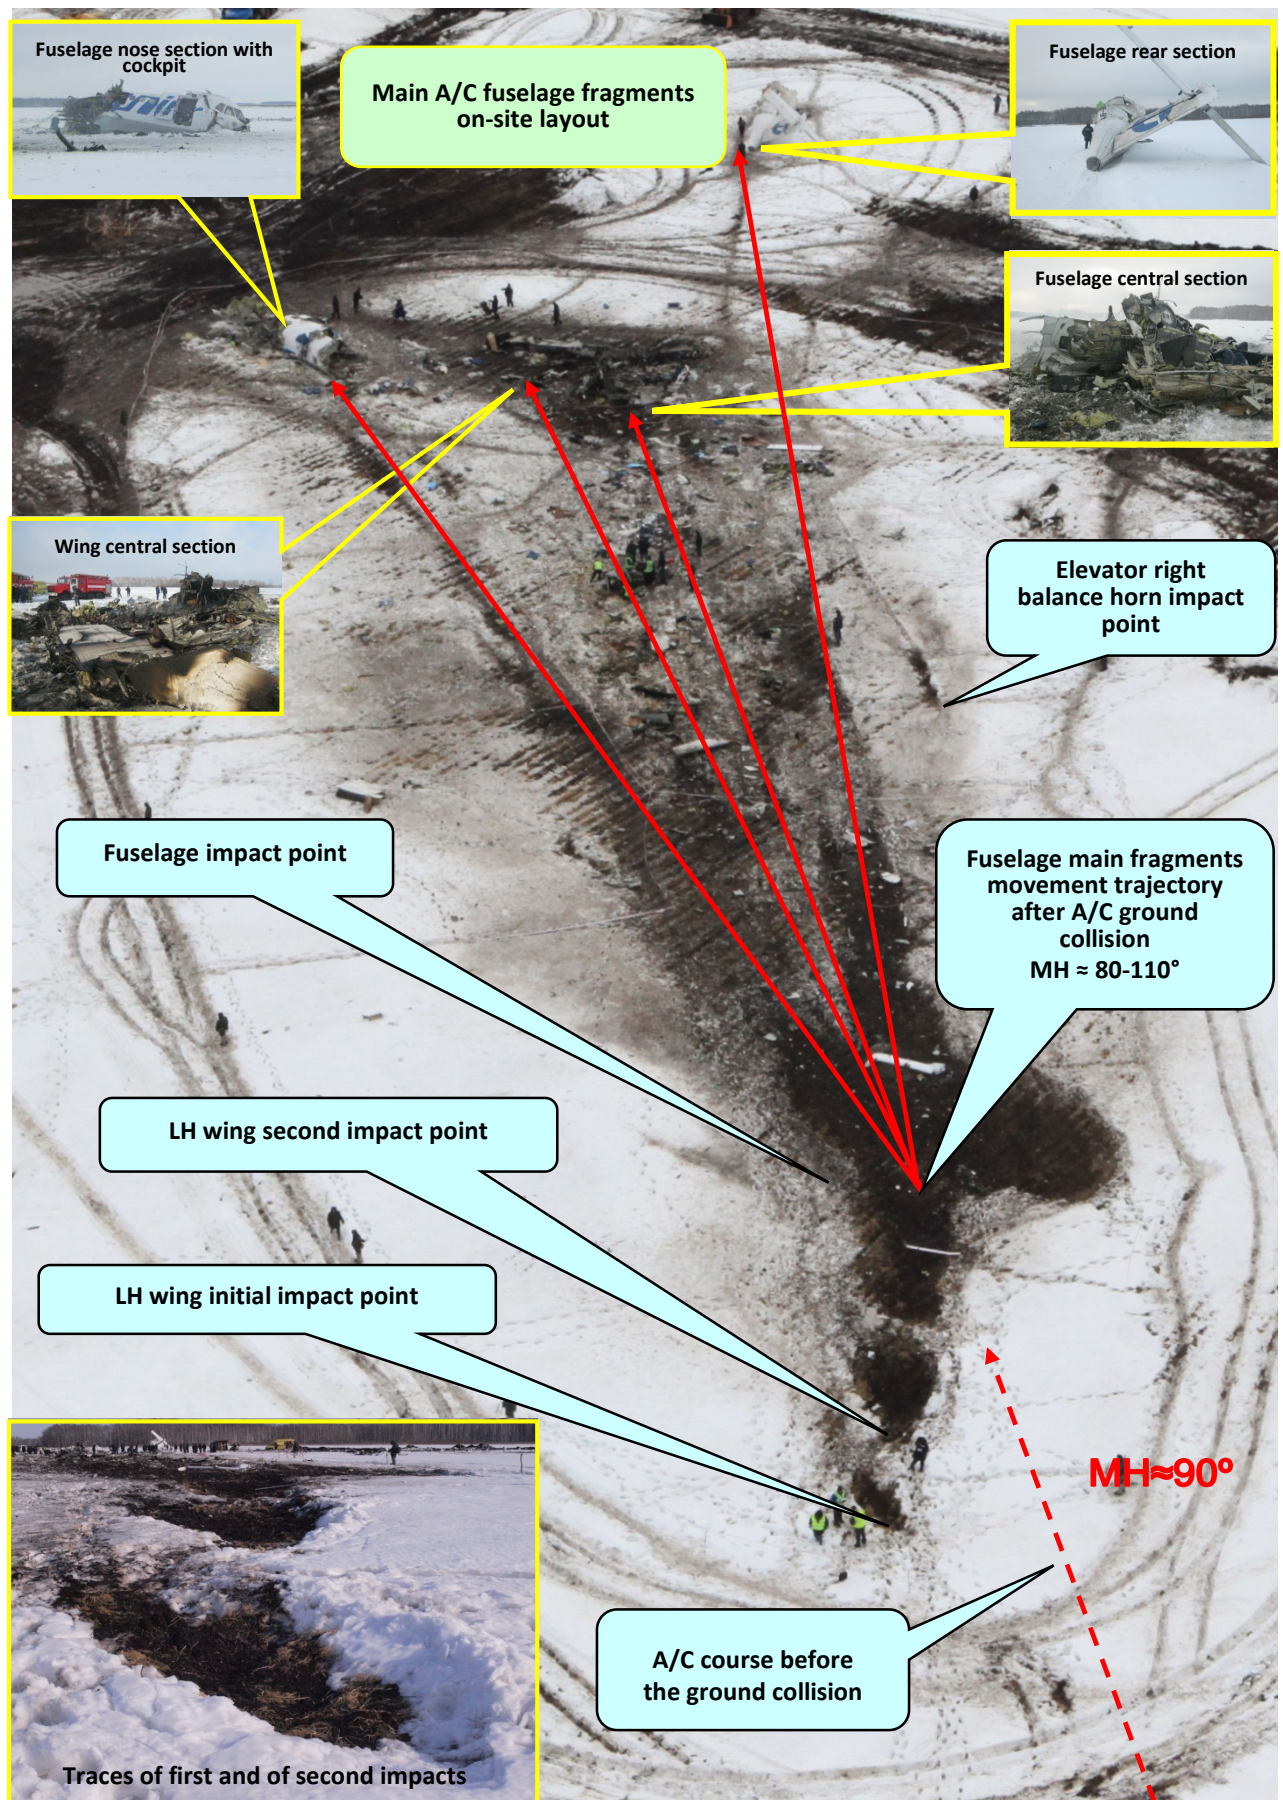
Figure 32 Airspace view of the accident site

The initial ground impact was with the LH outer wing and resulted in the outer wing destruction. The initial impact “spot” dimension is 1.6 x 4 m.

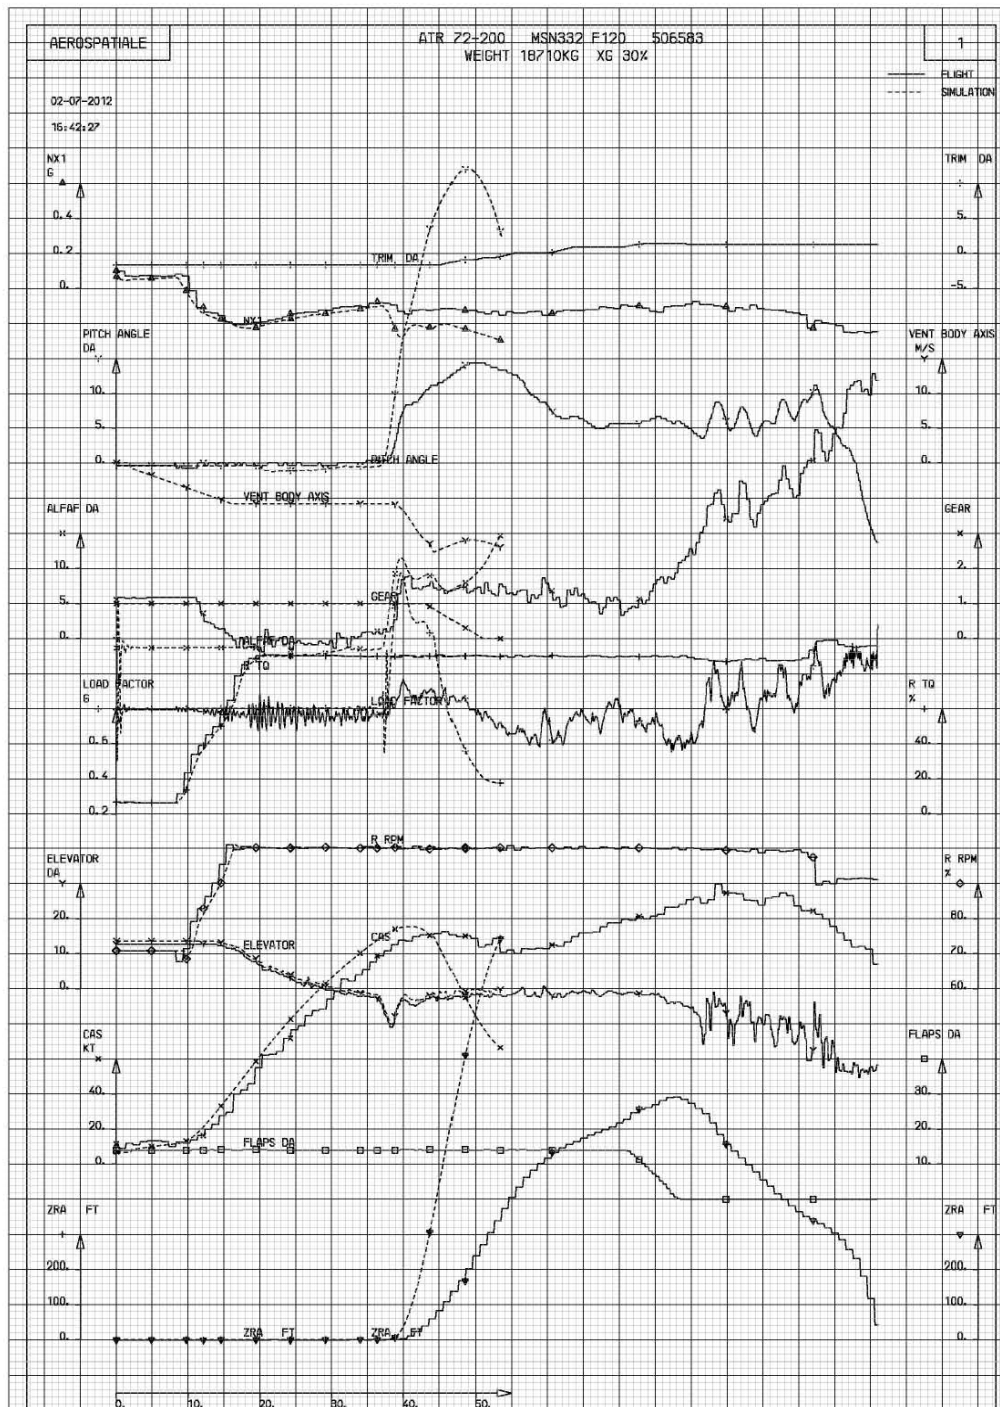
**Figure 424. Simulation compared to FDR Flight UTA-119 – with "normal" aerodynamic factors**

The accident flight simulation (Flight UTA-120) showed that with the actually realized deflection of the flight control surfaces, engine thrust and the aerodynamic data basis, the simulation did not match the DFDR parameters (Figure 44).

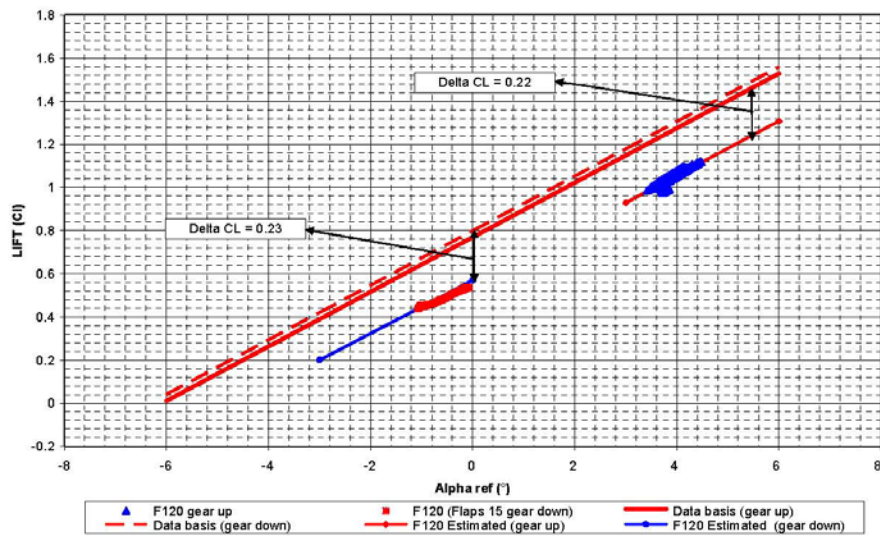
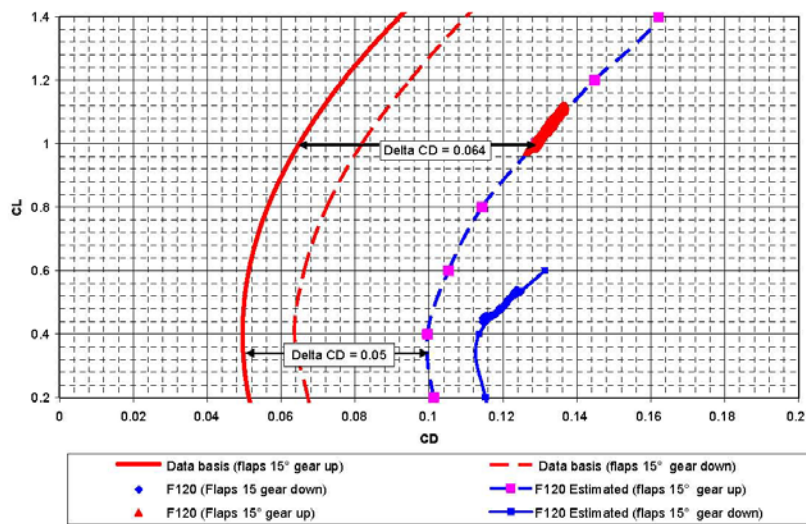
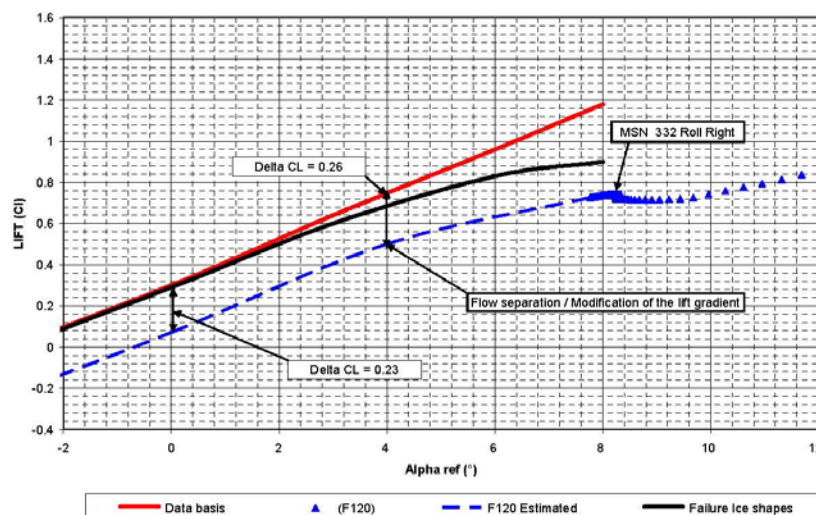
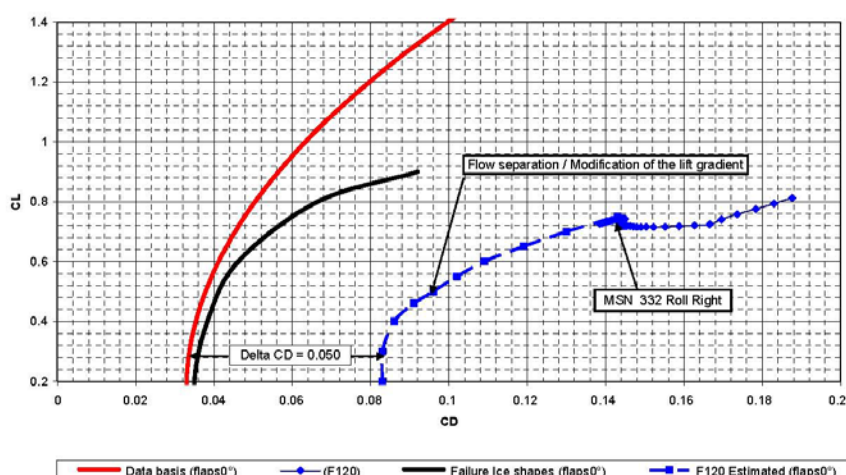
The simulation revealed that during the takeoff run at angle of attack near  $0^\circ$ , a loss of lift and an increase of drag were  $\Delta CL_0 = -0.23$  and  $\Delta CD_0 = 0.05$  (Figure 46). The graph analysis shows that at that phase of flight CL was reduced by approximately 25%, while drag was doubled. Further after the landing gear retraction the loss of lift remained more or less constant, while the drag increased with angle of attack, providing a  $\Delta CD_0 = 0.064$  (Figure 46). After the flaps retraction the loss of lift still remained almost constant, while the drag increasing was  $\Delta CD_0 = 0.05$  (Figure 47).

When the aircraft has been contaminated on ground (with frost, snow or ice) the aerodynamic lift surfaces are affected and produce a loss of lift and an increase of drag. The other surfaces (fuselage, fairing, nacelles, etc.), when contaminated, produce additional drag due to modification of surface roughness and, consequently, friction. The angle of attack increase does not change significantly the drag due to friction, but produces, because of early flow separation, a reduction of lift gradient, severe losses in maximum lift and large reduction in stall angle of attack.

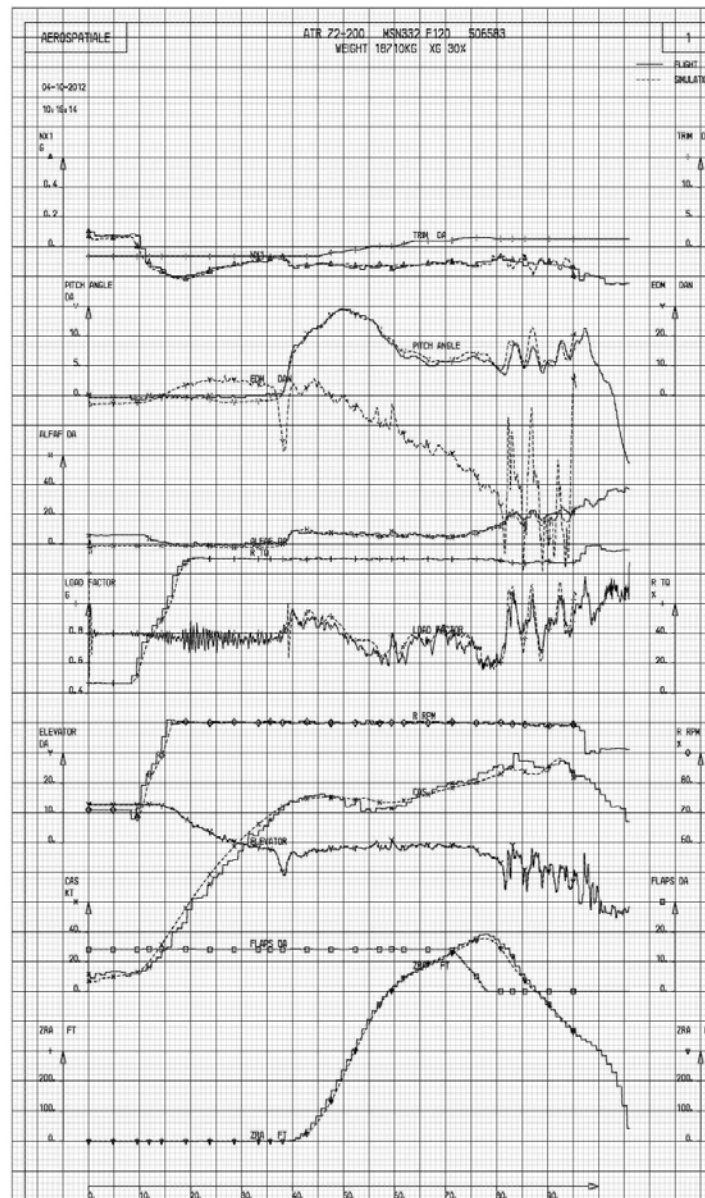
**Figure 468. Simulation of Flight UTA-120 with basic hinge moment**

According to the aircraft manufacturer's data, such incidents had occurred before. The plot below shows the simulated pilot's control column forces with basic hinge moment for a clean aircraft with DFDR elevator trim data. Figure 48 reveals that if the aircraft had been clean the crew would have experienced significant pitch up control column forces, while they actually trimmed the elevator for pitch down.

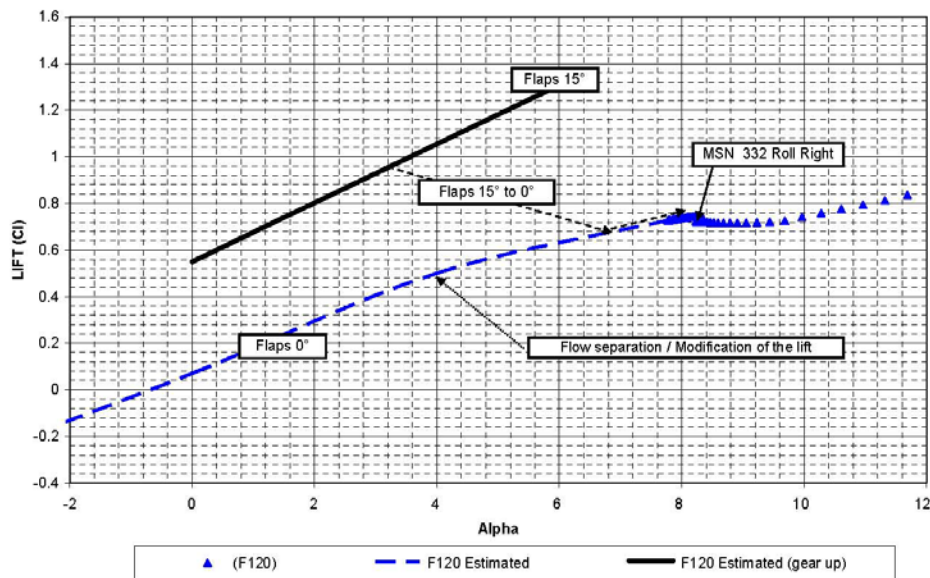
**Figure 479. Simulation of Flight UTA-120 (flaps 0°)**

Another conclusion drawn in the course of the simulation was that having the actual aerodynamic parameters it was impossible, after the flaps retraction, to obtain the lift required to continue flight at the current speed. It could be drawn from Figure 49 that the AOA increase cause stall before reaching the required CL. Thus, it was impossible to recover without setting flaps 15°.

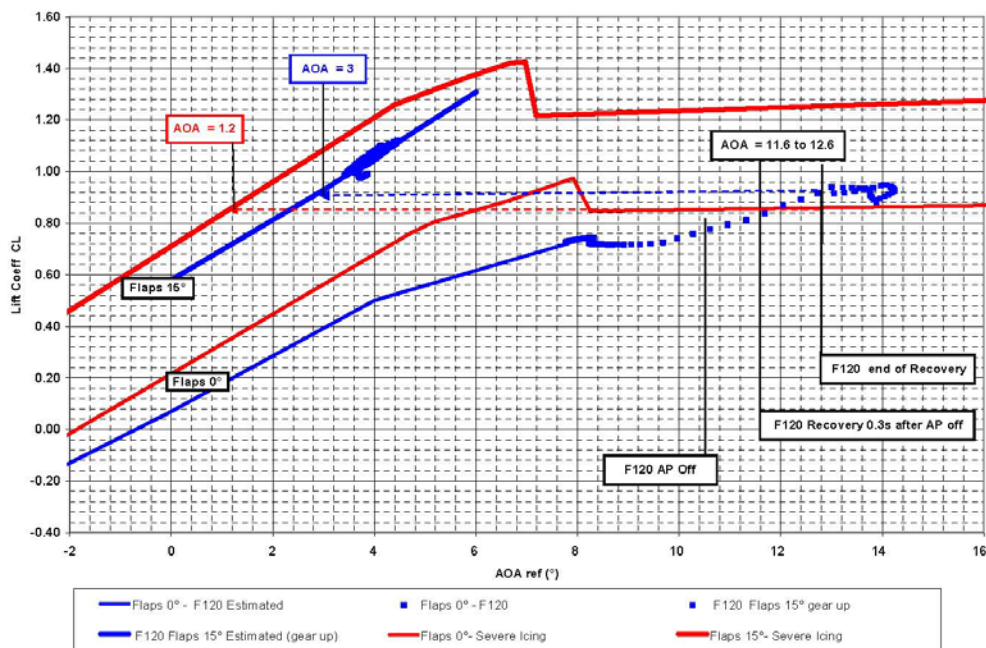
**Figure 50. FFS (severe icing) and FDR performance compared**

The analysis of drag and lift plots introduced in the FFS for severe icing conditions, and their comparison with the engineering simulation data (Figure 50) revealed that behavior of curves of CL versus alpha (AOA) in the FFS database and in the accident flight is almost similar (in linear range). They differ in absolute values (the curves are parallel) due to a difference in  $CL_0$ . The loss of lift after reaching the critical AOA as per the FFS database is more significant than in the accident flight. The effect of the flaps extension (in the way it reduces the required angle of attack to reach the same CL) is comparable. Thus, the FFS test findings can be used to assess the possibility to recover the aircraft performance after the stall in the accident flight.

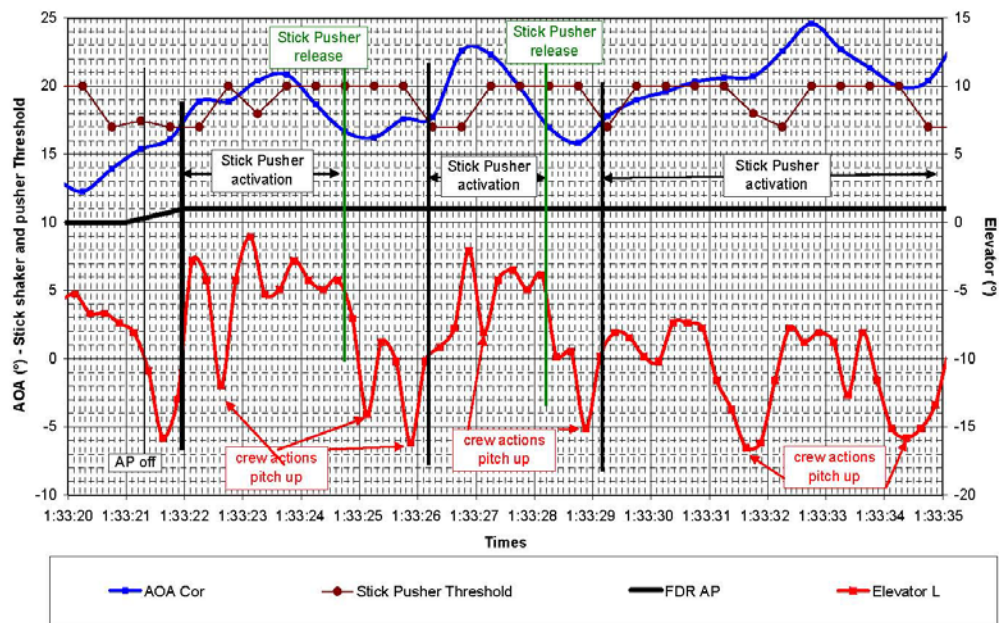
**Figure 53. The estimated times of the stick pusher activation**

According to the analysis, while the emergency developed, the conditions for stick pusher activation were met several times (Fig. 53)<sup>26</sup>. At the same time, it is necessary to note that the activation of the pusher is inhibited at the radio altitude less than 500 ft (after the time instant 01:34:16.5 of the accident flight), at that the inhibition in question is armed during the climb of the radio altitude more than 500 ft after takeoff (in the accident flight the maximum registered radio altitude was 701 ft at 01:34:06.5). The analysis of the record, given on Figure 53 shows that the first pusher activation occurred at 01:34:11 (B 01:33:22 by the time on Figure 53), at that the crew resisted the pusher operation (the elevator deflection to nose down). The force that is

necessary to apply on the control column to “overpower” the pusher is equal to 30-50 daN (depending on the elevator position). After the force from the control column is released and if activation conditions are still met the pusher will continue to deflect control column to pitch-down.

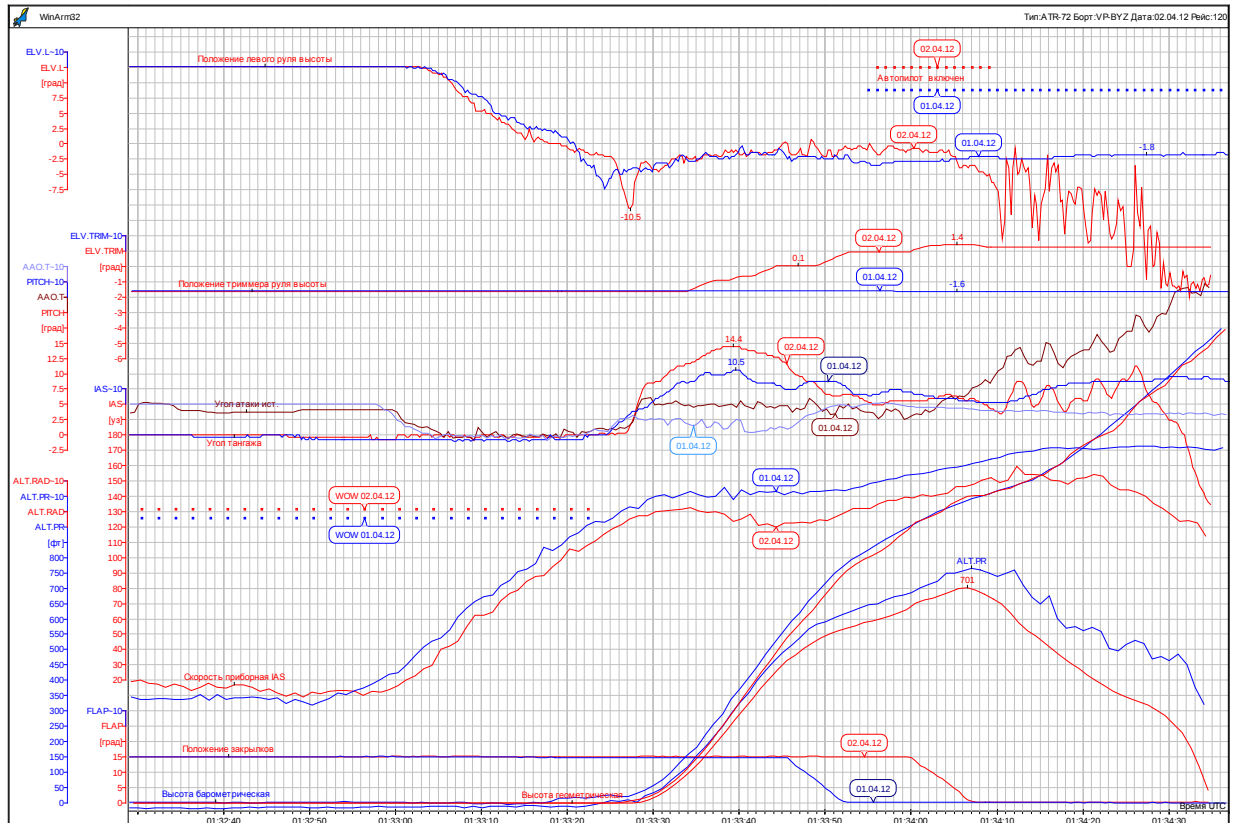
**Figure 54. The comparison of the climb envelopes in a previous and accident flight**

The comparison of the climb envelopes after takeoff (Figure 54) for the accident and the previous flight (TOW  $\sim 19\,350$  kg, OAT  $+6^\circ$ ) shows, that in the previous flight with greater TOW, with the same engine operating mode, a significantly smaller angle of attack value was necessary to climb with a greater vertical speed, meanwhile the speed in the previous flight also increased faster.

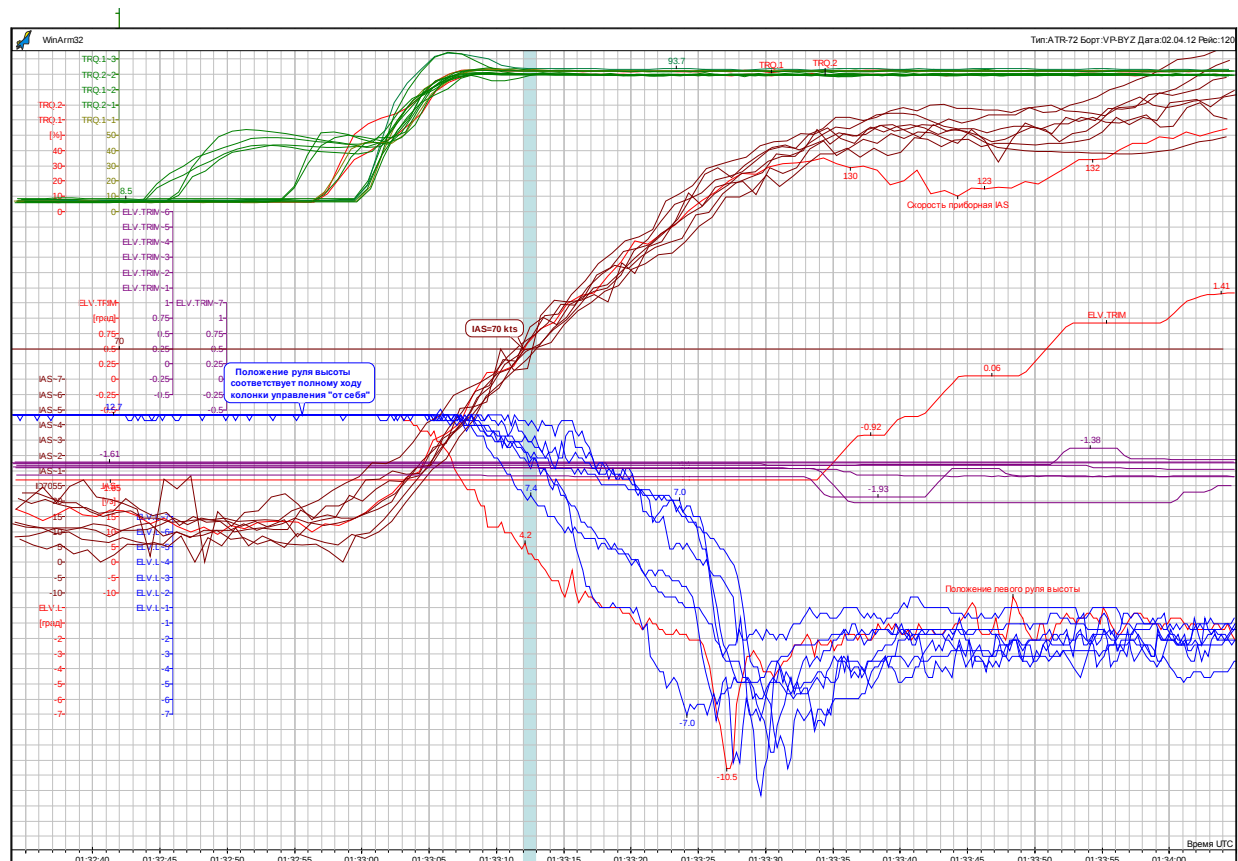
**Figure 55. The comparison of the elevator deflection at the takeoff run with the elevator trim position  $\approx -1.65^\circ$**

Figure 55 shows the changes in the elevator position in some flights with the elevator trim  $\approx -1.65^\circ$  nose up. As it can be concluded from the graph, at the initial phase of the takeoff run (up to the speed of 70-80 knots, when pilots hardly apply any forces on control column in pitch, that is the elevator is deflected under the effect of hinge moment) the way the elevator position was changing in the accident flight with the speed (hinge moment) increase is significantly different from the other flights, which confirms the difference in the air flow over the stabilizer and the elevator.

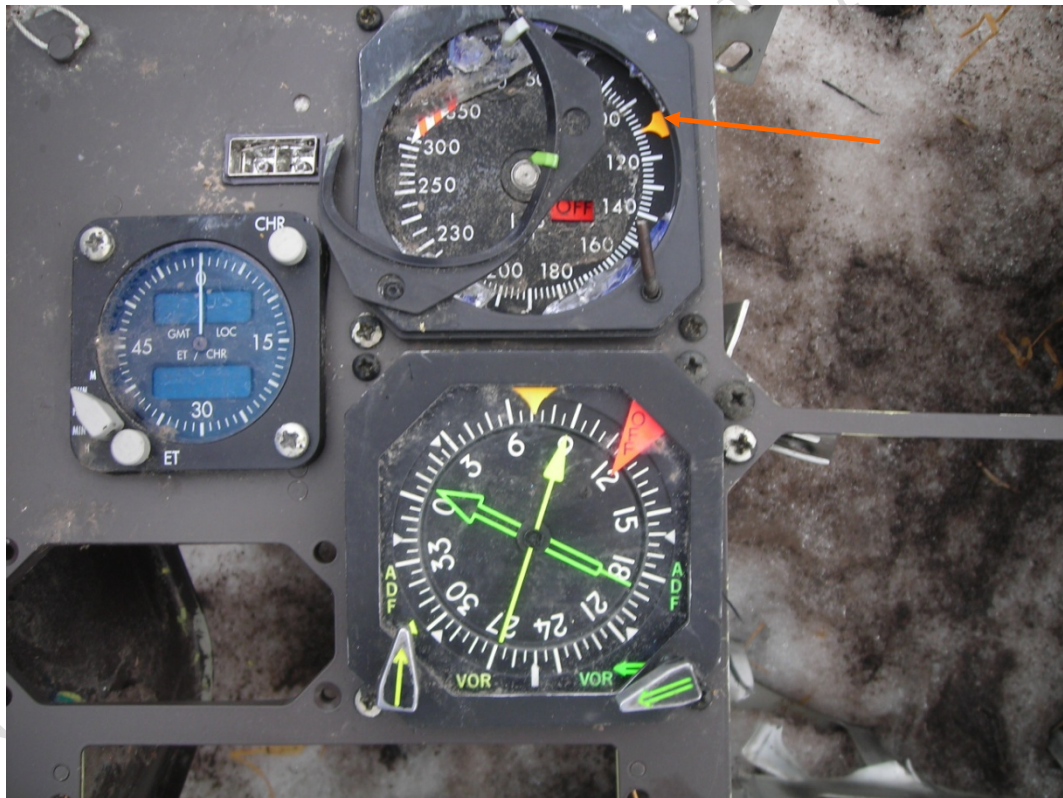
**Figure 57. PIC instrument panel**

All the crew further actions also confirm that they were not aware of the danger of aircraft takeoff with non-removed ground icing. The value of takeoff safety speed ( $V_2$ ) was set on the airspeed indicator for normal conditions but not for flight under the conditions of possible icing. During the inspection of the PIC's and F/O's instrument panels it was revealed that the  $V_2$  bugs were set at 111 kt. According to FCOM this speed value corresponds to takeoff normal conditions for the actual weight. For takeoff under possible icing conditions this value would be equal to 115 kt.

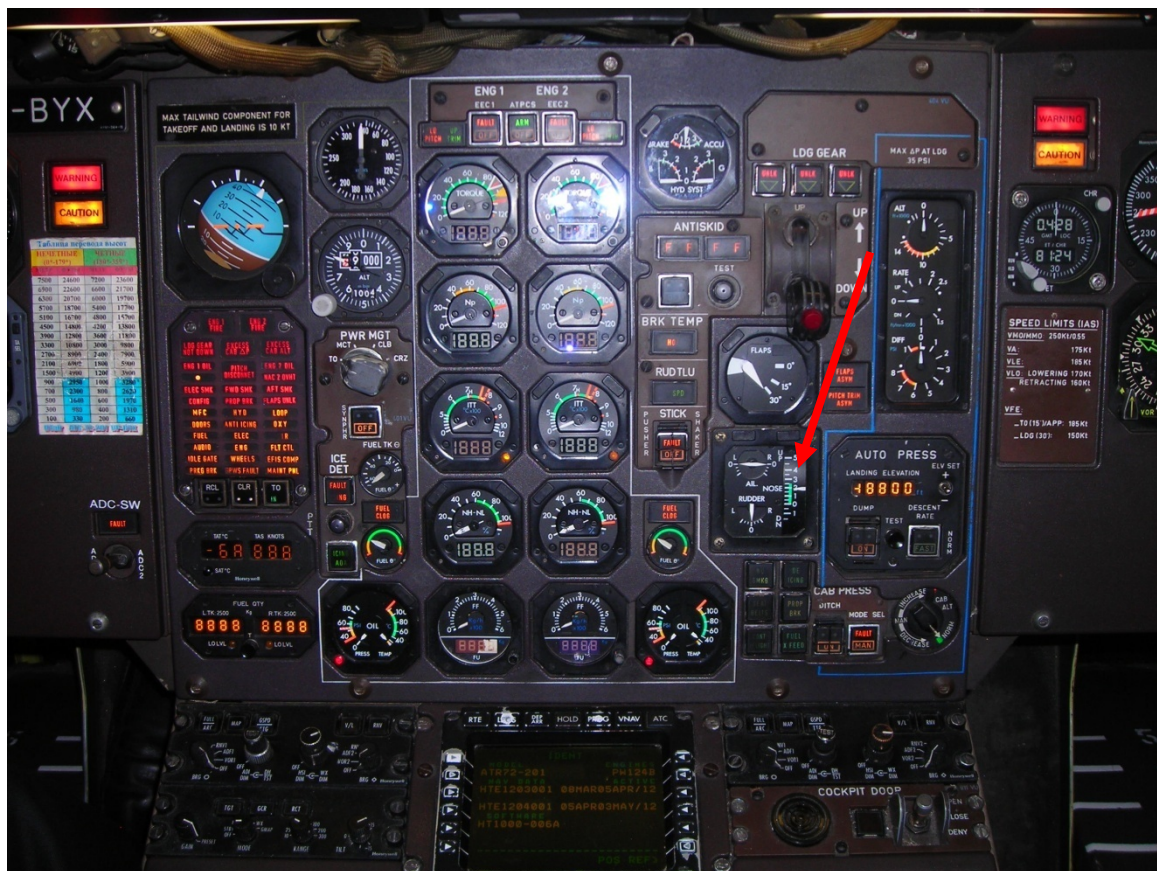
**Figure 59. The instrument panel with the indication of the elevator trim position**

Altogether, from the moment of the engines start-up and till the rise of the emergency the SOPs were fulfilled. It should be pointed as a shortcoming that before the flight the elevator trim was set by the crew incorrectly. The actual trim position ( $-1.65^{\circ}$ , nose up) did not comply with the

estimated one for CG 30.72% MAC ( $\approx -0.7^\circ$ , nose up), however the trim position was in a green zone permitted for takeoff (Figure 59).
