Collision with water involving de Havilland Canada DHC-2, VH-NOO

Jerusalem Bay (Hawkesbury River), New South Wales, on 31 December 2017

ATSB Transport Safety Report

AO-2017-118

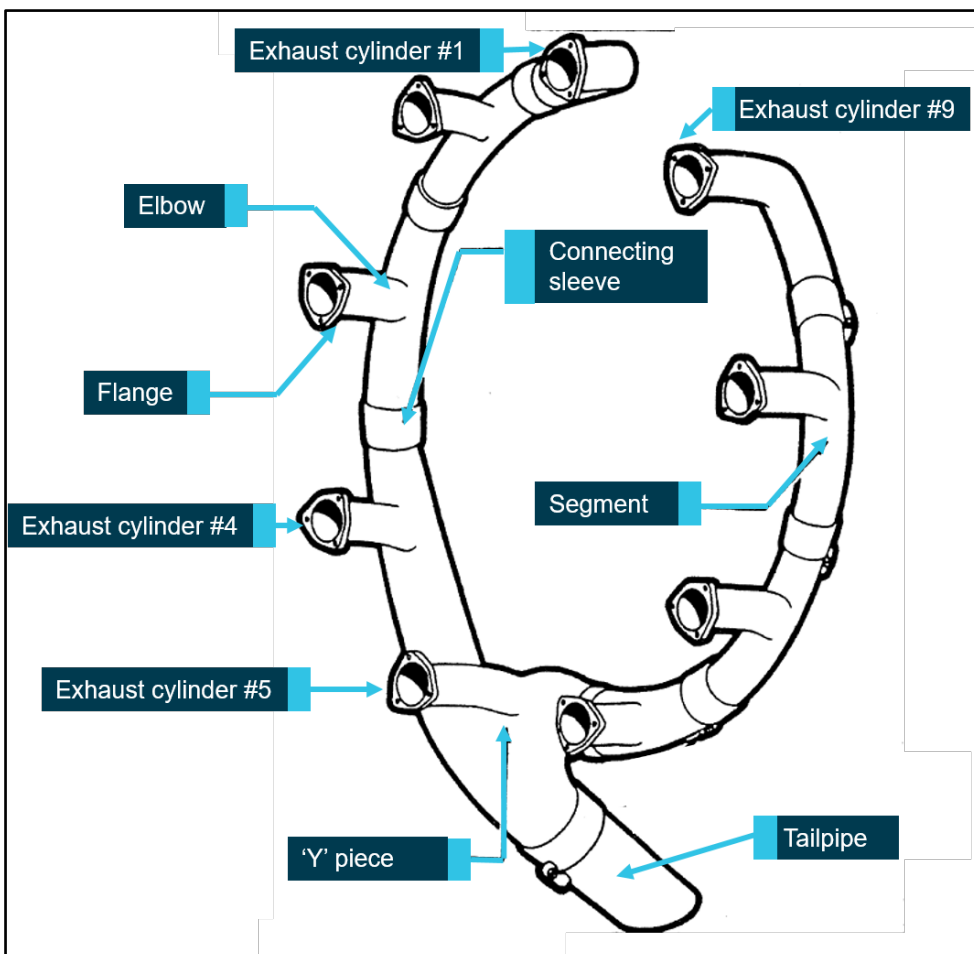
Figure 7: DHC-2 exhaust collector ring

The DHC-2 engine exhaust system (collector ring) consisted of seven segments, each of which connected to the cylinder exhaust port on the engine by an integral elbow and flange. The segments terminated in a 'Y' piece, which connected to the exhaust ports of cylinders number 4 and 5, and to the exhaust tailpipe (Figure 7). Exhaust gases were expelled through this tailpipe on the lower, right side of the engine bay.

Each of the segments were joined using connecting sleeves (slip joints). These were a friction-fit joint, which permit individual segment maintenance. They were designed to expand with heat when the exhaust system reaches operating temperature, effectively sealing the joints. A licensed aircraft maintenance engineer (LAME) from the maintenance organisation reported that the slip joints were generally not completely sealed.

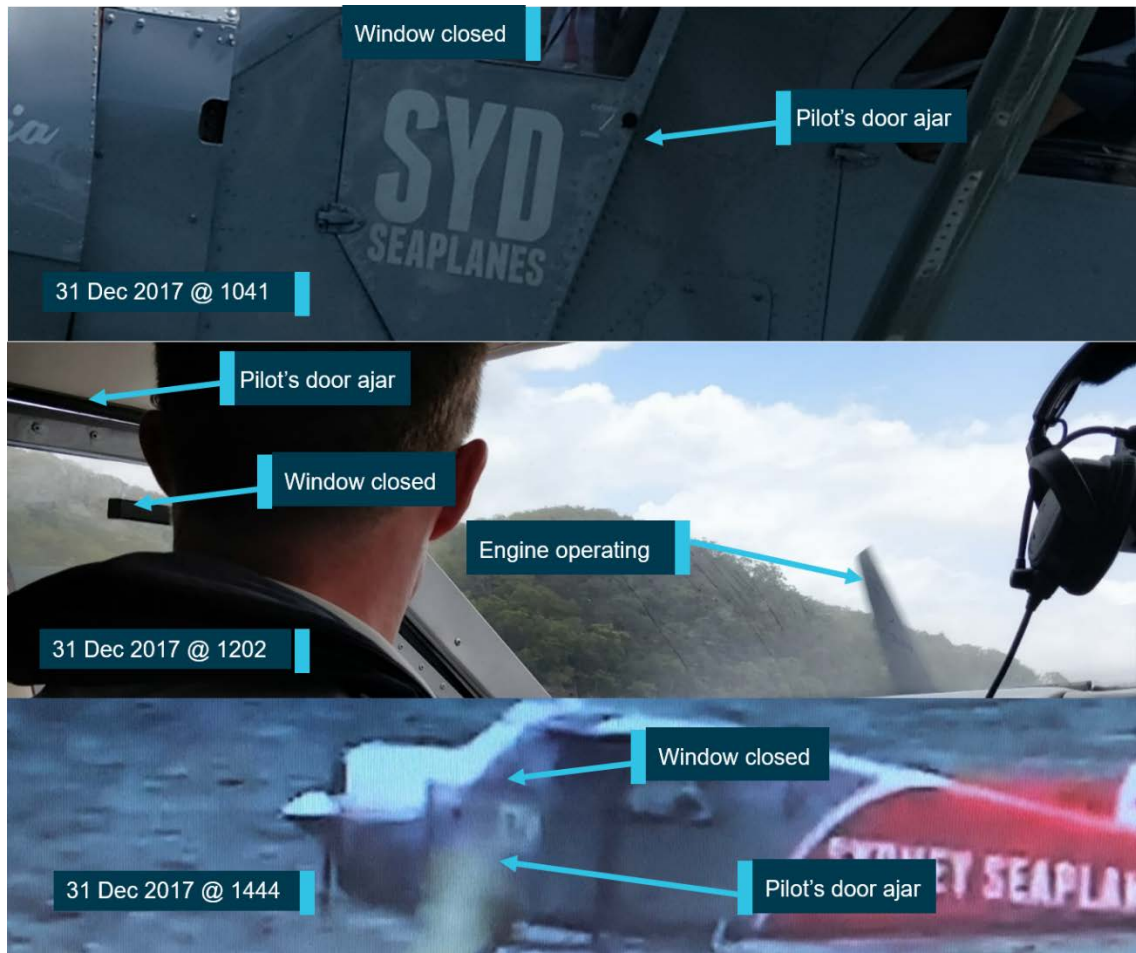
Figure 16: Pilot's door ajar and window closed during previous flights and extended taxi just prior to accident flight

Other company DHC-2 pilots advised that their routine was to open their sliding window rather than having the door ajar when ventilation in the cabin was required before take-off. Sydney Seaplanes indicated that taxiing with the door ajar was common practice in light non-airconditioned aircraft, especially in summer.

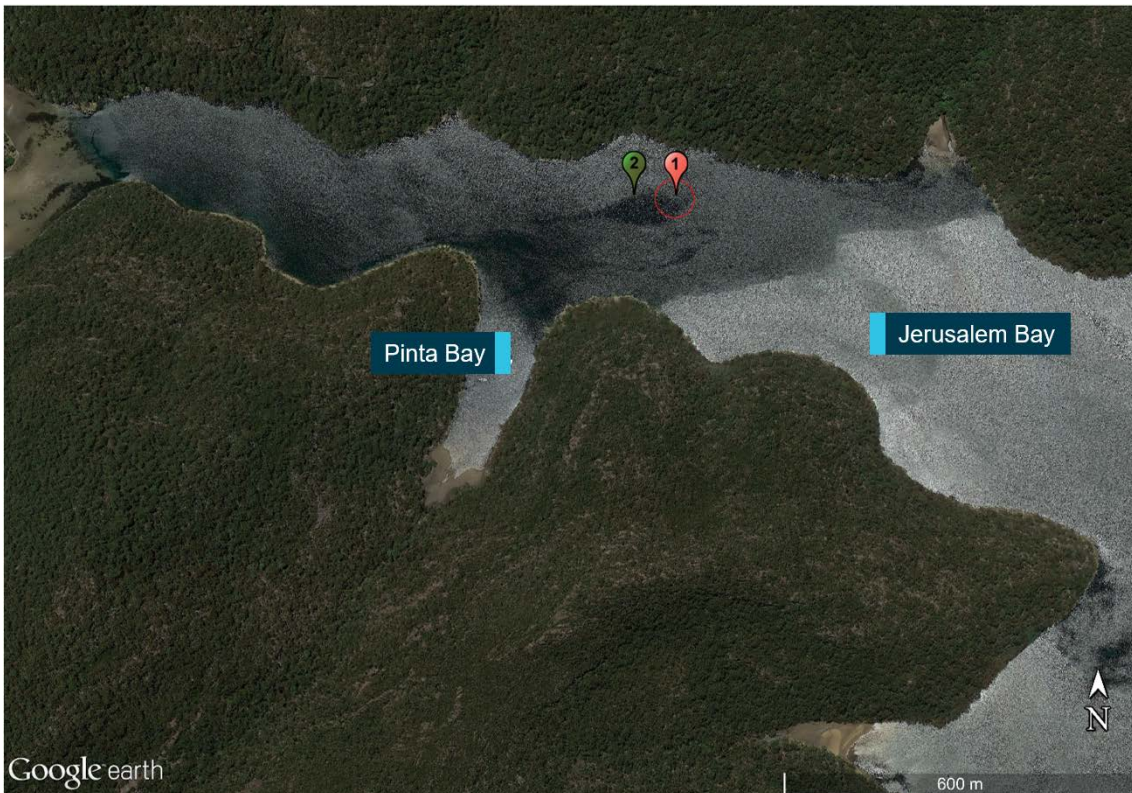
Figure 17: Location of the initial impact (circled) with the windscreen/left wing (1) and fuselage/tail/right wing floats (2) locations on the riverbed

The right wing and remainder of the floats remained with the inverted and partially submerged main fuselage, attached only by the control cables and strut structure. During the period when the main wreckage was floating, it drifted²⁸ about 75 m west into Pinta Bay before sinking near the entrance to Pinta Bay.

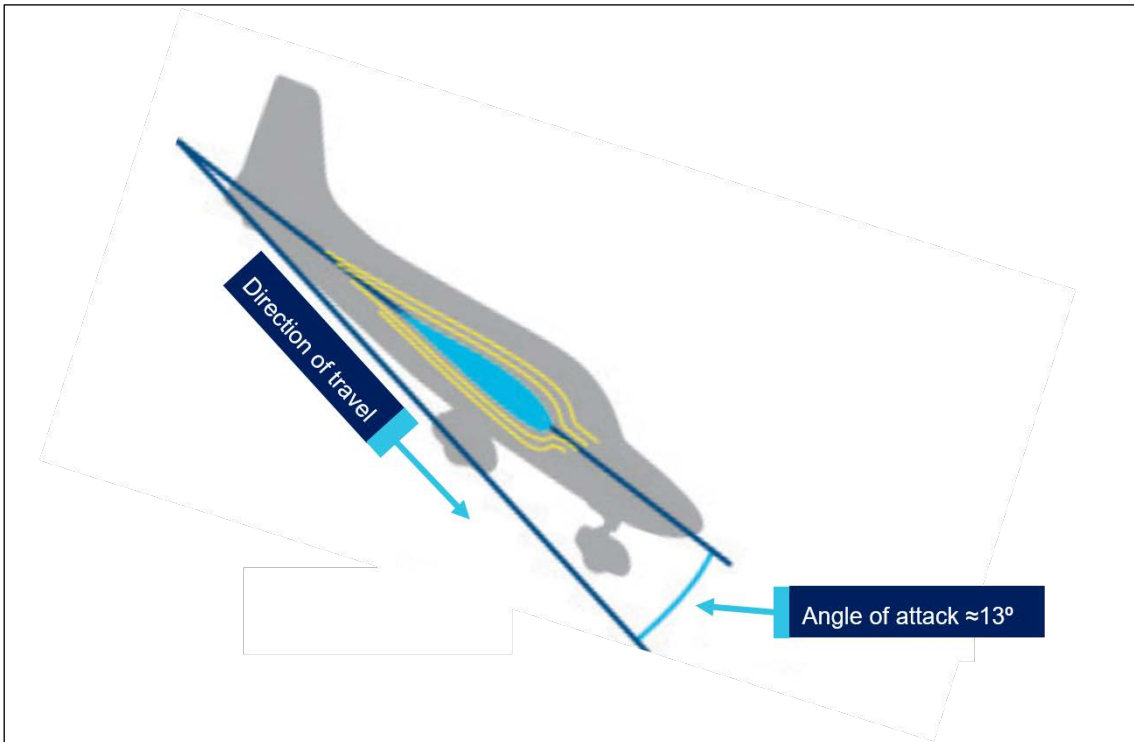
Figure 20: Aircraft descending with a high angle of attack

The damage to the aircraft suggested that the aircraft entered the water with the aircraft body at a high angle of attack³¹ relative to the direction of travel (Figure 20).

This high angle of attack was consistent with an aerodynamic stall and was evident by:

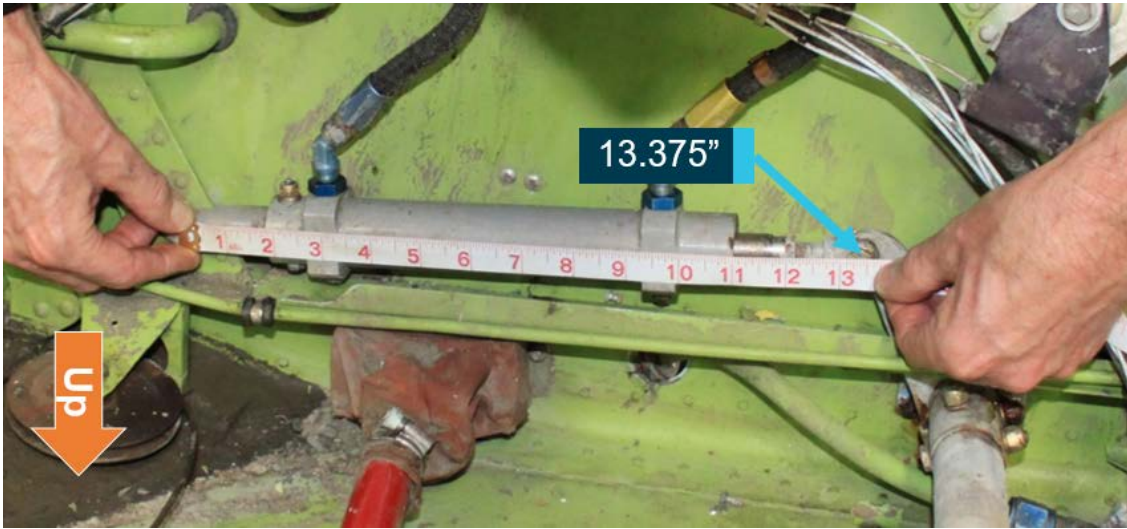
Figure 23: Flap actuator

The examination found that the flap actuator was extended to 13.375 inches (Figure 23), which was consistent with ‘climb’ flap of 15° (Figure 23 and Table 3) and the amount of flap visible in the witness photographs (Figure 2). The flap setting noted during the initial climb on a previous flight matched the setting observed in the witness photographs.

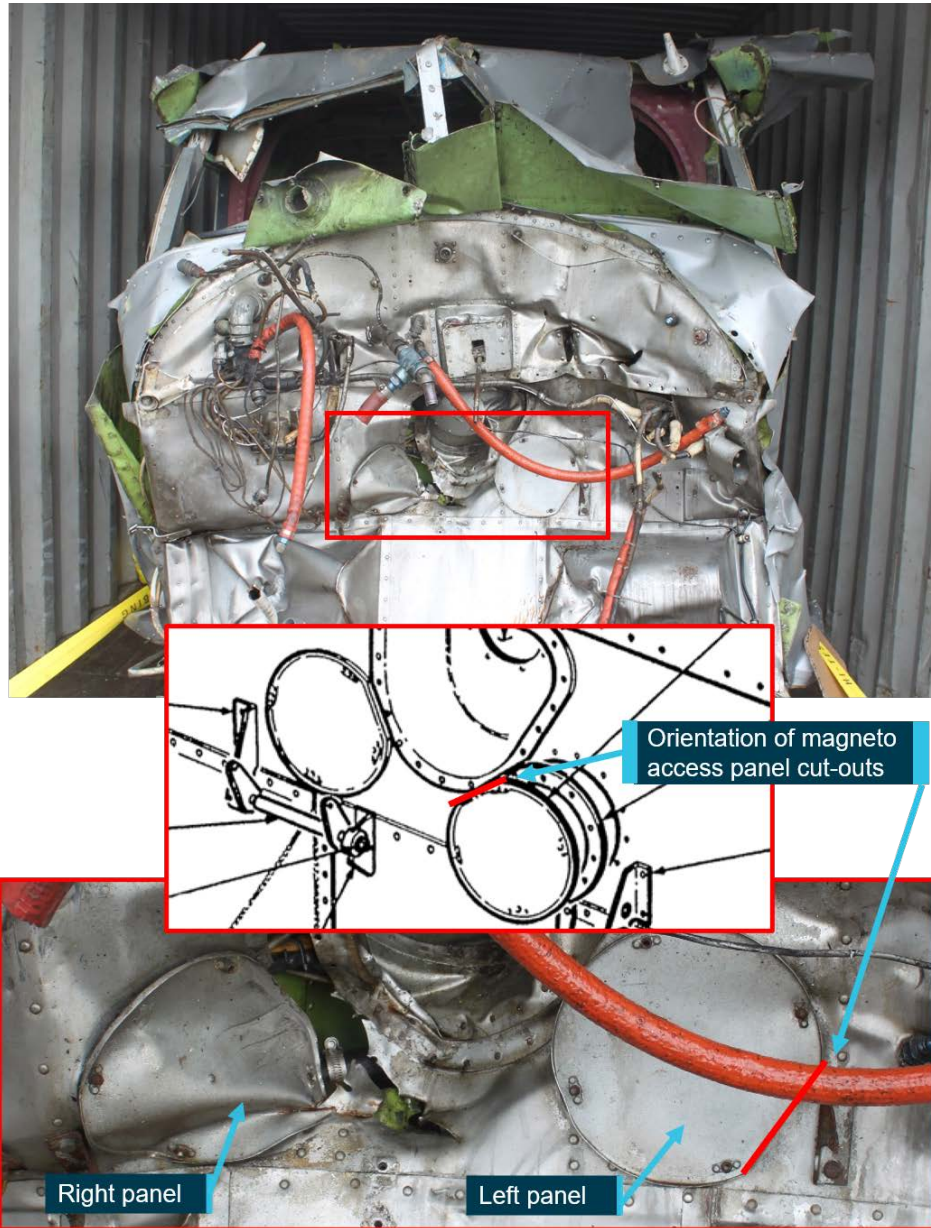
Figure 27: VH-NOO main firewall to aircraft cabin with magneto access panels highlighted

The engine main firewall was examined and the two magneto access panels were identified as a potential pathway for CO to enter the cabin. Both panels were found to be installed in the main firewall. The left panel had minor impact damage, while the right panel had significant distortion and impact damage (Figure 27).

Two bolts were installed at the 4 and 10 o'clock positions (when viewed from the cabin looking forward) in the left access panel, while the other two bolts were missing. One bolt (10 o'clock) was consistent with an AN3 bolt, but fitted with a 'butterfly' modification welded to the hex head. The other bolt (4 o'clock) was an unidentified wing-head screw, with a narrowed (necked) shank (Figure 28). The gasket was present and bonded to the panel but was noted to be in a deteriorated condition.

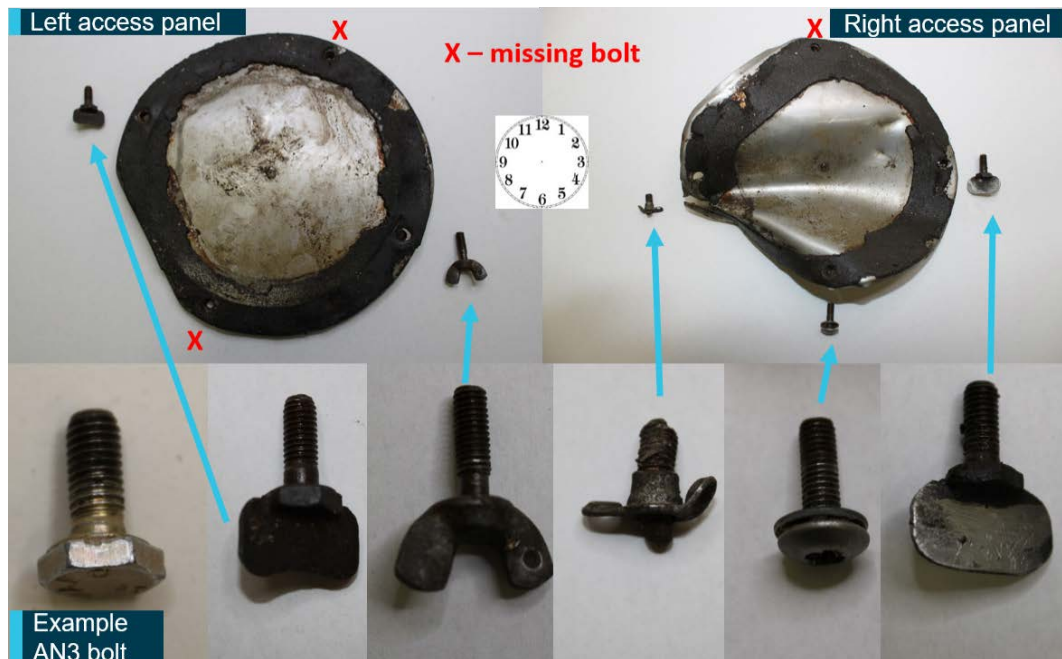
Figure 28: Magneto access panels, attaching hardware and gaskets

The installed bolts and a new AN3 bolt were tested in the missing bolt nutplate, with the same result as identified for the left panel.

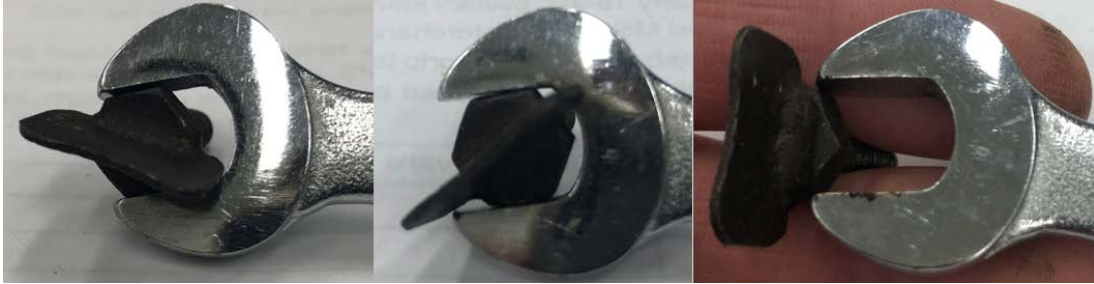
Figure 29: Spanner accessibility on AN3 modified bolt

A modified AN3 bolt was tested to determine if a standard 3/8” spanner could be utilised for the final torque. The spanner could be used to tighten the bolt on two of the three sides, but it did not fit onto the third due to the modification (Figure 29).

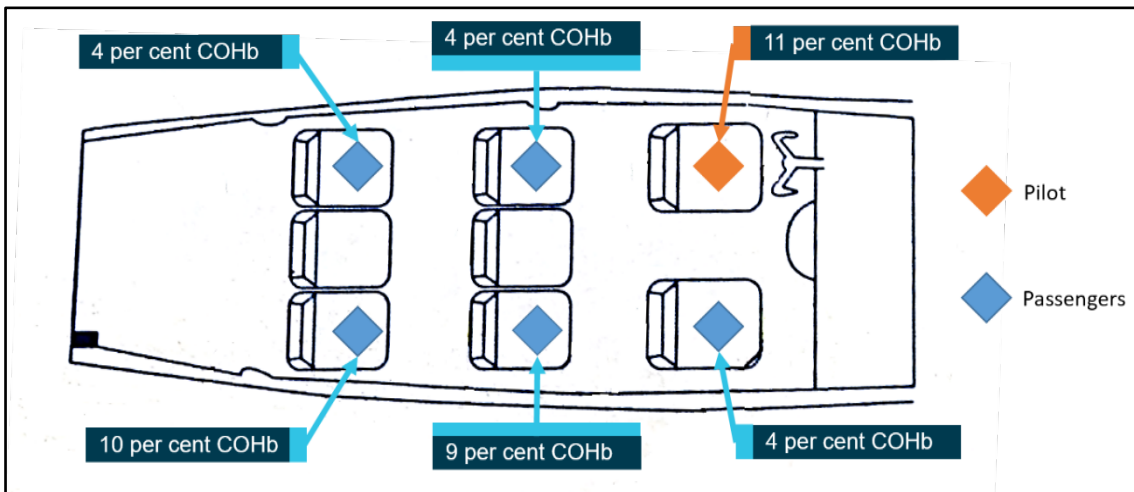
Figure 32: Occupant seating positions and associated COHb levels

The levels of COHb detected in relation to the occupants’ seating position within the aircraft cabin are shown in Figure 32. The significance of these results is discussed further in the section titled *Physical symptoms and cognitive performance effects of carbon monoxide exposure*.

Regarding the levels identified in the two passengers, the forensic pathologist assisting the NSW Coroner indicated that children have a higher metabolic rate and breathe at a faster rate. Therefore, the youngest occupant would have likely taken more breaths in the same period of time as the adults. Similarly, the eldest occupant may have also been breathing at a faster rate for medical reasons or was less conditioned. In which case, this passenger would have likely been more affected by CO at lower levels than an otherwise healthy adult.

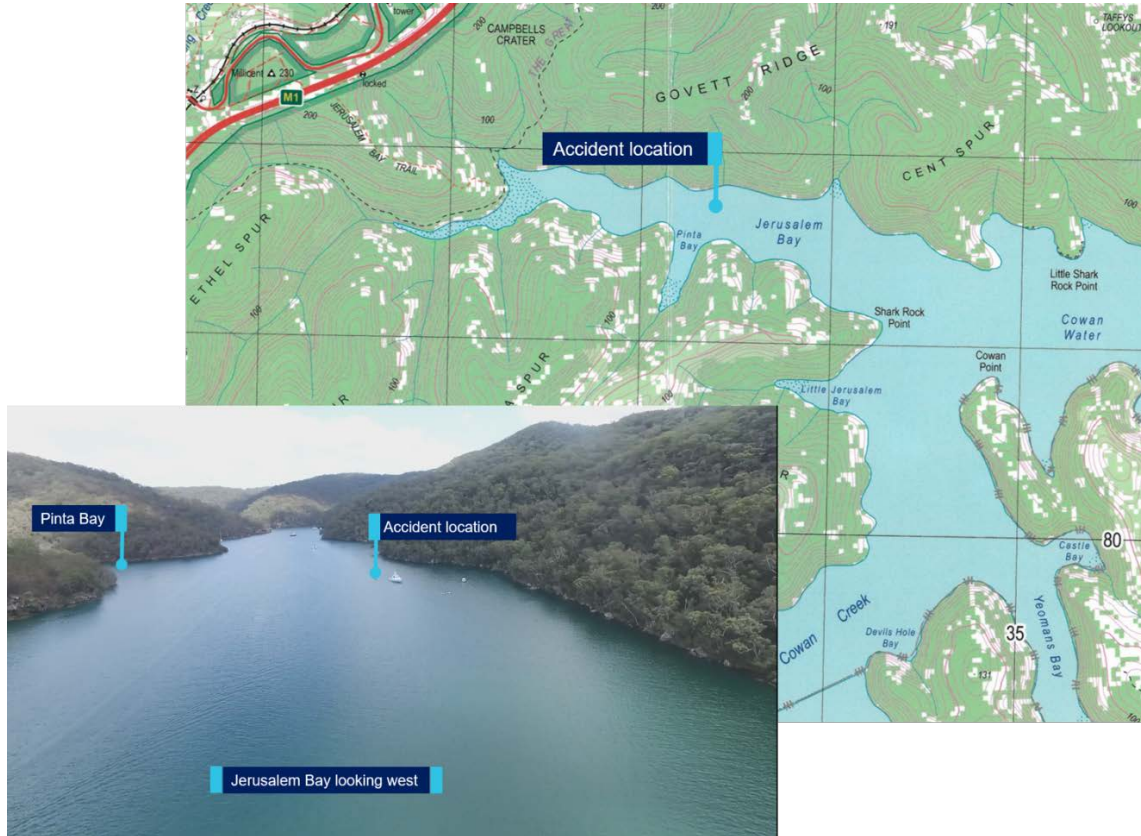
Figure 36: Jerusalem Bay topographic map (top) and image taken from drone footage looking west to the end of Jerusalem Bay (bottom)

Jerusalem Bay is part of the Cowan Water, Hawkesbury River waterway (Figure 36). The bay is surrounded by the Ku-ring-gai Chase National Park and is popular with recreational boaters. It is about 2.3 km long, 600 m wide at its entrance, and progressively narrows with the terrain rising steeply to an elevation above 200 m (650 ft). On both the northern and southern banks, the terrain

rises steeply with peaks of 200 m (650 ft). The distance from the accident site to the end of Jerusalem Bay at water level was about 1.2 km.

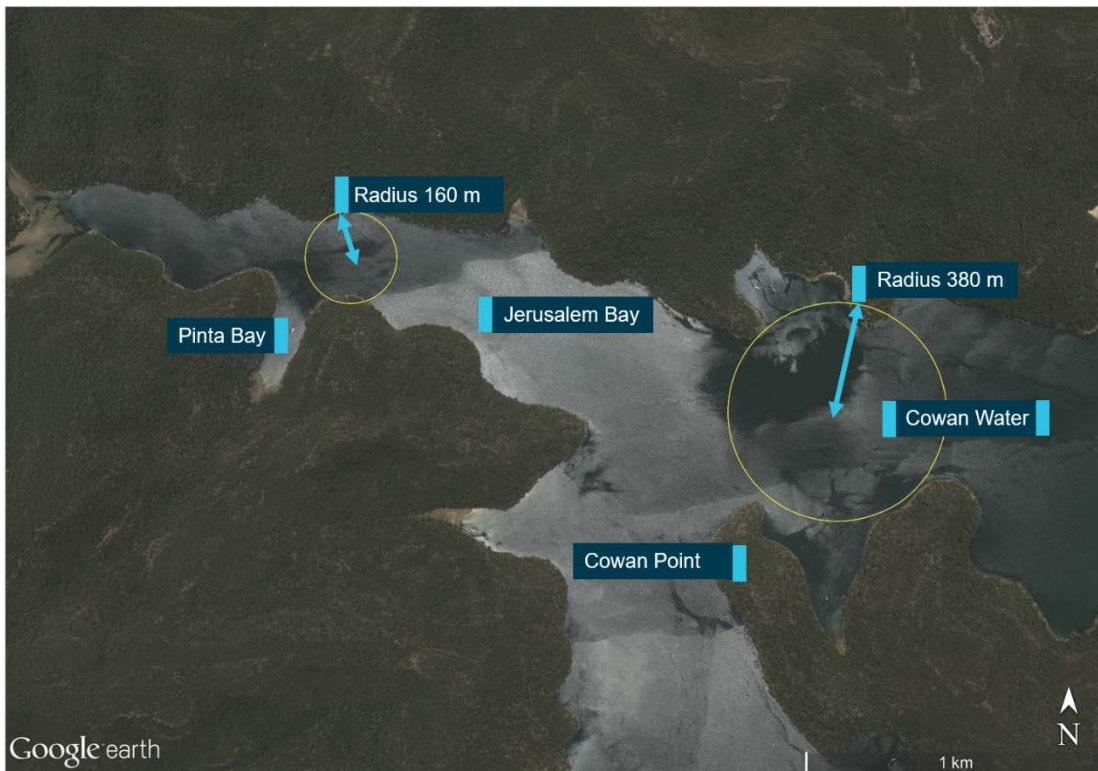
Figure 39: Radius of turn in Jerusalem Bay (left) and Cowan Water (right)

At the position where the initial turn in Cowan Water was conducted there was a width of about 760 m available in which to turn the aircraft over water (Figure 39). The ATSB estimated that for the 380 m radius turn, at an indicated airspeed of 70-80 kt, the minimum angle of bank required

At the location of the steep turn in Jerusalem Bay, there was a width of about 320 m available in which to manoeuvre over water (Figure 39). This 160 m radius turn would have required a minimum angle of bank of 41-49° to complete the turn at 70-80 kt. If the aircraft's speed was higher, the angle of bank required would have also increased.

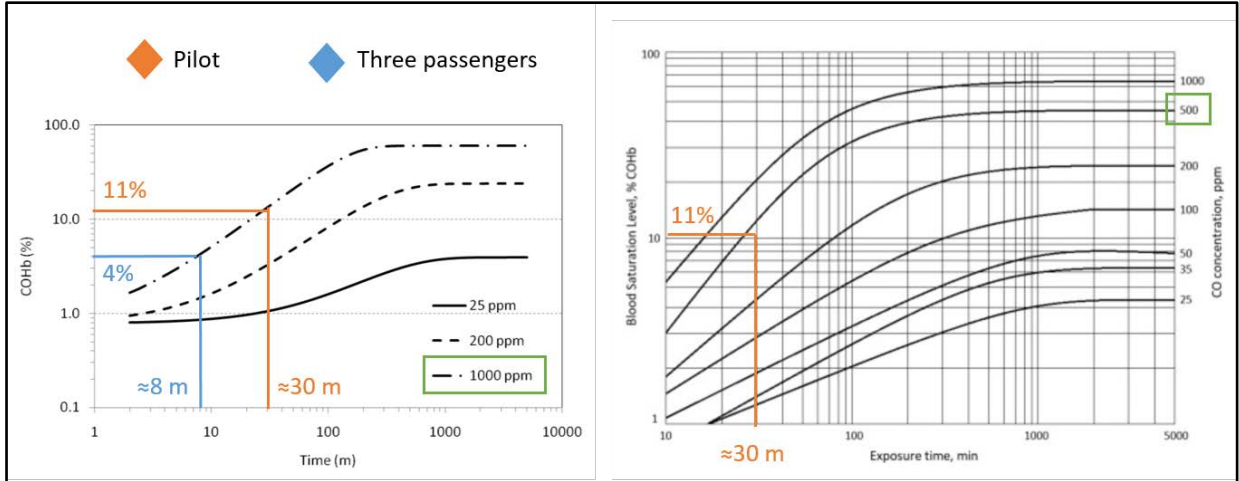
Figure 41: Relationship between COHb levels, CO exposure time and concentration

There are several graphical representations showing the relationship between COHb levels, exposure time and CO concentration (ppm) (Figure 41). While there is a noticeable disparity between the two graphs, the results indicate that, to attain a COHb level of 11 per cent (as found in the pilot) in about 30 minutes (the minimum exposure time for the pilot accounting for the 27 minute taxi prior to, and the taxi on the accident flight), this required a CO concentration of at least 500 ppm. According to the Occupational Safety and Health Administration as cited in Lacefield et al. (1982), exposure to concentrations between 500-1,000 ppm could result in 'the development of headache, tachypnea (rapid breathing), nausea, weakness, dizziness, mental confusion and in some instances, hallucinations, and may result in brain damage'. The ATSB recognised that the pilot may have been exposed to CO on previous flights that day for up to 200 minutes when the engine was running. A cumulative CO exposure time would require lower CO concentration levels to achieve the same COHb.

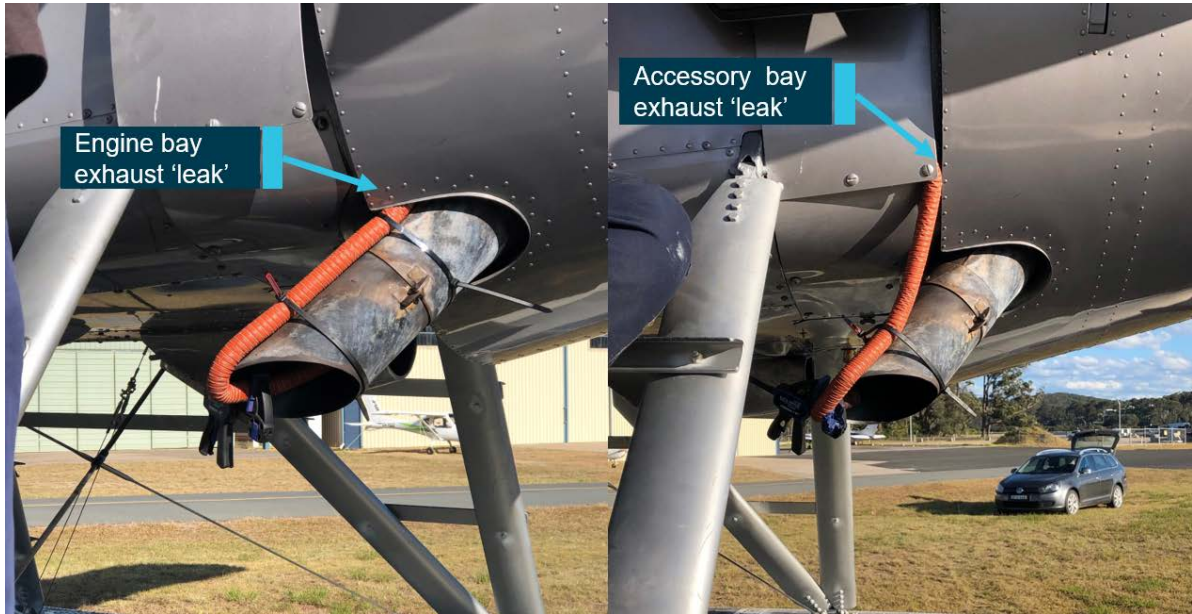
Figure 45: Simulated exhaust leak into the engine bay (left) and the accessory bay (right)

An engine exhaust leak was then simulated by feeding a small diameter hose from the exhaust tailpipe, initially into the engine bay and then into the accessory bay (Figure 45). The CO concentration level measured at the outlet of the simulated exhaust leak exceeded 500 ppm.

With the magneto access panel bolts removed and the simulated exhaust leak in the engine bay, the detector reached the second alarm level (60 ppm) with the door closed. This then increased quickly above 100 ppm when the pilot's door was ajar (Table 6). The levels were highest in the pilot's footwell adjacent to the holes in the firewall, and were less in the middle and rear rows. With the simulated exhaust leak in the accessory bay, the CO level quickly increased to 144 ppm, again highest in the pilot's footwell. The CO levels reduced slightly with the pilot's door ajar (Table 6). When the magneto access panel bolts were reinstalled with the simulated exhaust leak remaining in the accessory bay, the CO concentration level dropped considerably to 28 ppm with the pilot's door closed. With the door ajar the CO levels reduced slightly (Table 6).

This testing demonstrated that either the simulated exhaust leak or missing magneto access panel bolts did not result in high levels of CO in the cabin in isolation. However, the simulated exhaust leak in combination with missing magneto access panel bolts resulted in elevated CO levels in the cabin. The CO was more evident at the pilot's position and was exacerbated when the pilot's door was ajar with a simulated exhaust leak source in the engine bay. The CO levels reduced markedly in the cabin (by more than 80 per cent) when the access panel bolts were reinstalled with the exhaust leak remaining. The door position in this configuration did not adversely affect the CO levels.

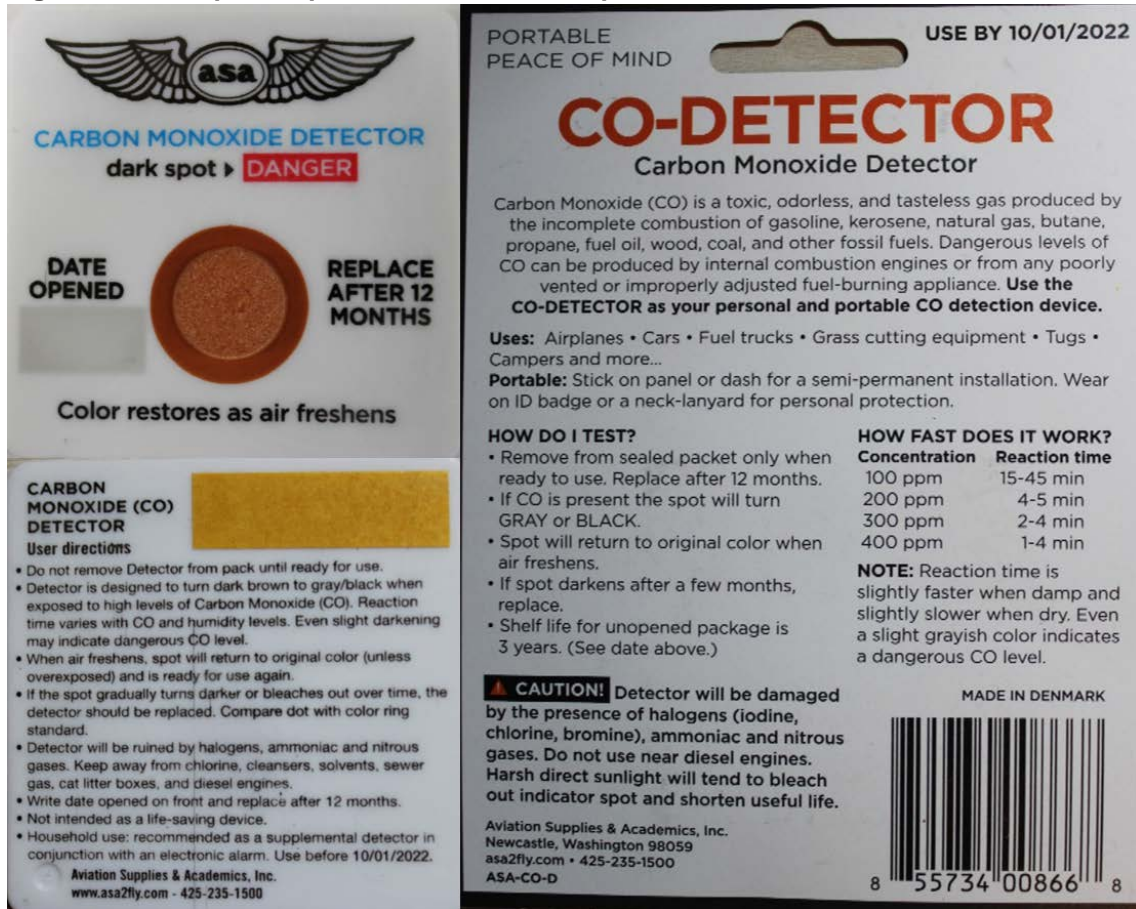
Figure 46: Exemplar disposable CO chemical spot detector

The manufacturers of disposable chemical spot detectors are openly transparent about the limitations of these types of devices. For example, the ATSB purchased the same detector that was fitted to VH-NOO at the time of the accident and noted that the back of the detector and the associated packaging detailed the limitations as (Figure 46):

Aside from highlighting the useful life of the detector, none of the above limitations were specified on the front of the detector for pilot awareness when the detector has been attached to the aircraft cabin.

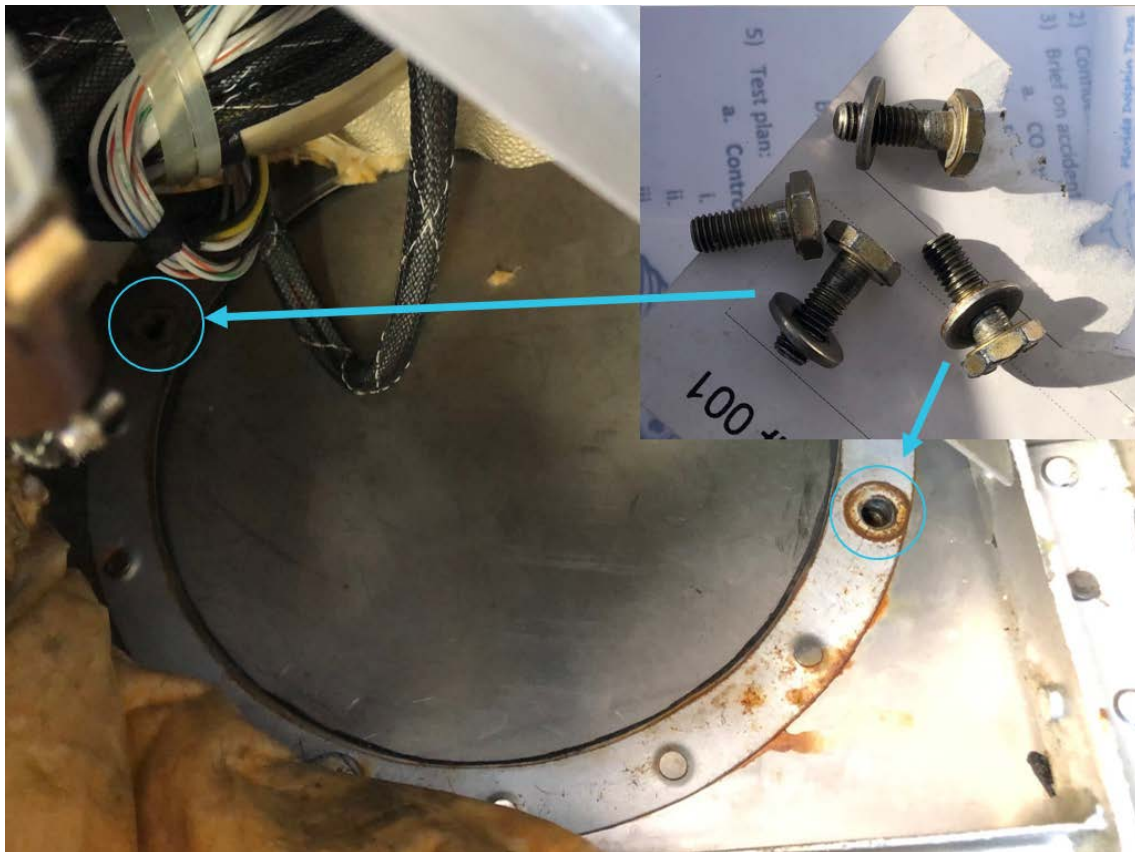
Figure 55: Magneto access panel during testing with bolts removed

Figure 55) to represent the condition known at the time of the accident. At the time of the CO testing, it was considered that four bolts were not in place at the time of the accident. This was later assessed to be three bolts, with two not in place on the pilot's side panel.

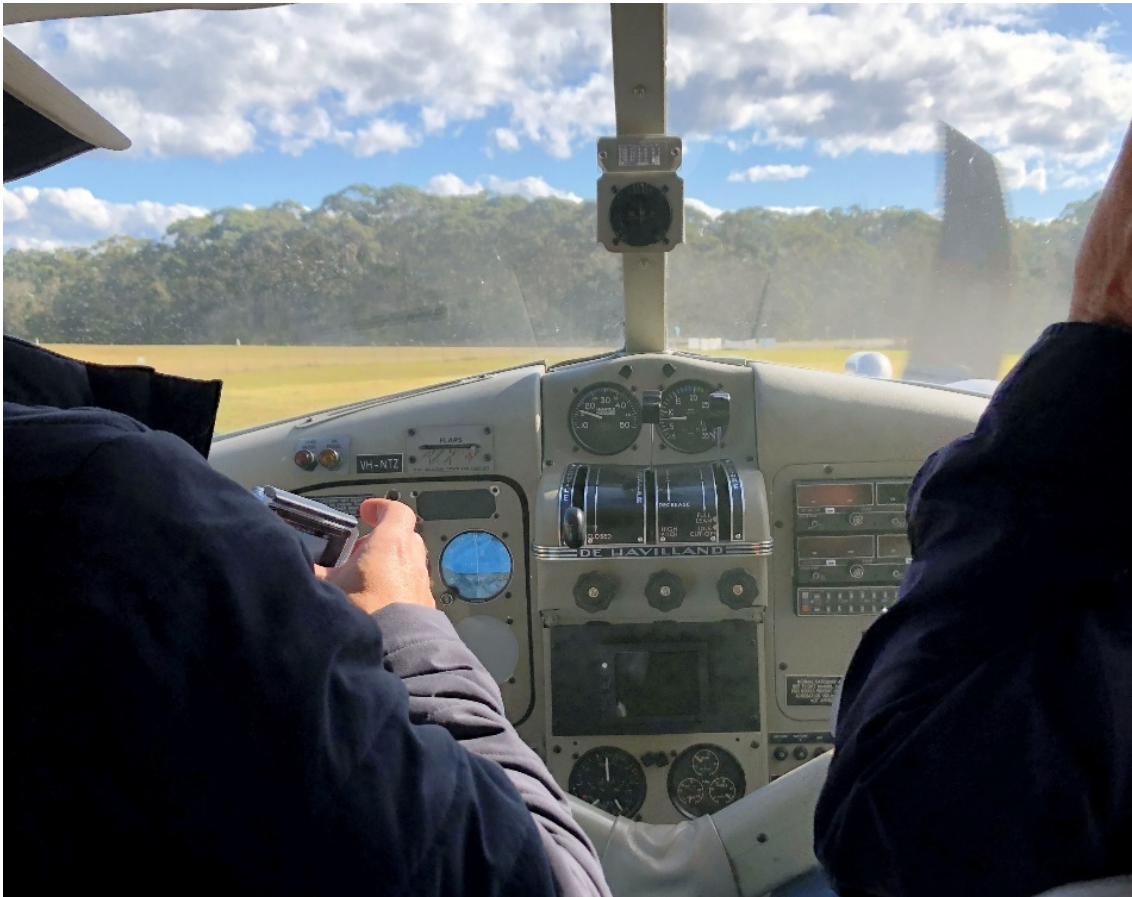
Figure 56: Cockpit during smoke test with bolts removed

A second smoke test was then conducted with the bolts removed and the snap vent open. The amount of smoke in the cabin was observed to be noticeably greater than the first test (Figure 56). With the pilot's door slightly ajar, more smoke was drawn into the cabin.

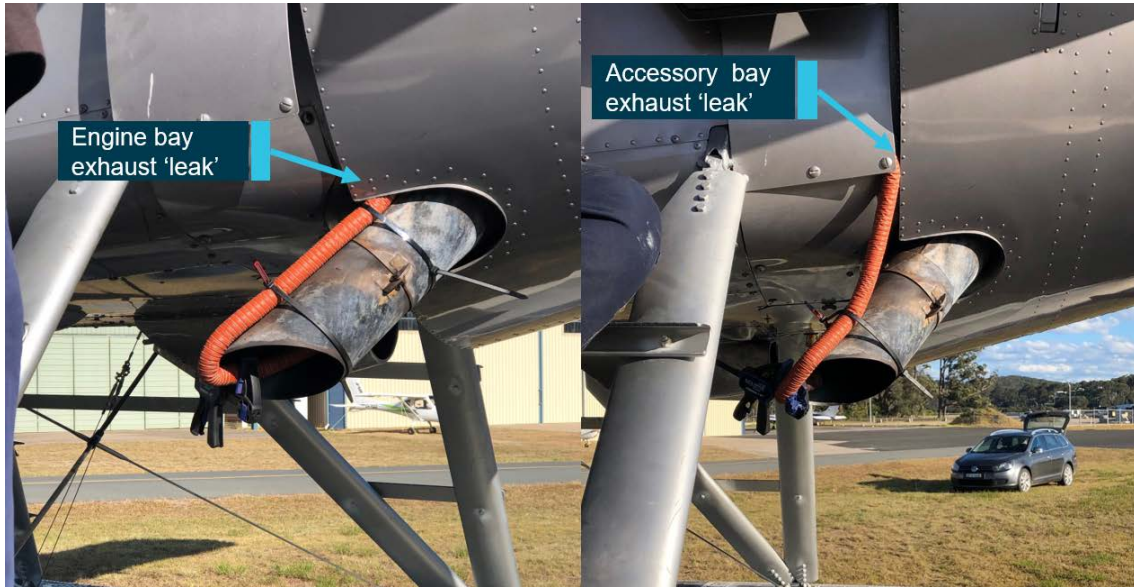
Figure 57: Simulated exhaust leak into the engine bay (left) and the accessory bay (right)

An exhaust leak was then simulated by extending a small diameter hose from the exhaust tailpipe into the engine bay in front of the accessory firewall (Figure 57). The CO concentration level was measured at the outlet of the simulated exhaust 'leak' and was found to be greater than 500 ppm.

The simulated exhaust leak was then moved to the accessory bay, in between the accessory and main firewalls (Figure 57). Even higher CO levels were detected in the pilot's side footwell with the door closed (144 ppm), compared with the right side at chest height (48 ppm). However, when the pilot's door was ajar the CO concentration levels reduced slightly.
