BCA Aviation Safety

National Airlines 747BCF
NAL 102 - Accident
Bagram, Afghanistan
April 29, 2013

Rick Mayfield
Air Safety Investigation
Boeing Commercial Airplanes

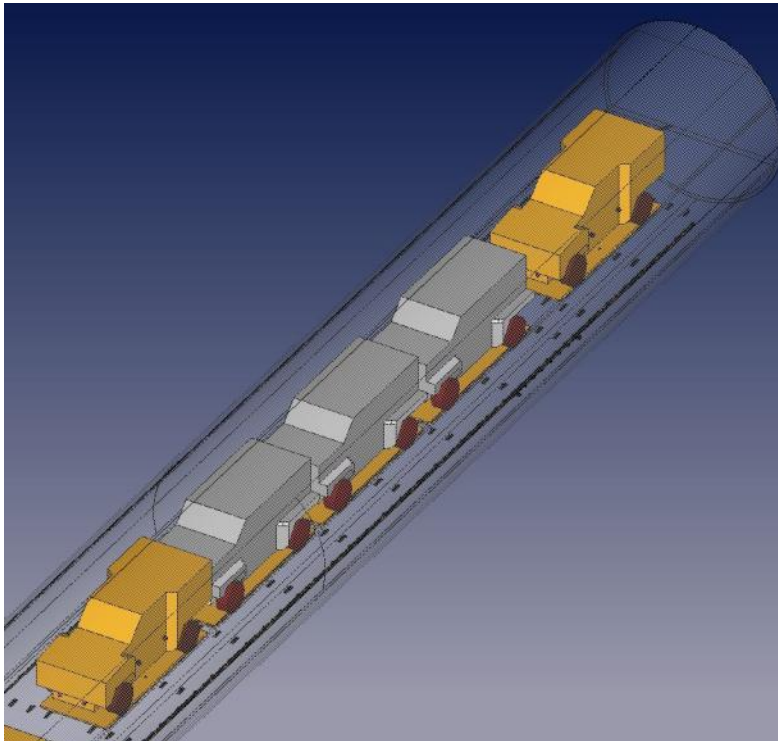
Loaded in the center position

Pallet/floor locks can't be utilized in center position – pallets float

5000 pound straps used to secure

National typically used procedures from their Cargo Operations Manual to secure the load

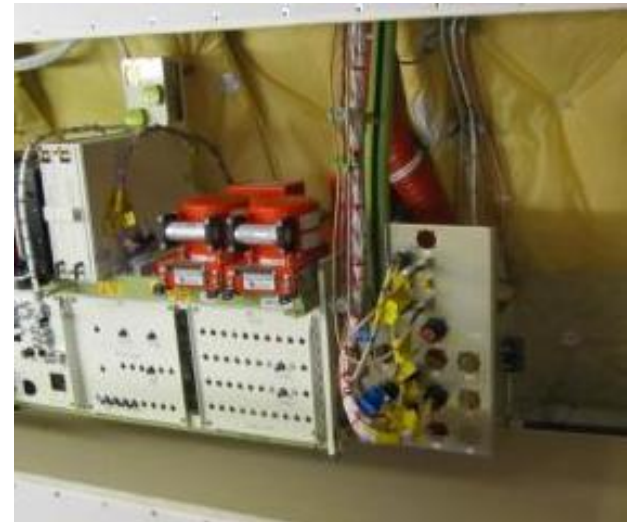
- During turn at Bagram the crew discussed the following:
 - Brake overtemp during landing
 - A load shift involving one or more MRAPs.
 - Straps securing aft were loose
 - A broken strap (involving a knot)
 - Replacing the broken strap
 - “Cinching down” the loose straps
- CVR and FDR both stop within seconds of liftoff (both are located in E8 cabinet)

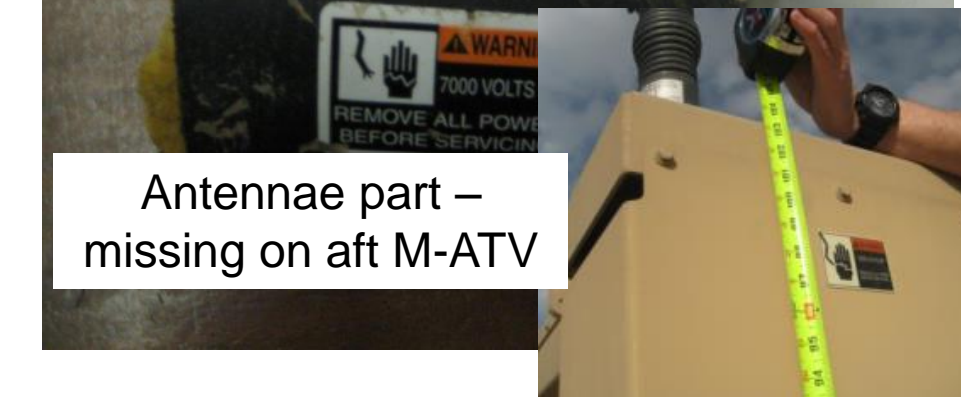
Antennae part – missing on aft M-ATV

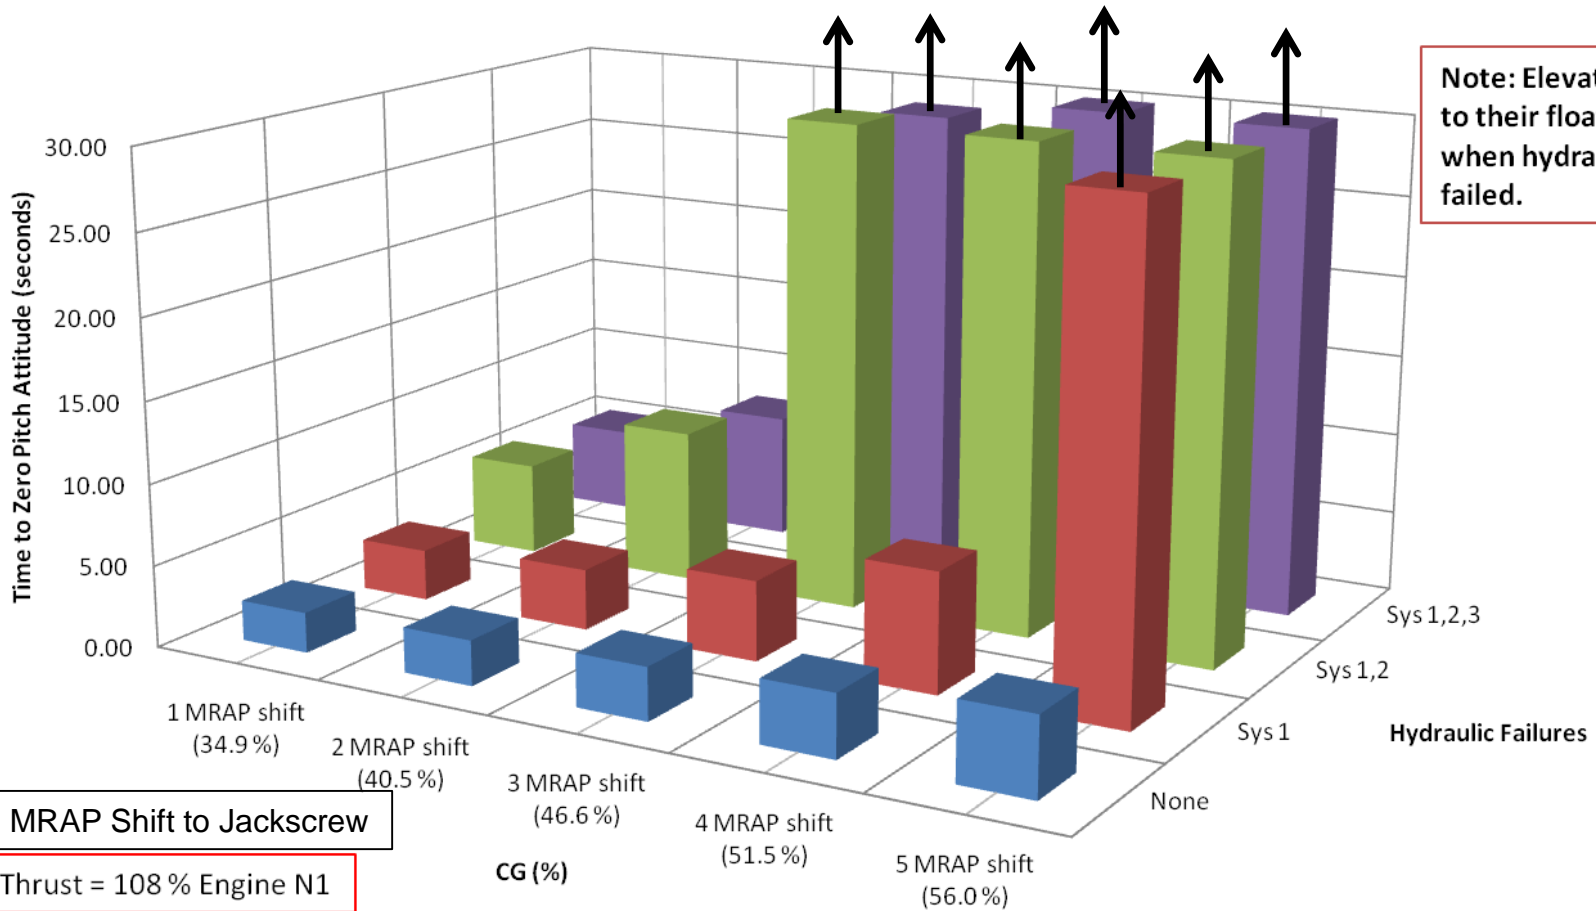
Simulation Scenario Results (Max Thrust, MRAP Shift to Jackscrew)

1 MRAP shift (34.9%)	2 MRAP shift (40.5%)	3 MRAP shift (46.6%)	4 MRAP shift (51.5%)	5 MRAP shift (56.0%)
None	2.46	2.75	3.22	3.81	4.76
Sys 1	3.14	3.74	4.92	7.36	30.00
Sys 1,2	5.73	9.46	30.00	30.00	30.00
Sys 1,2,3	5.24	7.76	28.77	30.00	30.00

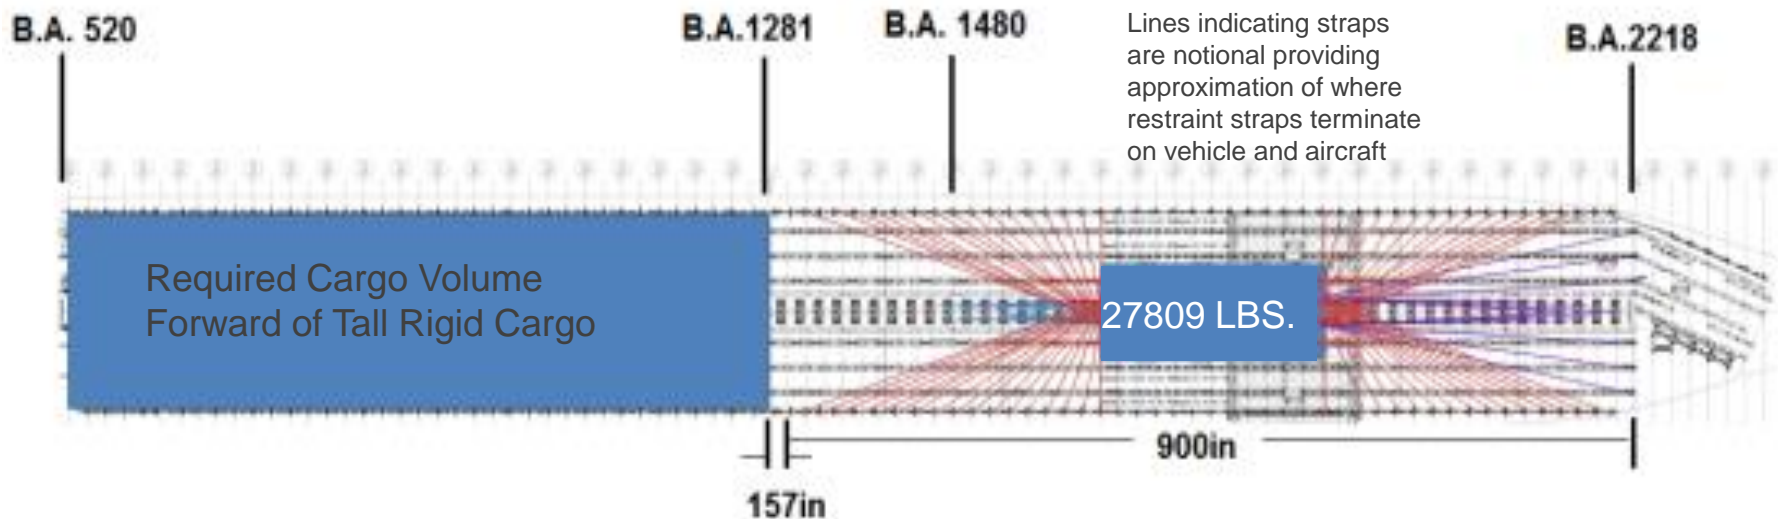
Cargo Tie Down

- Per the Boeing and Telair Weight and Balance Manuals, only one M-ATV can be tied down
- 60 straps would be required to restrain the M-ATV using the approved vehicle attach points
