For Prevention of Accidents
due to
Turbulence

FASTEN SEAT BELT

2015 JUNE

Case Study(1) The shaking of the aircraft by CAT(APR 2001)

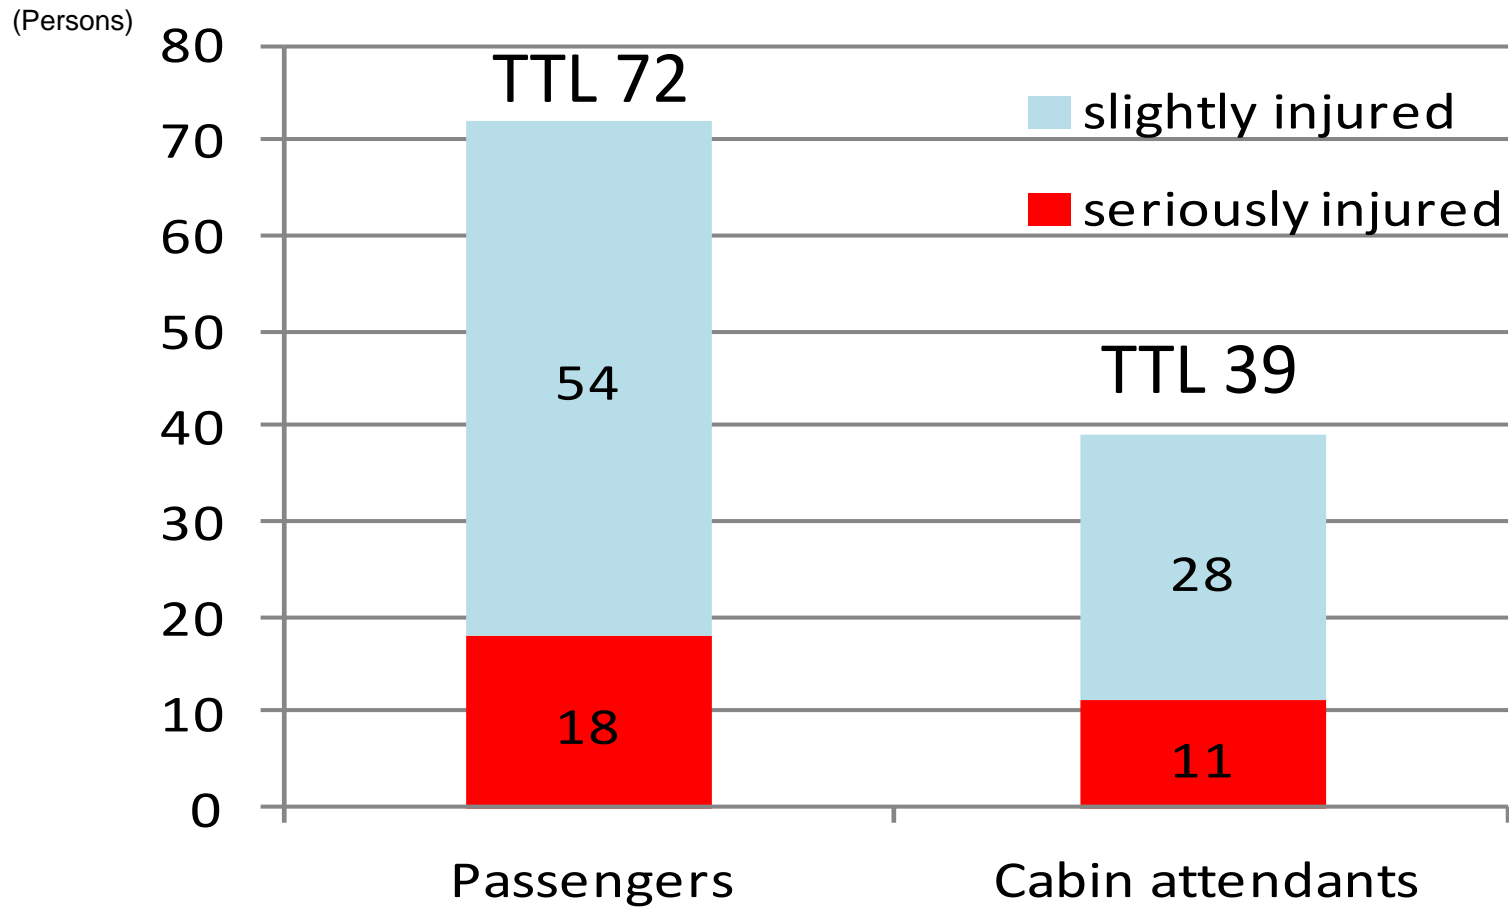
Fig.8: Attribute

Injury rate : cabin attendant > passenger

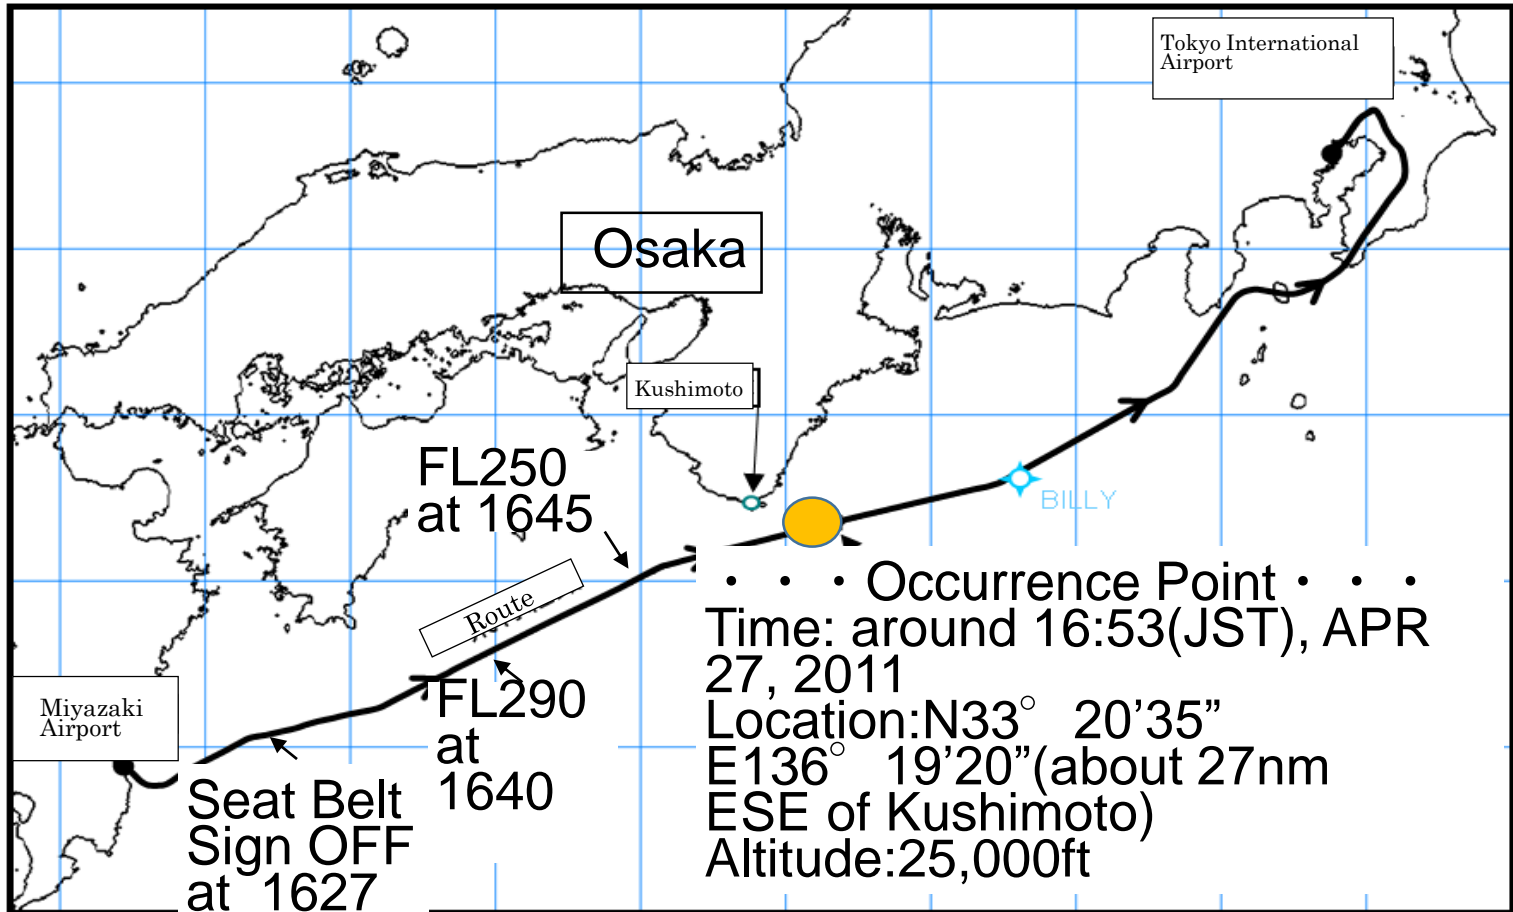
Fig.1 Summary of Flight

B767-300 took off from Miyazaki Airport at 16:16JST for Tokyo International Airport as a schedule flight. While flying at FL250, 27NM ESE of Kushimoto, around 16:53, the aircraft encountered turbulence. One cabin attendant was seriously injured in front of the left aft lavatory. 2 passenger and other 2 cabin Attendants were slightly injured.

119 people were on board(2pilots, 6cabin attendants, 111passengers) The aircraft was not damaged.

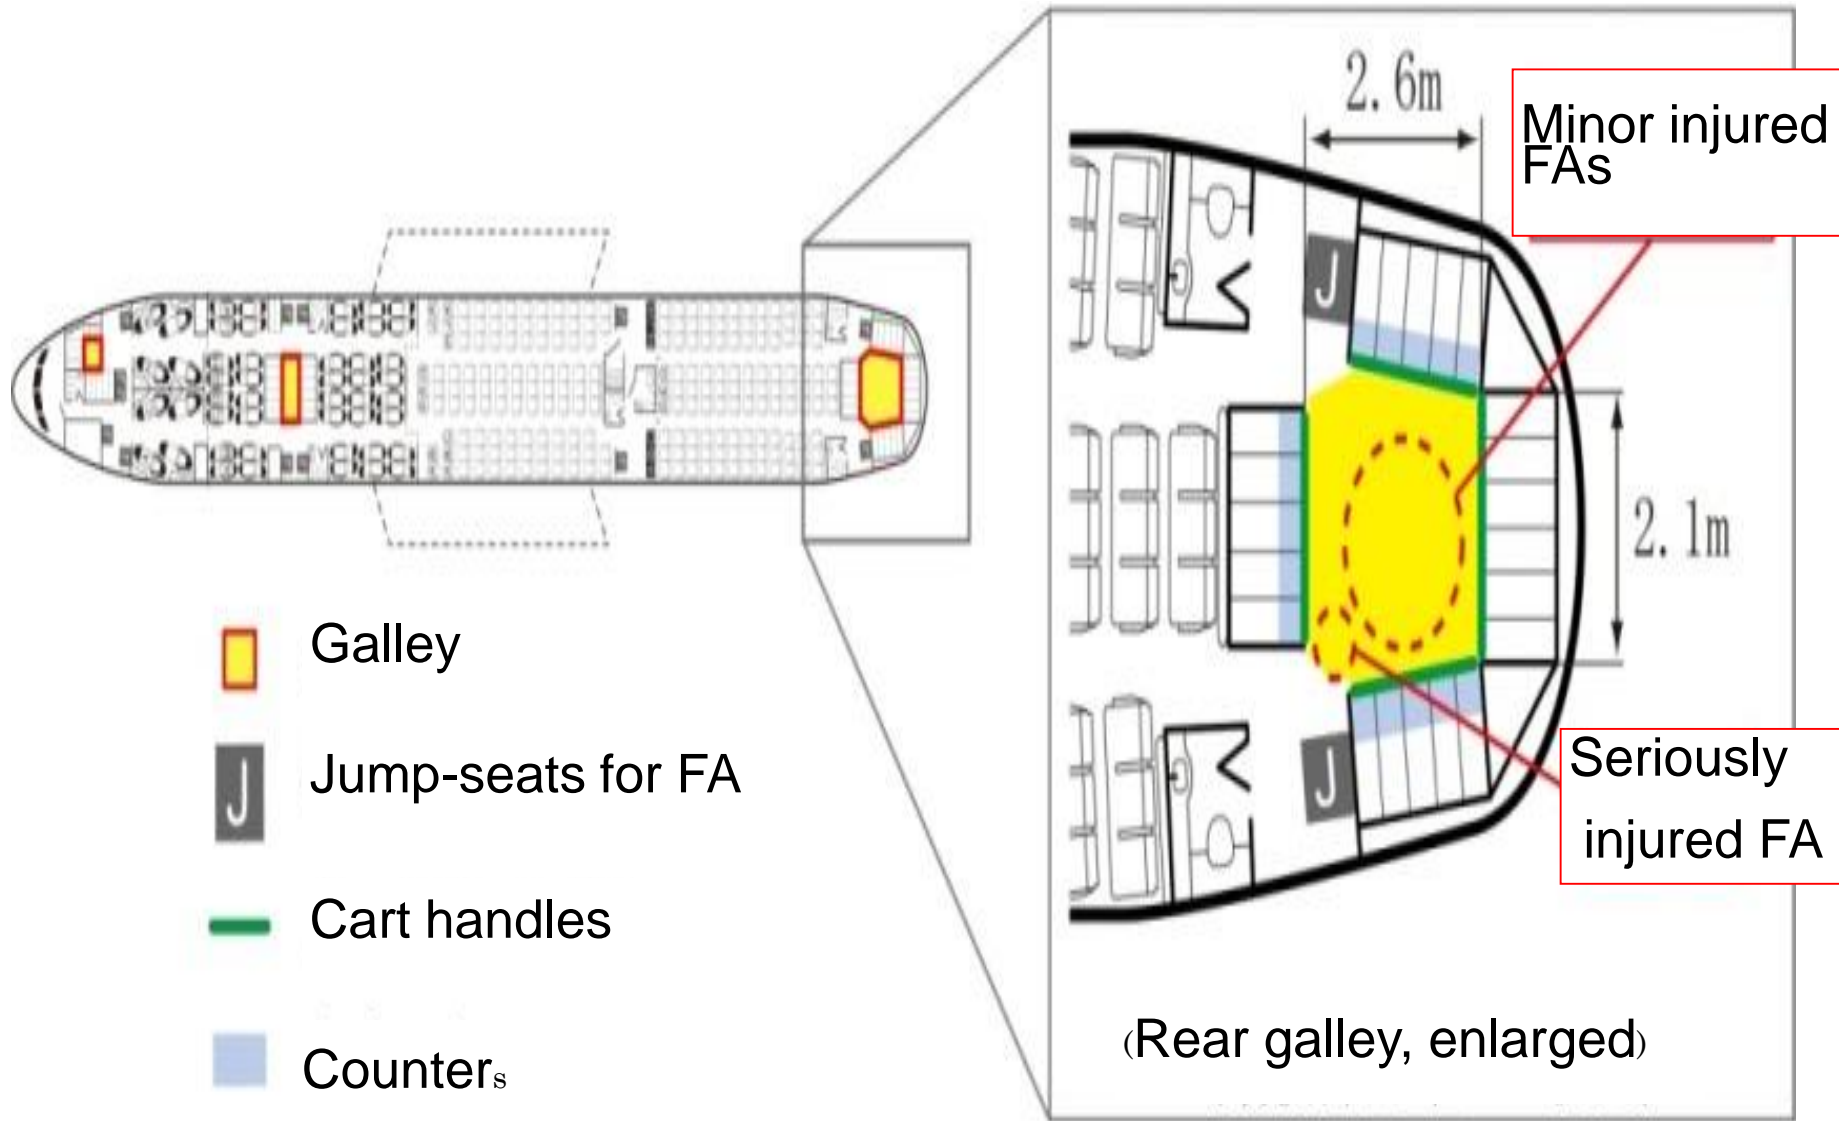
Fig.2

- > Handhold designed specifically for the shaking aircraft were not equipped.
- > Fixed objects such as the counters and the cart handles stored in the lower part of the galley on four sides were available to hang on as substitute for handholds.
(All carts had been stored when the accident occurred.)
- > Making the FAs and the fixed objects, when used as substitute for handholds, were slightly far apart.
