WORKING TOGETHER TO ENHANCE
AIRPORT OPERATIONAL SAFETY

Most common Infrastructural gaps identified

APEX in Safety Reviews 2011-2019

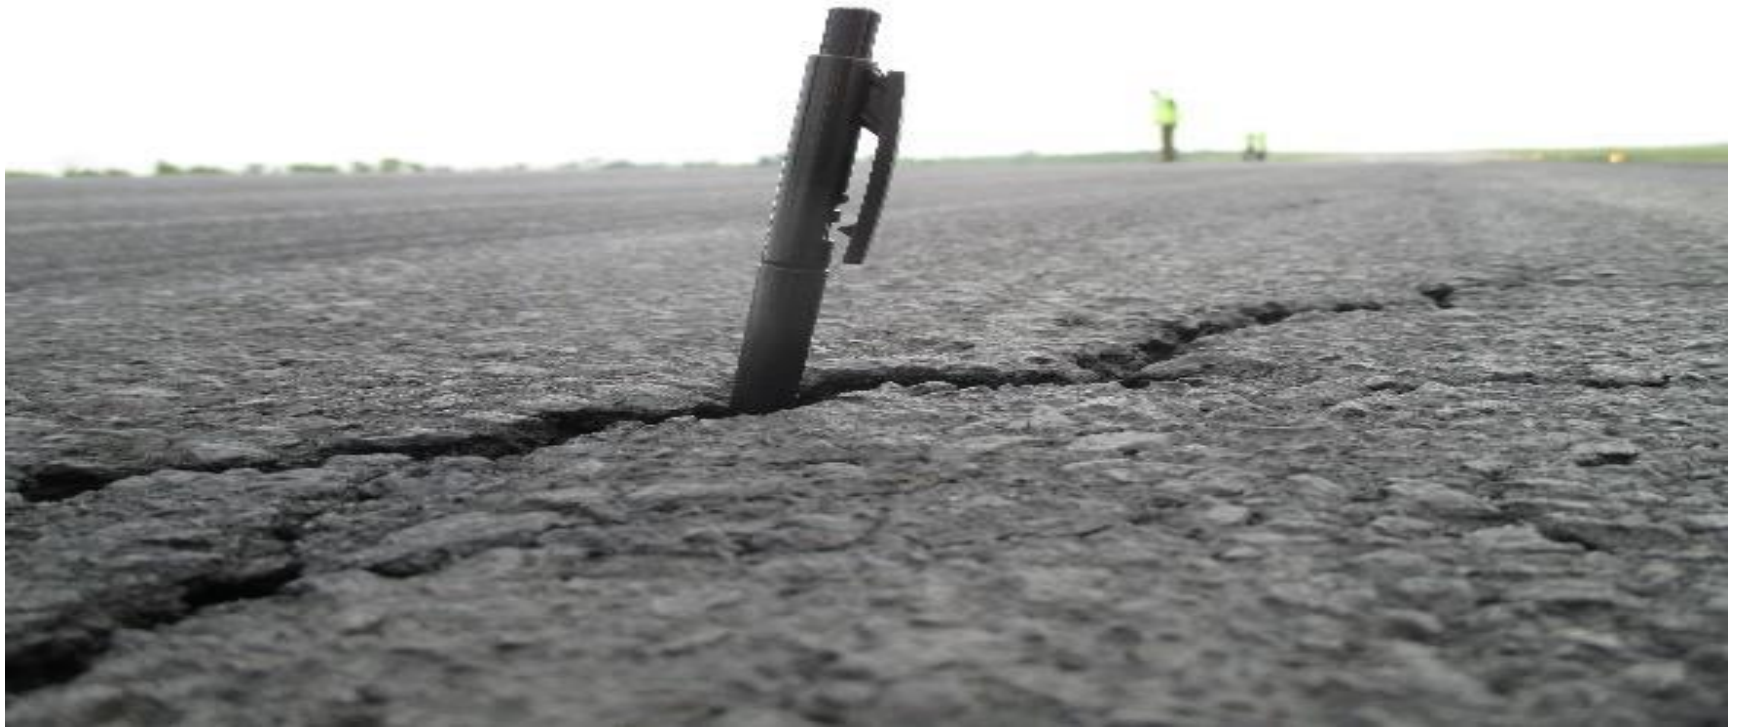
- Some Examples

As a matter of high priority, make all necessary repairs of all holes, cracks and areas that are creating foreign object debris/damage (FOD) on the runway; also, reinforce the inspection of pavements.

Issue a Notice to Airmen (NOTAM) indicating the pavement conditions of the runway.

Implement procedures and allocate adequate resources to ensure that cracks and holes are repaired before they escalate, becoming a hazard to aircraft operations, and grant runway closures when the damage (i.e. crack, hole, etc.) is sufficiently serious. Guidance material for conducting the inspections can be found in ICAO Doc.9137, Part 8, Chapter 3.

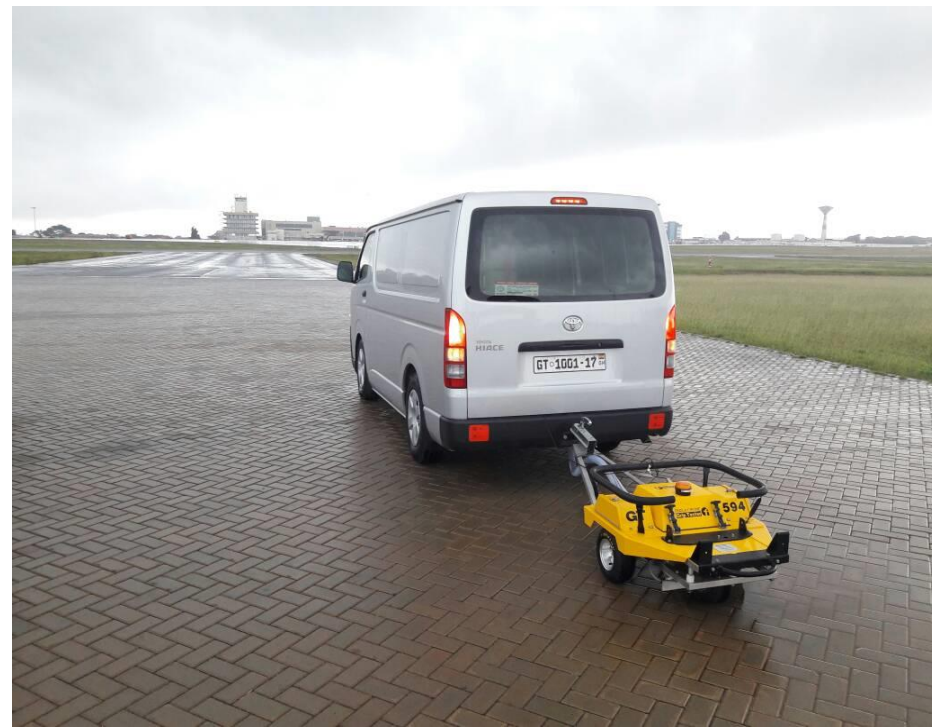
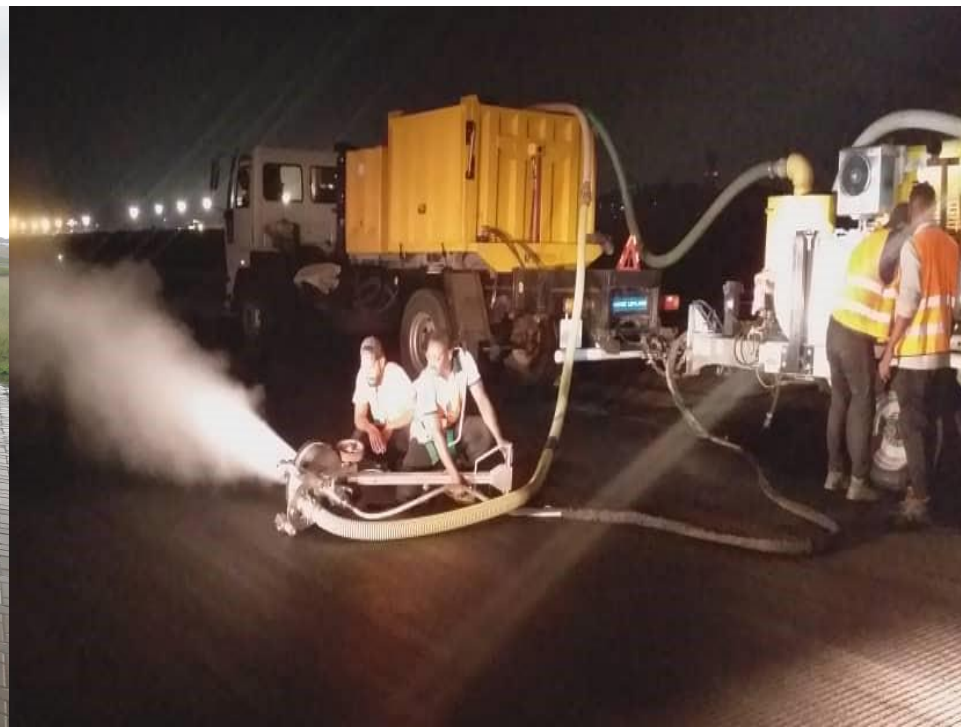
- Implementation of the new Global Reporting Format For Runway Surface Conditions (GRF2019)
- Main contaminants identified are
 - Rubber deposits
 - Ponding of water/Mud
 - Not snow or Ice
