International Civil Aviation Organization

Fifteenth Meeting (MIDRMA Board/15)
(Muscat, Oman, 29 – 31 January 2018)

WAKE TURBULENCE SEPARATION IN RVSM AIRSPACE

Interim Report

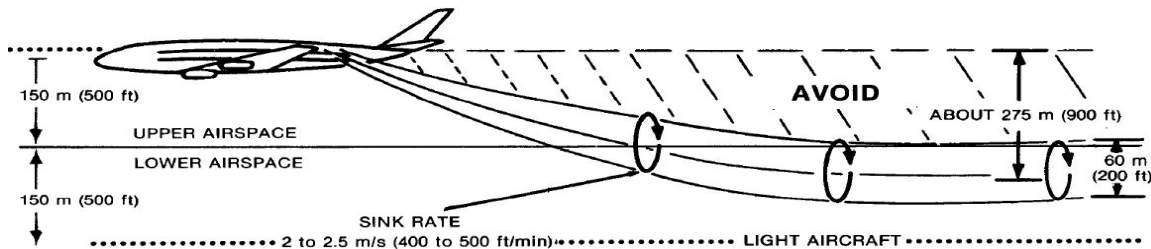
Figure 1.

1.4 Flight tests have shown that vortices from large aircraft sink at a rate of about 2 to 2.5 m/s (400 to 500 ft/min). They tend to level off at about 275 m (900 ft) below the flight path of the generating aircraft. Wake turbulence strength diminishes with time and distance behind the generating aircraft. (Figure 1 refers).

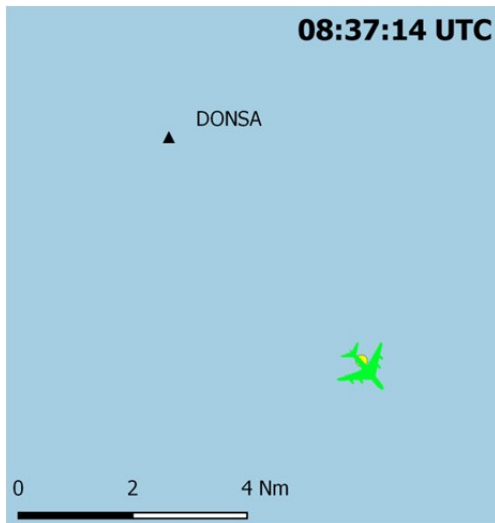
At about 0837:14 UTC the A380 passed at FL350 the position, where later the CL604 was subject to temporary loss of control.

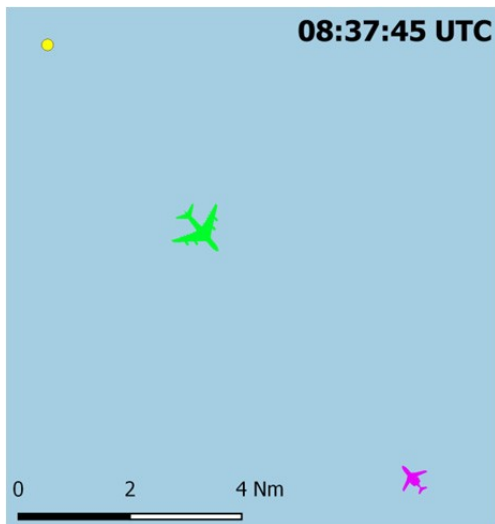
At about 0837:45 UTC the A380 TCAS captured the CL604 on opposite track (TCAS message proximate). At that time the distance between the two aircraft was 6 NM and 1,000 ft vertical.

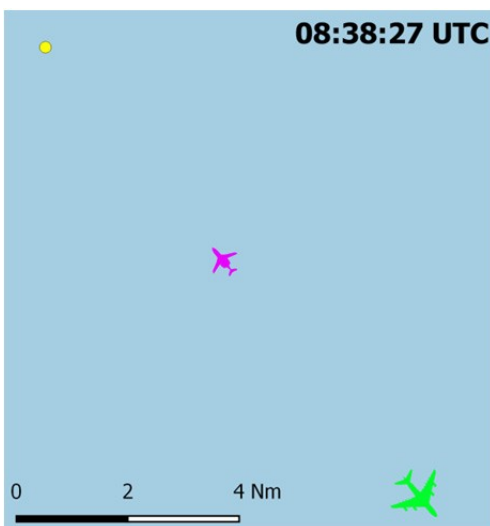
At about 0838:27 UTC the two aircraft left the capture area of their respective TCAS (TCAS message proximate). At that time the distance between the two aircraft was about 6 NM.
