ICAO Accident/Incident Investigation Workshop, Mexico 2015

Ricardo Asensio,
Air Safety Investigator
Textron Aviation
316-676-7824
rasensio@txtav.com

Case Studies

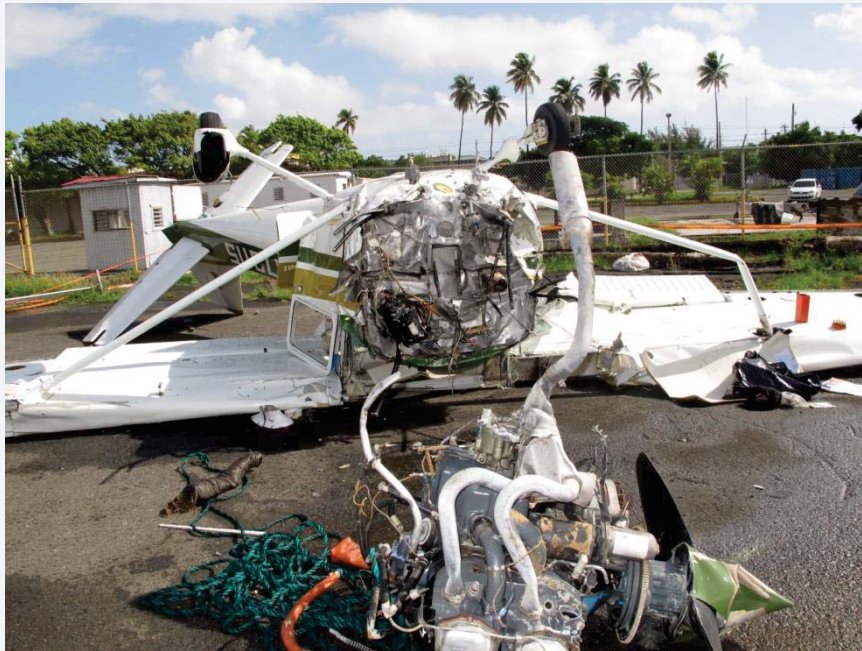
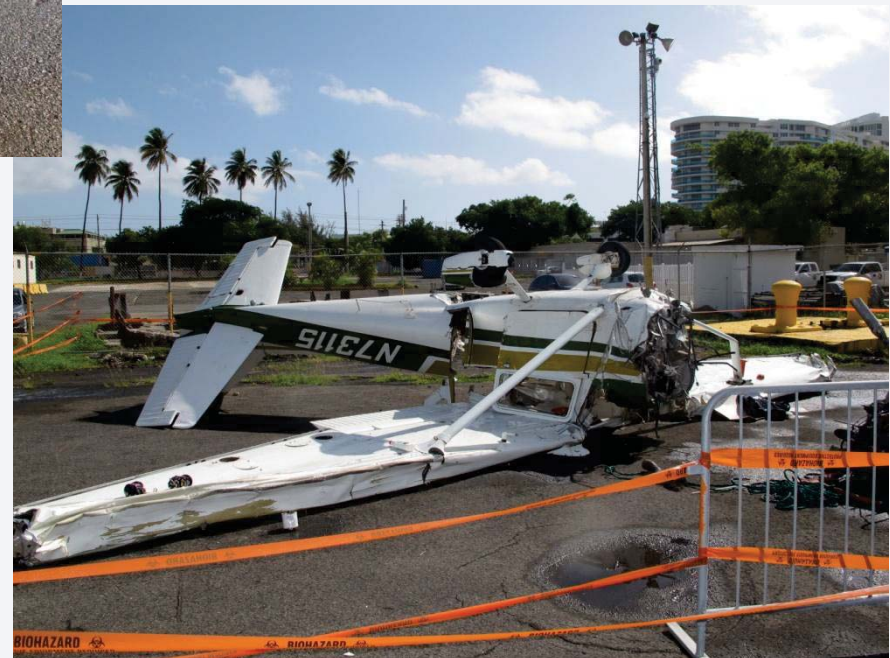
Investigation

- All flight control surfaces were observed and attached
- Left and right wings remained attached to fuselage
- Control cable continuity was established
 - Through multiple cable separations
- Flap actuator was found at 10°
- Elevator trim was found with 10° tab up
- Co-pilot control yoke was fractured
 - Recovered within the pilot's hands
- Pilot control yoke remained attached
 - Operation and continuity of the control yoke was confirmed

- Ailerons interconnect control cable exhibited broomstrawing
- Right aileron direct control cable was found separated
- Top left doorpost pulley exhibited signs of scoring on the rim

“Maintenance personnel’s improper lubrication of the right direct aileron control cable and failure to detect the severe corrosion of the cable during a maintenance inspection, which resulted in the in-flight failure of the cable, the pilot’s subsequent inability to maintain aircraft control, and the airplane’s impact with terrain.”
