**National  
Transportation  
Safety Board**

# Accident Case Studies

Tim LeBaron, IIC / US Acc Rep  
Washington, DC

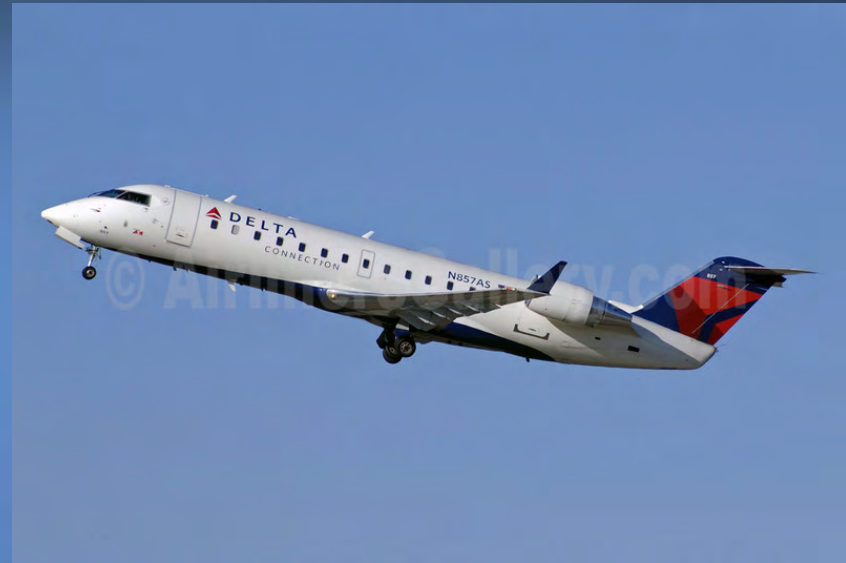
- September 2011
- Bombardier CRJ-200
- Baton Rouge, LA
- Landed with left main landing gear retracted

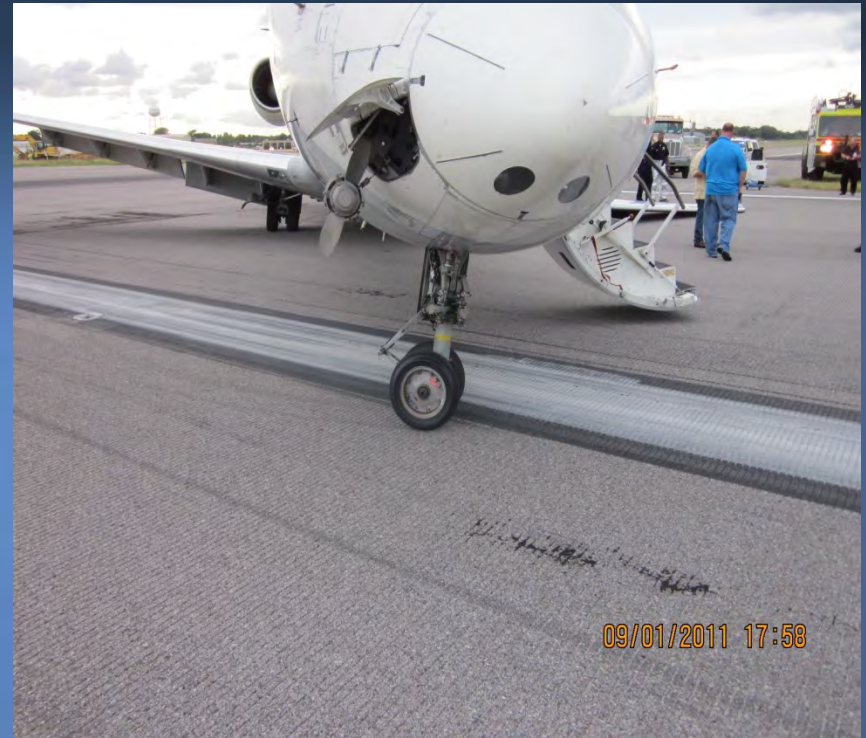
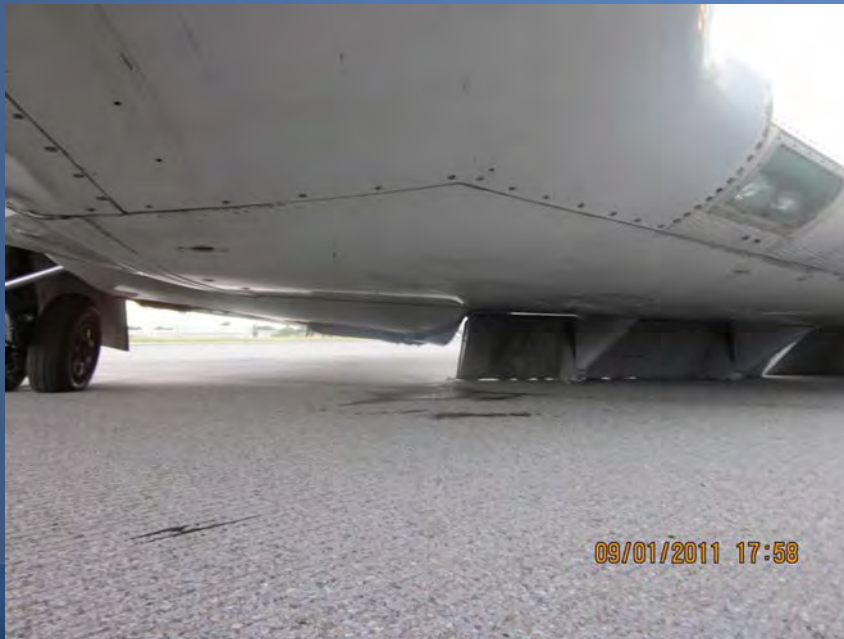
- No injuries
- No substantial damage

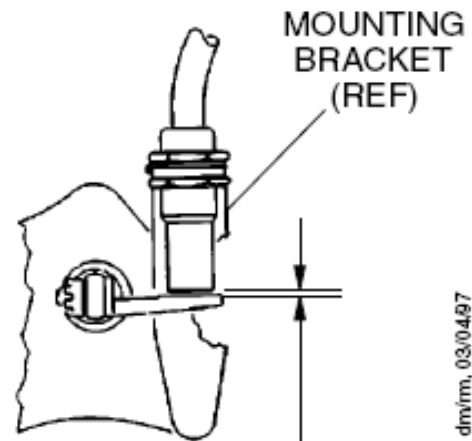
Bolt not fitted through uplock upper lugs

- #1 - Bolt installed through the Airframe Structure and MLG Uplock.
- #2 - Bolt not installed through the MLG Uplock, but Airframe Structure only.

The event flight was the first after maintenance had been carried out on the landing gear up-lock system. Preliminary investigation results revealed that the upper attachment bolt for the left up-lock assembly, which is designed to be attached to both the up-lock assembly and structure, was attached to the structure only, ref fig. 1. The left up-lock assembly had been replaced prior to the flight however AMM task 32-32-05-400-801 was not followed, and as part of this procedure the visual inspection as per Step 8 to make sure the attaching holes of the MLG up-lock assembly align with holes in the adjacent structure and the additional safeguard as per step 16, which instructs to manually move the up-lock up and down had also not been performed by either the Technician or the Inspector.

This was the second occurrence of this type of event with two different Operators and Fig 2 illustrates the proper and improper installation as found on the latest incident aircraft.

- The improperly installed upper attachment bolt in the left main landing gear uplock assembly, which led to the failure of the left main landing gear to extend before landing. Contributing to the accident was maintenance personnel's lack of training on the installation and inspection of the uplock assembly

**Action Required** When installing a MLG uplock assembly, ensure that you follow the AMM TASK 32-32-05-400-801 and/or Bombardier Task Card precisely.

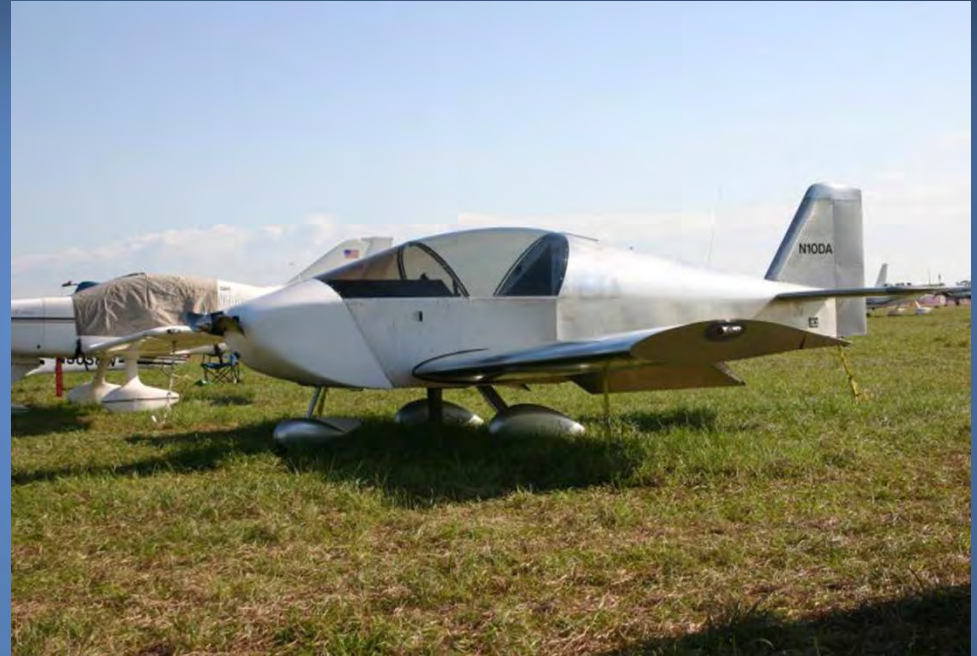
- Nov 2009
- Burnet, TX
- Sonex
- 1 fatal
- Loss of engine power
- Crashed during forced landing

- The pilot's failure to maintain aircraft control, resulting in an aerodynamic stall. Contributing to the accident was the loss of engine power due to a clogged fuel screen that resulted in fuel starvation caused by the builder's inappropriate use of a fuel tank sealant in a plastic tank

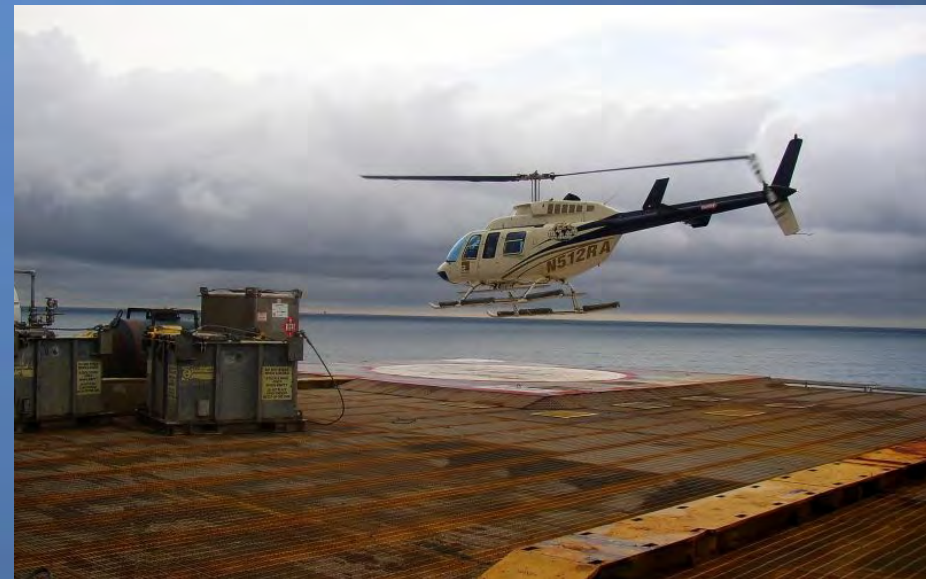
- March, 2006
- Patterson, LA
- Bell 206
- 2 fatal, 2 minor

- The improper installation of an engine fuel line by maintenance personnel, which resulted in a loss of engine power during cruise flight. Factors associated with the accident are a tailwind, and the lack of a suitable site for a forced landing

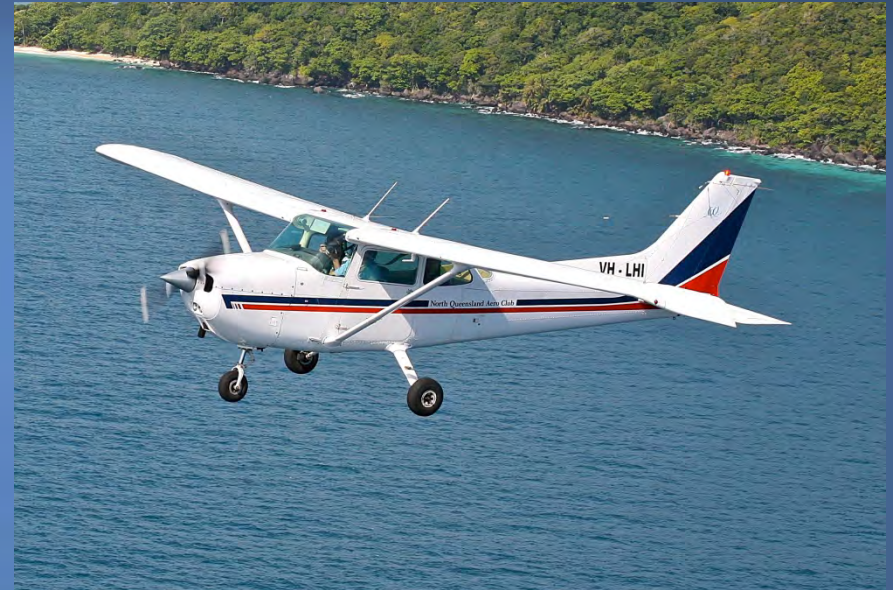
- July, 2006
- Petal, MS
- Cessna 172
- fatal
- Impacted trees on takeoff

- The pilot's improper use of flaps, which resulted in an impact with trees during takeoff-initial climb

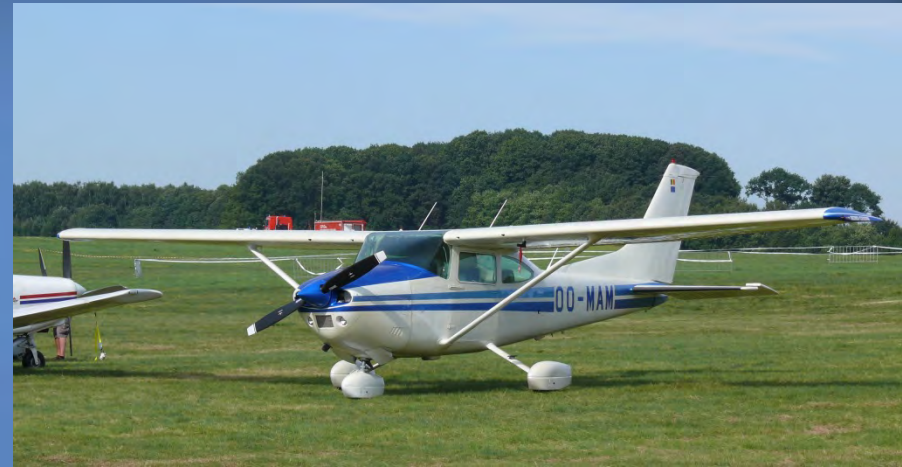
- Aug, 2004
- Port Angeles, WA
- Cessna 182
- VFR flight
- Dark night conditions
- Rain, clouds and fog
- 1 fatal 2 minor

- The pilot's VFR flight into IMC and his failure to maintain clearance from trees. Trees, mountainous terrain, dark night conditions, clouds and VFR flight into IMC were factors

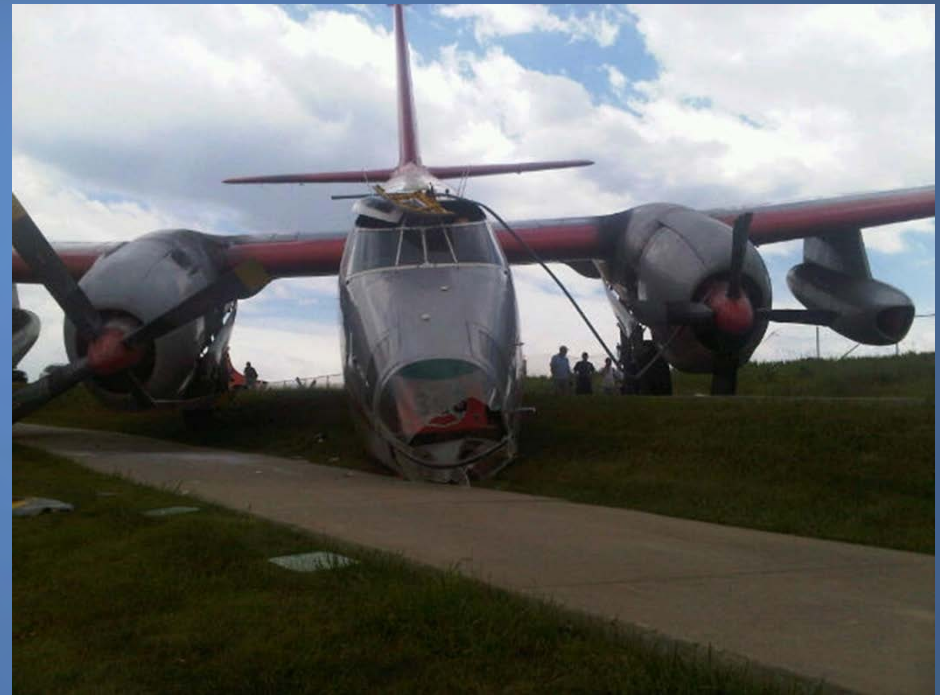
- June 2010
- Broomfield, CO
- P2V-5 air tanker
- Drop retardant drop on Fire.
- Following retardant drop, crew noticed flaps did not retract

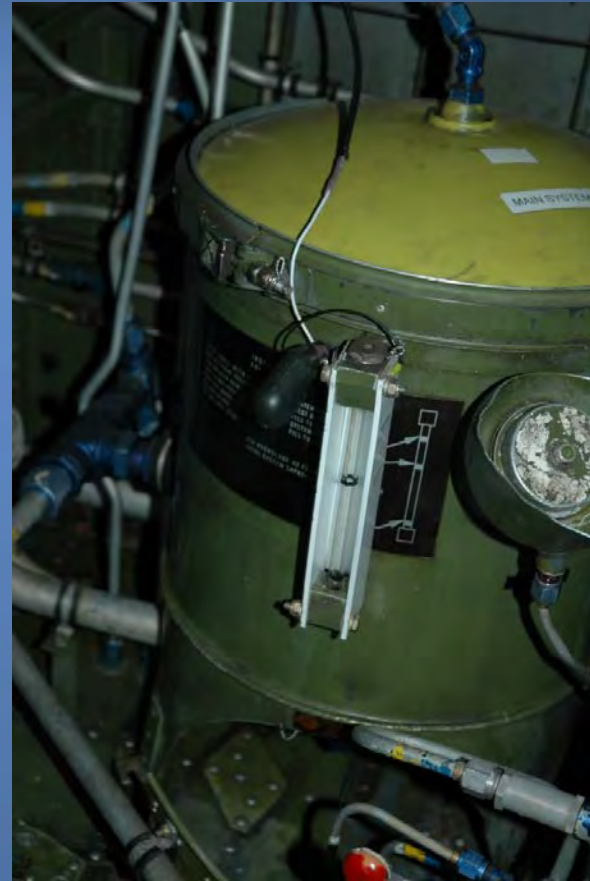
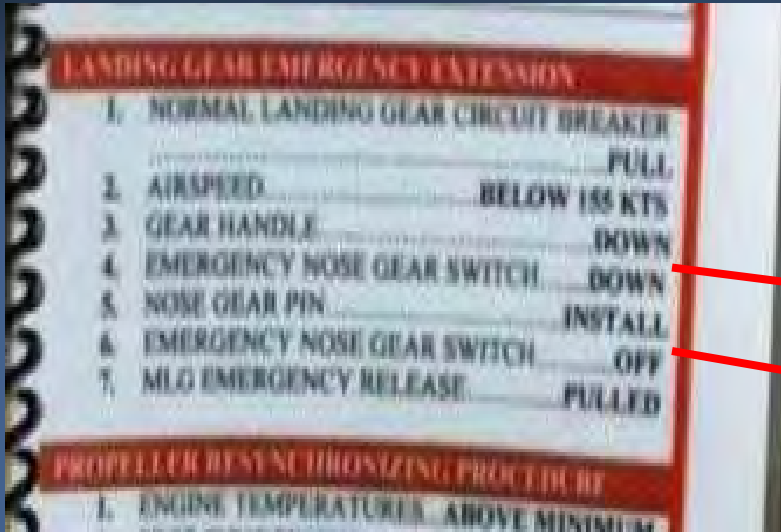
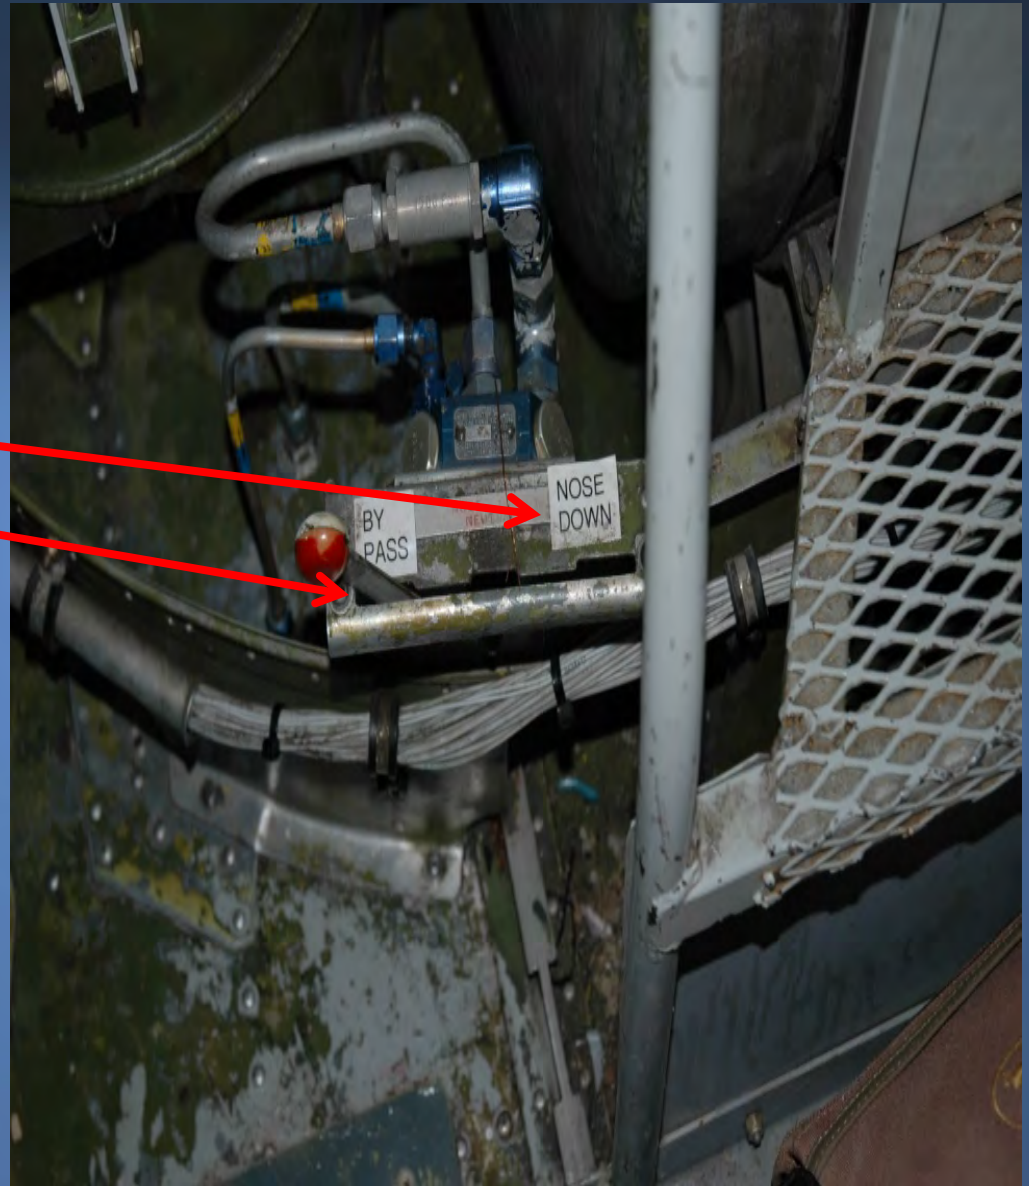
- Hydraulic systems had lost fluid and pressure
- Pilot declared an emergency and returned to land

- The pilot's failure to follow published emergency procedures by taxiing to the parking ramp with a known hydraulic system failure. Contributing to the accident was the co-pilot's improper selection of the bypass position on the emergency nose gear extension system, which shut off emergency hydraulic system pressure to the brakes, and a ruptured hydraulic line, which resulted in a total loss of the main hydraulic system pressure.

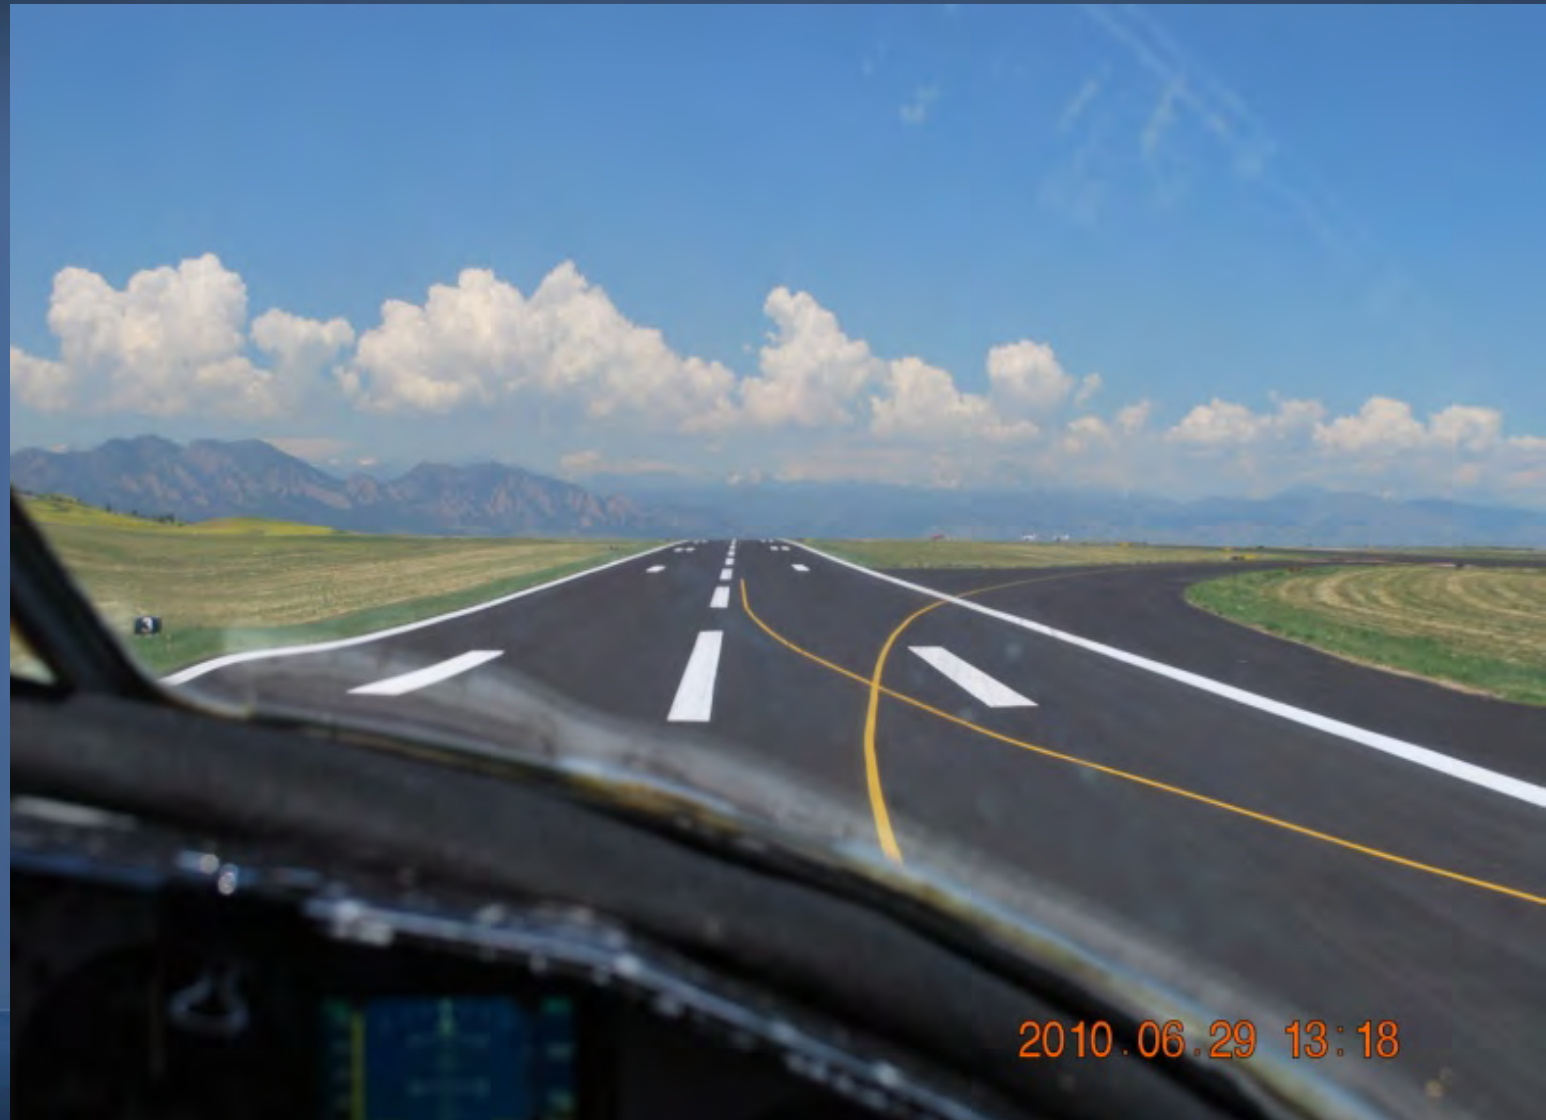
Upon arriving at the end of A-13 the pilot pulled the emergency brake with no result

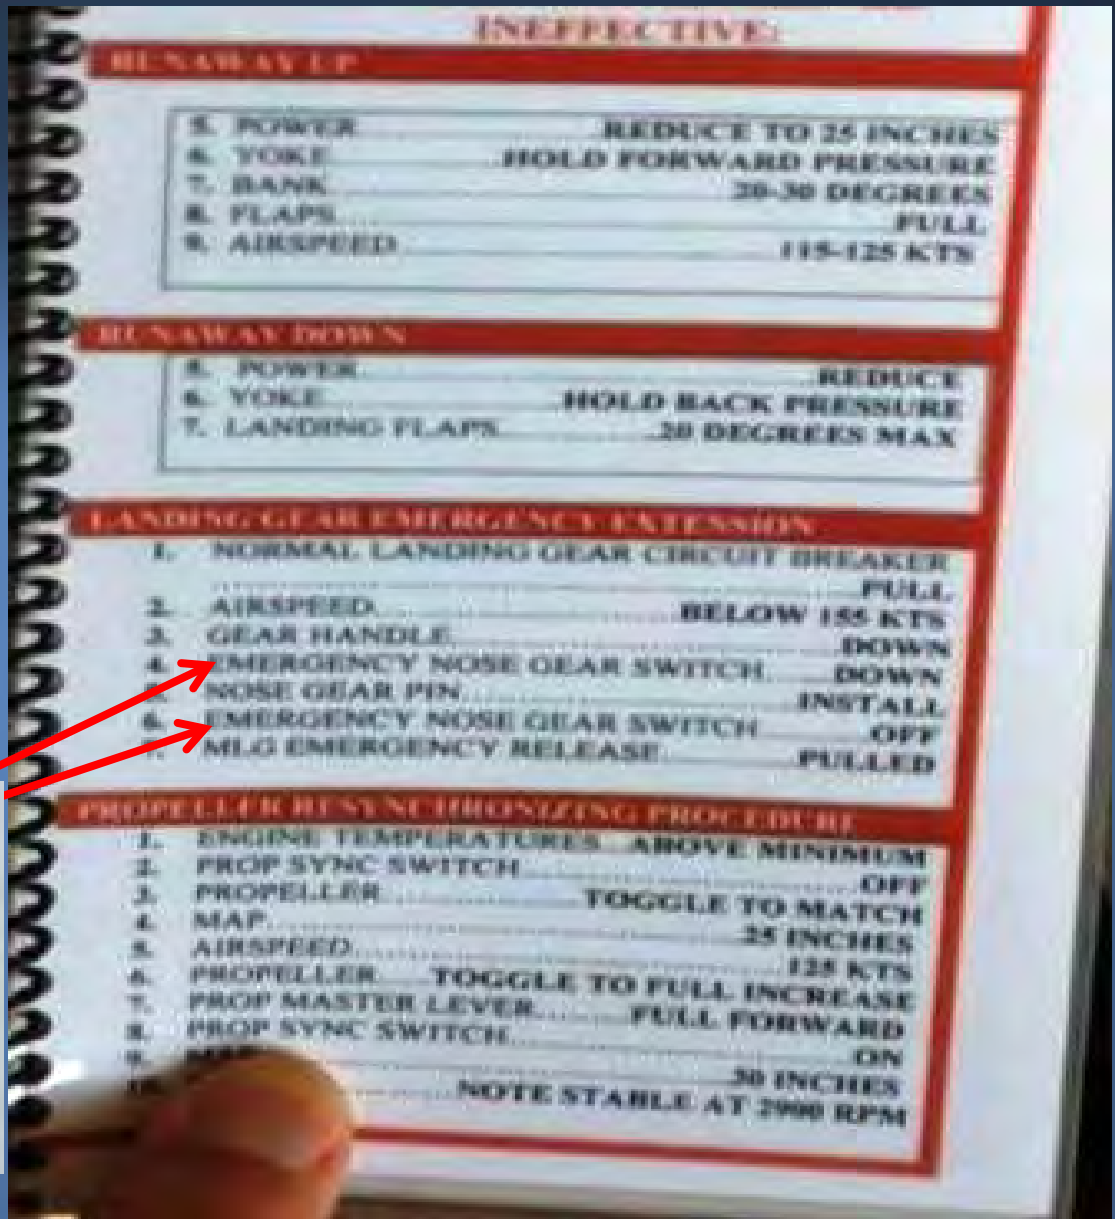
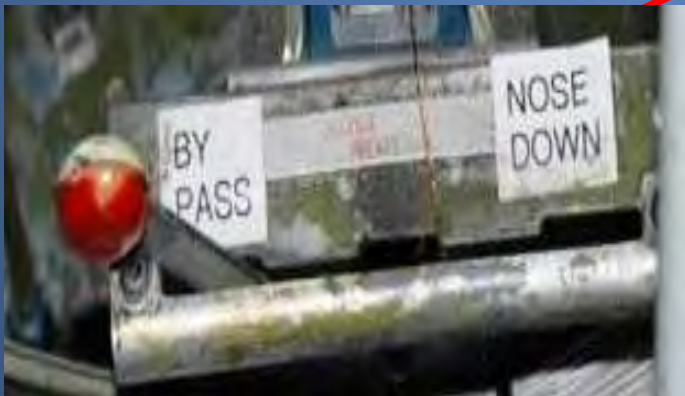
• Checklist was for different model of airplane

- Flight Manual – “Placing the nose gear emergency extension switch in “bypass” will result in loss of hydraulics to the emergency brakes”
- Emergency landing gear selector was placed in “bypass”, resulting in loss of pressure to the emergency brakes
- Company policy – Stay on runway until stopped

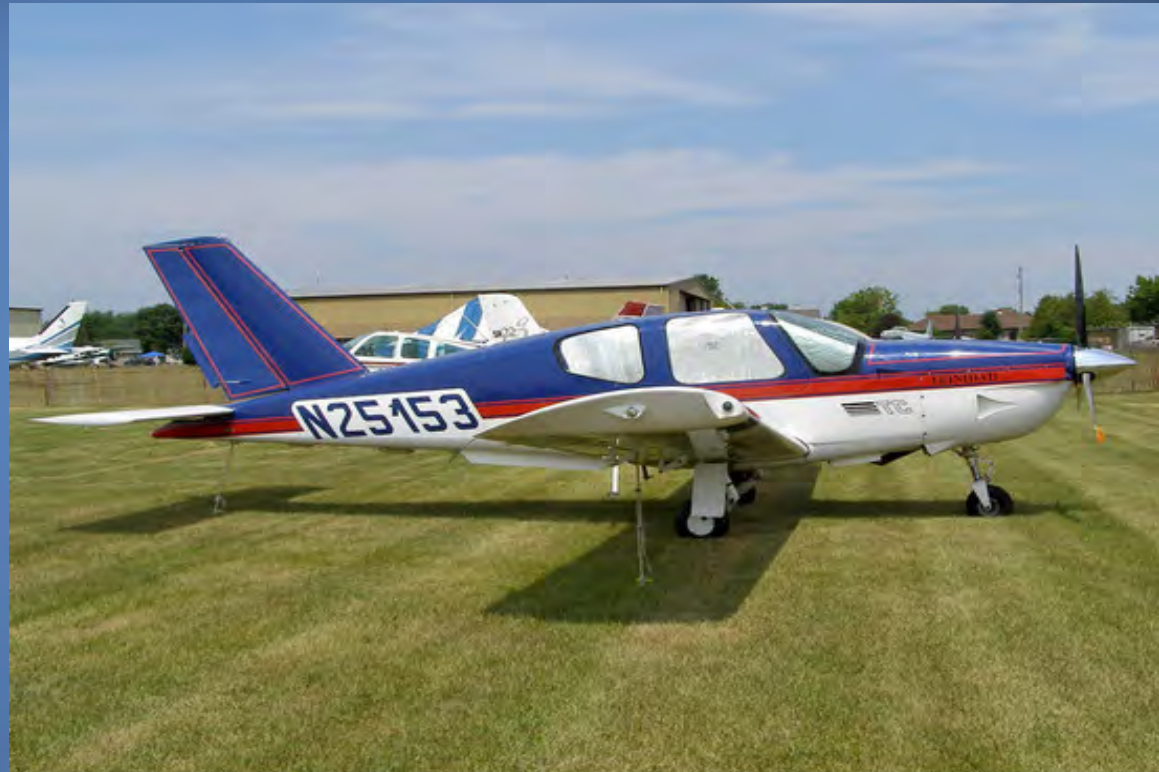
- Dec 3, 2011
- Silverton, CO
- Socata TB21
- 4 fatal

The non-instrument-rated pilot's decision to embark on a flight through forecasted instrument meteorological conditions (IMC), and his subsequent flight into IMC, which resulted in the pilot's spatial disorientation and subsequent maneuvering of the airplane in a manner that exceeded the airplane's structural limits

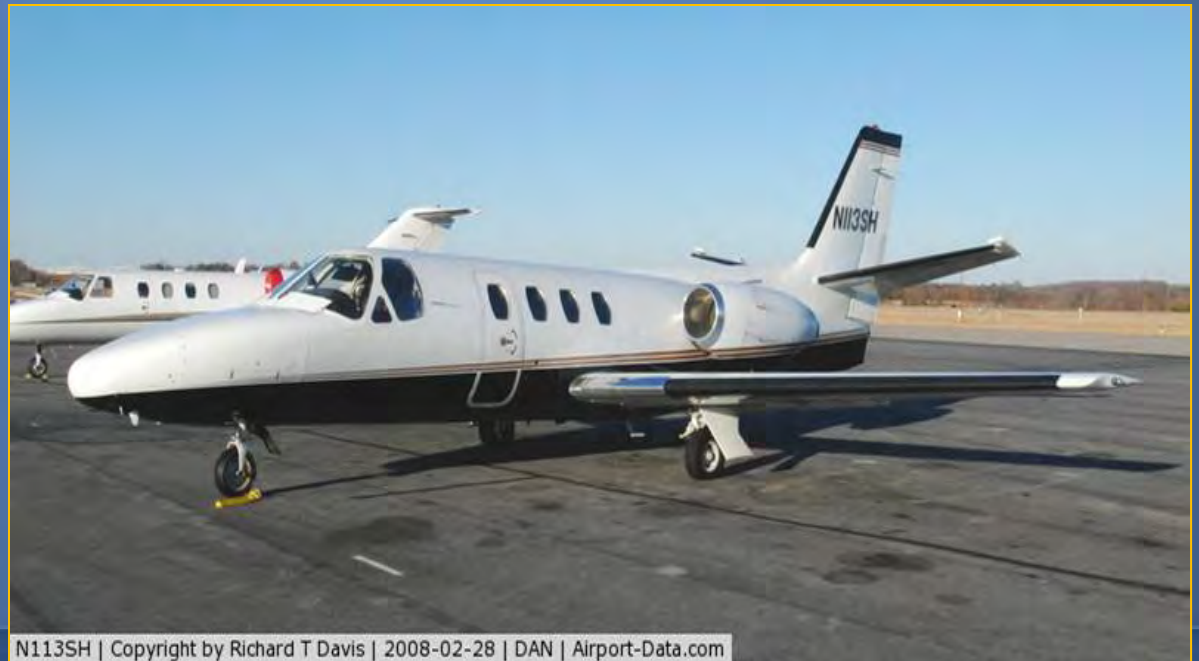
N113SH | Copyright by Richard T Davis | 2008-02-28 | DAN | Airport-Data.com

- March 4, 2008
- Oklahoma City, OK
- Cessna 500
- 5 fatal

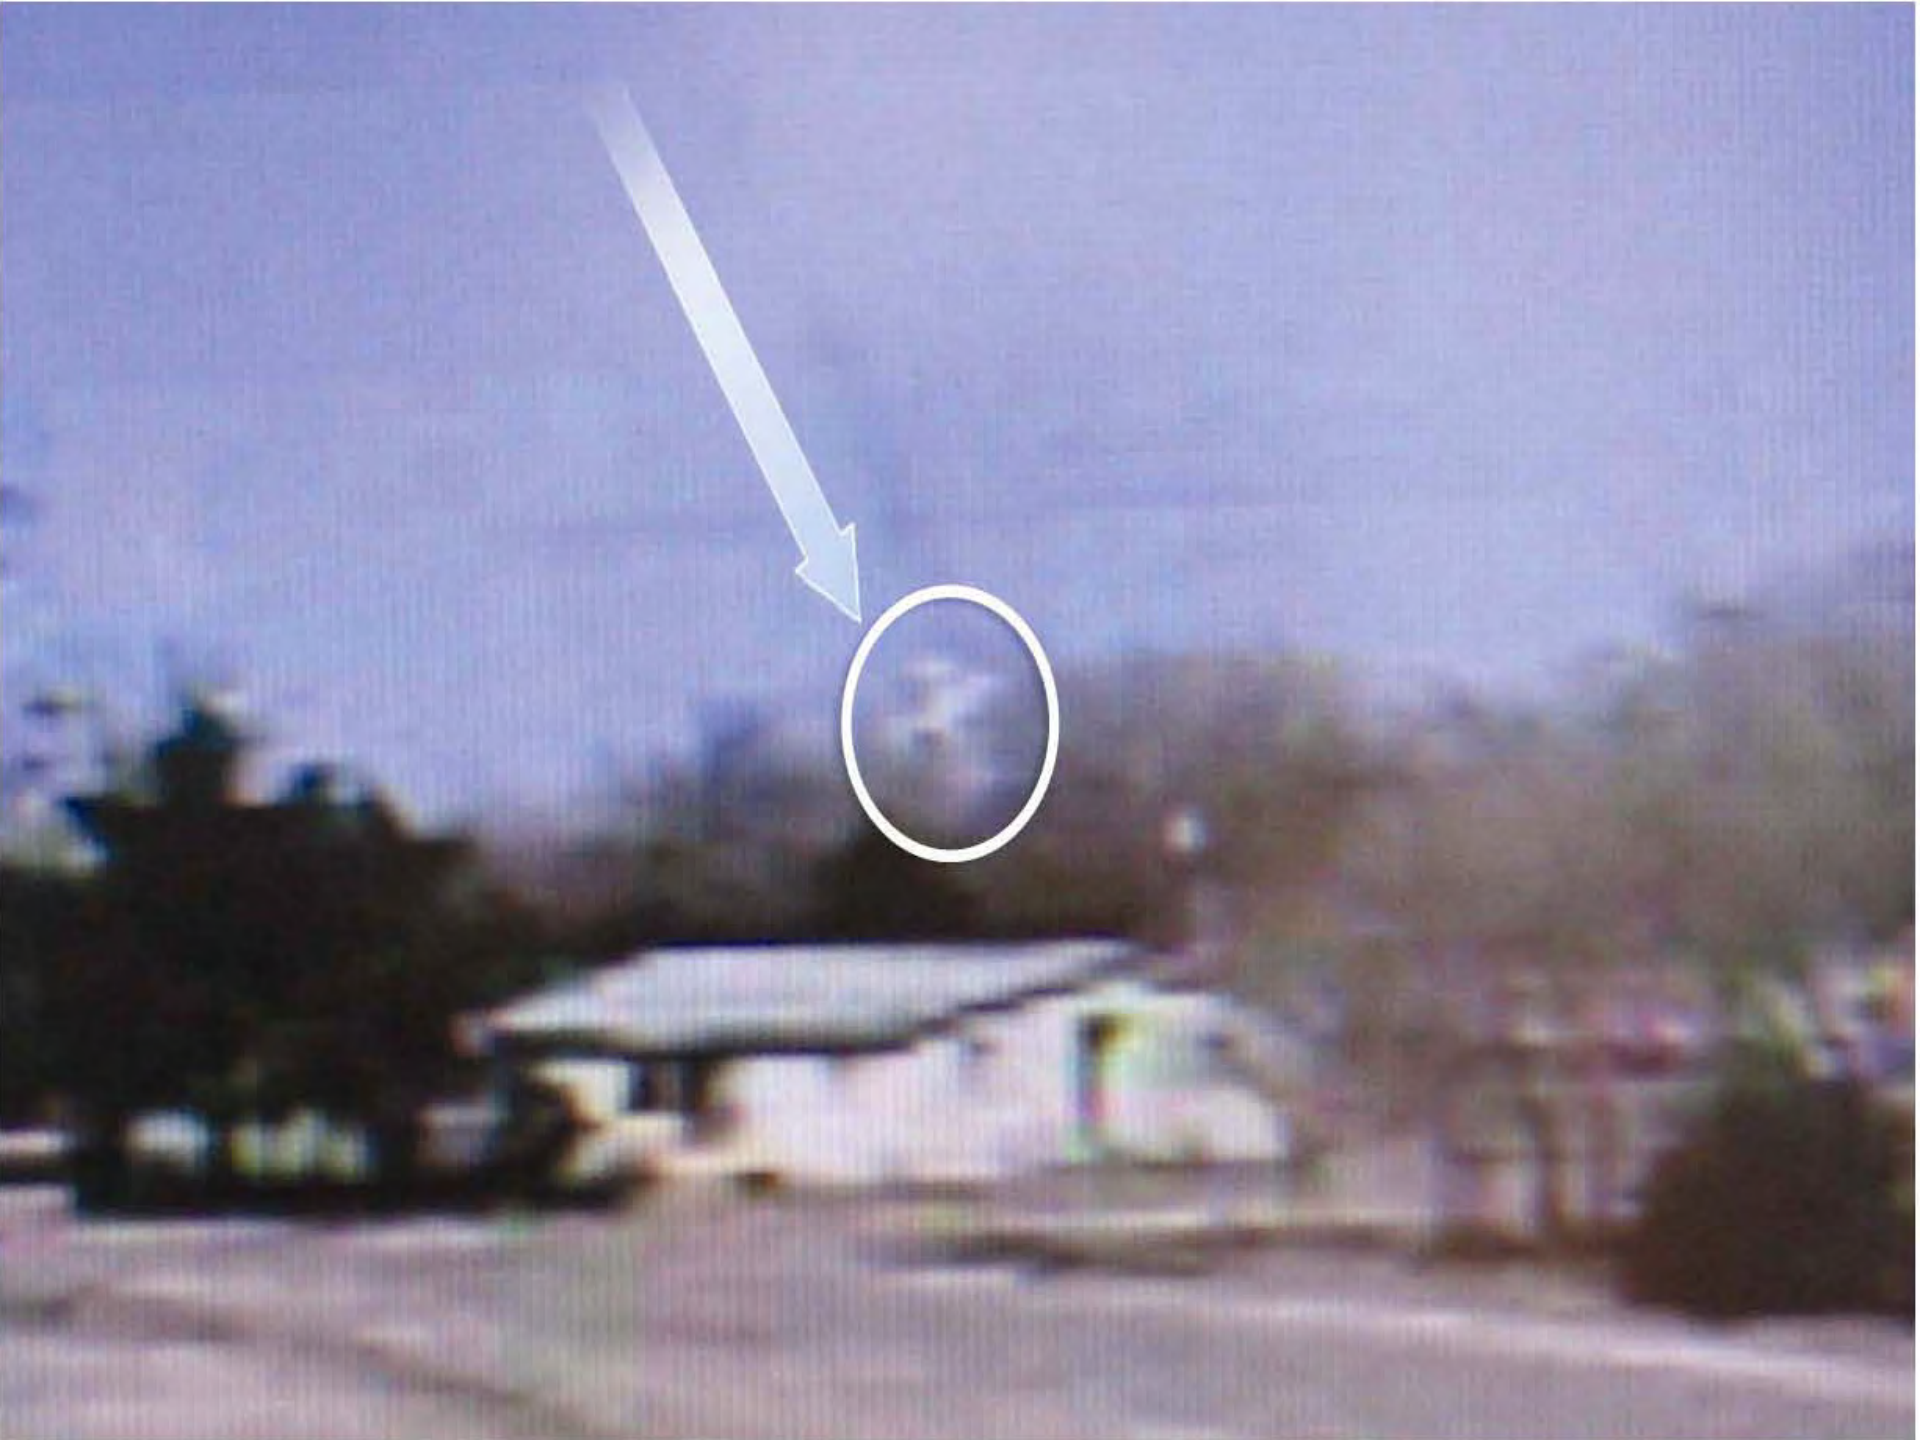
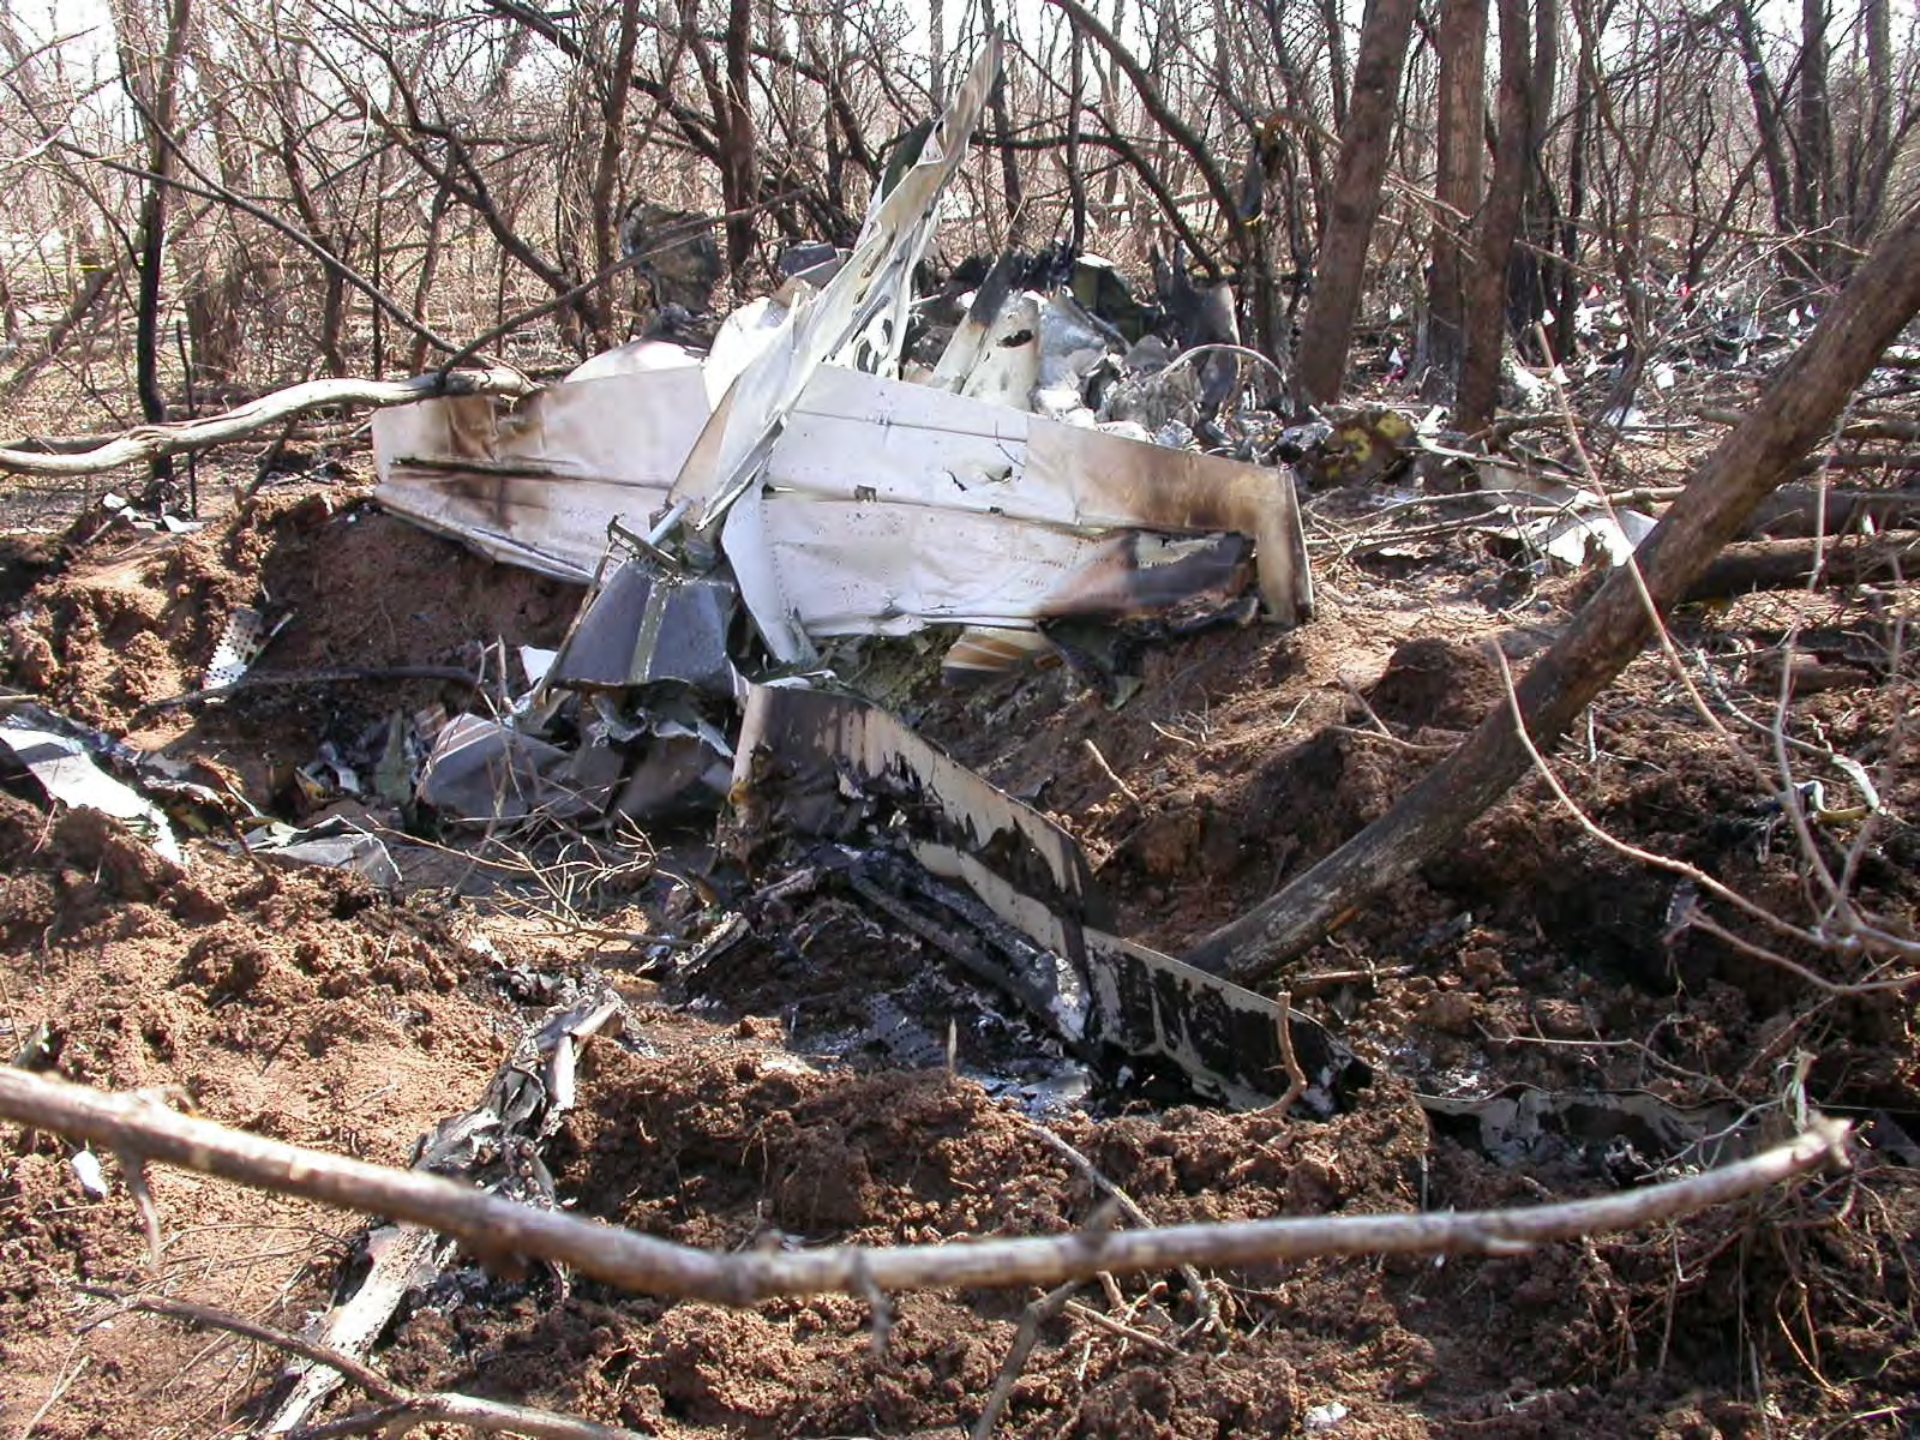
Splatter  
residue

- Right engine not producing power
- Cockpit voice recorder inoperative
- Airplane wing damage sustained during collision with American white pelicans

- Airplane wing-structure damage sustained during impact with one or more large birds (American white pelicans), which resulted in a loss of control of the airplane

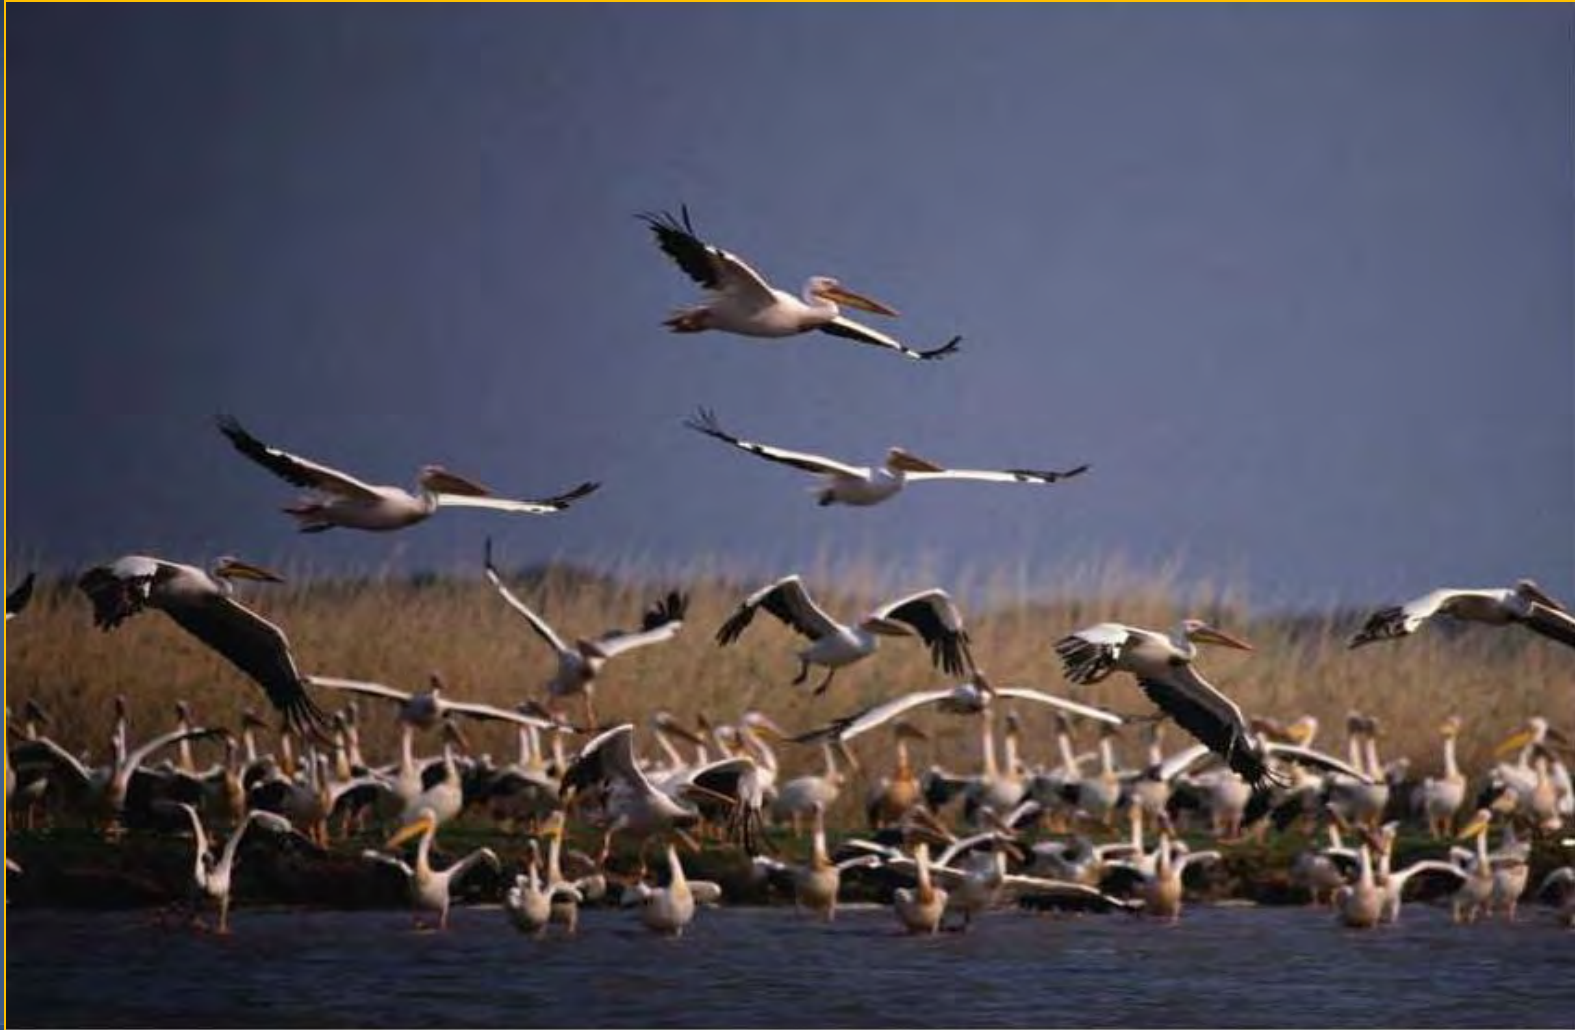
# American White Pelicans
