**National  
Transportation  
Safety Board**

# Accident Case Studies

Tim LeBaron, IIC / US Acc Rep  
Washington, DC

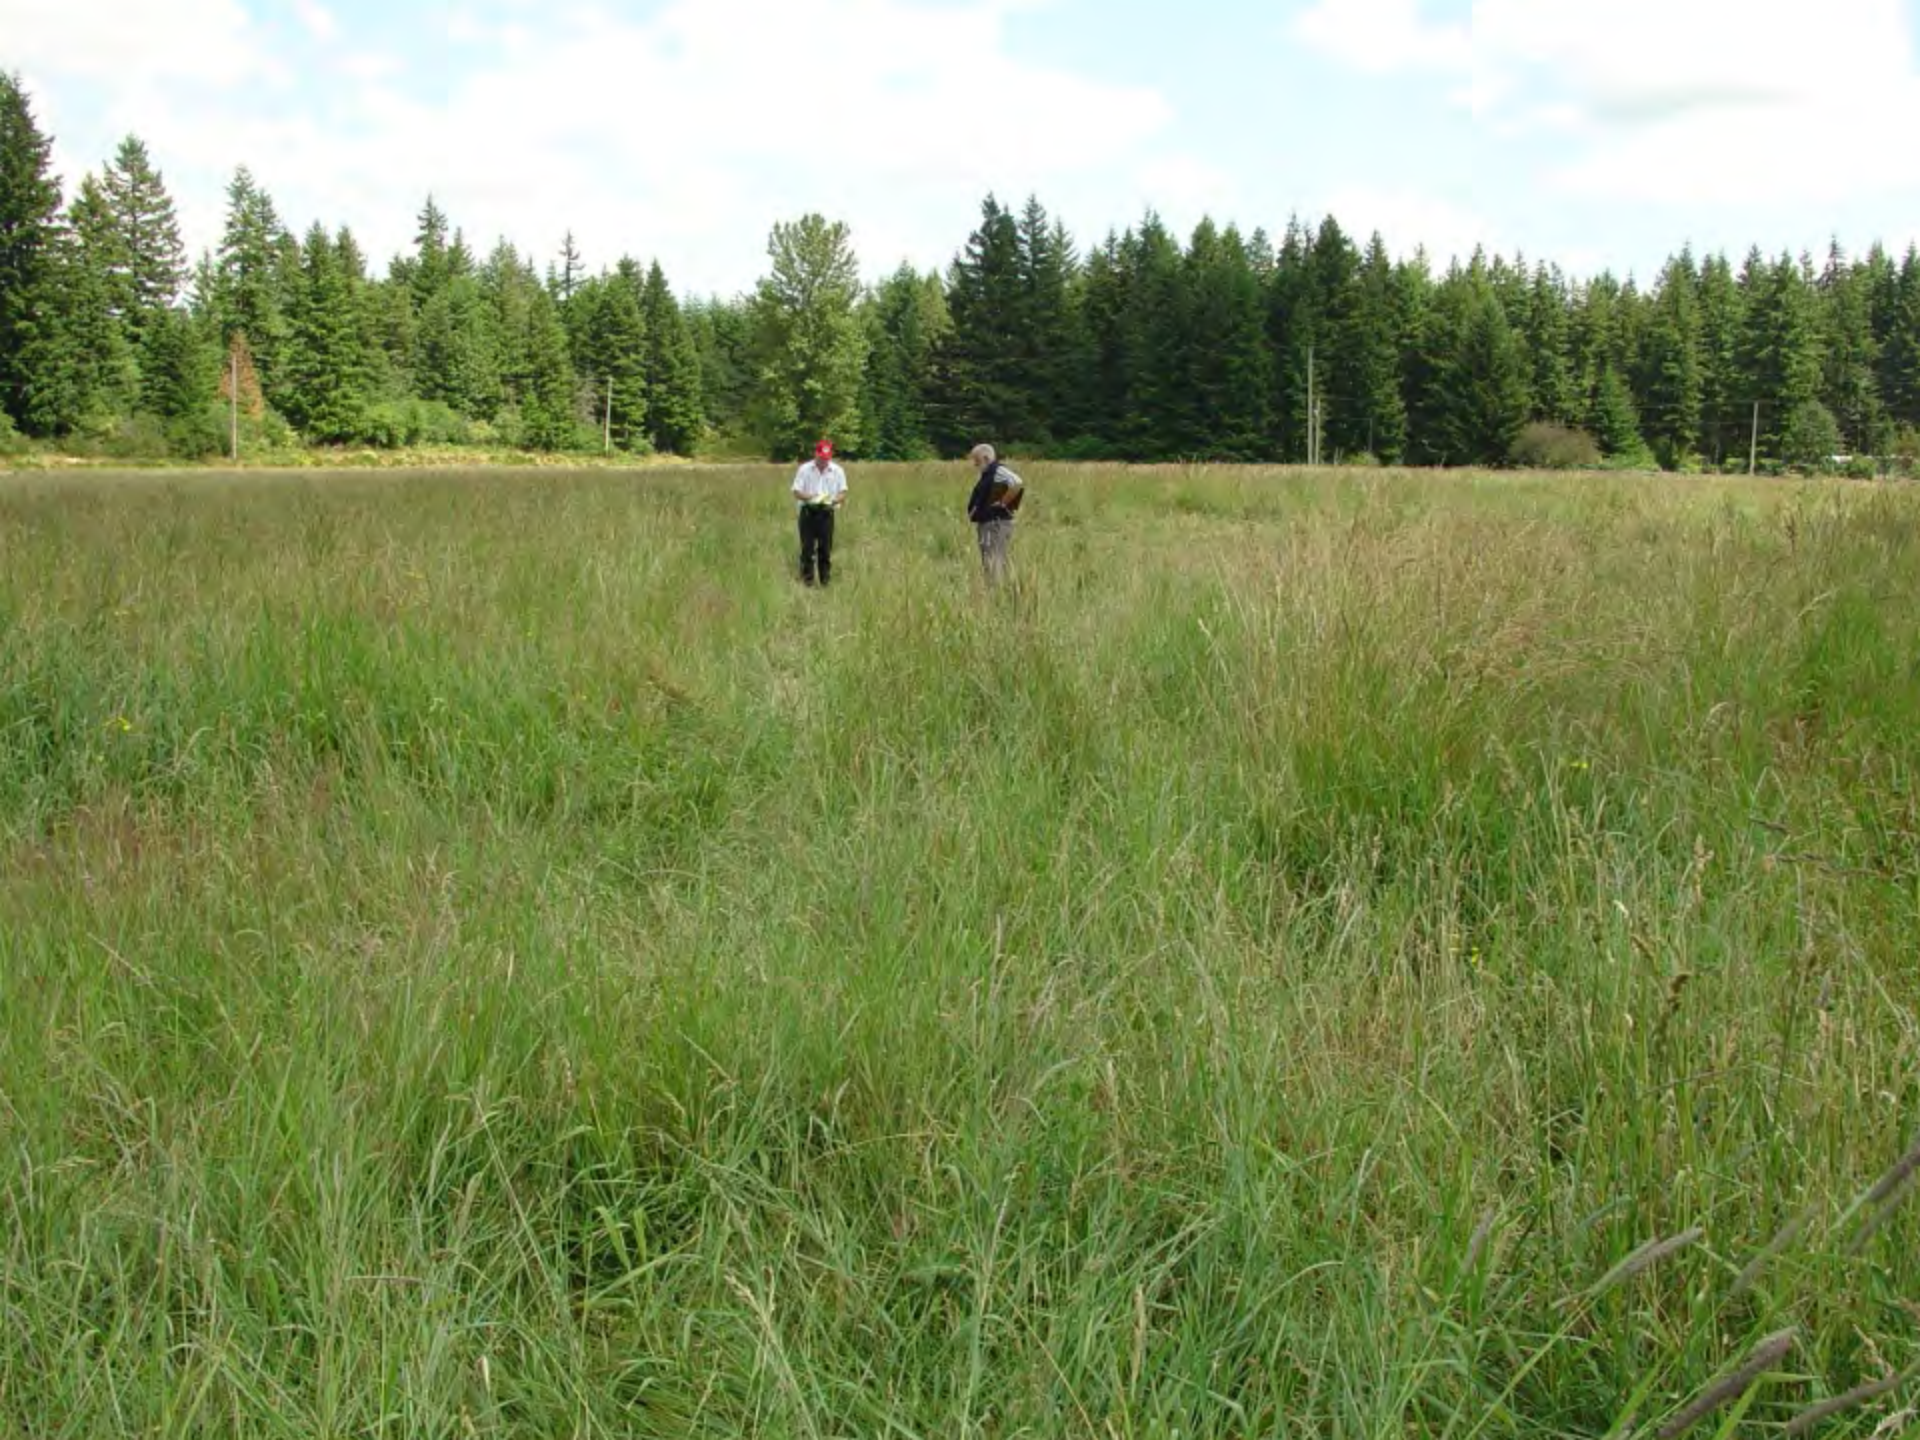
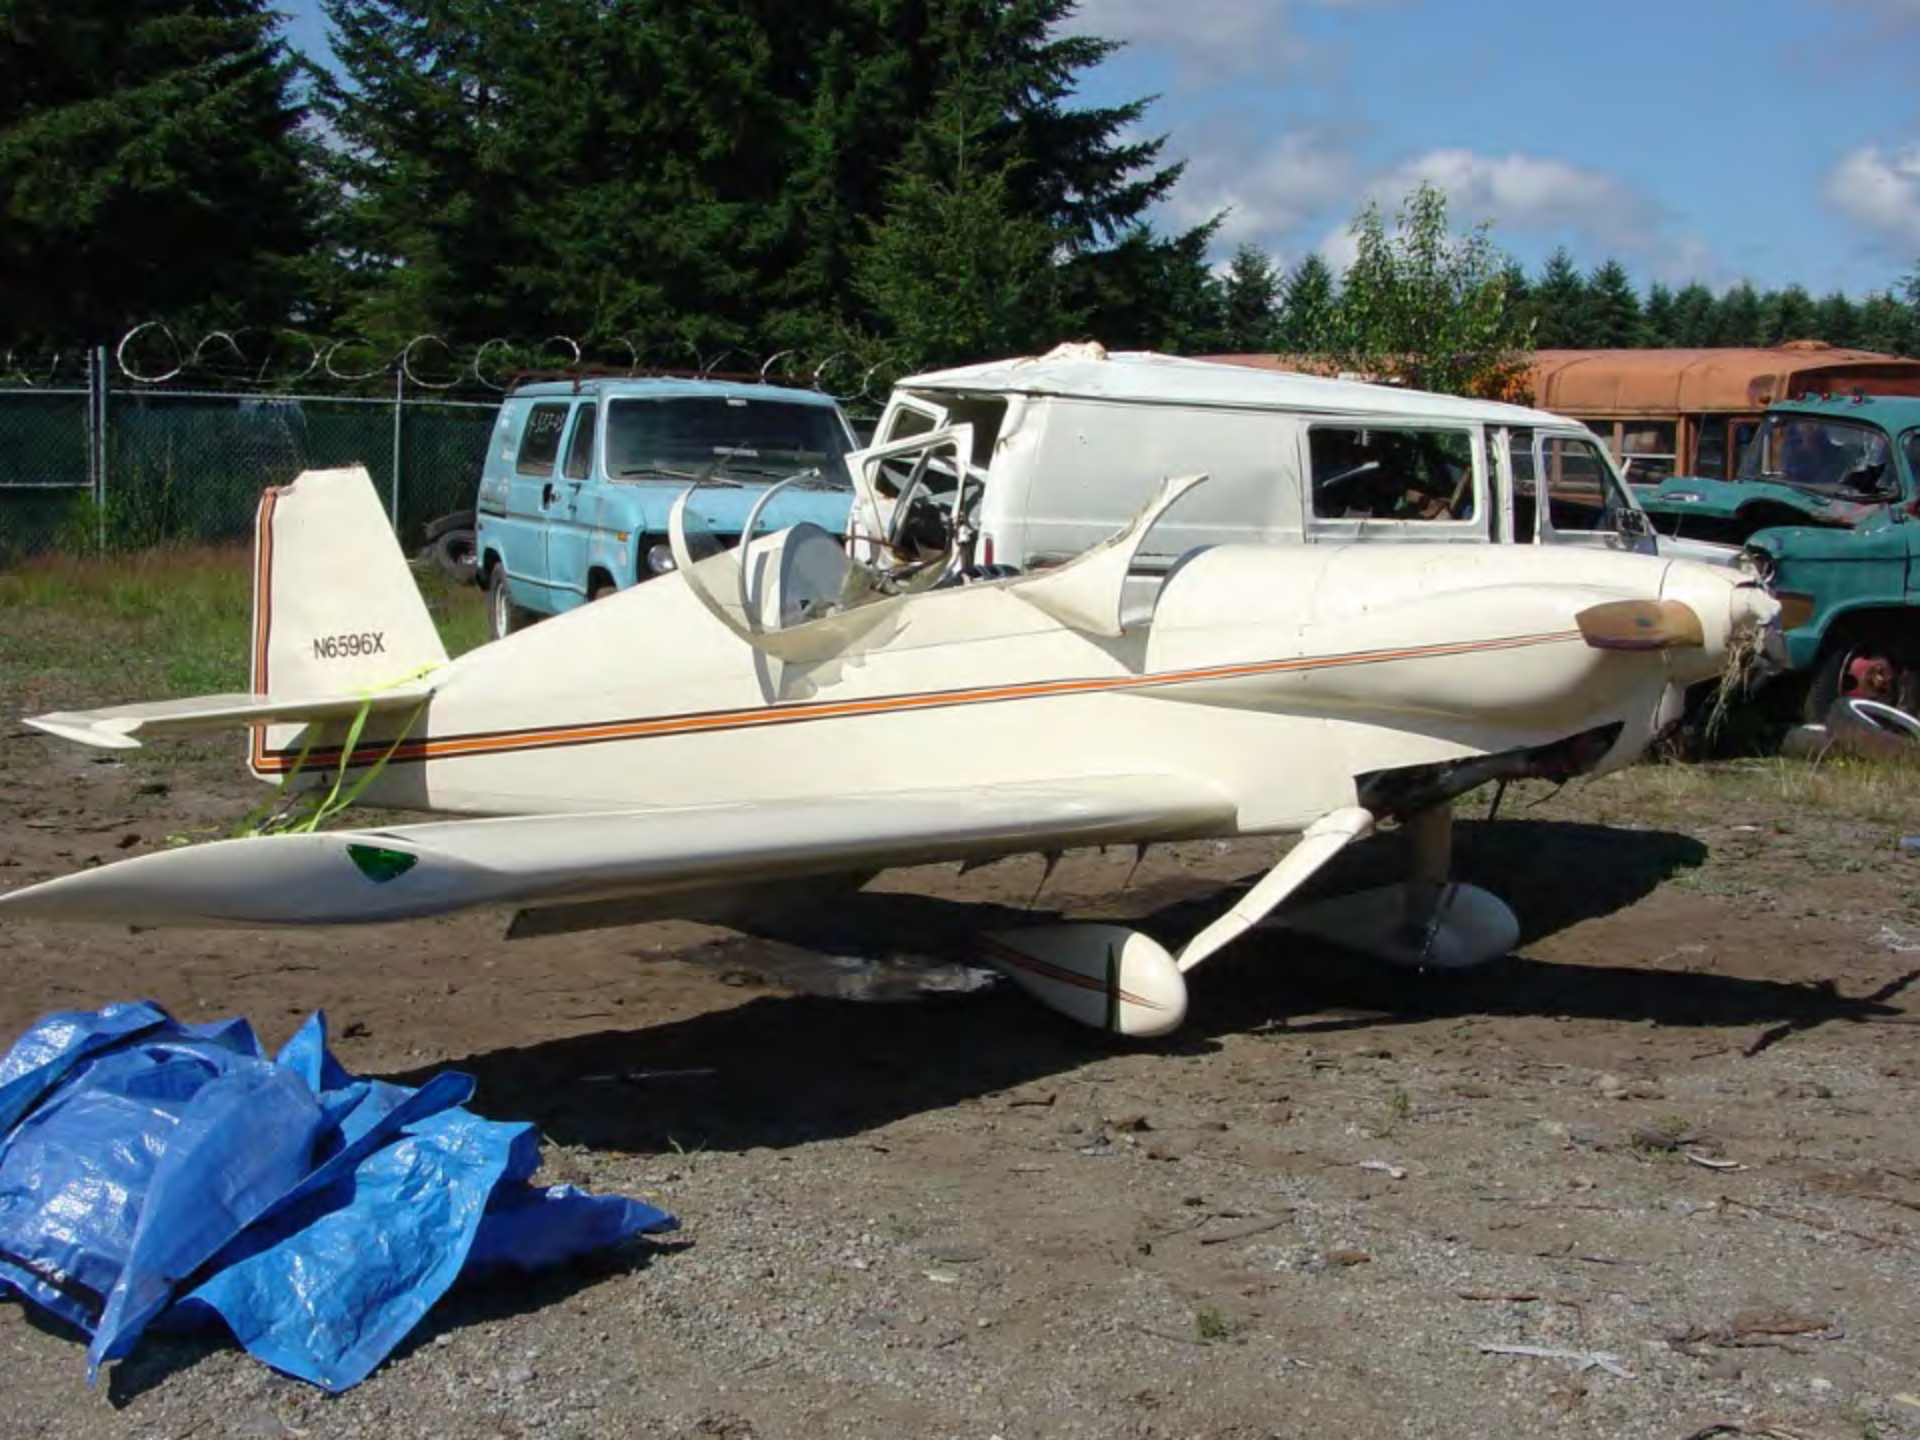
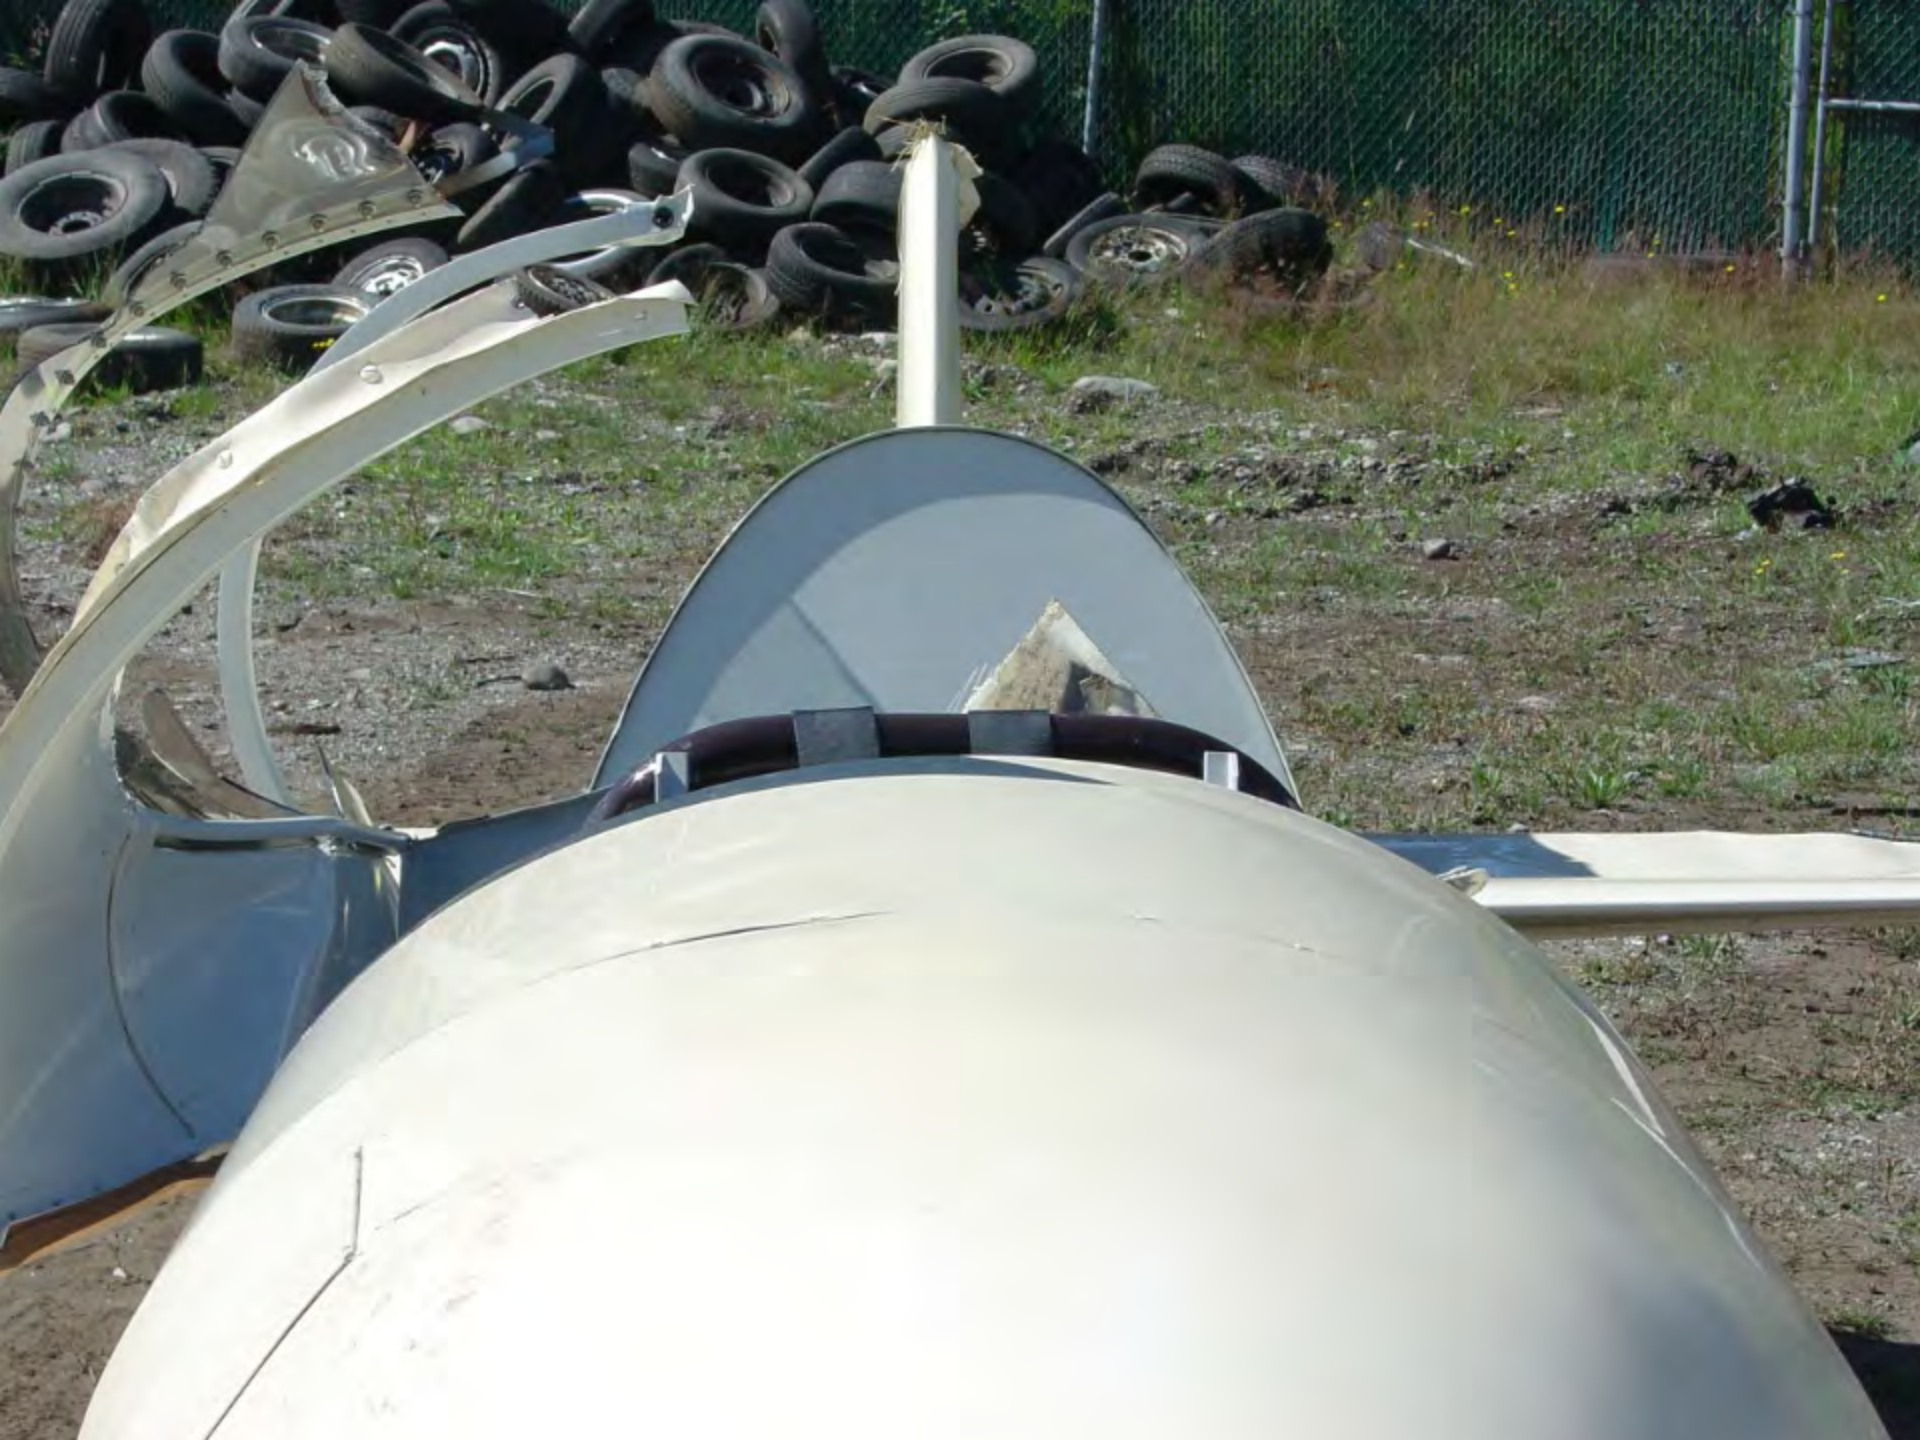
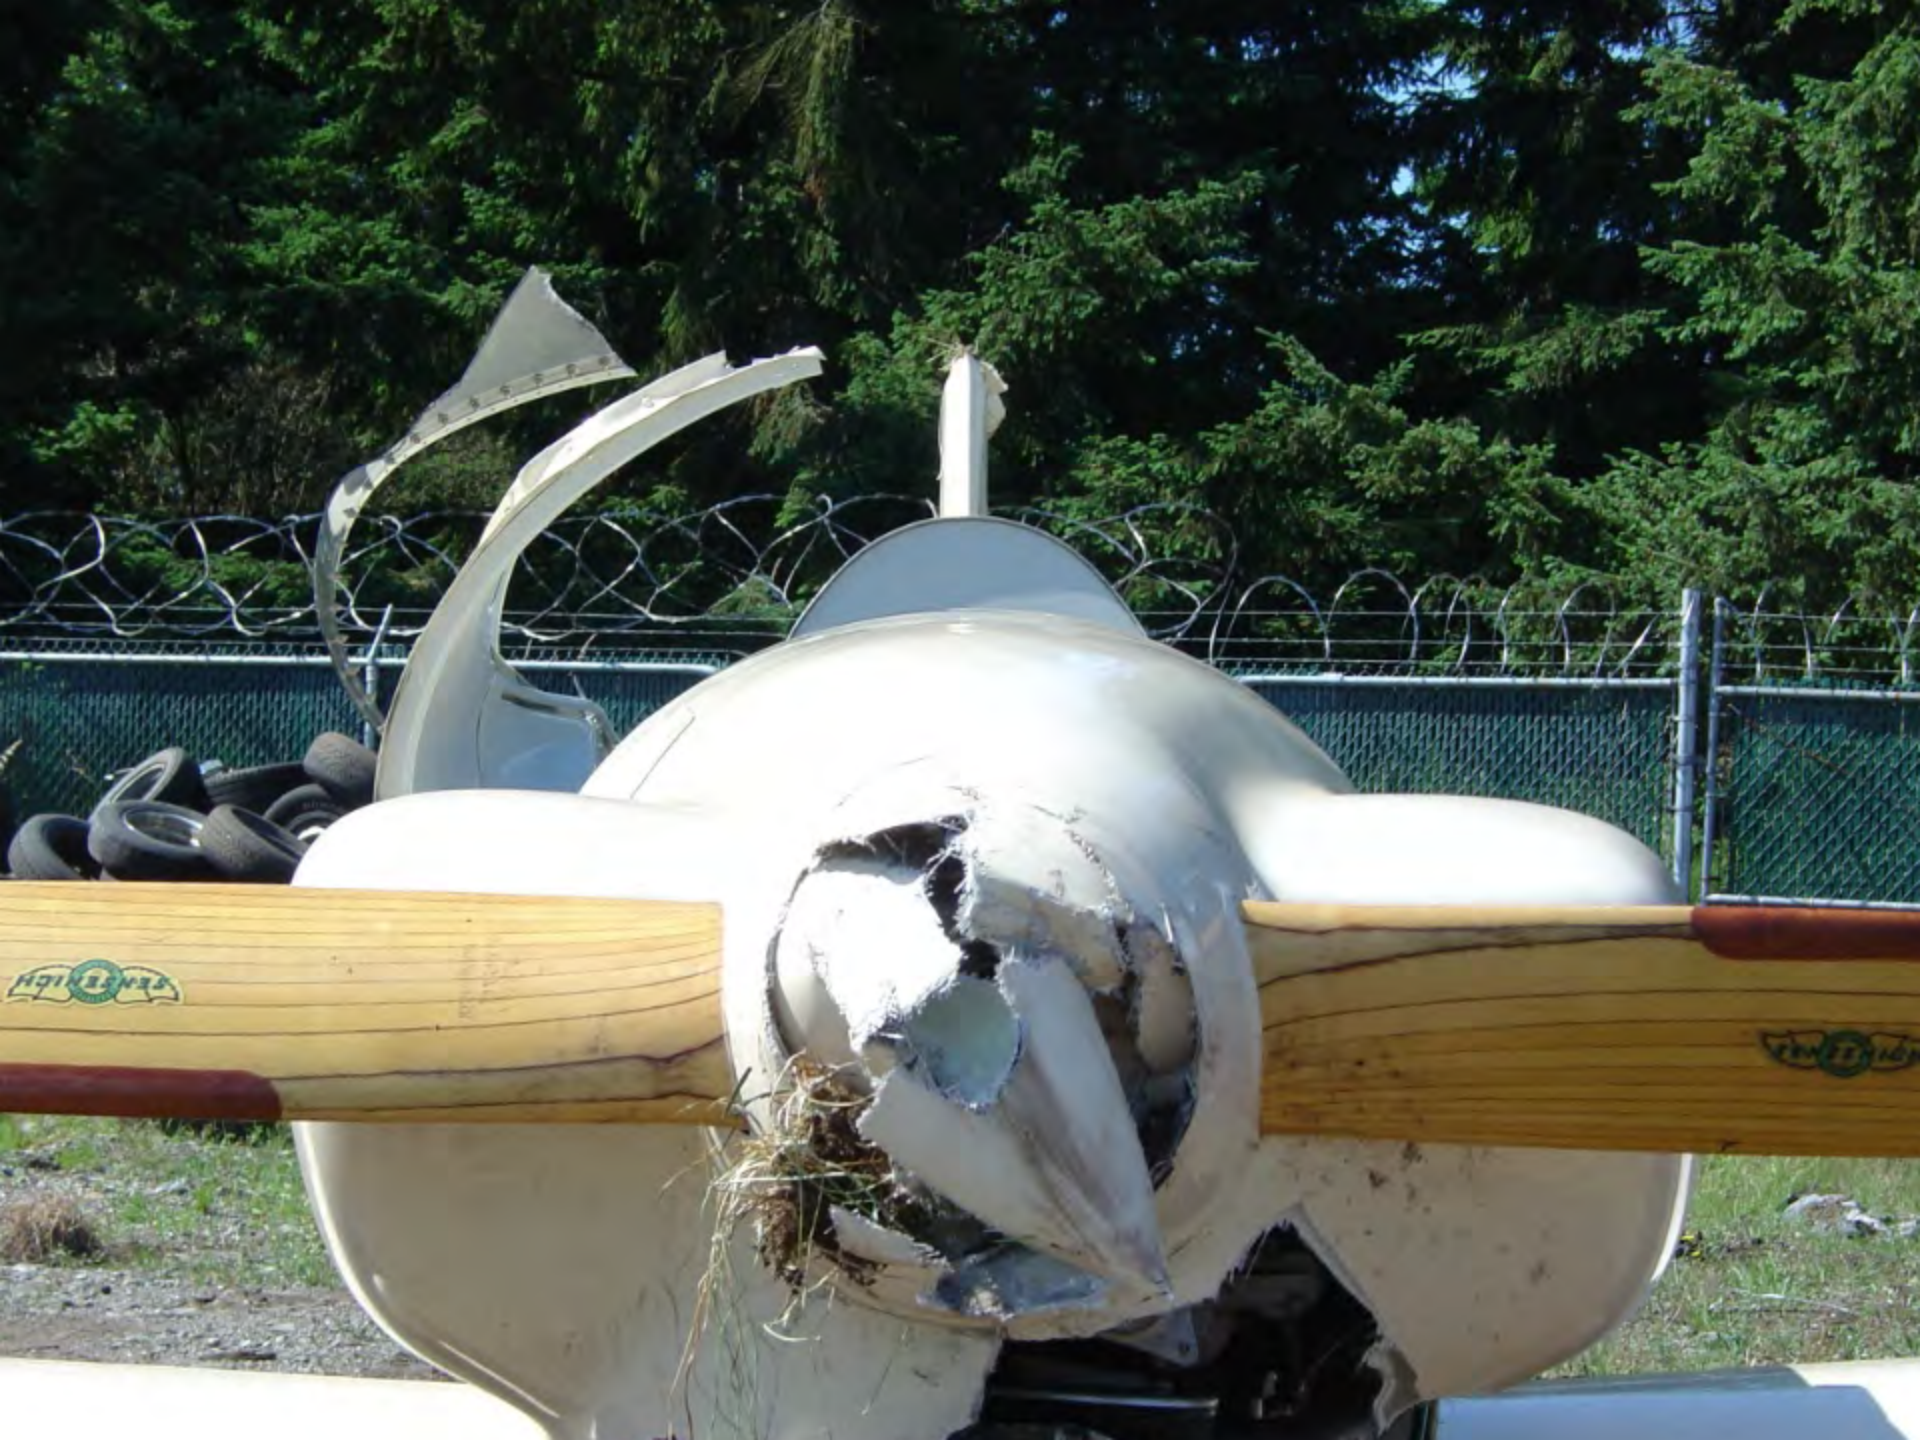
N6596X

- March, 2004
- Vail, Washington
- Van's RV-4
- 1 fatal
- Complete loss of engine power
- Nose over during forced landing

- A loss of engine power due to the pilot's inadequate in-flight decision by failing to refuel while en route, resulting in fuel exhaustion. Contributing factors were the non-operating (vandalized) runway lights, the pilot's delayed departure to his destination, dusk light conditions, rough/uneven terrain and high vegetation.

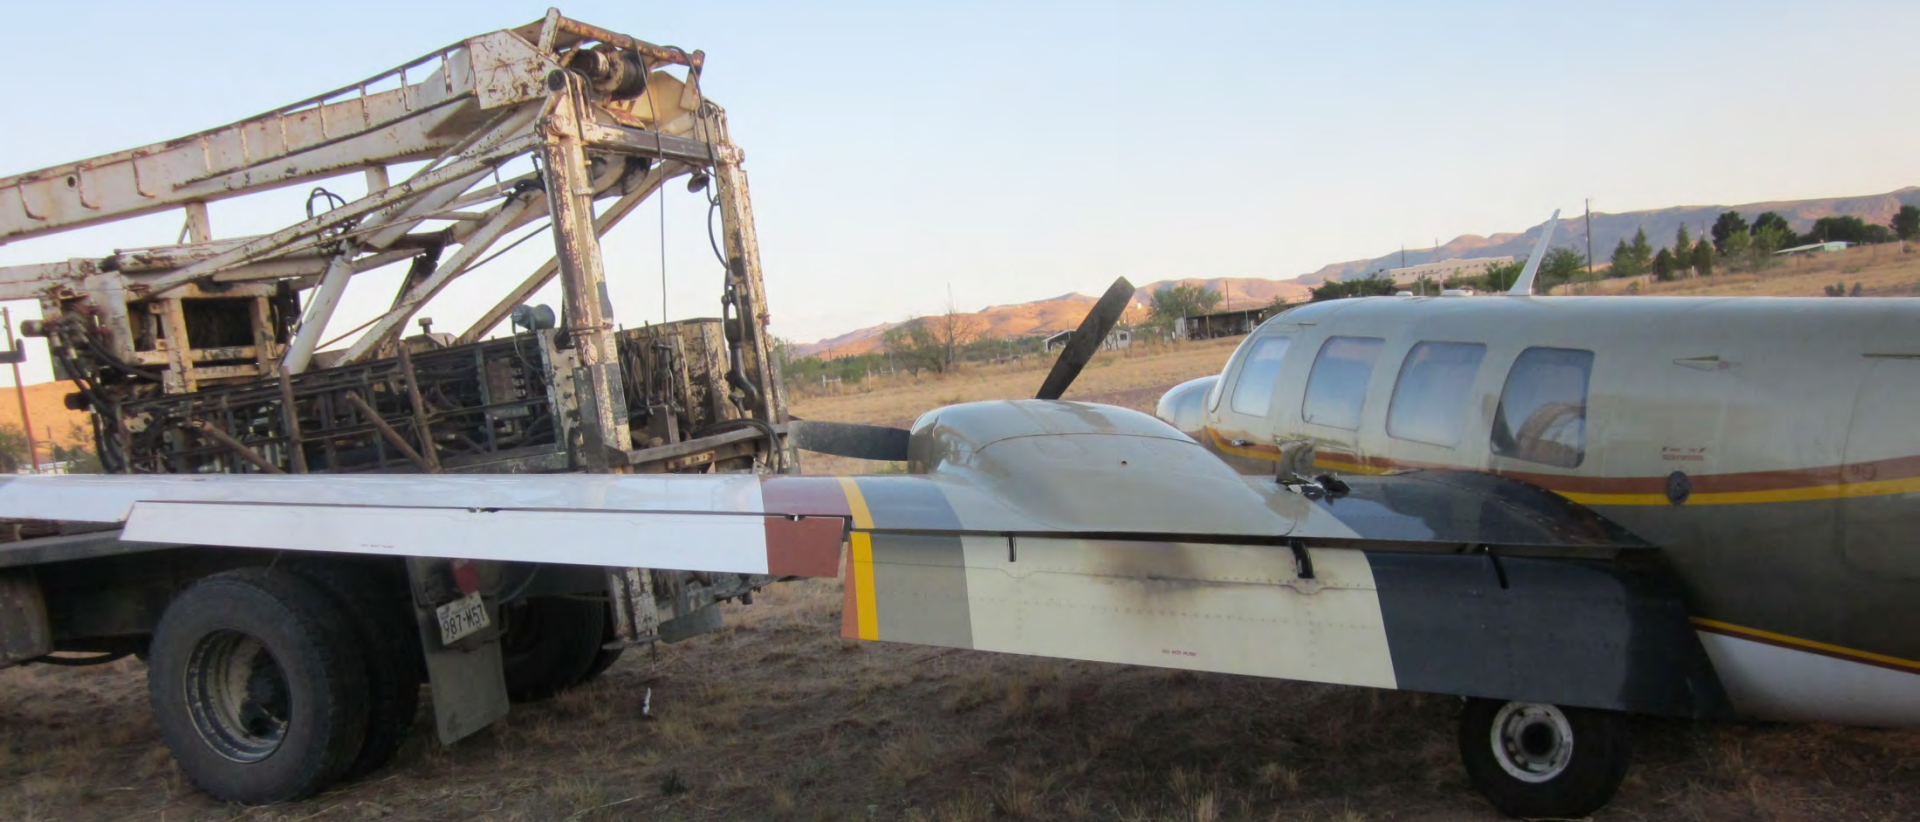
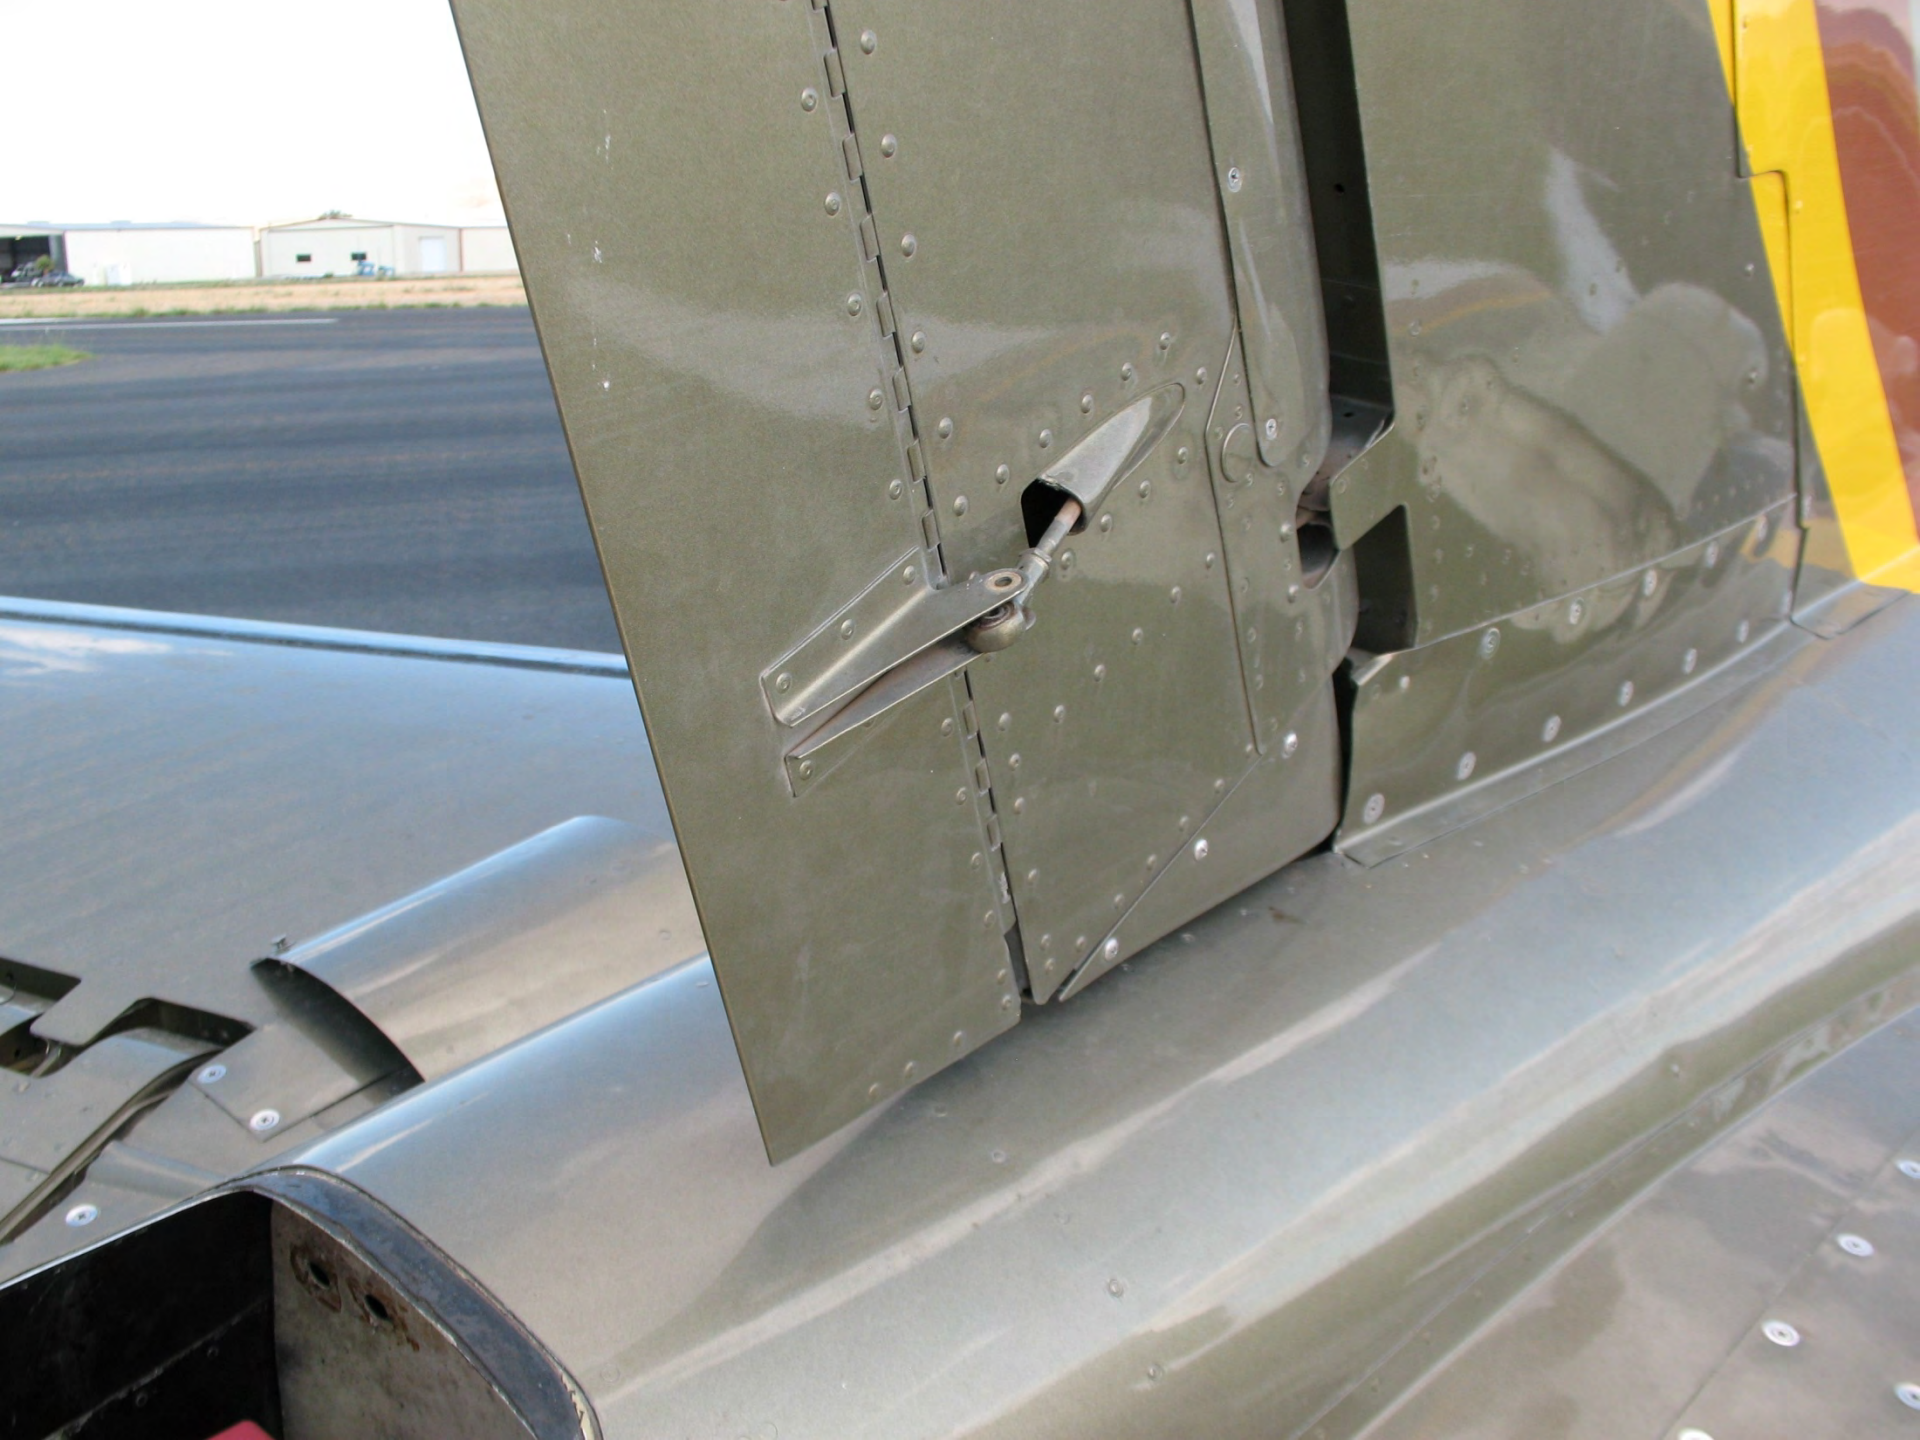
08/22/2011

- August 2011,
- Alpine, Texas
- Piper Aerostar
- Emergency landing due to a vibration in the tail

- The pilot's improper flare which resulted in a hard landing.  
Contributing to the accident was the pilot's improper decision to fly the airplane with a known mechanical deficiency
