**National  
Transportation  
Safety Board**

# Accident Case Studies

Tim LeBaron, IIC / US Acc Rep  
Washington, DC

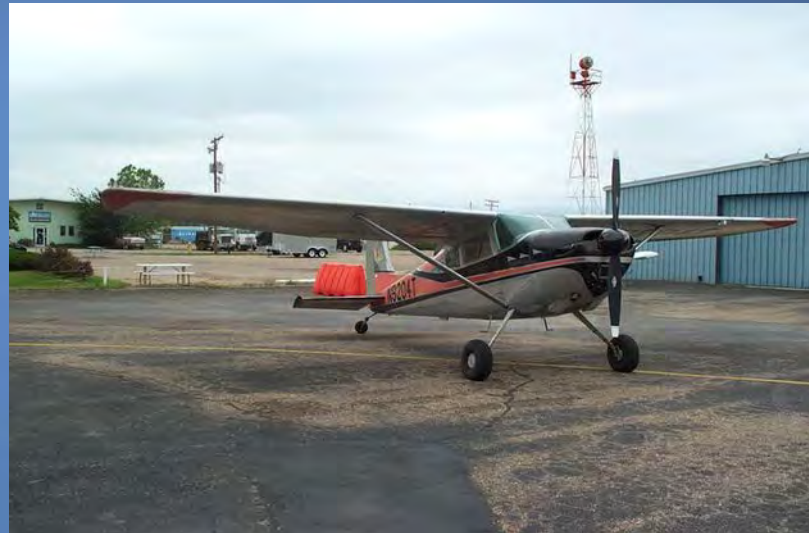
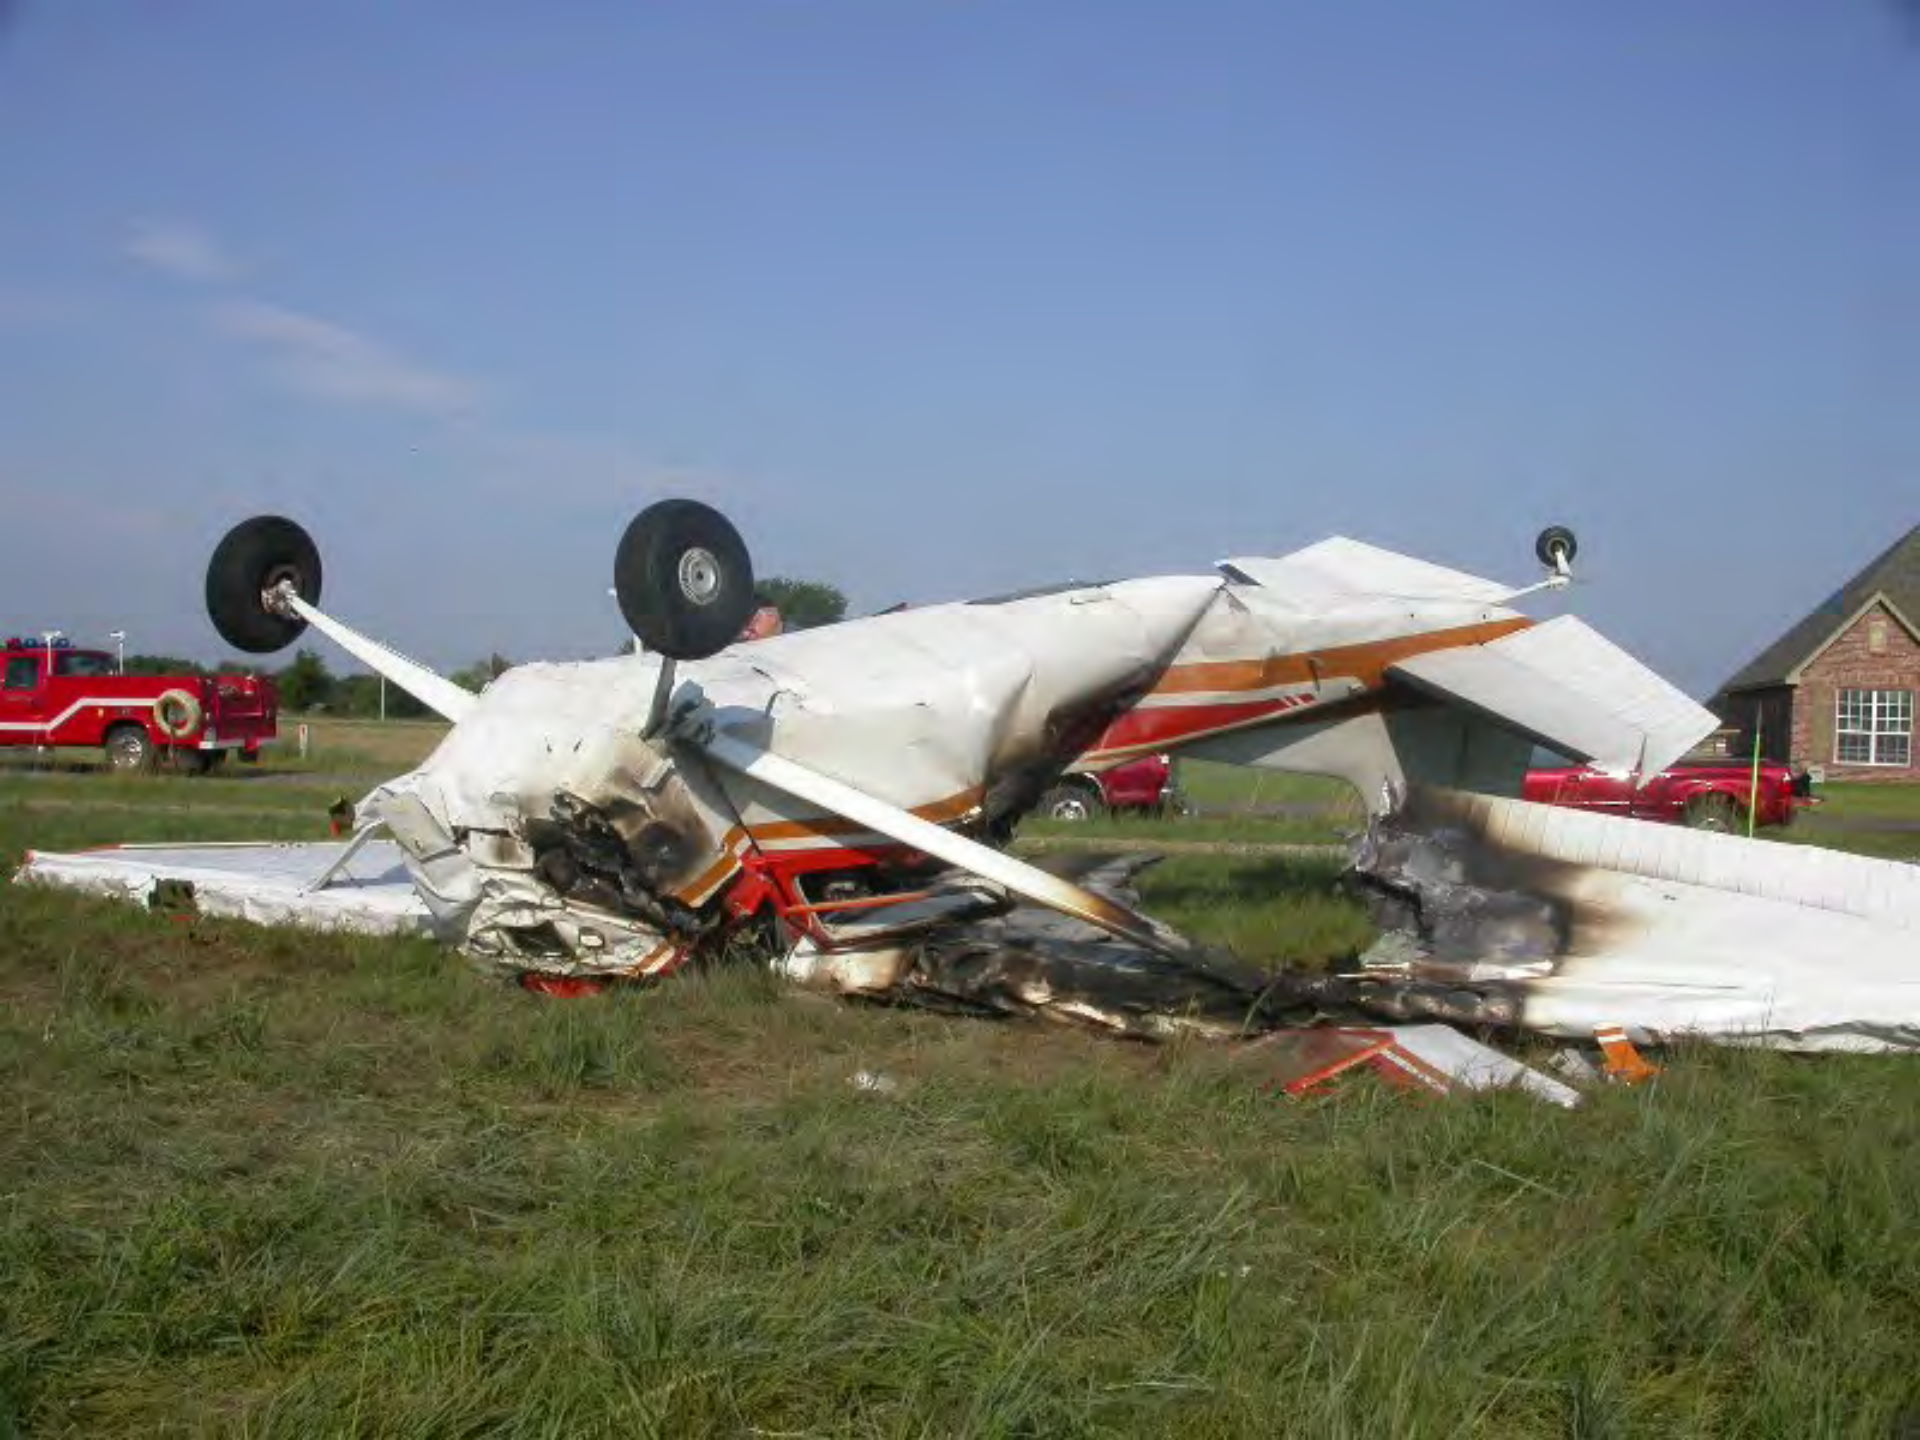
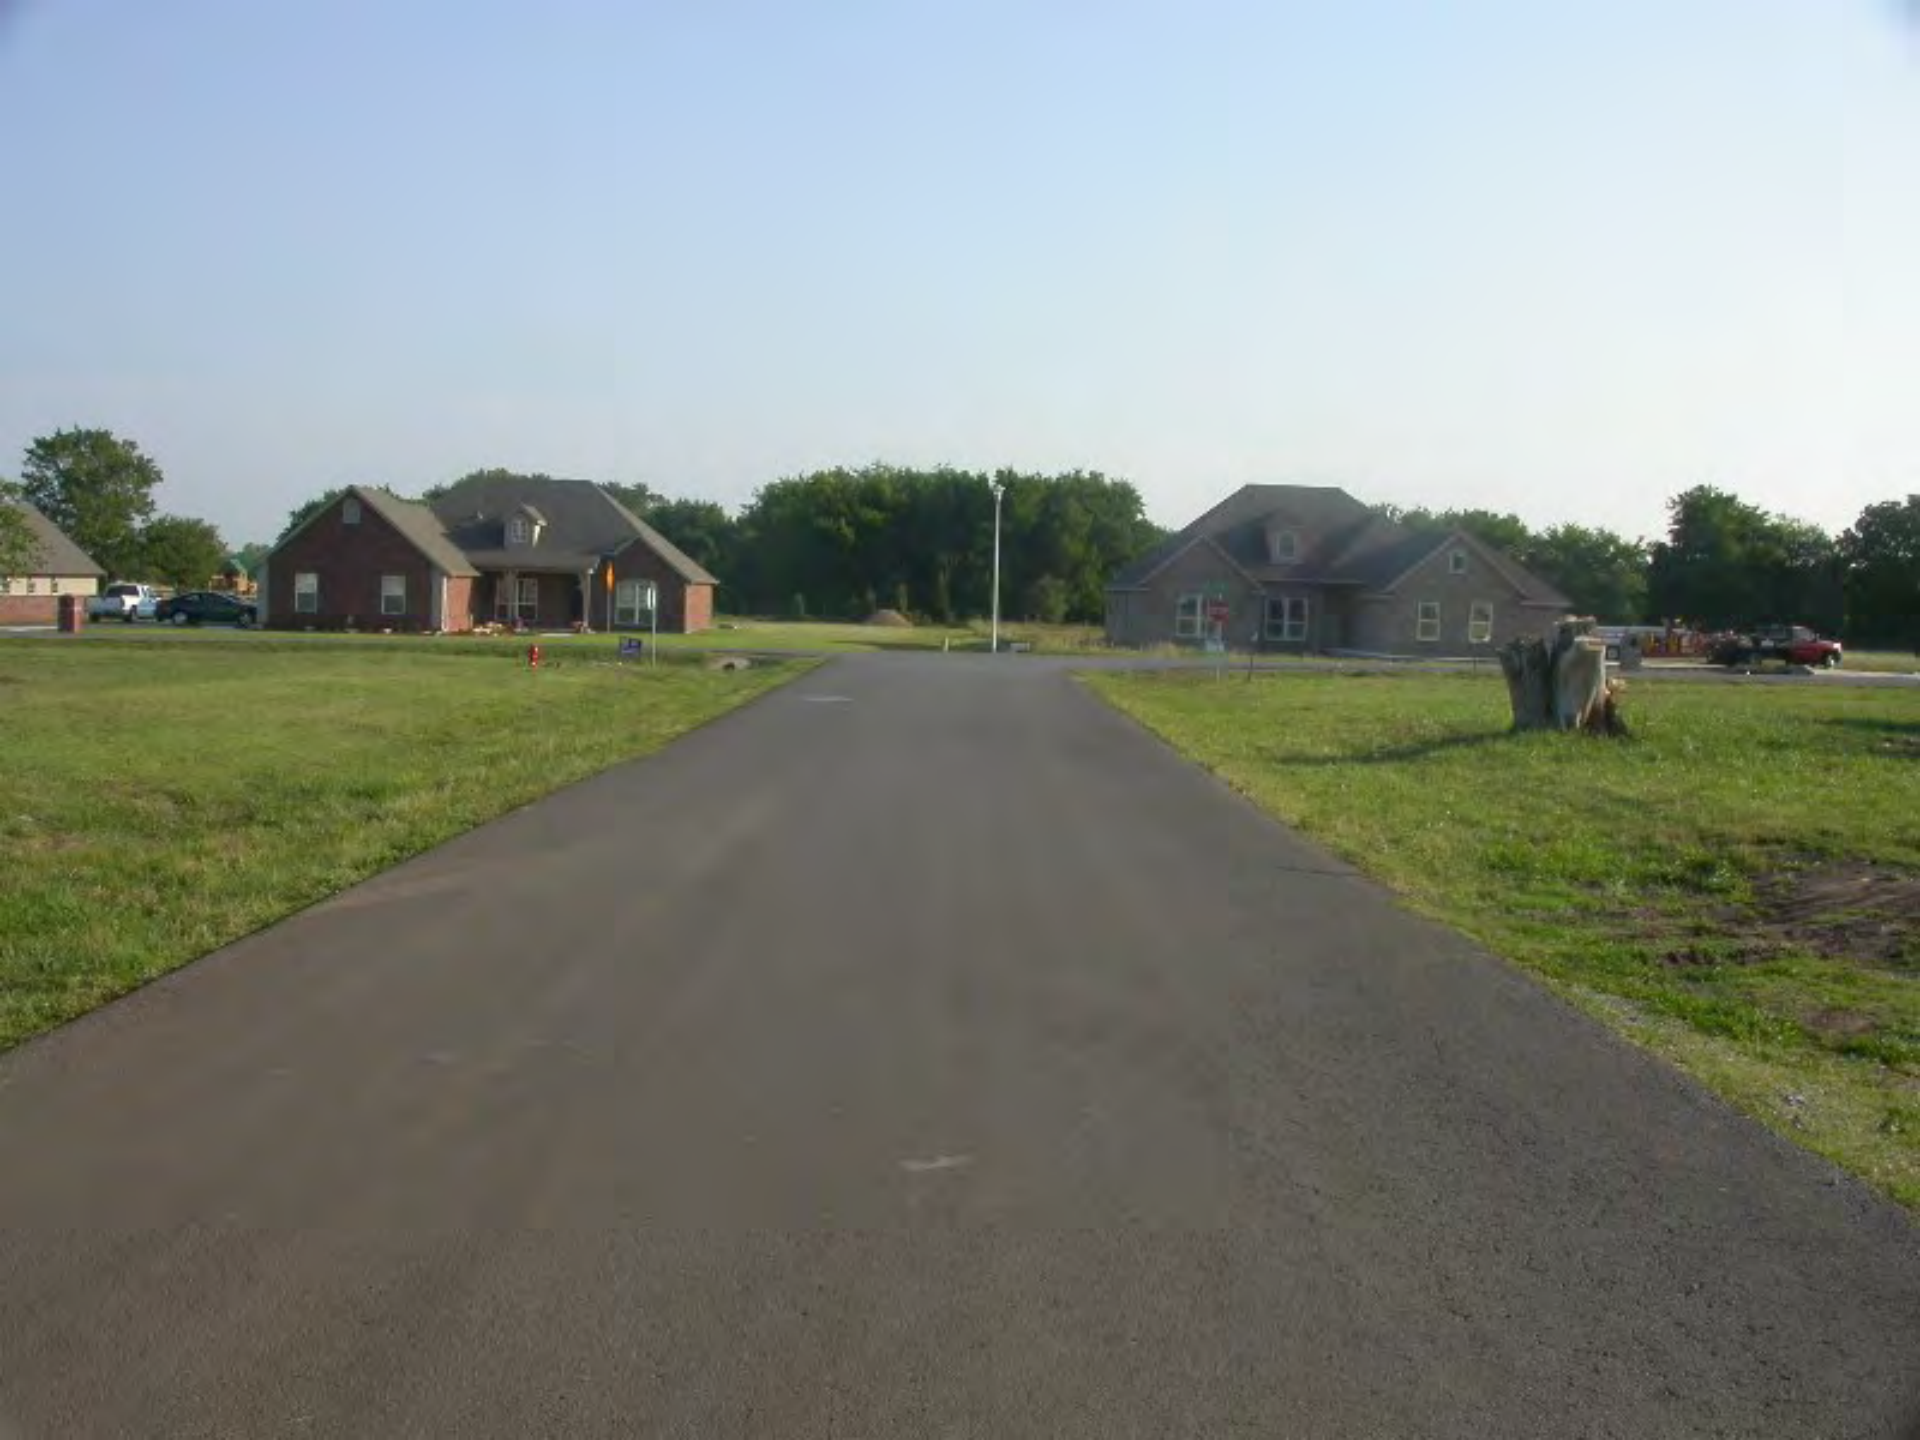
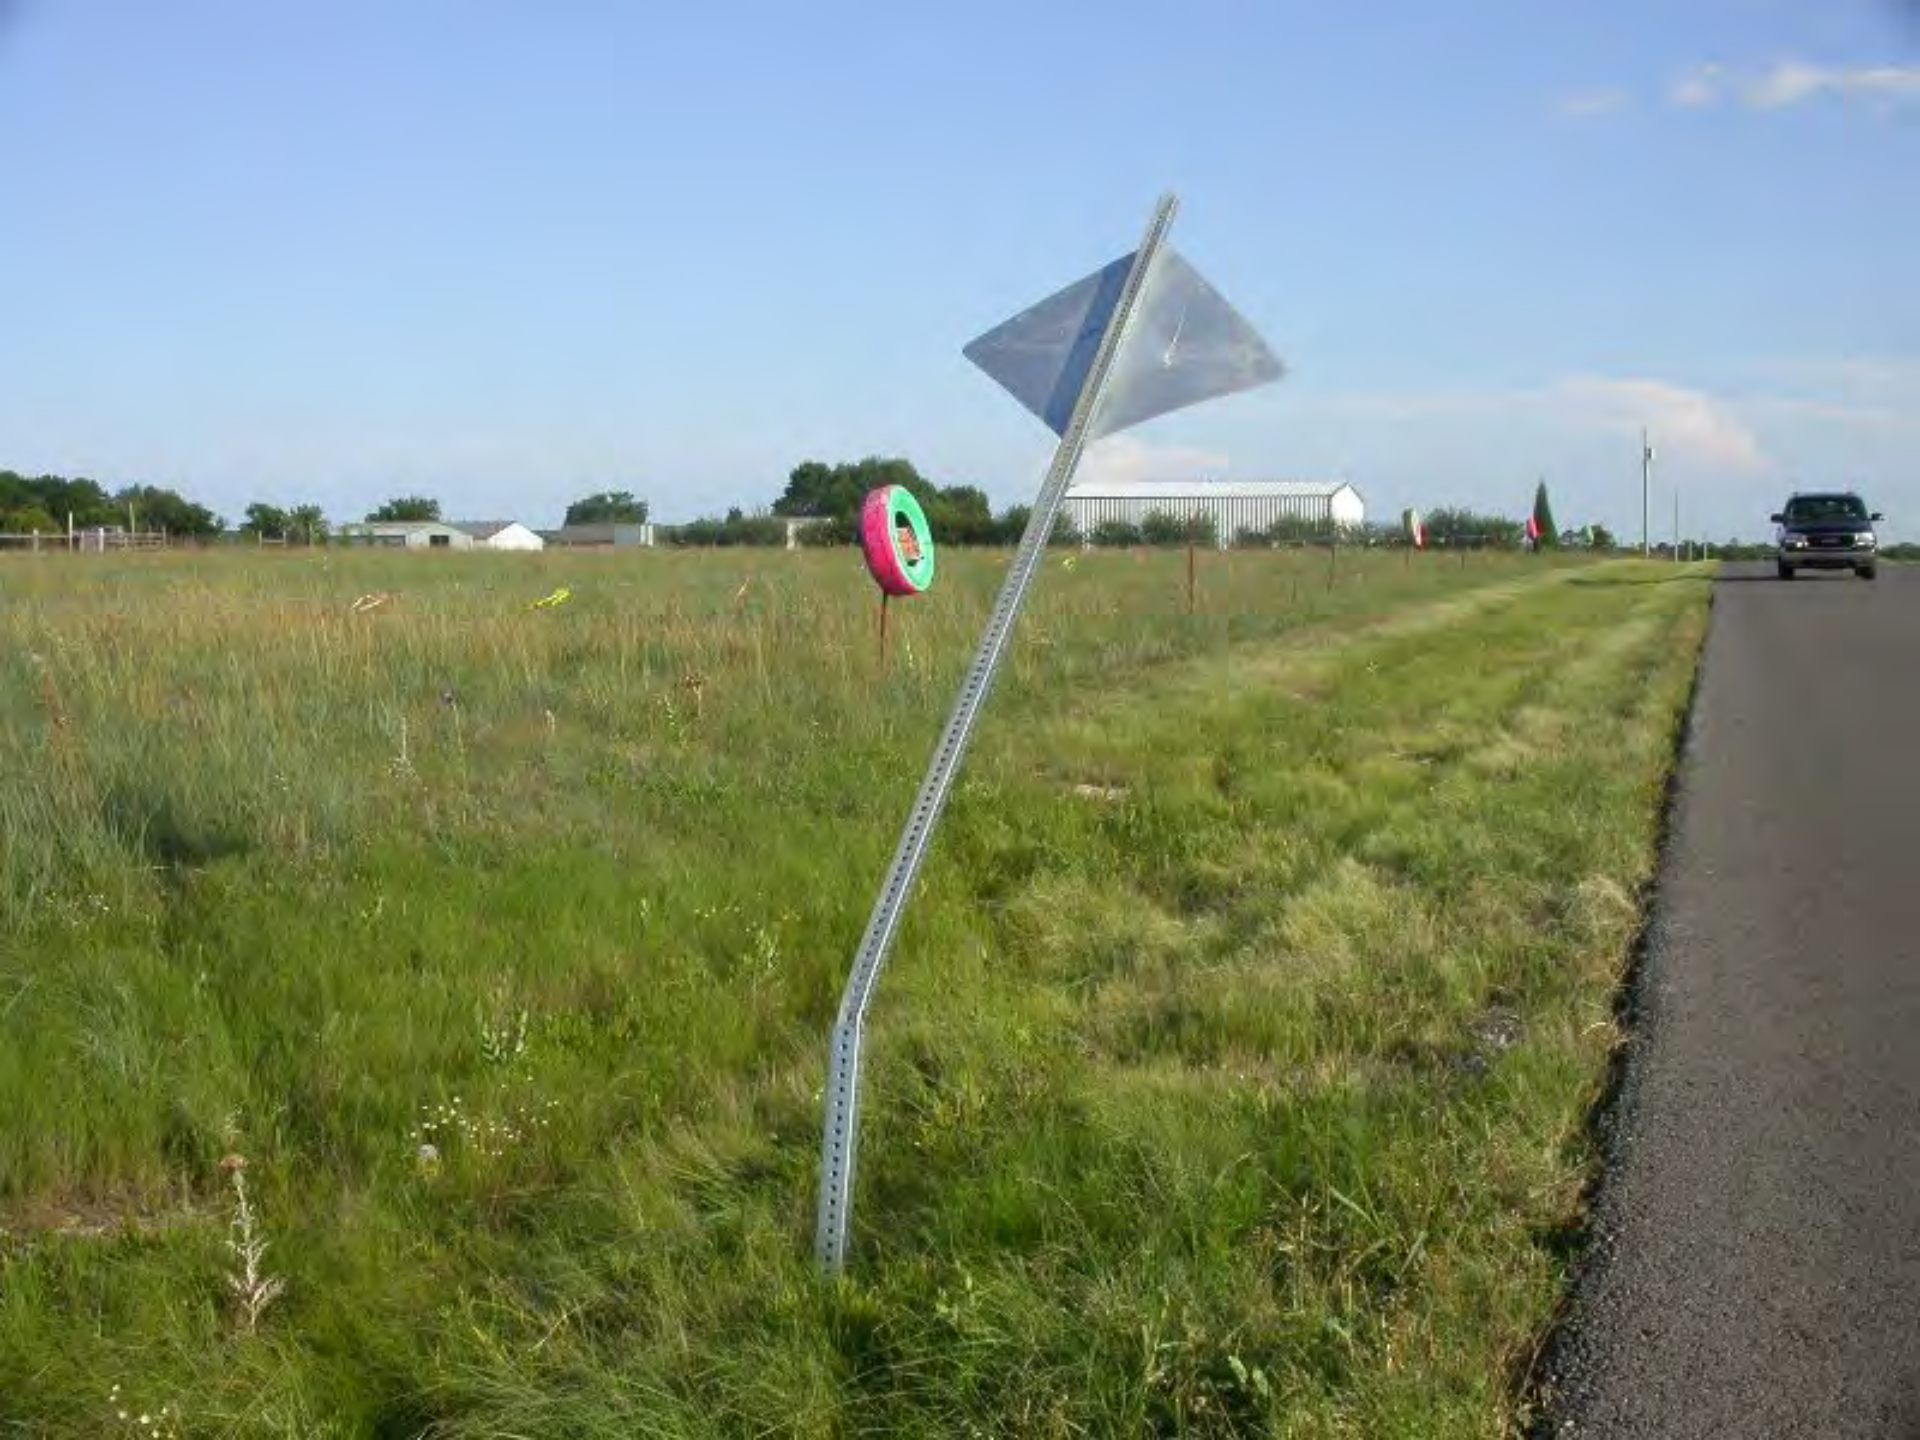
- July 2006
- Owasso, OK
- Cessna 180
- 1 fatal
- 1 serious

- The pilot's selection of unsuitable terrain, a residential street, for both takeoff and landing, which resulted in a collision with a static wire and terrain during takeoff-initial climb

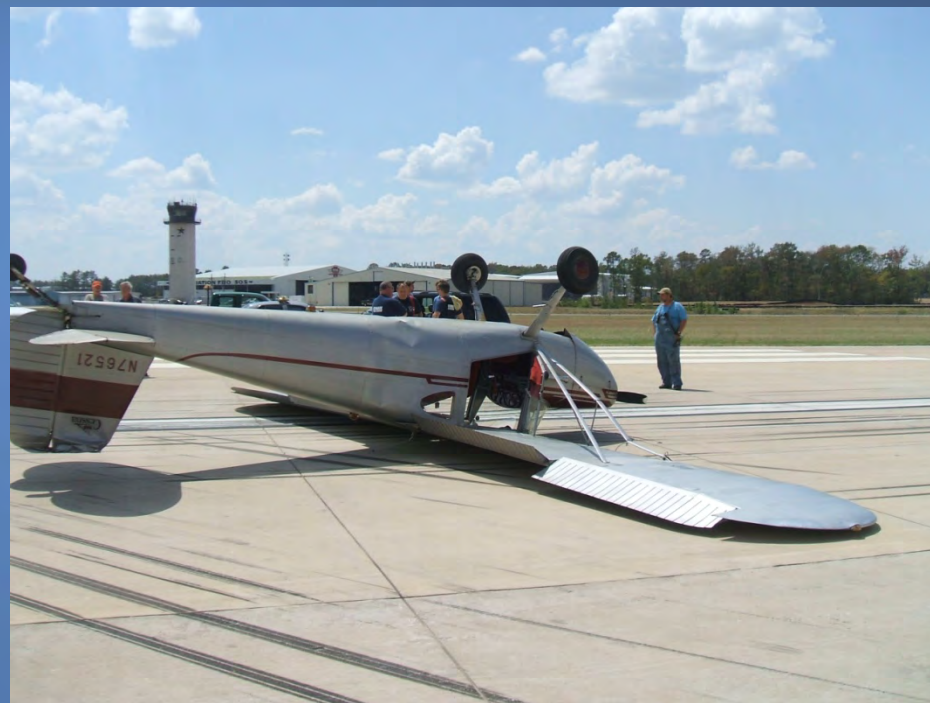
- Landing rollout
- Hard braking
- Airplane nosed over
- Substantial damage
- No injuries
- Known circumstances with little no safety payback

- The pilot's excessive use of brakes during the landing
