**The 2nd Meeting of the Future Air Navigation Systems Interoperability
Team-Asia (FIT-Asia/2)**

Agenda Item 4: Data Link Guidance Material

REPORTING BACK ON ROUTE

This paper provides an overview of the procedures associated with reporting back on route by CPDLC following a weather deviation.

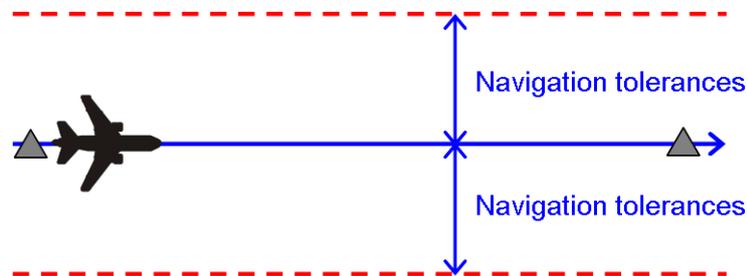
2.1 Outside the range of radar/ADS-B, controllers procedurally separate aircraft by applying navigational tolerances to the route of flight of an aircraft. These tolerances may vary depending on the airspace and the navigation approvals of the aircraft being separated.

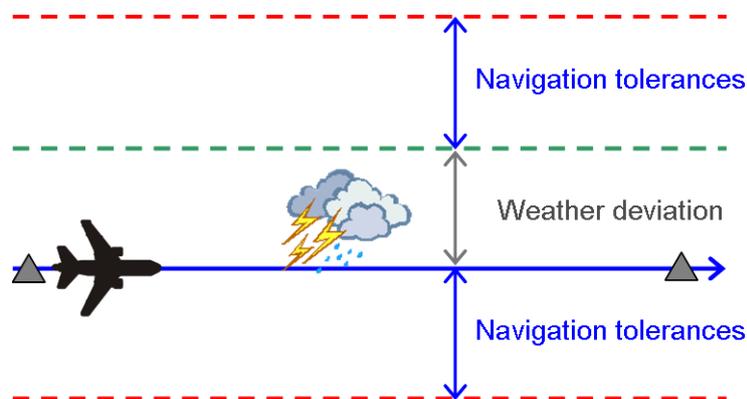
2.2 When a weather deviation clearance is issued to an aircraft, the controller must add the size of the requested weather deviation to the appropriate navigational tolerances:

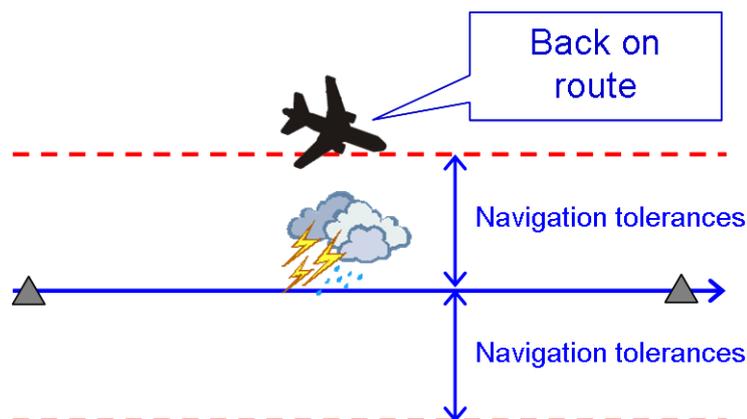
2.3 When the aircraft reports back on route, the controller releases the additional tolerances associated with the weather deviation. If the aircraft is still off track when it reports back on route, this will result in inappropriate tolerances being applied by the controller. In fact it may even result in the aircraft being outside the separation tolerances that are being applied.
