*ICAO Safety Management  
Systems (SMS) Course  
Handout N° 4 – Accident  
Boeing 747-412 – Taipei  
International Airport*

## SAFETY MANAGEMENT SYSTEMS (SMS) COURSE

### *Exercise 05/01 – Accident Boeing 747-412 –Taipei International Airport*

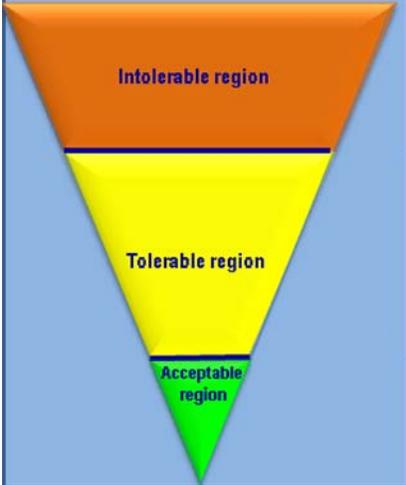
Risk management	Assessment risk index	Suggested criteria

<p>Intolerable region</p>	<p><b>5A, 5B, 5C, 4A, 4B, 3A</b></p>	<p><b>Unacceptable under the existing circumstances</b></p>
<p>Tolerable region</p>	<p><b>5D, 5E, 4C, 4D, 4E, 3B, 3C, 3D, 2A, 2B, 2C</b></p>	<p><b>Acceptable based on risk mitigation. It might require management decision</b></p>
<p>Acceptable region</p>	<p><b>3E, 2D, 2E, 1A, 1B, 1C, 1D, 1E</b></p>	<p><b>Acceptable</b></p>
